Failure Analysis of a Failed Anchor Chain Link

(Accepted for publication in Engineering Failure Analysis, 4 March 2018)

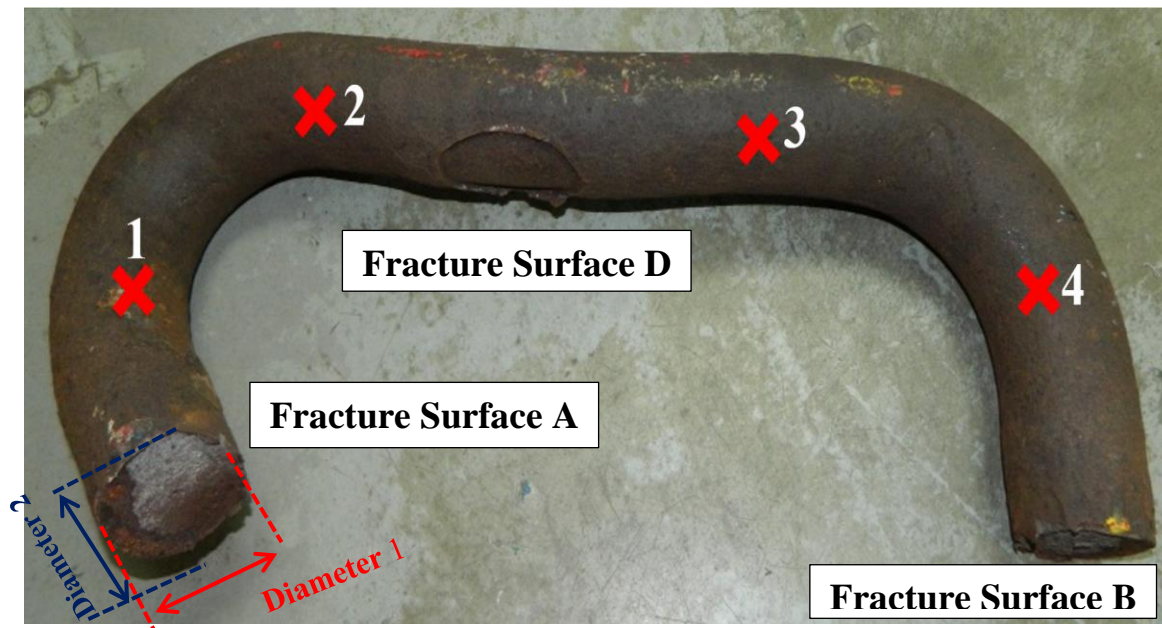
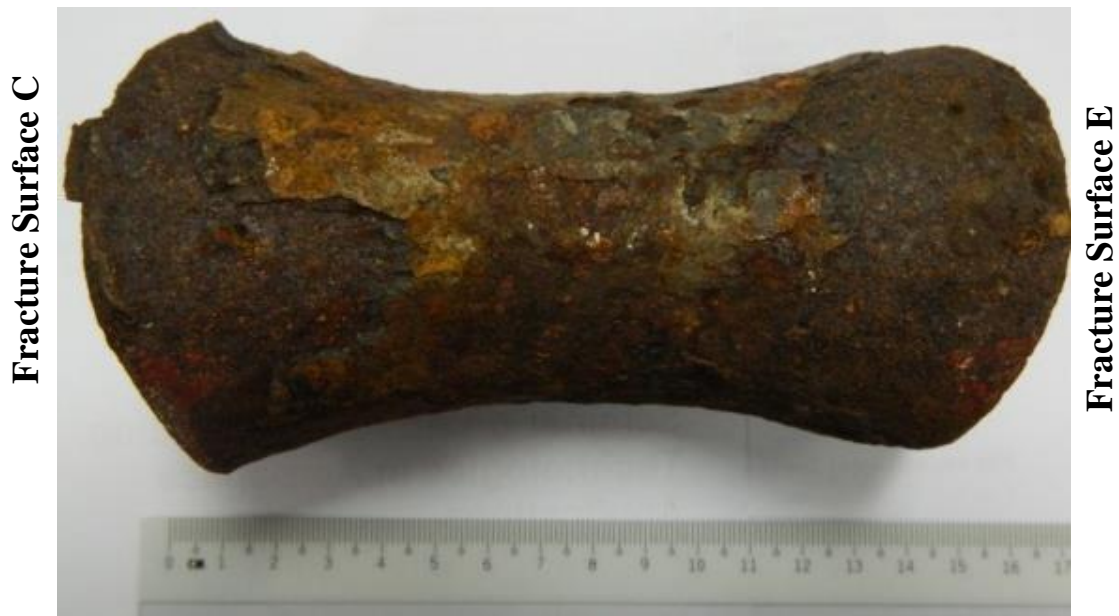
One set of the failed anchor chain link and the associated stud, hereafter referred to as the ‘sample’, is shown in Fig 2b,c. Prior to the failure, the stud link would have been attached to the anchor chain link, at the mid length of the chain, via a fillet weld with one end of the stud welded over and across the flash butt weldment of the anchor chain link, as per the schematic shown in Fig 1. The effect of the interaction between the chain link flash butt weld and the chain link-stud weld on the failure of the chain link is explored in the current study.

Figure 2: (a) Schematic diagram of the failed anchor chain link showing the location of the fracture surfaces A, B, C, D, E and F, (b) the as-received failed anchor chain link and (c) the detached stud link. The locations of where the diameter is measured are indicated as Points 1, 2, 3 and 4.

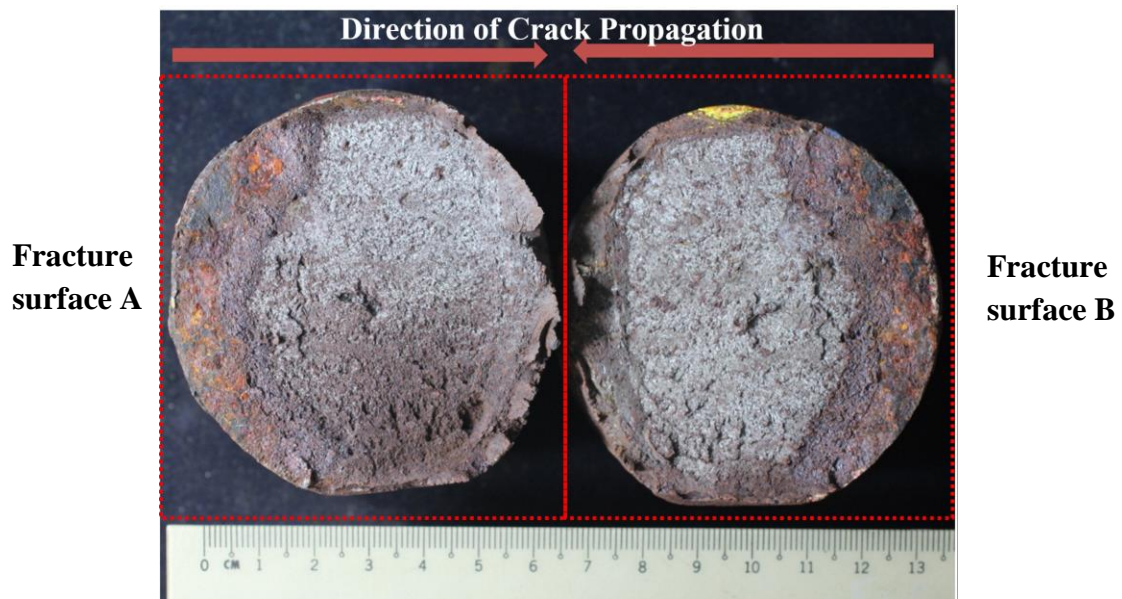
The occurrence of failure at the weld revealed the presence of pre-existing defect before the final failure and significant level of corrosion. Relatively fresh, shining mating fracture surfaces were found at the two fractured surfaces A and B at the ends of the anchor chain link (Fig 3a). In addition, two corroded mating fracture surfaces were found where the stud link was welded to the anchor chain link (Fig 3b,c).

Macroscopic examination was performed on the primary fracture surfaces of the sample using a low magnification stereo microscope to scrutinize the characteristics of the fracture. The two mating fracture surfaces A and B exhibited similar features in terms of characteristics, size, topography and colour intensity, see Fig. 3a, c. Both fracture surfaces had a mostly flat topography, except for a small crater in the middle of Fracture Surface A (Fig 4). The mating surface in the middle of fracture surface B was slightly popped out (Fig 3c). In addition, there were jagged shear lips found on the inner circumference of the fracture surface of the chain link directly beneath the contact surface with the stud (Fig. 3a, c).

Figure 3: The failure surfaces. (a) Mating fracture surfaces A and B on the chain link, (b) fracture surface D and (c) fracture surface F.

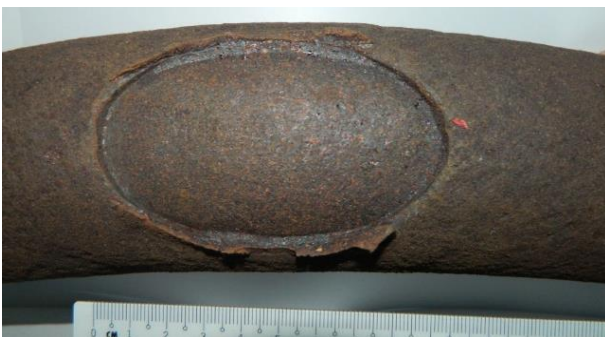
Scrutiny of the remnants of fillet weldment of the stud to the chain link revealed that the two mating fracture surfaces C and D formed one of the joints that connected the stud link to the anchor chain link at the other side of the chain flash weld. Fracture Surface D exhibited an oval shape located at the mid length and inner perimeter of the anchor chain (Fig 3b). The oval shape of fracture surface D on the inner surface of the chain link was surprisingly found to be bigger than the corresponding mating fracture surface C on the stud. This is indicative of failure of the stud link – chain link weld failure preceding plastic deformation at the inner perimeter of the anchor chain link. Both fracture surfaces and the area bounded by the fracture surfaces were severely corroded. Examination of the as-received photograph taken an hour after fracture revealed a silver fracture surface suggestive of a fresh fracture.

(b) Fracture surface D

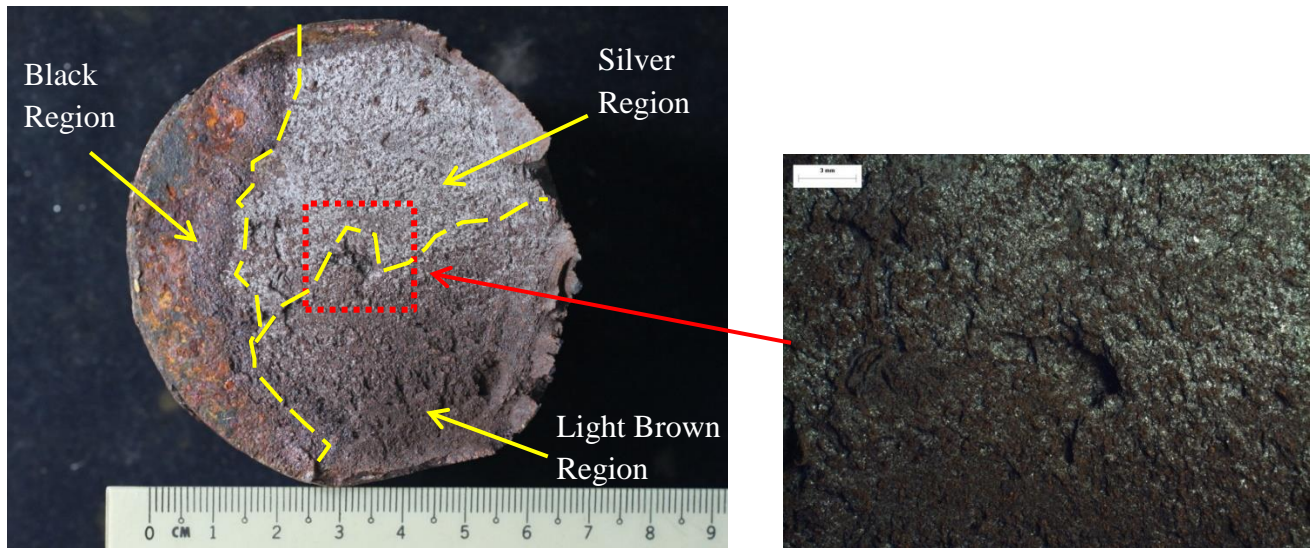
- (i) Black Region – approximately a quarter of the outermost facing part of the surface was covered by a black-coloured paint-like coating up to a radial depth of 15 mm (Fig. 3a and Fig. 4). Small amount of brownish-orange deposits, appearing to be rust, were present on the coating. This is indicative of a relatively deep edge crack that existed on the surface of the chain link prior to the final failure and had been painted over without the presence of the edge crack being noticed during any of the condition monitoring inspections. With a quarter of the fracture surface covered in this black-coloured paint, there would have been a significant reduction in the available net section surface area of the material to support the applied loads. This pre-existing defect is a possible origin of final fracture of the chain link. Microscopic examination described below was used to further assess the origin of this surface crack, e.g. if it was due to fatigue loading or not.

- (ii) Silver Region - the primary fracture surface was predominantly shining and silver-coloured at the centre of the surface; this is indicative of a fresh fracture (Fig 3a & Fig 4).
- (iii) Light Brown Region - there was a light brown colour region on fracture surface A but not on fracture surface B. A set of photographs of the failed chain were taken onsite about one hour after the fracture occurred. The failed chain was received for analysis two months after the incident, and another set of photographs were taken. A comparison of the two sets of photographs revealed that the light brown region present on fracture surface A was probably due to post-fracture corrosion that took place in the intervening time between the incident and the samples being made available for analysis.

Figure 4: The different colour intensities on fracture surface A and the centrally located crater

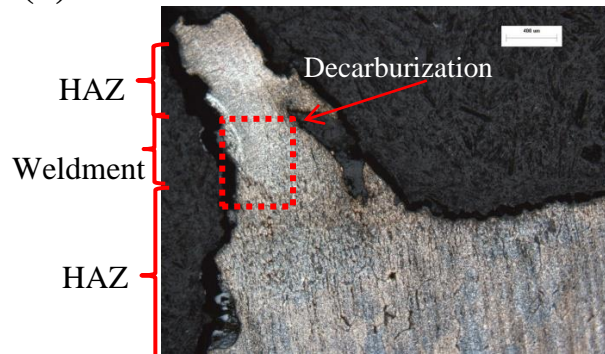
(c)

Microstructural examination of the base metal revealed a tempered martensitic microstructure (lighter etched phase) with longitudinal heavily banded lines (darker etched phase) of carbides (Fig 5). The bandings were particularly segregated near the centre of the chain link. Sulphide-type stringers were also observed in the longitudinal direction. The cross-section of the fracture surface was relatively flat, except for the crater in the middle and a shear lip on the inner edge of chain directly beneath the stud weld (Fig 5b). A thin strip of decarburized weldment (whiter etched phase) was found on the fracture surface, particularly at the inner and outer perimeter of the chain link (Fig 5c).

At the heat-affected zone (HAZ) near the inner and outer circumference, carbide segregation appear to be located at austenite grain boundaries (Fig 5c). At the crater (corresponding to the mid thickness crater on Fracture Surface A), fine secondary cracks appeared to propagate along the heavily segregated longitudinal banding lines (Fig 5d).

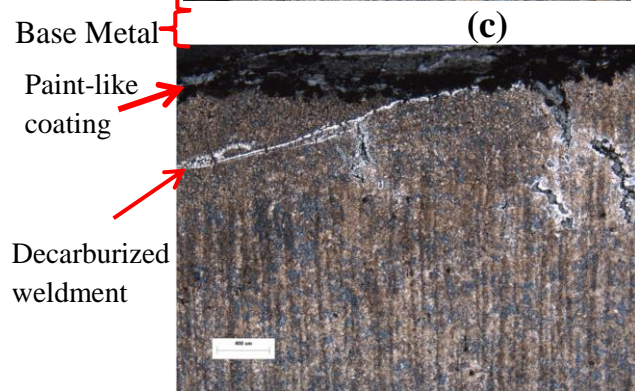
(e)

Scrutiny of the suspected fracture origin at the outer circumference (corresponding to the black region on Fracture Surface A) revealed a black colour paint-like coating without decarburization. Beneath the paint-like coating, multiple greyish crack-like inclusions with decarburized boundaries (whiter etched phase) appeared to have penetrated perpendicularly from the fracture surface (Fig. 5d). These crack-like inclusions are connected to the thin strip of decarburized weldment (Fig. 5e).

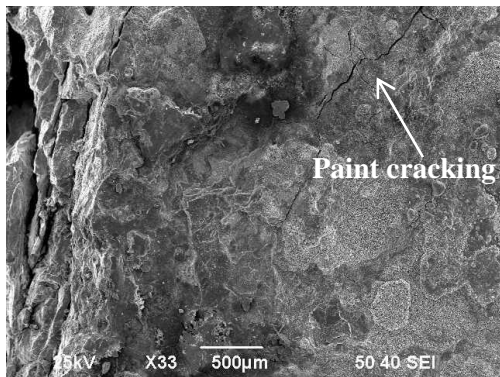
(b)

In particular, the three distinct regions of different colours observed during the macroscopic examination were also observed under SEM. At the black region (location 1 in Fig 6a), the paint-like coating covered nearly a quarter of the fracture surface, hindering the identification of any fracture features without having to remove the paint. We believe this section of the fracture surface is a pre-existing edge crack not noticed during any of the inspections and has been painted over. There were surface cracks on the paints (Fig 6b) which would have led to ingress of water and corrosion. This was further confirmed by the cleavage facets found at location 2 (see Fig 6a) amidst the corrosion deposits where the painting has been exposed (Fig. 6c).

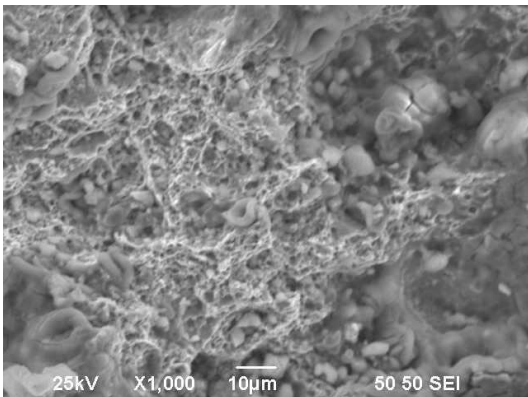
(d)

At the light brown region (location 3 in Fig 6a), a brittle fracture morphology similar to the silver region (location 4 in Fig 6a) was observed. However, corrosion deposits rendered most of the fracture features unidentifiable. Small shear dimples were observed on the shear lips at the circumference (Fig. 6d) while at the silver region (location 4 in Fig 6a), brittle cleavage facets were observed (Fig. 6e).

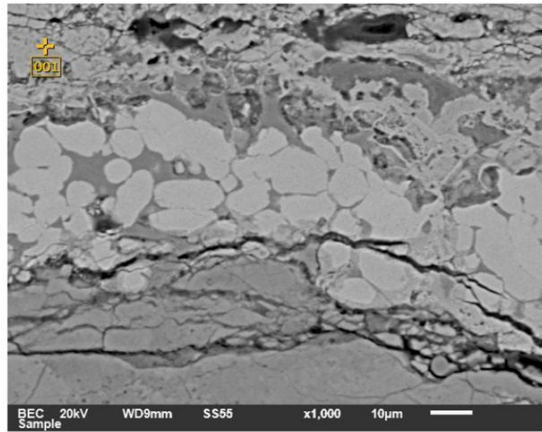
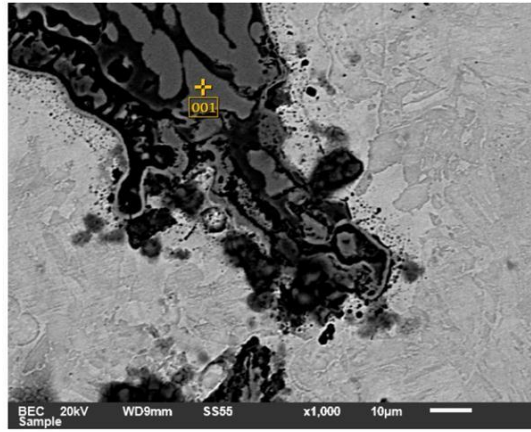
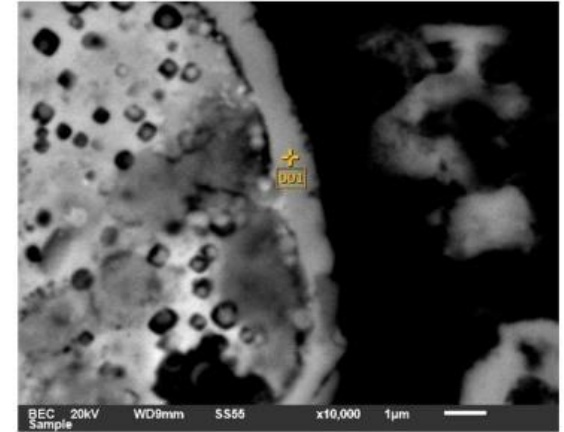
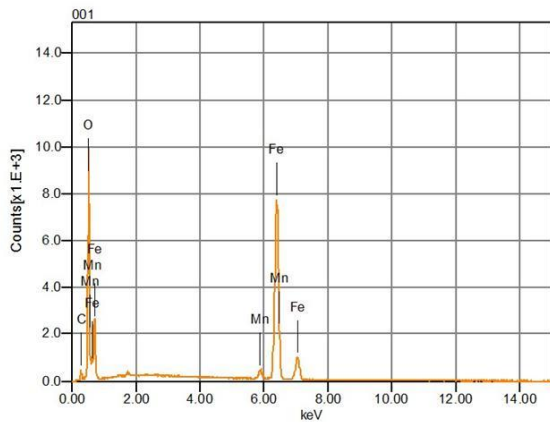
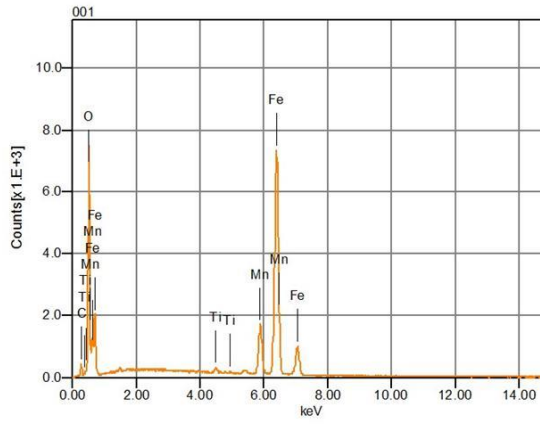
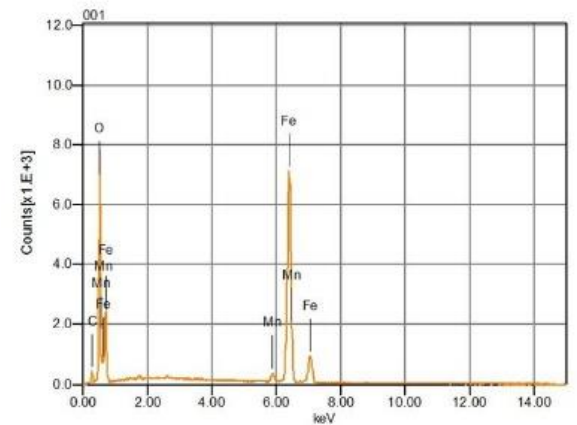
Figure 7: EDX analysis of different locations on fracture surface A

For the paint-like coating present at the black region of fracture surface A, a major presence (>10 mass%) of iron, oxygen and a minor presence (< 10 mass%) of carbon and manganese were detected (Fig 7a). We note that the element composition of the paint present on the outer circumference of the chain link (not shown) was similar to that found on the fracture surface; this further confirms that the pre-existing crack was not detected when the painting was carried out.

For the light grey nodules (i.e. the inclusions), a major presence (> 10 mass%) of iron, oxygen, manganese and a minor presence (< 10 mass%) of carbon and titanium was detected (Fig. 7b); while for the light grey boundary separating the inclusion and base metal, a major presence (>10 mass%) of iron, oxygen and a minor presence (< 10 mass%) of carbon and manganese were detected. The high amount of iron and oxygen content in the inclusions and paint-like coating suggest that they likely consisted of a high amount of corrosion deposits within it.
