47TH TURBOMACHINERY & 34TH PUMP SYMPOSIA
HOUSTON, TEXAS | SEPTEMBER 17-20, 2018
GEORGE R. BROWN CONVENTION CENTER

Gas Seal Failures Caused by Axial Vibrations

James Byrne – BRG Machinery Consulting
Patrick Potter – Cincinnati Gearing Systems
Jose Vazquez – BRG Machinery Consulting

This case study describes the root cause investigation of 12 dry gas seal failures in three integrally geared centrifugal compressors over a period of 12 years. These compressors are in fuel gas booster service, supplying a 500 MW gas turbine combined cycle power plant.

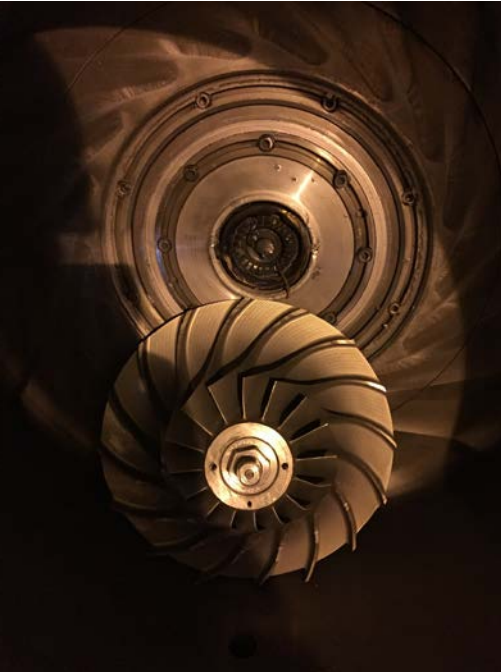
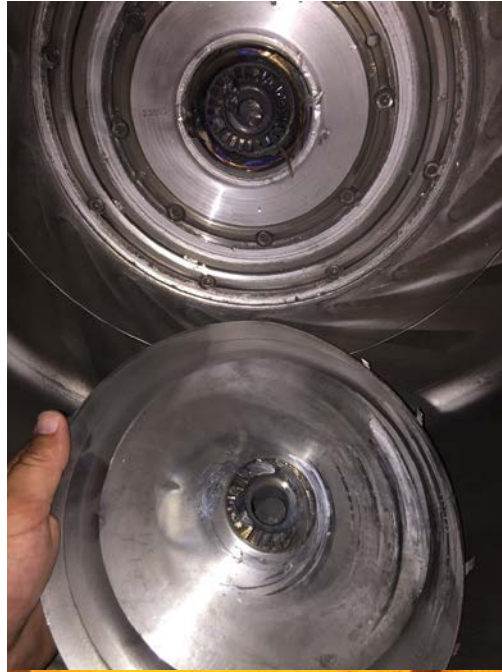
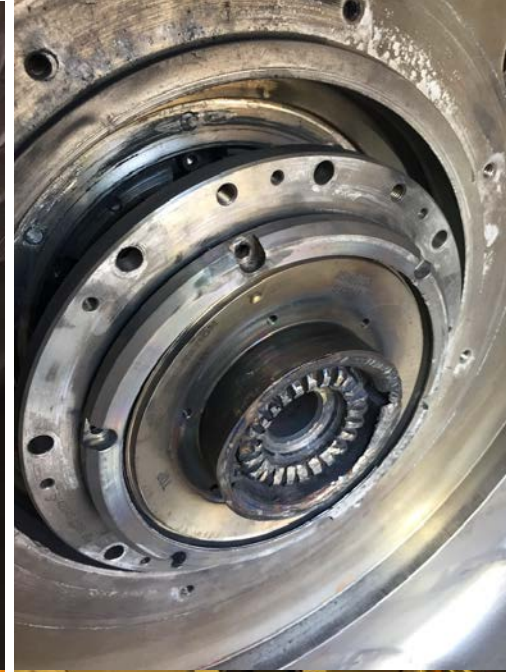
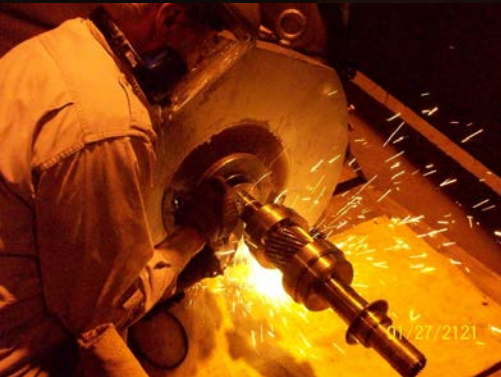
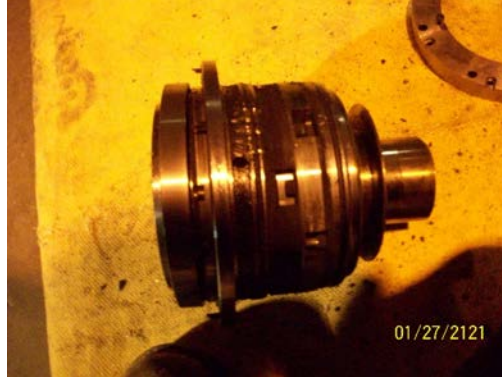
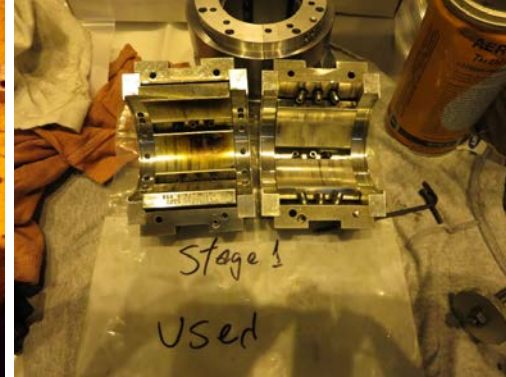
Failure pictures

Damaged parts include:
Impellers
Pinion
Bearings
Dry gas seals
Gear
Casing
Laby Seals

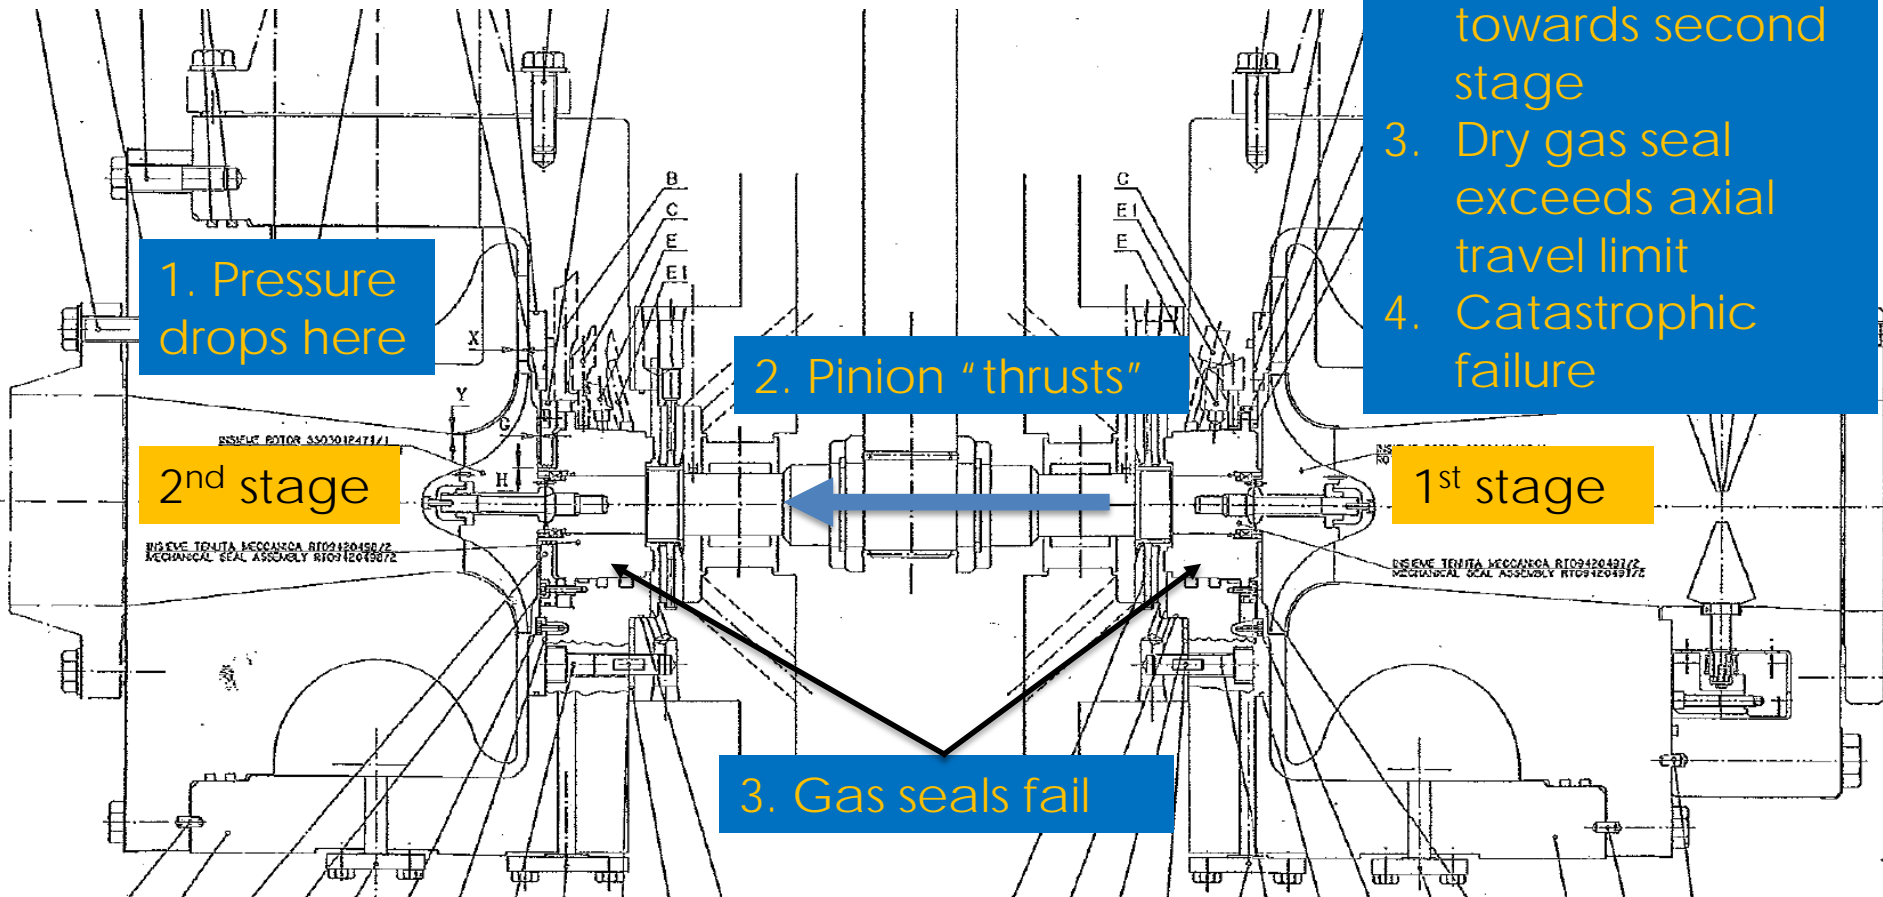
Excessive axial displacement failures - description

- Sequence:
1. Vent causes 2nd stage pressure to drop faster
 2. Pinion "Thrusts" towards second stage
 3. Dry gas seal exceeds axial travel limit
 4. Catastrophic failure

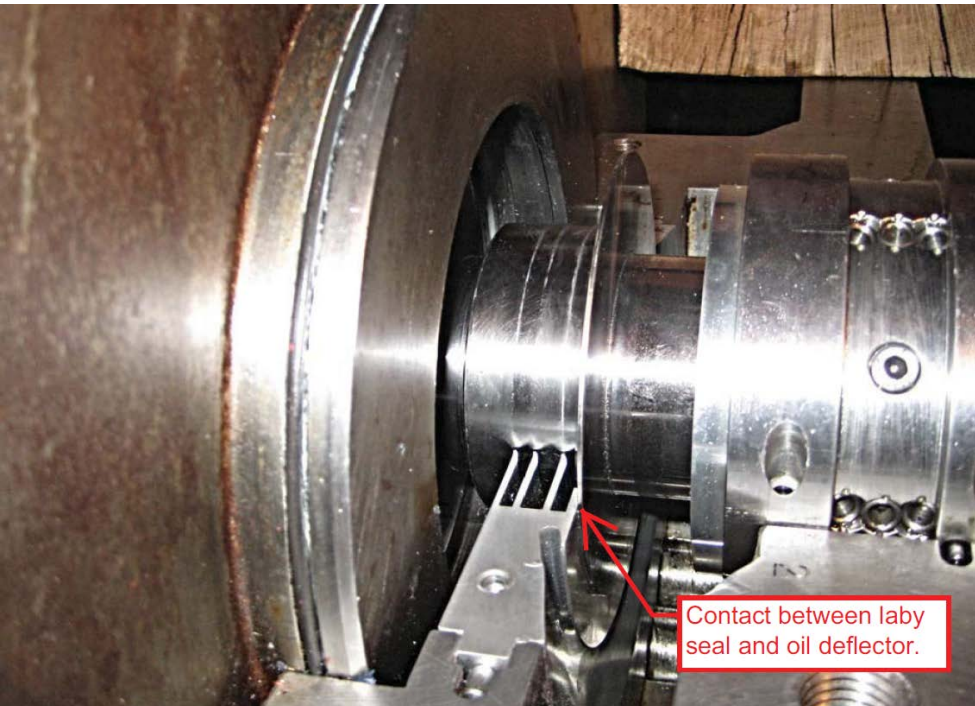
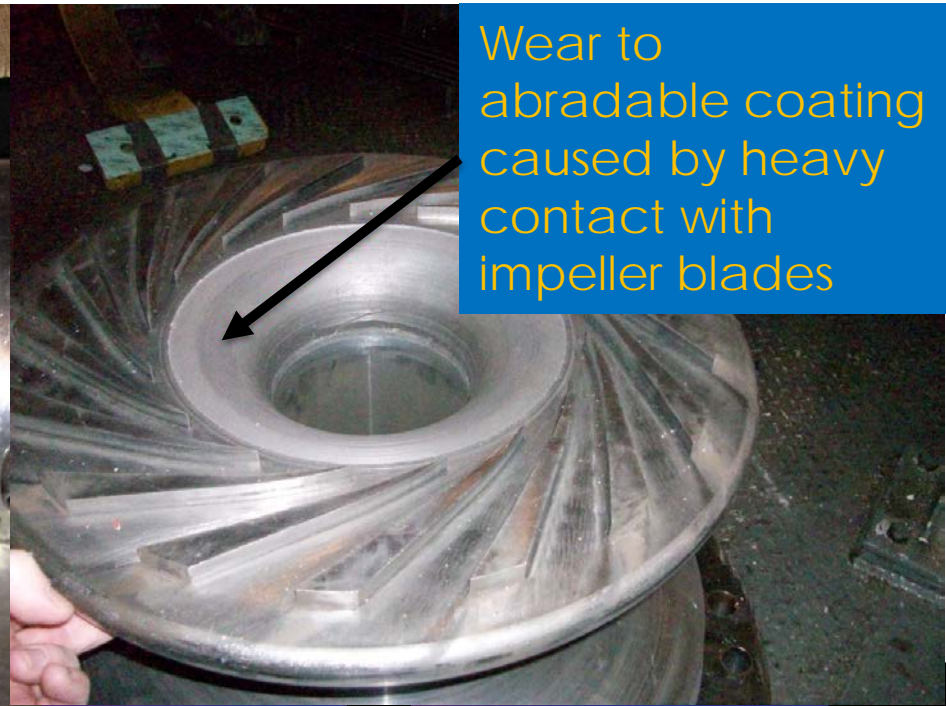
Excessive axial displacement failures - evidence

- Heavy axial rubs
 - Slinger laby seal
 - Impeller shroud

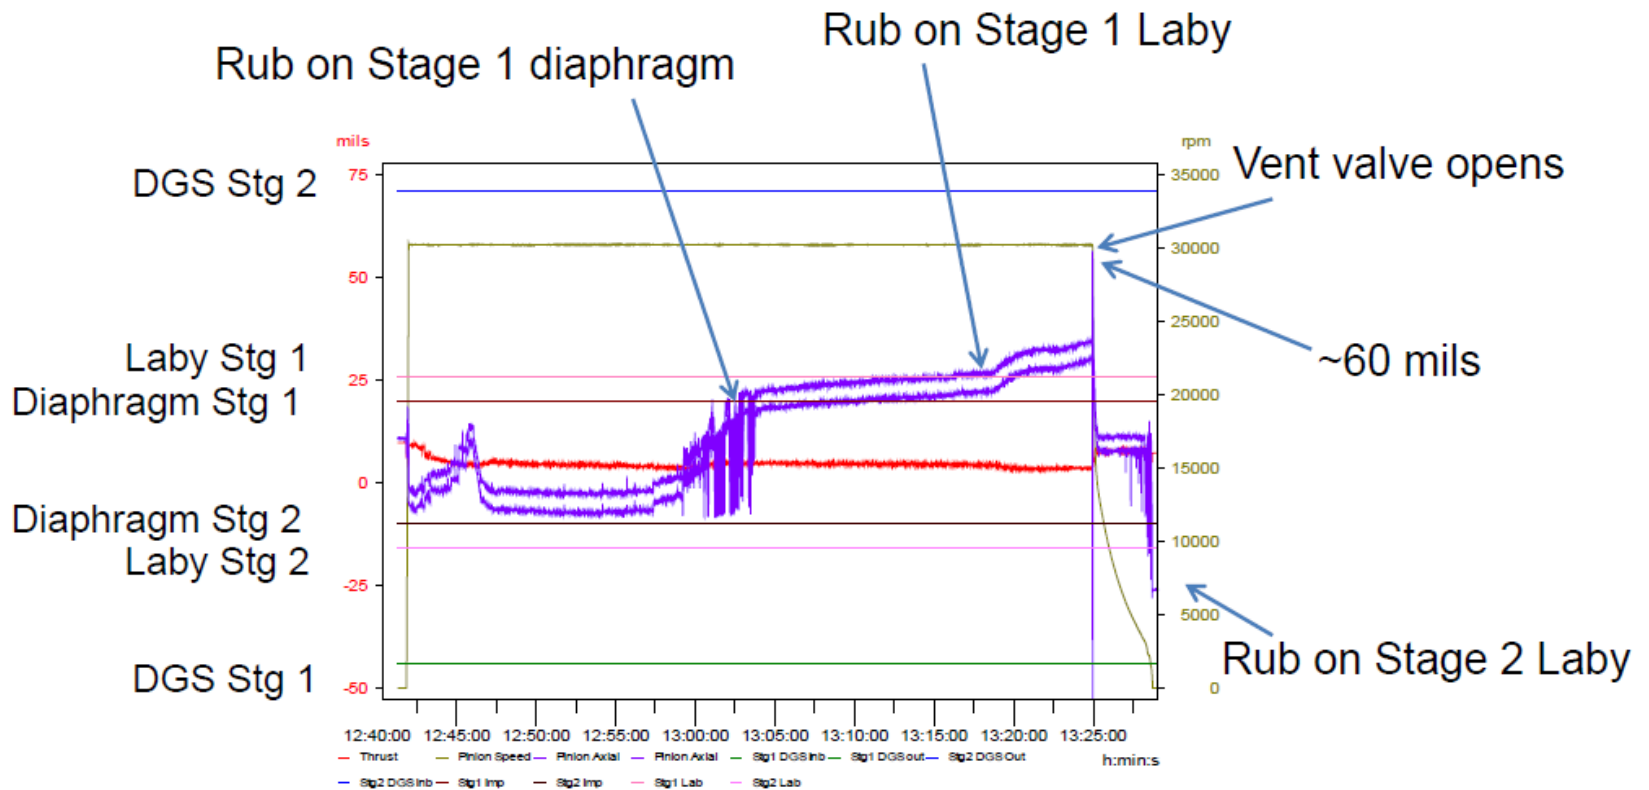
Excessive axial displacement failures - evidence

- Pinion axial displacement “measured” using bull gear displacement (proximity) probes

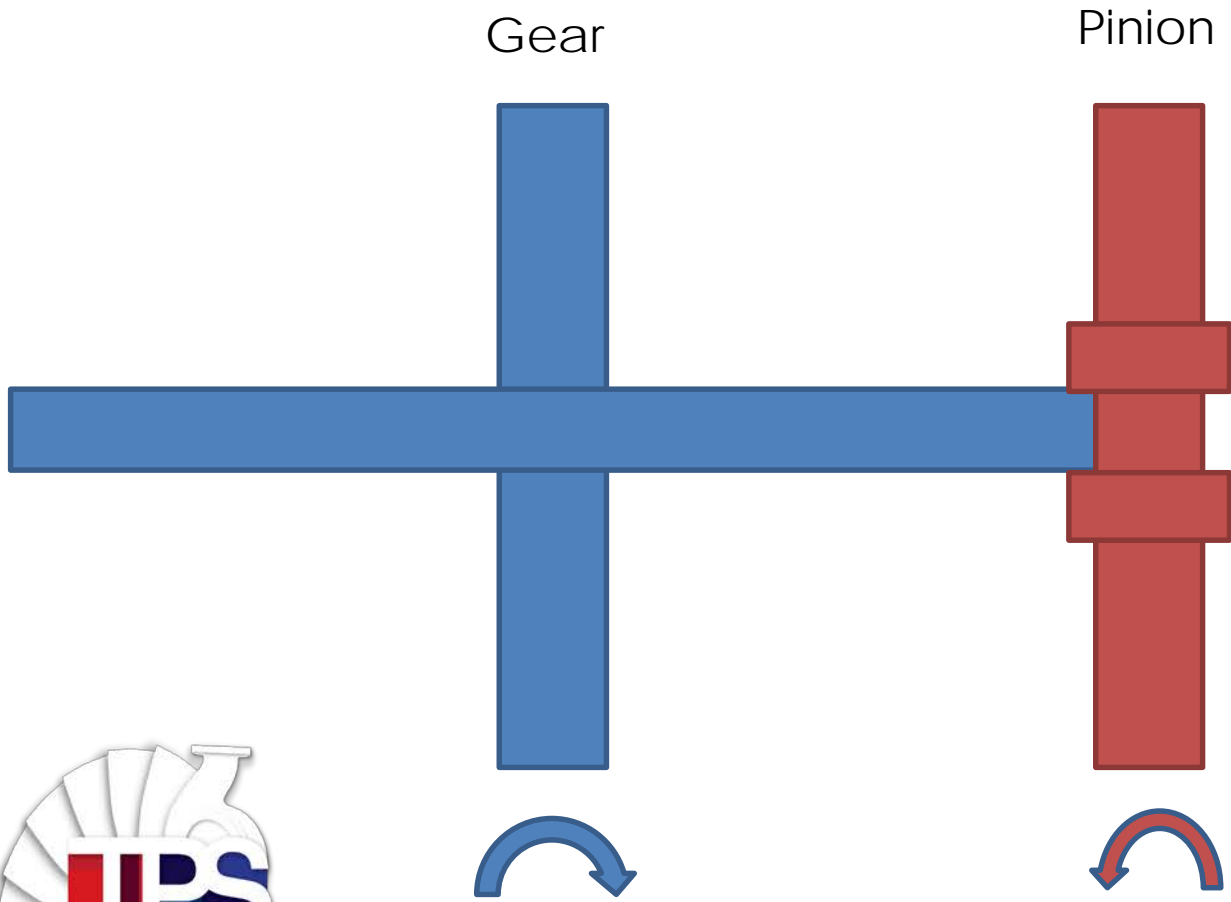
Thrust rider ring design

Description:
1. Thrust collars or "Rider rings" on pinion contact sides of bull gear
2. Axial forces on pinion reacted through the bull gear

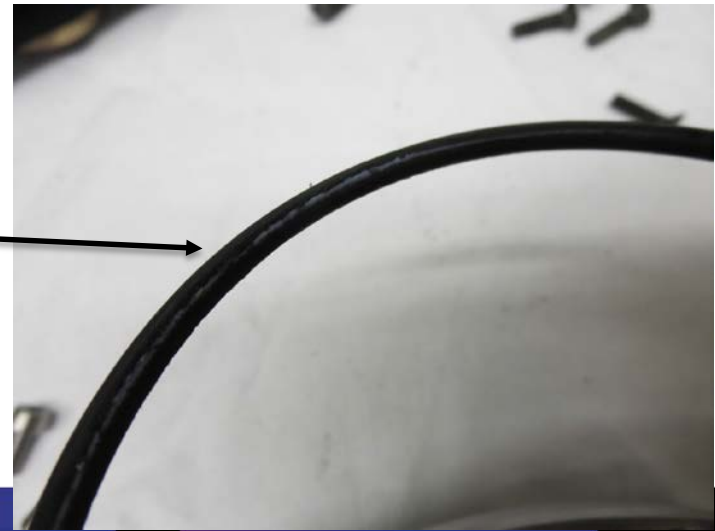
Fretted
o-ring

- Some gas seal failures occurred when seal faces “stuck” open
- Disassembly inspection identified:
 - “fretted” o-rings
 - Carbon dust resulting from face contact
- Axial vibrations suspected

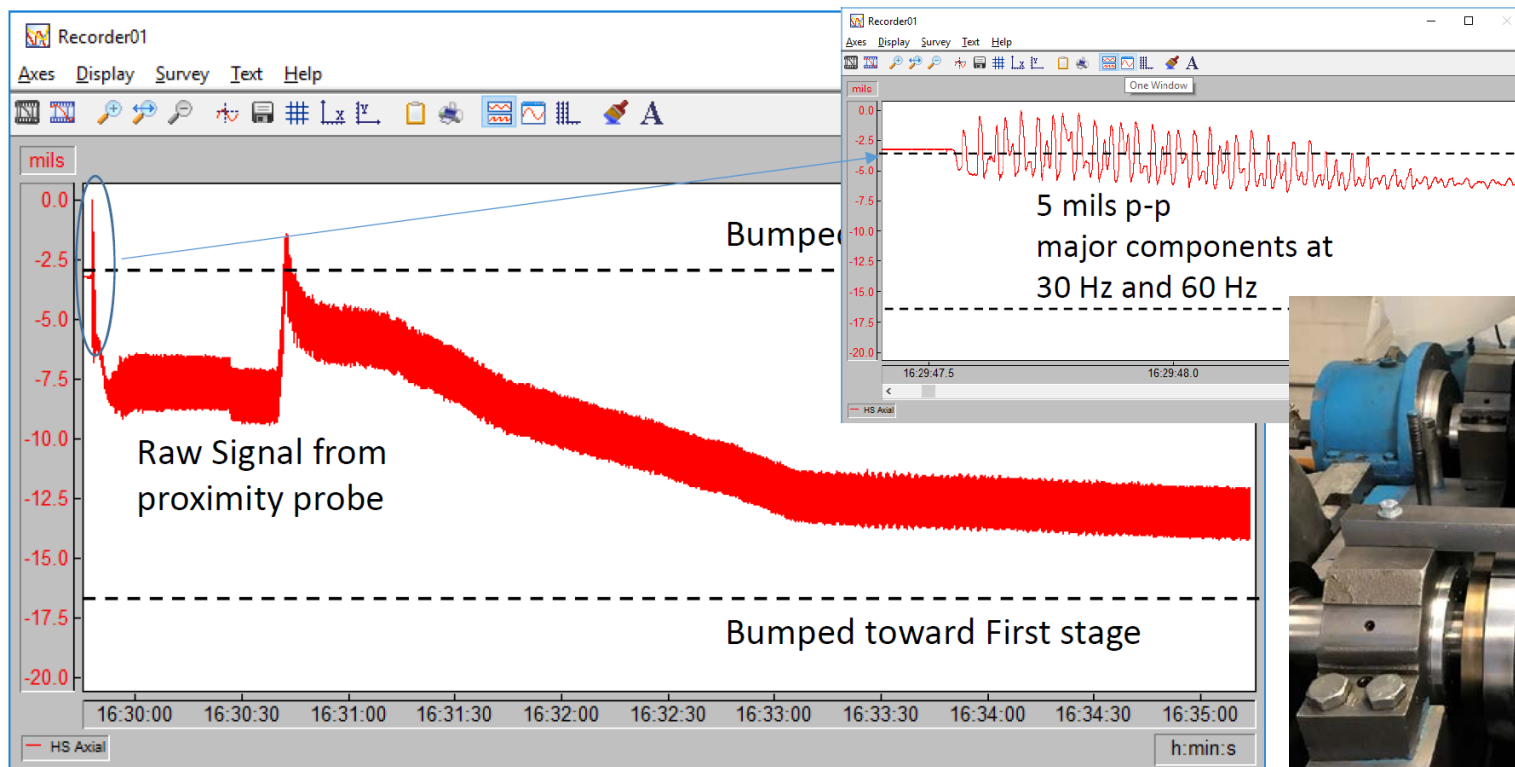
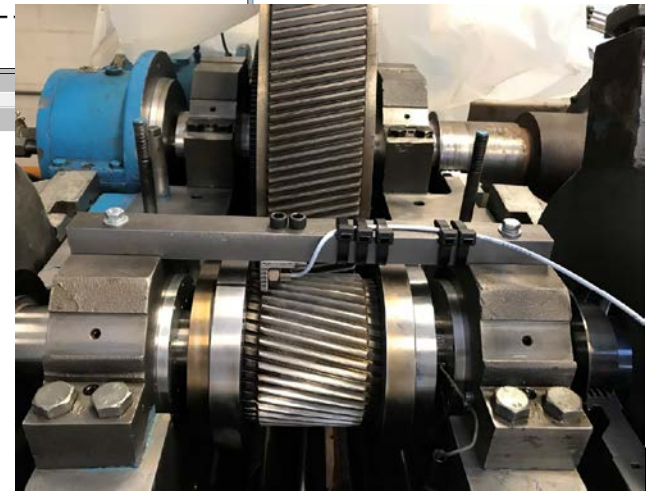
Axial vibration failure - measurements

- Axial proximity probe installed to measure pinion axial vibs
- Axial vibs exceeded 5 mils p-p
- Axial vibe limit???? 1 mil p-p – ask seal mfg

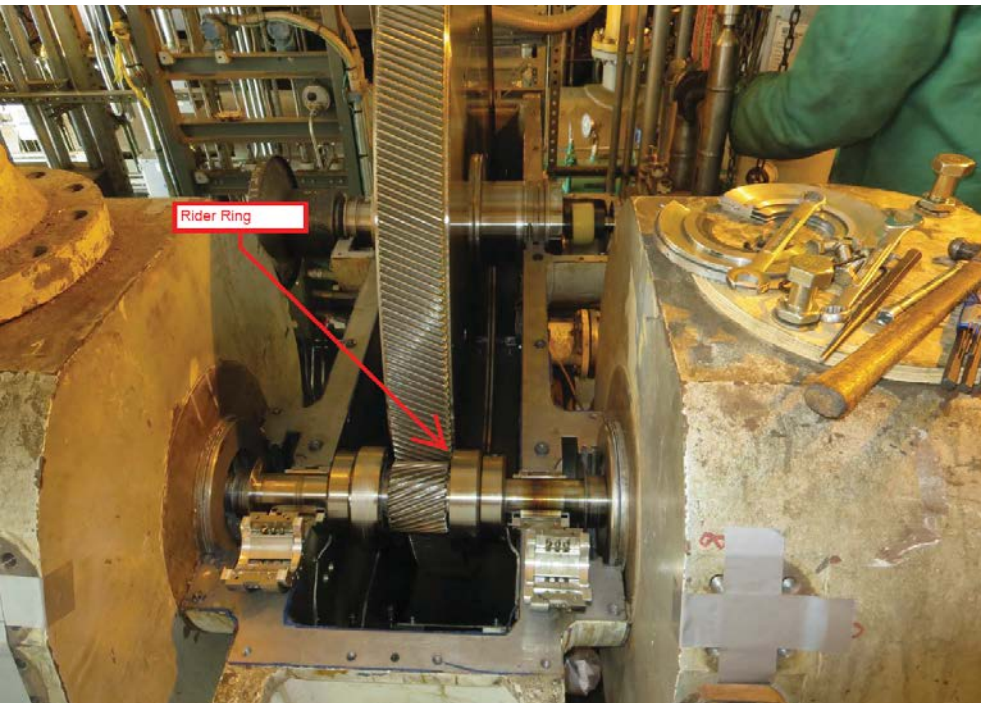
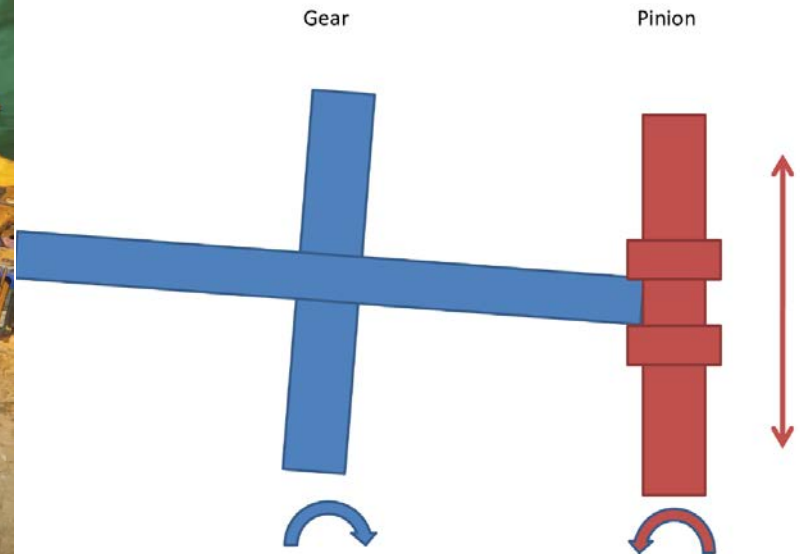
Axial vibration failure - cause

- Pinion axial position established by thrust “rider rings” to bull gear rim
- Bull gear axial runout and vibrations (wobble) **cause** pinion axial vibrations
