47<sup>TH</sup> TURBOMACHINERY & 34<sup>TH</sup> PUMP SYMPOSIA  
HOUSTON, TEXAS | SEPTEMBER 17-20, 2018  
GEORGE R. BROWN CONVENTION CENTER

# Analysis and Countermeasures for Sideband of Gear Mesh Frequency(GMF) Induced by Shaft Fretting Corrosion in a Gearbox

Seungil Bae / Bumsu Kim  
Jongoh Jang / Sangjoo Lee

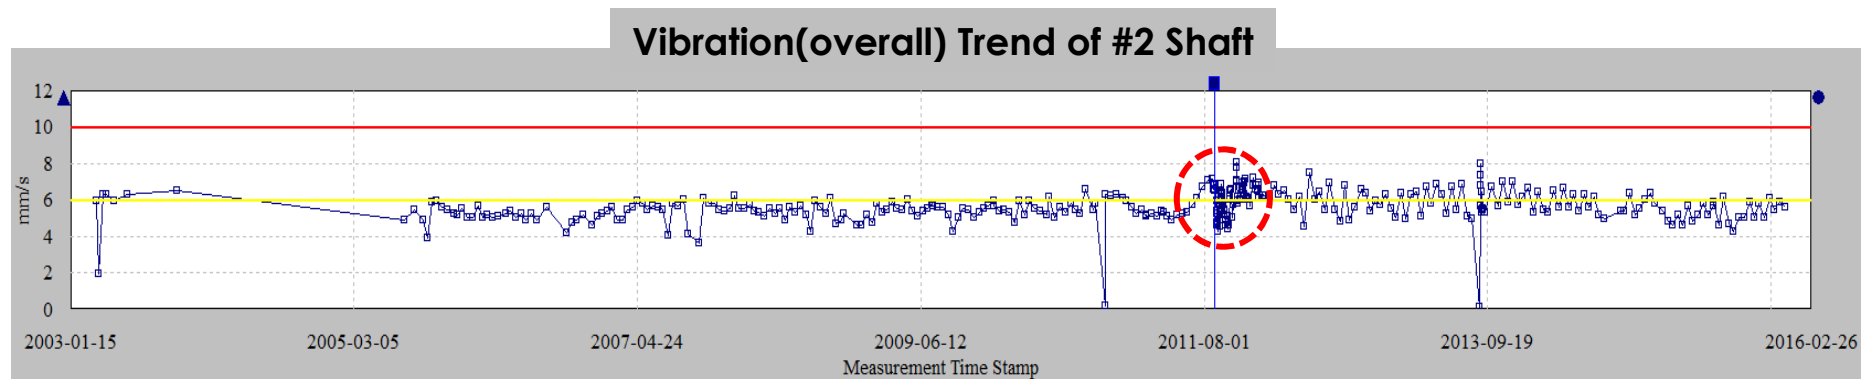
Increased vibration of #2 shaft (5.8 mm/s → 6.9mm/s)

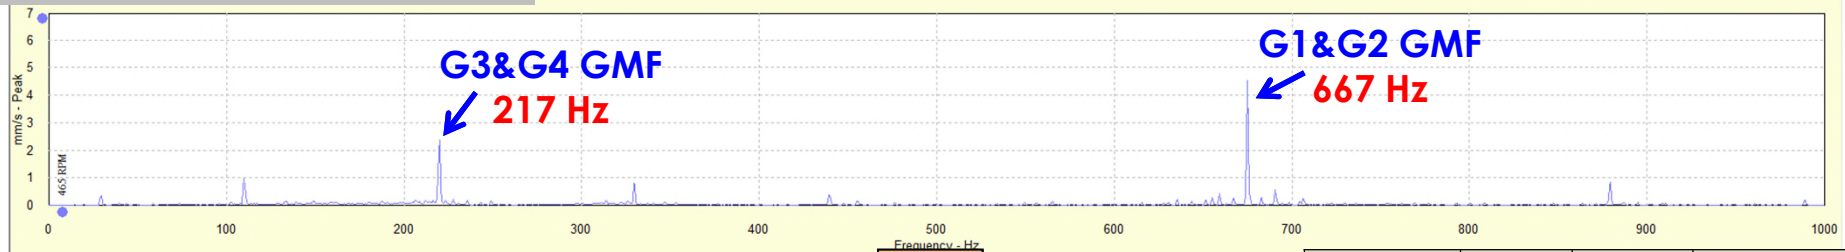
Before increasing vibration

GMF side band frequency appeared, and affected vibration increase

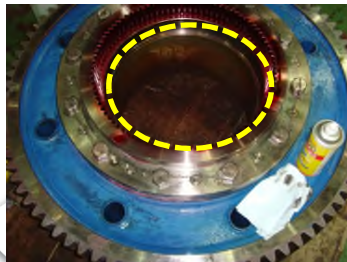
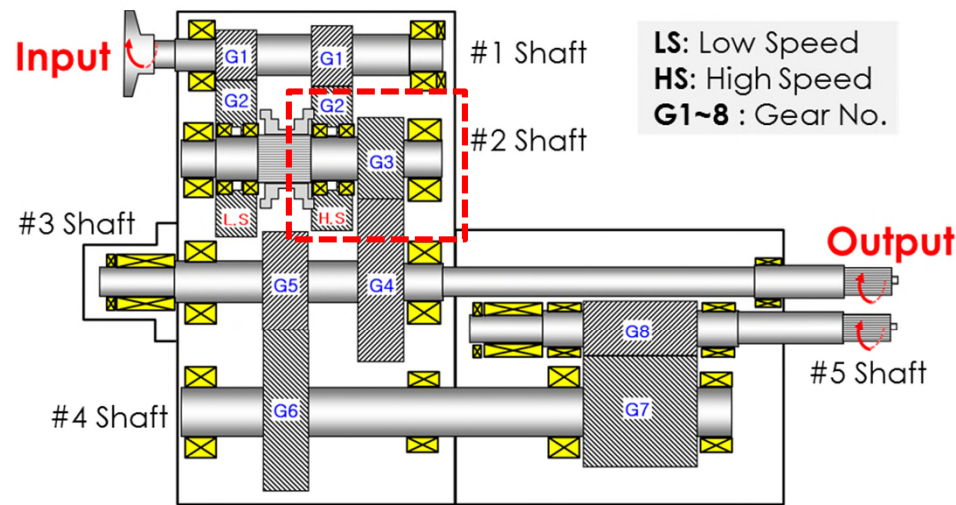
No.2 Shaft  
(HS G2 Gear Inner Bearing Mating)

**Severe damage:** Fretting corrosion damage on #2 shaft.

G2 Gear  
(Inner Bearing Mating)

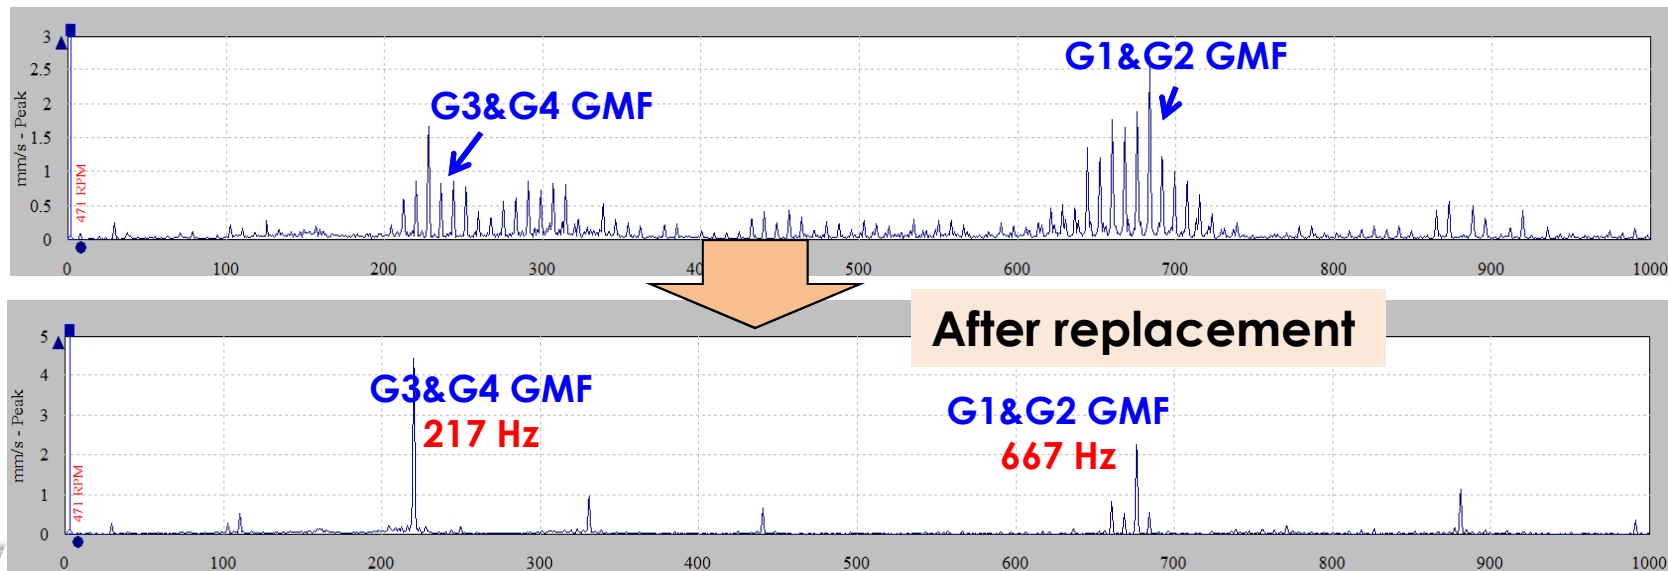
After replacing shaft and bearings,  
Vibration side bands disappeared.

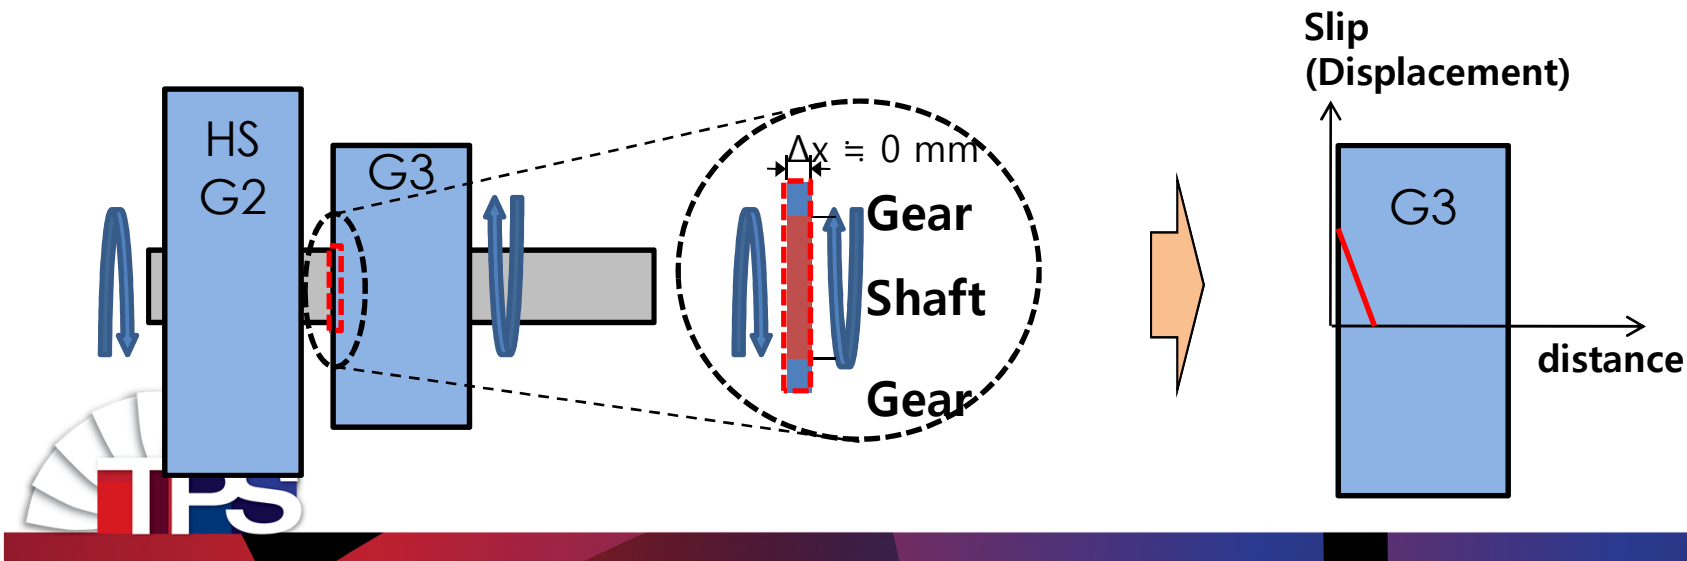
Relative movement can occur at the gear edge zone  
(red dotted box)

**As transmitted torque increases, the relative movement at the edge zone accordingly increases.**

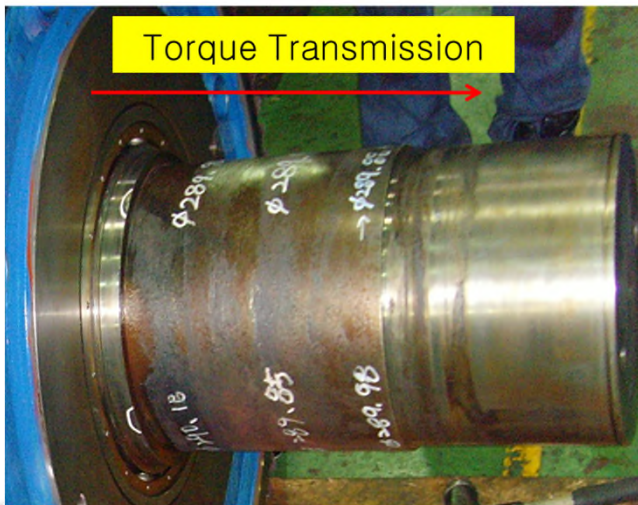
Gearbox Shaft

Fretting corrosion starts from torque input & output by torsion and bending, then propagates to opposite side

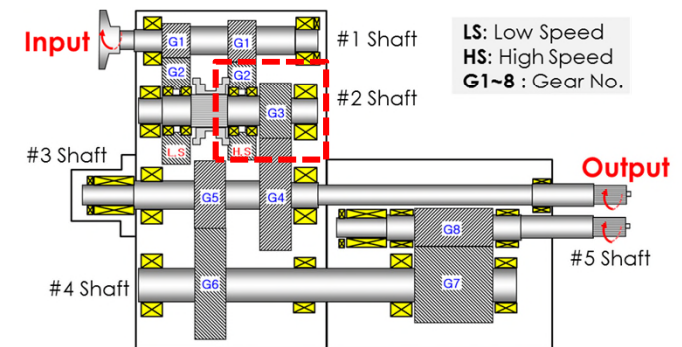
Thus, the distance between two gears is a critical parameter for causing fretting corrosion b/w a gear and shaft

Since G2 & G3 are too close together (25mm),

#2 shaft has the highest potential risk for fretting corrosion.

To prevent reoccurrence of fretting corrosion on #2 shaft, The distance between G2 and G3 must be increased.

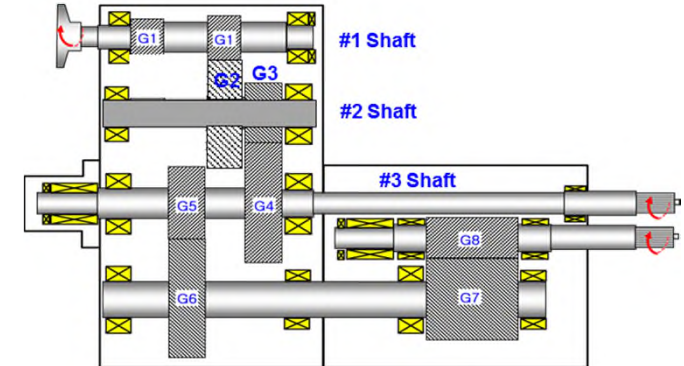
Fretting corrosion fully eliminated,  
and vibration significantly reduced  
(max. 7.9 mm/s → 2.9mm/s).

The improvement allowed to  
increase 10% in extruder capacity.
