FIELD OBSERVATIONS ON THE PERFORMANCE OF HERITAGE STRUCTURES IN THE NEPAL 2015 EARTHQUAKE

Arun Menon⁽¹⁾, Shivangi Shukla⁽²⁾, Shibu Samson⁽²⁾, N. Aravaind⁽²⁾, Xavier Romão⁽³⁾ and Esmeralda Paupério⁽⁴⁾

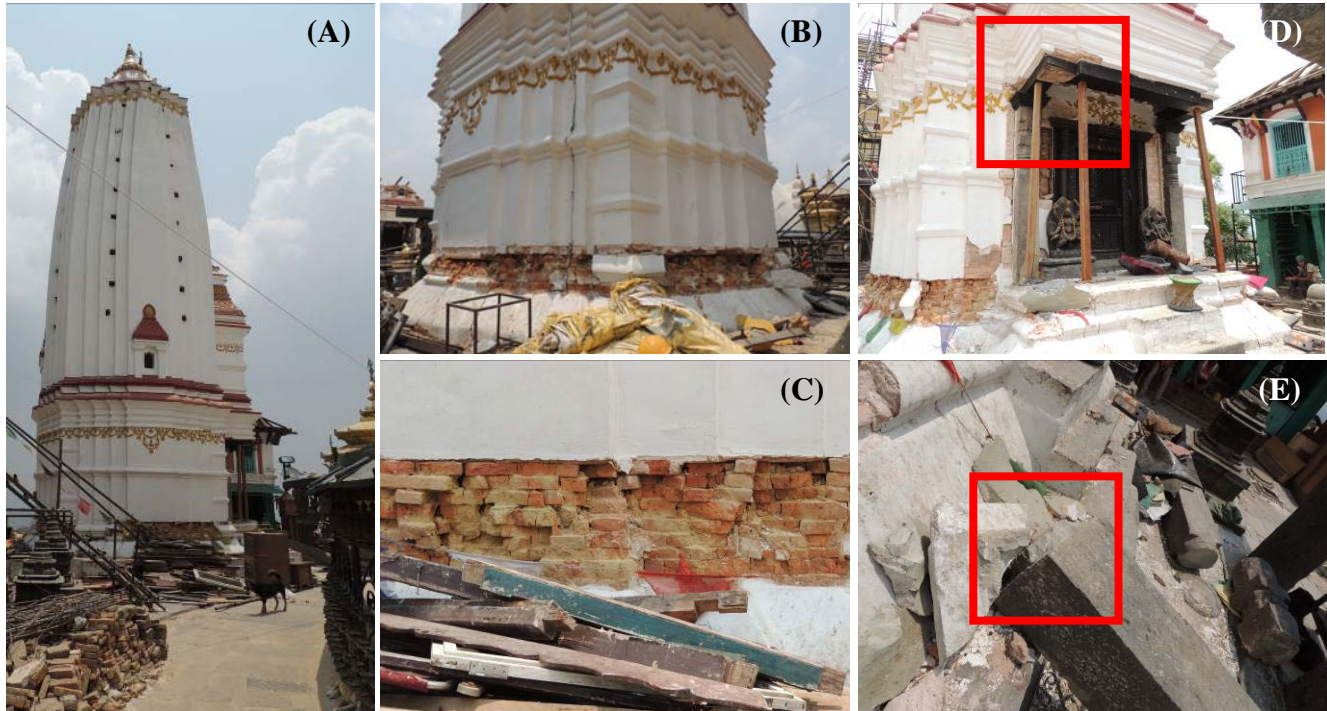
At first instance, the Pratappur Temple almost looks intact except for the collapsed portico (see Fig. 3A, 3D). On closer examination, one notices damage localized at the interface between the superstructure and the plinth all around the main structure on the northern, eastern and western sides (see Fig. 3B). About eight courses of masonry appear to be affected in the region. A series of vertical and sub-vertical cracks can also be noticed confirming crushing mode of failure of the masonry (see Fig. 3C). These courses of masonry show evidence of mud mortar as the bed and head joint mortar. As reported earlier, rest of the superstructure was reconstructed in brickwork with lime mortar, thereby introducing a weaker and a softer layer in the load path, and more so at a critical section. The large displacement response, seen in Fig. 1, induced by the earthquake has resulted in the entire, relatively stiffer superstructure rocking as one unit, hinged at the plinth, thereby causing significantly high flexural compressive stresses at the compressed toe for the brick masonry in mud mortar.

It is clear that in the case of this structure, it was the earlier intervention, which was responsible for the triggering of such a critical damage mechanism, i.e. flexural compression failure of the masonry in the critical section. The situation could have been different if care was taken in the earlier reconstruction efforts in creating better connection between the plinth and the superstructure. Interestingly, in the next example that is studied, a similar structural configuration has shown a different mechanism. At the entrance, the collapsed stone pillars of the portico demonstrates the insufficient connection, both at the base and the top of the pillar (see Fig. 3D, 3E). This is a recurring feature of the temples in the Valley, which should be addressed in reconstruction efforts.

Fig. 3: (A) Pratappur Temple; (B) Damage to masonry plinth; (C) Crushing of brick masonry layers in mud mortar; (D) Collapsed portico of the temple; and (E) Lack of good connectivity at stone pillar base

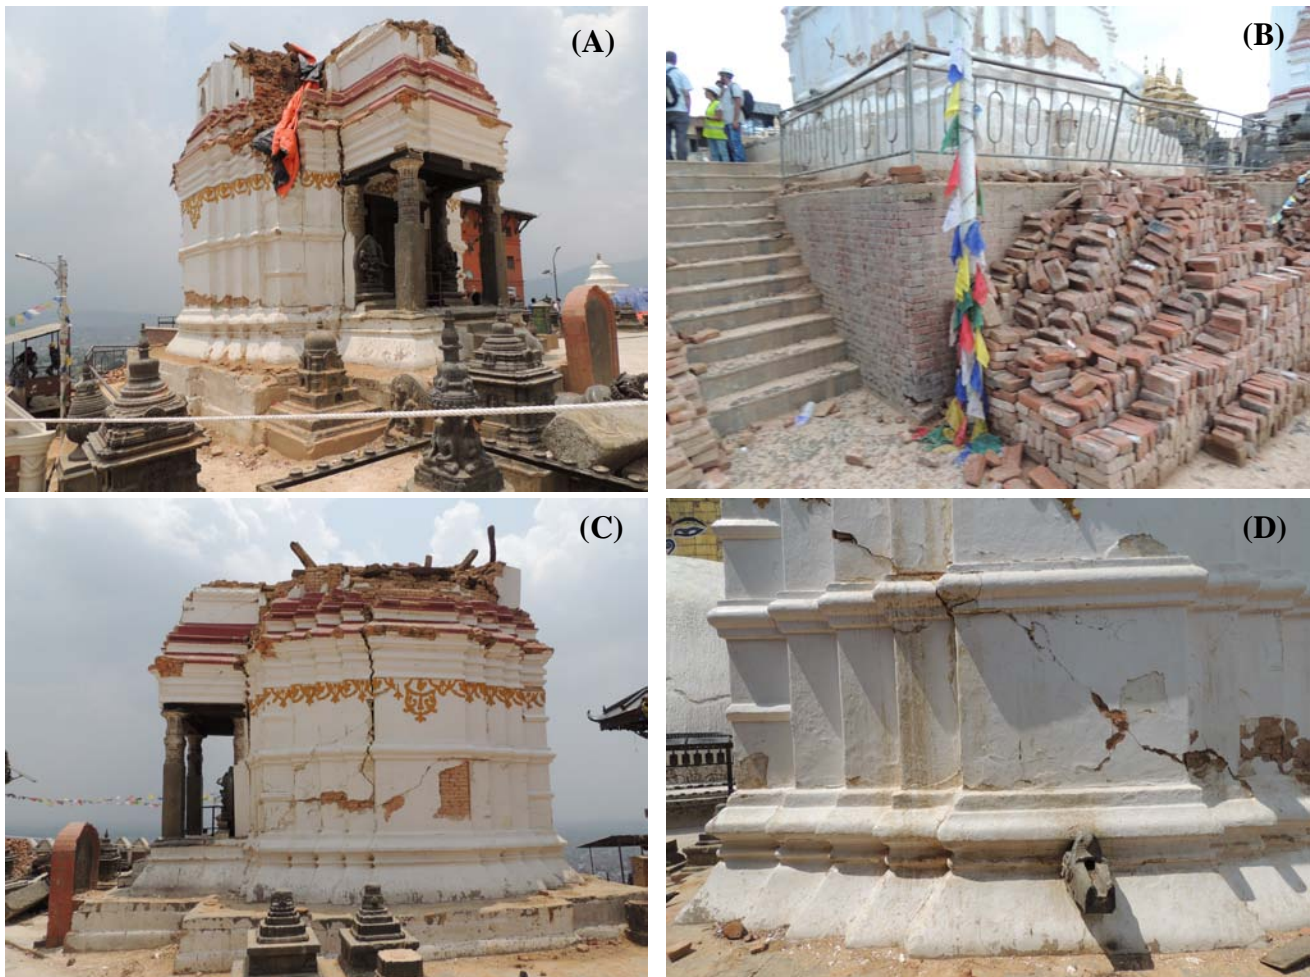
Due to the ground shaking, the *shikhara* had completely collapsed and the walls had also undergone significant damage, as observed from the photographs in Fig. 4. Despite the presence of the embedded timber frames, the four walls of the structure could not be held together, and significant dilation of the superstructure is noticed from the formation of large vertical separation cracks (see Fig. 4A and 4C). Homogeneity across the masonry cross section of the walls is apparently lost, despite the presence of the embedded timber framing. This points

either to a deteriorated state of the timber framing elements of inadequate timber framing for the level of displacement demand that the structure was subjected to in the earthquake. On the rear wall, diagonal shear cracks are observed, indicating the predominant direction of the ground shaking, i.e. east-west at the site. This also indicates that largely, out-of-plane mechanisms have been overcome (towards which the embedded timber framing and superimposed load of the shikhara have contributed) and the in-plane resistance of the shear walls has been garnered. This is in contrast to the Pratappur Temple where damage is localized at the base.

It is noticed that the front portico of the main temple has almost detached itself from the main structure, again, owing to lack of adequate interlocking of the structural elements of the portico to the masonry walls. The portion itself stands risk of collapse due to further ground motions (i.e. aftershocks) and temporary interventions must address this aspect prior to salvage of the contents of the structure.

Fig. 4: (A) Anantpur Temple with collapsed shikhara; (B) Rear view of the structure showing repaired plinth; (C) Vertical cracks showing dilation of the structure; and (D) Shear cracks on the rear wall.

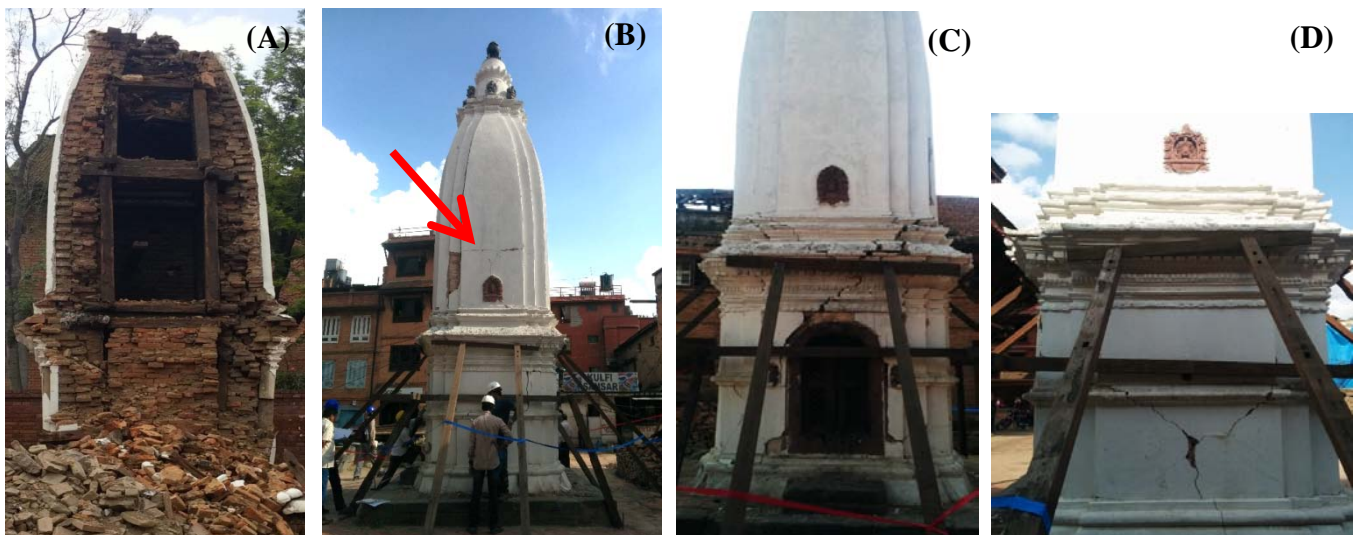
The details of the timber framing can be observed in another structure in Kathmandu that partially collapsed in the earthquake. The nature of interconnection, entirely by timber dowels, and the levels at which the framing is provided are visible in the photograph in Fig. 5A. More importantly, it must be observed that the interconnections do not traverse the entire masonry cross-section or wall thickness, but are limited to the inner

masonry leaf, raising doubts on their effectiveness in tying. The collapse mechanism triggered in this structure itself, points to lack of effective tying between orthogonal walls provided by the embedded timber framing.

In the Narayan Temple in Bhaktapur, the earthquake ground shaking caused considerable damage to all the four walls of the and the shikhara. The main axis of the structure is oriented along the NNE-SSW direction and typical diagonal shear cracks are noticed on the south-eastern and north-western facades, implying dominant in-plane response (see Fig. 5C and 5D). On the front facade, the cracking is more pronounced due to the presence of the arched opening. Vertical splitting of the masonry is observed on the front facade, primarily due to insufficient interlocking of the masonry units at corners. Since the timber frame is present inside the masonry façade, the horizontal tie beams fail to provide any confinement or effective tying to the masonry. On the side walls, horizontal cracks have been observed occurring both in the walls and in the shikhara as shown in Figure 14. These cracks can be attributed flexural tension along the out-of-plane direction. The horizontal crack on the shikhara (see Fig. 5B) is again indicative of the poor interconnectivity of the embedded timber frame with the outer masonry leaf, which responds almost independently. This horizontal crack in the shikhara could also be aligned with the level at which the horizontal timber element is provided. This could not be verified as the structure was unsafe for access to the interior.

Fig. 5 – (A) Embedded timber frames seen in another damaged shikhara-style structure; (B) Temporarily shored Narayana Temple showing horizontal cracks on the shikhara; (C) Damaged south-eastern facade showing shear cracks (D) Damaged north-western facade showing shear cracks

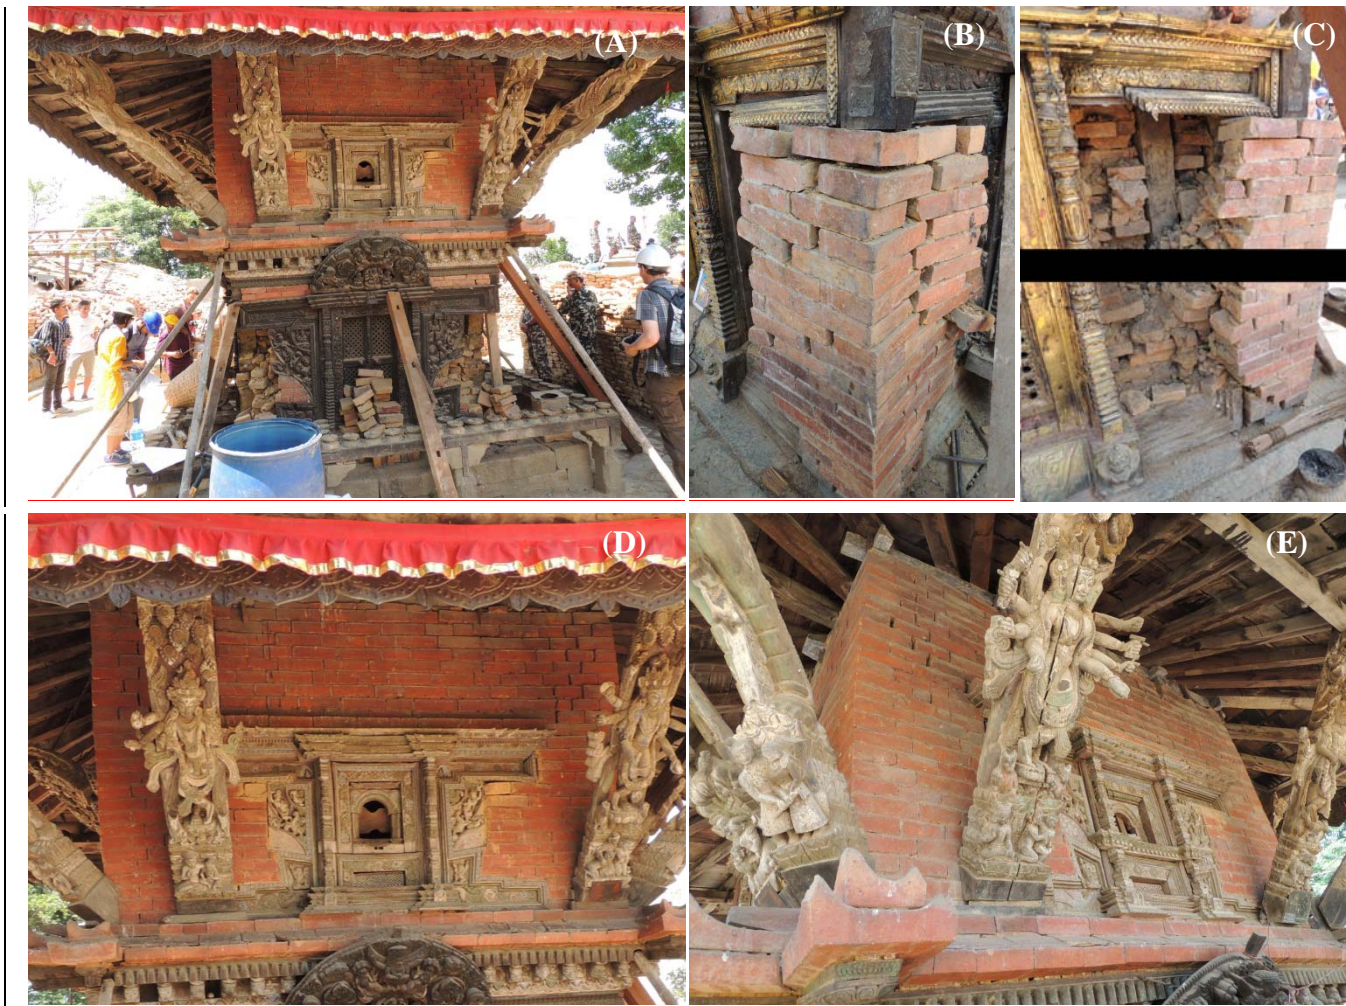
The brick masonry walls of the temple have been severely affected with the earthquake. Both inner and outer leaf masonry have collapsed at the corners leaving the inner timber post and upper floor timber band exposed, and this is attributable to the fact that there was no tying member between the masonry leaves along the height (see Fig. 8A-C). In the upper floors, there is no collapse but cracks and out of plane deformation are visible (see Fig. 8D and 8E). Despite the extremely high standard attained in the brick firing, the quality of the brickwork and, as a result, the structure of the building is surprisingly weak, which can only be attributed to the following reasons: the use of mud mortar; poor bonding between the facing and the backing brickwork, difference in size between the face brick and the standard brick and the fact the orthogonal walls have no ties at the corners.

The double framed doors and windows act as reinforced openings. Posts are erected at strategic points along the walls to support the flooring system, which is supported by different framing systems independent of each other. The masonry is only partially used to support the flooring and acts as a curtain wall. Thus, the timber frame inside does not restrain the masonry facade from falling in the out-of-plane direction.

Another possible contributory factor for the out-of-plane collapse of the masonry leaves is wedge-shaped configuration of the units of the outer leaf (recall photograph in Fig. 6B). In the absence of through-stones or interconnecting elements with the inner leaf of sun-dried bricks, the outer-leaf by itself has almost no out-of-plane resistance and individual units will rotate about the thicker end due to the gaps created by deteriorated mud mortar joints above and below along the width of the unit, thereby making the wall very susceptible to out-of-plane shaking.

Fig. 8 - Kileshwar Mahadev temple: (A) Collapsed masonry at corners; (B)-(C) Dislodged outer leaf; (D) Shear cracks and dislodged masonry in north wall at first floor level and (E) Split in the timber strut of the west wall.

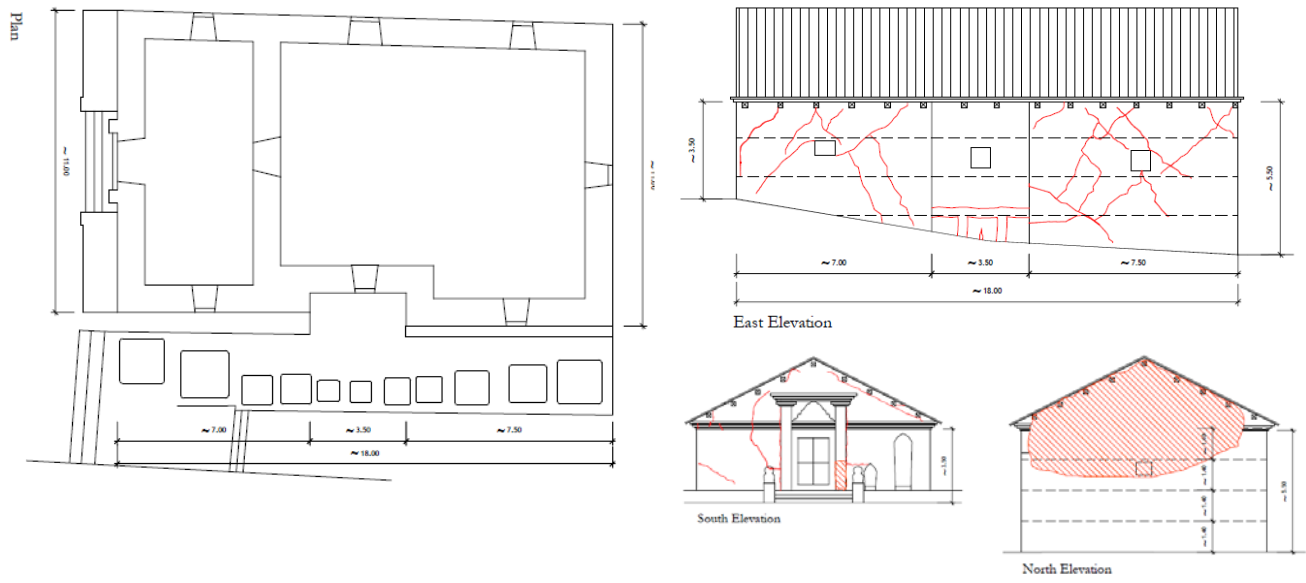
Fig. 9 - Plan and elevations of the Shantipur Temple, Swayambhunath

A simple damage map showing the observed distress in the eastern, northern and southern elevations is shown in Fig. 9. The longitudinal axis of the temple is aligned North Northeast-South Southwest.

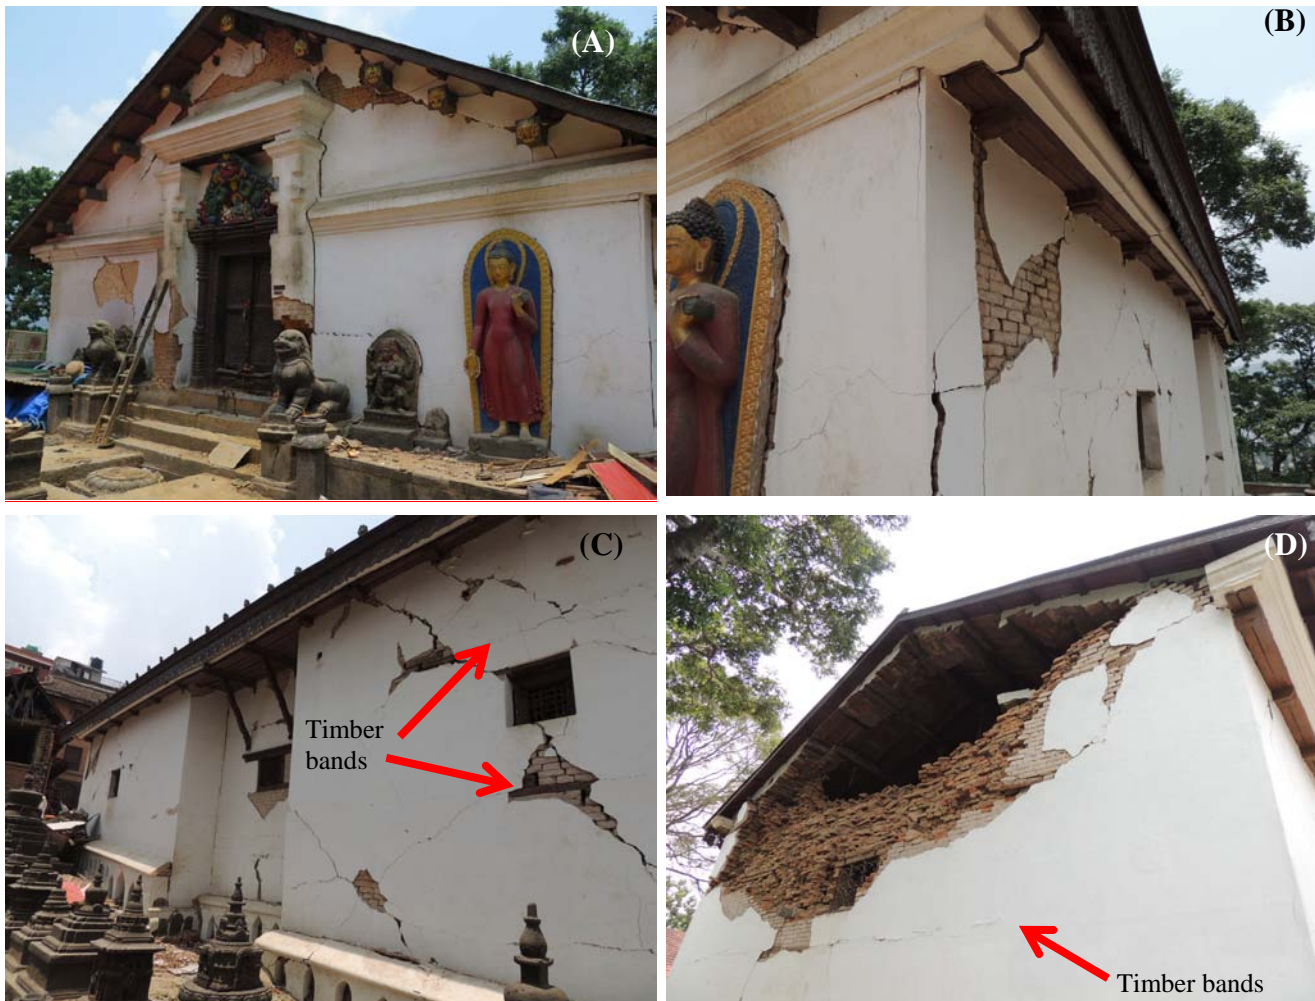
Fig. 10 - Shantipur temple: (A) Front facade (south); (B) Eastern facade showing out-of-plumb; (C) Eastern facade showing in-plane shear cracks and timber bands and (D) Rear facade with out-of-plane gable failure.

As can be seen from Fig. 10B-C, the left and right side walls of the temple, parallel to NNE-SSW direction, exhibit diagonal shear cracks with different levels of severity, typical of dominant in-plane earthquake loading. Clearly, there is distributed cracking owing to the presence of timber bands along the height. Some of the small horizontal cracks found across the left, right and rear walls of the temple are the locations of the embedded horizontal timber ties. Slight out-of-plane bulging is also observed on the eastern wall.

Partial out-of-plane of the gable wall was observed on the northern wall or rear facade as shown in Fig. 10D. This points to two important aspects of these constructions: Firstly, there is very little to no load transferred from the roof to the masonry walls. The load is mostly carried by the interior timber posts. Such a situation reduces the overturning resistance of the walls due to superimposed loads. The gable wall here acted almost as a free cantilever with no superimposed load. Secondly (and possibly, more important), the timber horizontal ties, which extend to a height of 5.5m do not continue into the gable wall, which could have prevented the out-of-plane collapse. This must be noted for future reconstruction as a possible deficiency in the original configuration. Finally, it is noted that based on the brief access that was granted to the interior of the temple, the interior wall suffered a partial out-of-plane collapse and that 2 timber beams also collapsed.

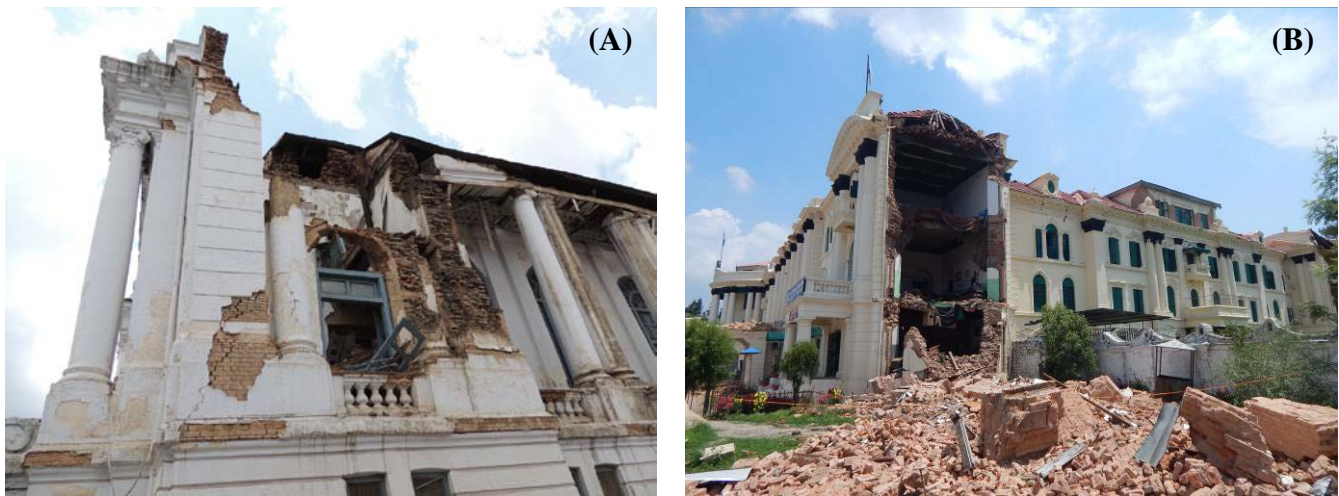
Fig. 11: (A) Extensively damaged Hanuman Dhoka; (B) Out-of-plane collapse in Nepal Academy of Fine Arts

These massive masonry constructions have seen disastrous performance (see Fig. 11) due to their excessive inertial mass and lack of earthquake-resistant features, particularly, lack of tying elements critical for monolithic behaviour. The classical out-of-plane failure seen in Fig. 11B points to the vulnerability of such multi-storied constructions.

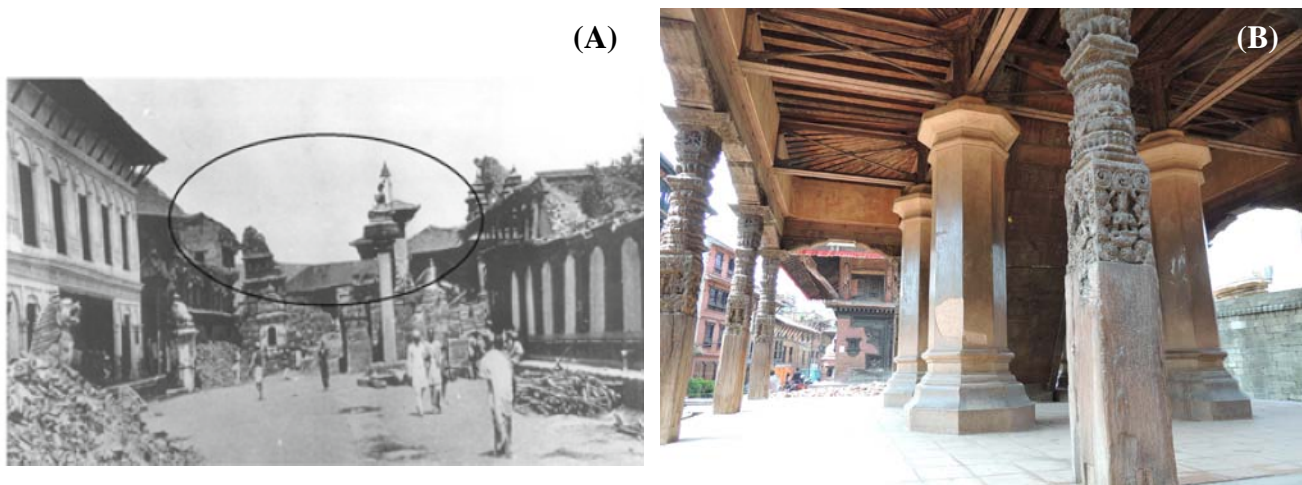
Fig. 12 - (A) Collapsed Cyasilin Mandap in the 1934 earthquake [8]; (B) Reconstructed and seismically strengthened Cyasilin Mandap that survived the 2015 earthquake [9]

- (6) Seismic strengthening must be seriously considered in the reconstruction of collapsed or partially collapsed historical monuments, incorporating new detailing, improving upon vernacular or historical designs, which at times have proven inadequate. The good performance of the strengthened Cyasilin Mandap in Bhaktapur [9], reconstructed after the 1934 earthquake is a case in point (see Fig. 12).
