**XVIII ЮБИЛЕЙНА МЕЖДУНАРОДНА НАУЧНА КОНФЕРЕНЦИЯ ПО
СТРОИТЕЛСТВО И АРХИТЕКТУРА ВСУ'2018
XVIII ANNIVERSARY INTERNATIONAL SCIENTIFIC CONFERENCE BY
CONSTRUCTION AND ARCHITECTURE VSU'2018**

**FATIGUE DAMAGE AND REPAIR OF AN ORTHOTROPIC PLATED
BRIDGE DECK AFTER 23 YEARS OF SERVICE**

Philippe Van Bogaert¹

Civil Engineering Department, Ghent University (Belgium)

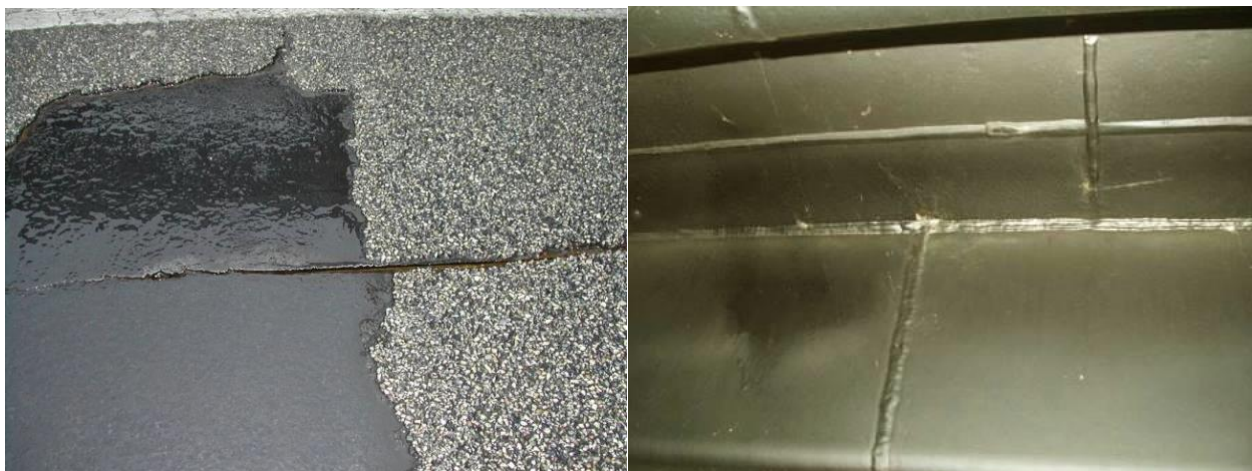
Already in 2004, after 10 years of service, the OSD showed rapidly increasing cracks [3] at the connection of closed-section stiffeners and the deck plate. A rapid repair method was implemented. Fig. 3 shows the crack through the surfacing. Obviously the crack grew from the right side of the picture to the left. At the time, the writer was contacted, the crack through the 12 mm thick steel deck plate had grown already to a length of 600 mm. Inspection of the crack surface was impossible, although one could suspect that fatigue was the cause of such a rapidly growing crack.

As the lower side of the bridge deck was inspected, the initiation of the cracks appeared to correspond to the location of the connection of the closed stiffener to the deck plate, more precisely to the intersection of this weld with the butt weld in the stiffener as shown in Fig. 3. The stiffener to deck plate connection is known to be a detail, particularly prone to fatigue. If this fatigue detail is combined with the transverse butt weld a particularly heavy stress concentration is introduced. As can be noticed from Fig. 3 none of the butt welds received post-treatment such as grinding, as should certainly be applied in

orthotropic plated bridge decks. It was immediately suspected that this particular situation was the cause of the rapidly growing crack.

Fig. 3. Crack in deck plate (left) interference with stiffener butt weld (right)

Simultaneously, numerical simulations proved that cracking was due to fatigue of the stiffener to deck plate welding and that the 10 year life time could easily be explained. Due to the intersection of welds, the stress at the connection itself is increased by the butt weld by a concentration factor of 1.19. Hence, the problem was local only and further general cracking was not expected immediately. However, the general condition of the OSD appeared rather poor and the prediction was that fatigue cracks of the type of Fig. 3 would become general within 6 to 10 years. The present paper reports on the fatigue damage that occurred, 14 years later and recent measures that were taken.

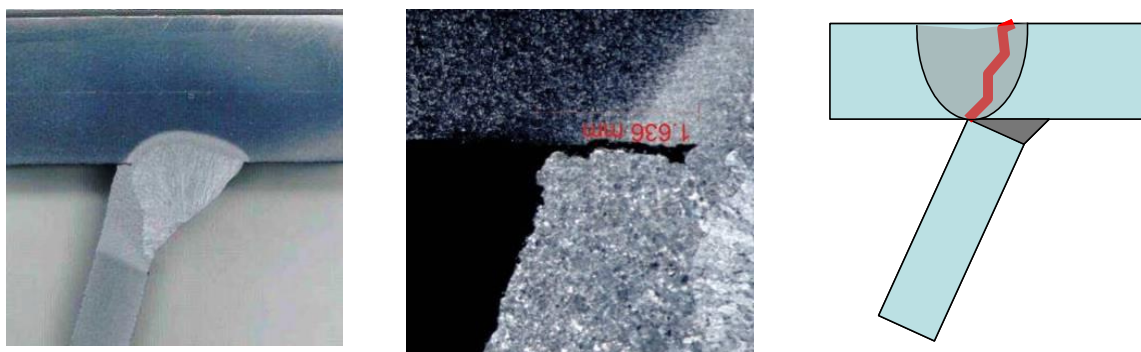
As the most critical section of the stiffener to deck plate connection is located at the root of the welding, shown in Fig. 4. This is why there is no direct evidence that the extrapolation method for hot spot stress may be copied for this particular welding detail. However, the latter is frequently assumed, also in the former paper on fatigue damage of the River Scheldt bridge [3]. Fig. 4 left shows a macrographic photo of the typical one-sided welding connection of the stiffener to the deck plate, whereas the right hand side displays the orientation of the fatigue crack, originated at the weld root and progressing to the top of the deck plate. The shaded area in the figure corresponds to the heat affected zone.

Fig. 4. (left) single side welding (centre) detail of stiffener (right) fatigue crack path

Obviously, the numerical modelling of this connection must include the small gap or lack of welding penetration. Most simulations introduce such a gap, including a round tip at the end. Microscopic research has proven that such a fillet rounding is close to reality. However, there is little difference in fatigue strength between a connection of 20% lack of penetration and a full penetration welding. This is due to the high influence of residual stress at this location. The crack path of Fig. 4 right can only be found numerically if the effect of residual stress is included.

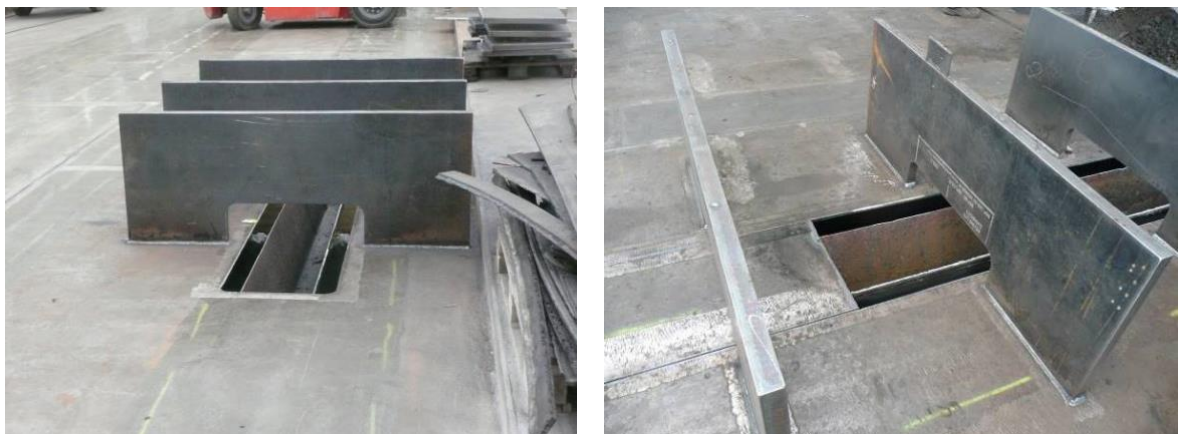
In 2017 TOFD non-destructive testing was carried out on the deck plate of the movable part of the River Scheldt bridge. It demonstrated that the plate was cracking rapidly, since 14 m length was seriously affected. Some cracks already were visible through the 7 mm pavement of the bridge deck, and there was a high probability that more in depth cracking was initiated or already. As these cracks are invisible, extensive testing became necessary. The owner decided to have these parts of the deck plate repaired, according to a procedure involving the replacement of the plate from above and rewelding of the connection of Fig. 4 [8] from below the bridge.

Fig. 6. Removal of cracked parts of deck plate

The repair method may best be illustrated through the pictures of Fig. 6. Vertical plates, are bridging the cracked part of the deck plate. This allows to burn the circumference of the plate area and to cut the welds of the connection of Fig. 6. This condition is shown in Fig. 6 left. Fig. 6 right shows the precise cut in the deck plate.

Subsequently, a new part of deck plate is being placed and welded to the free edges. As for the connection to the closed stiffeners, this is welded from below, using a suspended rack. The replacing deck plate is increased from 12 to 16 mm. Hence, a higher resistance for bending is obtained and cracking will become less critical.

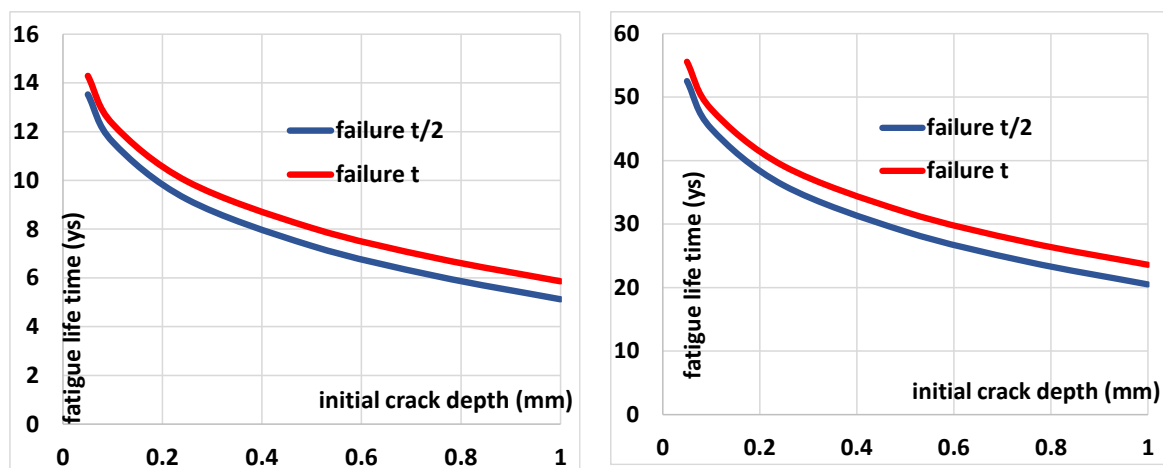
Using the value of $f(a)$ derived in [8], which include the effect of residual stress, the crack depth can be calculated. Obviously, the value of the initial crack depth is a dominant factor. The graphs of Fig. 8 show the result, to the left for a 12 mm thick deck plate and to the right this plate is increased to 15 mm.

Fig. 8. Fatigue life prediction by LEFM

The graphs of Fig. 8 each show 2 curves, the failure point being an uncertain condition. Generally, failure is considered to occur when the crack depth reaches half the plate thickness and the curve $t/2$ is relevant. From the tests reported in [8] the initial crack depth is close to 0.1 mm. In that case, the result of LEFM is that for the initial structure fatigue life would have been 13.53 years, whereas if the deck plate thickness is increased to 15 mm it would become 52.53 years. The latter does not comply to the requirement of

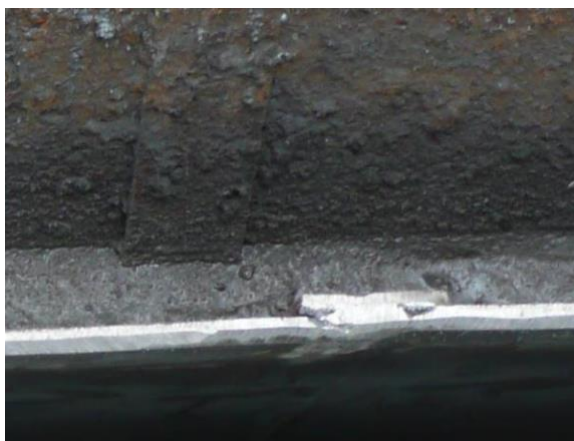
During the aforementioned repair works, welders found that the actual joint of the stiffener to the deck plate showed less penetration than Fig. 4 left. This is based on testimony from persons and could not be confirmed directly by material evidence. However, the cut edge of the stiffener could be examined closely and the flat part of the web plate top has been measured. Details of this are shown in Fig. 9.

Fig. 9. Closer image of stiffener upper edge

The value of the horizontal flat part of the web edge varies from 4.7 to 6.3 mm, the web thickness being 8 mm. This may confirm the claim of the welders. Obviously, the flat part of the web thickness is irregular and may be influenced by the cutting itself. Nevertheless, a rather evenly distributed area was found as the pictures of Fig. 9 may display.

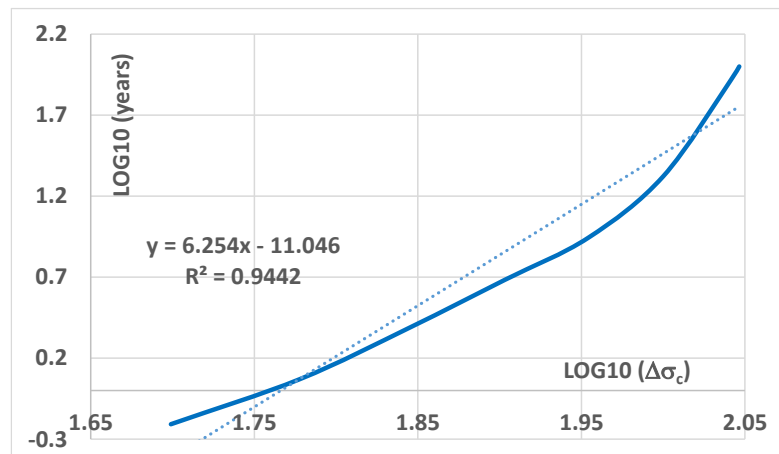
Fig. 11. Relation of design fatigue category and fatigue life

The process has been repeated for various values of the design stress variation, resulting in the bi-logarithmic graph of Fig. 11. A linear relation may be expected, although the ascending curve may be explained by the exceeding of the cut-off limit. Since the required design category needed to obtain 100 year fatigue life equals 111.3, no practical solution exists to replace the movable part of the bridge. Should the deck plate thickness be increased to 15 mm, the design stress category should equal to 71.3 MPa, which is consistent with the code.

Hence, the fatigue damage and subsequent general failure of the River Scheldt bridge may well be due to insufficient welding quality and the movable part may be substituted by an identical structure, provided the deck plate thickness is increased to 15 mm and partial penetration welding is used. In this manner, this historic structure, inspired by its predecessor from Eiffel's time, may be preserved for the future and standing as a landmark.
