FULL-SCALE VEHICLE CRASH TEST ON THE IOWA STEEL TEMPORARY BARRIER RAIL

TRANSPORTATION RESEARCH REPORT TRP-03-20-89

December, 1989

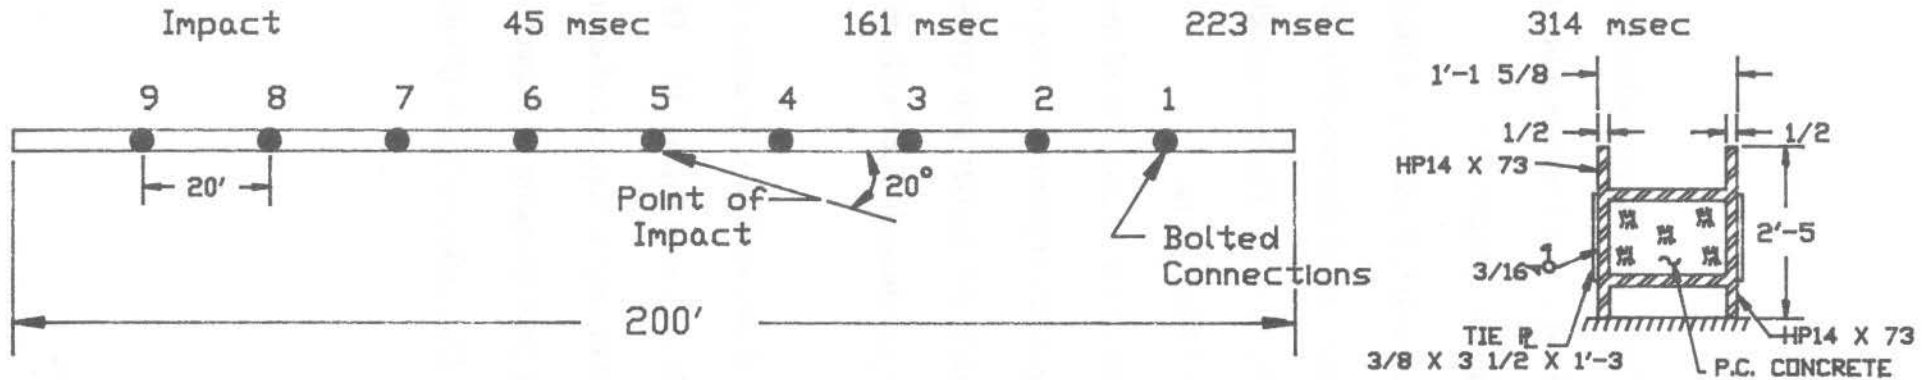
Test No.	I5-1	Barrier Damage (deflections)	
Date	8/25/89	Connection (no. 5)	17 9/16 in.
Test Vehicle		Permanent Set (Member 5-6).	1/8 in.
Model	1983 Chev. Pickup	Vehicle Damage	
Weight		TAD	1-RFQ-4
Test Inertia	5,500 lbs.	VDI	01RYEN2
Gross Static	5,500 lbs.	Occupant Impact Velocity	
Impact Conditions		Longitudinal	13.5 fps
Speed	60.6 mph	Lateral	19.6 fps
Angle	22.5 deg.	Occupant Ridedown Decelerations	
Exit Conditions		Longitudinal	+4.7 g's/-6.7 g's
Speed	49.4 mph	Lateral	12.8 g's
Angle	1.5 deg.		
Rebound (max)	2.0 ft @ 65 ft

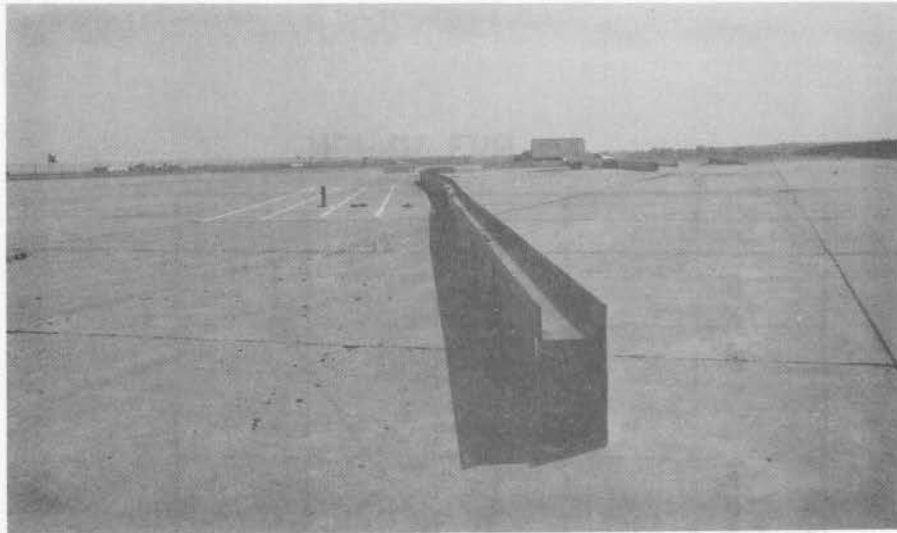
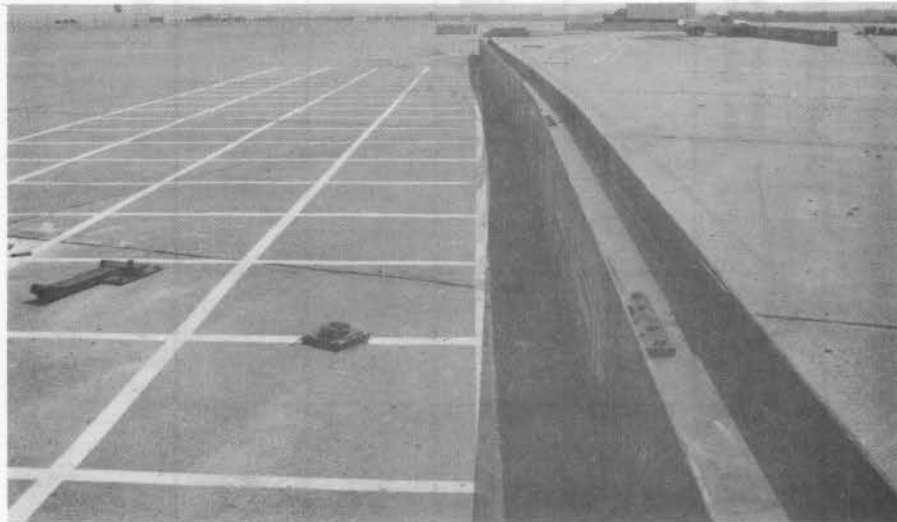
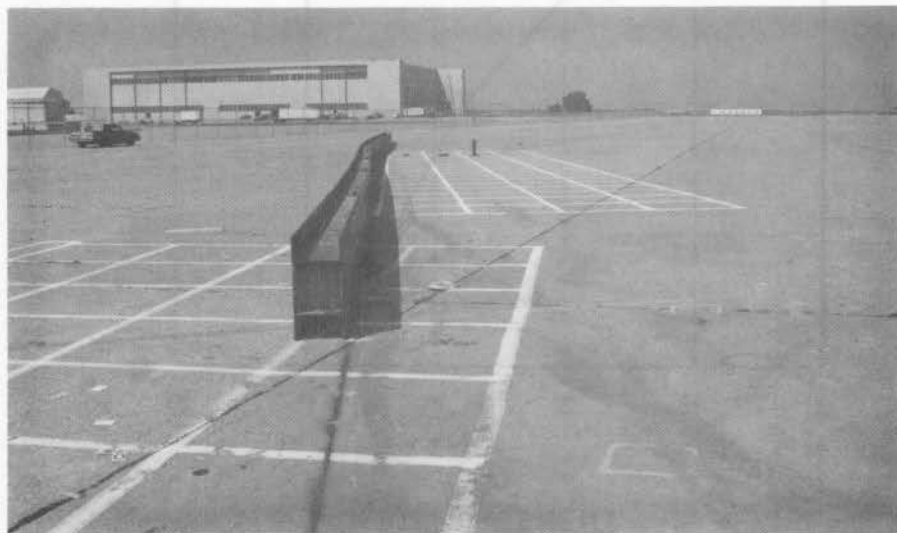
FIGURE 14. PHOTOGRAPHS OF BARRIER RAIL AFTER IMPACT.

Photographs of the barrier after impact are shown in Figure 14 and a sketch of the displacements of the barrier bolted connections is shown in Figure 15. The maximum displacement of 17 9/16-inches occurred at the point of vehicle impact and connection Joint No. 5. Member 5-6, the first member downstream from the point of impact, was the only member to experience a permanent deformation. This deformation is 1/8-inch.

After the vehicle had impacted and displaced the barrier rail, removal of the connection bolts was found to be both time consuming and difficult. The time required to assemble and disassemble the barrier rail installation could be reduced if the bolted connections were redetailed.

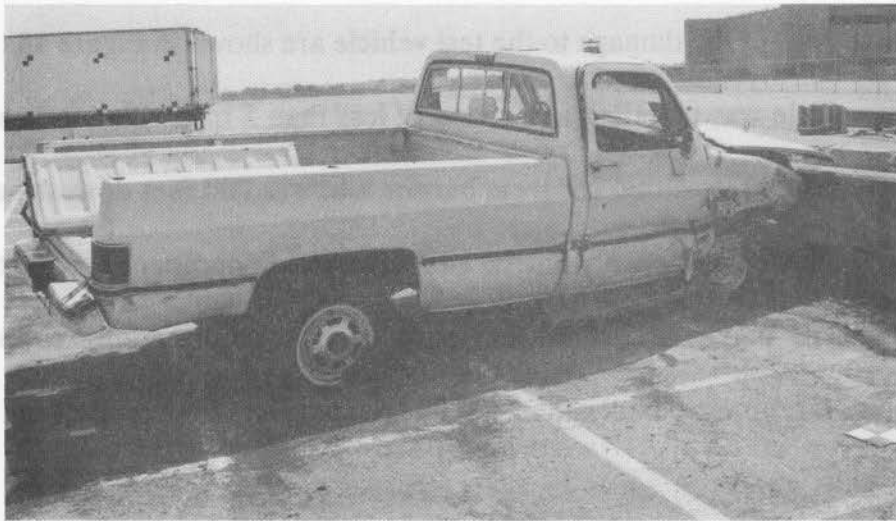
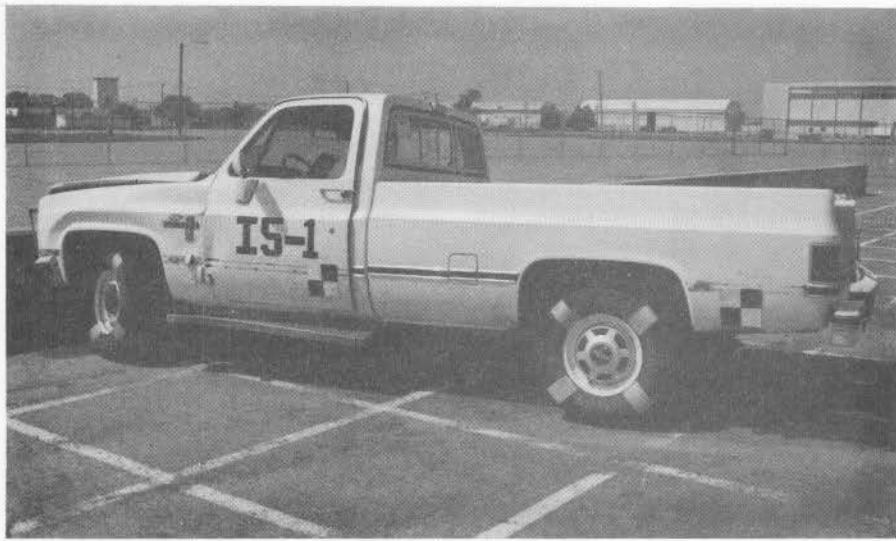
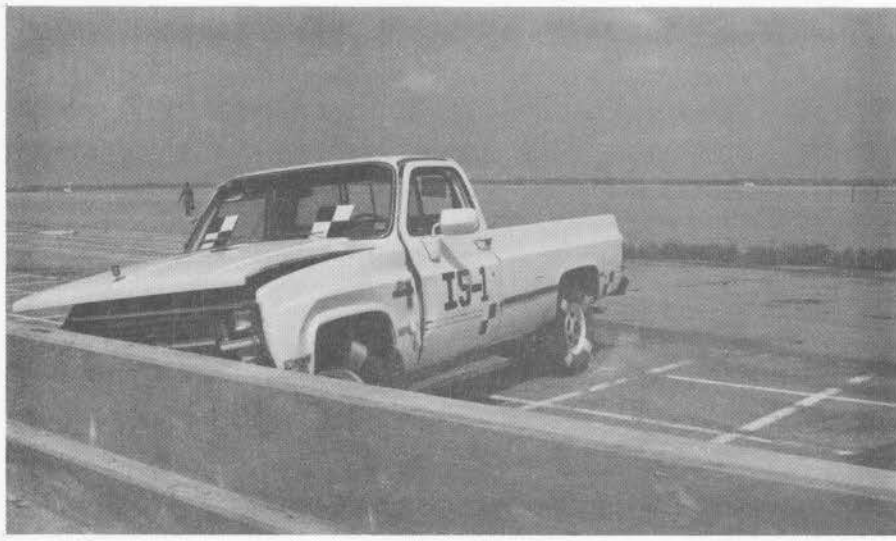
FIGURE 16. PHOTOGRAPHS OF VEHICLE DAMAGE.

Photographs of the damage to the test vehicle are shown in Figure 16. It is estimated that the test vehicle was traveling at a speed of less than 5 mph when it impacted head-on the previously tested retrofitted concrete barrier that was 200 feet downstream and 24 feet to the right of the steel temporary barrier rail. The inside occupant compartment cab area was intact with no barrier intrusions and essentially no deformation. It appears that the right rear tire and rim were badly damaged due to snagging on several of the 3/8-inch thick welded tie plate straps.
