# On conservation issues of contemporary architecture: The technical design development and the ageing process of the Jubilee Church in Rome by Richard Meier

Luciano Cardellicchio

In May 2017, a technical survey was run by the author of this paper fourteen years after the opening day of the church, to measure the ageing process of the church especially with regards to the innovative solutions developed.

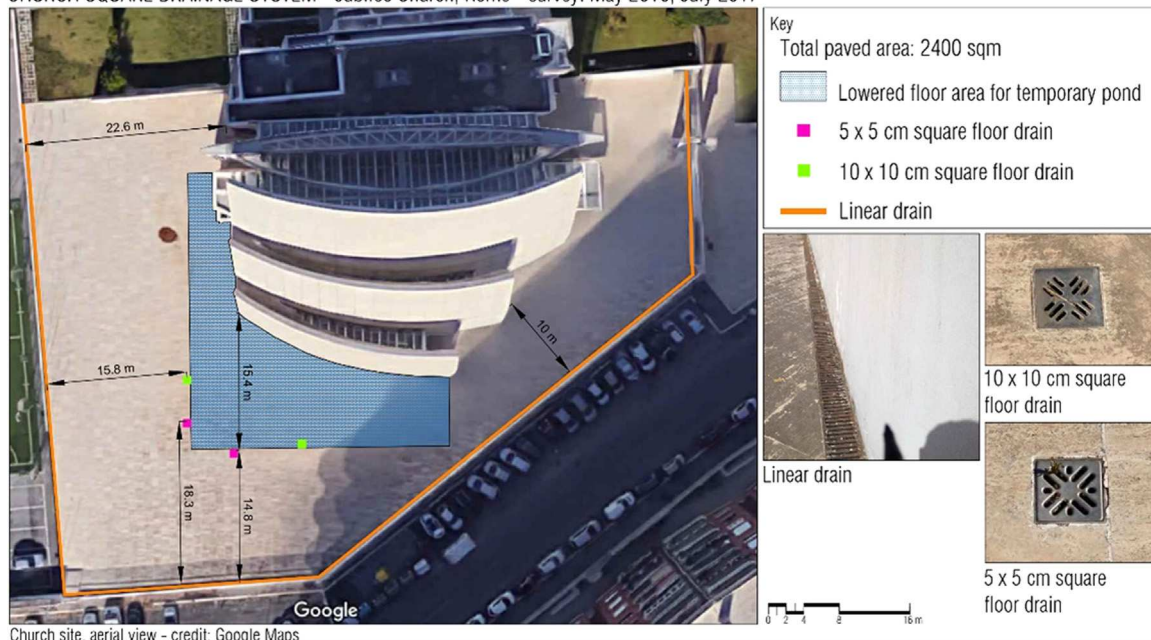
CHURCH SQUARE DRAINAGE SYSTEM - Jubilee Church, Rome - survey: May 2016, July 2017

Fig. 6 The drainage system of the church square (drawing and pictures by the author).

The drainage system of the wide church square paved with travertine stones was severely underestimated in the design phase. As has been previously reported, a large pond was designed to surround the shells at the competition stage. Following the change during the Developed Design stage, a much smaller squared area of the external floor bordering the shells and the back of the church was constructed slightly lowered to collect the rain water and create a temporary pond, noticeable only when it rains. In addition

to this solution, very few drains were arranged in the rest of the paved area. The whole area is 2400 m<sup>2</sup> and the rain water is collected only by linear drains along the perimeter of the plot together with 3 (5 × 5 cm) drains at the edge of the lower area and 2 more (10 × 10 cm) drains in the middle of it (Fig. 6). With the effect of rain-water stagnation and without regular cleaning, the surface is affected by high levels of depositions of sulphur dioxide and oxides of nitrogen (Fig. 7). The level of the deposition rises along the temporary pond at the back of the church where clearly the rain cannot be collected. A long crack is visible on the travertine floor in an area near the small shell suggesting poor execution of the floor together with the supply of shallow travertine tiles not properly sized for both the usage and thermal excursion.

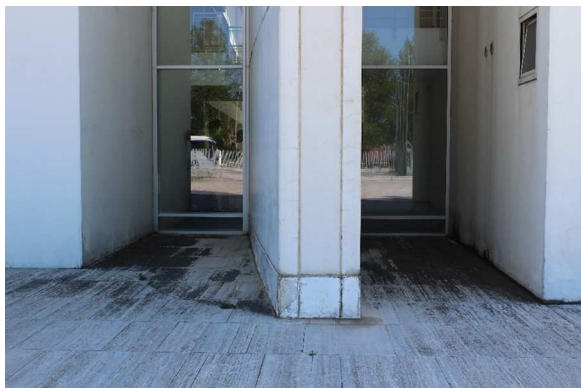
**Fig. 7** The area of the external pavement most affected by the acid rain deposits (Picture by the author, taken 22/05/2016).

Acids have a corrosive effect on limestone, sandstone, and marble.

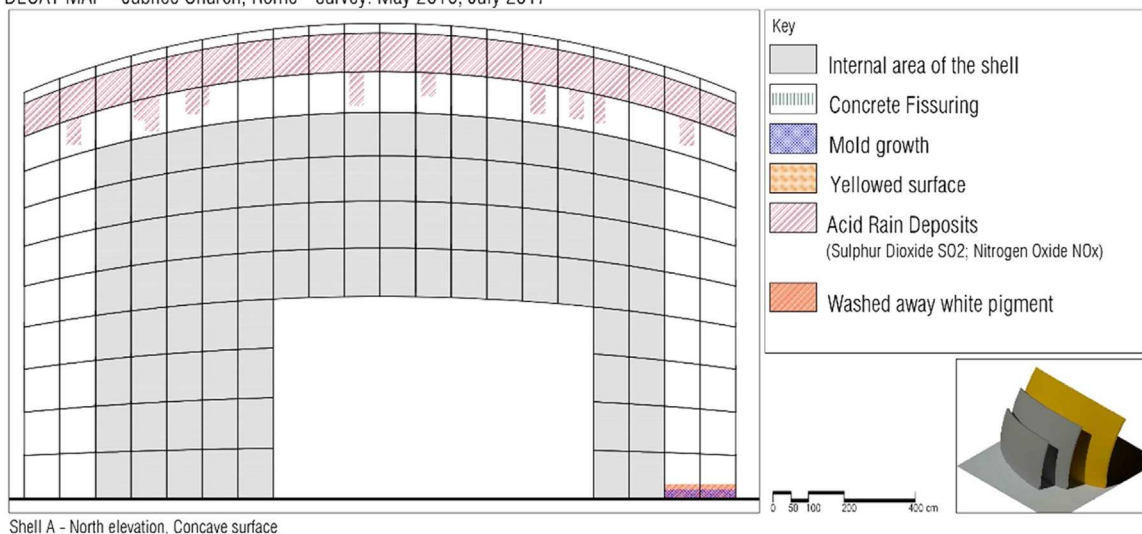
DECAY MAP - Jubilee Church, Rome - survey: May 2016, July 2017

**Fig. 8** Decay map of the concave side of the large-size shell (drawing by the author).

shell. In detail, on the first course, concrete fissuring, moulds and washing-off of white pigmentation are visible where the shells meet the ground whilst extensive black stains are visible at the top of the northern side of each shell. The black deposition on the shells is more visible on the surfaces which constantly shaded, where the surface remains wet for longer and the sun cannot start the catalysing process with the dioxide of titanium contained in the TX Millennium concrete. This happens mostly at the back of the church, where the shells are closer to each other, or on the surfaces exposed to the north (Figs. 8, 10, 12).

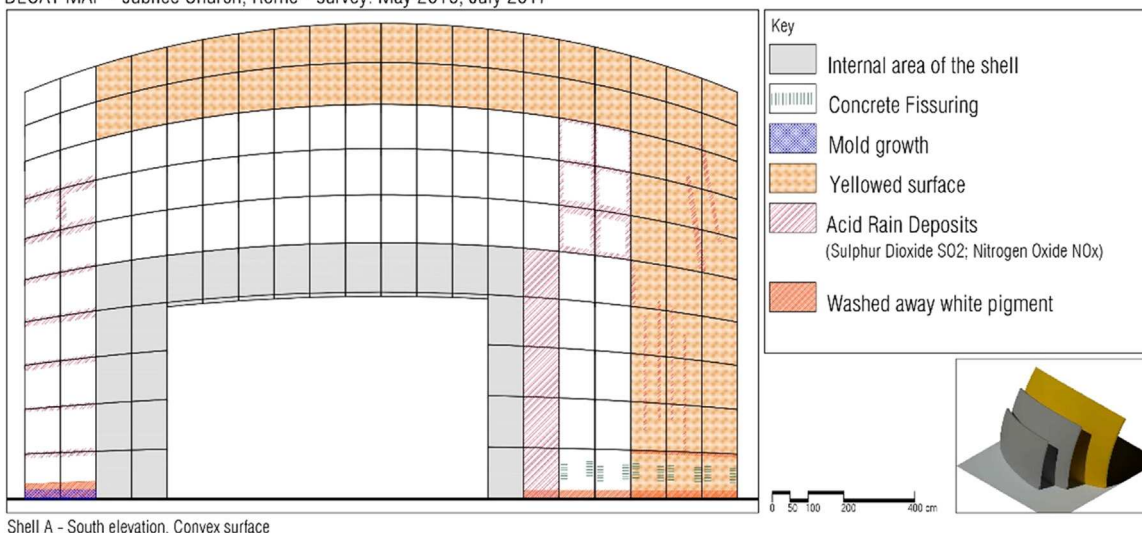
DECAY MAP - Jubilee Church, Rome - survey: May 2016, July 2017

**Fig. 9** Decay map of the convex side of the large-size shell (drawing by the author).

whilst blackening and fissuring along the edges. This is why the rain stagnates on the wider joints between the concrete blocks, blackening them extensively (Figs. 9, 11, 13). As this was the first time this cement mix was used it is not possible to compare this data with other case studies or measure the ageing process against the expectations of the Italcementi Group (Fig. 14).

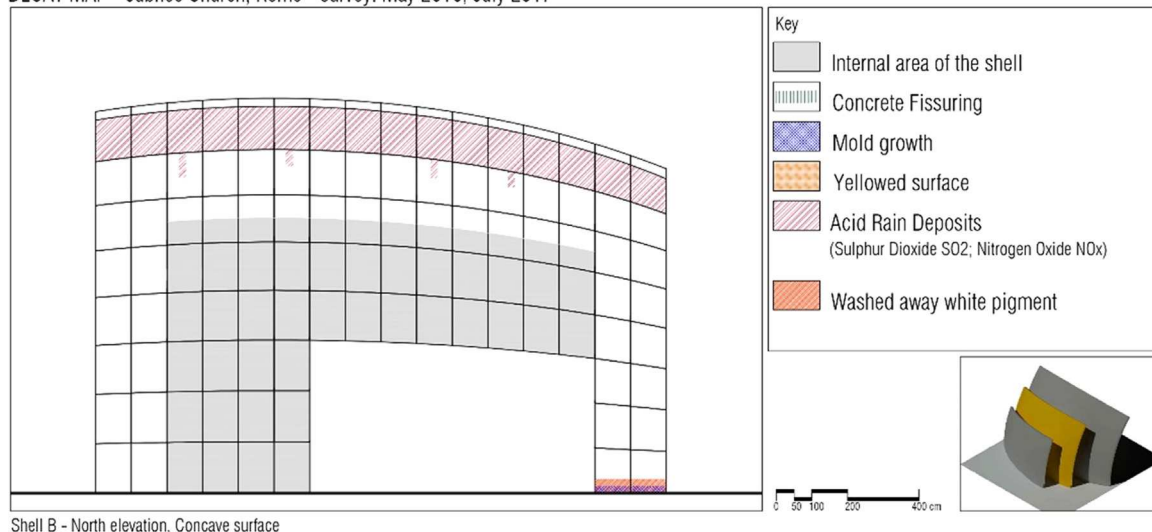
DECAY MAP - Jubilee Church, Rome - survey: May 2016, July 2017

Fig. 10 Decay map of the concave side of the medium-size shell (drawing by the author).

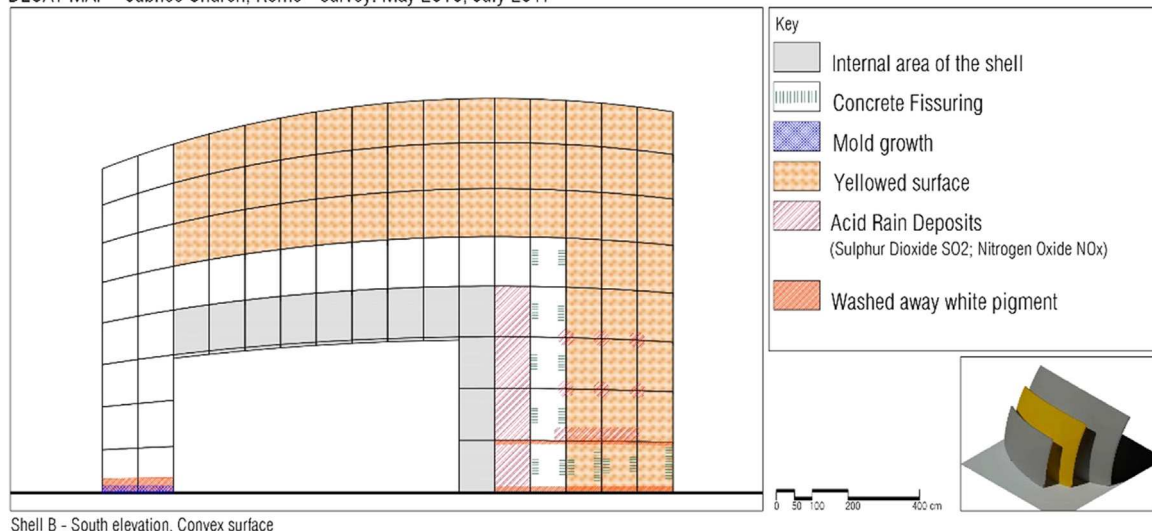
DECAY MAP - Jubilee Church, Rome - survey: May 2016, July 2017

Fig. 11 Decay map of the convex side of the medium-size shell (drawing by the author).

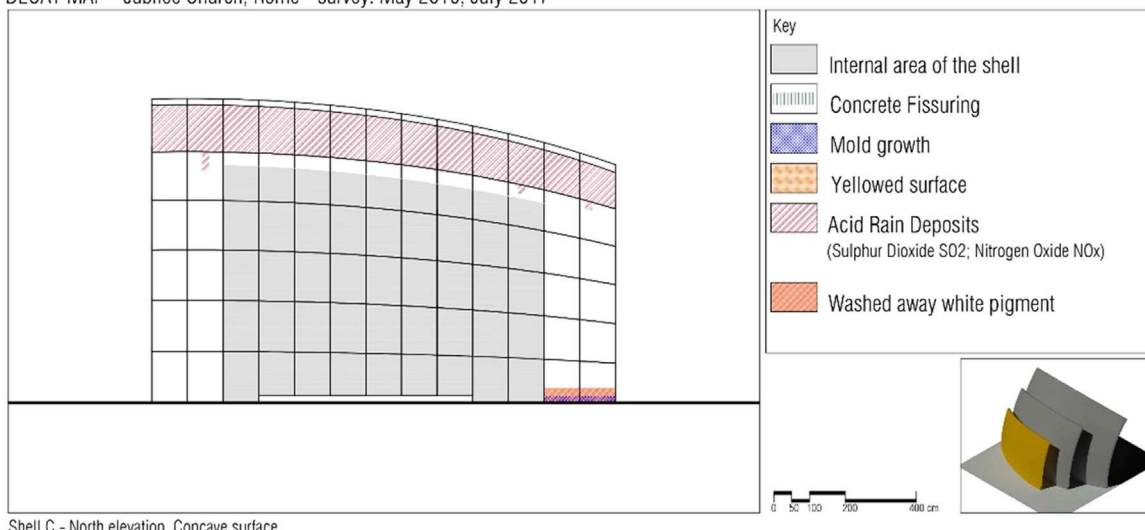
DECAY MAP - Jubilee Church, Rome - survey: May 2016, July 2017

Fig. 12 Decay map of the concave side of the small-size shell (drawing by the author).

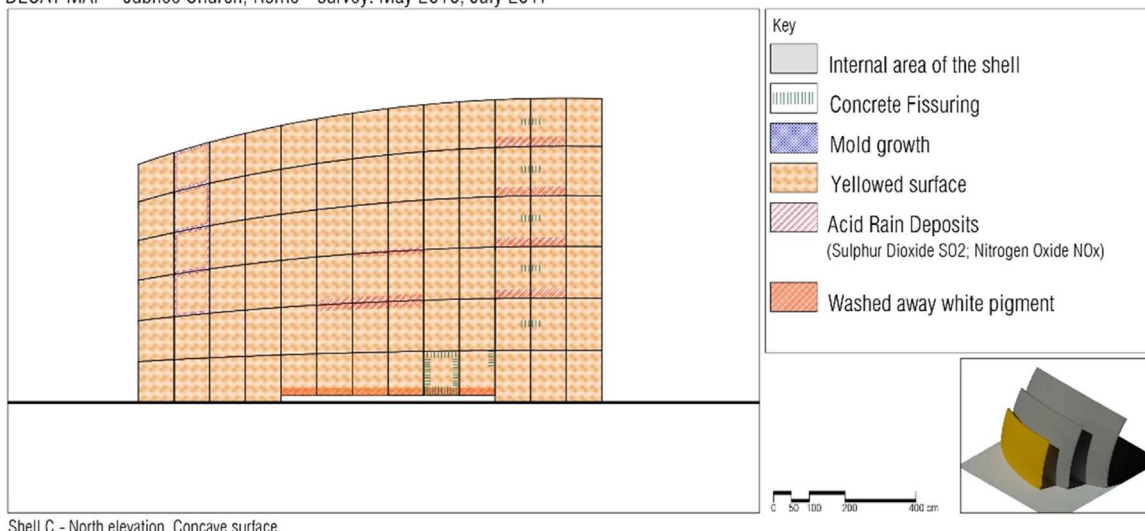
DECAY MAP - Jubilee Church, Rome - survey: May 2016, July 2017

Fig. 13 Decay map of the convex side of the small-size shell (drawing by the author).

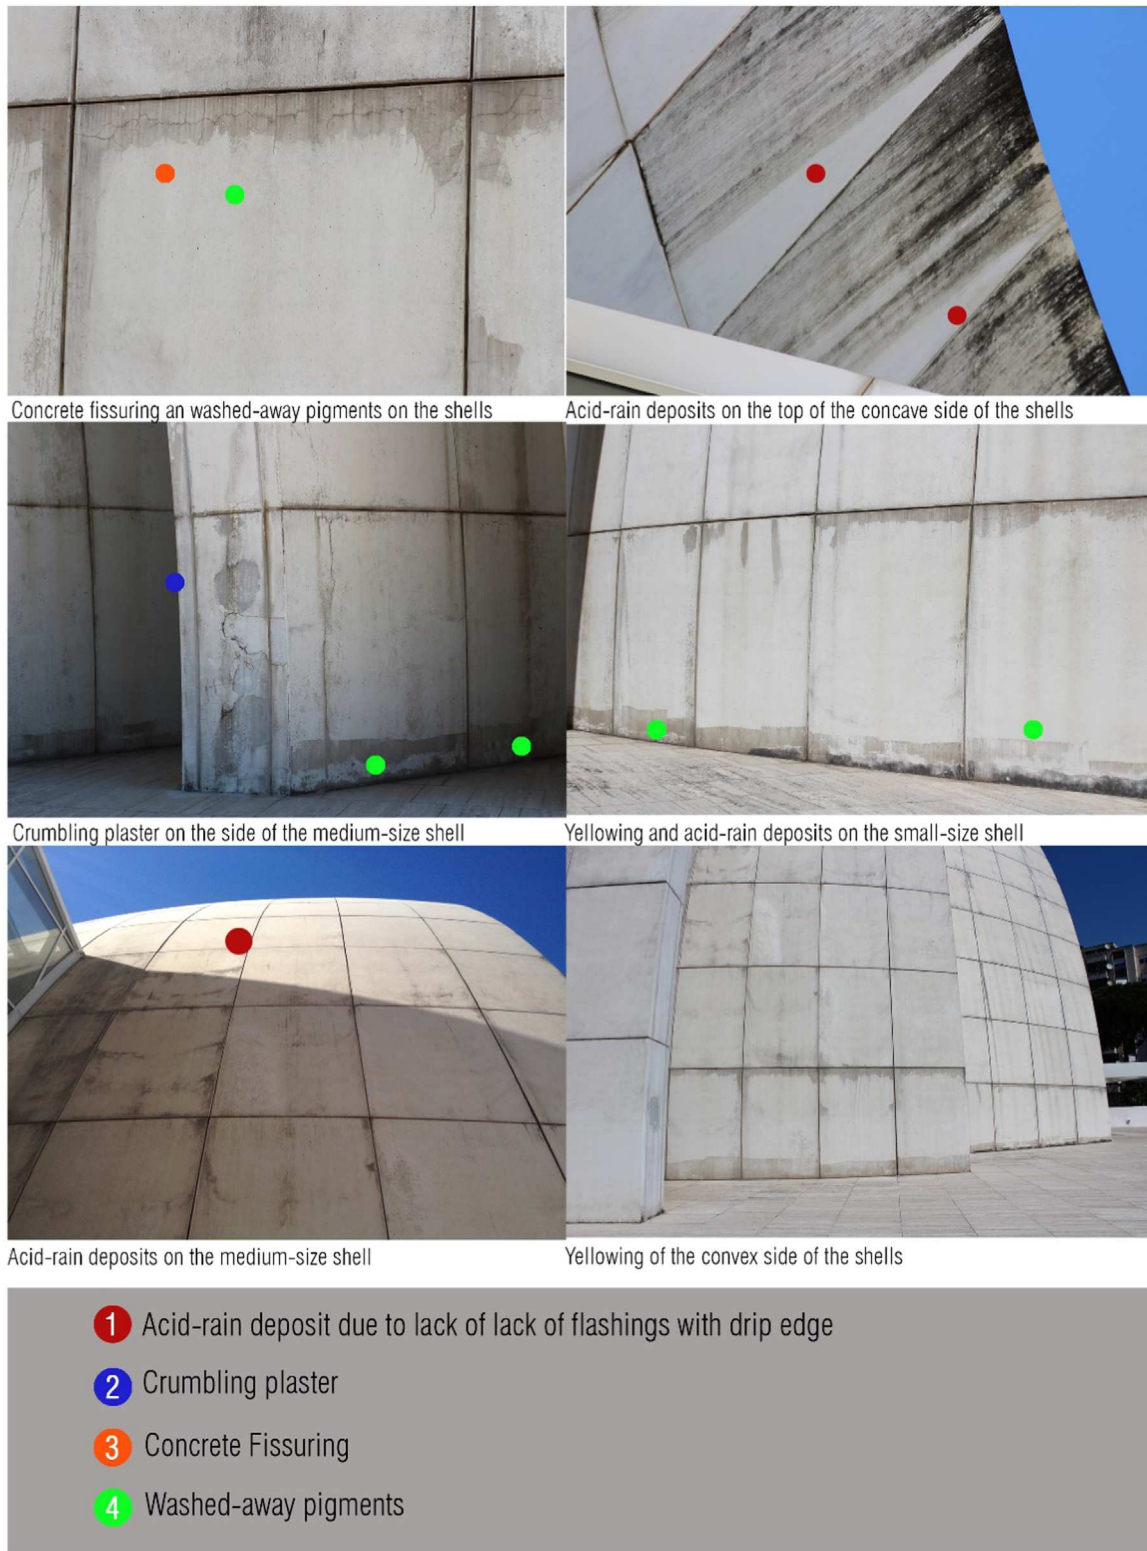
DECAY MAP - Concrete Shells - Jubilee Church, Rome - survey: May 2016, July 2017

Fig. 14 State of decay of the shells (Pictures by the author, taken 22/05/2016 and 28/07/2017).

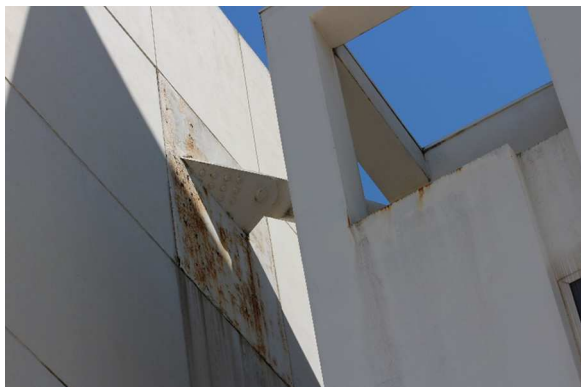
**Fig. 15** Presence of rust on the pinned joint of the roof beam (Picture by the author, taken 22/05/2016).

The pinned joints connecting this wall with the curved beam and some of the pendula are visibly rusted, suggesting a poor level of galvanisation prior to their construction (Fig. 15).

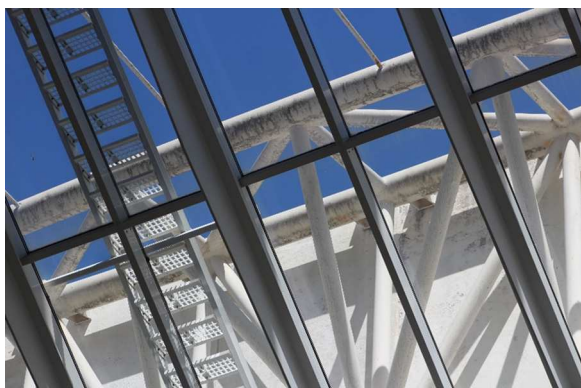
**Fig. 16** Presence of acid rain deposits on the roof beam and on the roof truss. Some rusted roof pendula are visible as well as the crumbling plaster behind the steel truss (Picture by the author, taken 22/05/2016).

On the intrados of the curved beam and inside the cross bracing of the truss, large depositions of sulphur dioxide and oxides of nitrogen are visible from the inside of the church hall. Plaster detachment is visible on the wall against the steel truss (Fig. 16).

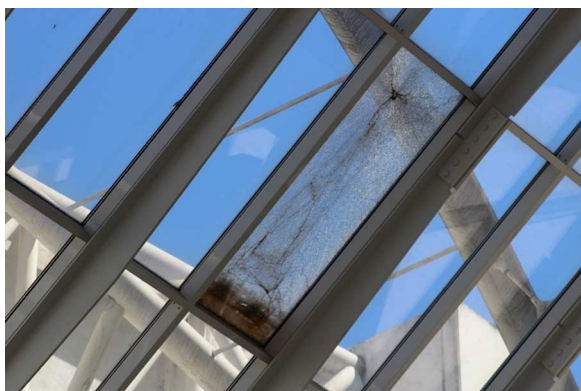
**Fig. 17** A broken glass panel of the roof truss (Picture by the author, taken 22/05/2016).

In April 2012, a seagull flying over the church dropped an object from its beak onto the glazed roof. The impact broke a glass panel which has not been replaced yet due to the high cost, unaffordable for a small parish on the outskirts of Rome (Fig. 17). The rest of the glass panels and their mullions and transoms are in good-shape.

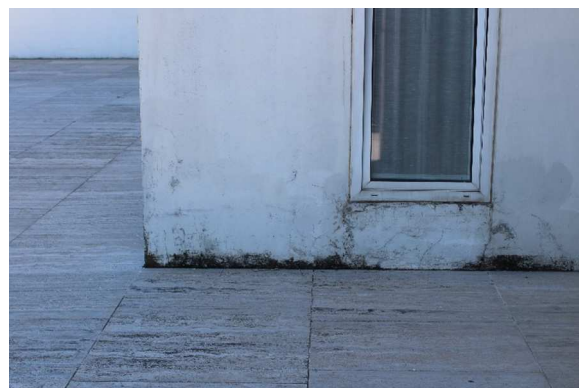
The sacristy and the altar are designed into a plastered block which encloses the space of the hall on the west side of the church. The volume is located half inside and half outside the church. The part protruding on the outside is bordered by the lowered floor acting as a temporary pond when it rains. In the construction detail, no waterproofing membrane, nor a stone skirting board, nor a linear drain were designed where the block meets the travertine floor. Therefore, the stagnation of the water has caused diffuse crumbling plaster and visible mould at the bottom of the block (Fig. 18).

**Fig. 18** Mould growth at the bottom of the block of the altar.

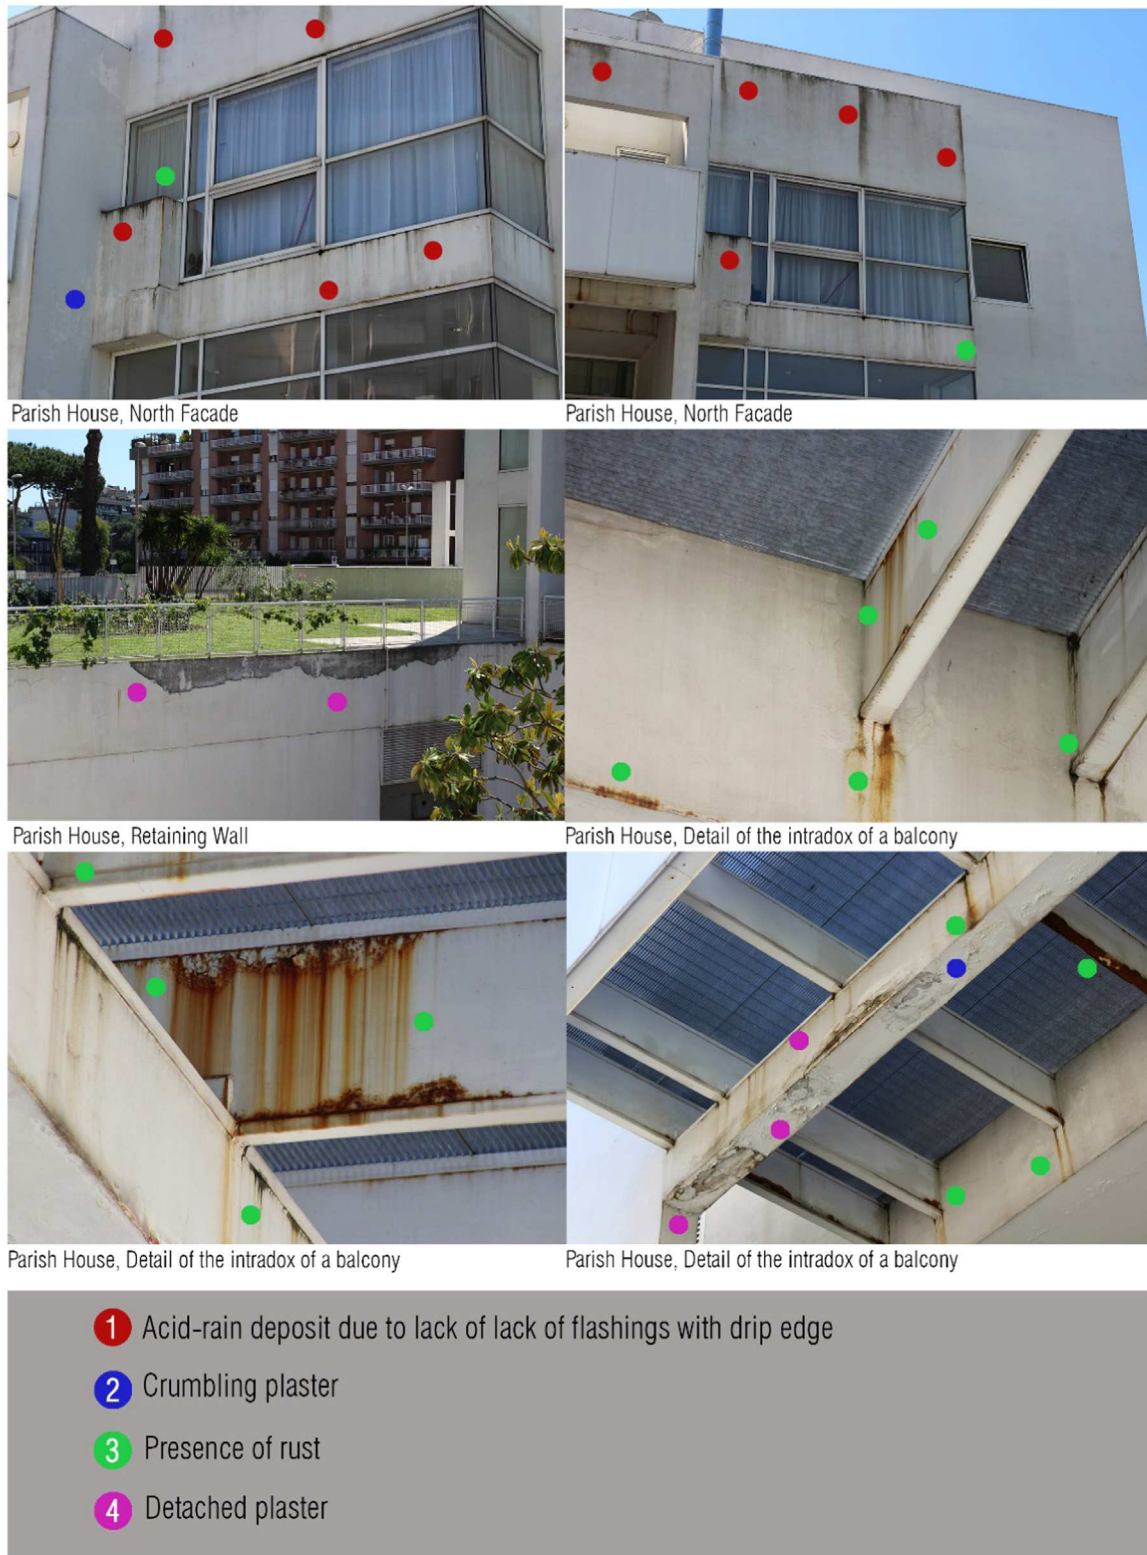
DECAY MAP - Parish House - Jubilee Church, Rome - survey: May 2016, July 2017

Fig. 19 State of decay of the northern façade of the parish house truss (Picture by the author, taken 22/05/2016).

On the northern façade of the parish house several damages have occurred. The balconies are built with a system of exposed steel girders supported by a reinforced concrete beam, plastered with stucco. Due to a poor level of galvanisation, all of the girders are visibly rusted while the concrete beams have experienced severe crumbling and detachment of the plaster. As the floor of the balconies is built in metal grill, rain water falls directly on these structural members which have not been built with proper waterproofing elements.

The northern façade of the parish house is severely damaged by the lack of flashing with drip edges. The windows are aligned with the plastered wall and they are not protected either by being set back or by canopies. In addition, the flashing topping that there is on the façade does not protrude enough to protect the walls from acid rain. The result is the presence of diffuse stains from black particles all along the façade and around the frames of the windows. On top of the east side of the retaining wall bordering the lowered courtyard, designed to naturally light up the basement of the parish house, extensive portions of detached plaster are visible. Again, this is due to a poorly designed drainage system and poor execution (Fig. 19).
