GEO-ENGINEERING EXTREME EVENTS RECONNAISSANCE (GEER) ASSOCIATION

Turning Disaster in Knowledge

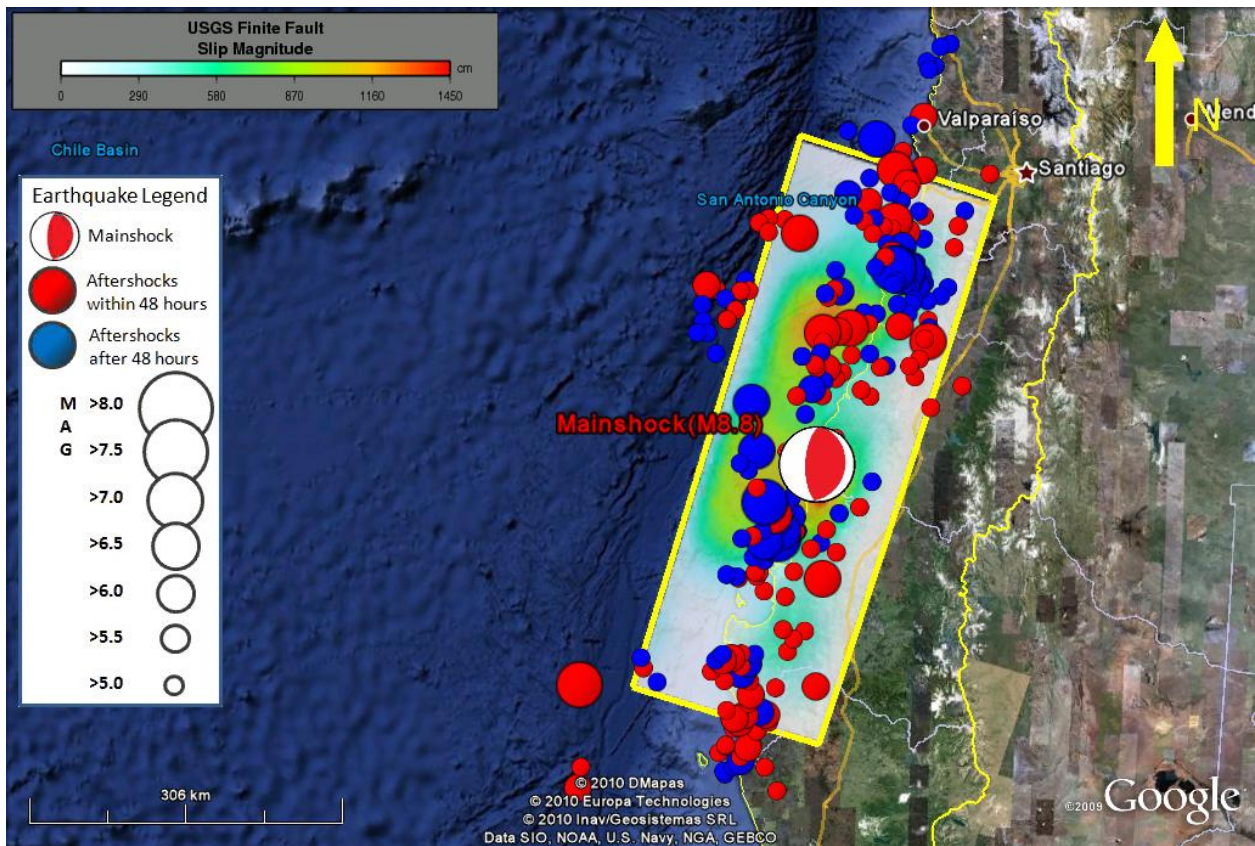
Figure 2.1. Google Earth image superimposed with aftershock distribution (locations from USGS) and fault plane solution from G. Hayes (obtained from USGS web page)

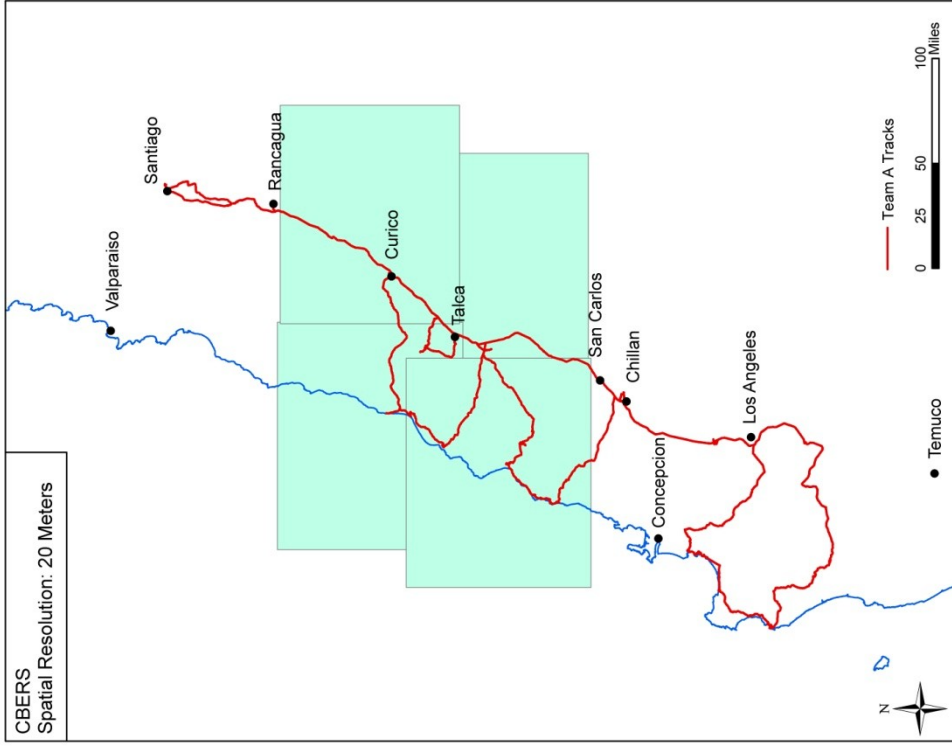
Figure 3.15. CBERS post coverage

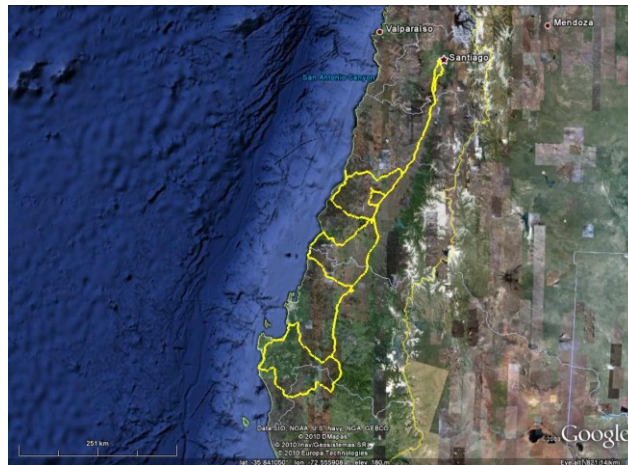
Figure 3.16. Google Earth based image of Team A reconnaissance tracks.

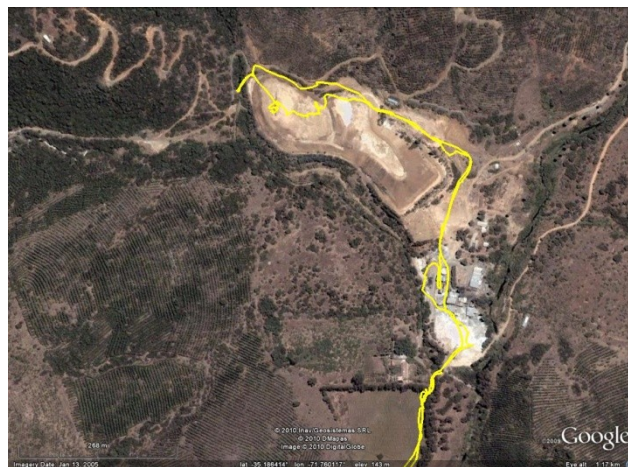
Figure 3.17. Google Earth based pre-event image of Las Palmas Tailings Dam that failed.

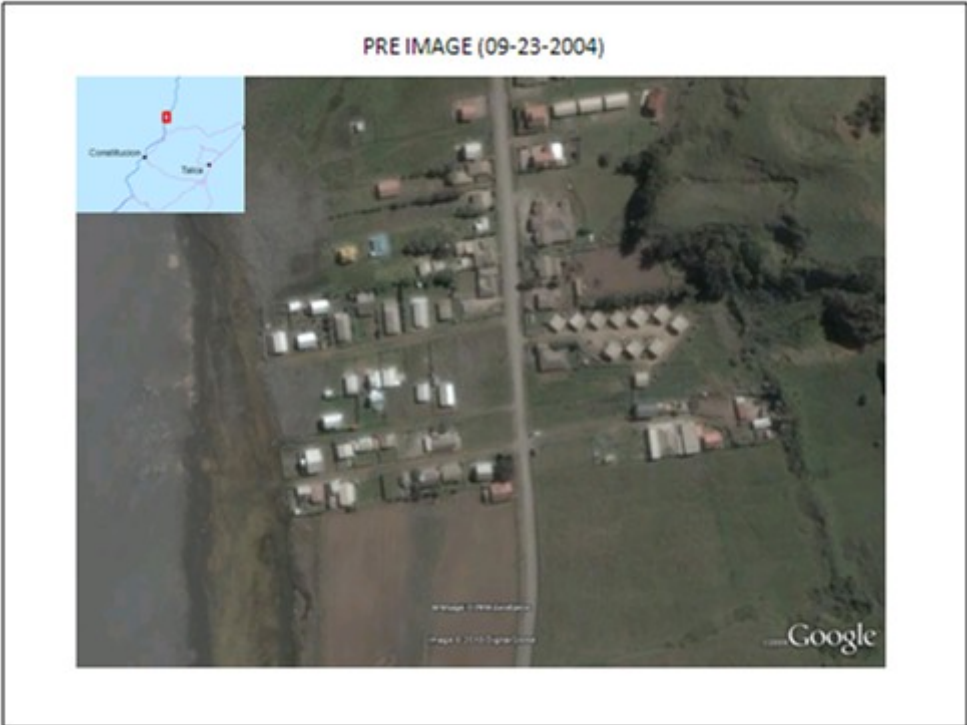
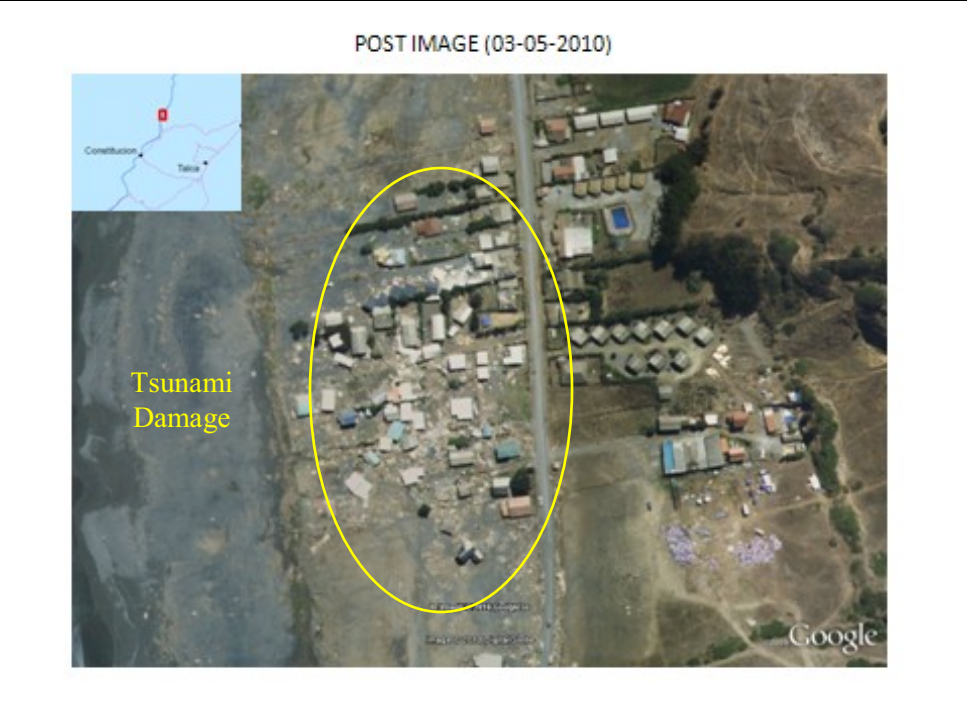
Figure 3.18. Pre/Post Imagery of Iloca (34.924° S, 72.179° W)

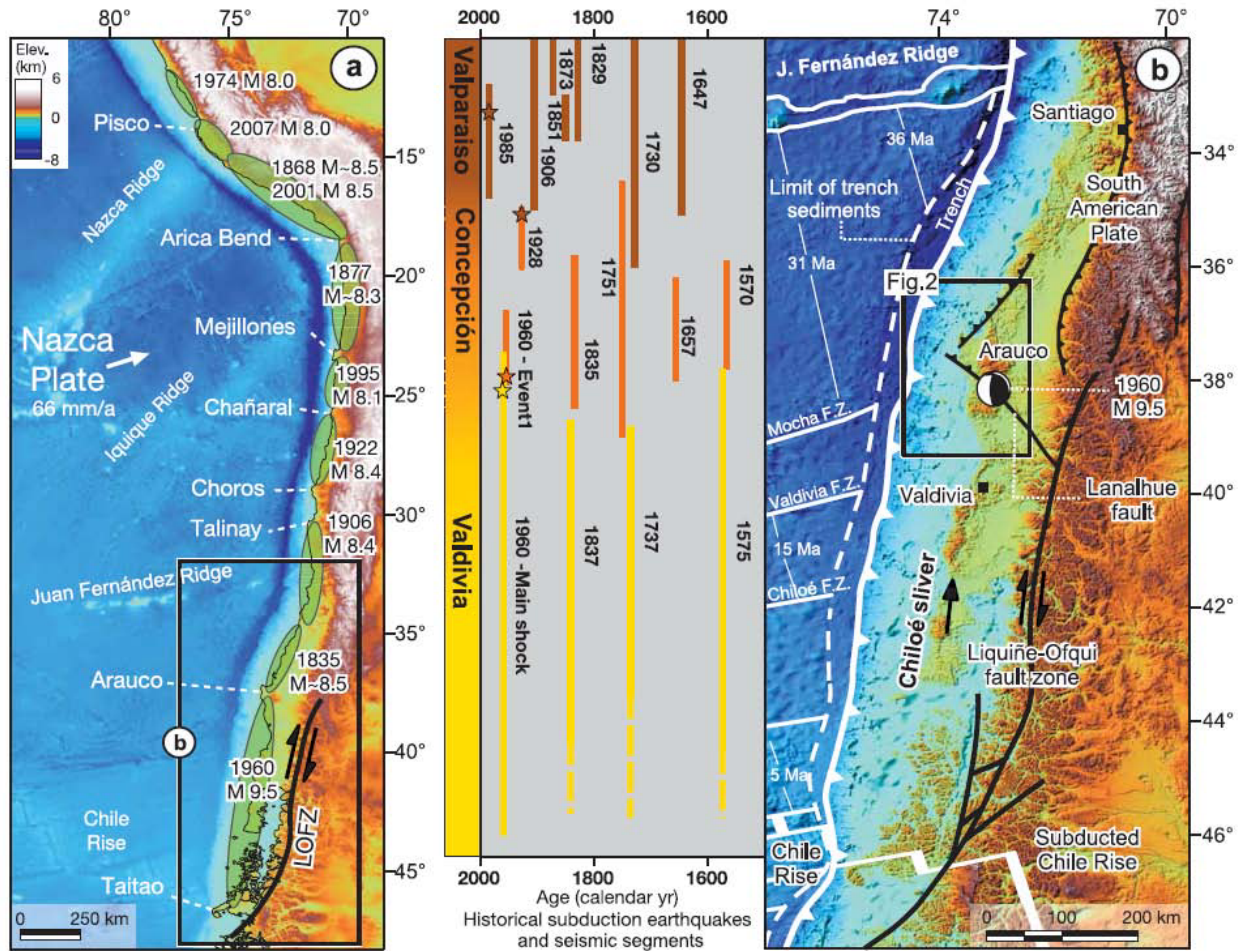
Figure 4.1. (from Melnick et al., 2009) A: Major seismotectonic features along the Chilean coastline of South America, including rupture segments of large historical earthquakes; LOFZ: Liquiñe-Ofquí fault zone; B: Major Quaternary faults within south-central Chile, seismotectonic segments, rupture zones of large historical earthquakes, and main tectonic features of the south-central Andean convergent margin.

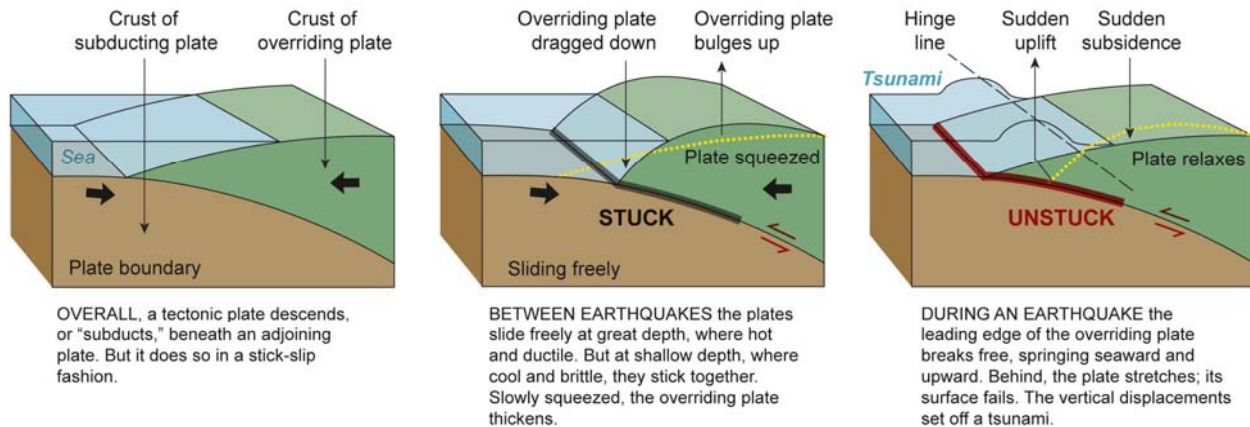
After Atwater et al. (2005)

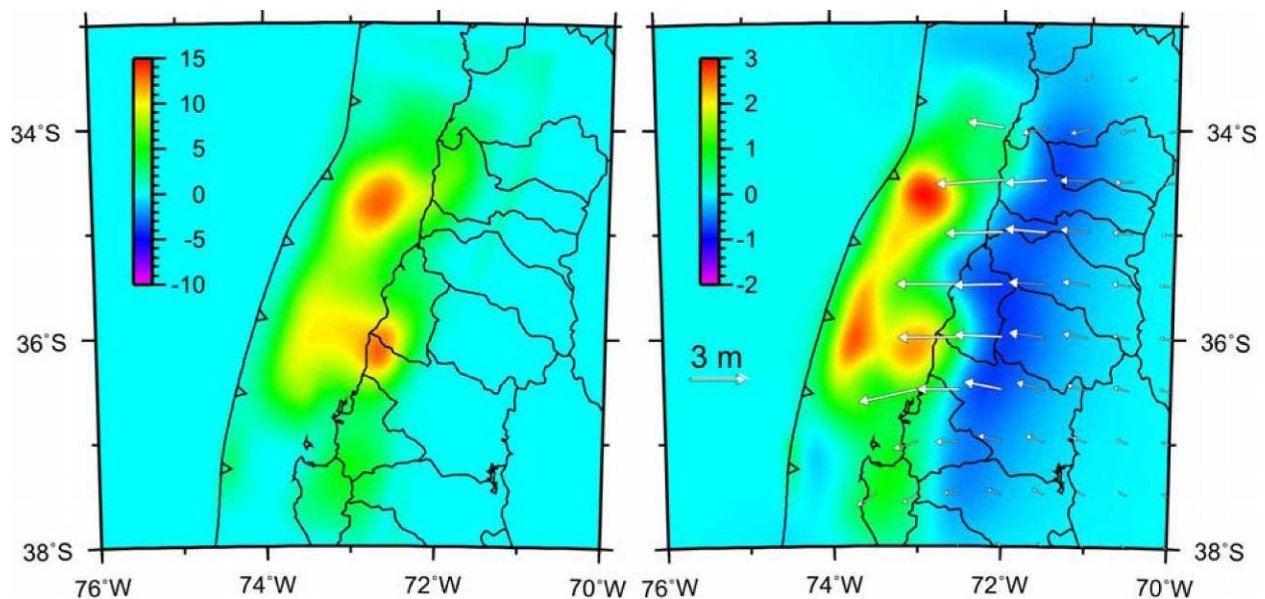
Figure 4.3. Left: fault slip (color in m) model by Gavin Hayes (USGS) inverted from seismic data. Right: coseismic vertical deformation (color in m) and horizontal displacements (arrows) predicted by a uniform half-space dislocation model (personal communication, K. Wang, March 2010).

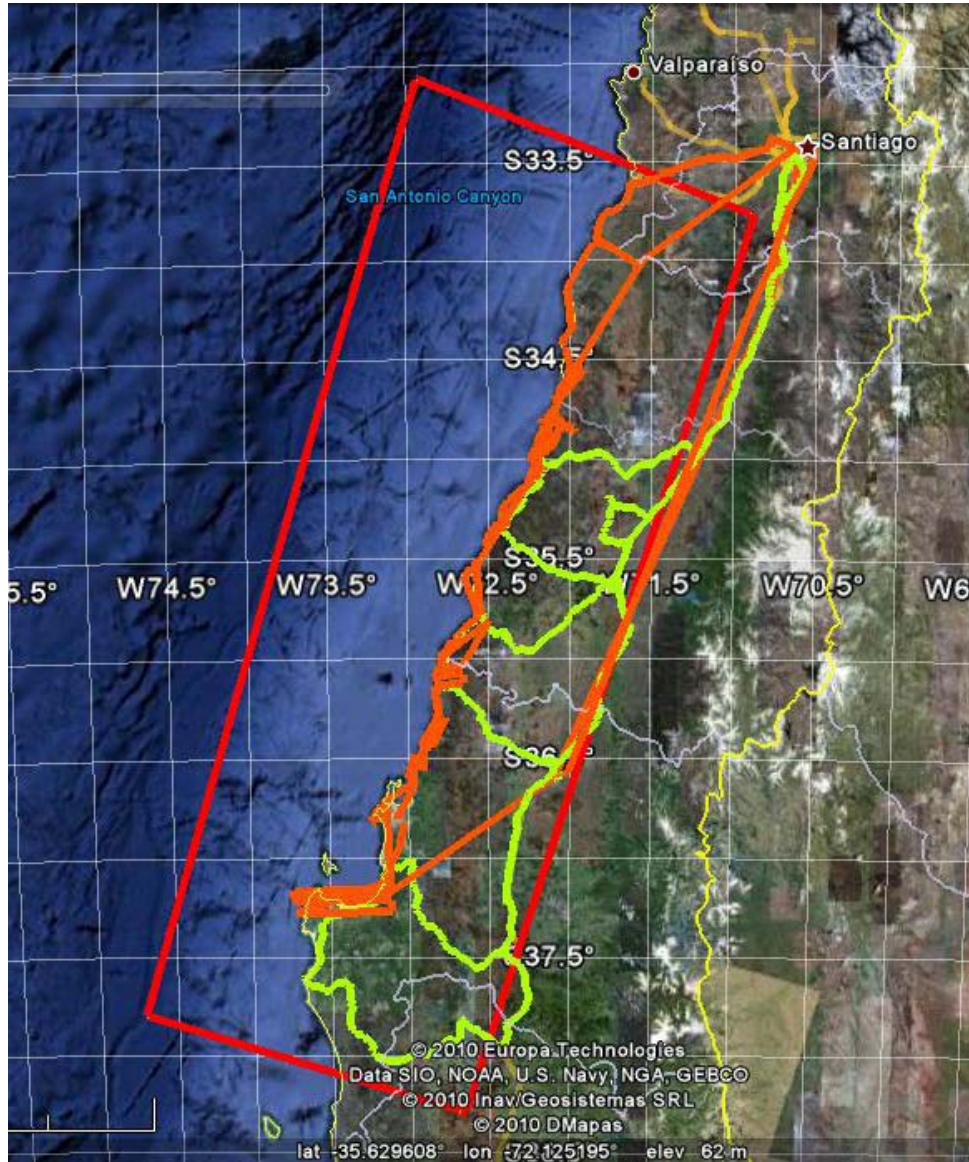
Figure 4.4. Map from GoogleEarth showing tracks of aerial (orange) and ground reconnaissance traverses (green) related to assessment of regional geology and tectonic deformation (red).

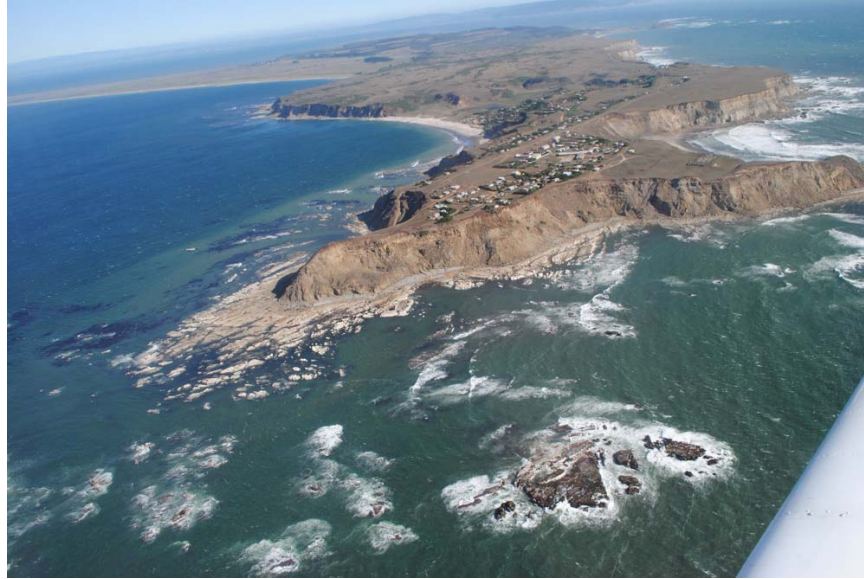
Figure 4.12. Northern end of Isla Santa Maria, looking south toward wave-cut platforms on uplifted coastline and islands. (S37.593958° W73.668225°; 1910 hrs on 03/9/2010).

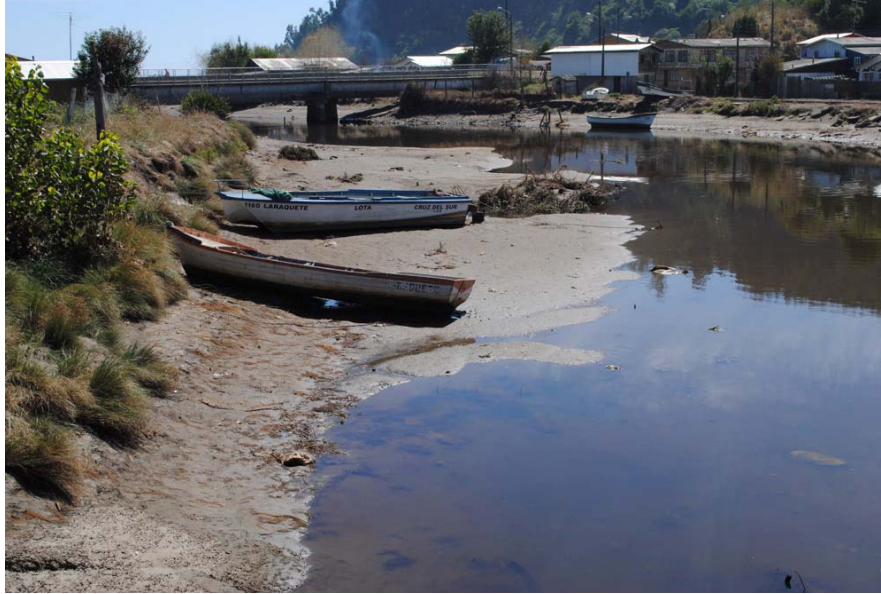
Figure 4.13. Ground view looking north in village of Laraquete, from the highway bridge toward the estuary outlet. Fishing boats stranded on left bank; tsunami high water mark approximately at the bank crest. Light, wooden-frame residences on both banks were unaffected by tsunami waves confined within existing tidal channel. Local witness indicated that the sea level went down about 0.5 m after the earthquake, and that the estuary bottom had not been exposed before (i.e., uplift of about 0.5 m). (S37.166661° W73.184481°; 1238 hrs on 03/10/2010)

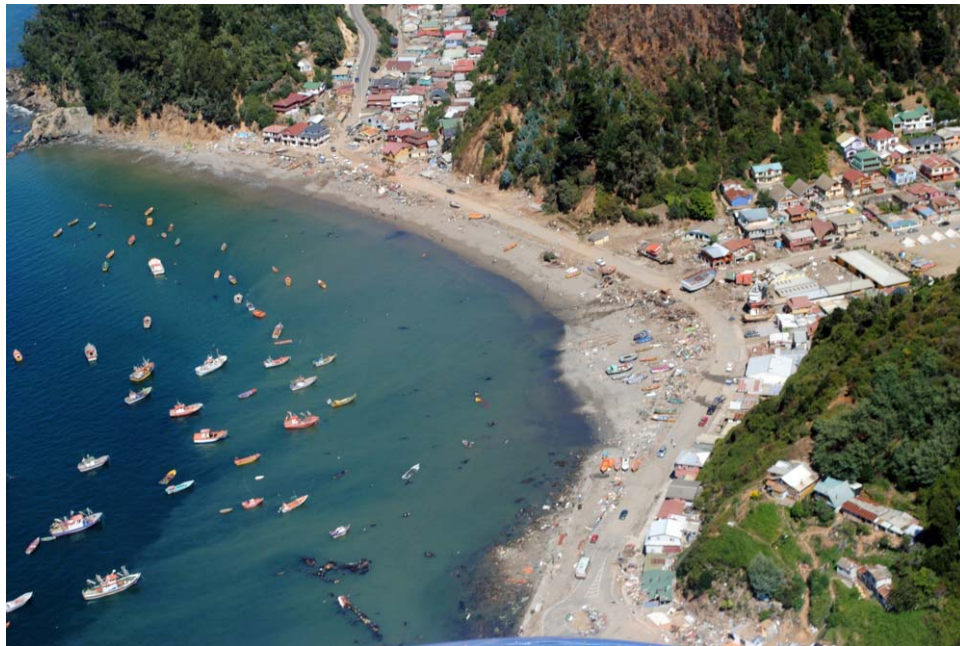
Figure 4.15. Aerial view of village on the eastern shoreline of Punta Tumbes, on western side of Bahia Talcahuano; substantial tsunami damage from runup into urbanized valleys. (S36.639522° W73.093267°; 1312 hrs on 03/09/2010)

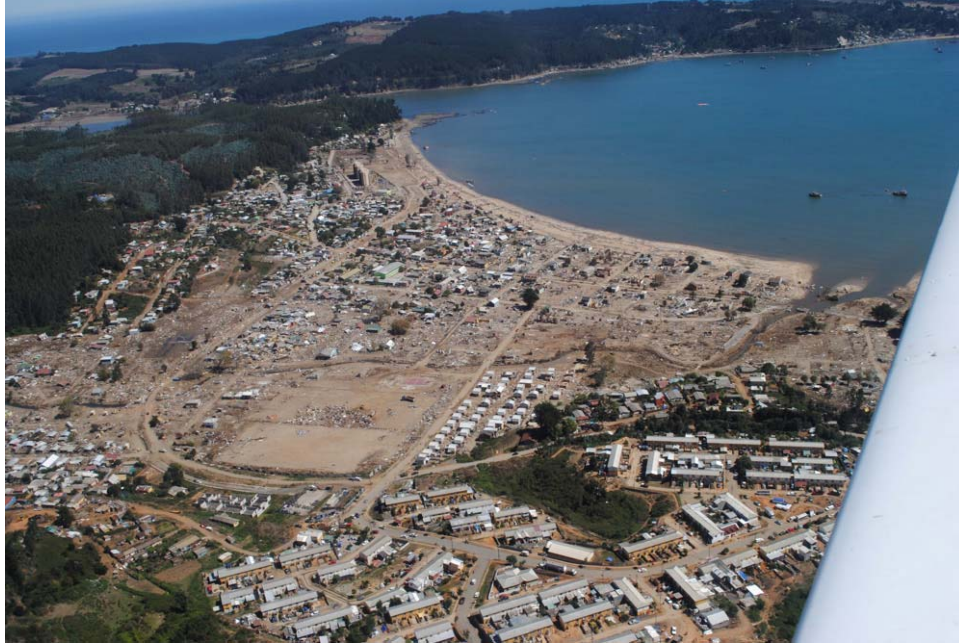
Figure 4.16. Aerial view looking west of town of Dichato, showing tsunami damage focused on north-facing shoreline in Bahia Talcahuano. (S36.548022° W72.922225°; 1301 hrs on 03/09/2010)

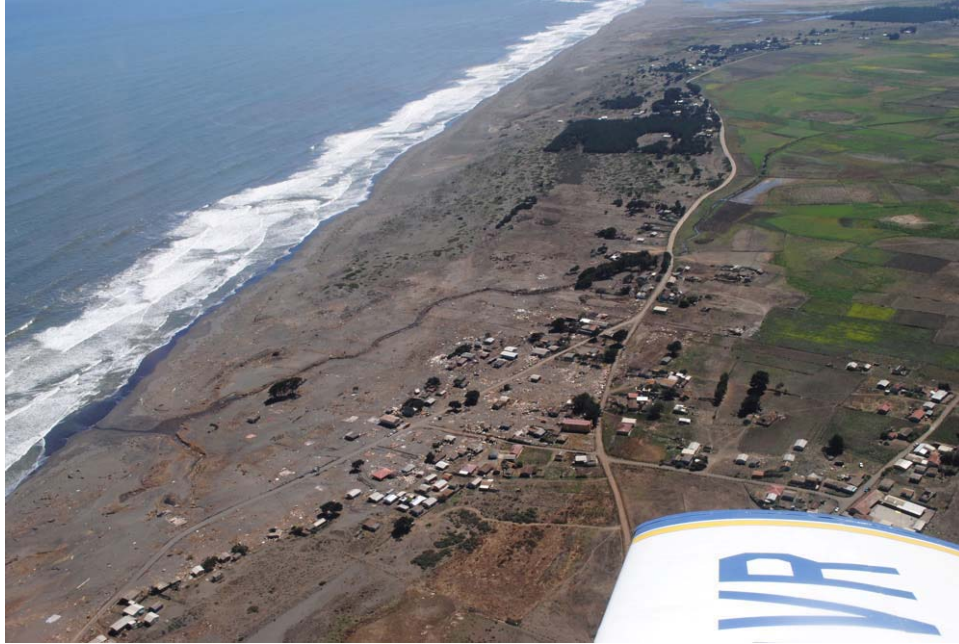
Figure 4.17. Aerial view looking north at village of Vegas de Itata, showing substantial tsunami damage. No evidence was observed of substantial uplift of this area. (S36.429192° W72.871433°; 1255 hrs on 03/09/2010)

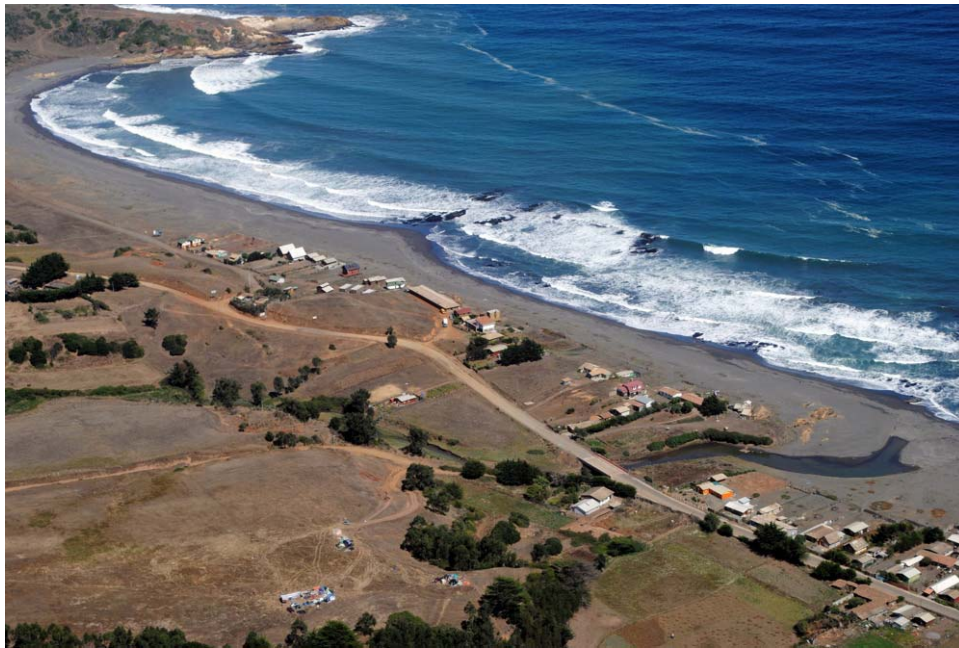
Figure 4.18. Aerial view looking southwest of shoreline at latitude of town of Cobquecura, near the Feb 27 epicenter. The tsunami extended up the tributary valley but apparently did not produce damage of residential structures close to the west-facing shore. (S36.172950° W72.808775°; 1242 hrs on 03/09/2010)

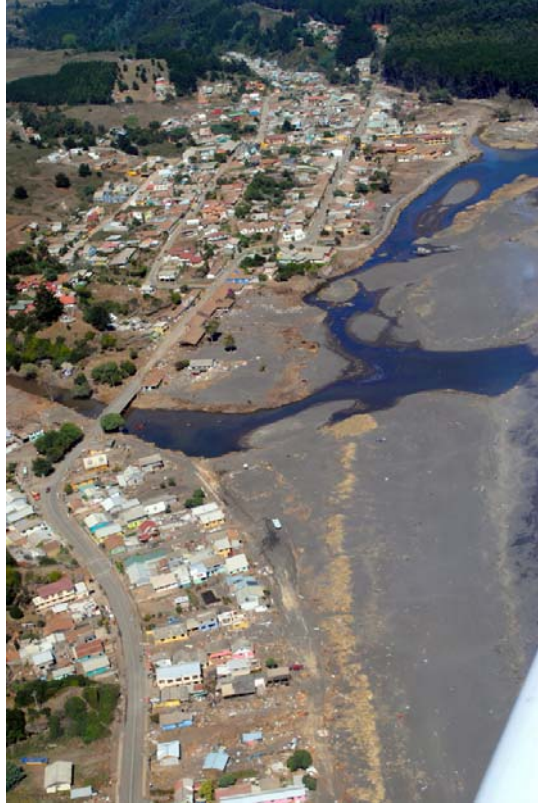
Figure 4.19. Aerial view looking south at village of Curanipe, including evidence of tsunami damage (i.e., red truck beneath bridge). Field observations of wave-cut platforms in this area indicate earthquake-related uplift of approximately 2 m. (S35.843297° W72.631214°; 1225 hrs on 03/09/2010)

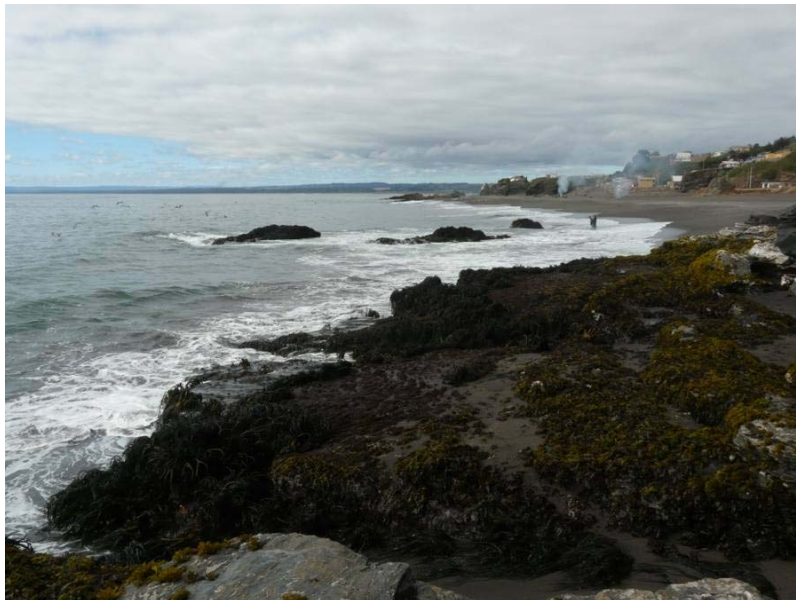
Figure 4.20. Intertidal mussels and algae exposed on rocky reefs south of Pelluhue suggest as much as 2.0 m of uplift. (S35.821915° W72.602106°; 1706 hrs on 03/17/2010).

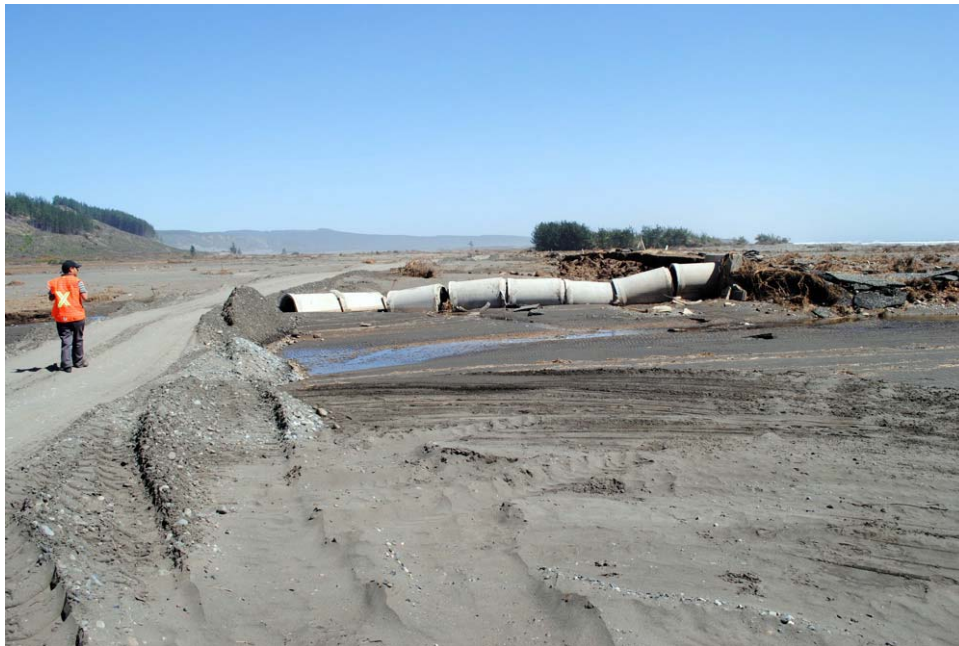
Figure 4.21. Ground photograph of area inundated and scoured by tsunami between Rio Mataquito and the town of Putú. Sections of concrete pipe were exposed and highway asphalt was eroded by tsunami flow, suggesting very high velocities; the extensive inundation in this area suggests possible land subsidence. (S35.115414° W72.203106°; 1500 hrs on 03/08/2010)

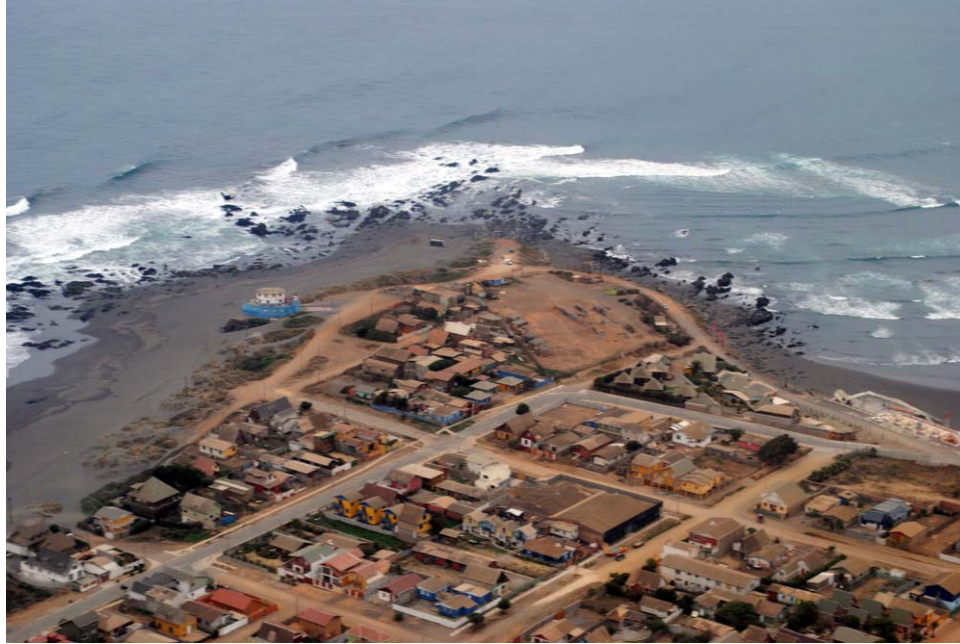
Figure 4.26. Aerial view looking northwest of shoreline in town of Pichilemu, showing bedrock underlying low-elevation marine terrace. The town of Pichilemu sustained local tsunami damage at elevations lower than this marine terrace or areas not protected by beach dunes. (S34.389619° W72.016661°; 1552 hrs on 03/12/2010)

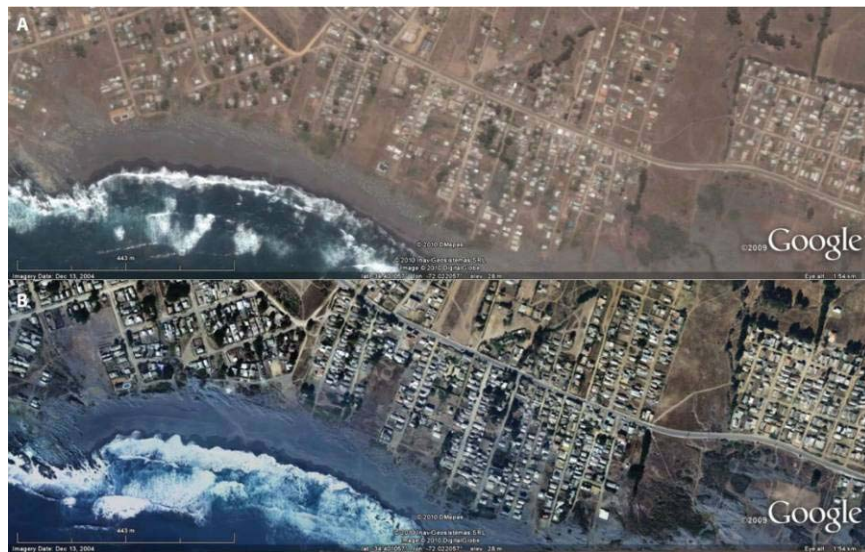
Figure 4.27. (A) Pre-earthquake satellite image of Pichilemu. (B) The same site after the February 27, 2010 earthquake shows no discernible evidence of changes in the shoreline that could be attributed to tectonic vertical land-level change.

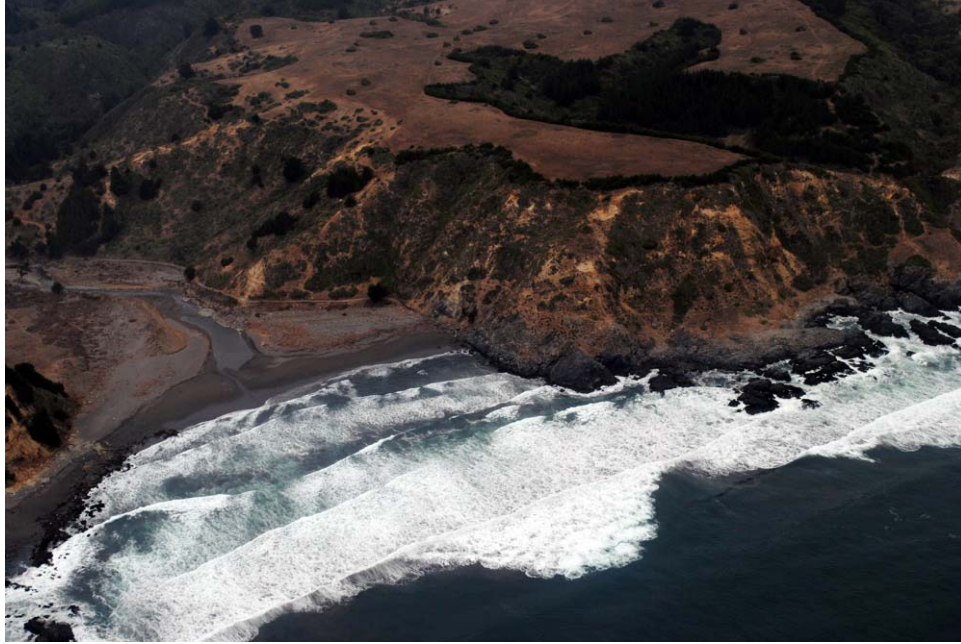
Figure 4.28. Aerial view looking southeast at shoreline on remote coastline between Pichilemu and Navidad, showing low-elevation marine terrace on far right, and thick marine deposits underlying high marine terrace in background. No evidence of earthquake-related uplift or subsidence was observed in this area. (S34.233969° W71.992883°; 1457 hrs on 03/12/2010)

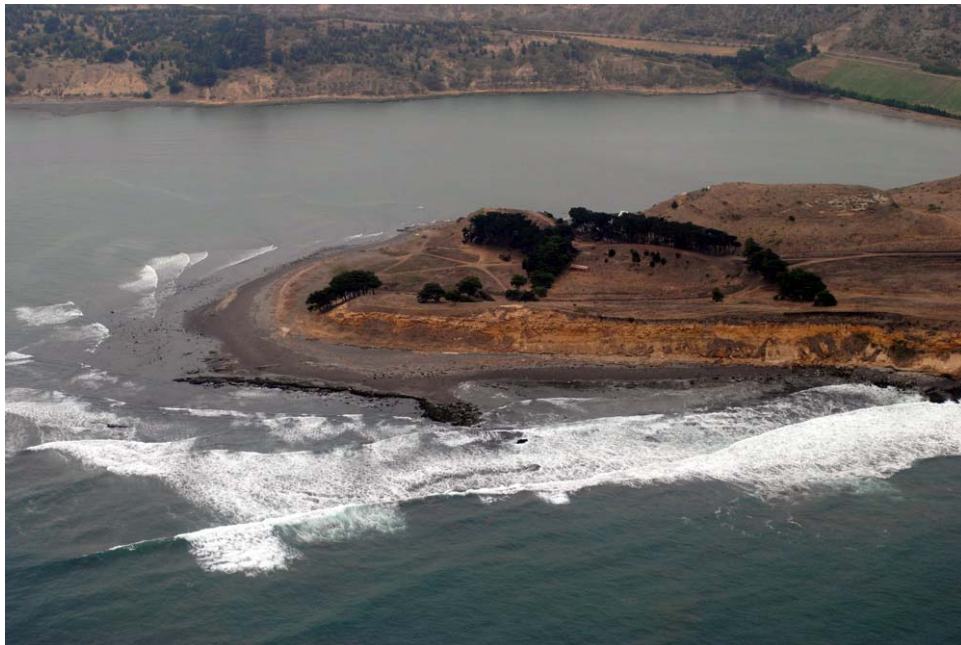
Figure 4.29. Aerial view looking east at shoreline at mouth of Rio Rapel near town of Navidad, showing low-elevation bedrock marine terrace in center, and thick marine deposits underlying high marine terrace. No evidence of earthquake-related uplift or subsidence was observed in this area. (S34.898536° W71.844794°; 1511 hrs on 03/12/2010)

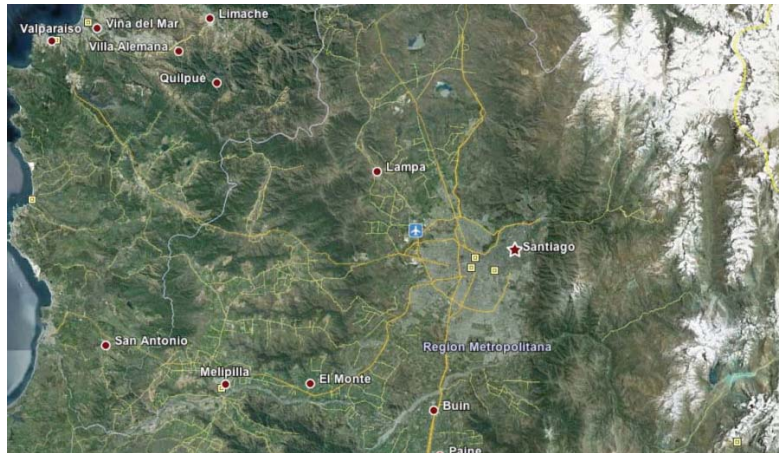
Figure 5.1. Satellite image and geology map of the Santiago basin

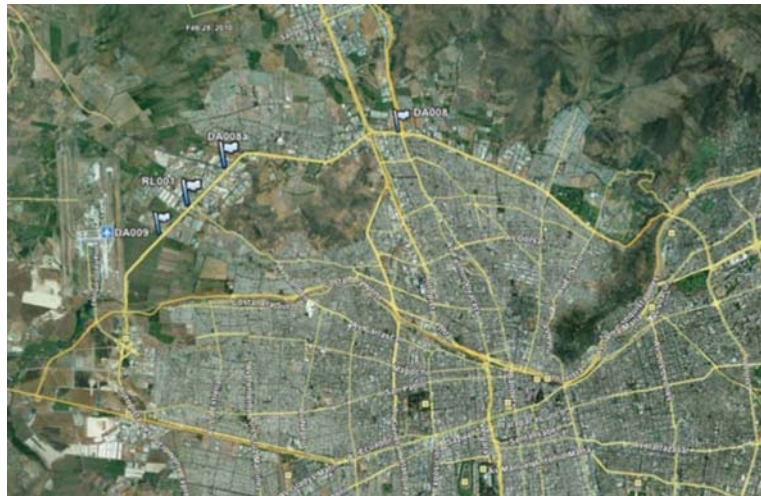
Figure 5.2. Four Americo Vespucio Ring Road bridges visited during the reconnaissance.

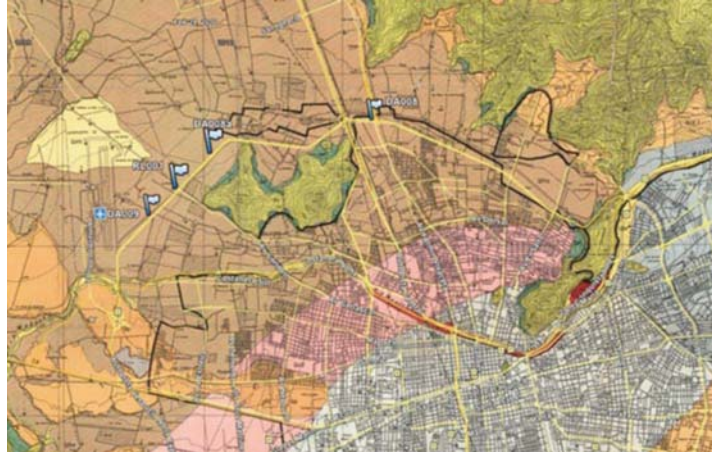
Figure 5.3. Location of the four bridge sites on the geology map of Santiago Metropolitan Area (Dr. Christian Ledezma, personal communication; approximate map overlay on Google Earth)

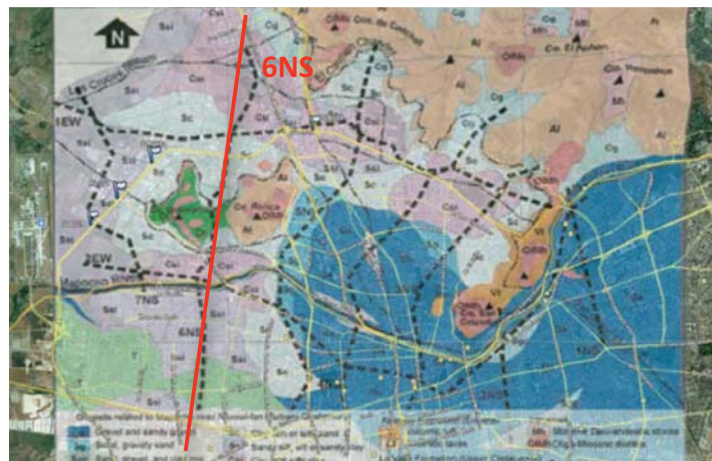
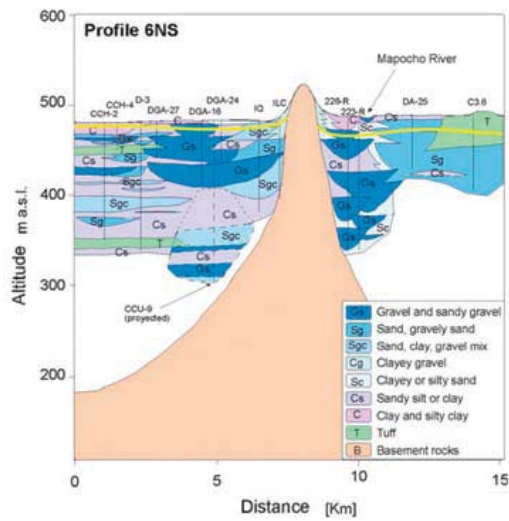
Figure 5.4. Location of the four bridge sites on the map of geological cross-sections in the North-Western part of Santiago de Chile; and Geological cross-section along profile 6NS (Iriarte-Diaz, 2003). Site DA008 (minor damage) is located on clay/silty clay, DA008a (collapsed) on clay/silty sand, and sites RL001 (minor damage) and DA009 (damaged) on sandy silt or silt.

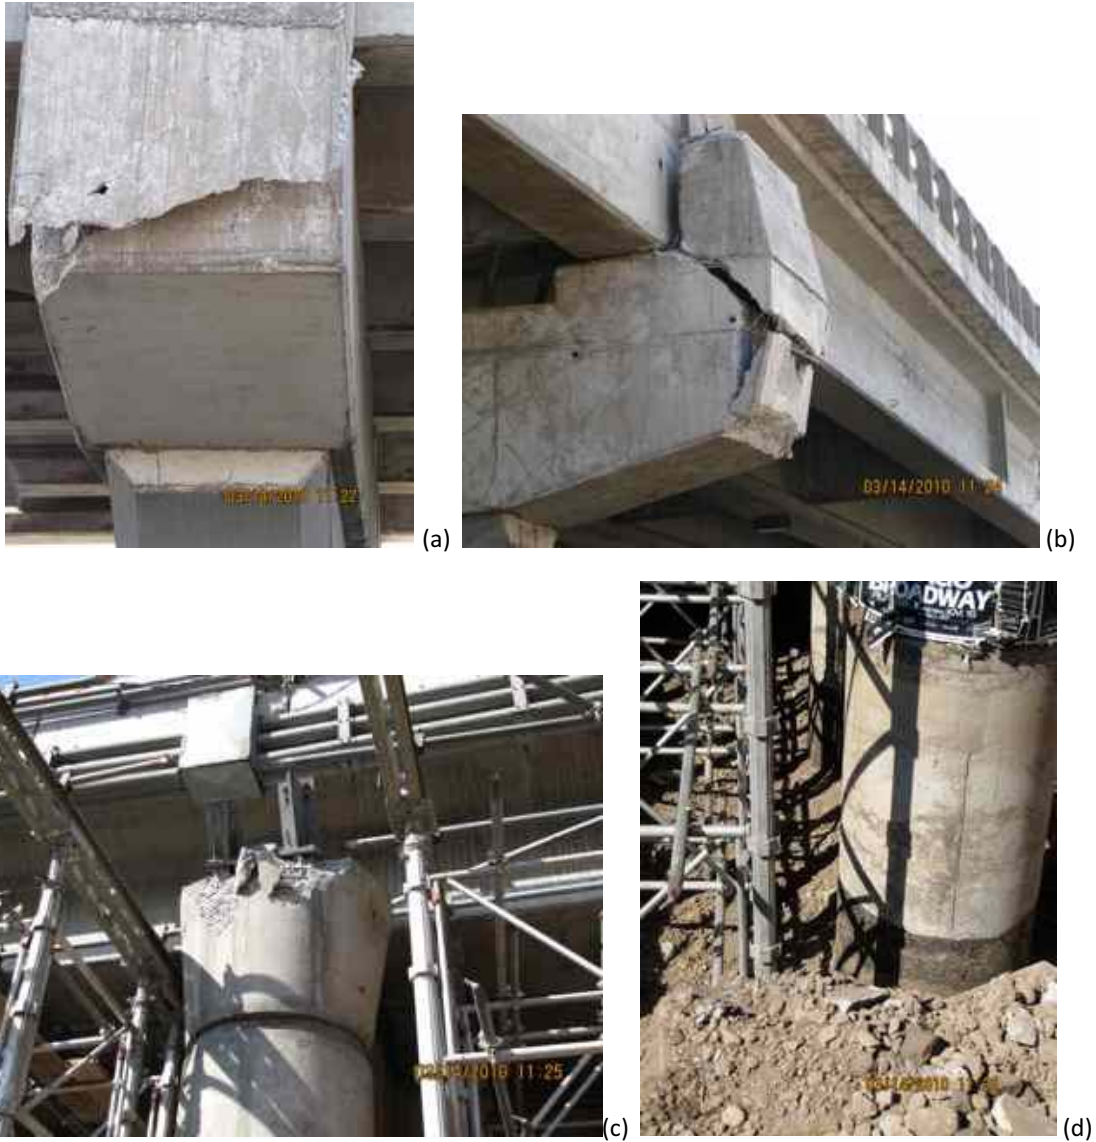
Figure 5.5. Paso San Martin (S33.3660° W70.6891°, 1122 hrs on 03/14/2010). Shear key failure and longitudinal, transverse deck displacement.

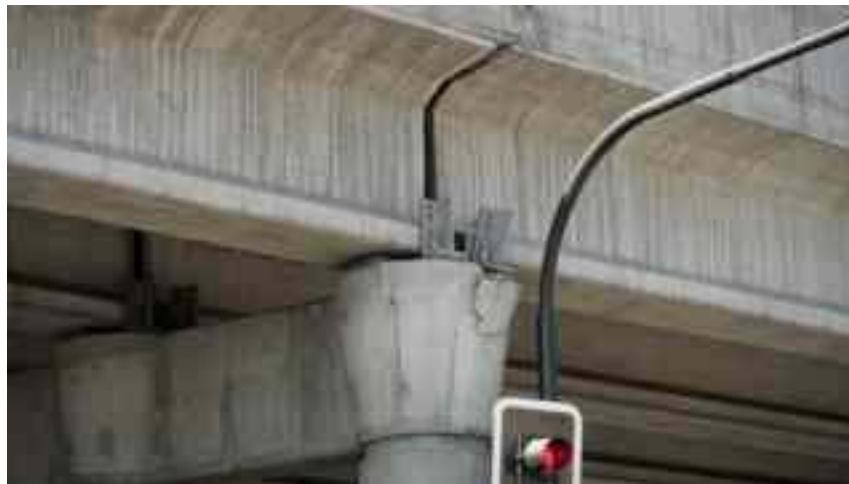
Figure 5.7. Paso Lo Boza (S33.3865° W70.7601°). Minor structural damage of shear keys (Source: Dr. Roberto Leon, personal communication).

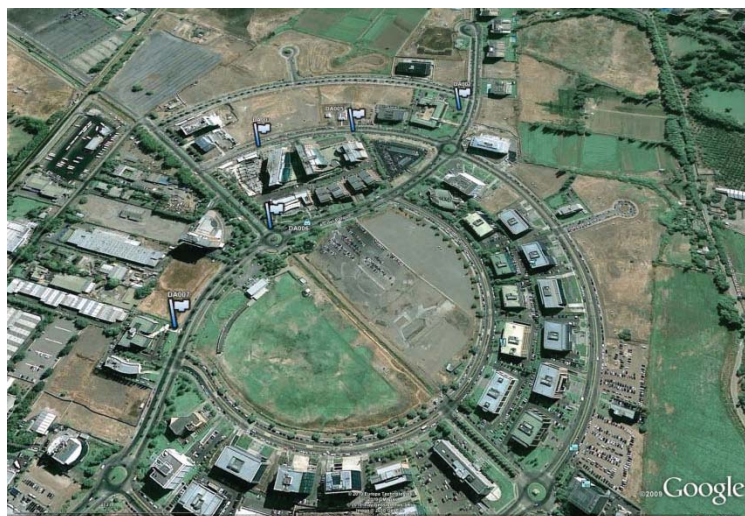
Figure 5.9. Aerial view of Ciudad Empresarial, depicting the structures that were inspected during reconnaissance.

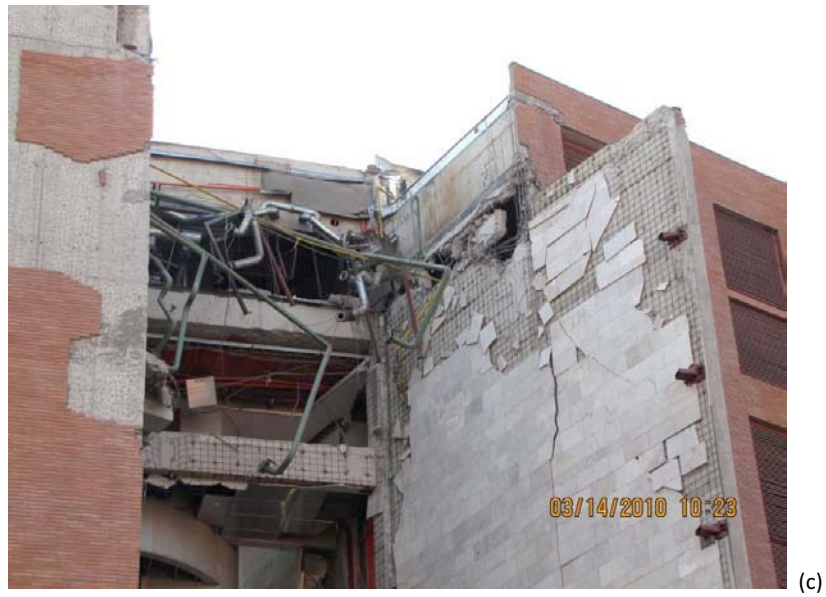
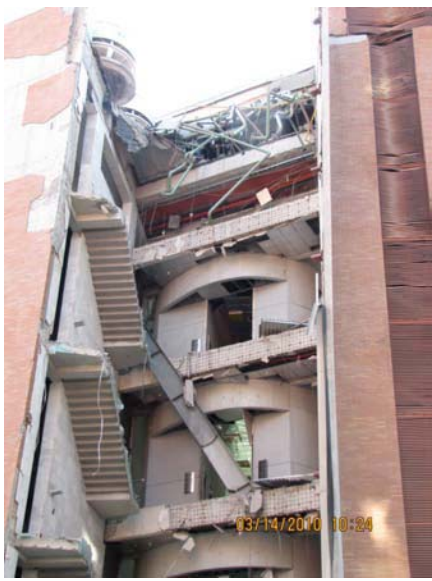
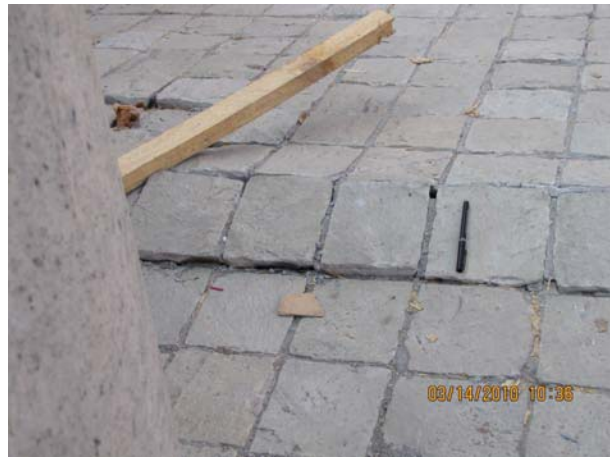
Figure 5.11. Site DA003 ($S33.387985^{\circ}$ $W70.618815^{\circ}$, 1015 hrs on 03/14/2010) 6-story commercial building. Damage of non-structural elements (glass windows, red brick façade) (Figures 11a,b) and emergency staircase (Figures 11c,d). Evidence of ground deformation (Figure 11e).

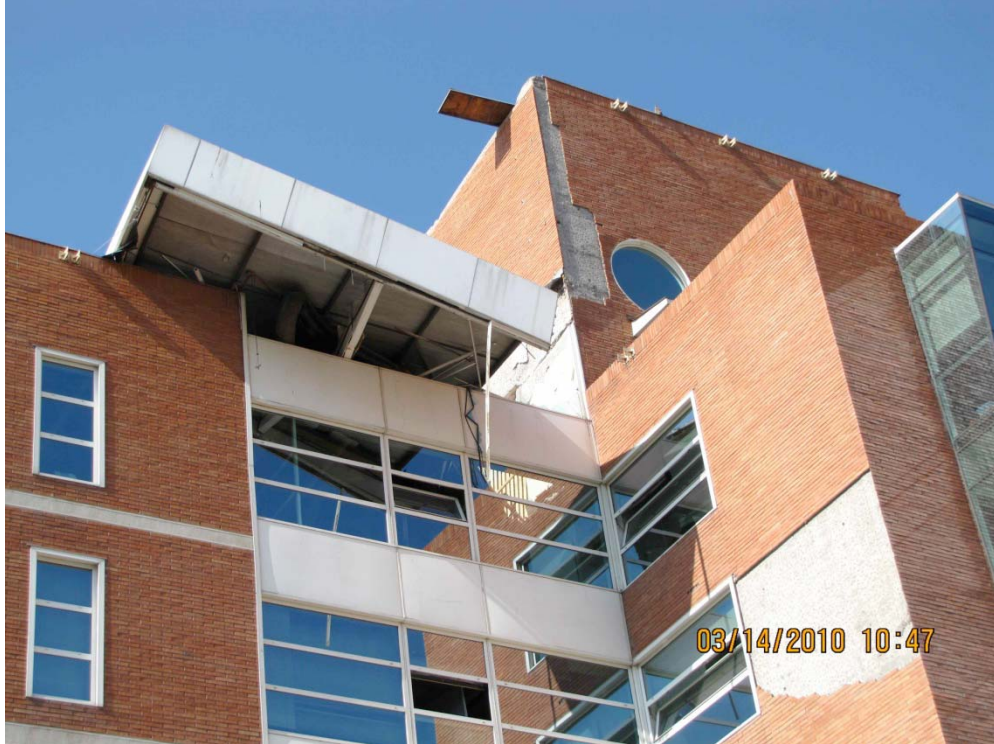
Figure 5.12. Site DA004 (S33.387652° W70.617122°, 1047 hrs on 03/14/2010) Identical 7-story buildings connected; damage was observed in only one of the two.

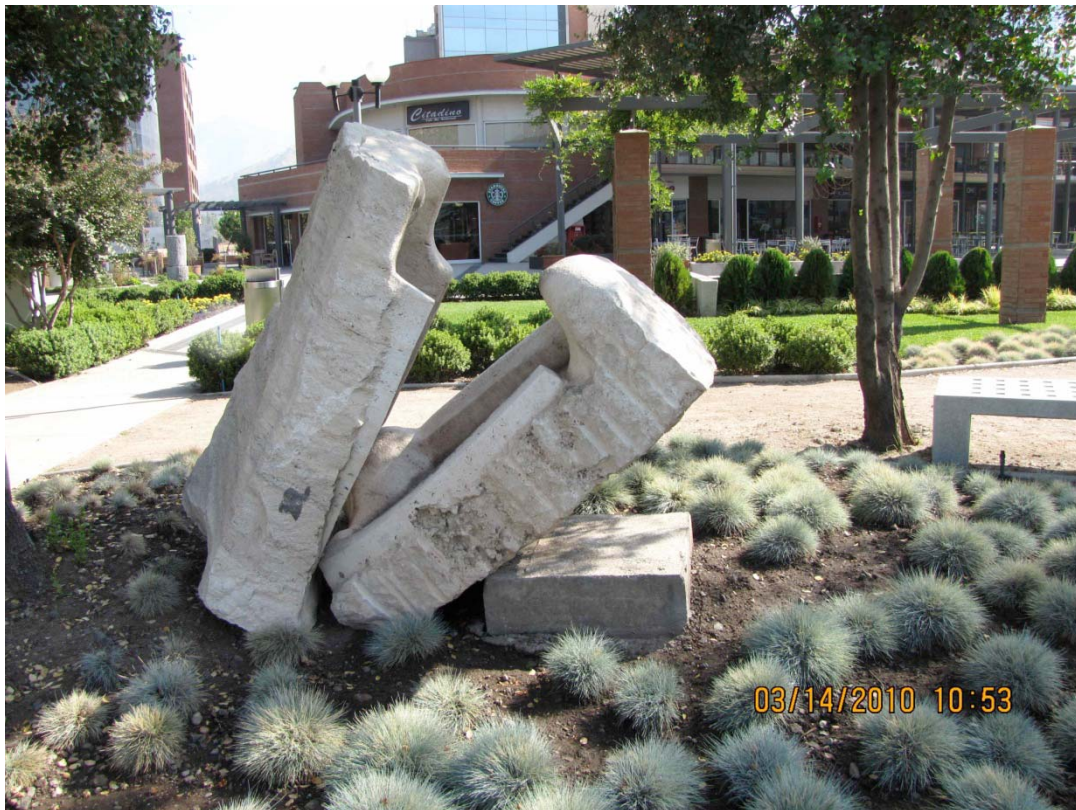
Figure 5.13. Site DA005 (S33.387652° W70.617123°, 1053 hrs on 03/14/2010) Overtopped art.
