GEO-ENGINEERING EXTREME EVENTS RECONNAISSANCE (GEER) ASSOCIATION

Turning Disaster in Knowledge

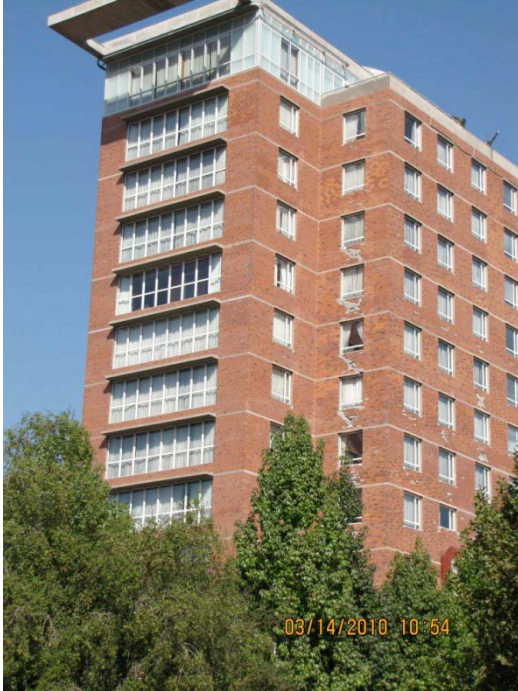
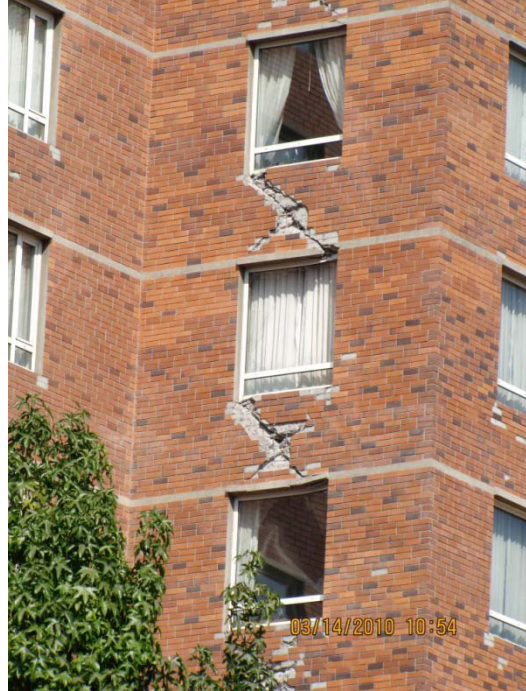
Figure 5.14. Site DA005 (S33.387652° W70.617123°, 1054 hrs on 03/14/2010) 12-story building with severe structural damage.

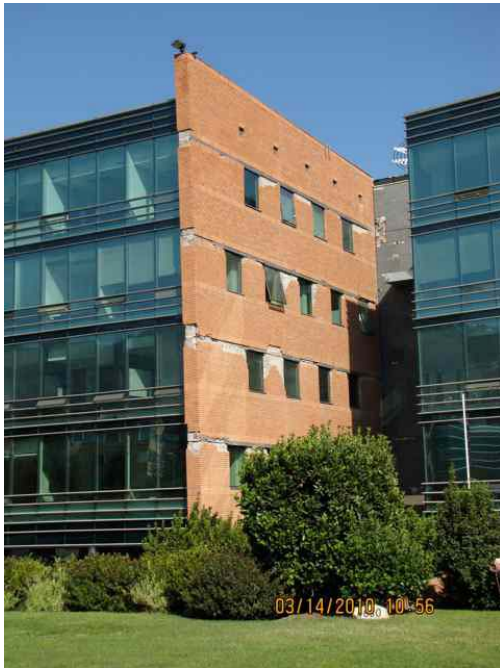
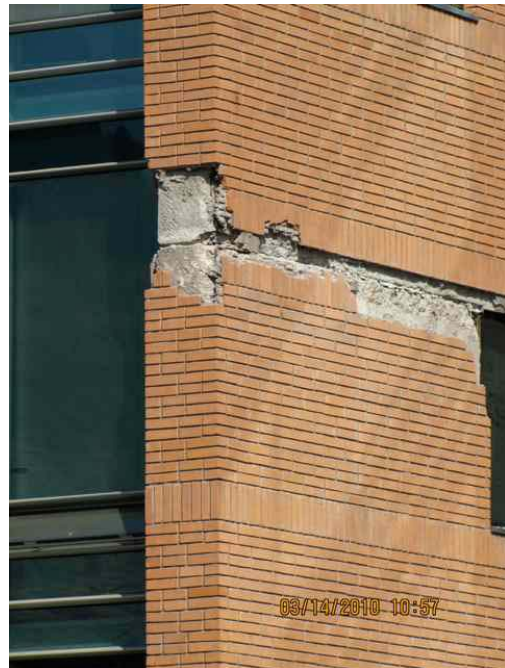
Figure 5.15. Site DA006 (S33.389586° W70.618349°, 1056 hrs on 03/14/2010) 5-story building, structural damage.

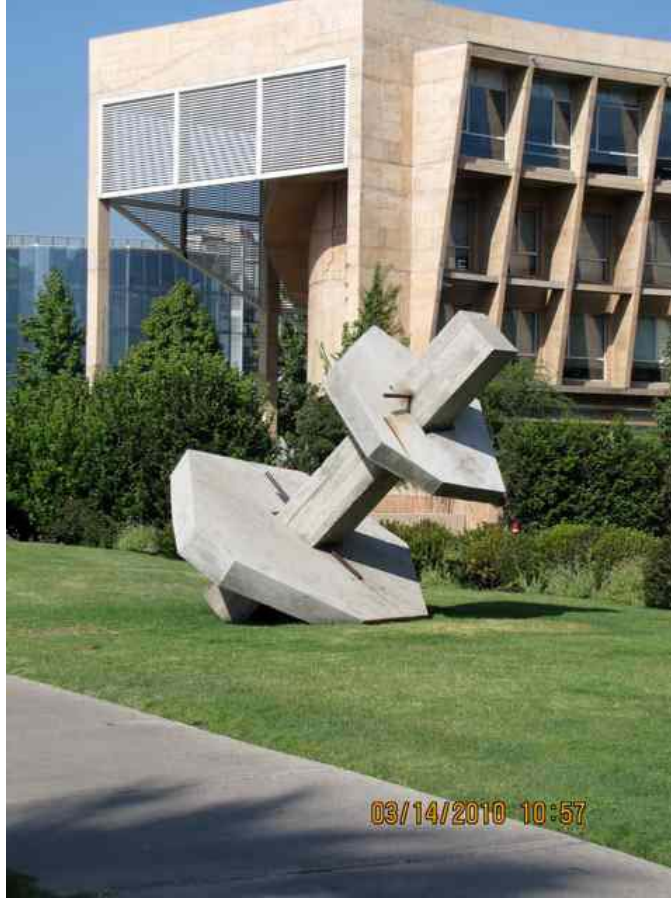
Figure 5.16. Site DA007 (S33.391163° W70.619502°, 1057 hrs on 03/14/2010) Minor external damage – non-structural. Overtopped art.

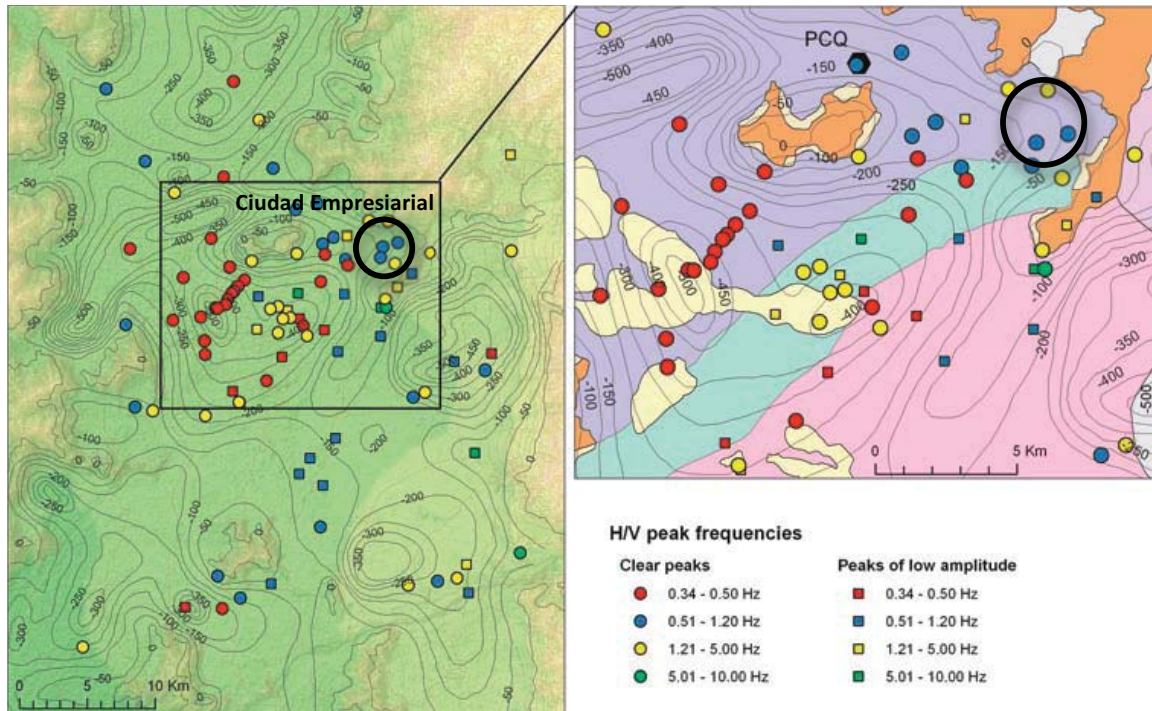
Figure 5.17. Spatial distribution of H/V peaks from ambient noise measurements in NE Santiago, denoted according to their frequencies: (red) 0.3–0.5, (blue) 0.51–1.2, (yellow) 1.21–5 and (green) 5.1–10 Hz (after Bonnefoy et al, 2008). Green circle corresponds to Ciudad Empresarial.

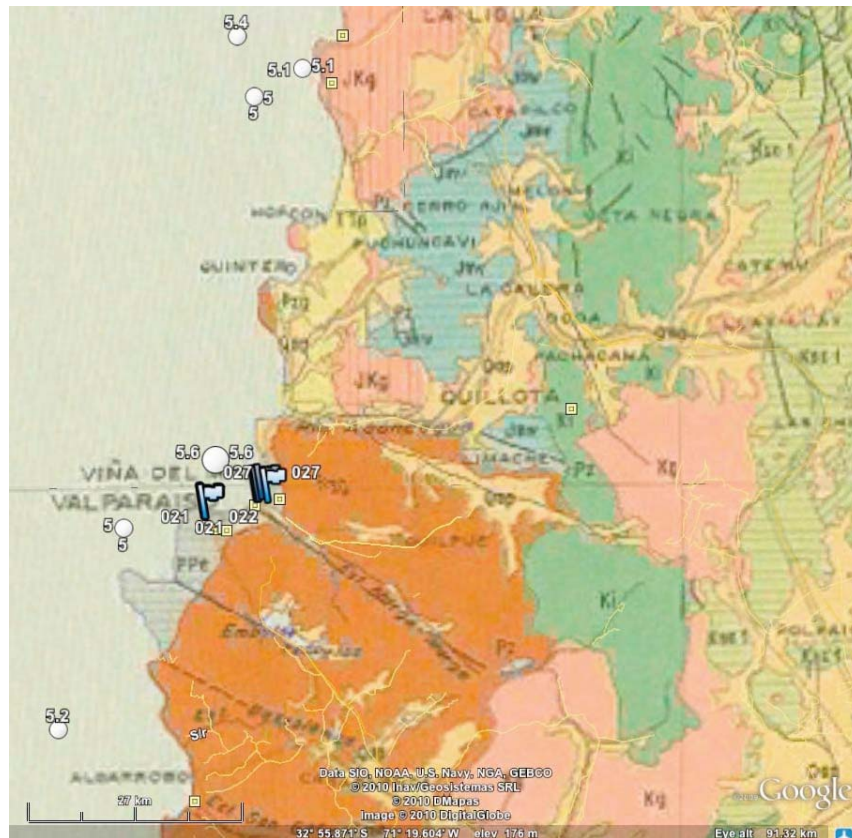
Figure 5.18. Geology of the Viña del Mar/Valparaíso region. Site conditions are described as weathered rock.

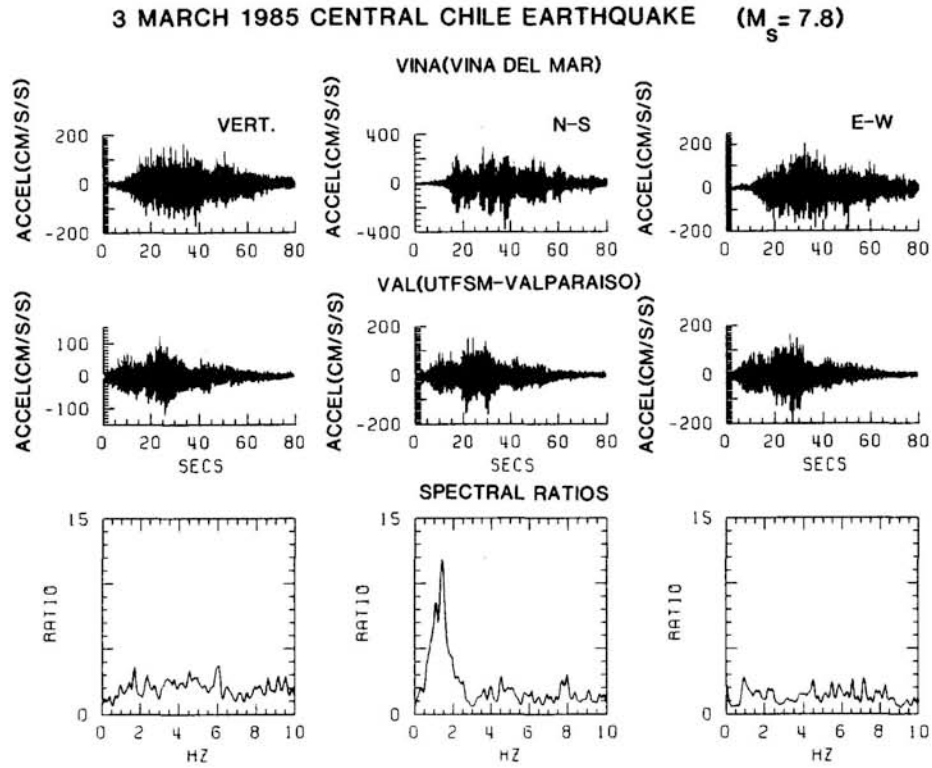
Figure 5.19. Acceleration seismograms of 3 March 1985 Central Chile earthquake ($M_s = 7.8$) recorded at the strong-motion stations VINA (Viña del Mar) and VAL (UTFSM-Valparaiso) and their corresponding spectral ratios (after Celebi, 2003).

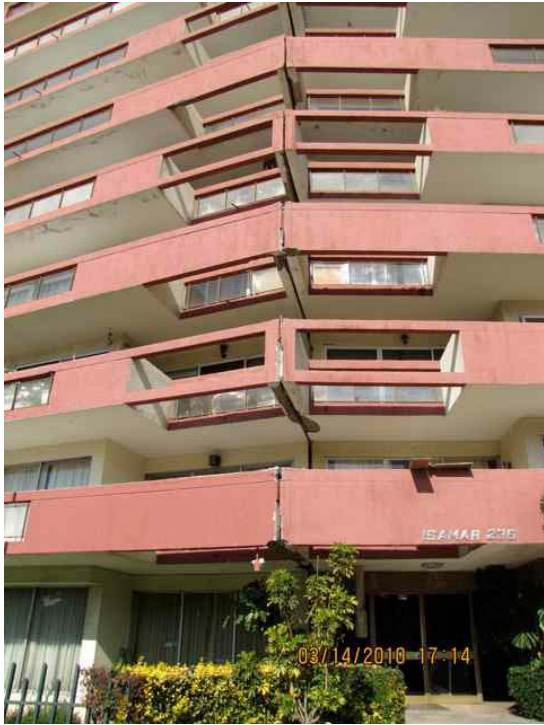
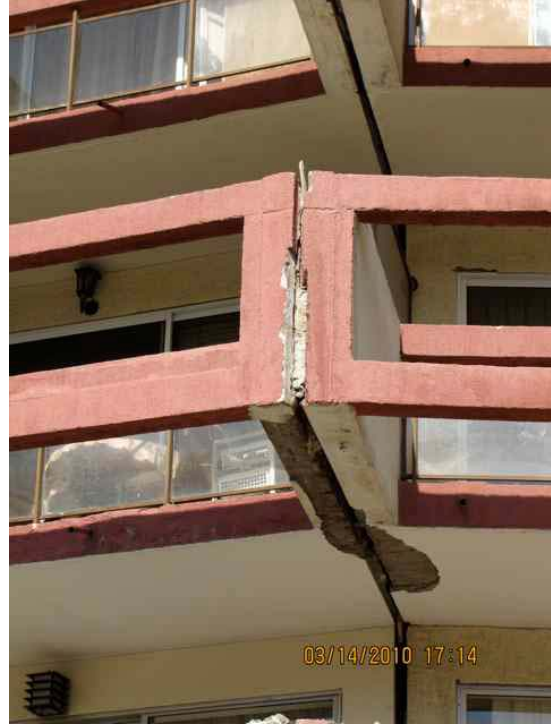
Figure 5.22 Site DA017 (S 33.018904° W 71.559206°, 1714 hrs on 03/14/2010) Damaged 9-story building.

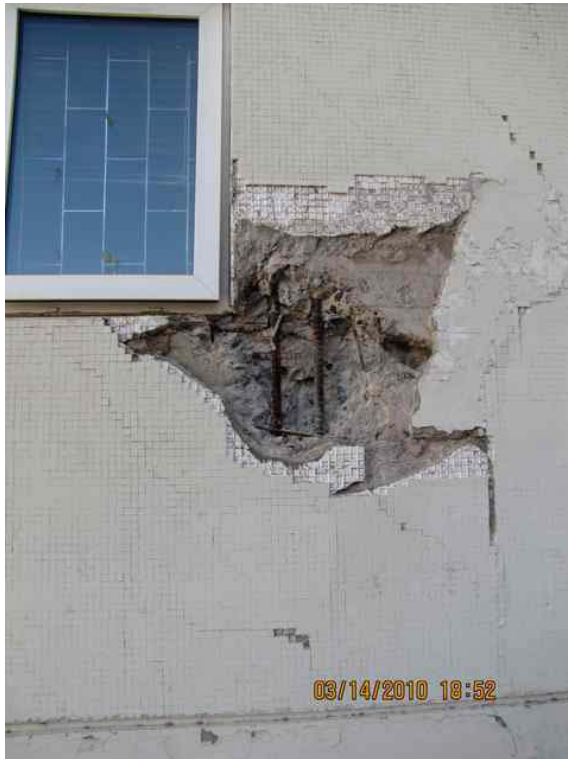
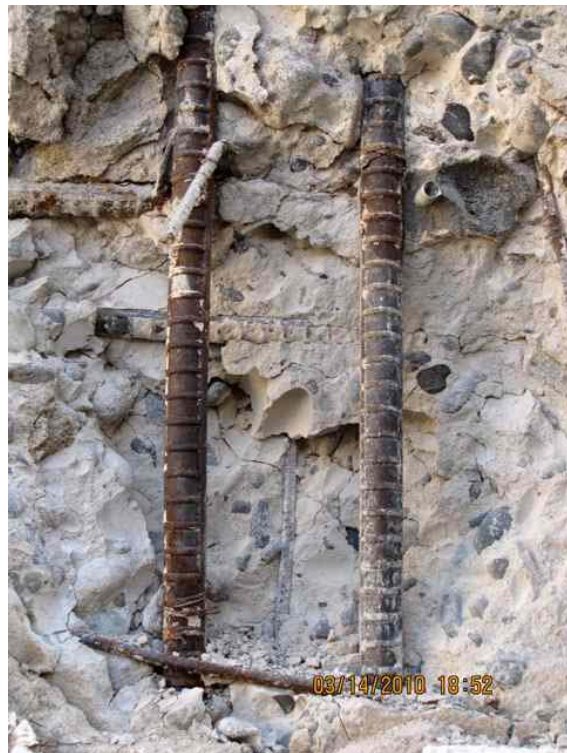
Figure 5.23. (continued)

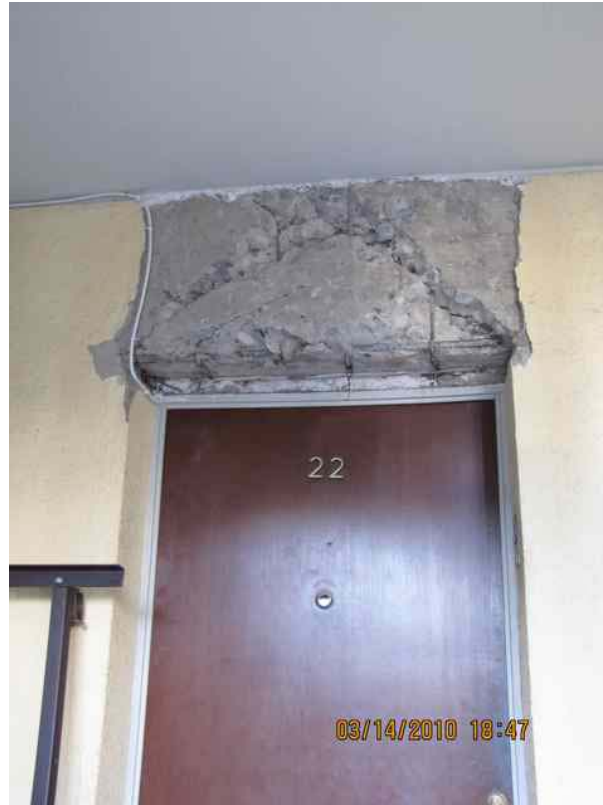
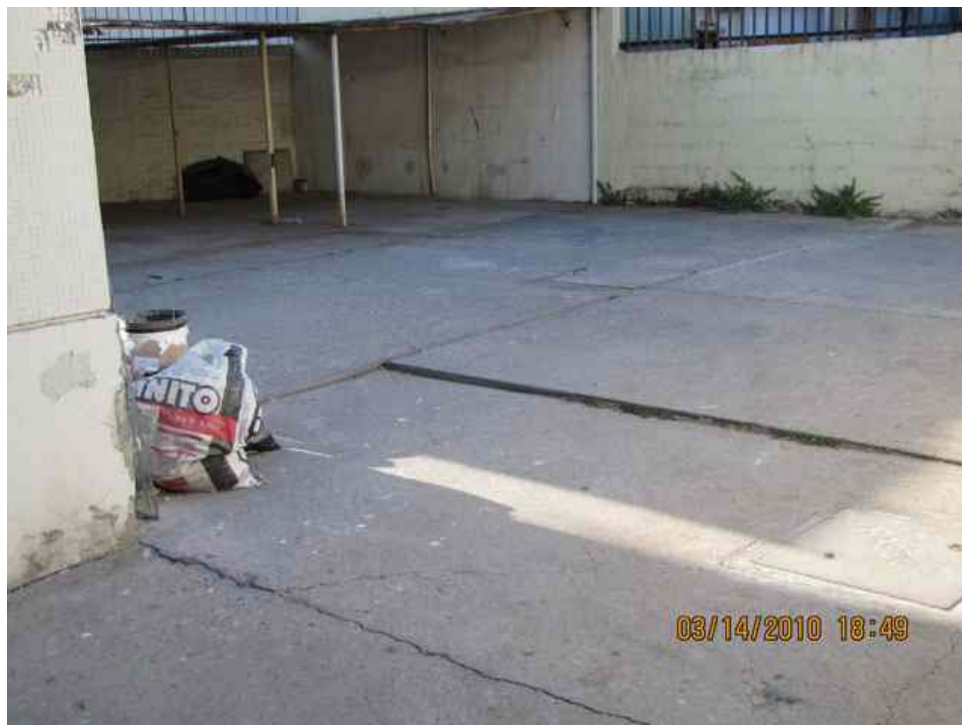
Figure 5.23. Site DA018 (S 33.017386° W 71.557107°, 18:48 hrs on 03/14/2010) Damaged 6-story building. Evidence of ground settlement.

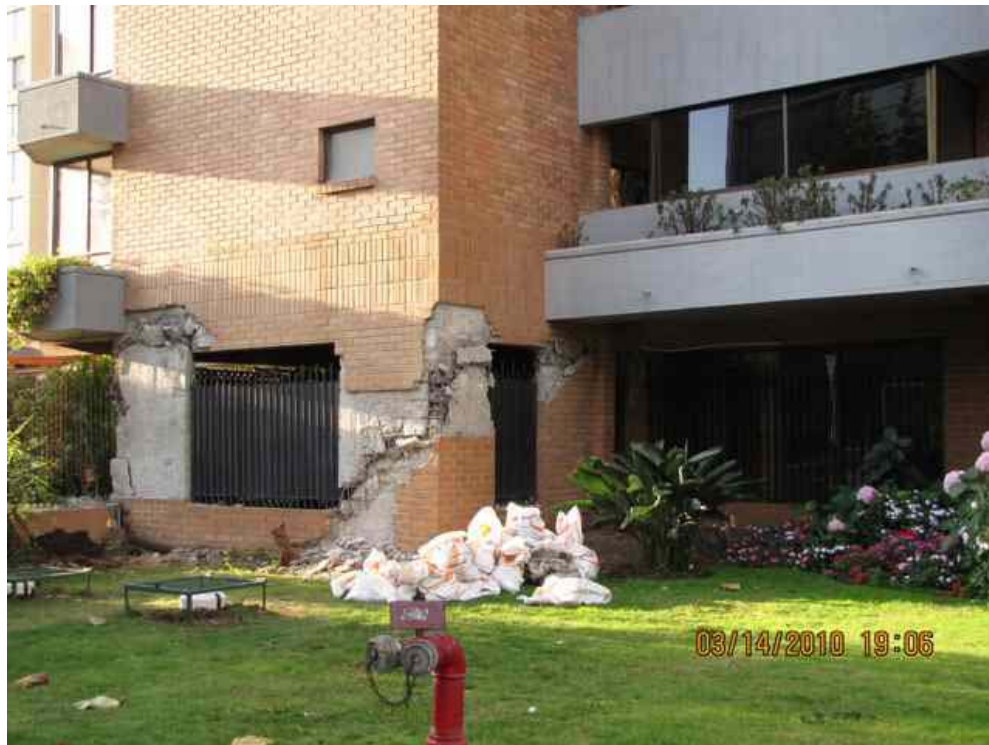
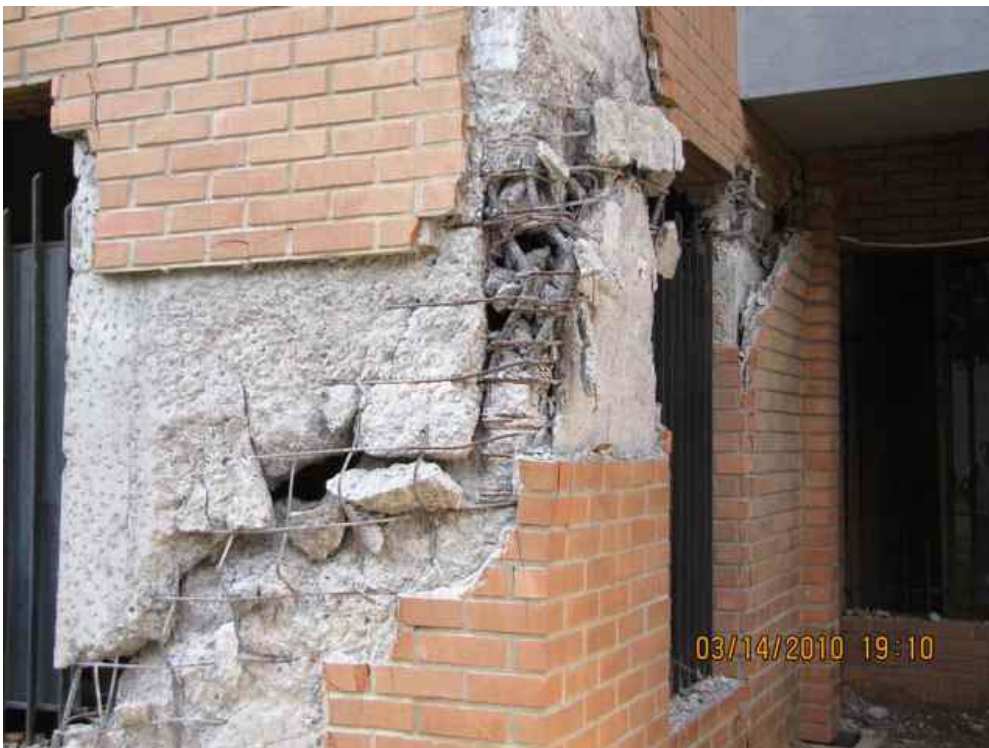
Figure 5.24. (continued)

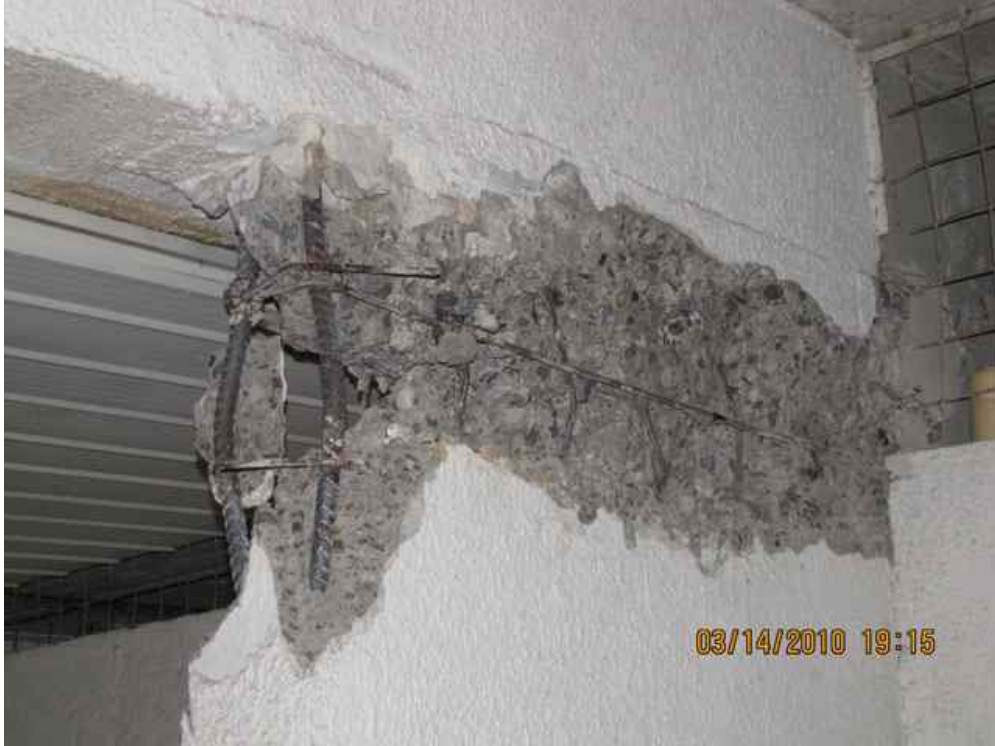
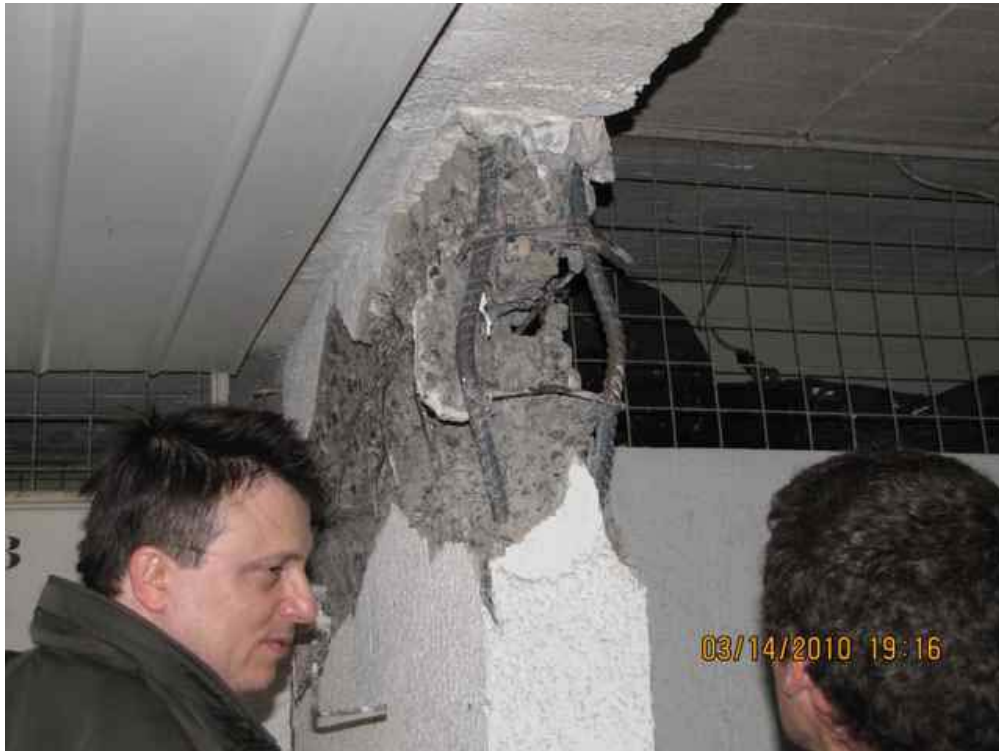
Figure 5.24. Site DA019 (S33.016045° W 71.551990°, 1916 hrs on 03/14/2010). Damaged 10-story building. Lack of confinement beam-column joints and low quality concrete.

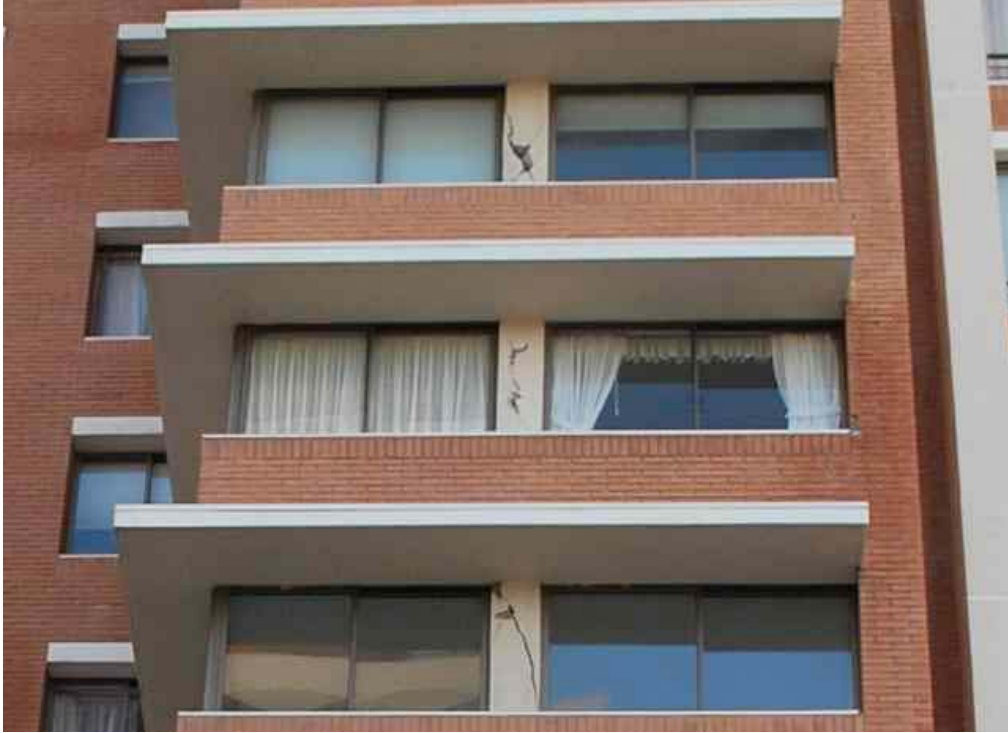
Figure 5.25. Site DA020 (S 33.018678° W 71.556288°, 1953 hrs on 03/14/2010). Diagonal cracks of columns in all the floors of 19-story building.

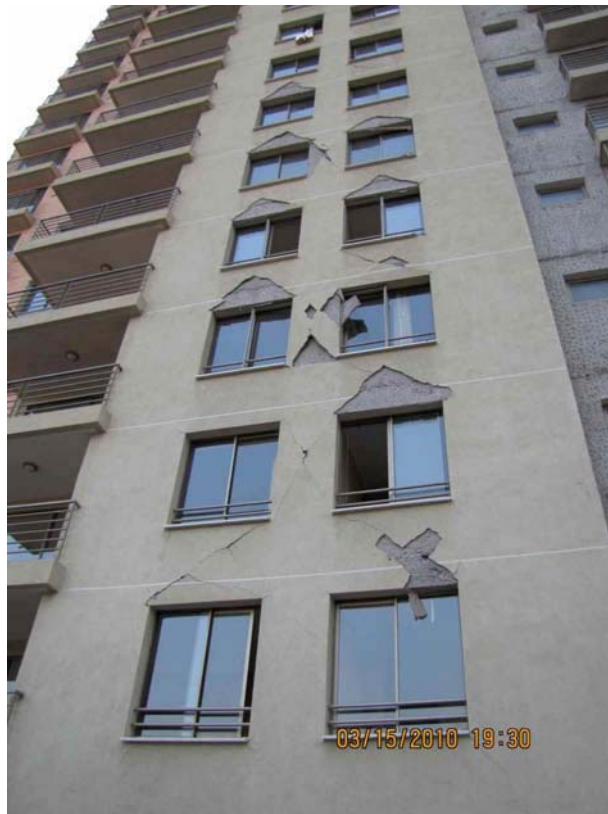
Figure 5.26. (continued)

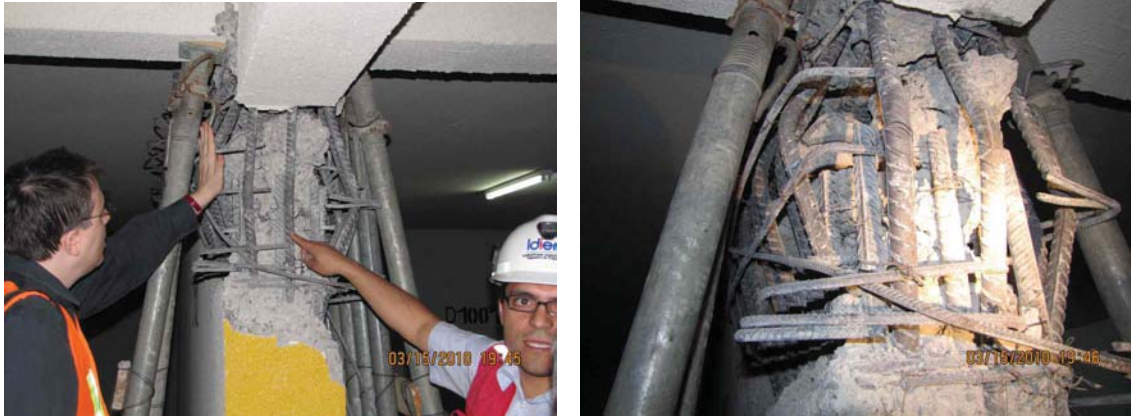
Figure 5.26. Site DA027 (S 33.020074° W 71.544055°, 1945 hrs on 03/15/2010). Heavily damaged 20-story building, lack of confinement at beam-column joints.

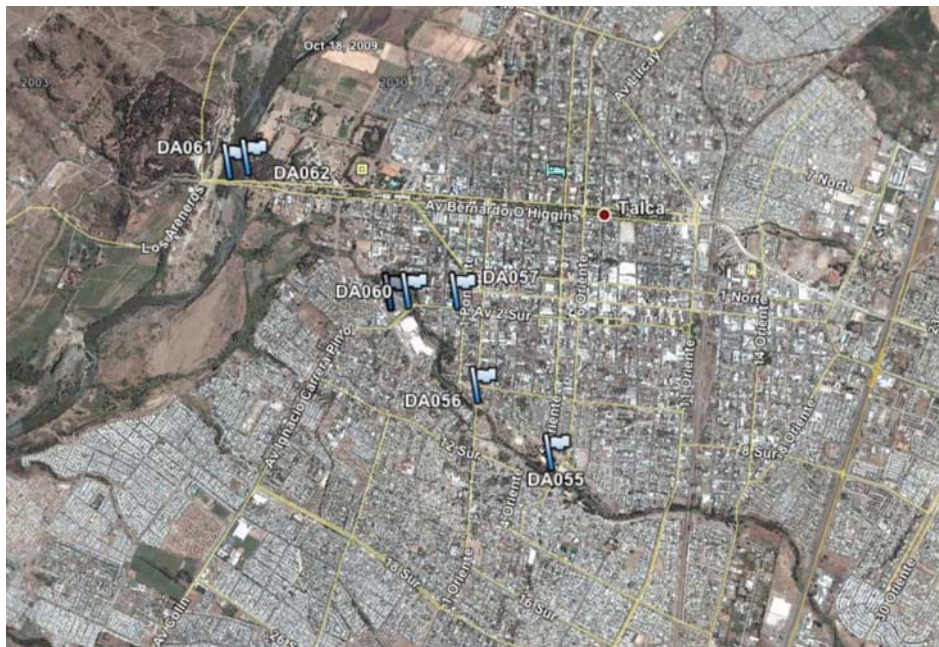
Figure 5.27. (continued)

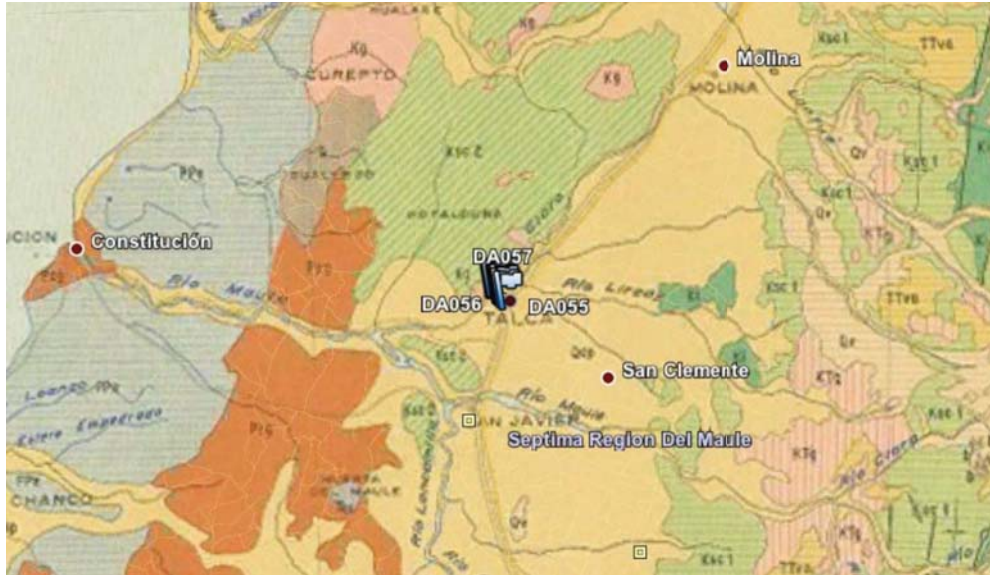
Figure 5.27. Aerial Google earth view and regional geology for the city of Talca.

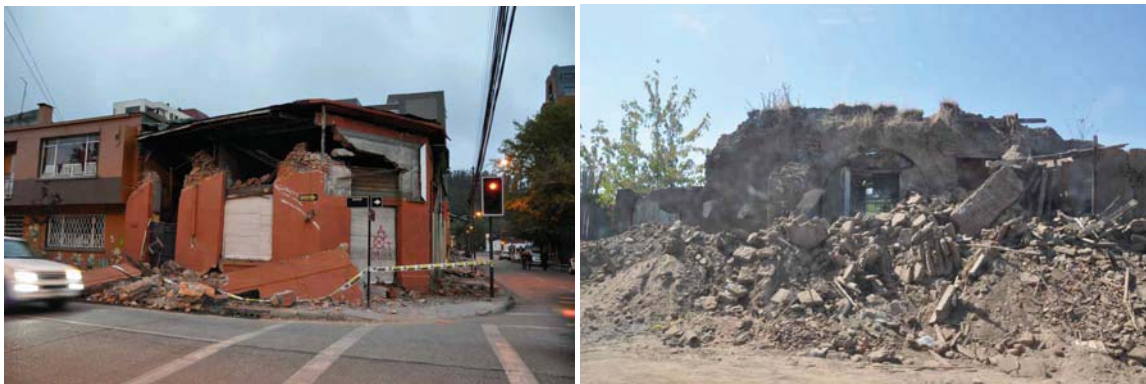
Figure 5.28. Adobe and unreinforced concrete damage concentrated adjacent to the Maule river across Talca (pictures shot from passenger seat while driving).

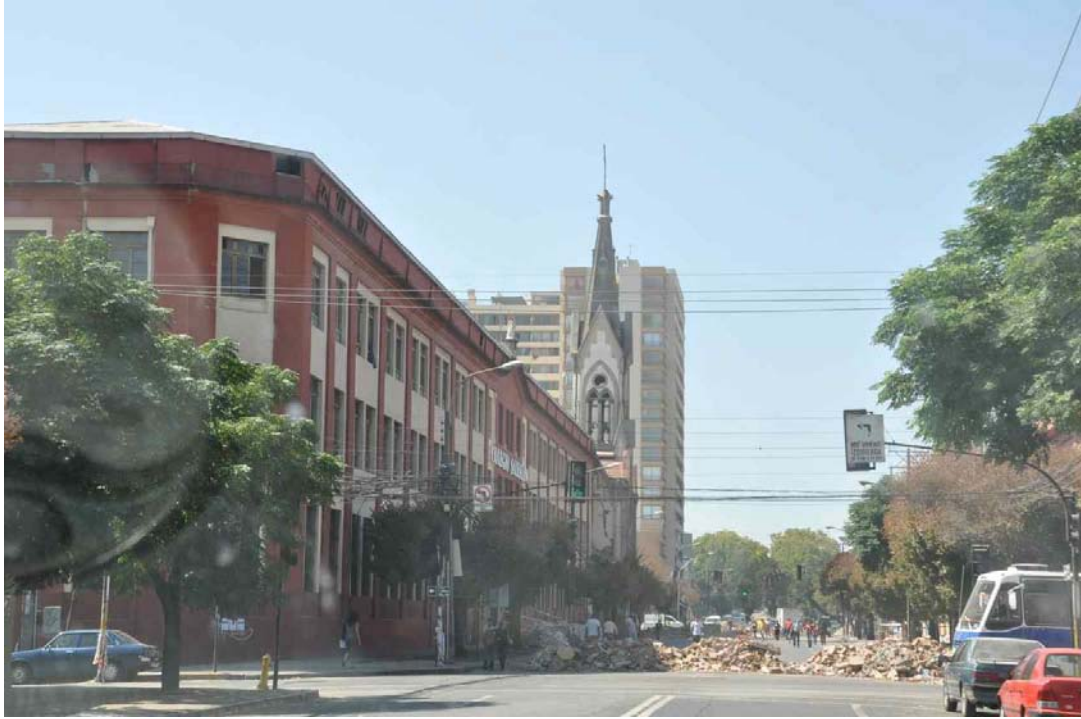
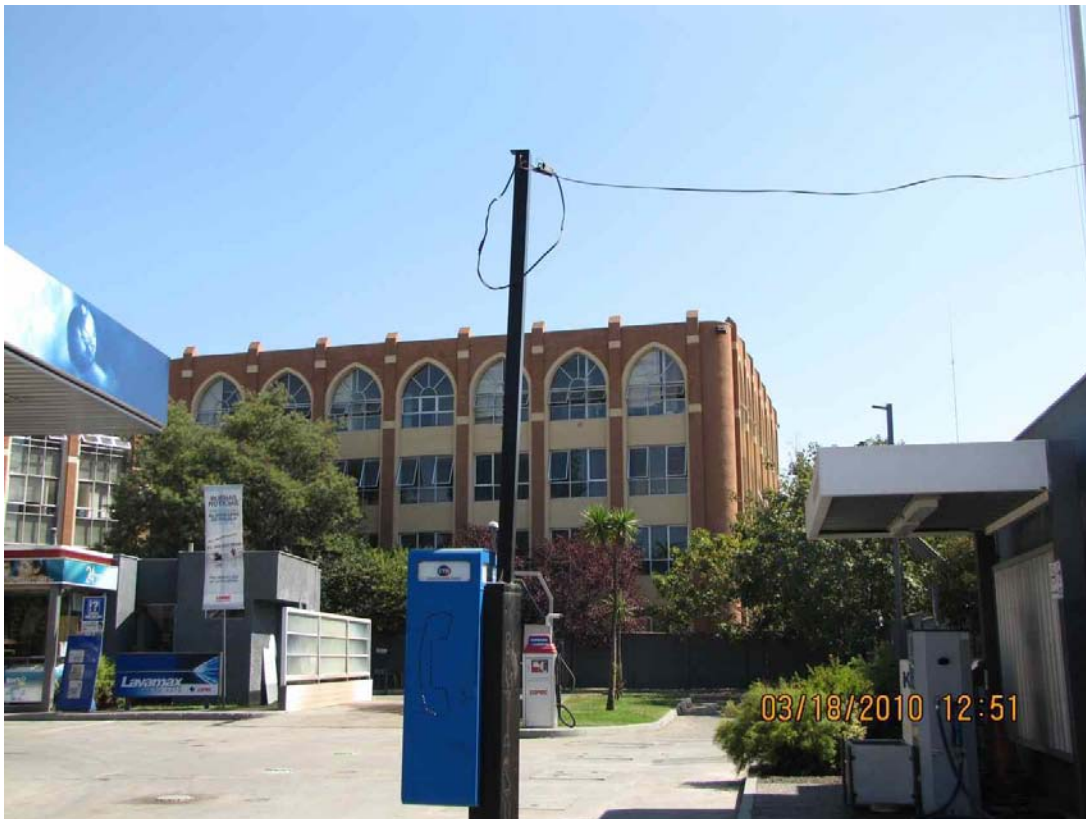
Figure 5.29. (continued)

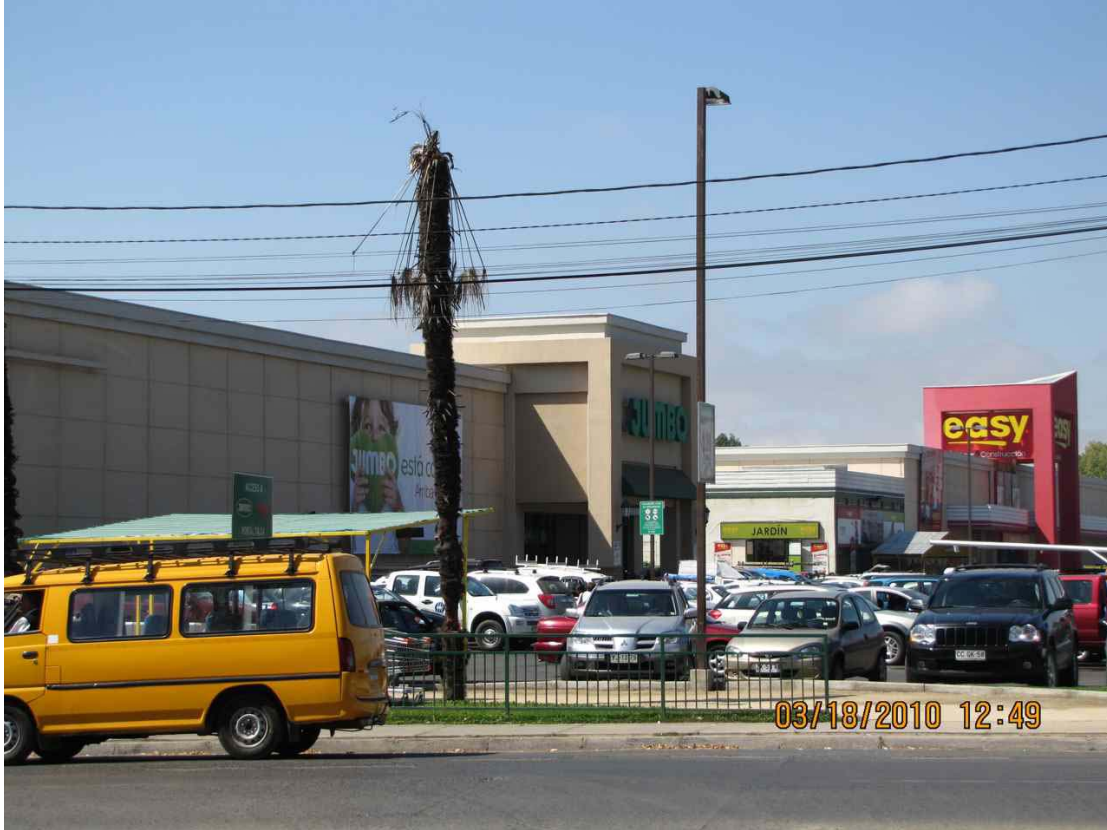
Figure 5.29. Modern (engineered) structures adjacent to the river that showed no or minor damage (S 35.437897° W 71.660151°, 1249 hrs on 03/18/2010).

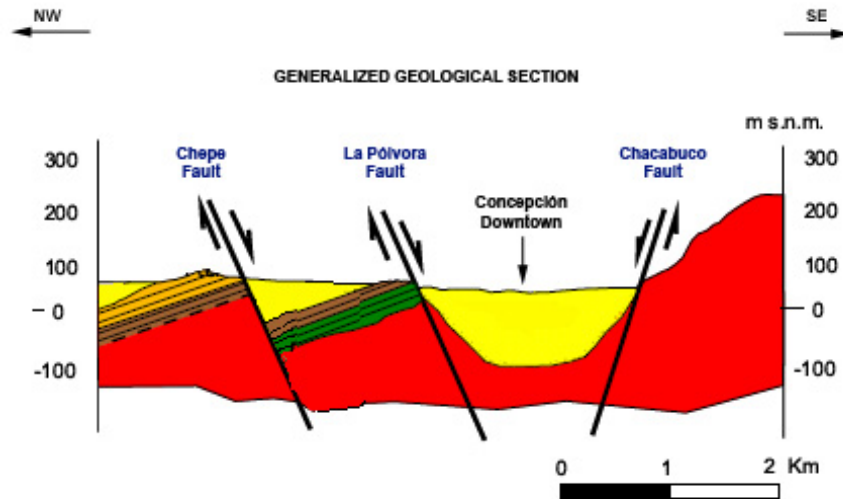
Figure 5.30. Geologic cross-section of Concepción, depicting a sedimentary valley and the major faults running through the region.

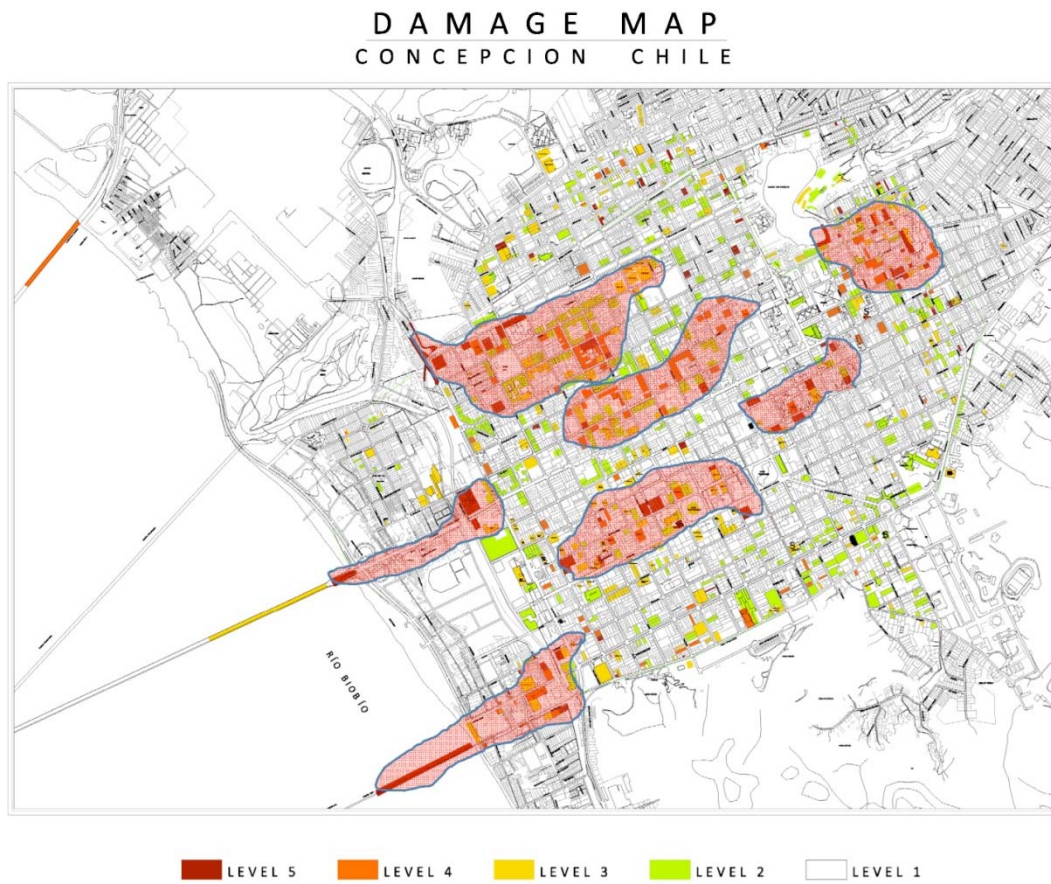
Figure 5.31. Damaged sections in downtown Concepción; 6 out of 7 are parallel to La Polvora fault.

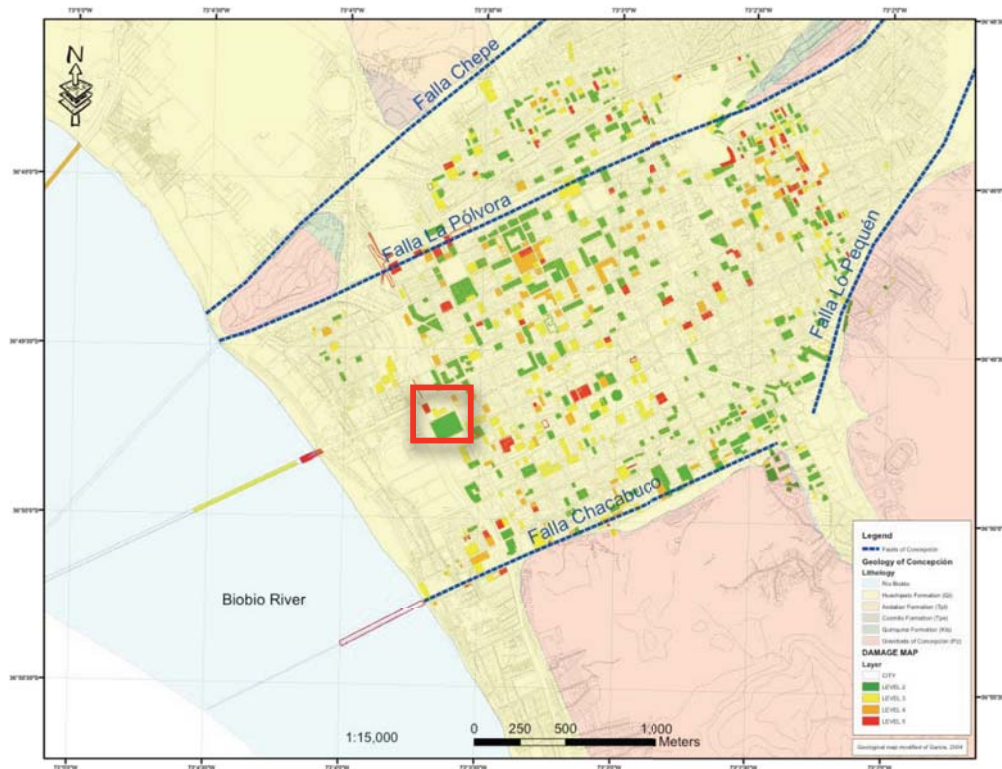
Figure 5.32. Inspected buildings and damage level in downtown Concepción, superimposed on geology map of the region.

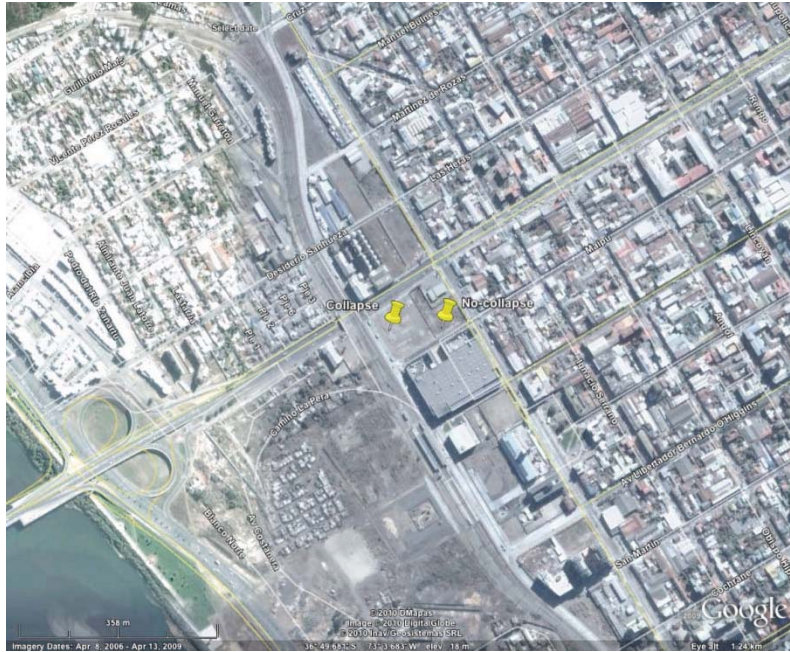
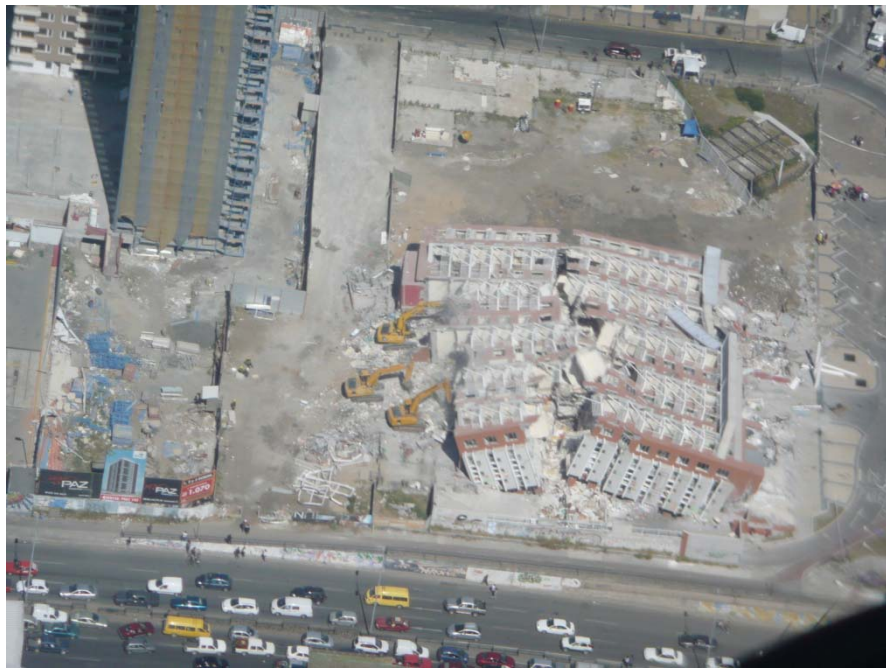
Figure 5.33. Locations of two adjacent buildings designed with using different site conditions in Concepcion (map and aerial view).

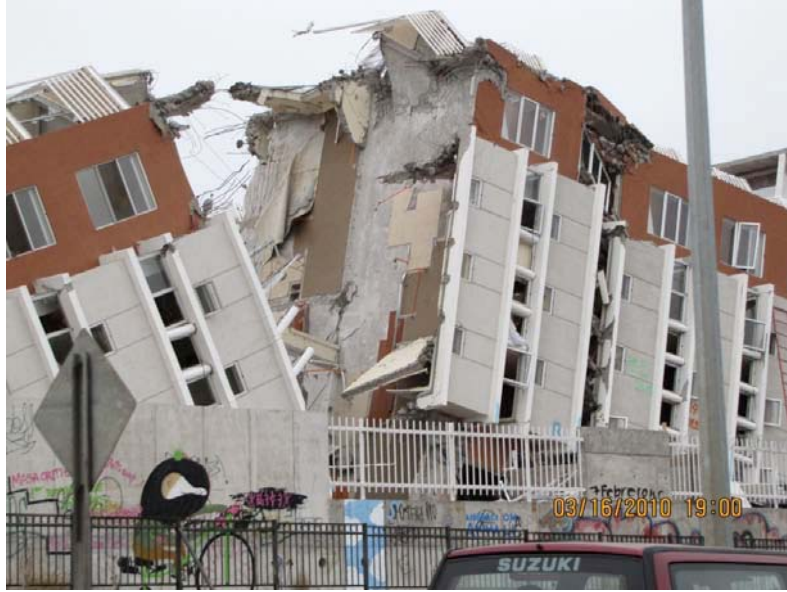
Figure 5.34. Collapsed structure (S 36.828067° W73.061639°, 1900 hrs on 03/16/2010) designed using Soil Type II conditions.

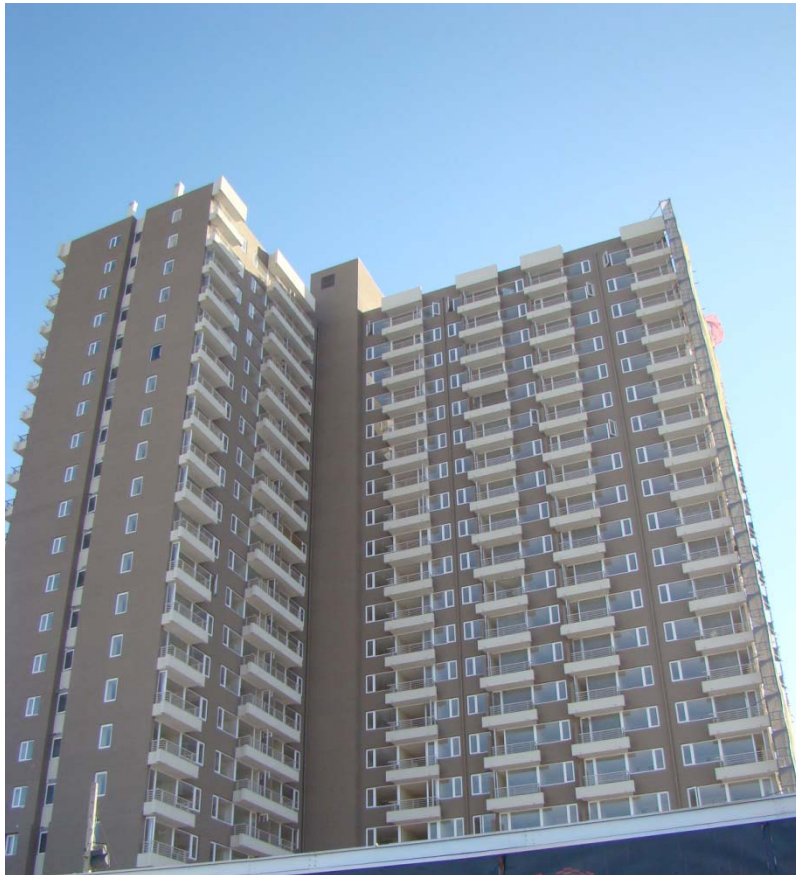
Figure 5.35. 20-story structure adjacent to collapsed (S 36.828083° W 73.060600°, 1910 hrs on 03/16/2010) designed using Soil Type III conditions, and suffering only minor damage.

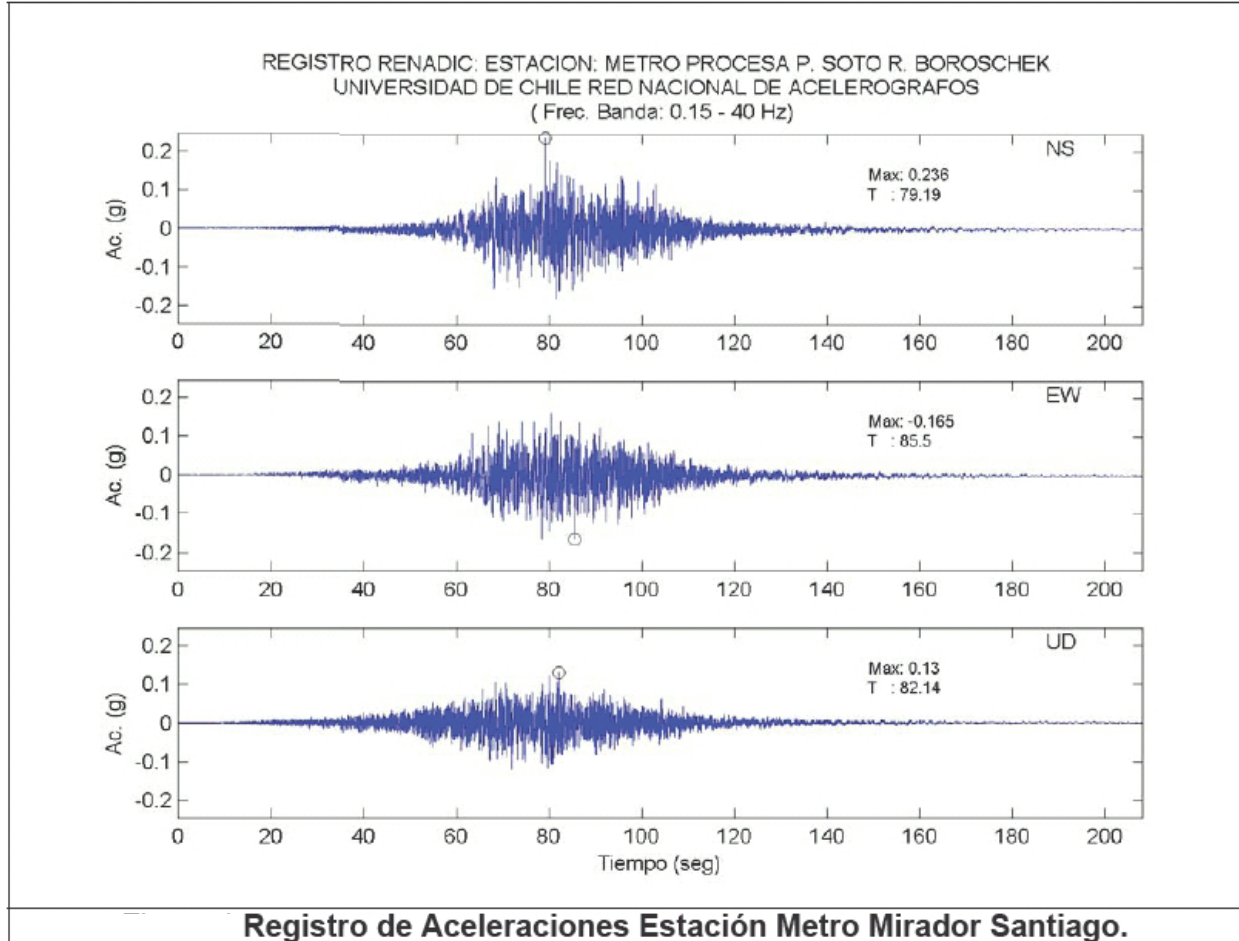
Figure 6.1. Typical ground motion from the Santiago area showing the long duration which can produce a large number of strain cycles in liquefiable sediments.
