GEO-ENGINEERING EXTREME EVENTS RECONNAISSANCE (GEER) ASSOCIATION

Turning Disaster in Knowledge

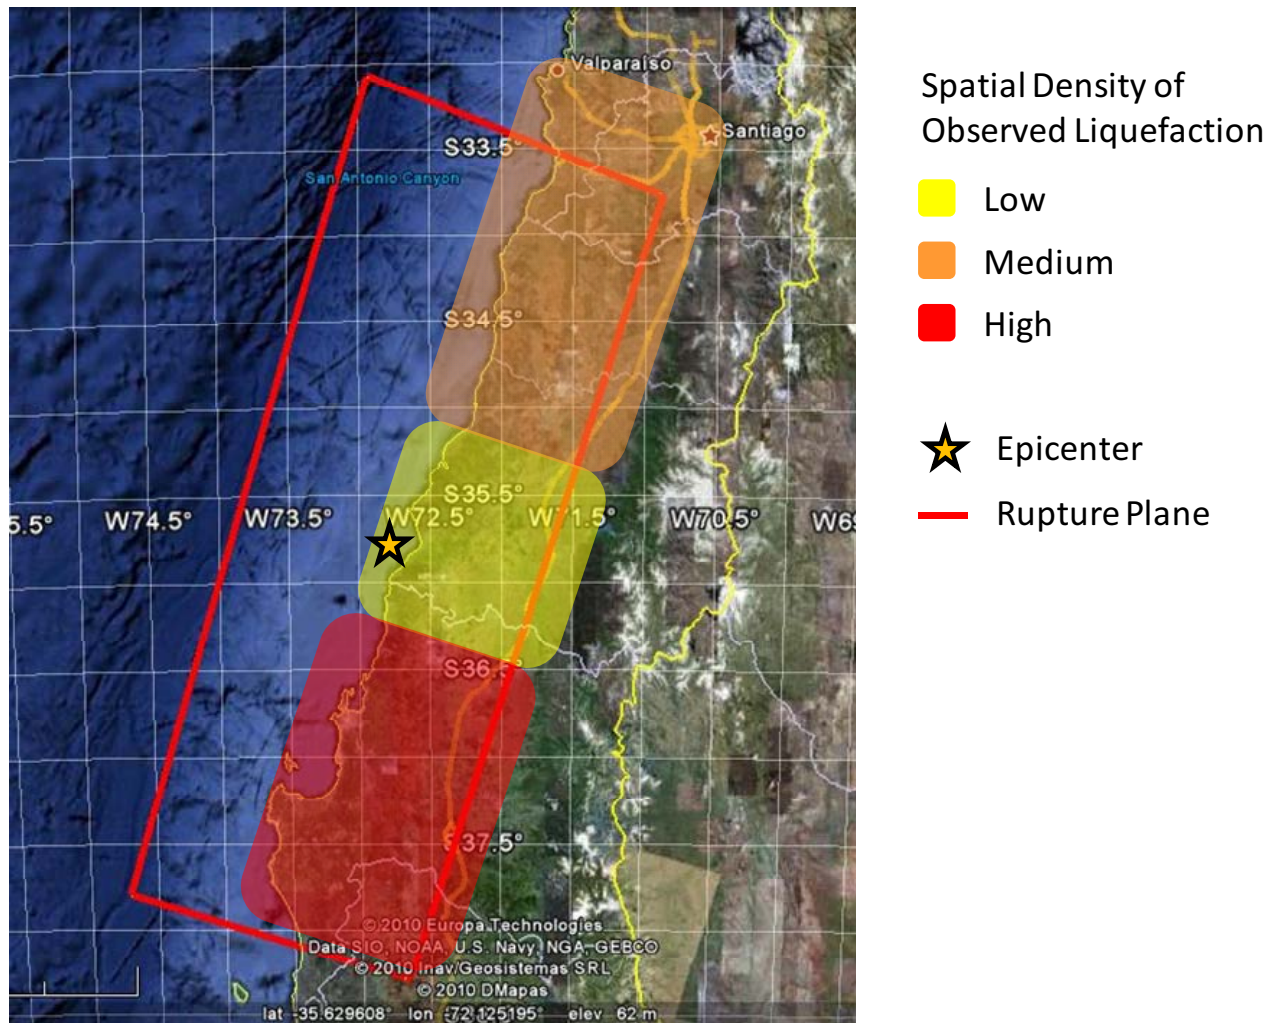
Figure 6.2. Spatial distribution of observed liquefaction. Because of the widespread nature of liquefaction it is shown here in terms of zones of low, median, and high spatial density. Observations include surface evidence of liquefied ejecta and lateral spreading.

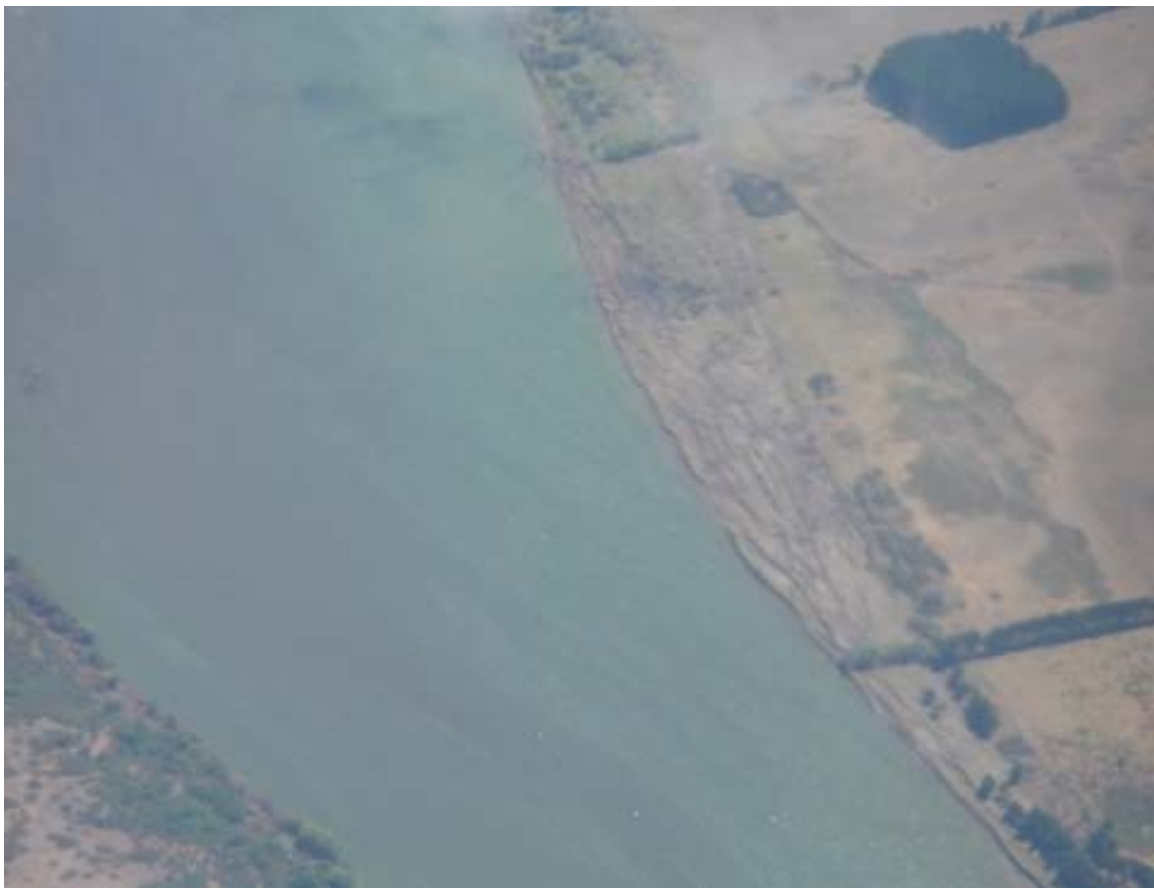
Figure 6.3. Lateral spreading feature observed along Rio Maipo towards the northern extents of damage (S33.9913° W71.5316°, 12:30, 3/6/2010).

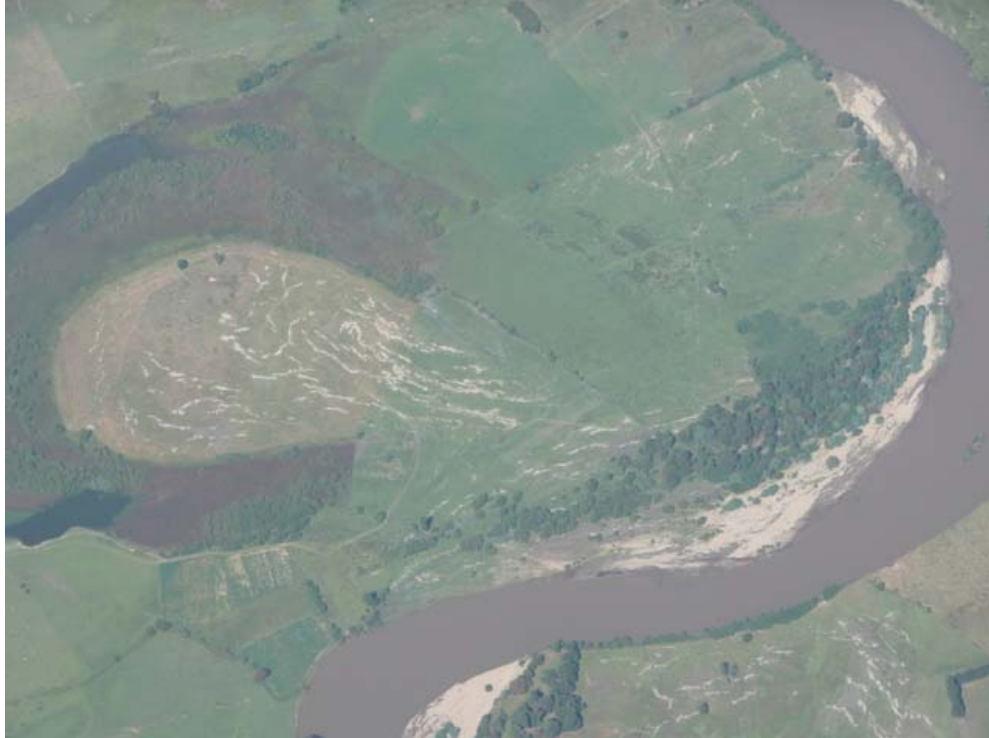
Figure 6.4. Liquefaction ejected and lateral spreading features observed along Carampangue River towards the southern extents of damage (\sim S37.2780°, \sim W73.2541°, 17:00, 3/6/2010).

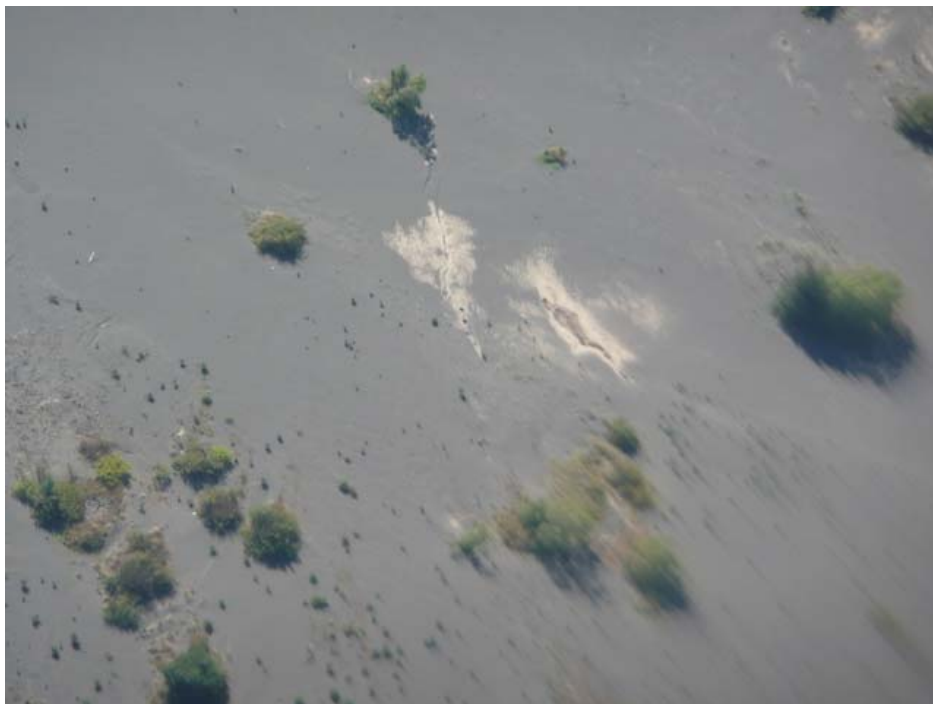
Figure 6.5. Lower elevation view of fissures and liquefaction ejecta. This was taken along the lower Rio Bio Bio near Concepcion (\sim S36.8239°, \sim W73.0944°, 15:00, 3/6/2010). The dark surface sediment is from the Rio Laja that intersects the Bio Bio approximately 20-30 km upstream from this point. The light ejected sediment is supplied by the main stem of the Rio Bio Bio upstream of the Rio Laja.

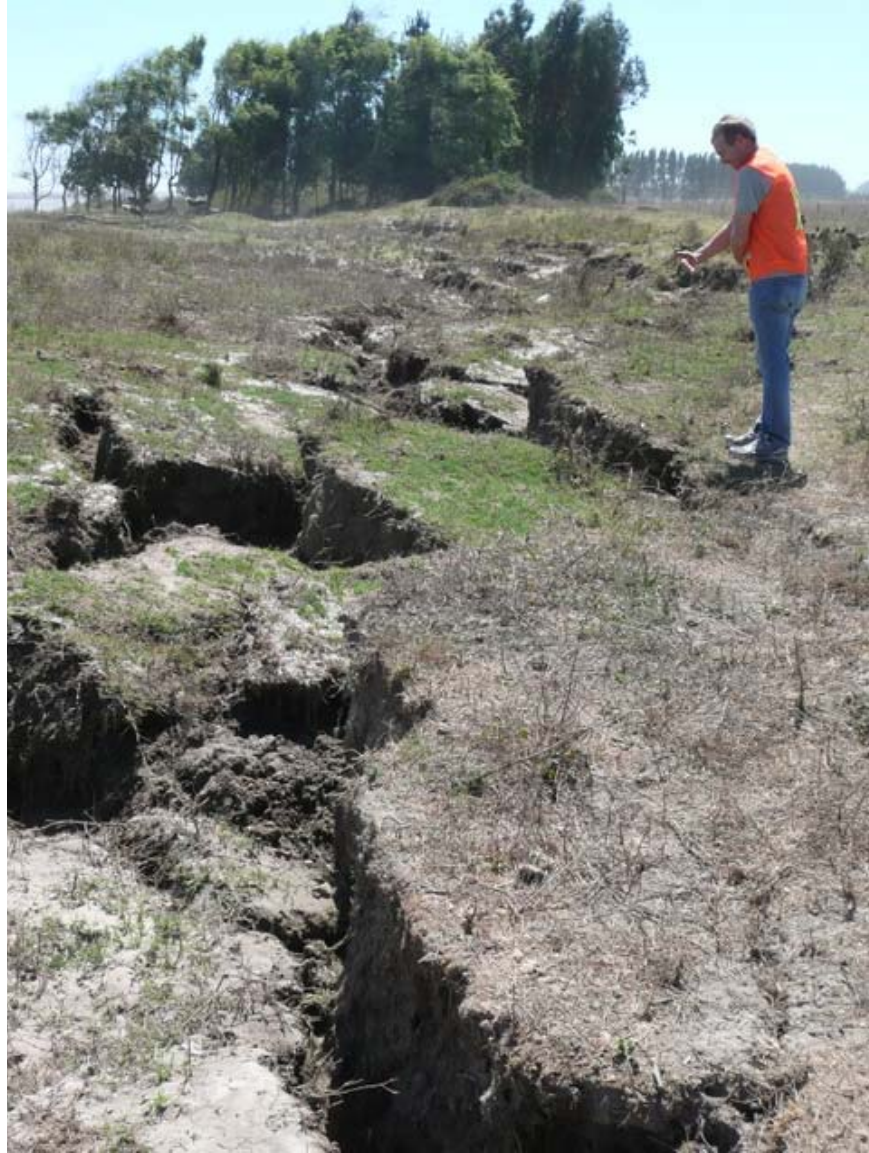
Figure 6.6. Lateral spreading blocks translated and rotated towards the river. This picture shows Keith Kelson standing on the north bank of the Mataquito River downstream of the coastal highway bridge (S3505078°, W72.16240°, 11:00, 3/8/2010).

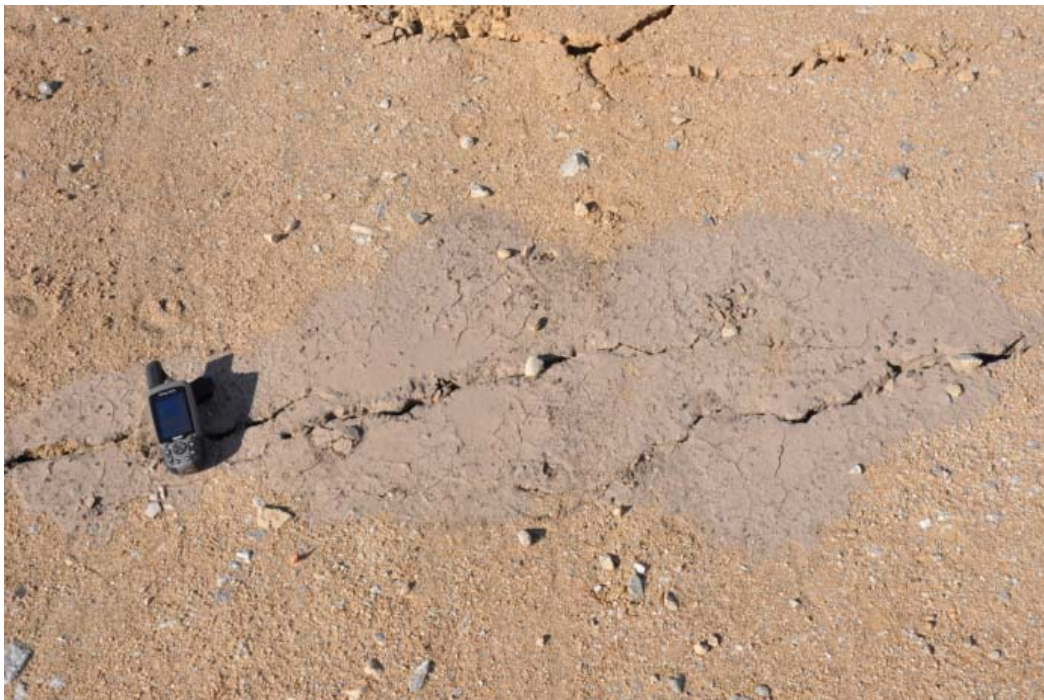
Figure 6.7. Liquefaction boils in undeveloped land area along west shore of Tres Pasuales lagoon in Concepcion (S36.8155°, W73.0460°; 3/14/2010)

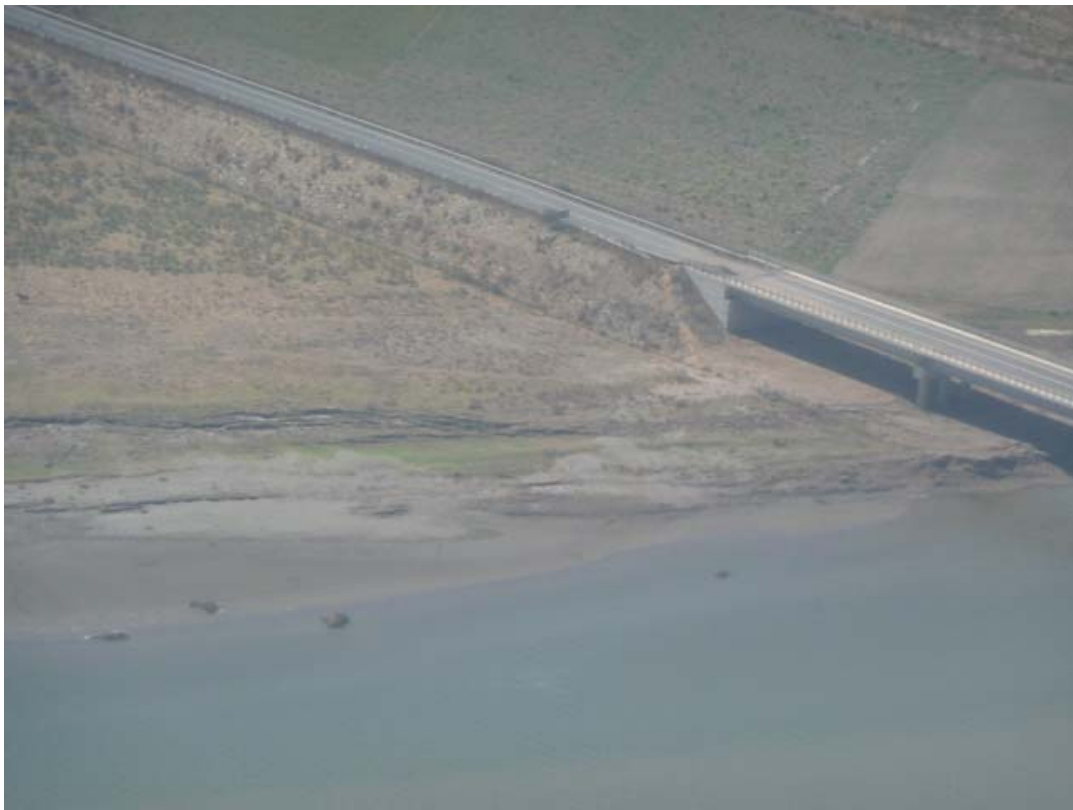
Figure 6.10. Lateral spreading on the north bank of the Mataquito Bridge along the coastal highway (S3505078 °, W72.16240°, 11:00, 3/10/10).

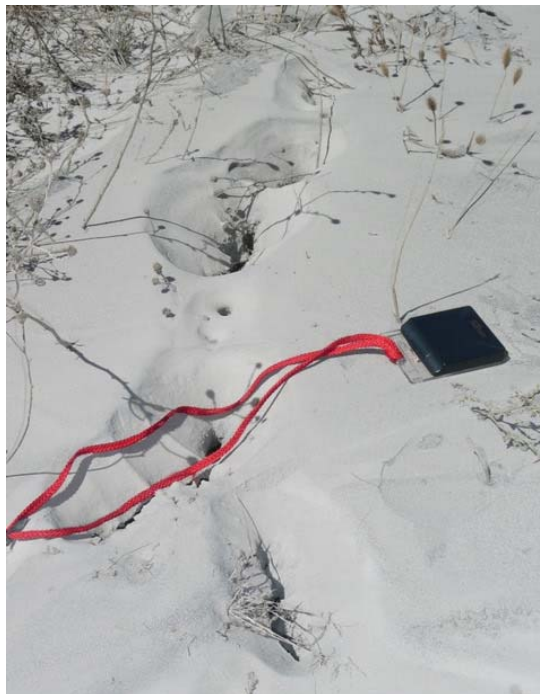
Figure 6.14. Typical liquefaction ejecta found at Mataquito bridge (S3505078°, W72.16240°, 11:00, 3/8/2010). The ejecta consisted of medium to fine sand with some fines.

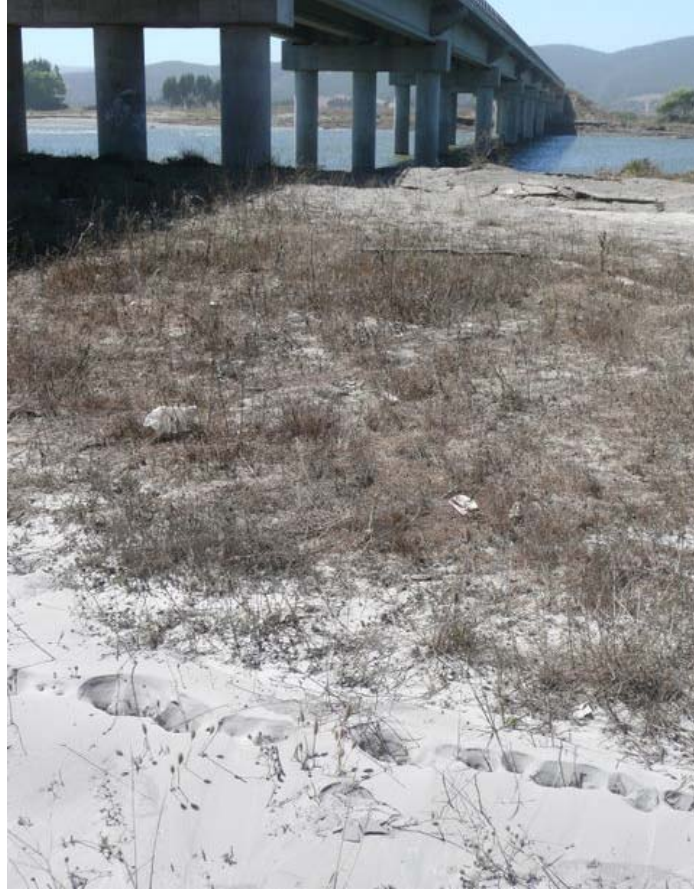
Figure 6.15. Ejecta in the foreground and lateral spreading cracks in the back ground along the south landing of the Mataquito bridge (S3505078°, W72.16240°, 11:00, 3/8/2010).

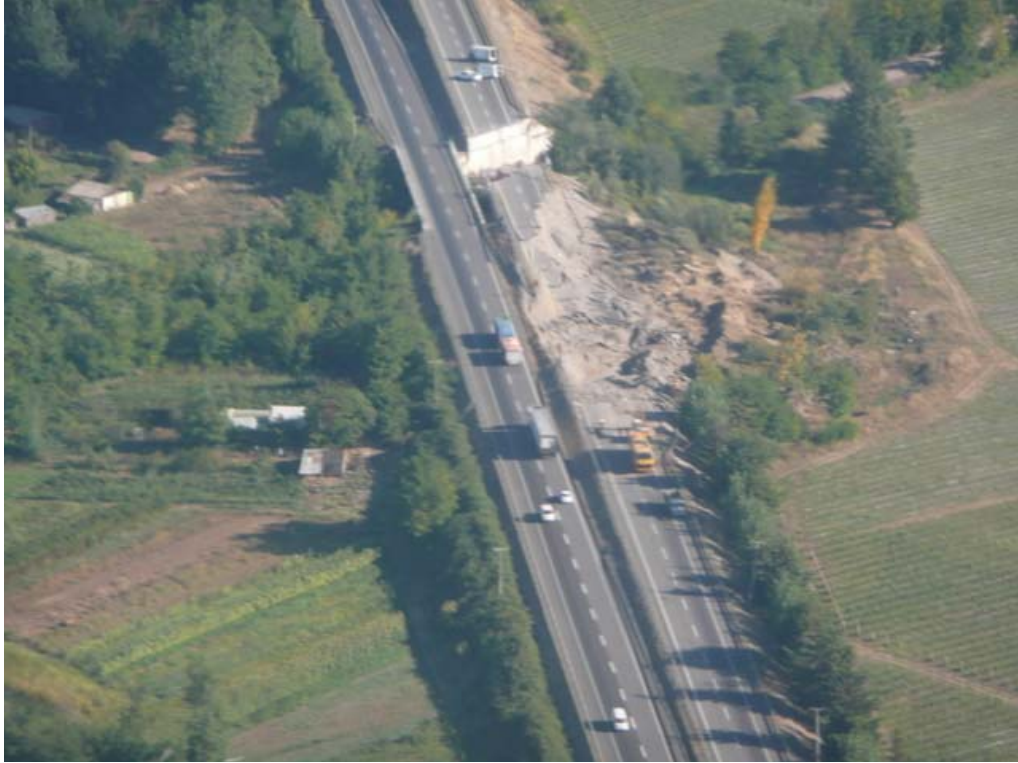
Figure 6.16. Typical road base failure along Pan American highway. Line of trees show where the water crossing intersects the highway. These type of road failures were observed at regular intervals corresponding to the minor water crossings. This picture is from near the town of Curico ($\sim S34.7794^\circ$, $\sim W71.1599^\circ$, 17:30, 3/6/2010).

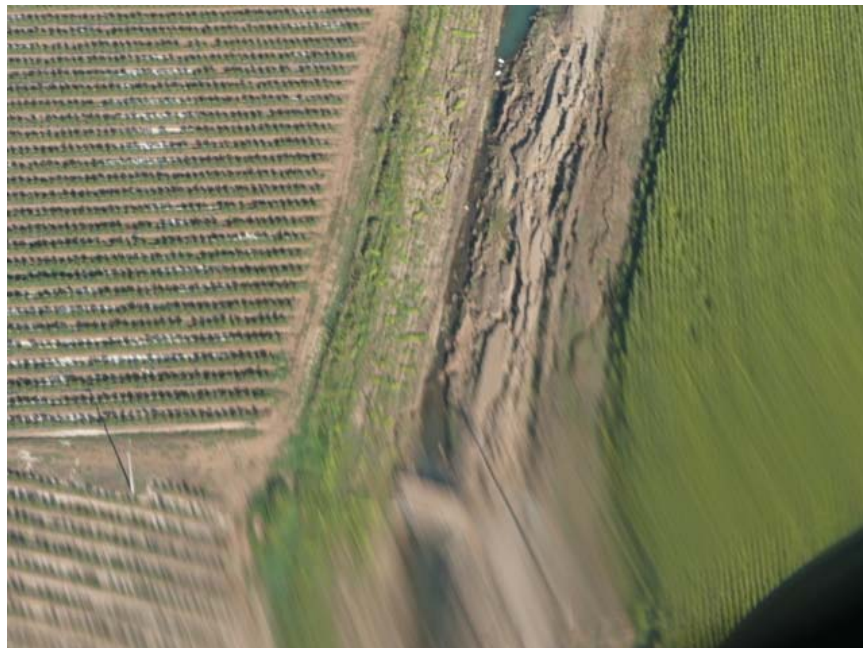
Figure 6.17. Lateral deformations in an agricultural ditch along the Pan American highway. Along the highway these non-engineered features performed very poorly in comparison with the engineered water crossings that fared much better ($\sim S34.7794^\circ$, $\sim W71.1599^\circ$, 17:30, 3/6/2010).

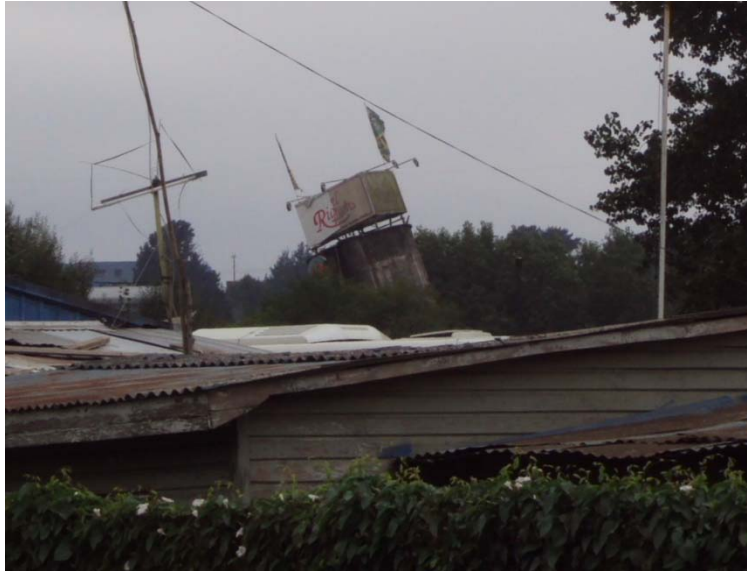
Figure 6.18. Leaning tank due to liquefaction of the foundation soil, near Arauco (S37.2458°, W73.3197°).

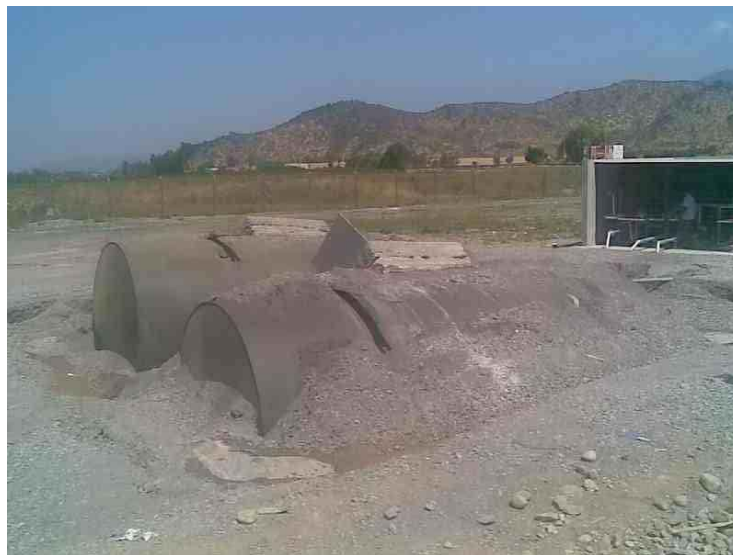
Figure 6.19. Tanks buoyed above the ground surface when the higher unit weight soil fluidized due to excess pore pressure generation. This occurred near San Fernando (~S34.5898°, ~W70.9890°)

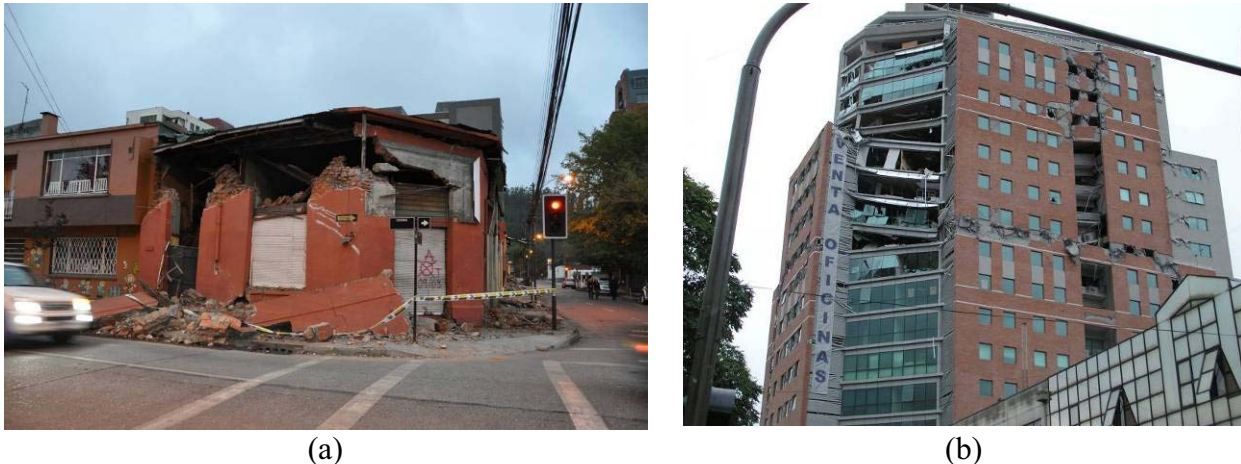
Figure 7.1. (a) Typical construction type and observed damage within the city of Talca ($S36.8323^\circ, W73.0554^\circ$; 1230 hrs on 3/18/2010) and (b) Significant structural damage, including partial collapse of a floor, of a modern high-rise building in downtown Concepción ($S36.8296^\circ W73.0550^\circ$; 2000 hrs on 03/17/2010).

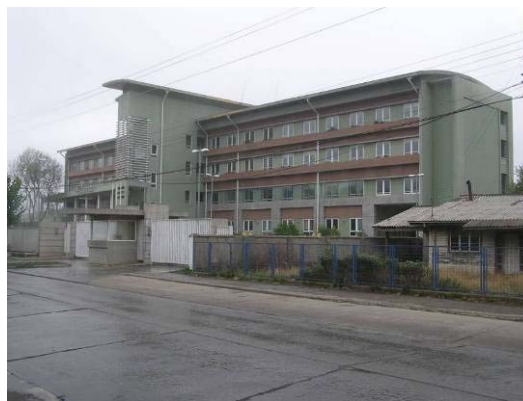
Figure 7.5. View of front of Wings 1A and 1B looking south (S37.47355° W73.34799°; 1900 hrs on 03/16/10)

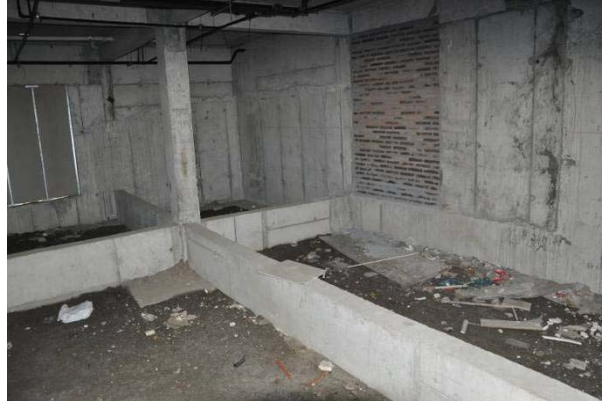
Figure 7.6. General configuration of the foundation, perimeter structural shear walls and interior gravity columns (view at ground floor of wing 2I looking east) (S37.47366°, W73.34761°; 1625 hrs on 3/16/2010)

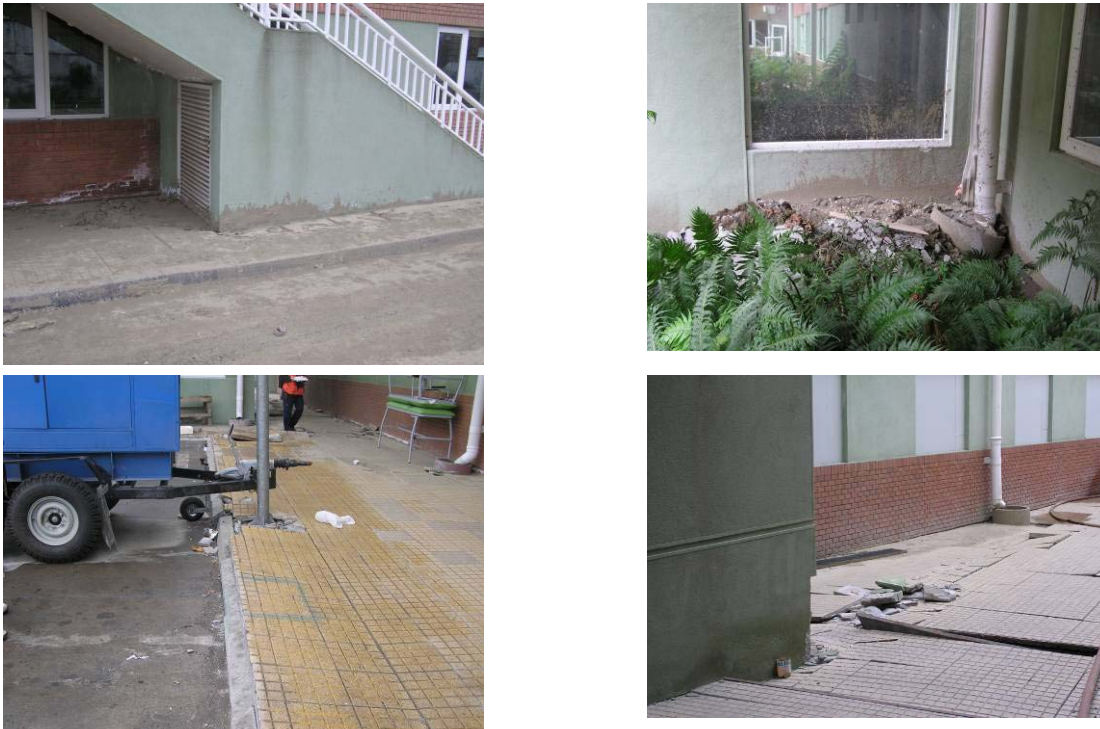
Figure 7.7. Sediment ejecta observed around hospital wings; (a) ejecta observed along exterior staircase of Wing 1D (S37.47358°, W73.34890°), (b) ejecta observed along exterior of Wing 1C (S37.47342°, W73.34829°), (c) ejecta observed along south side of Wing 1D(S37.47375°, W73.34851°), and (d) ejecta observed along east side of Wing 2G (S37.47343°, W73.34788°).

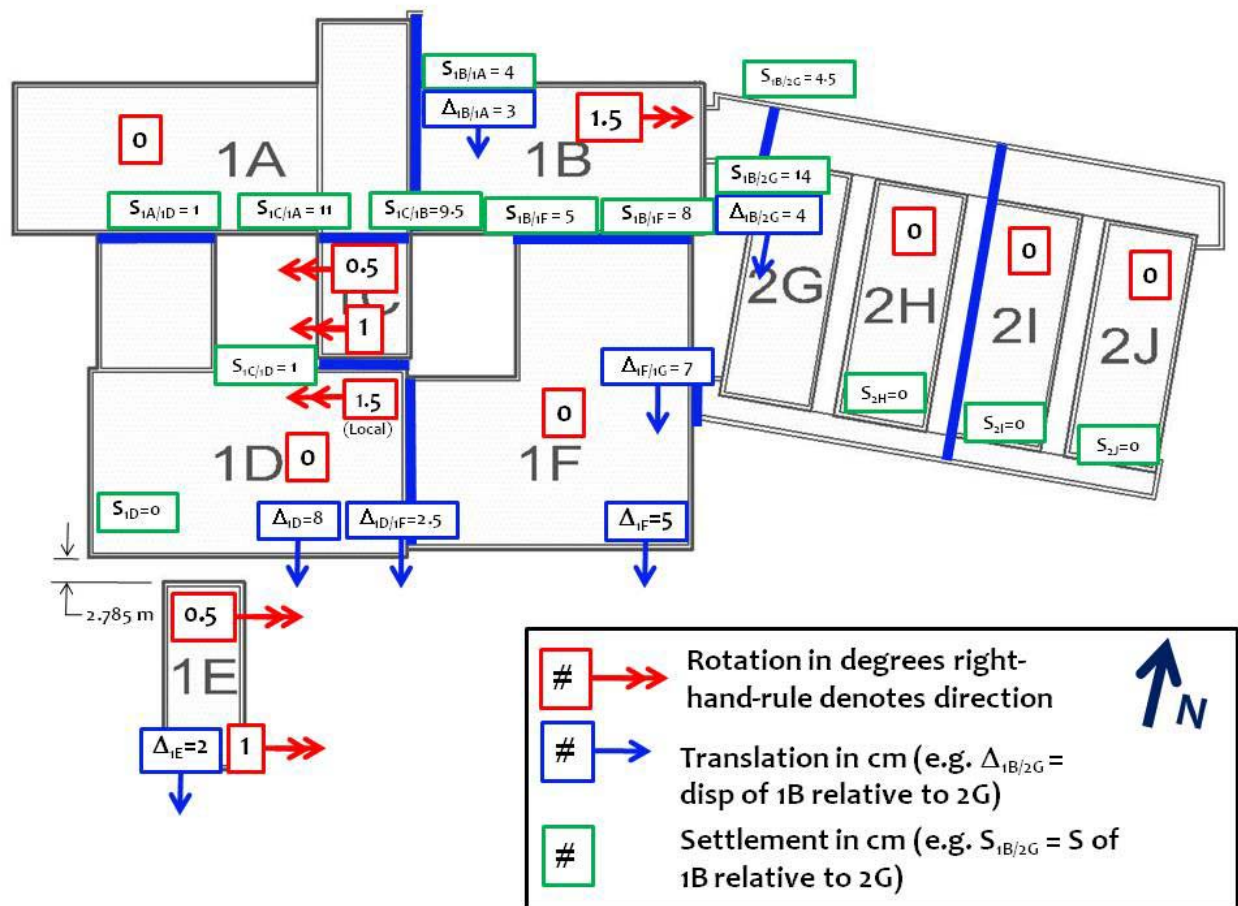
Figure 7.8. Measurements of relative building movement (Bray, Hutchinson, Arduino, and Maureira).

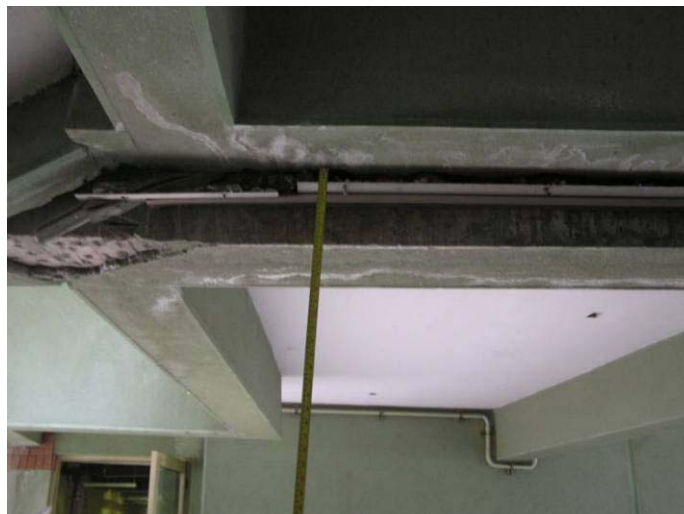
Figure 7.10. Relative movement between Wing 1B (in the background) and Wing 2G (in the foreground) (S37.47335°, W73.34786°; 03/16/10).

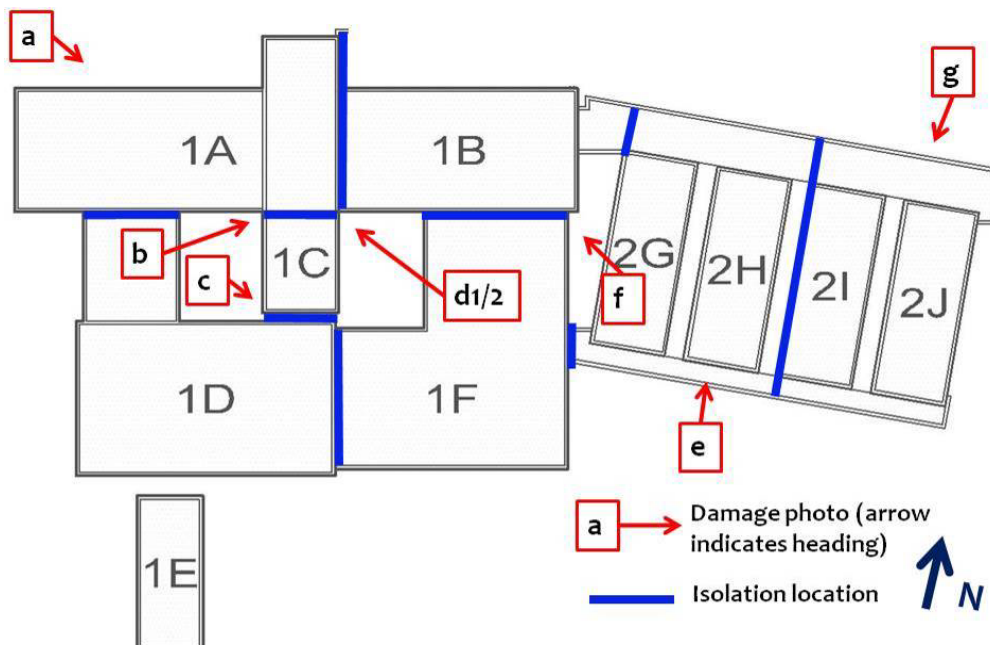
Figure 7.11. Damage map denoting select locations of observed perimeter damage; refer to Figure 7.12 for photographs and description of observation associated with letter annotations in this figure.

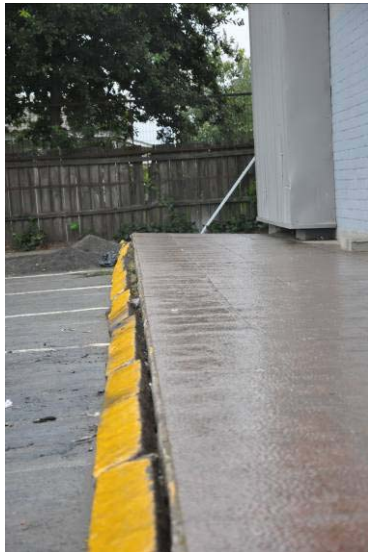
Slight evidence of liquefaction was observed to the north of the hospital in the parking lot area of a market (Figure 7.14a). Minor pavement distress and minor uplift of manholes in this area were observed. However, the pervasive liquefaction that was observed at the hospital was not observed here or at other locations in the city. Lastly, ground failure was observed near the river that is located south of the hospital (Figure 7.14b); however, the street that ran along the north side of the river showed no damage to its north, which indicates that the ground failure near the river was localized and did not extend to the hospital grounds.

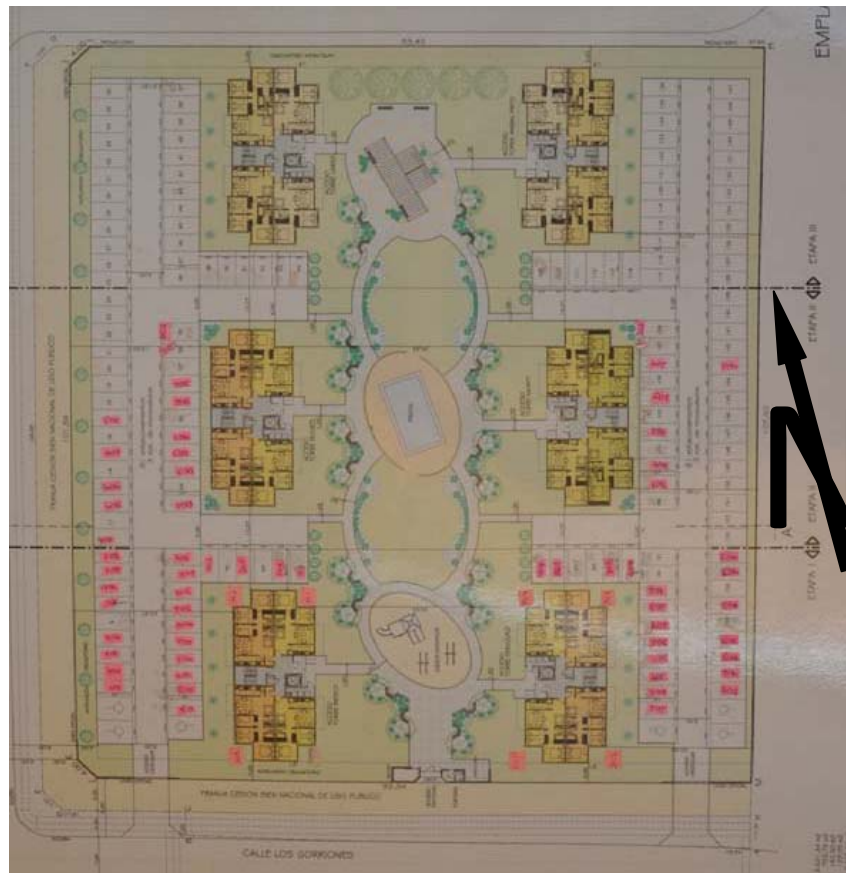
Figure 7.15. Master plan at the Condominio los Presidentes site.

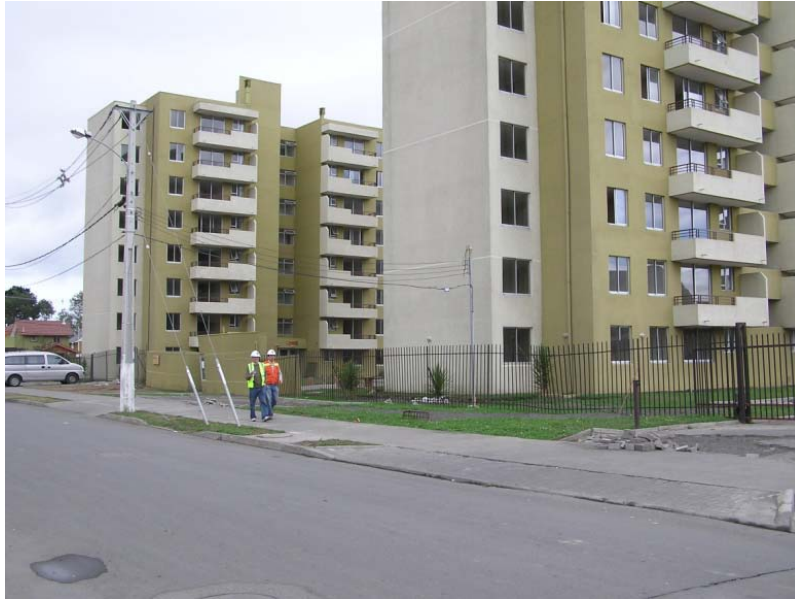
Figure 7.16. Southern most buildings at the four 8-story condominium building site (S36.791026°; W73.081235°; 1300 hrs on 03/17/10).

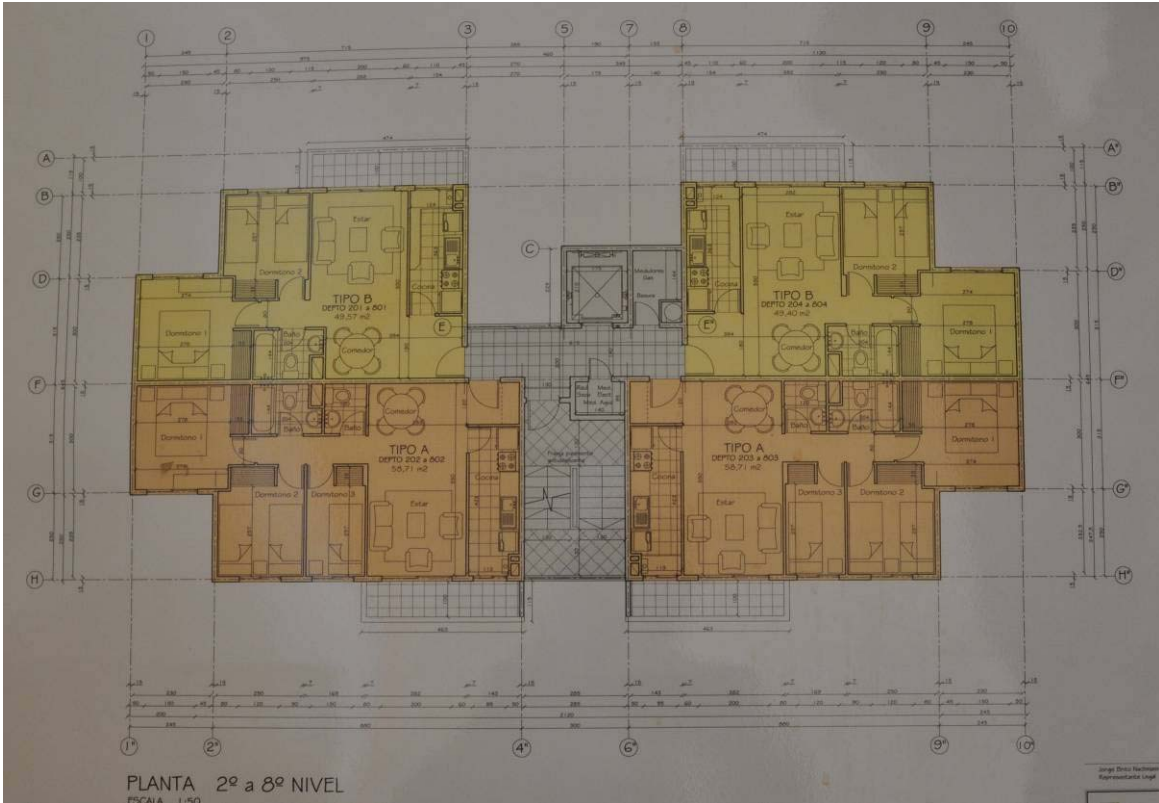
Figure 7.17. Architectural plan of the Riesco, Errázuriz, Montt, and Bulnes buildings (image taken at 1615 hrs on 3/17/2010).

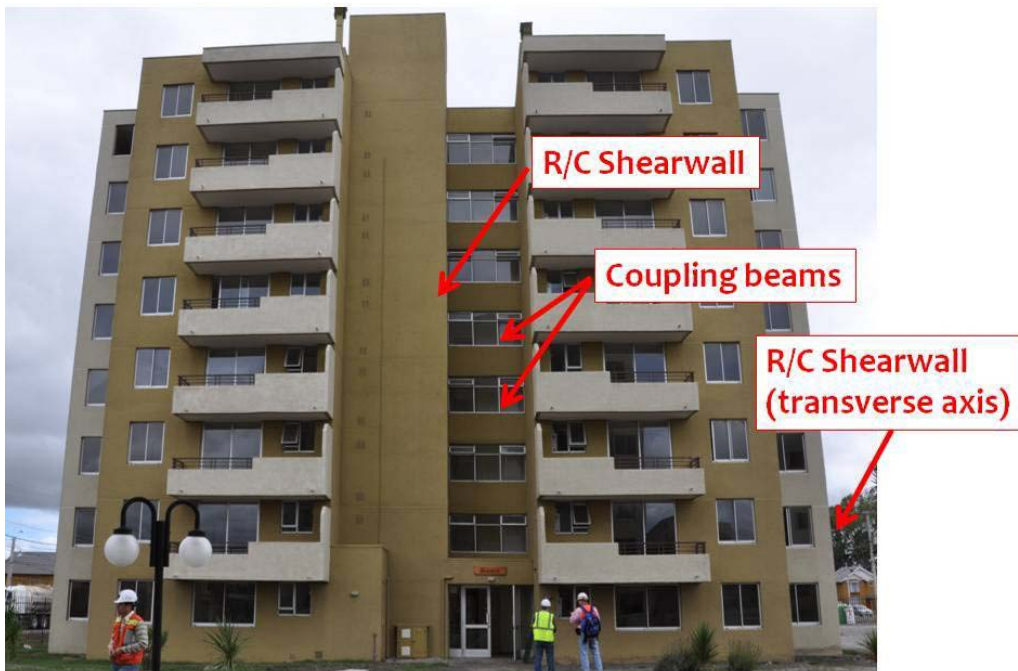
Figure 7.18. Elevation of the Riesco building depicting the general components of the structural system of the building (image taken at S36.790929°, W73.081296°; 1400 hrs on 3/17/2010).

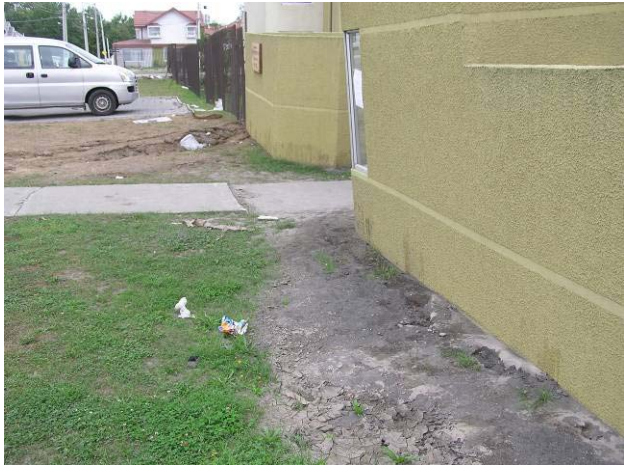
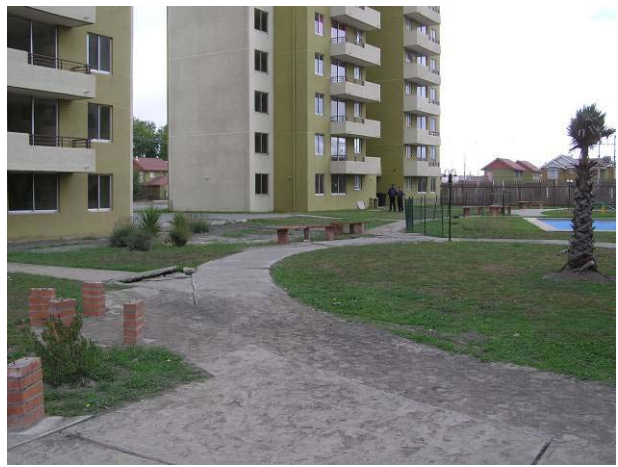
Figure 7.19. Sediment ejecta, ground cracks, and other evidence of liquefaction of the sandy fill were found throughout the condominium site; however, street curbs around the property did not show evidence of liquefaction (S36.79107°, W73.08149°; 1300 hrs on 03/17/10).

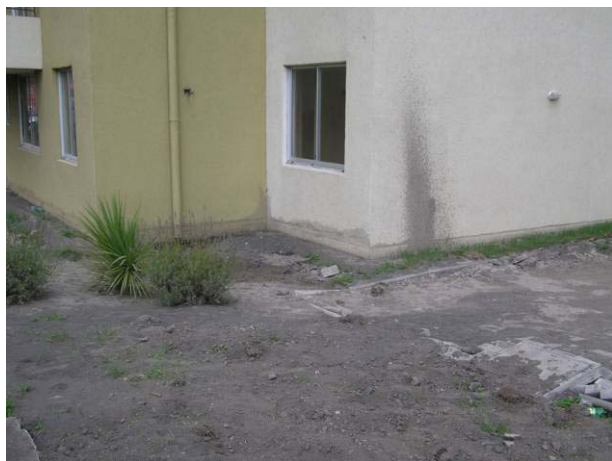
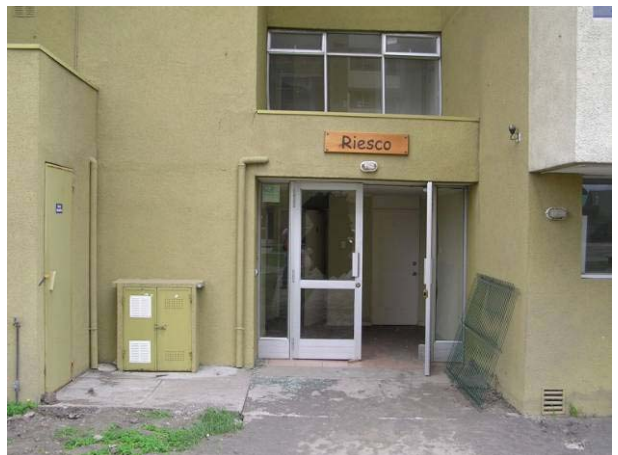
Figure 7.20. Riesco building that underwent most significant liquefaction-induced movement. Left photo shows evidence of large sediment ejecta at its northeast corner (S36.79077°, W73.08124°; 1330 hrs on 03/17/10). Right photo shows entrance to the building in the middle of its east facing side (S36.79089°, W73.08131°; 1310 hrs on 03/17/10).

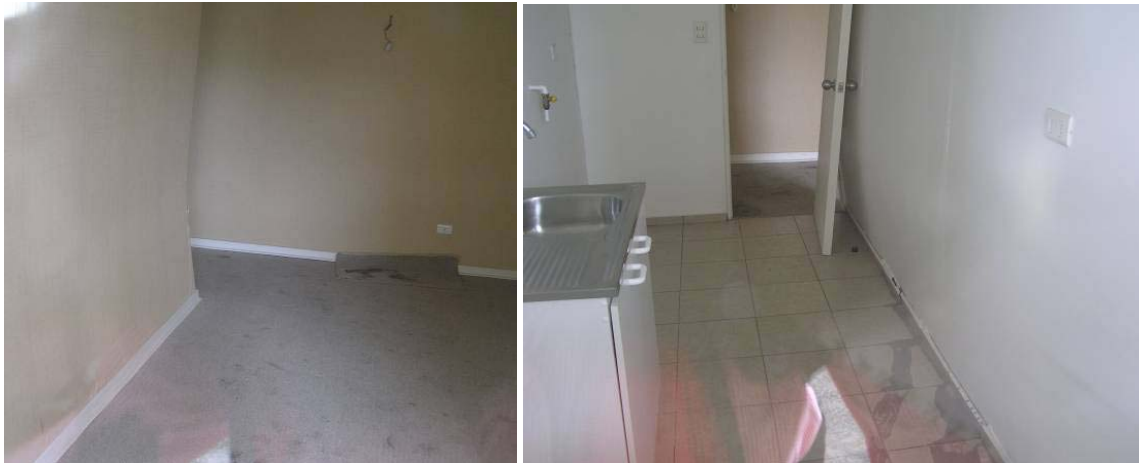
Figure 7.21. Evidence of interior damage to Riesco Building due to differential foundation movement (S36.79085°, W73.08128°; 1320 hrs on 03/17/10).

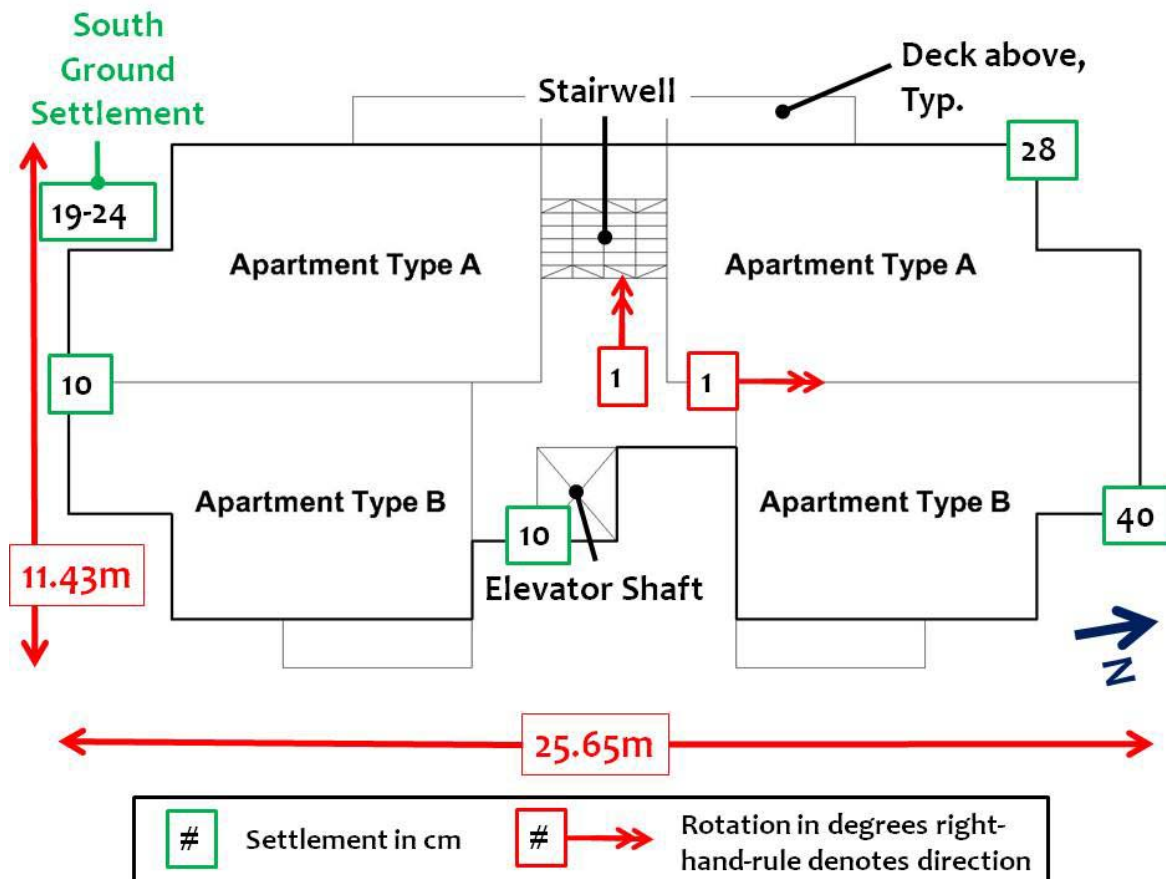
Figure 7.22. Schematic plan view of the Riesco building depicting measured movement of foundation. (note that rotation about the transverse axis of the building is believed to largely hinge about the shear wall-coupling beam interface as shown in Figure 7.23 (Bray, Hutchinson, Arduino, and Maureira).

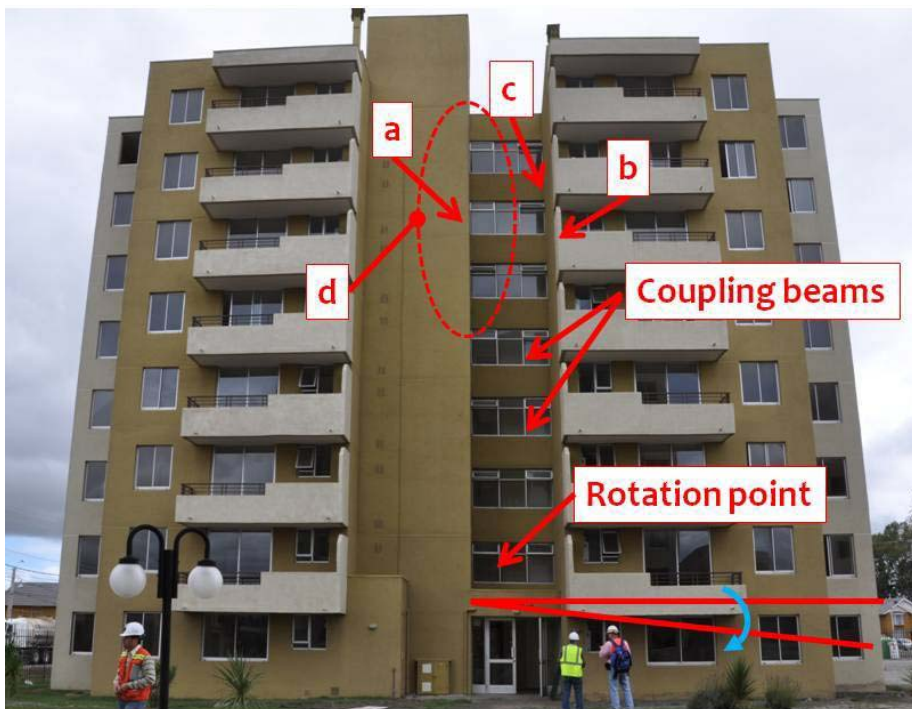
Figure 7.23. Elevation of the Riesco building depicting the movement characteristics (about transverse axis only) and resulting damage map – refer to Figure 7.24 for images of a-d (image taken at S36.790929°, W73.081296°; 1400 hrs on 3/17/2010).

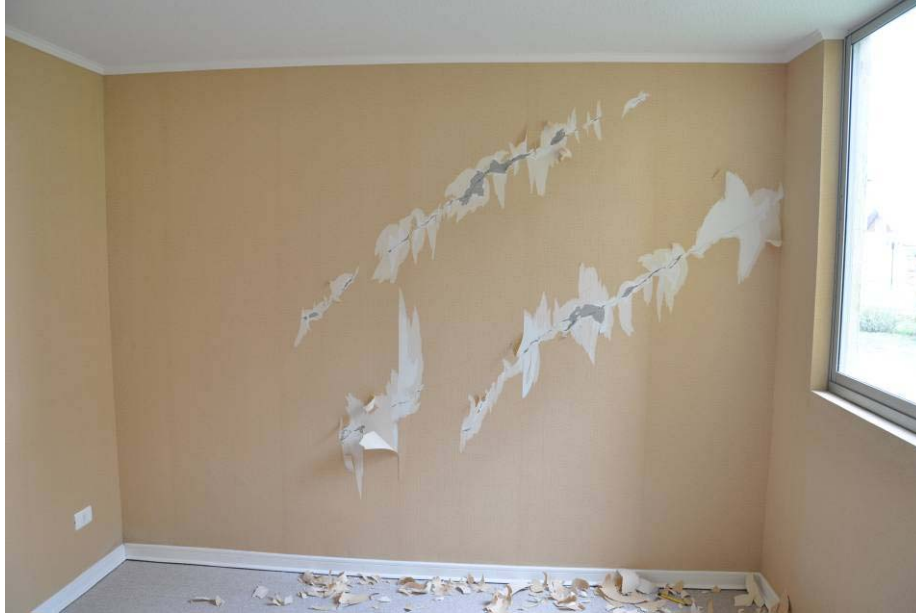
Figure 7.25 Damage to ground floor shear walls of the Montt building (S36.790737°, W73.080901°; 1545 hrs on 3/17/2010)

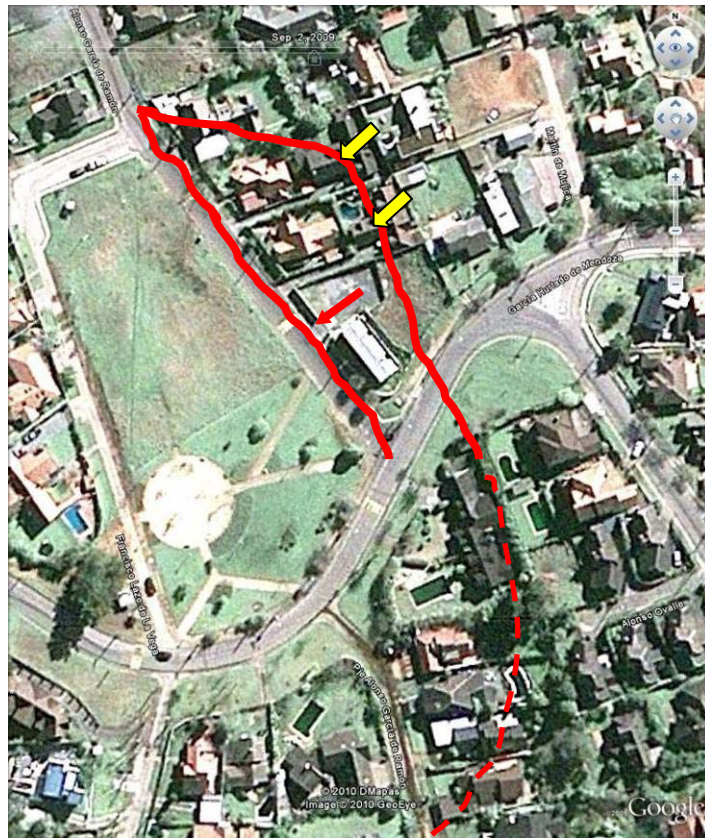
Figure 7.29. Affected area with approximate limits of the translational earth movement; the toe of the slide is along the eastern side of Alonso García de Ramón Road and the head scarp runs through the houses and the open field behind the rectangular apartment complex. (S36.791841°, W73.056996°). The yellow arrows denote the location of two severely damaged home which are shown in Figure 7.31.
