GEO-ENGINEERING EXTREME EVENTS RECONNAISSANCE (GEER) ASSOCIATION

Turning Disaster in Knowledge

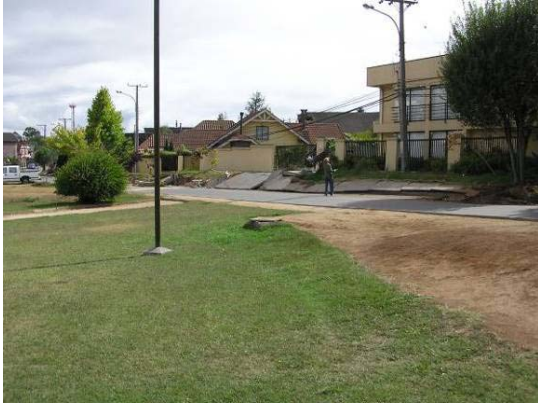
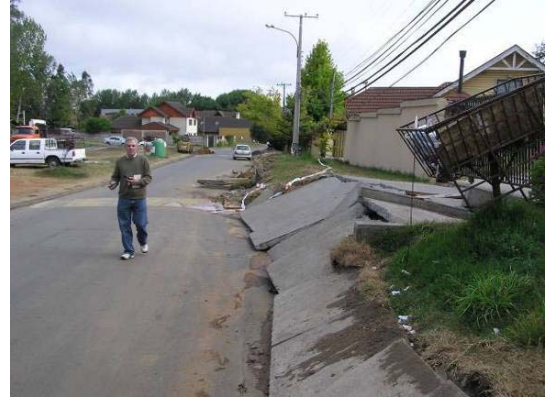
Figure 7.30. View to the north showing toe of slide in left photo, and view to the northwest of toe of slide along Alonso García de Ramón Road (right photo taken near its intersection with García Hurtado de Mendoza Road; S36.79146°, W73.05754°; 1200 hrs on 3/17/10).

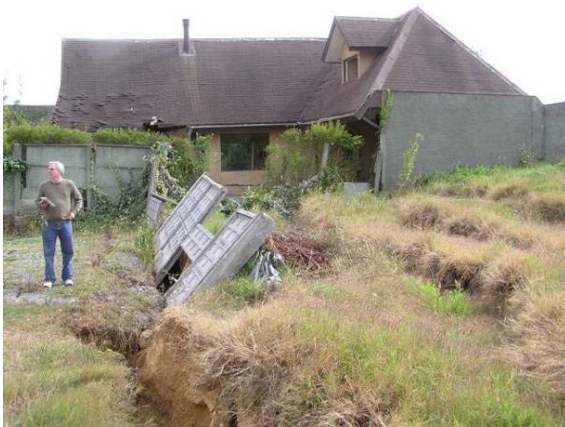
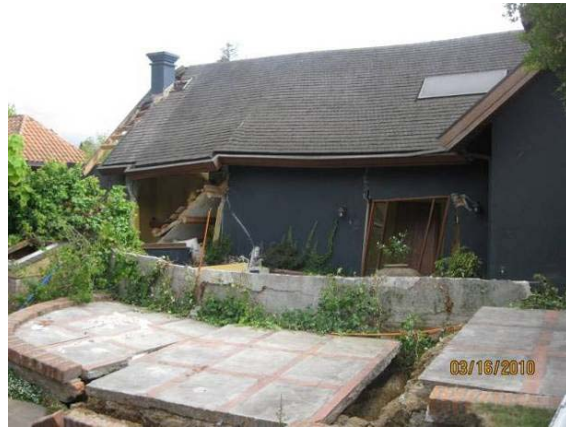
Figure 7.31. View of extension zone in open field behind apartment building (left photo(S36.79126°, W 73.05714°; 1120 hrs on 03/17/10), and view of damage to a home due to ground extension across its foundation (right photo, S36.79108°, W73.05728°; 1200 hrs on 3/17/2010).

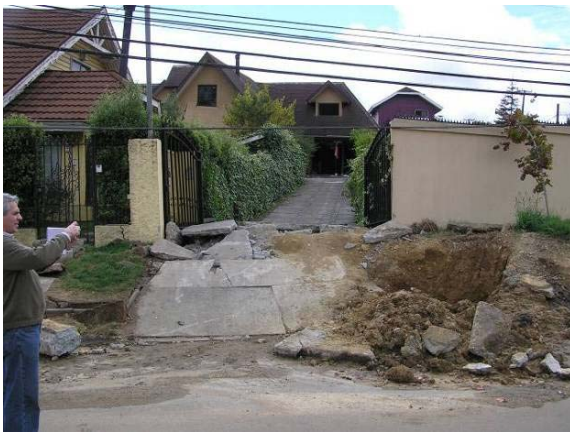
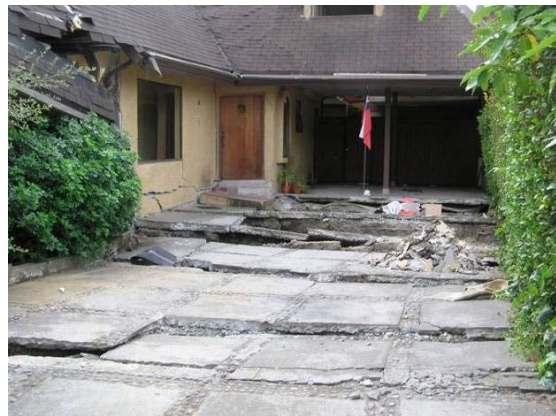
Figure 7.32. View of toe of translation slide in foreground of left photo (also note that the driveway behind the toe is not damaged(S 36.79134°, W 73.05762°; 1150 hrs on 03/17/10), and view of the head scarp of the translation slide at back of driveway in the right photo (S36.79126°, W73.05719°; 1130 hrs on 03/17/10).

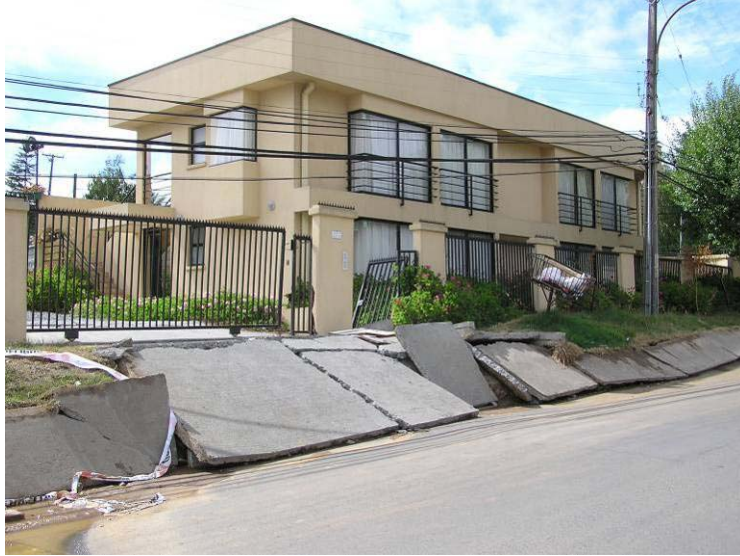
Figure 7.33. Apartment building underwent translation and tilt, but suffered no significant structural damage. (S 36.79167°, W 73.05721°; 1200 hrs on 03/17/10).

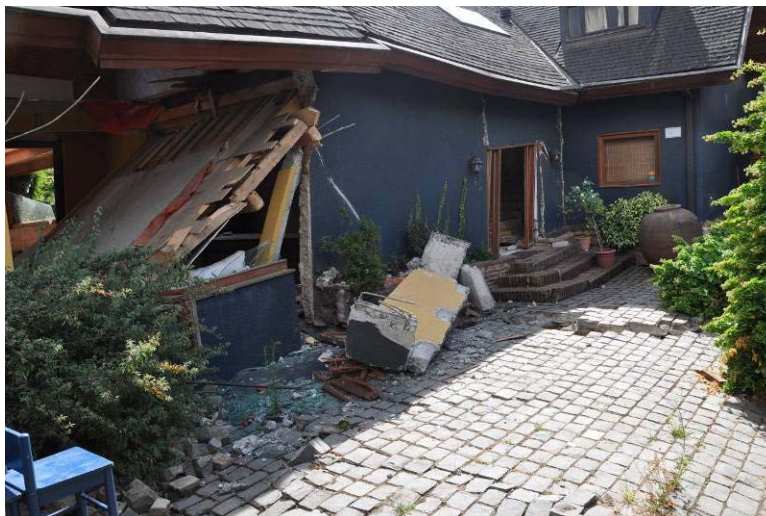
Figure 7.34. Single family residence severely damaged at backside of scarp (S36.79108°, W73.05728°; 1200 hrs on 3/17/2010).

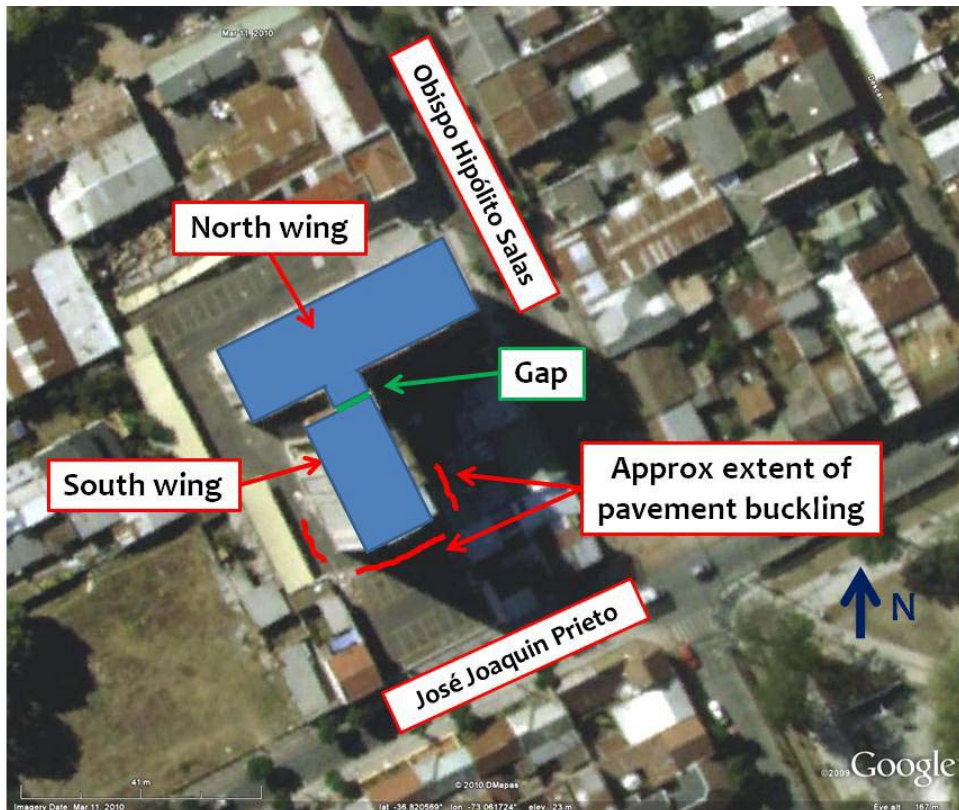
Figure 7.35. Annotated GoogleEarth image of 1343 Salas two wing apartment complex (S36.8205°, W73.0619°) (Image taken on March 11, 2010).

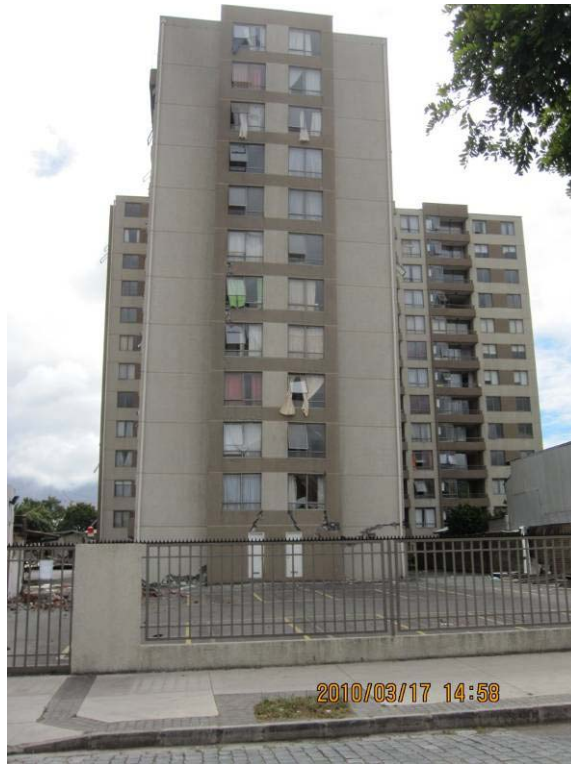
Figure 7.36. Elevation view of 1343 Salas, looking north. North wing in is the background, while the south wing is in the foreground. Note shear and horizontal cracks in the wall on first floor of south wing. (S36.8205°, W73.0619°; 1458 hrs on 03/17/10).

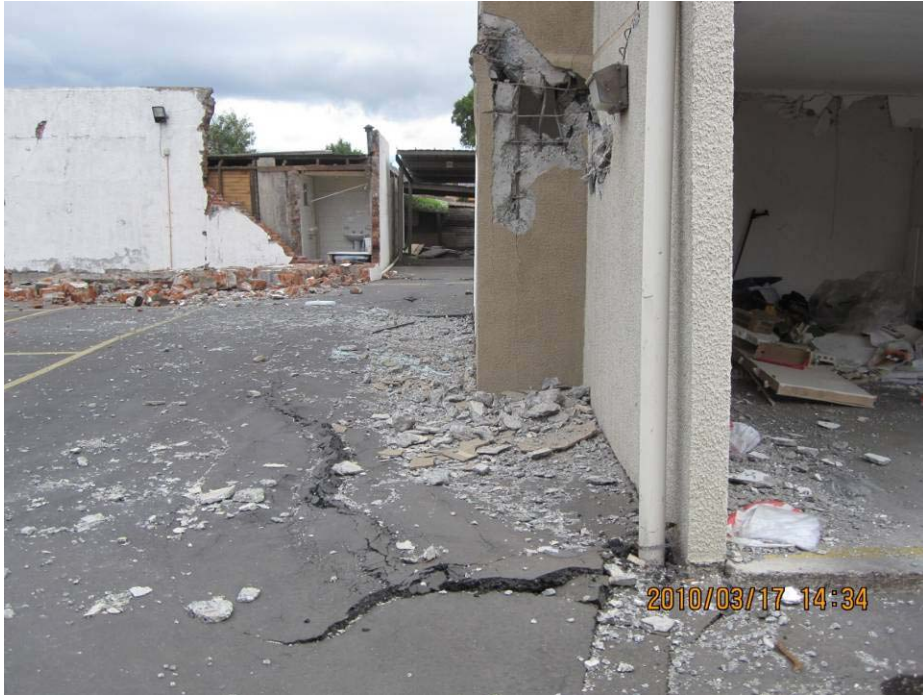
Figure 7.38. Pavement buckling on south side of south wing, view looking west (S36.8205°, W73.0619°; 03/17/10).

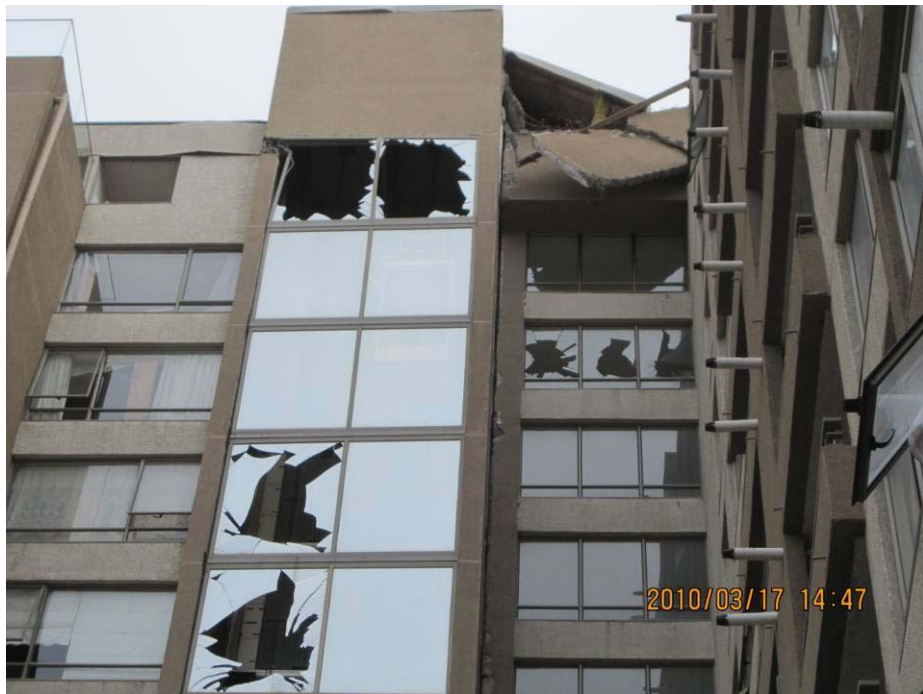
Figure 7.39. Interface between the north and south wings at the upper floors (north wing on right of photograph) showing evidence of minor pounding (view of east side, looking west) (S36.8205°, W73.0619°; 03/17/10).

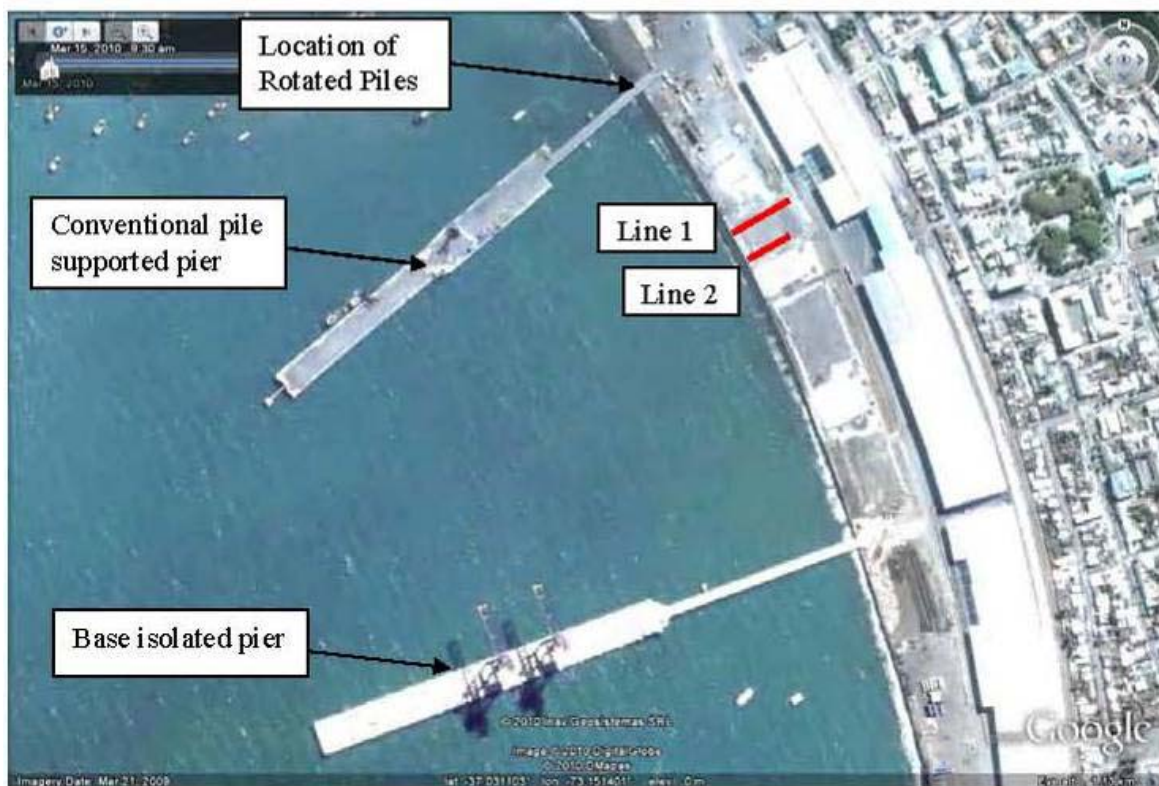
Figure 8.1. Location of lateral spread displacement measurements relative to sheet pile wall at Coronel Port. Photo from Google Earth™ (S37.0281°, W73.1507°).

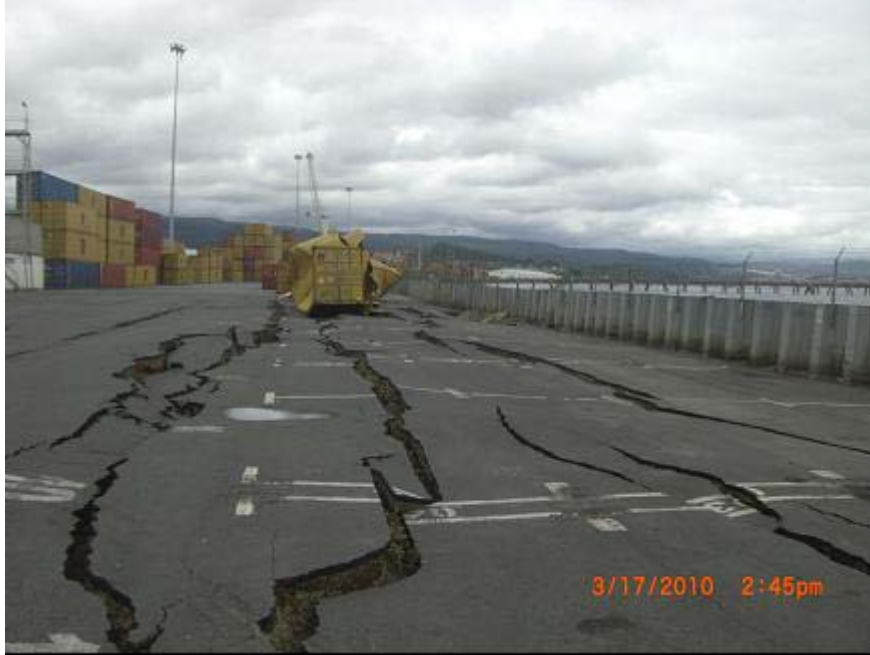
Figure 8.2. Photograph of lateral spread displacements at the Port of Coronel (S37.028680°, W73.150054°; 1445 hrs, 03/17/2010).

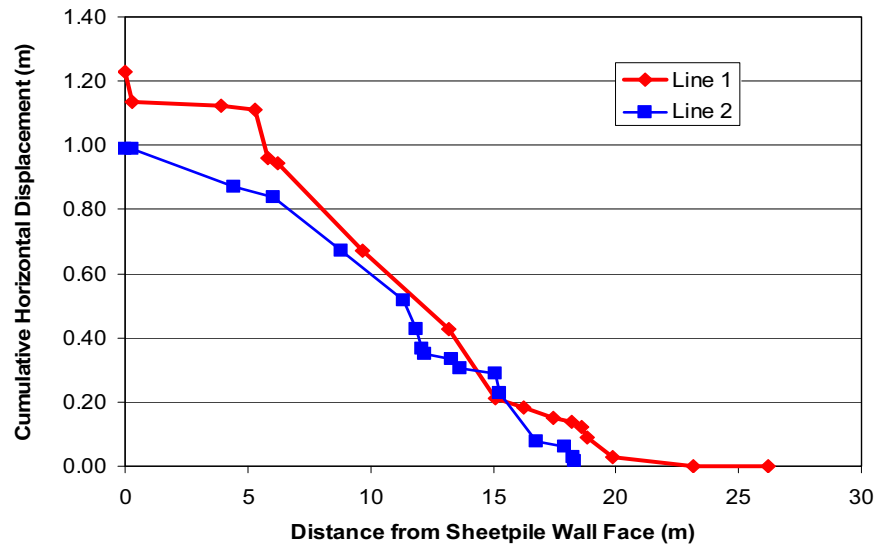
Figure 8.4. Cumulative horizontal displacement vs. distance from the sheet pile face resulting from lateral spreading at the port of Coronel, Chile. (Rollins, Mylonakis, and Assimaki).

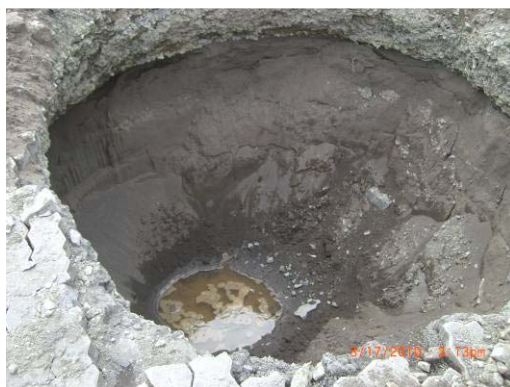
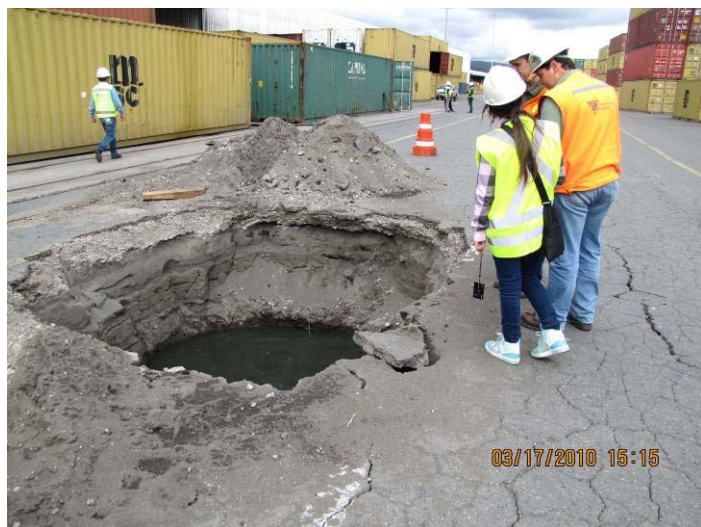
Figure 8.5. Development of sinkholes (2.2 m deep, 3.5 m diameter) as a result of crack (gap) in pipe (S37.0339°, W73.1467°; 1513 hrs, 03/17/2010).

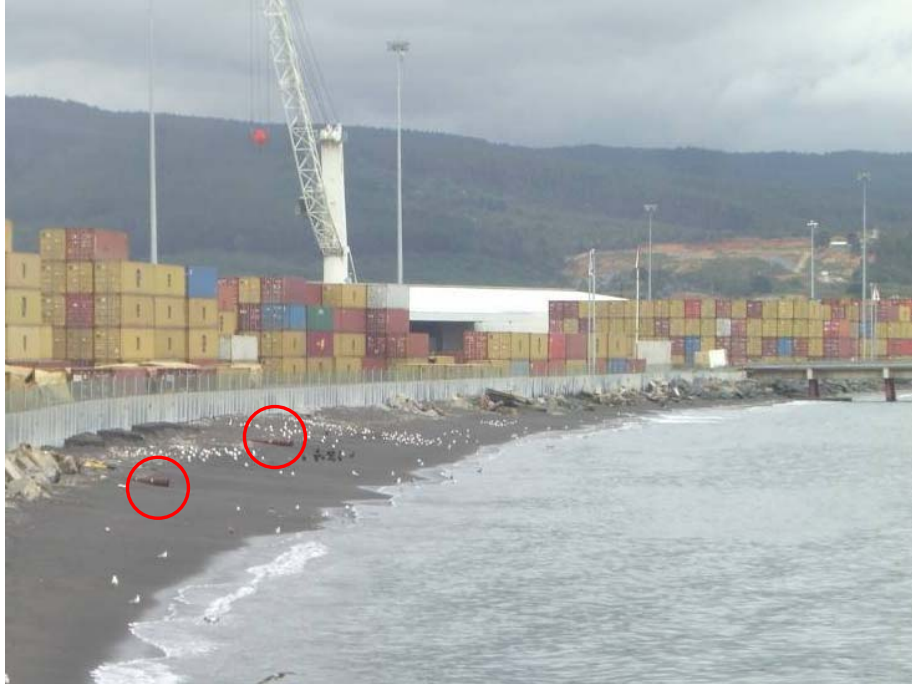
Figure 8.6. Pipelines running transverse to sheet-pile wall which were subjected to longitudinal strain due to lateral spreading (S37.028680°, W73.150054°; 1520 hrs, 03/17/2010).

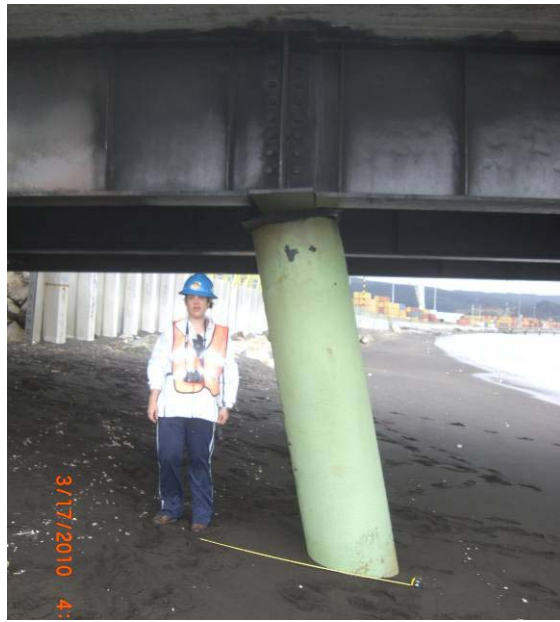
The measured lateral spreading of 1 to 1.2 m caused the 0.5 m diameter steel pipe piles supporting the northern pier to rotate 14° from vertical to accommodate the movement as shown in Fig. 8.7. There were, however, no obvious signs of distress in the surface of the pier. Drawings of the piles and their connection to the pier are provided in Fig. 8.8 based on measurements made in the field and information provided by engineers at the port. The piles were welded to plates which were in turn welded to steel beams on the pier as illustrated in Fig. 8.8. Pile rotation due to lateral spreading caused buckling of the stiffeners on the compression side and yielding of the stiffeners on the tension side of the beam as shown in photos in Fig. 8.7.

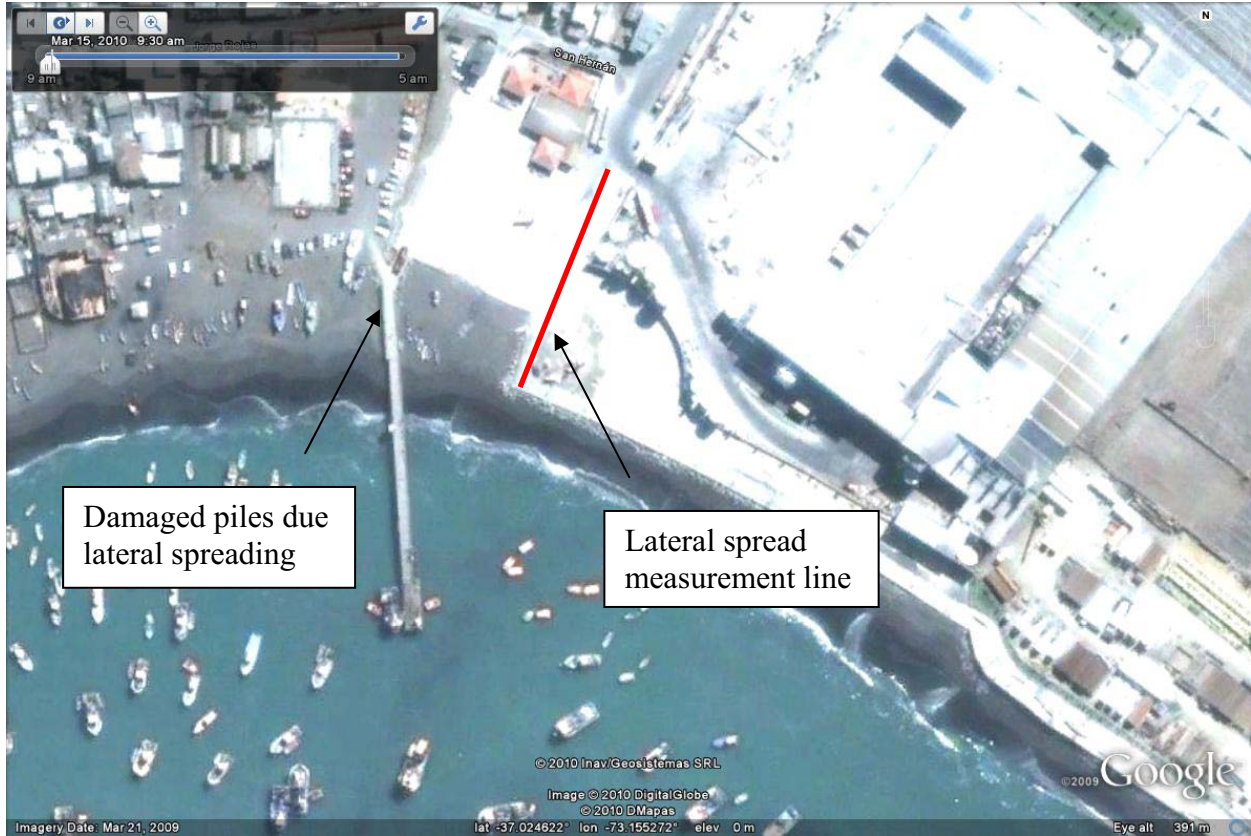
Figure 8.9. Location of lateral spread measurement line and damaged pile cap with battered piles supporting pier at fishermen port north of the main Port at Coronel (S37.024622°, W73.155272°).

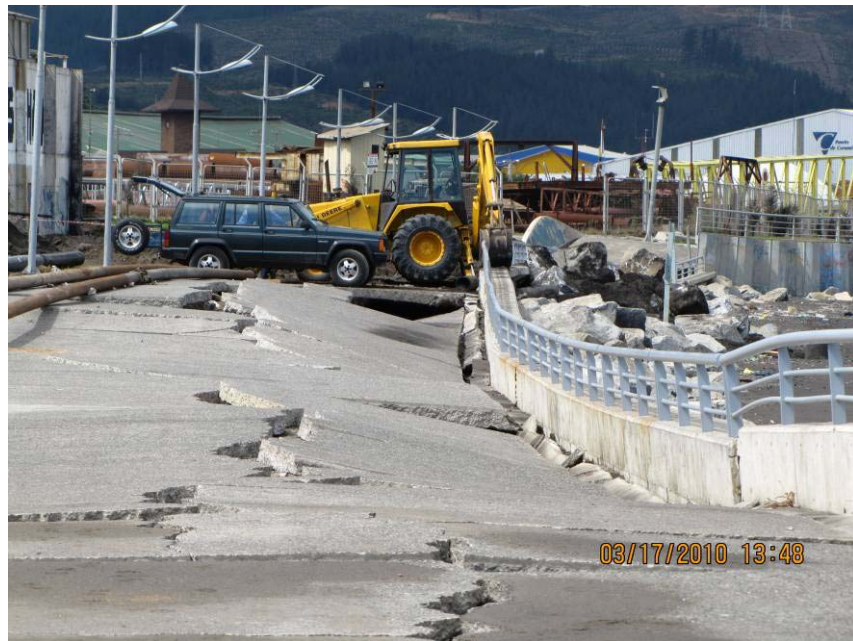
Figure 8.10. Photograph of lateral spreading which destroyed pavement and cracked walls at the fishermen's Port of Coronel (S37.0247°, W73.1550°; 1348 hrs, 03/17/2010).

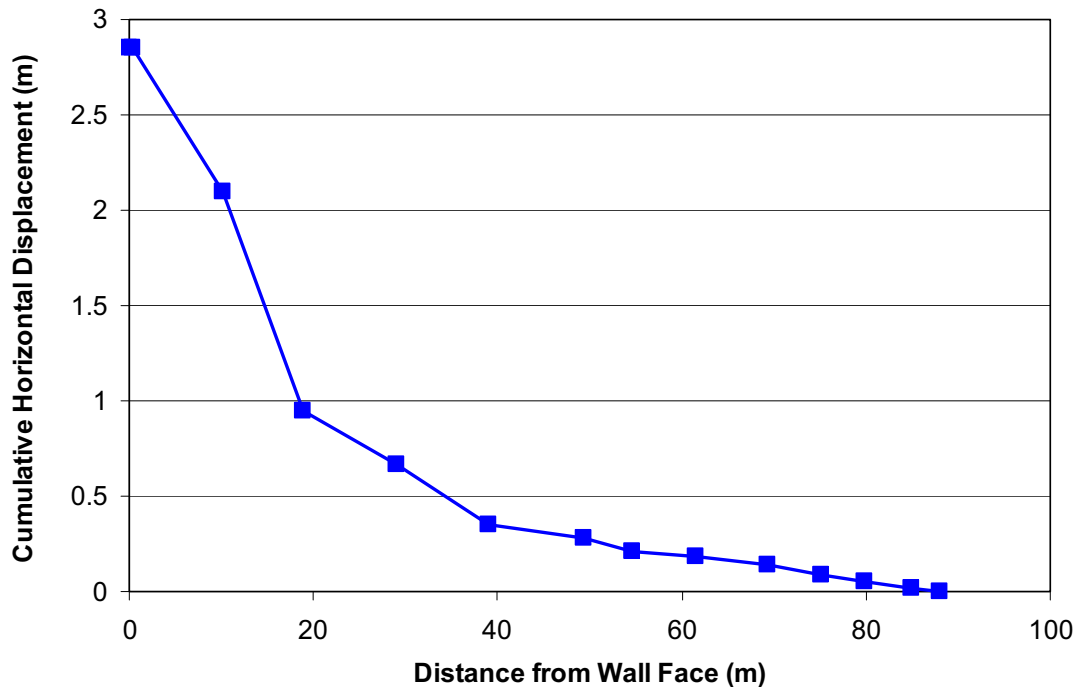
Figure 8.11. Cumulative horizontal displacement vs. distance from wall face due to lateral spreading at Pier on small fishermen’s port at north end of Port of Coronel. (Rollins, Mylonakis, and Assimaki).

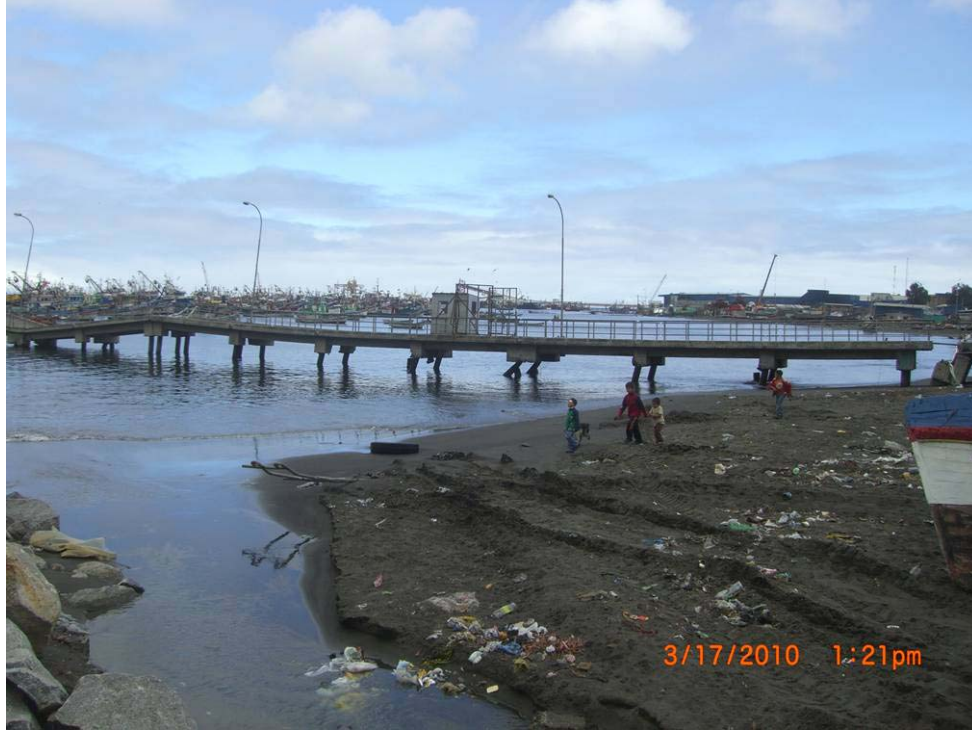
Figure 8.12. Damage to pile supported pier at small fishermen's Port of Coronel due to lateral spreading (S37.024319°, W73.156210°; 1321 hrs, 03/17/2010).

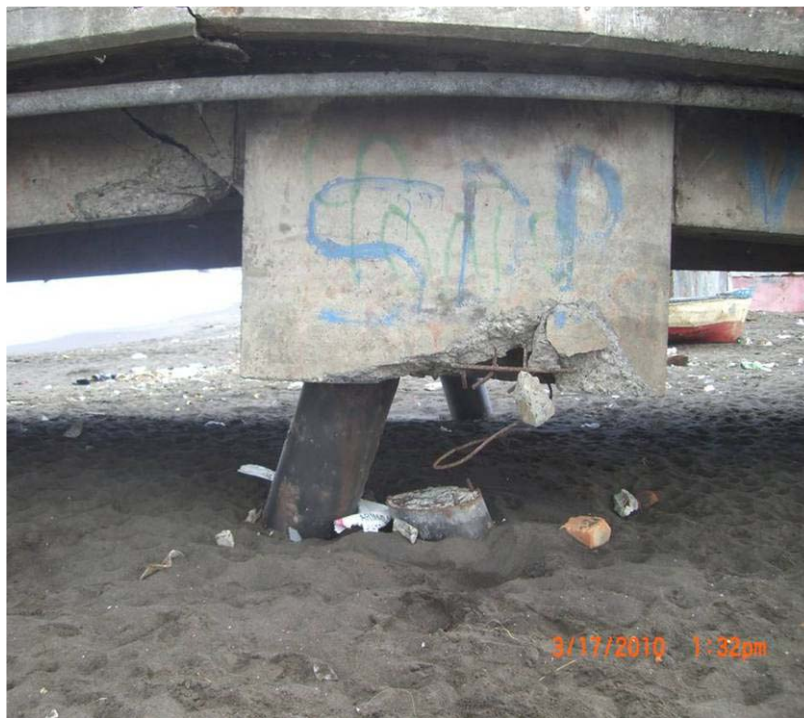
Figure 8.13. Photograph of pile cap with battered piles supporting pier at small fishermen's Port of Coronel showing pull out of trailing row piles (S37.024319°, W73.156210°; 1322 hrs, 03/17/2010).

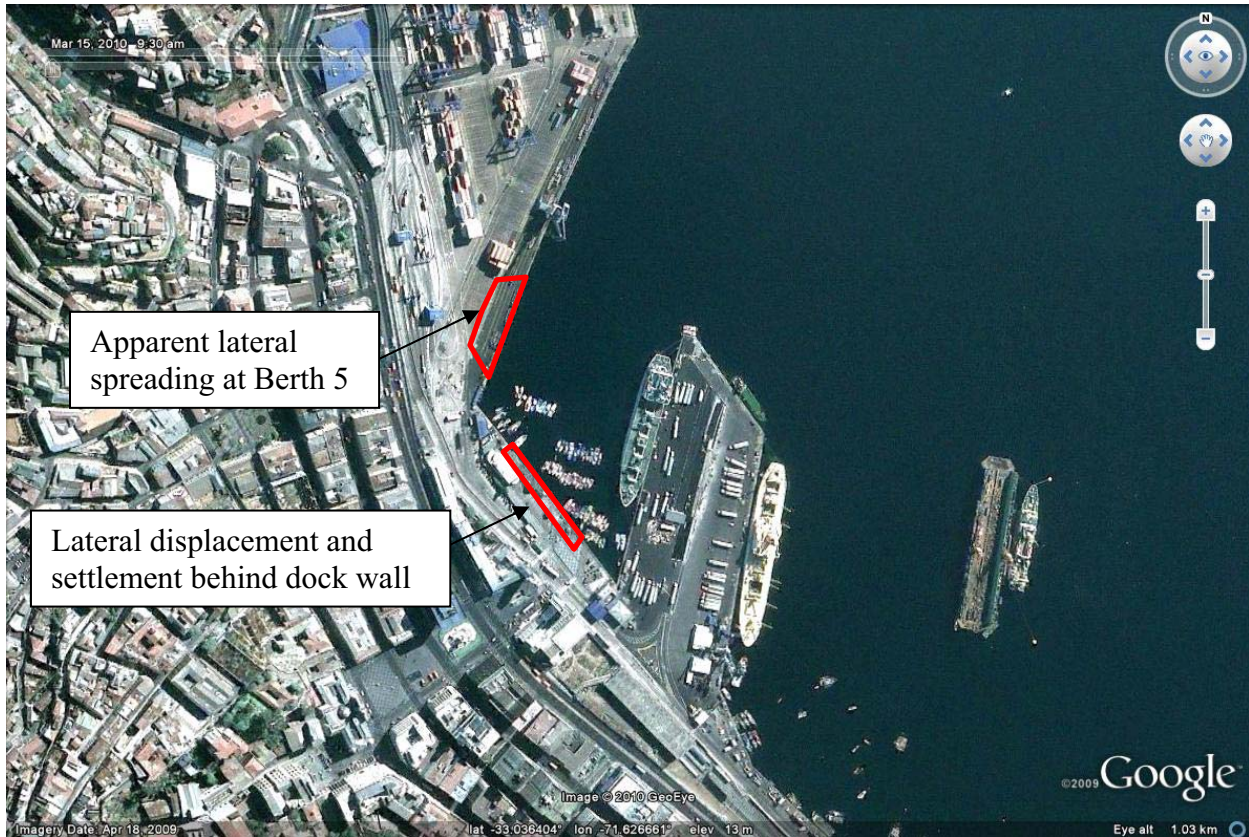
Figure 8.15. Google Earth™ photo of Valparaiso port area (S33.0364°, W71.6267°).

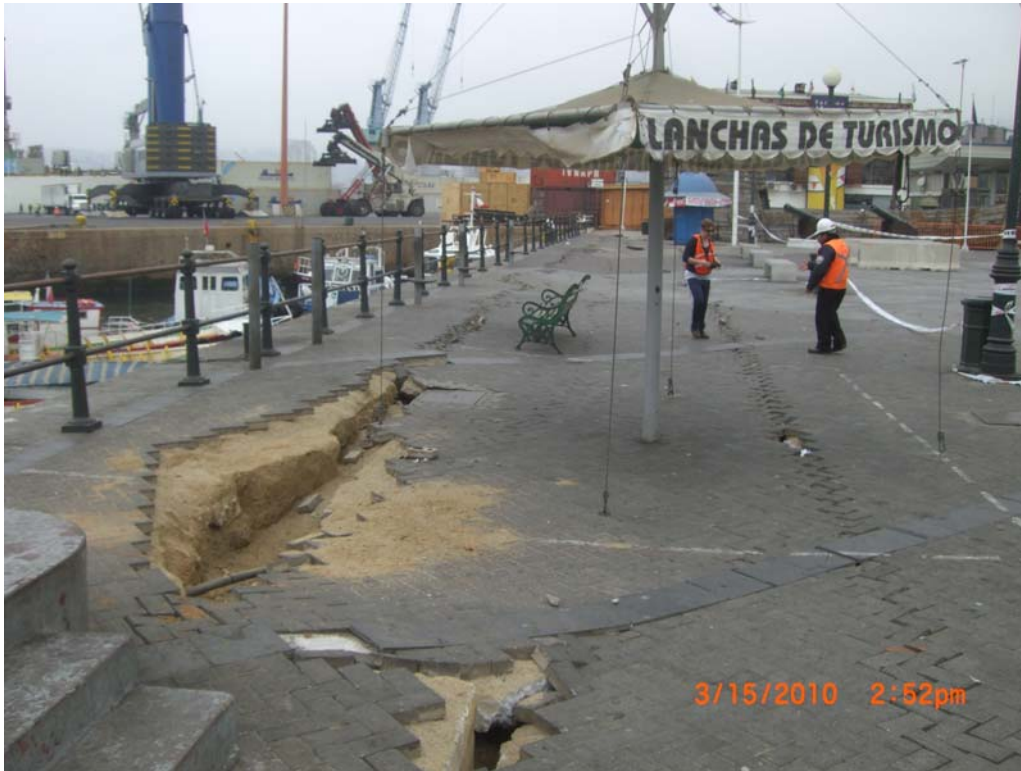
Figure 8.16. Photograph of lateral movement and vertical displacement of ground behind public dock at port of Valparaiso (S33.0375°, W71.6274°; 1452 hrs, 03/15/2010).

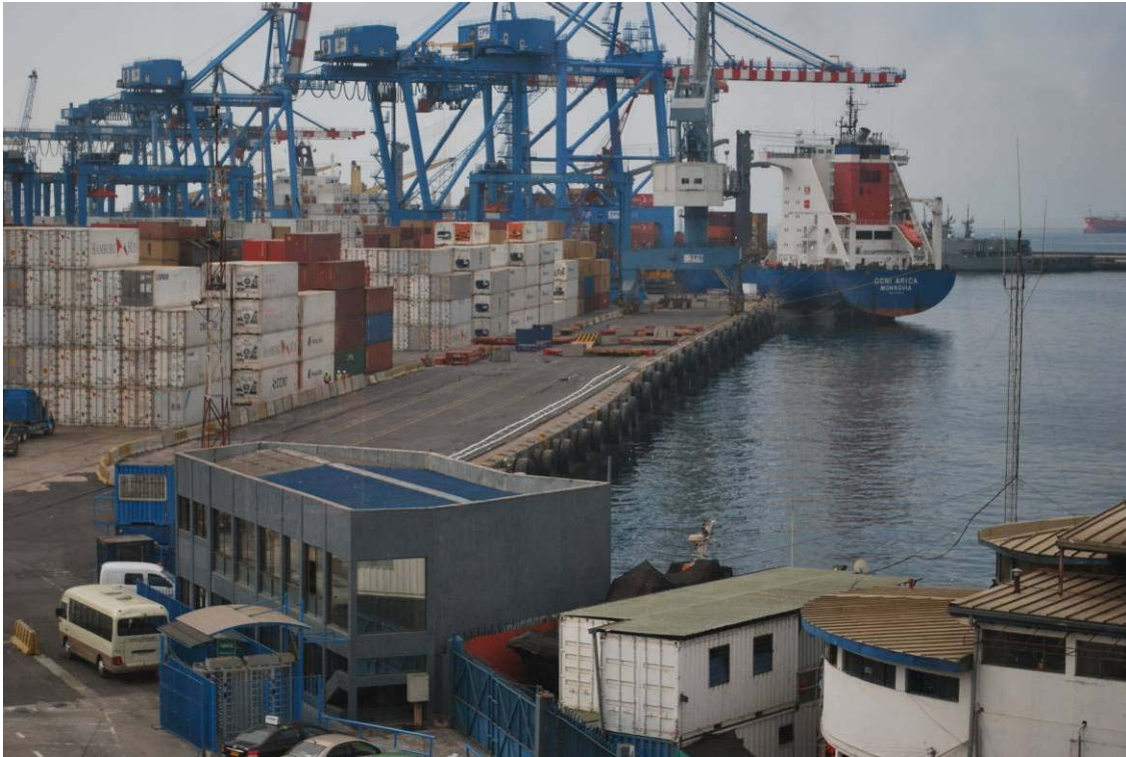
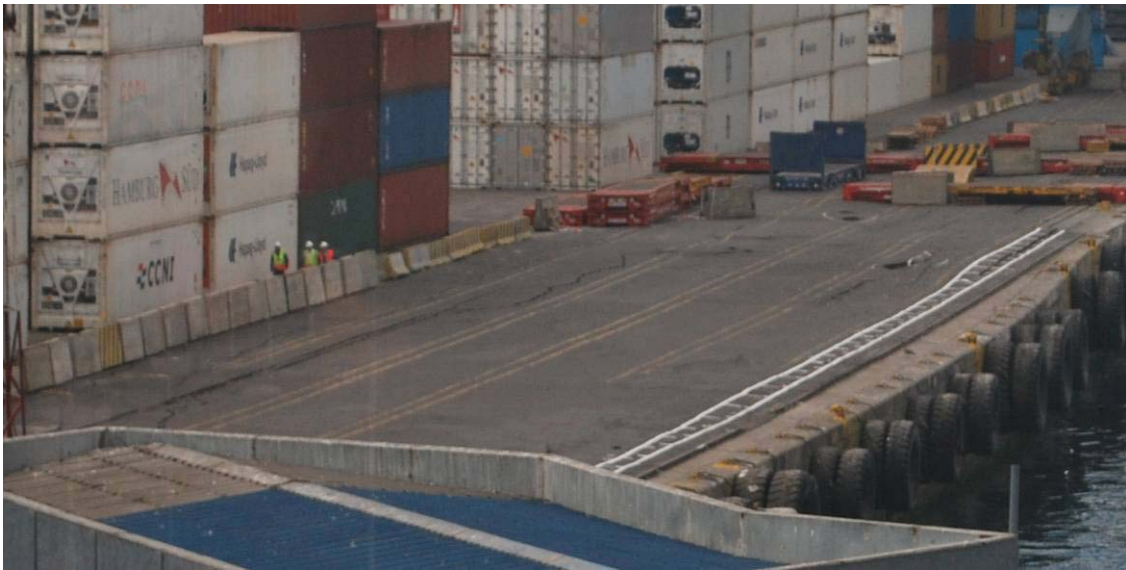
Figure 8.18. Outward movement of quay wall and asphalt pavement cracks at commercial dock of Valparaiso port (S33.036°, W71.628°; 1640 hrs, 03/15/2010).

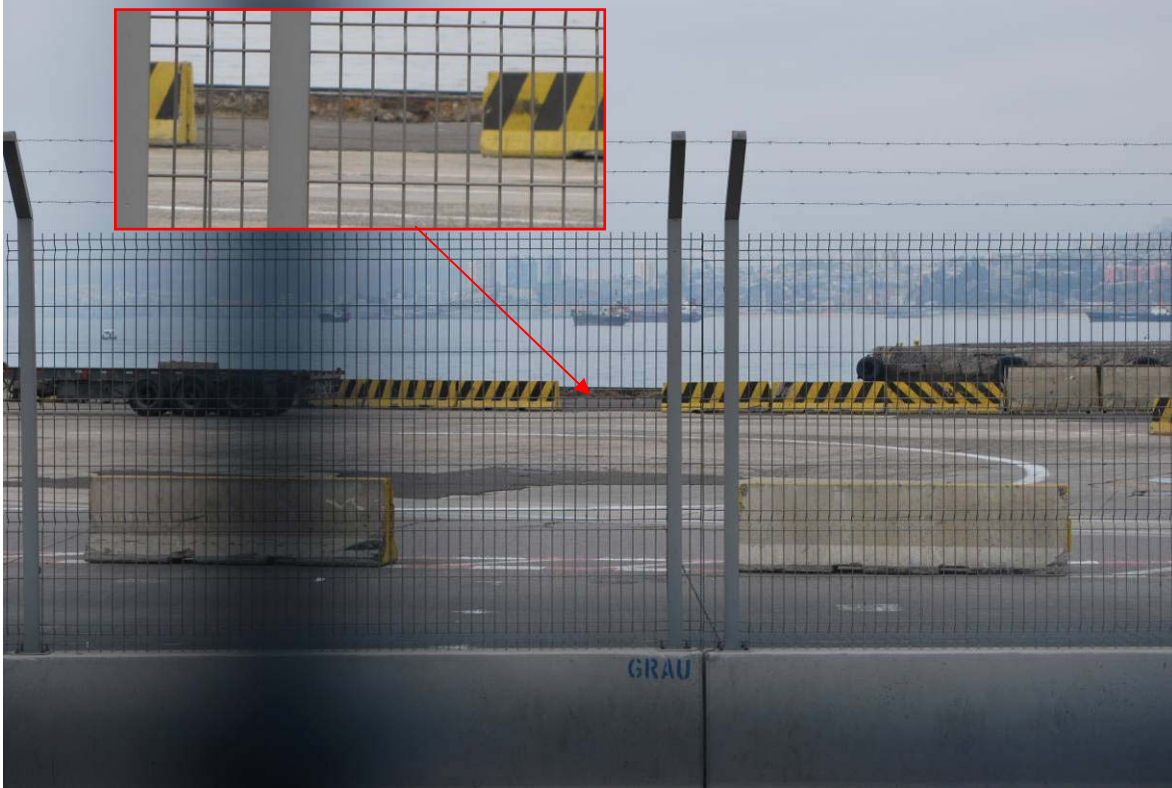
Figure 8.19. Settlement in backfill behind the quay wall at commercial dock of Valparaiso port (S33.034°, W71.627°; 1620 hrs, 03/15/2010).

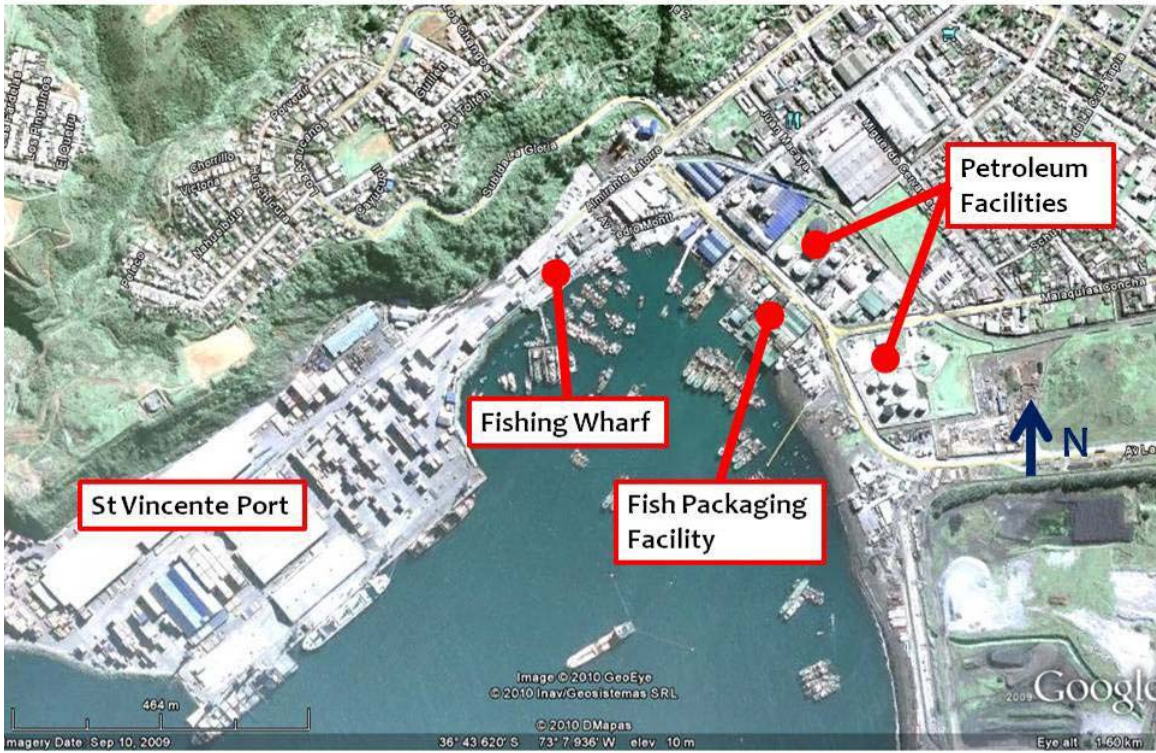
Figure 8.20. Google Earth™ overview of Concepción port area (S36.727°, W73.1322°).

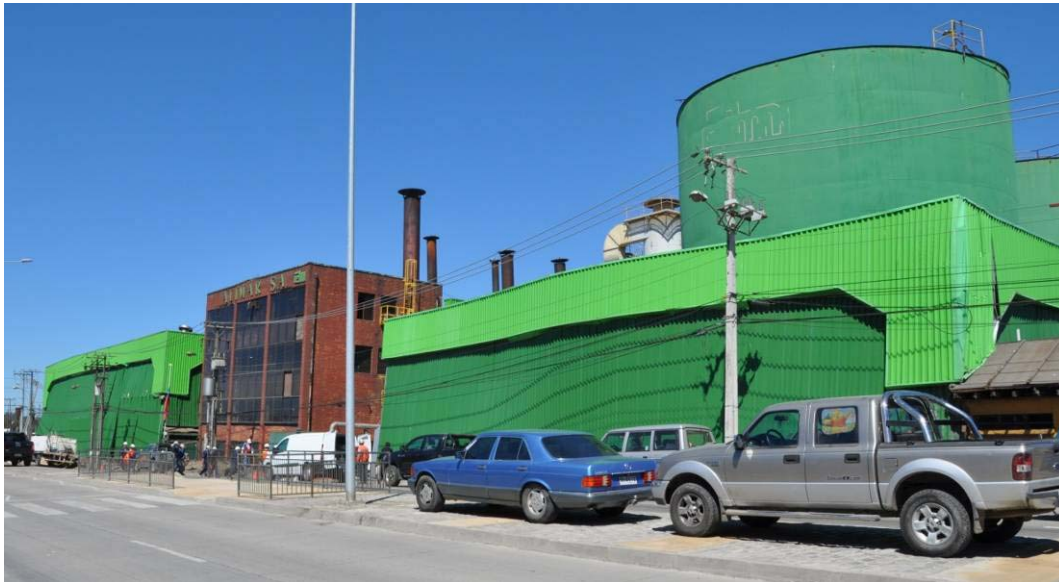
Figure 8.23. Damage to fish packaging facility (S36.7260°, W73.1288°; 1356 hrs, 03/15/2010).

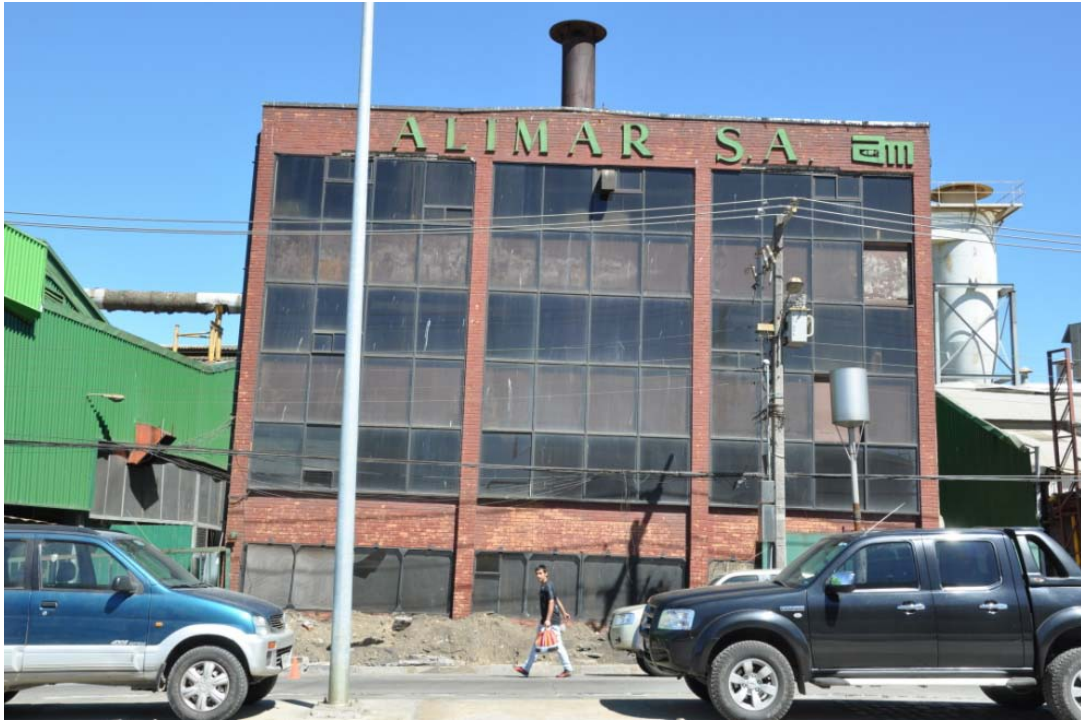
Figure 8.24. Damage to fish packaging facility (S36.7260°, W73.1288°; 1345 hrs, 03/15/2010).

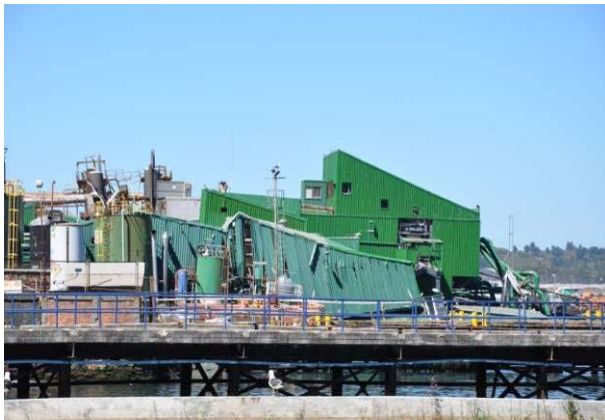
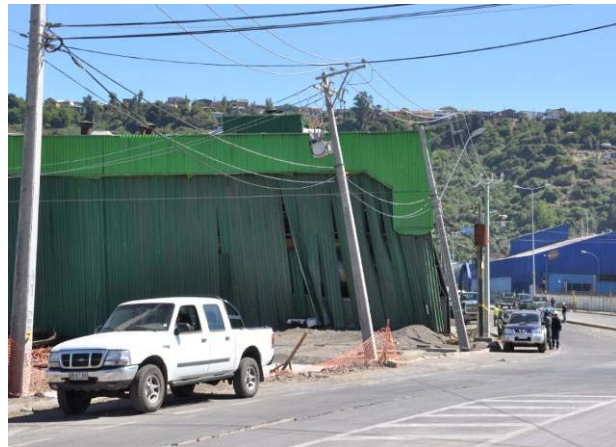
Figure 8.25. Damage to fish packaging facility (S36.7260°, W73.1288°; 1400 hrs, 03/15/2010).

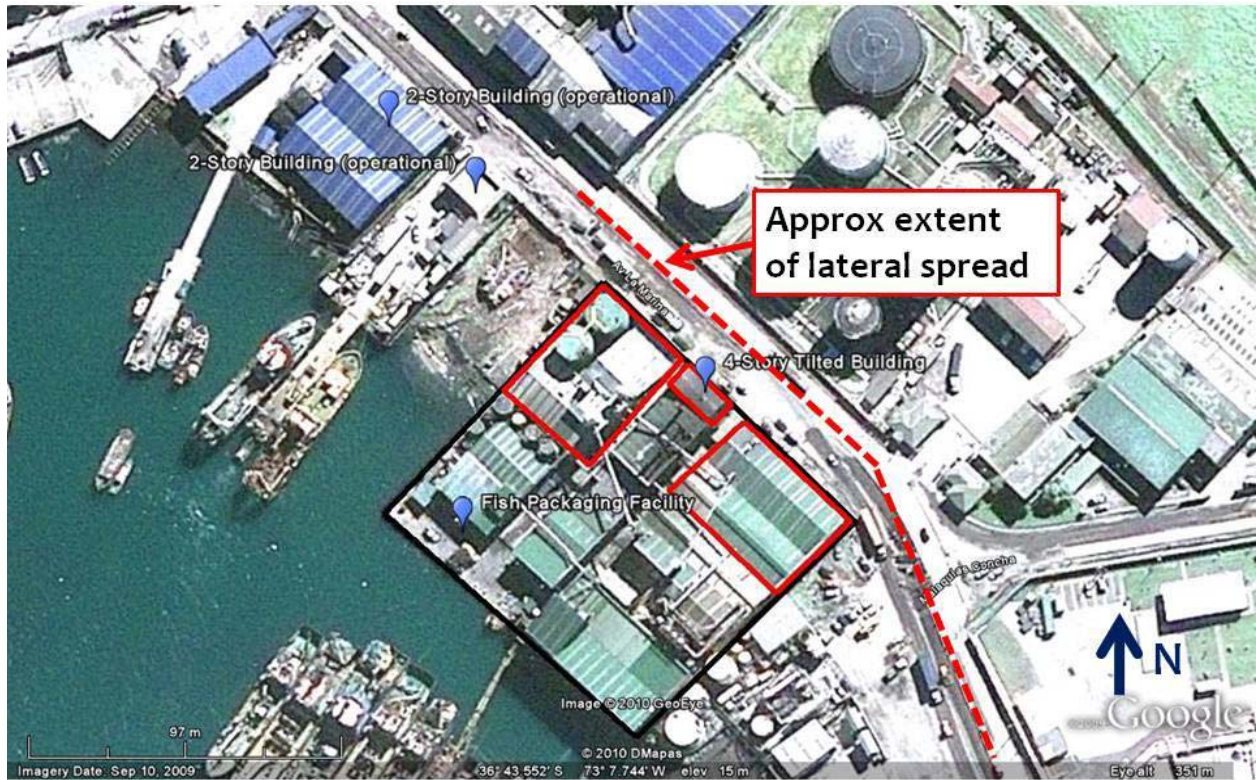
Figure 8.26. Google Earth™ overview map of fish packaging facility and neighboring structures (S36.7259°, W73.1291°).

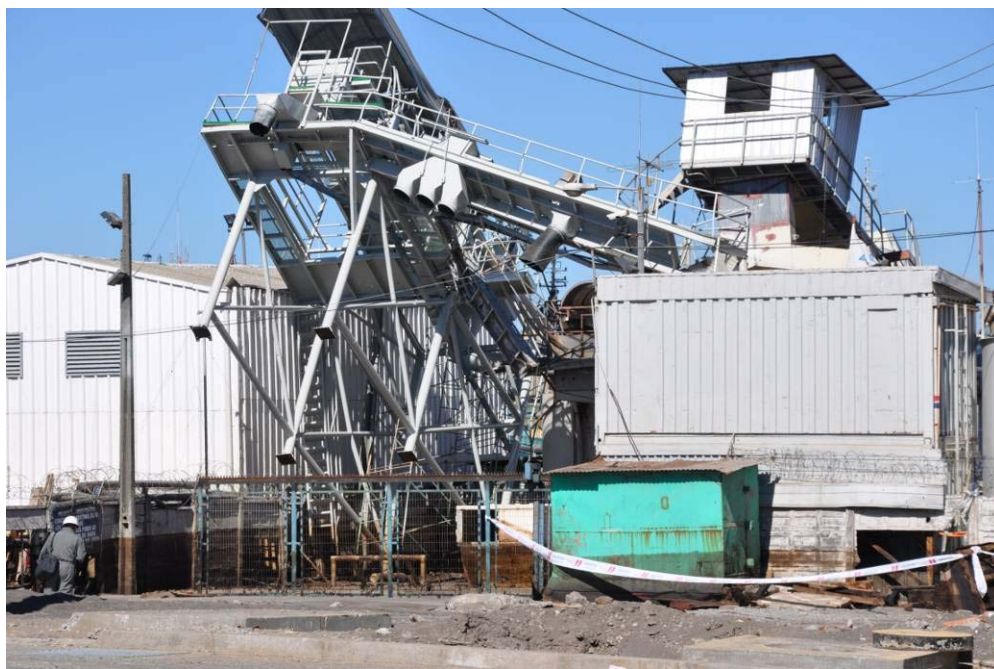
Figure 8.27. Damage to structures neighboring the fish packaging facility (S36.7267°, W73.1282°; 1200 hrs, 03/15/2010). Note the scum level at the base of the structure of approximately 1-2 m evidence of the water rise.

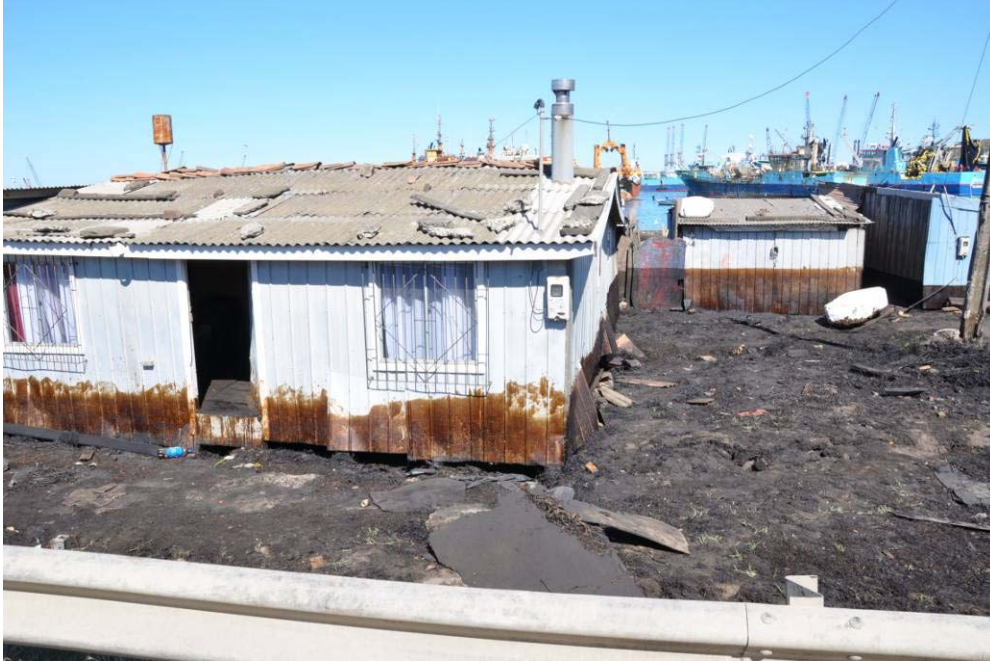
Figure 8.28. Evidence of water level rise at port area – neighboring fish packaging facility (S36.7267°, W73.1282°; 1200 hrs, 03/15/2010).
