GEO-ENGINEERING EXTREME EVENTS RECONNAISSANCE (GEER) ASSOCIATION

Turning Disaster in Knowledge

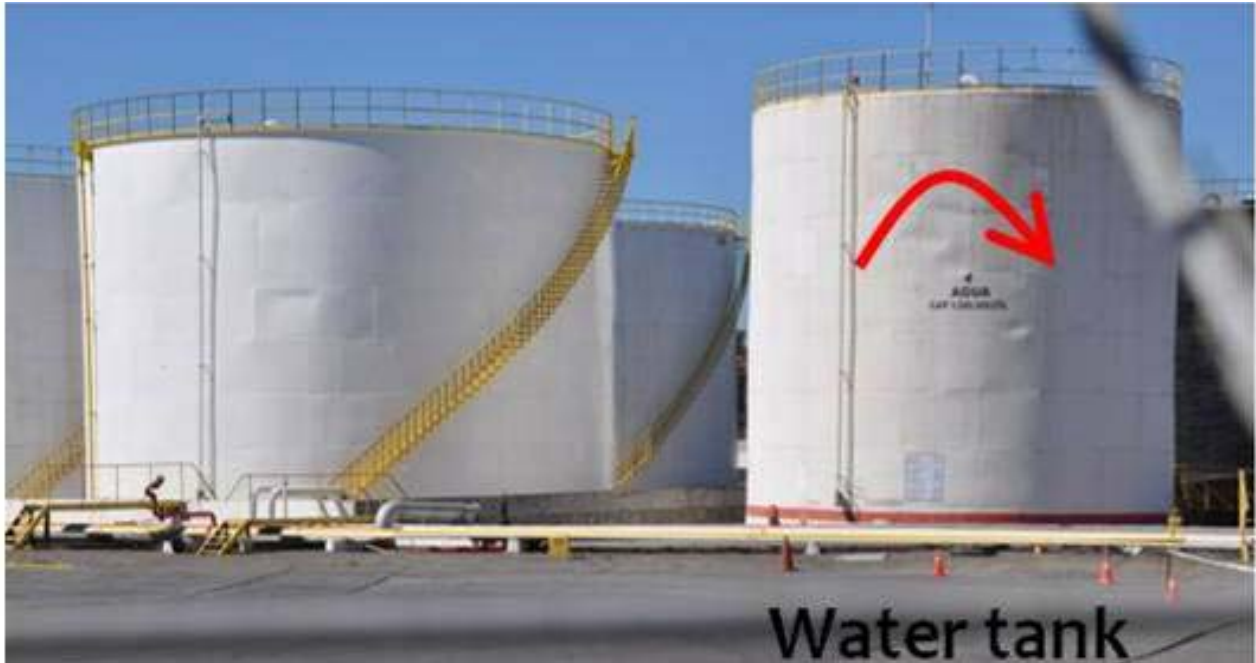
Figure 8.30. Tilted water tank at Petrobras gas facility (S36.7270°, W73.1272°; 1250 hrs, 03/15/2010).

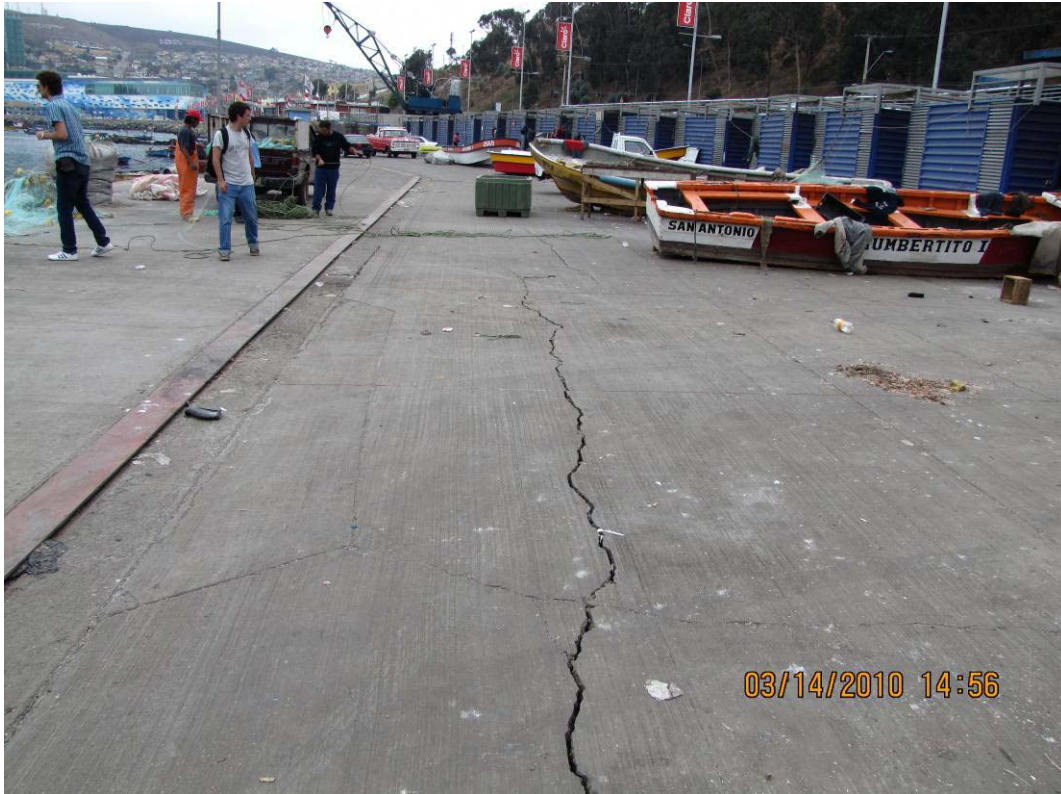
Figure 8.31. Cracks on asphalt pavement behind quay wall in San Antonio Port (S33.5870°, W71.6132°; 1456 hrs, 03/14/2010).

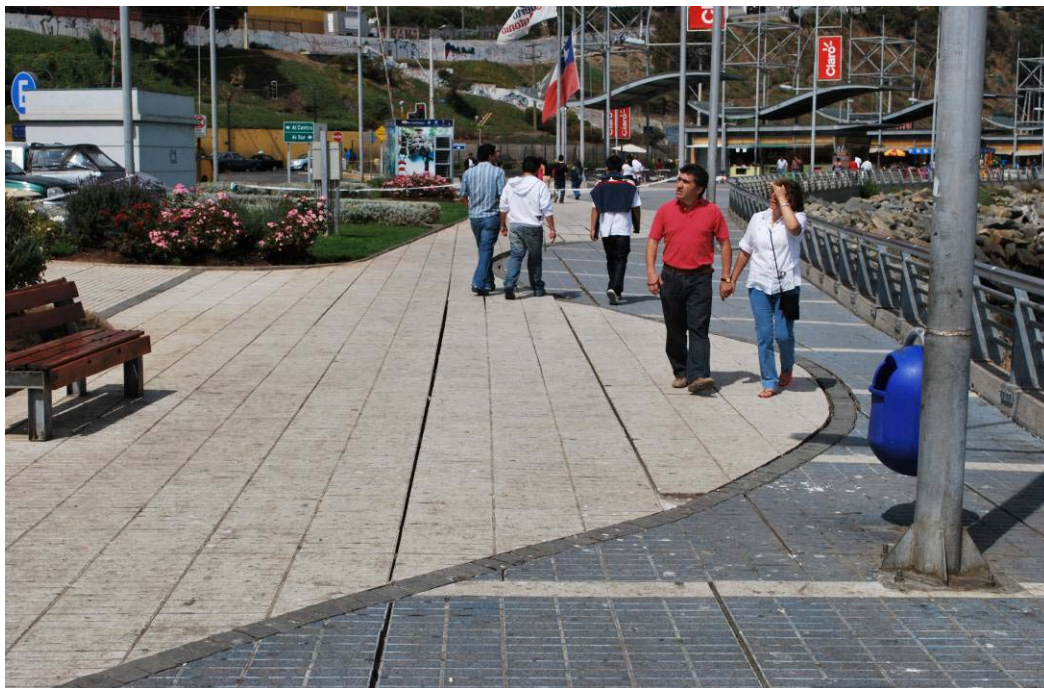
Figure 8.32. Cracks on brick pavement behind quay wall in San Antonio Port (S33.5830°, W71.6138°; 1432 hrs, 03/14/2010).

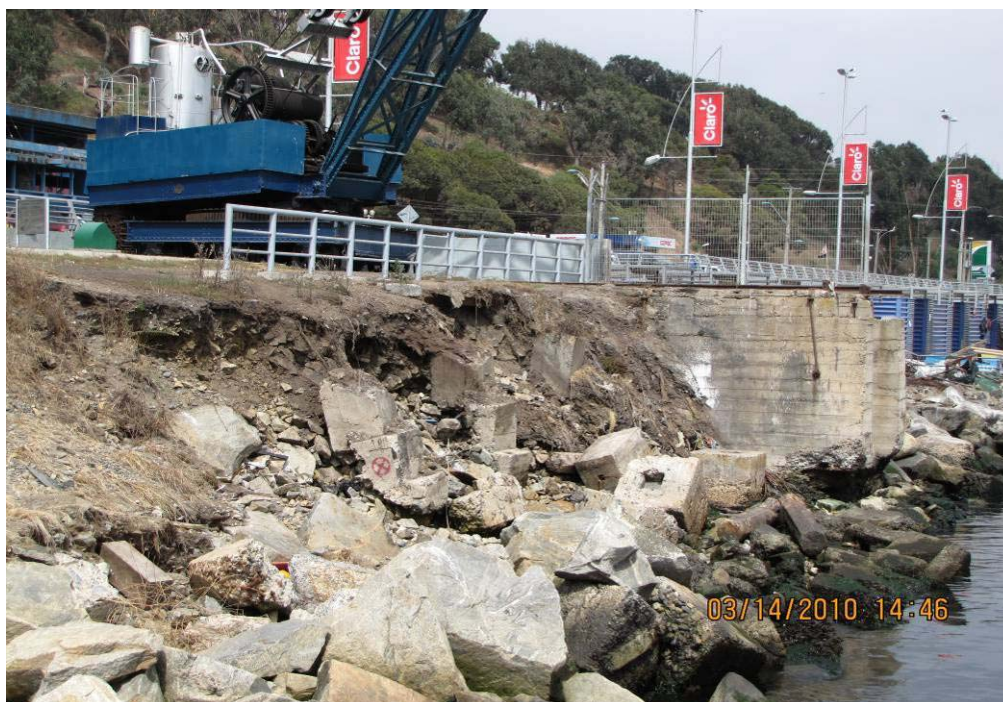
Figure 8.33. Rockfalls in San Antonio Port (S33.587°, W71.613°; 1446 hrs, 03/14/2010).

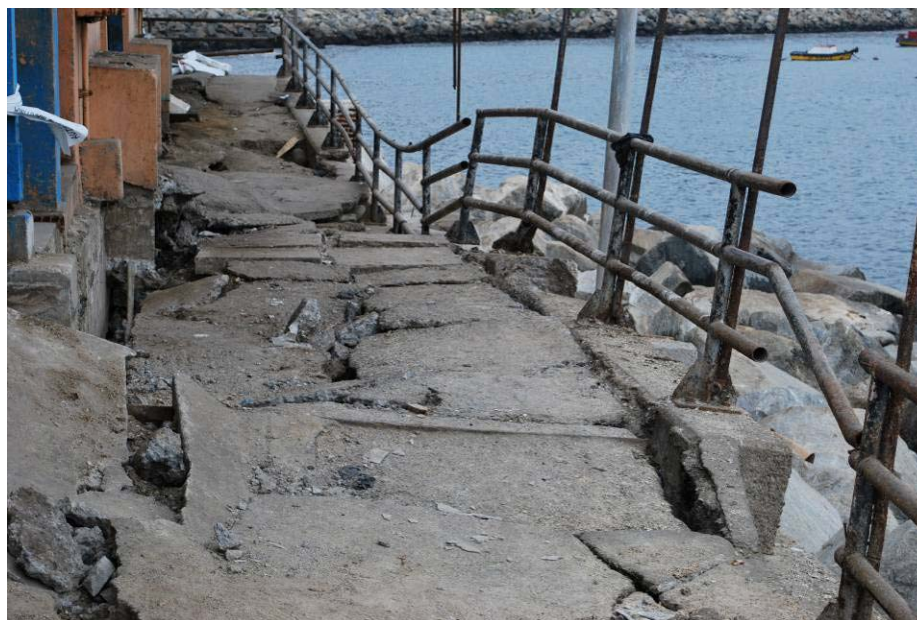
Figure 8.34. Severely damaged old dock in San Antonio Port (S33.5817°, W71.6154°; 1448 hrs, 03/14/2010).

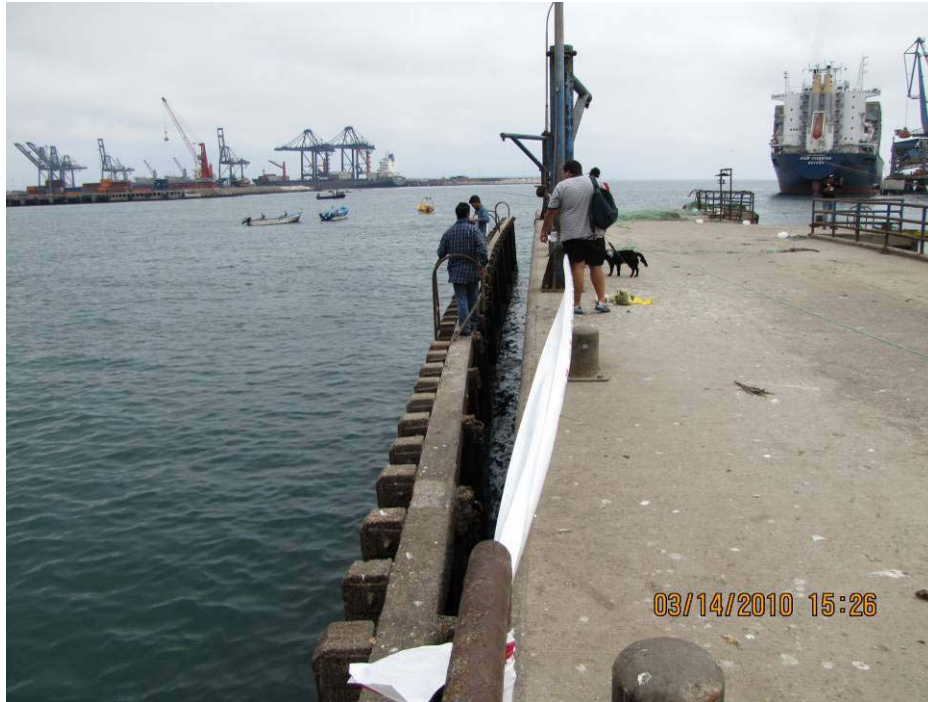
Figure 8.35. Separation from lateral pile screen of wharf structure in San Antonio Port (S33.5817°, W71.6154°; 1526 hrs, 03/14/2010).

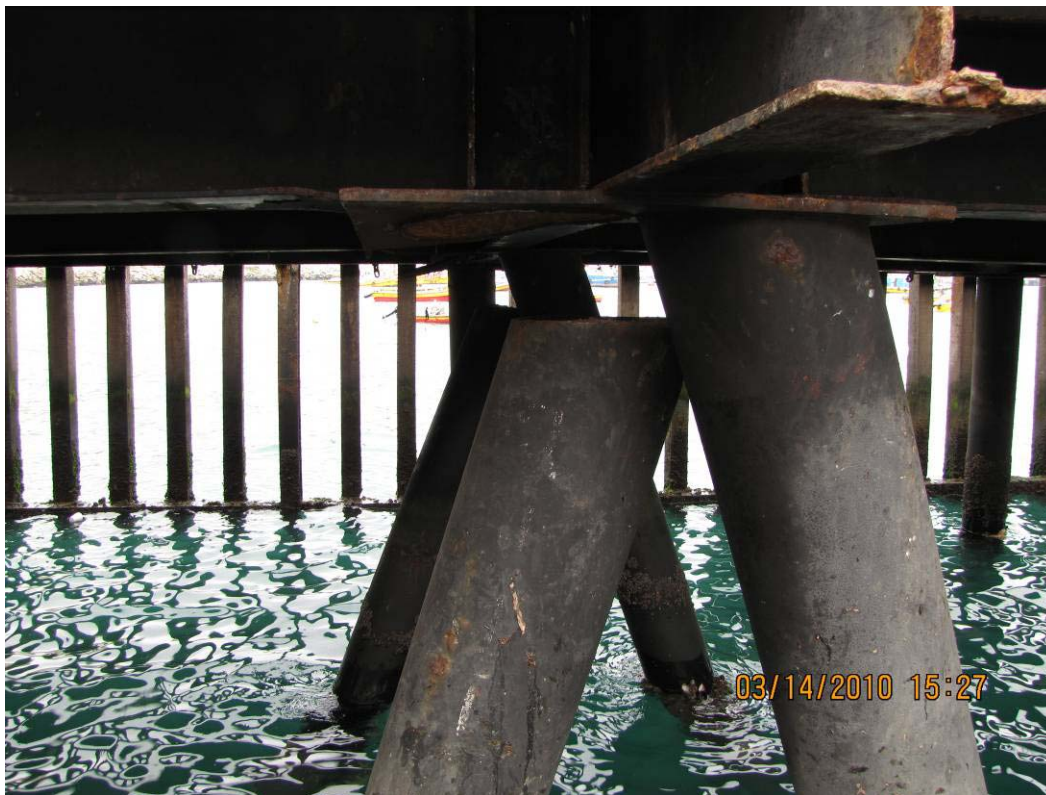
Figure 8.36. Failure of head connection between wharf and raked piles in San Antonio Port (S33.5817°, W71.6154°; 1527 hrs, 03/14/2010).

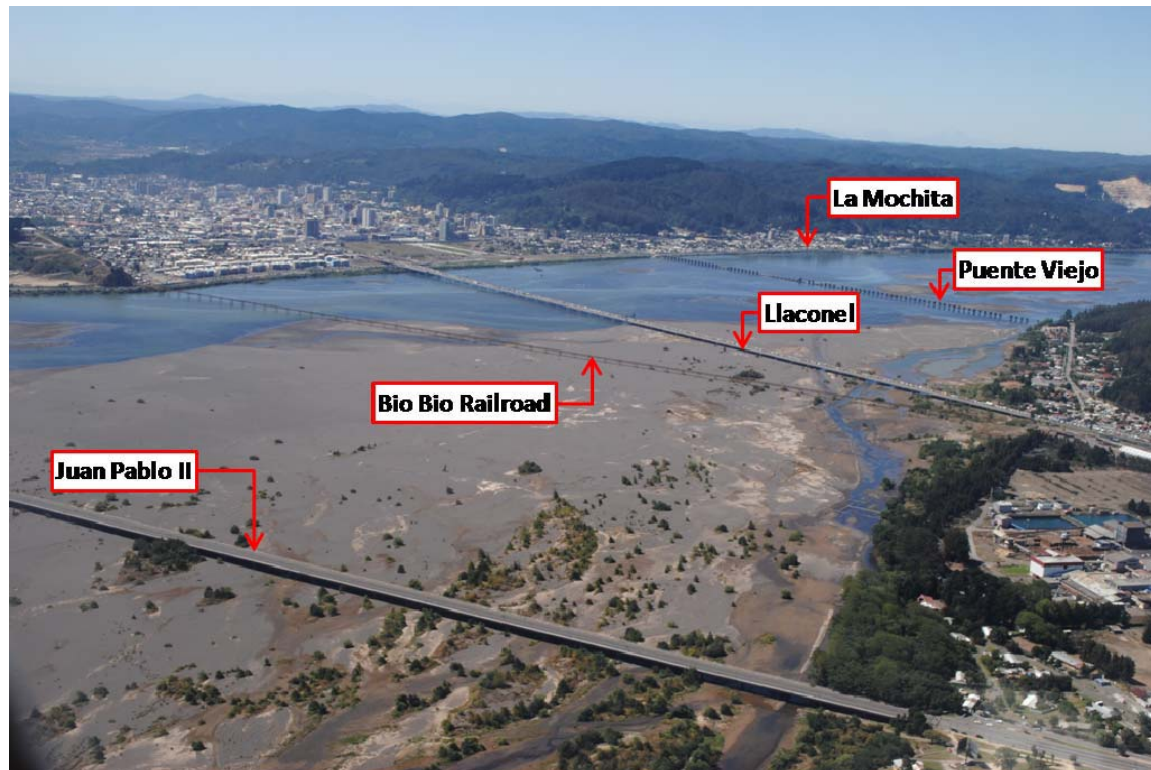
Figure 9.1. Aerial view of Concepción metropolitan area and Bio-Bio river main crossings

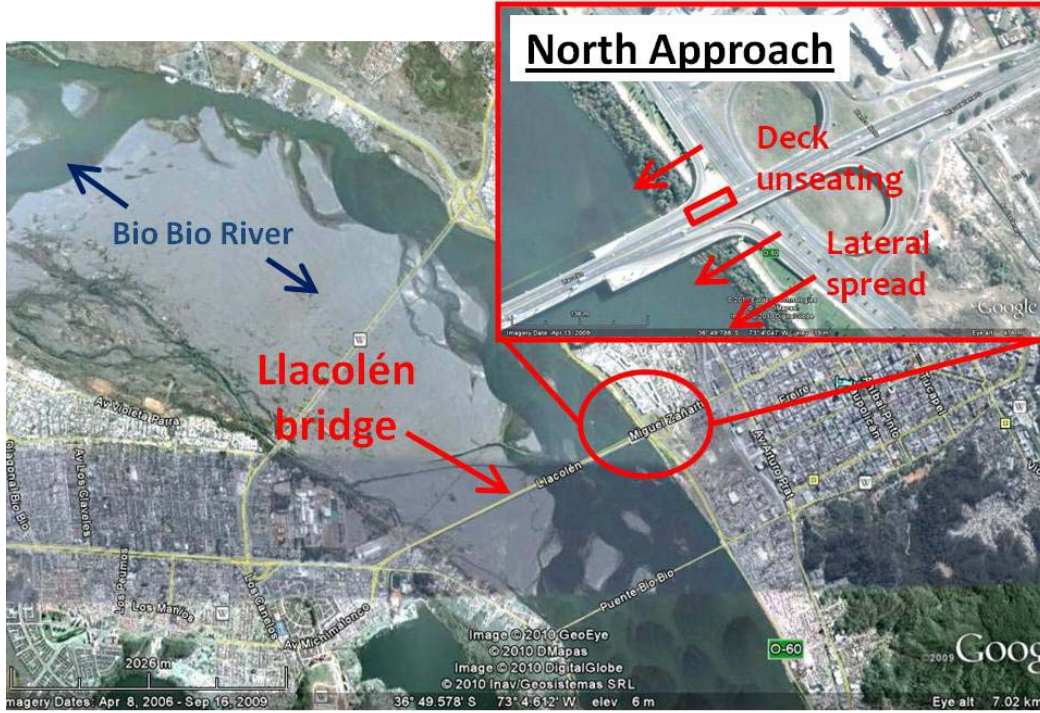
Figure 9.2. Plan view of the Bio Bio river region locating the damaged region of the Llacolén bridge in Concepción (S36.830108°, W73.067991°)

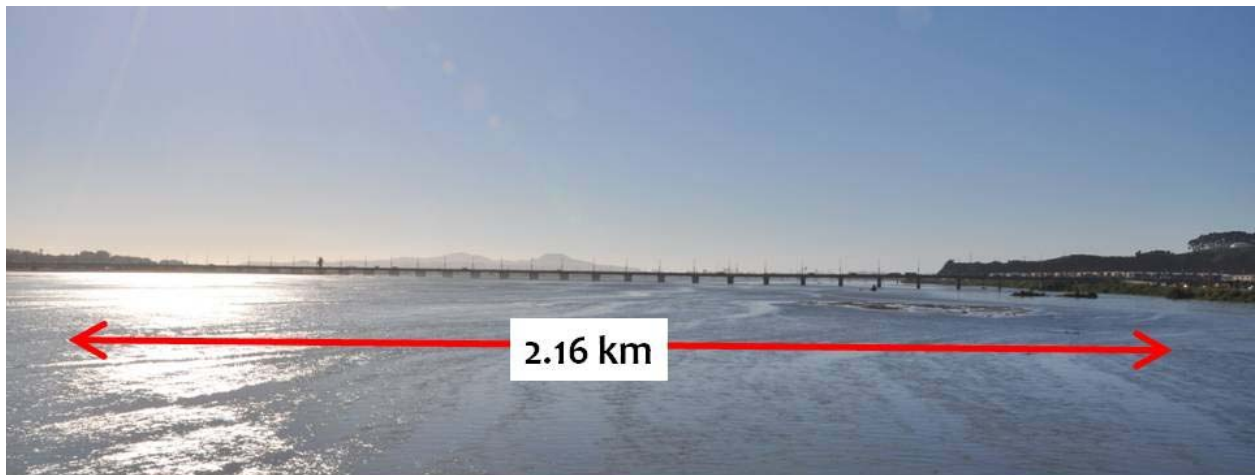
Figure 9.3. Elevation photograph of the Llacolén bridge in Concepción (S36.830108°, W73.067991°).

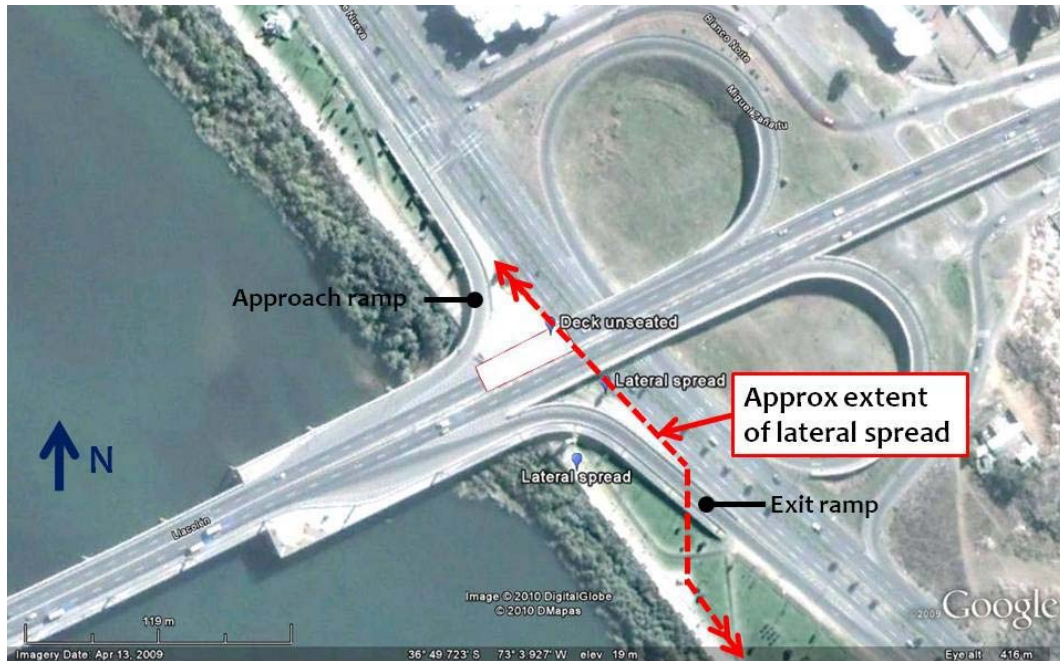
Figure 9.4. Plan view of the North approach to the damaged Llacolén bridge in Concepción ($S36.830108^\circ$, $W73.067991^\circ$).

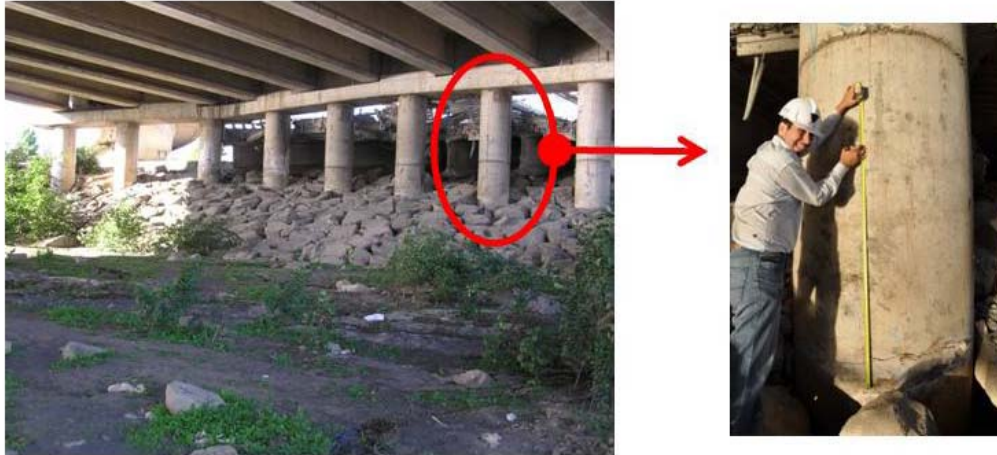
Figure 9.6. Substructure of the north approach at the damaged Llacolén bridge in Concepción showing the unseated deck in the foreground. Flexural cracking of the column supports was observed at ground level and extending to the construction joint (2-2.5m above ground)

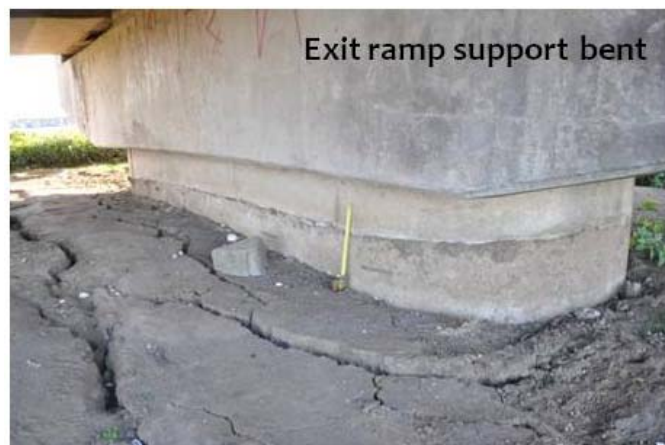
Figure 9.7. Ground settlement surrounding an exit ramp support bent at the Llacolén bridge in Concepción (S36.830380°, W73.067541°, 1901 hrs. on 3/14/2010).

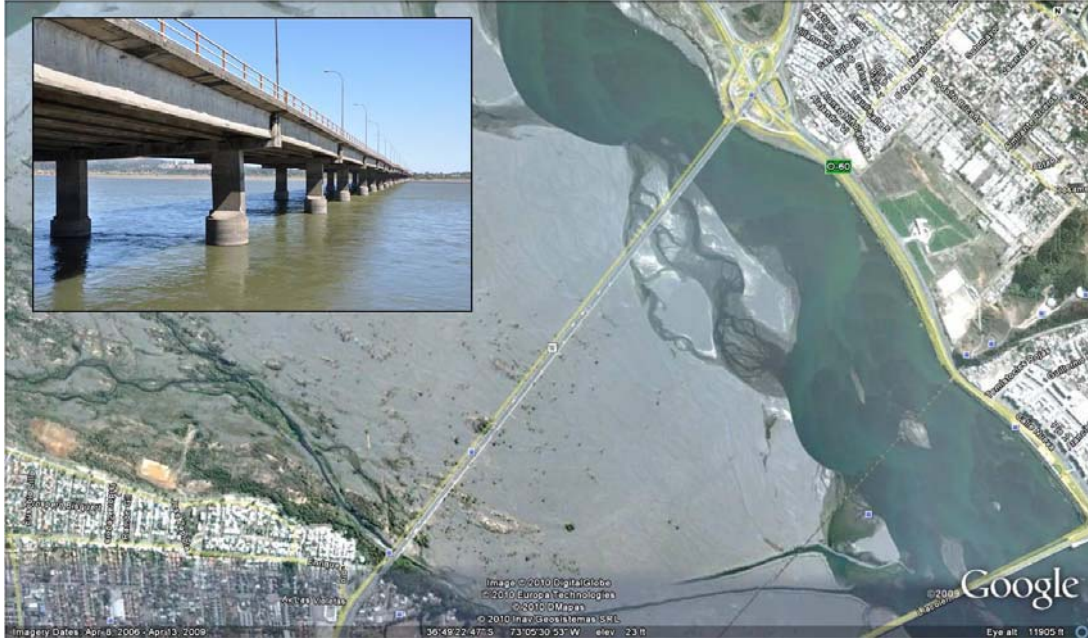
Figure 9.8. Juan Pablo II bridge connecting the cities of Concepción and San Pedro de la Paz across the Bio Bio River (S36.815122° W73.084369°; 1453 hrs on 3/15/2010)

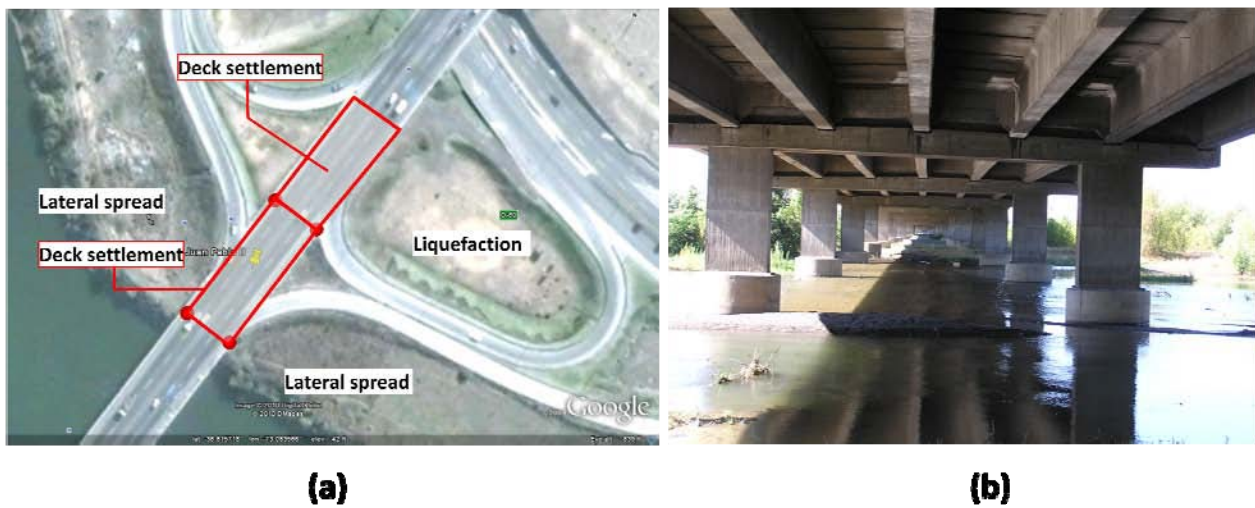
Figure 9.9. Juan Pablo II Bridge (a) Google Earth view of northeast Approach with schematics of observed damage (S36.815864° W73.083674°) (b) Typical bridge bent configuration (S36.828181° W73.095850°; 1636 hrs on 3/15/2010).

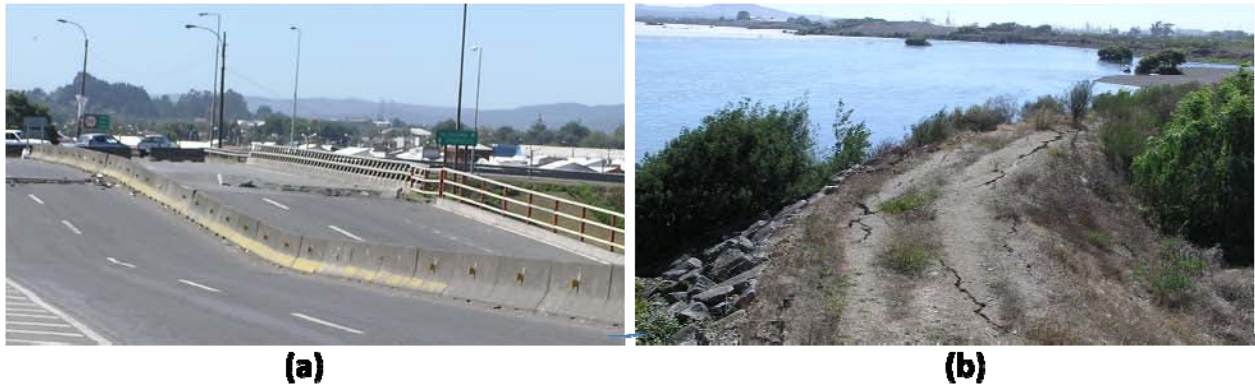
Figure 9.10. Juan Pablo II northeast approach: (a) Settlement of bridge deck near bridge approach (S36.815900° W73.084064°; 1455 hrs on 3/15/2010), (b) Lateral spreading on northeast bridge abutment.

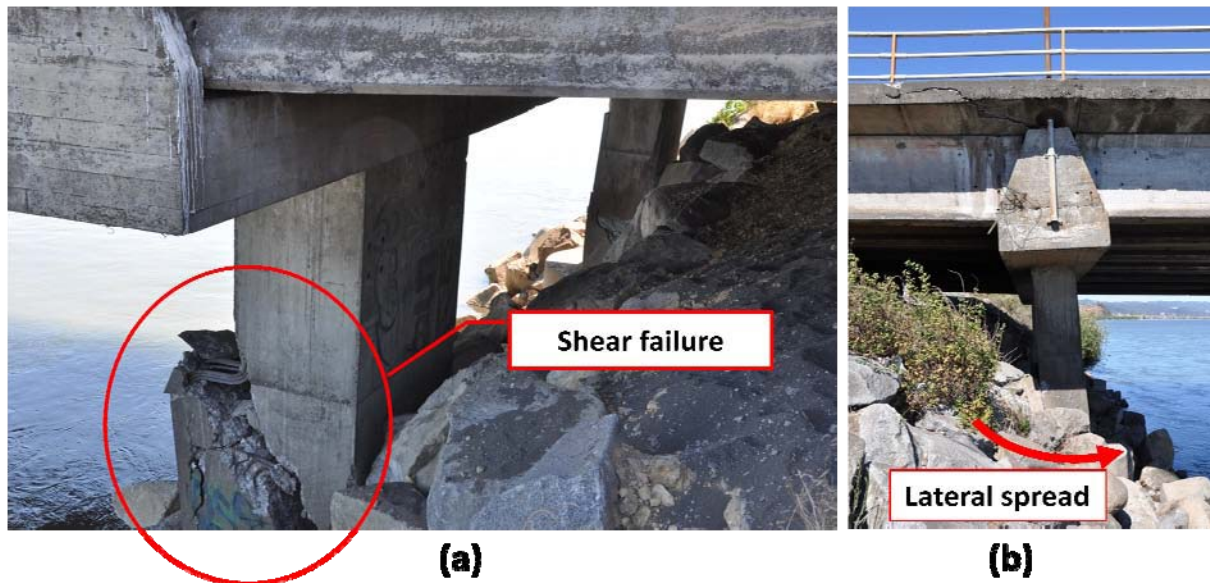
Figure 9.11. Juan Pablo II northeast approach: (a) Column shear failure (S36.816233° W73.084144°; 1528 hrs on 3/15/2010) (b) Rotation and lateral displacement of bridge bent (S36.816233° W73.084144°; 1530 hrs on 3/15/2010)

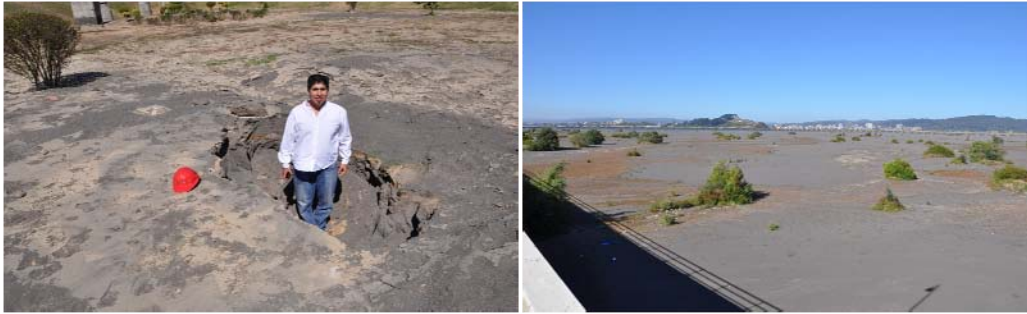
along the bridge spans (in sections not covered by water). The presence of fine material is clearly shown in Figure 9.12(b).

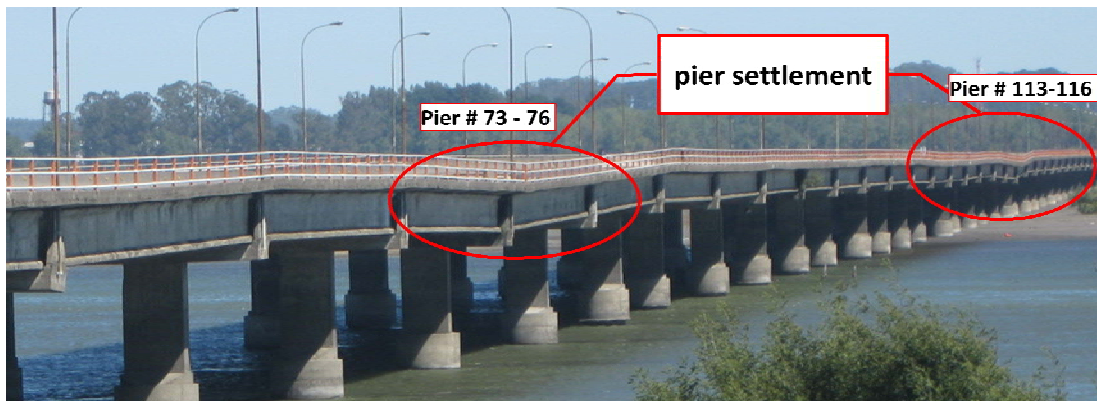
Figure 9.13. Juan Pablo II bridge – Pier settlements (S36.815122° W73.084369°; 1453 hrs on 3/15/2010)

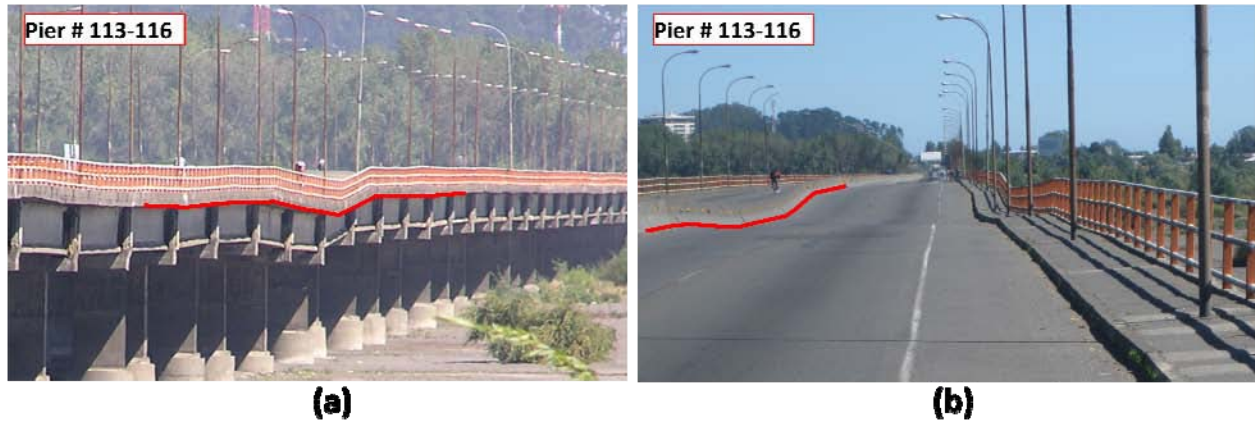
Figure 9.14. Juan Pablo II bridge (a) View of bridge bent settlement (S36.826596° W73.094345° on 3/15/2010)(b) View of bridge deck settlement (S36.826596° W73.094345° on 3/15/2010)

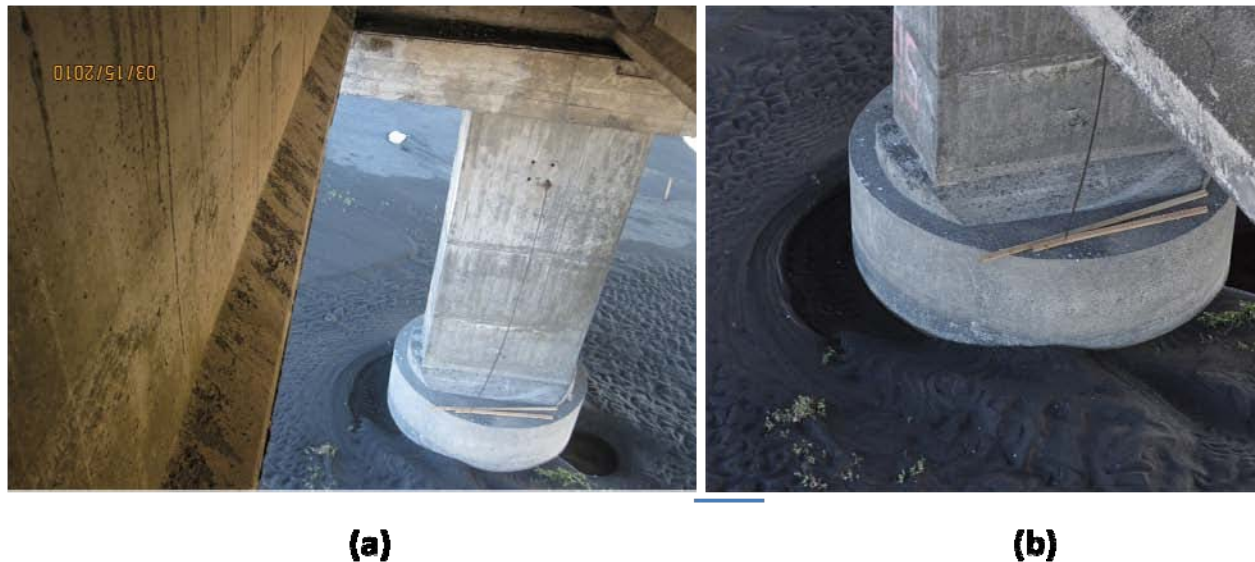
Figure 9.15. Juan Pablo II bridge—Evidence of liquefaction at piers subjected to settlements. (a) column and pier, (b) detail of pier and surrounding soil. (S36.826596° W73.094345° on 3/15/2010)

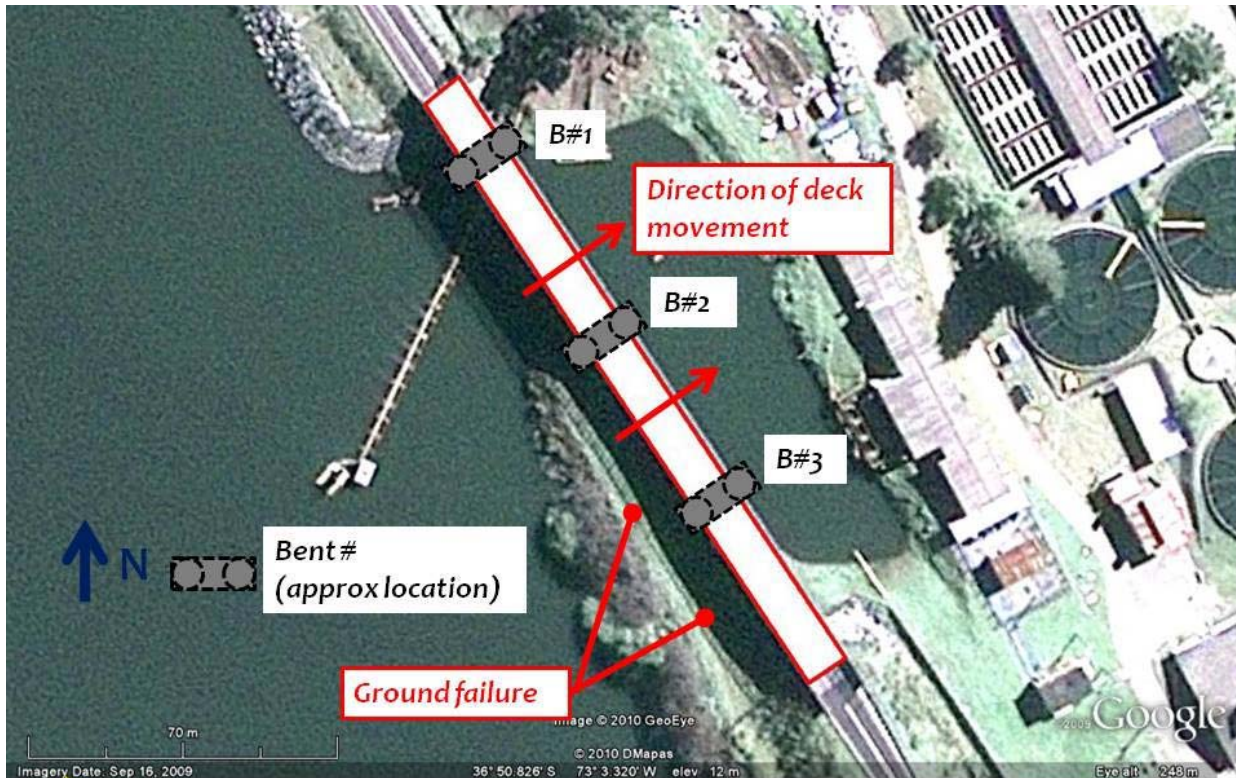
Figure 9.16. Plan view of the La Mochita bridge in south Concepción describing observed damage (S36.846841° W73.055496°).

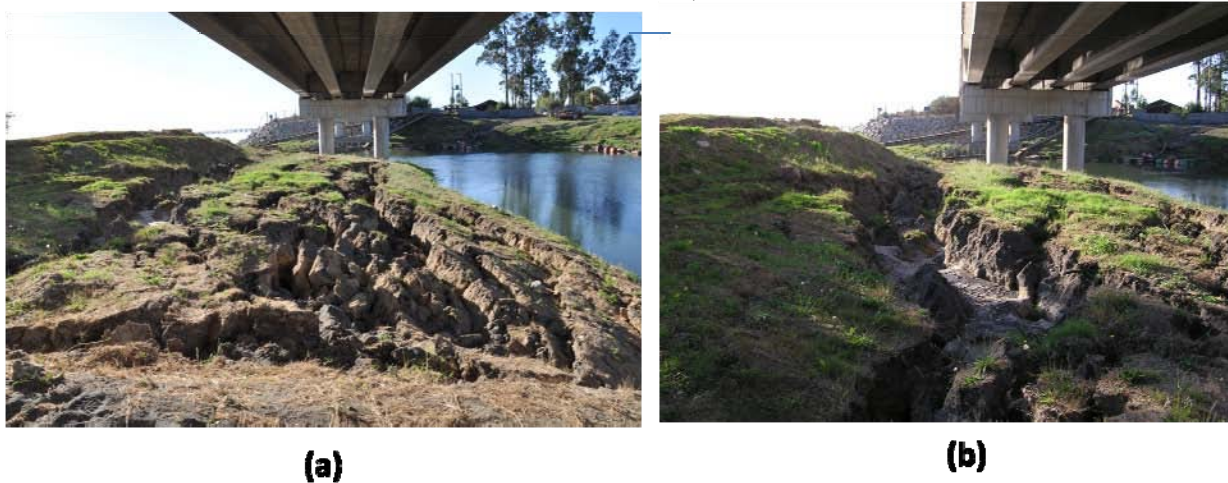
Figure 9.17. Ground failure at the La Mochita bridge, (a) looking north at bent #3 (S36.847389°, W73.055219°; 1831 hrs on 3/15/2010) and (b) looking north at bent #2 (S36.847495°, W73.055027°; 1835 hrs on 3/15/2010)

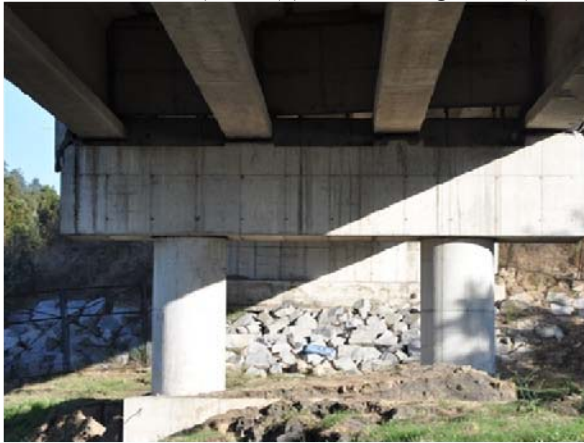
Figure 9.18. La Mochita bridge: (a) Sand boils observed below the bridge (S36.847456°, W73.055129°; 1830 hrs on 3/15/2010), and (b) View looking north (S36.847453° W73.055225°; 1830 hrs on 3/15/2010)

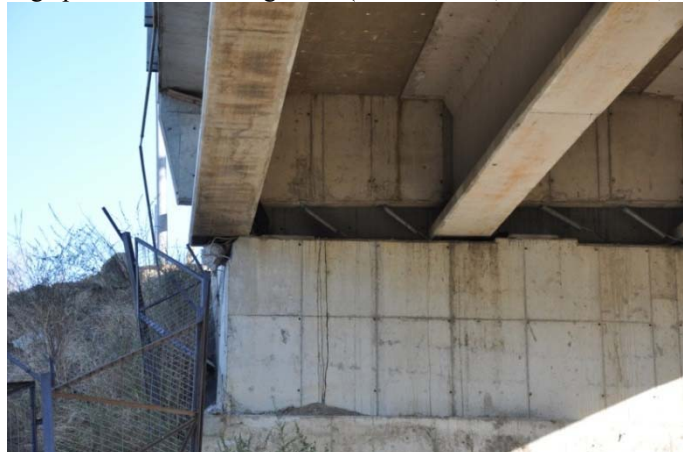
Figure 9.20. Transverse shift of deck relative to south abutment at the La Mochita bridge (S36.847547°, W73.054876°; 1834 hrs on 3/15/2010).

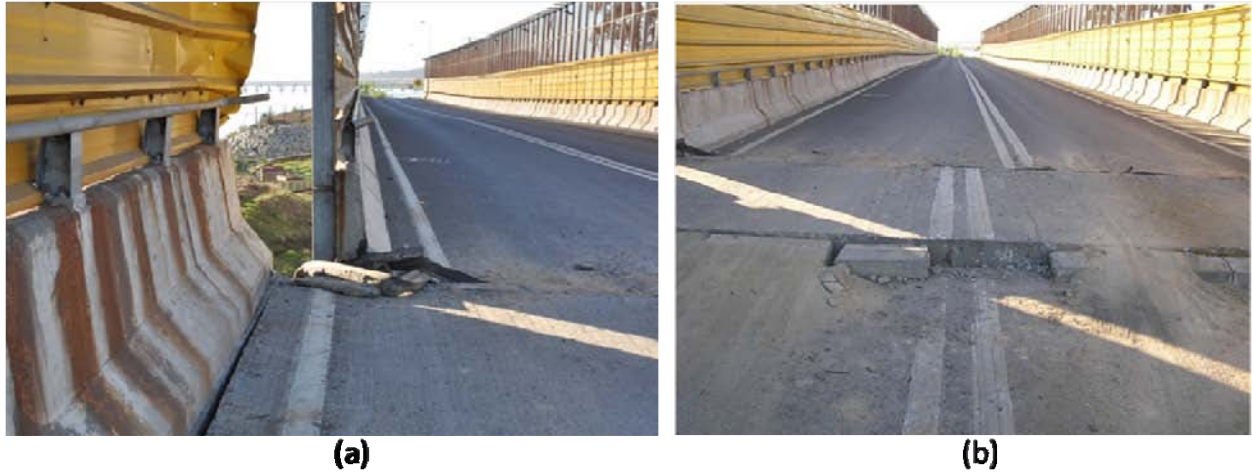
Figure 9.21. La Mochita bridge (a) Transverse gap developed between deck and south abutment. View looking north. (-36.847798°, -73.054797°; 1856 hrs on 3/15/2010), (b) Damage at the south abutment-road-deck interface due to transverse shift of the deck. View looking north. (S36.847761°, W73.054777°; 1856 hrs on 3/15/2010).

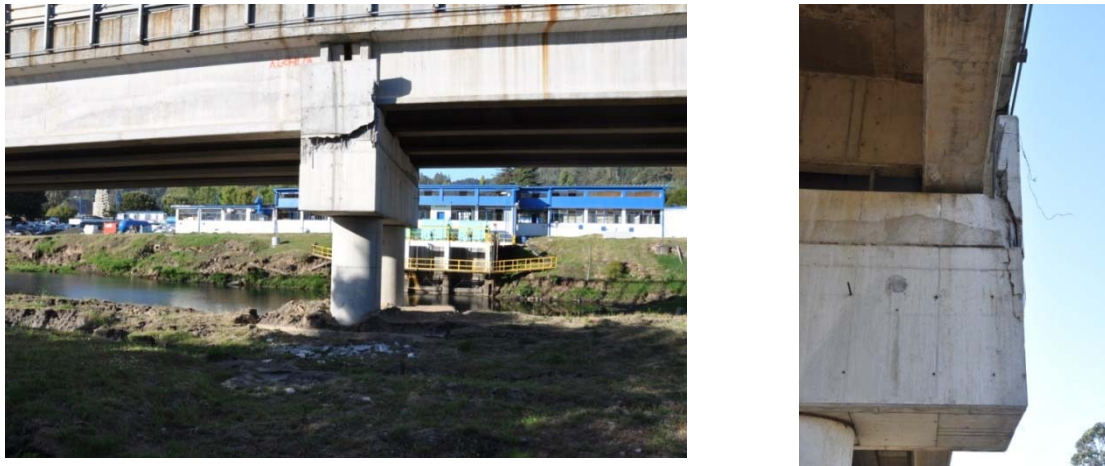
Figure 9.22. Damage to transverse shear keys at bent #3 due to movement of the La Mochita bridge (S36.847405°, W73.055084°; 1830 hrs on 3/15/2010).

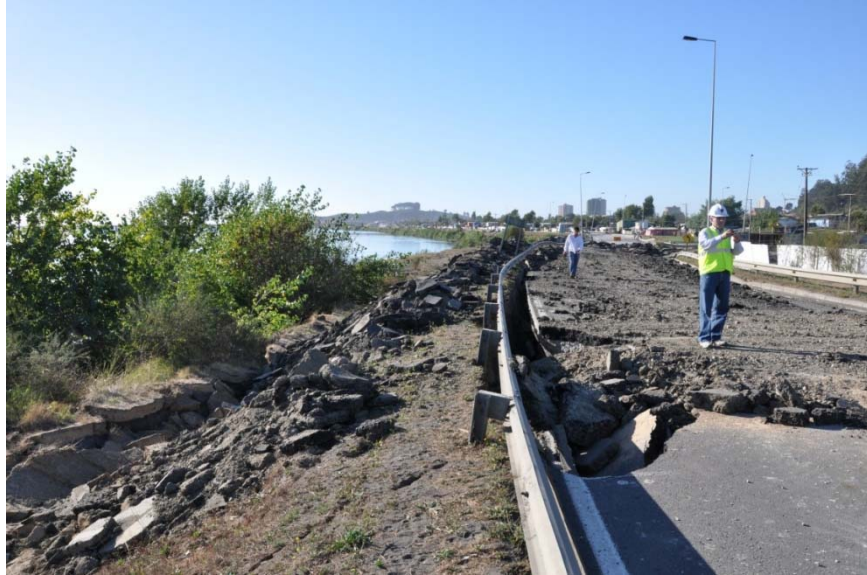
Figure 9.23. Damage to the approach road north of the La Mochita Bridge (S36.846473°, W73.055881° on 3/15/2010). View looking north. The Bio Bio river is shown on the left (west) of the view.

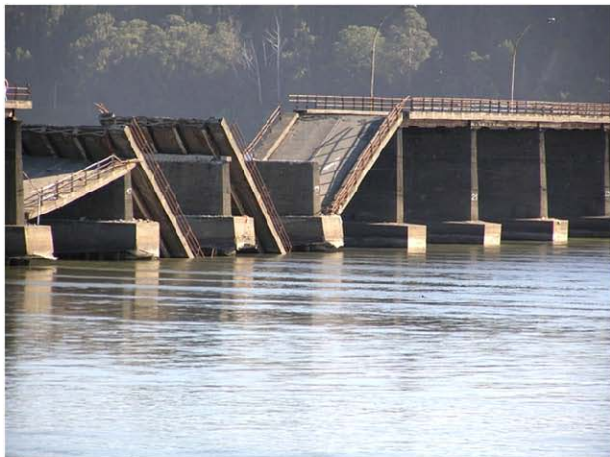
The Bio-Bio bridge, also known as Puente Viejo (Old Bridge), was built in the 1930s and inaugurated in 1937. The bridge connected the cities of Concepción and San Pedro de la Paz and had a length of 1,419 m. For many years it was the only vehicular bridge connecting the two cities. Due to its precarious structural condition the bridge was closed in May 2002 and used only for pedestrian transit. During the 2010 Chile earthquake the bridge suffered severe damaged with many slab sections collapsing (Figure 9.24a). Several bridge bents also collapsed during the seismic event (Figure 9.25). Evidence of liquefaction was observed at the East bridge abutment with visible lateral deformations and vertical settlements.

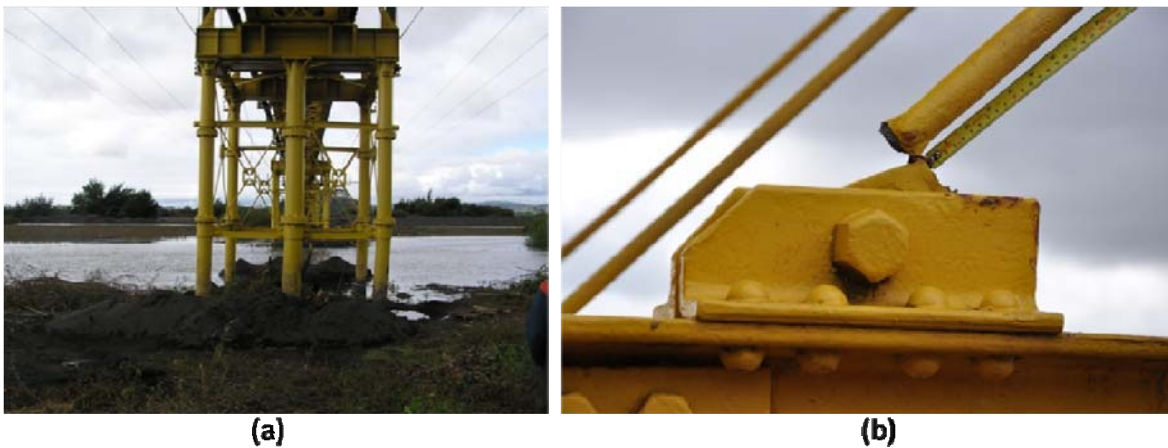
Figure 9.26. Bio Bio Railroad crossing (a) Pillars move and rotated during earthquake (b) Detail of broken crossbar, (S36.836075° W73.086969°; 1717 hrs on 3/17/2010)

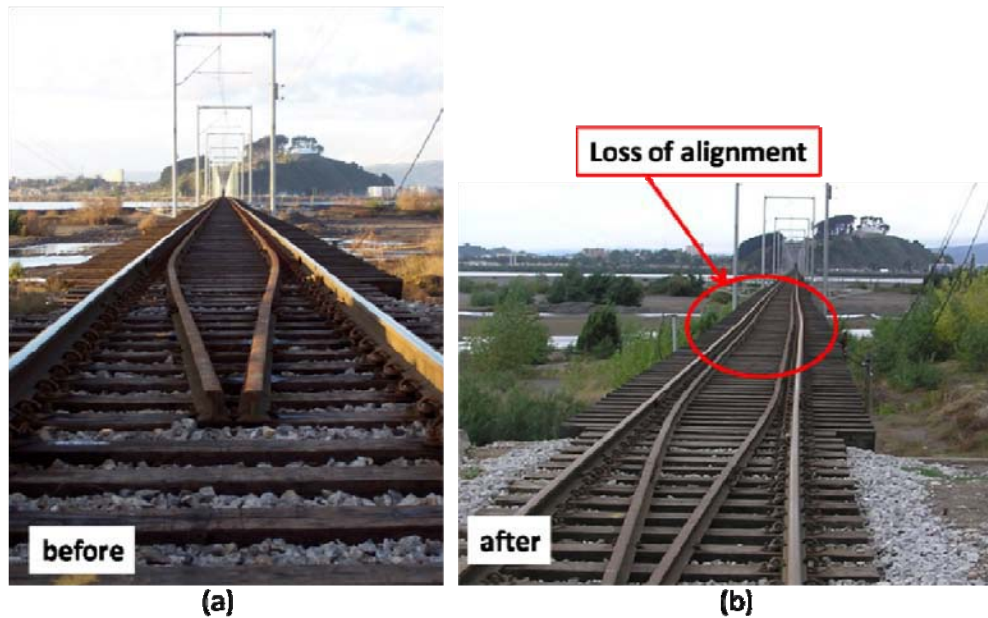
Figure 9.27. Bio Bio Railroad crossing (a) rails aligned before earthquake, (b) rails bended after earthquake (S36.836097° W73.087094° on 3/17/2010)

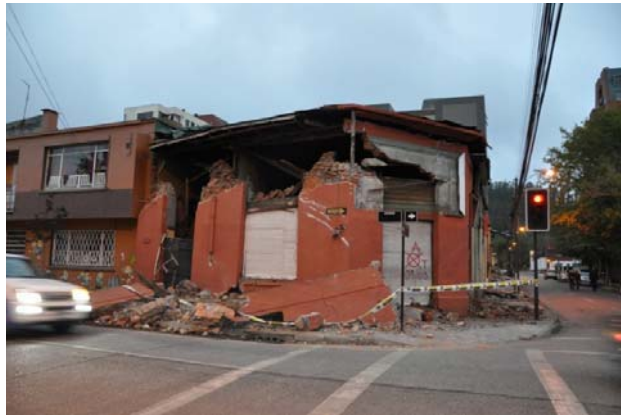
Figure 9.28. Typical construction type and observed damage within the city of Talca (S36.832375,W73.055439; 2016 hrs on 3/17/2010).

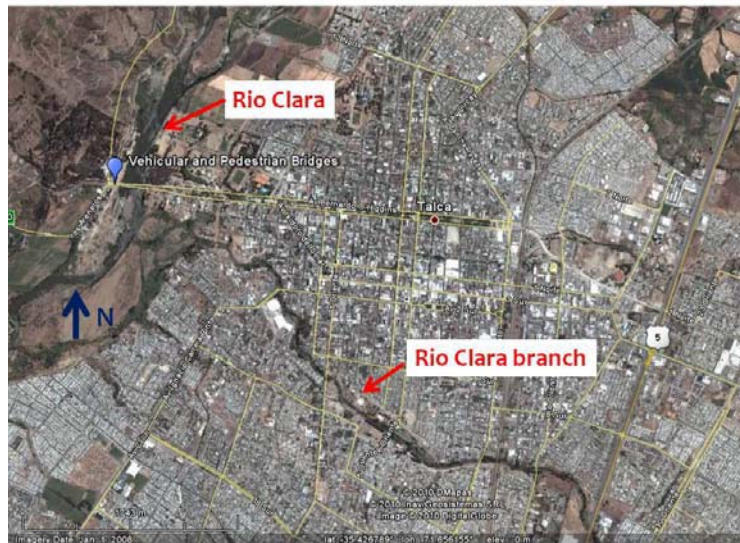
Figure 9.29. Plan view of city of Talca locating the Rio Claro and Rio Claro branch inspected by GEER team (S35.440800° W71.647233°).

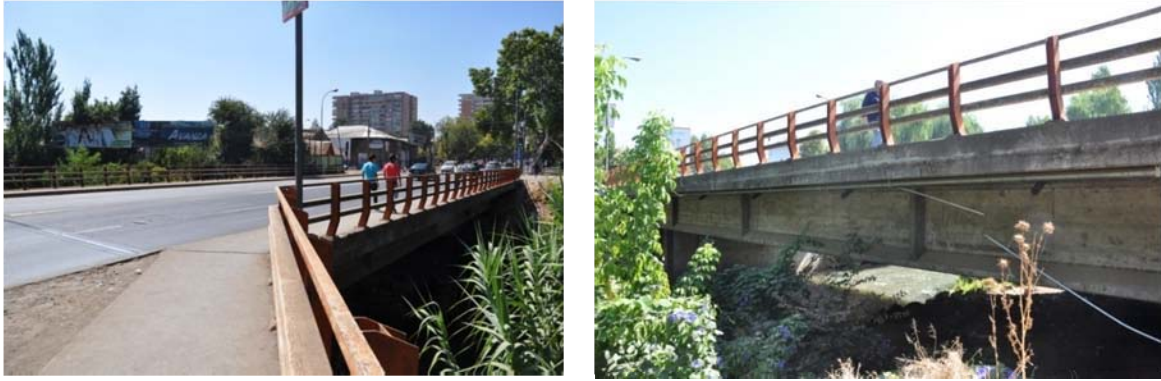
Figure 9.30. (a) Typical short span bridge construction on the branch of the Rio Claro, city of Talca (S35.428011° W71.670269°; 1302 hrs on 3/18/2010). (b) Bridges were observed to remain undamaged (S35.428086° W71.669894°; 1303 hrs on 3/18/2010).

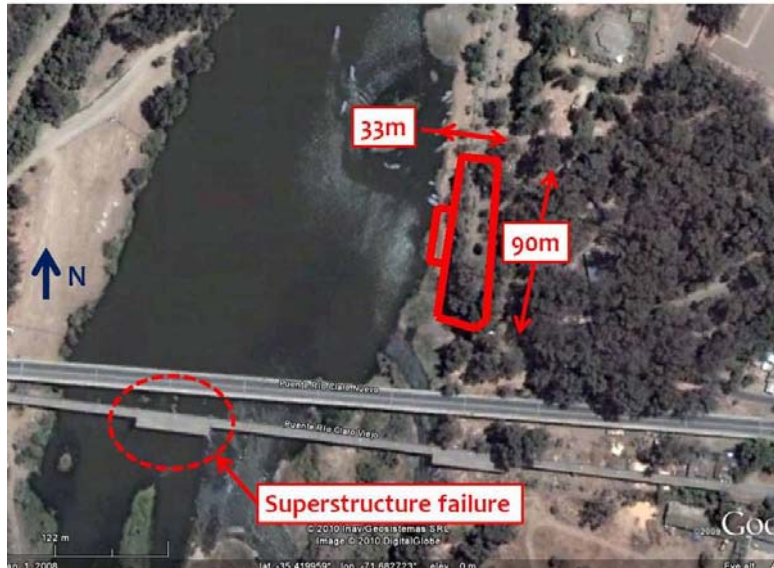
Figure 9.31. Plan view of the Puente Rio Claro Nuevo and Puente Rio Claro Viejo, locating the observed ground failure area to the north (S35.420772° W71.682932°).

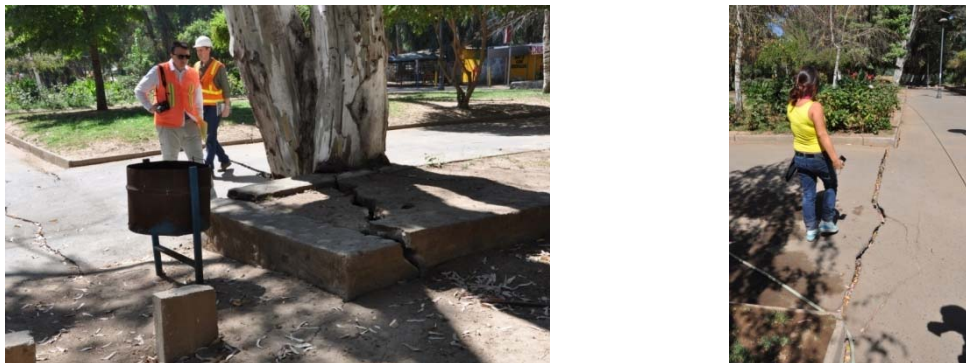
Figure 9.32. Ground failure in a park area near the shore of the Rio Claro in Talca (S35.419919°, W71.682289°; 1408 hrs on 3/18/2010), views looking north and south, for left and right images, respectively.

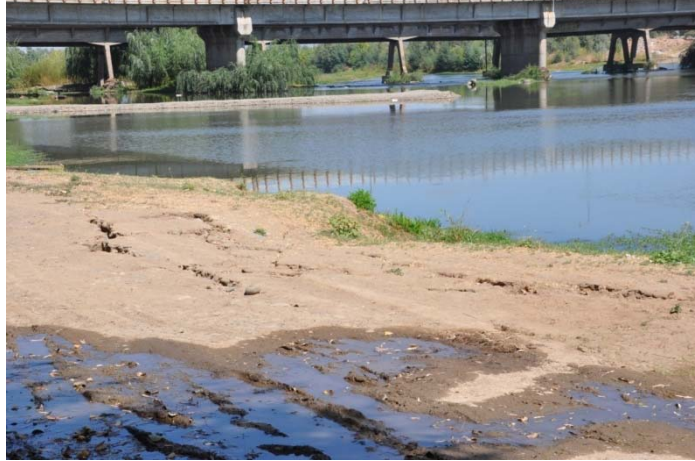
Figure 9.33. Near shore lateral spread on the western shore of the Rio Claro in Talca, view looking south. (S35.419682°, W71.682359° on 3/18/2010). Both the pedestrian and vehicular crossing bridges are shown in the background.

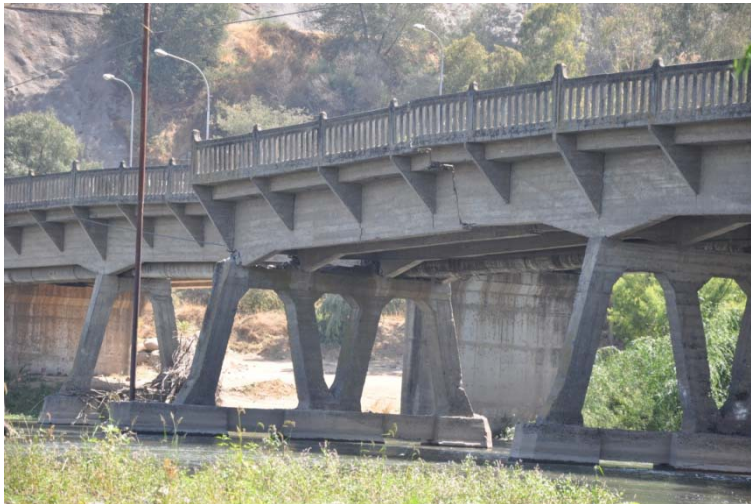
Figure 9.34. Deck unseating and shear failure of longitudinal spanning girders of the Talca pedestrian bridge at the vista area (S35.421044, W71.683197; 1354 hrs on 3/18/2010)
