GEO-ENGINEERING EXTREME EVENTS RECONNAISSANCE (GEER) ASSOCIATION

Turning Disaster in Knowledge

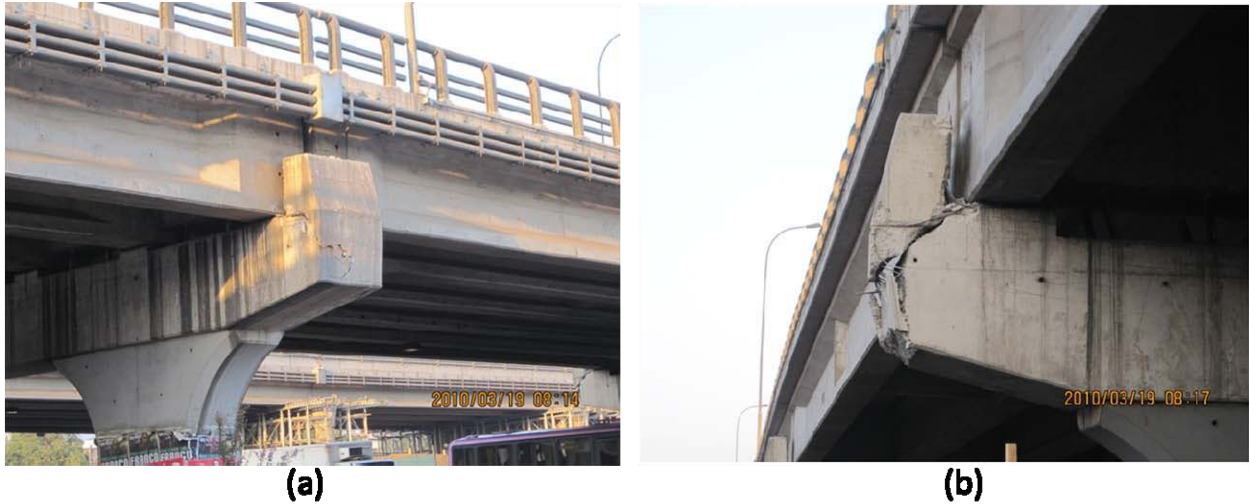
Figure 9.35. (a) Damaged shear key is an example of typical performance on bridges along this section of Vespucio Norte Expressway in Quilicura (S33.365585, W70.688657; 814 hrs on 3/19/2010), (b) Close up of damaged shear key along Vespucio Norte Expressway (S33.365893, W70.688584; 817 hrs on 3/19/2010).

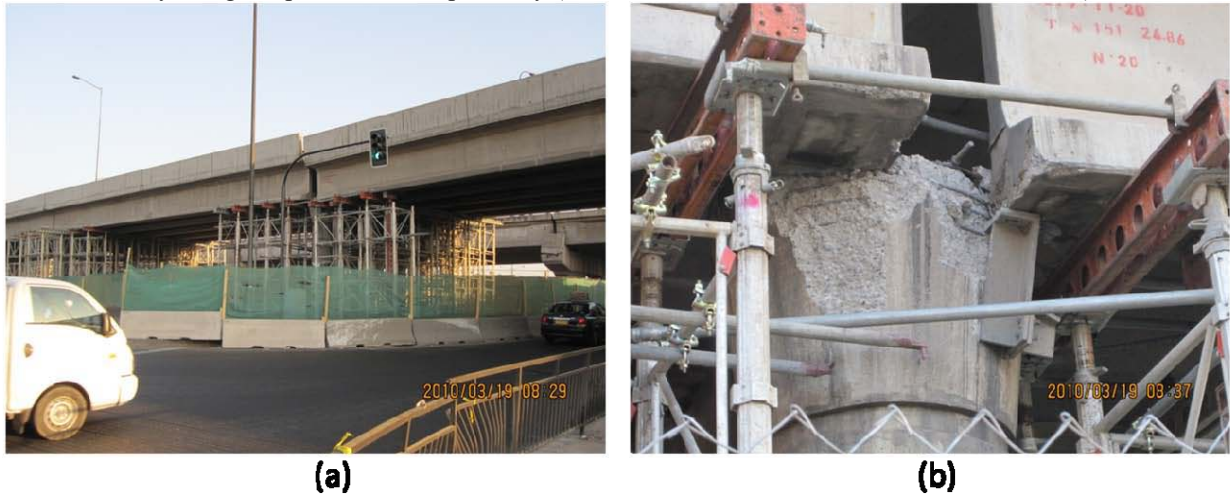
Figure 9.36 (a). Example of one of the newer under crossings that suffered damage along the Vespucio Norte Expressway. The right span became unseated due to excessive transverse movement (S33.36245, W70.688865; 829 hrs on 3/19/2010) (b) Close-up of shear key area on bent cap, with metal shear key or keeper bar hanging on right side of bent cap. Note complete unseating of I-girder on right side of bent cap (S33.366638, W70.689301; 837 hrs on 3/19/2010).

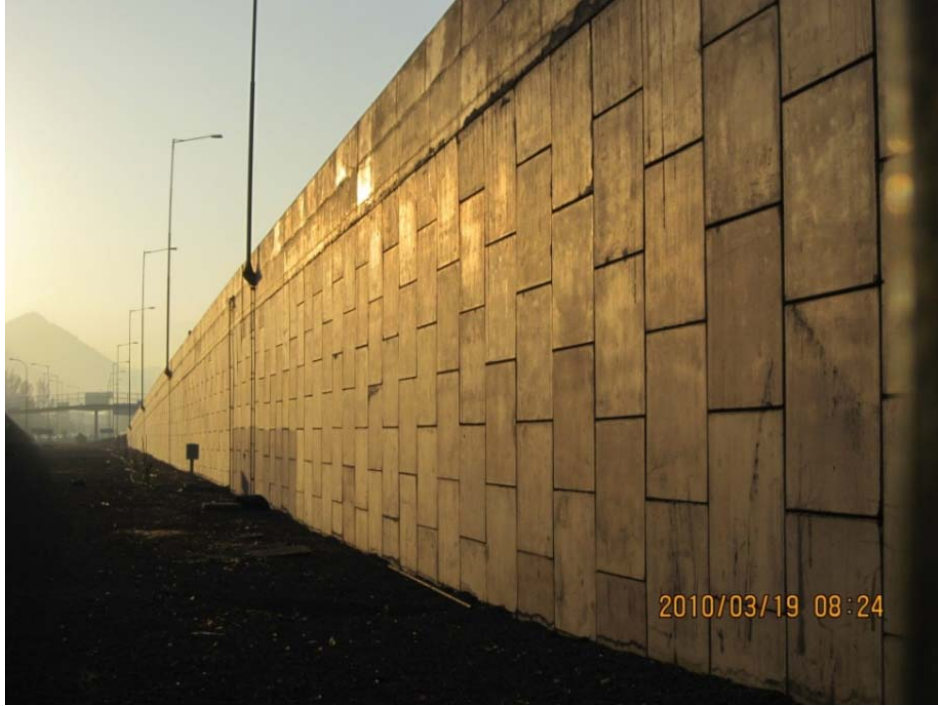
Figure 9.37. Retaining walls and mechanically-stabilized-embankment (MSE) walls appeared to perform well in the Quilicura area of Santiago (S33.366137, W70.688913; 824 hrs on 3/19/2010)

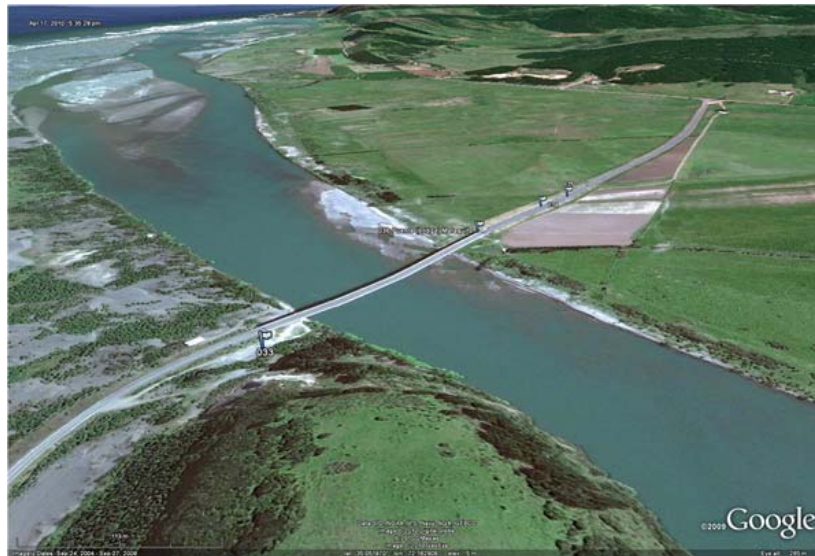
Figure 9.38 Puente Mataquito, looking north, S35.050712°,W72.162258°, April 16, 2010

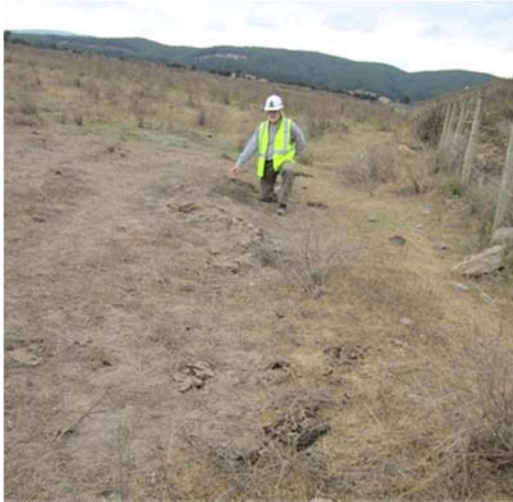
Figure 9.40. (a) Settlement of the north abutment of the bridge, 70 cm offset at the bridge deck, Puente Mataquito, S35.050712°,W72.162258°, April 16, 2010. (b) Cracking and transverse movement (60 cm on each side) of embankment due to liquefaction of underlying soil

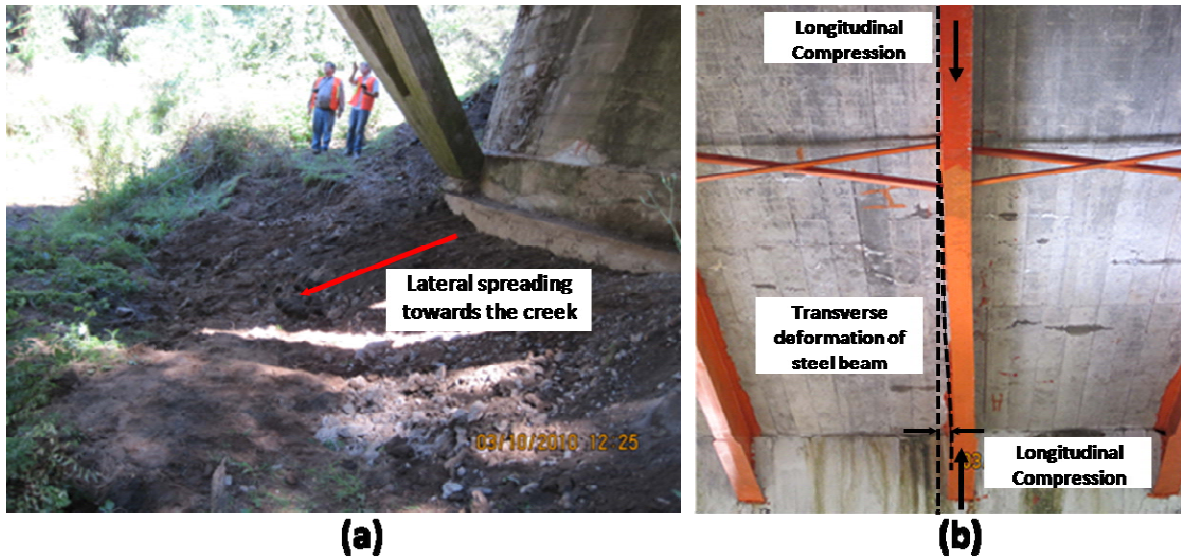
Figure 9.44. Pulen Bridge-(a)Evidence of lateral spreading at the north abutment (b) Loss of longitudinal alignment of steel I-beam (S37.112036, W72.986902, 1225 hrs on 3/10/2010)

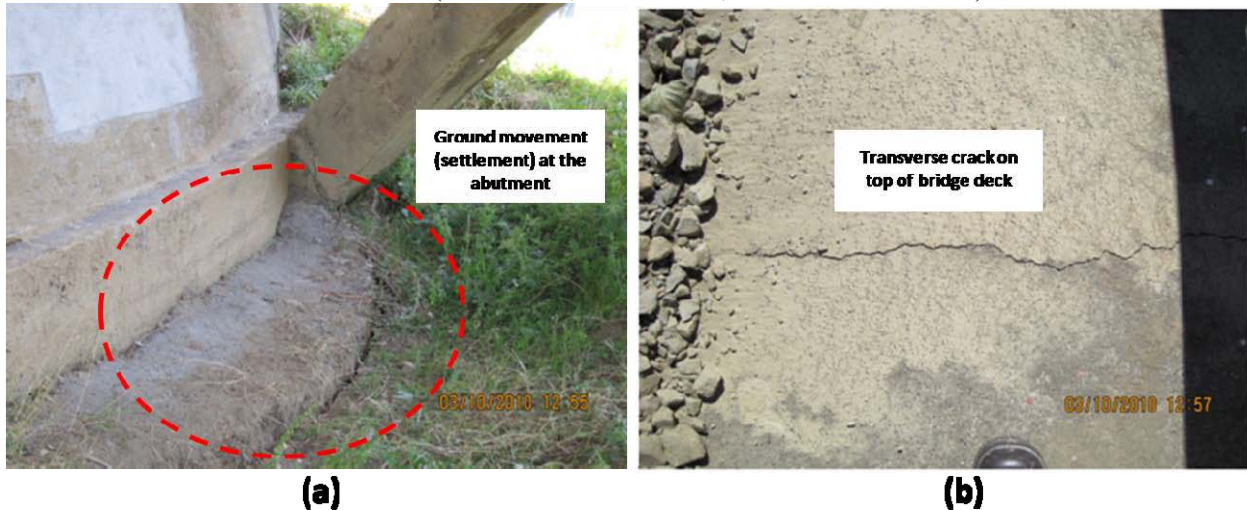
Figure 9.45. Patagual Bridge-(a) Ground movement at the abutment (b) Sidewalk crack in the transverse direction on the top of the bridge deck(S37.111325, W72.987583, 1257 hrs on 3/10/2010).

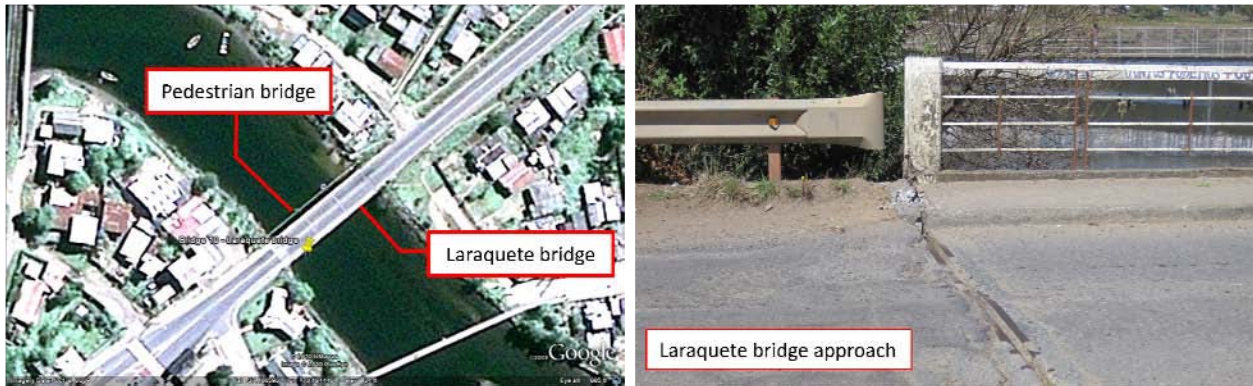
Figure 9.46. Laraquete bridge (a) Aerial view (S37.166788° W73.184486°), (b) Bridge approach (S37.166804° W73.184760°; 1430 hrs on 3/10/2010)

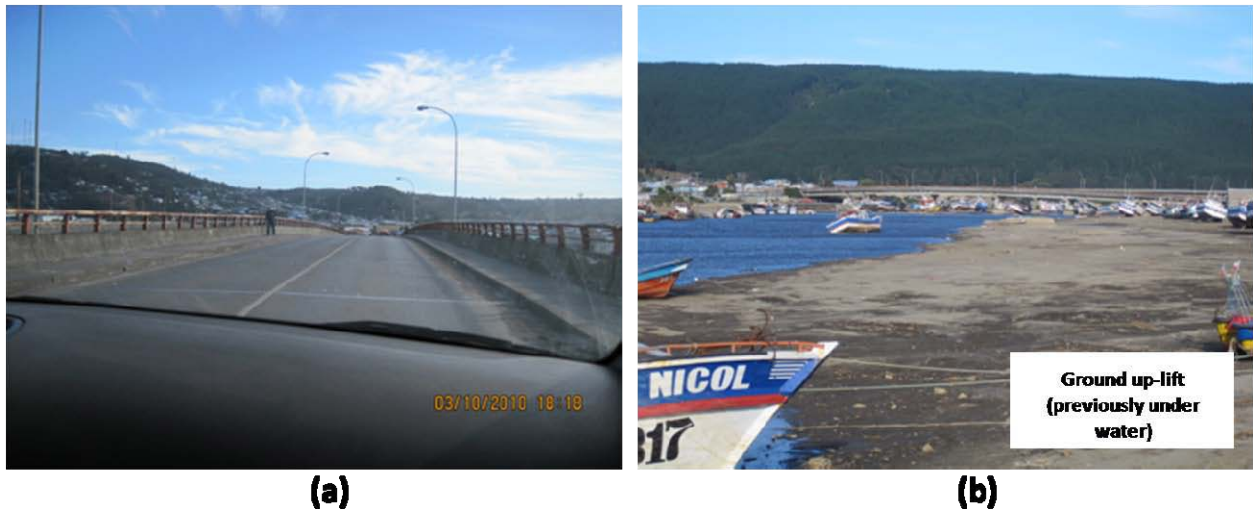
Figure 9.48. Lebu bridge: (a) Crossing Lebu bridge fully functional, and (b) Lebu bridge from the distance (S37.606344, W73.649496, 1818 hrs on 3/10/2010)

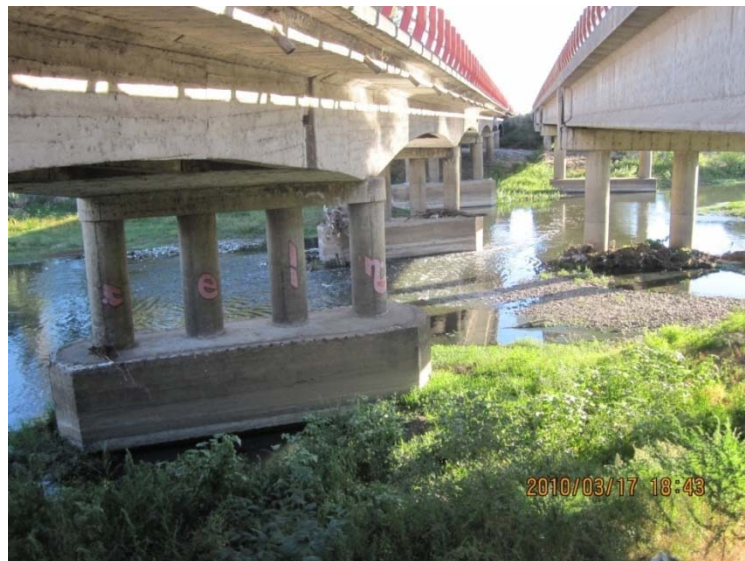
Figure 9.49. This pair of bridges crosses the Rio Nebuco along Route 5 (S36.641846° W72.211264°; 1843 hrs on 3/17/2010).

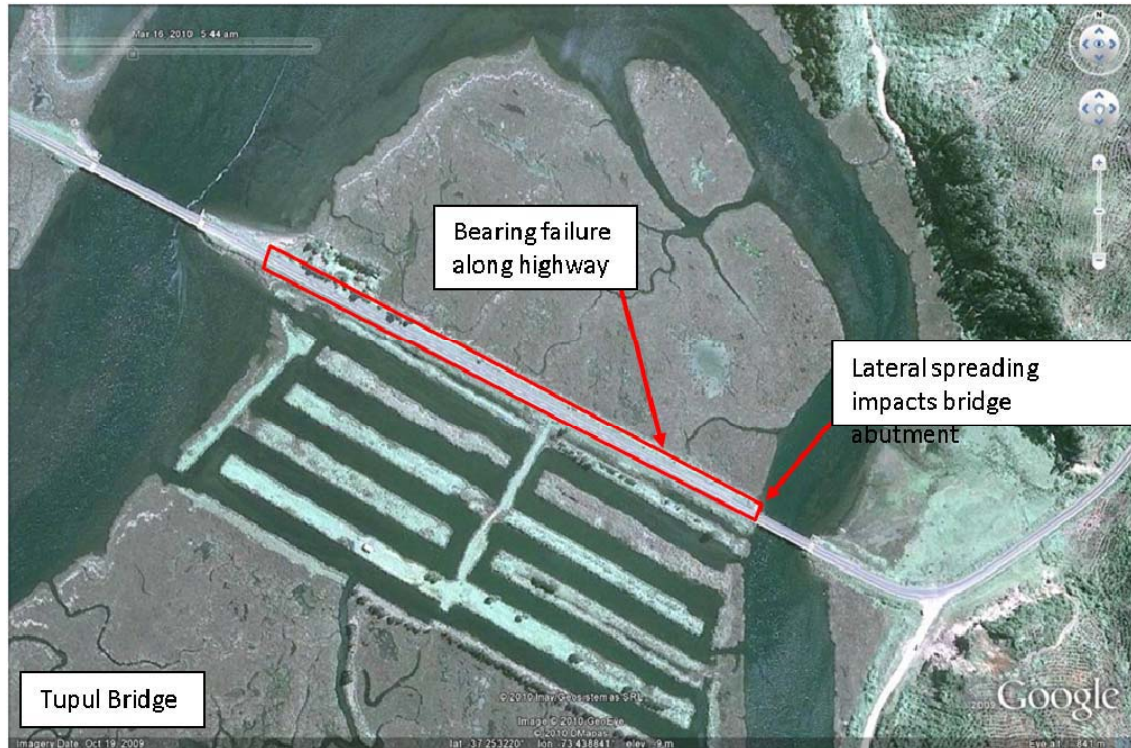
Figure 9.50. Damage to roadway and bridge due to ground failure near town of Tubul, Chile (S37.254345°, W73.437021°).

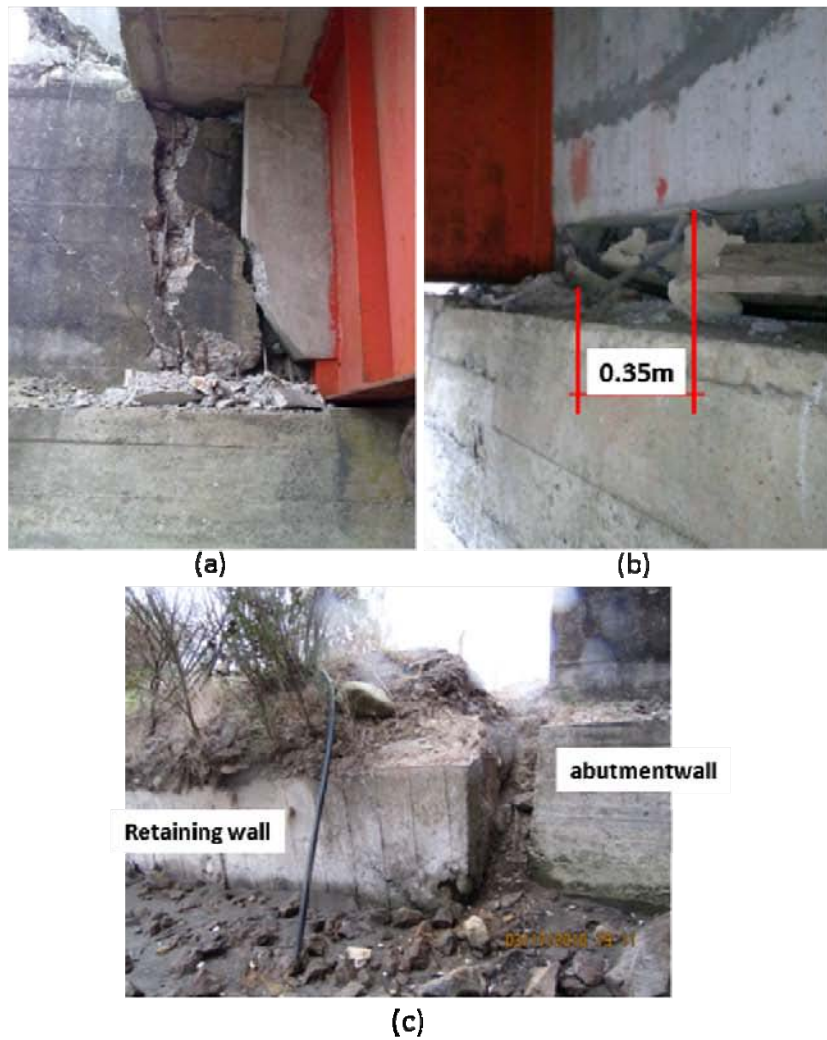
Figure 9.51. Damage to bridge abutment due to lateral spreading of soil around bridge abutment. (a) abutment wall movement relative to beams, (b) deformation of vertical restraining bar due to abutment movement relative to beams, (c) movement of retaining wall relative to abutment. (S37.254345°, W73.437021°; 1911 hrs on 3/17/2010)

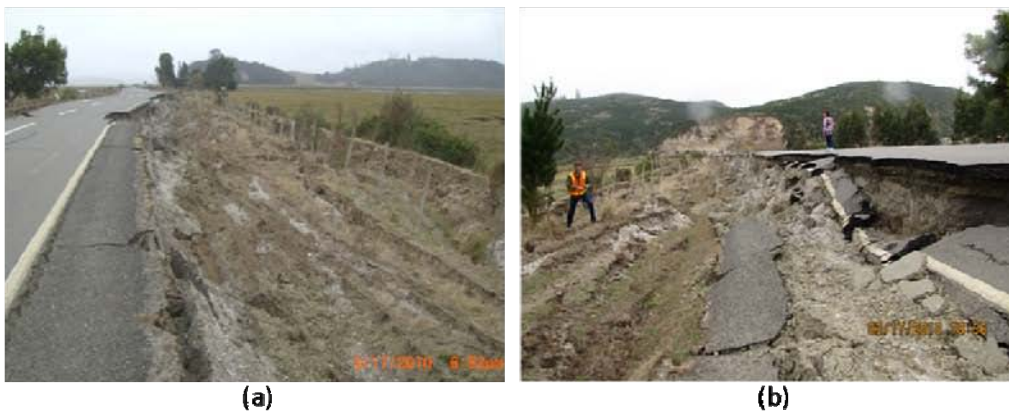
Figure 9.52. Photos showing scarps along both sides of the roadway due to bearing capacity failure in soil underlying the fill. Note lateral spreading in upper photo (S37.254161°, W73.437577° on 3/17/2010)

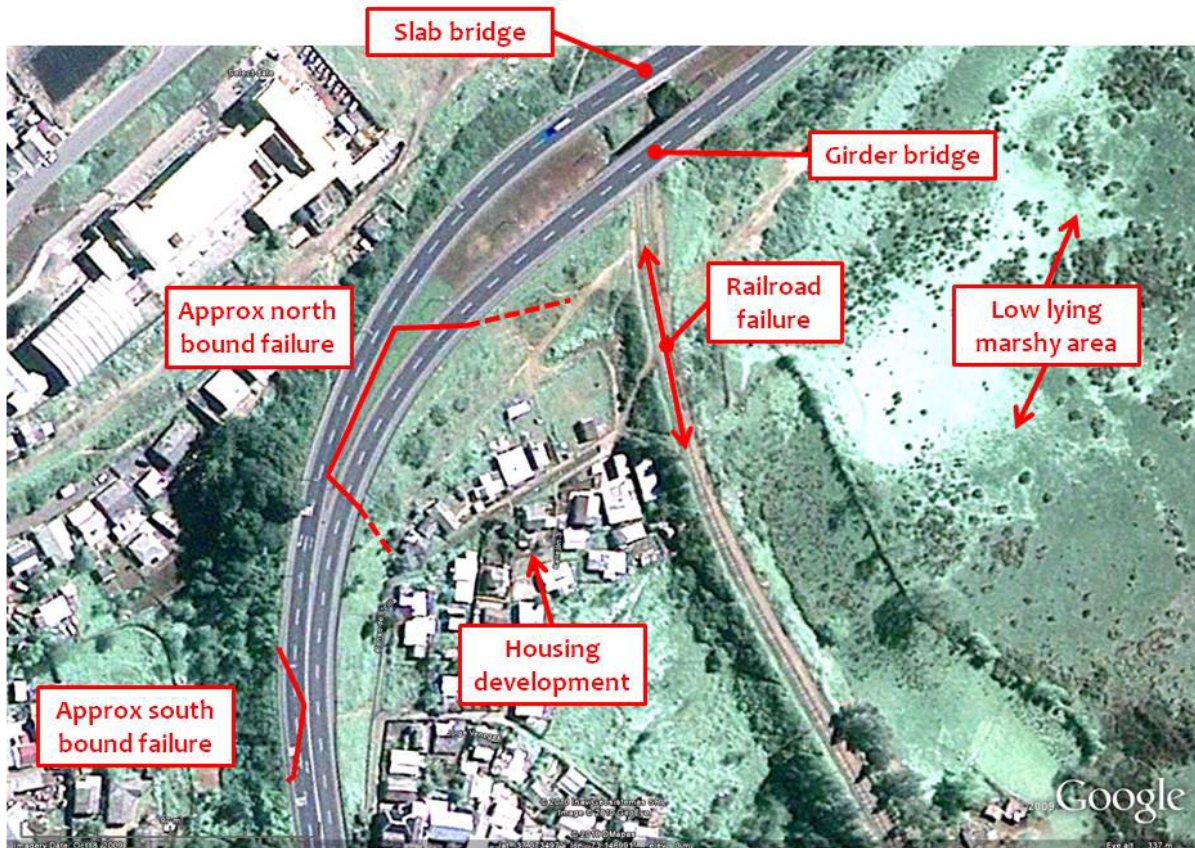
Figure 9.53. Plan view of approximate affected area (Google Earth image at S37.0734°, W73.1469°).

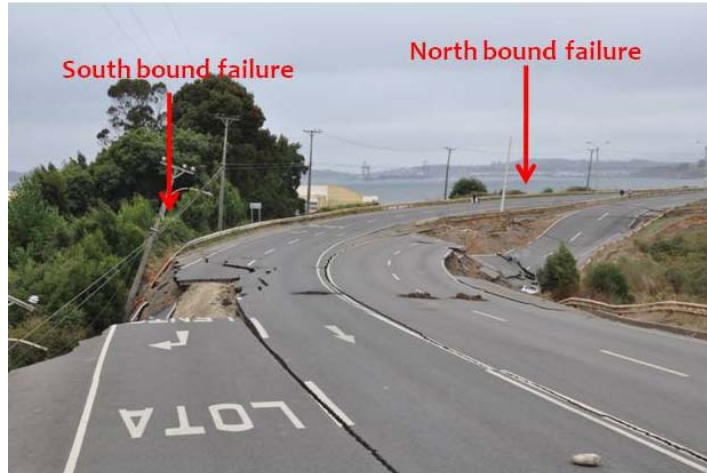
Figure 9.54. View looking north on route 160 showing south bound and north bound failure areas (S37.0744°, W73.1480°; 1220 hrs on 3/16/2010).

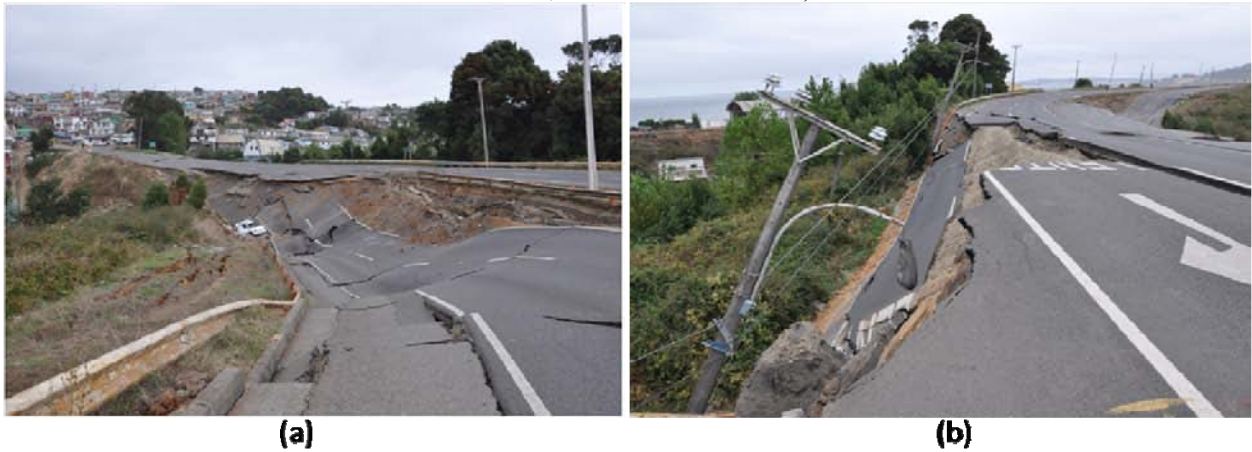
Figure 9.55. Lota (a)View looking south on route 160 showing north bound failure area (S37.0730°,W73.1475°; 1145 hrs on 3/16/2010) (b)View looking north on route 160 showing south bound failure area (S37.0746°, W73.1479°; 1215 hrs on 3/16/2010).

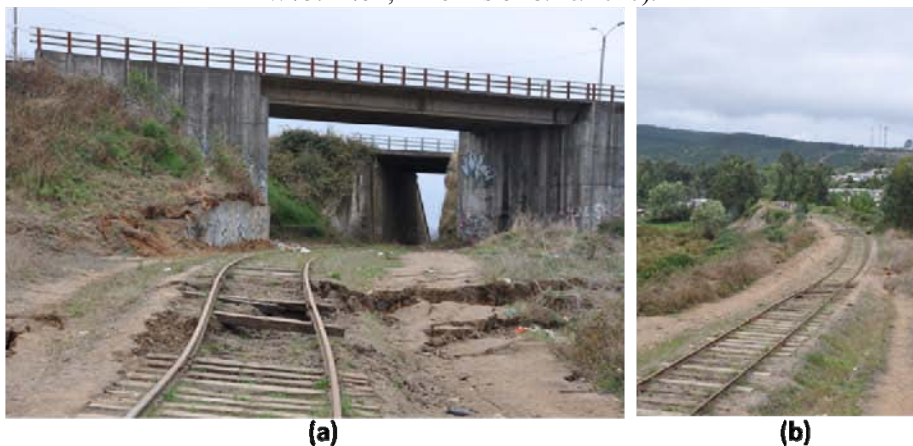
Figure 9.56. Lota (a) Slab and girder-type overpasses at northern end of road embankment failure area, showing railroad and supporting ground settlement. View looking west. (S37.0729°, W73.1469°; 1150 hrs on 3/16/2010), (b) Ground failure below elevated railroad east of road embankment failure. (image looking east; S37.0727°, W73.1471°; 1150 hrs on 3/16/2010)

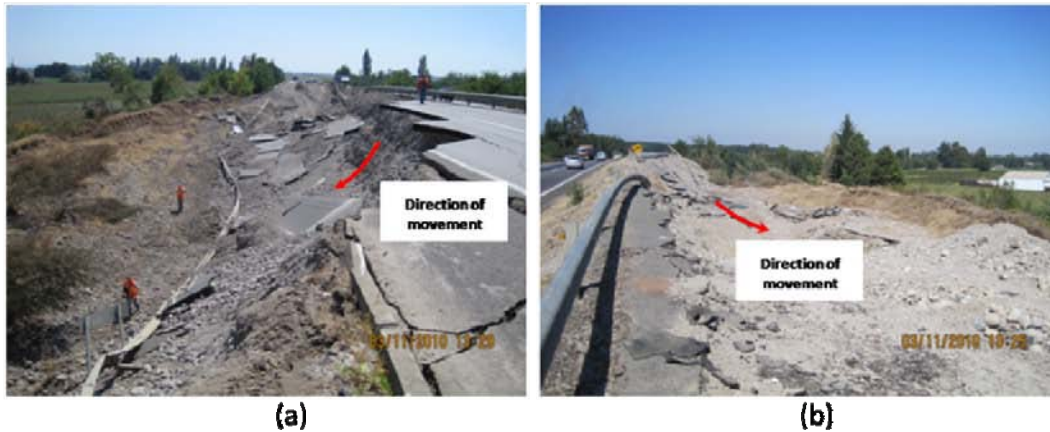
Figure 9.57. This embankment fill collapsed together with an overhead near Copihue, north of Parral, closing the South bound of Route 5 (a) View from the South, (b) View from the North (S36.087891, W71.791513, 1325 hrs on 3/11/2010)

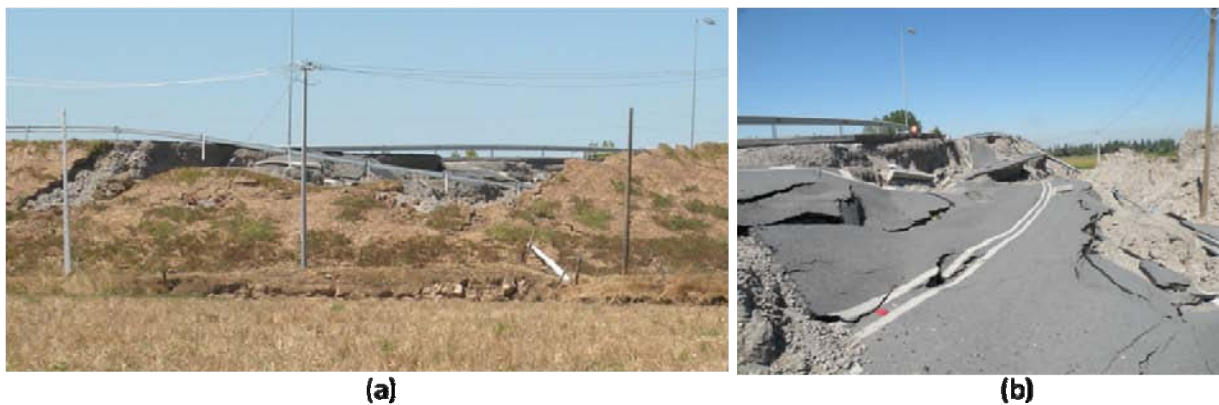
Figure 9.58. Curved overpass embankment failure 13 km North of Parral (a) Translational 3-D slide failure, (S36.0343 W71.7568; 1405 hrs on 3/11/2010) and (b) Failed outside of the curved embankment (S36.0347 W71.7558; 1409 hrs on 3/11/2010)

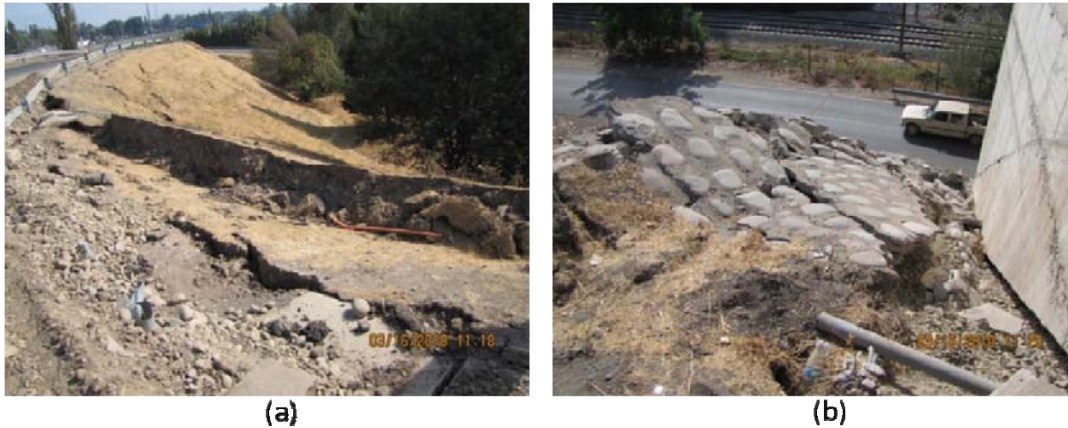
Figure 9.59. Highway 5 crossing near Paine; (a)View of bridge approach from East (S33.854592° W70.747687°; 1118 hrs on 3/16/2010); (b) View of damaged bridge abutment (S33.854211° W70.747784°; 1120 hrs on 3/16/2010)

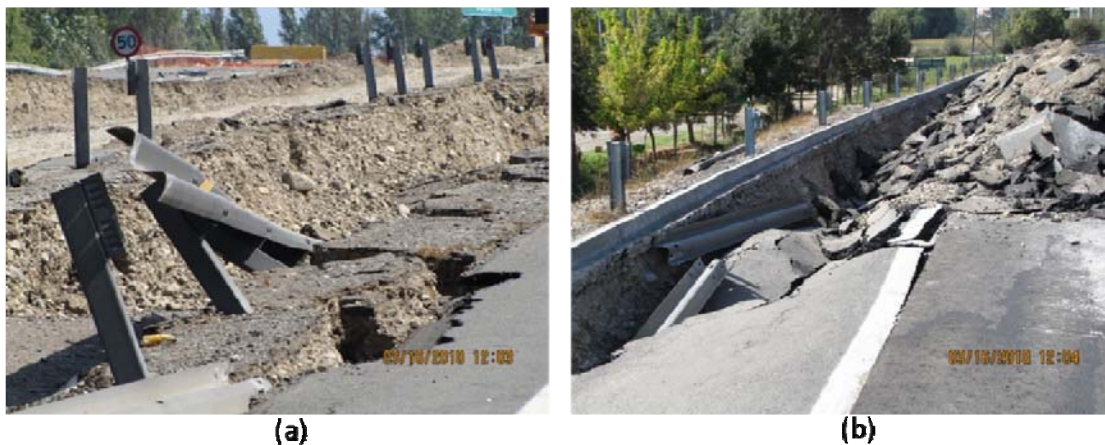
Figure 9.60. Highway 5 failure near Paine; (a)shoulder settlement due to poorly compacted soil (S33.864897° W70.742222° 1203 hrs on 3/16/2010), and (b) road failure due to poorly compacted soil (S33.864897° W70.742222°; 1204 hrs on 03/16/2010)

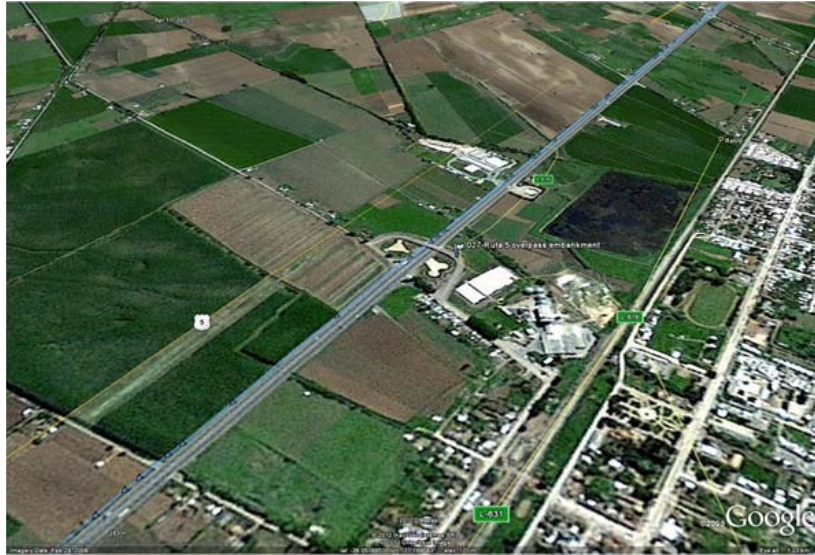
Figure 9.61 Ruta 5 Sur overpass embankment, looking north, to Retiro at Tucapel Mill (S36.051209°, W71.768005°).

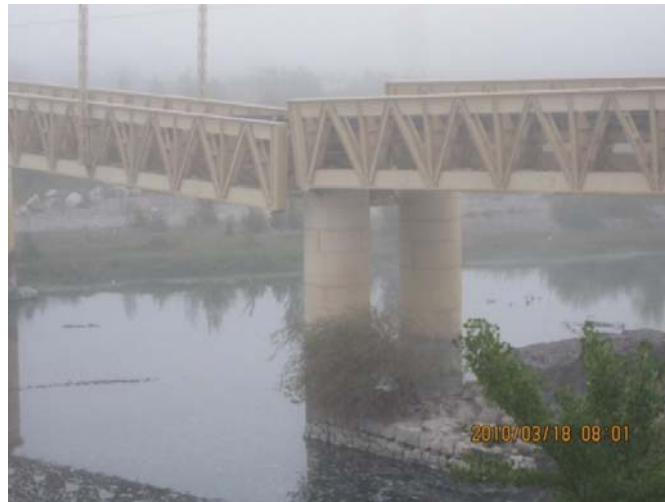
Figure 9.63. Unseated railway bridge span near Longavi from excessive transverse movement (S36.004136, W71.726193, 0801 hrs on 3/18/2010)

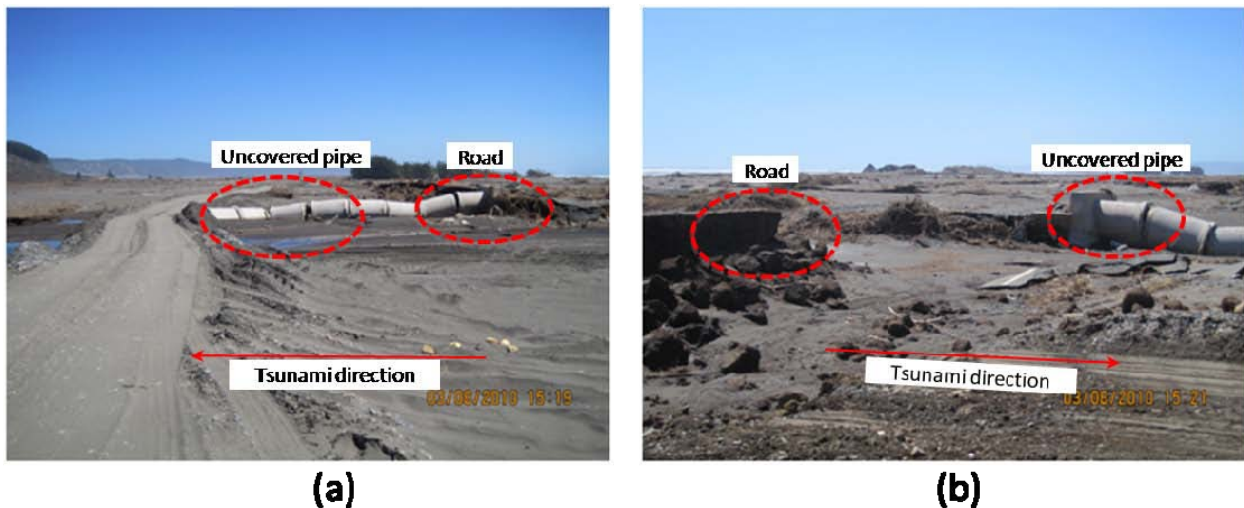
Figure 9.64. Failed culvert pipe: (a) View from the north, and (b) View from the south (S35.115611, W72.203245, 1519 hrs on 3/8/2010)

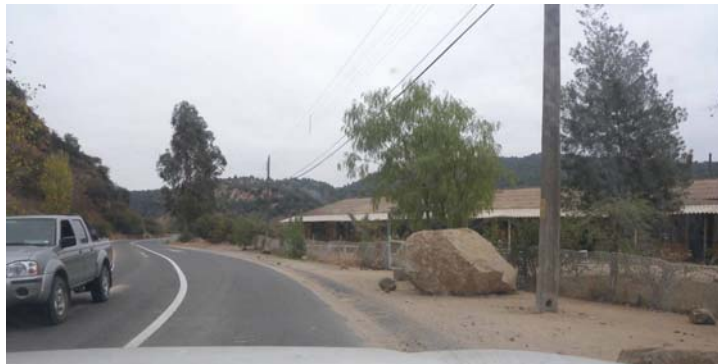
Figure 10.1. Rock fall from a road cut at the approach to Rapel Dam (34.0365°S, 74.586983°W).

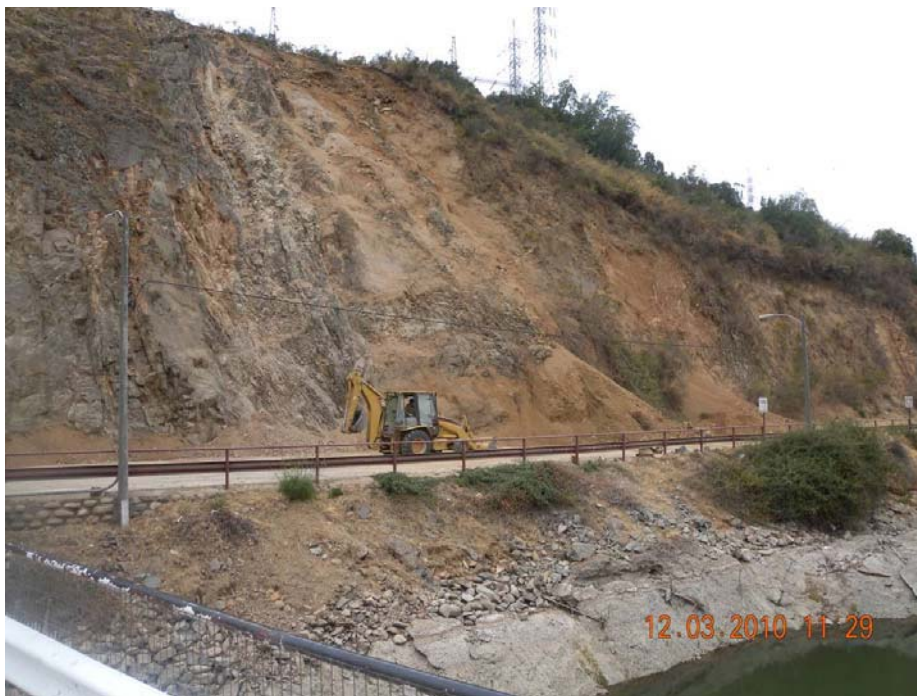
Figure 10.3. Shallow raveling failure of a road cut in weathered and heavily jointed granitic rock at Rapel Dam (34.0407421°S, 71.587153°W).

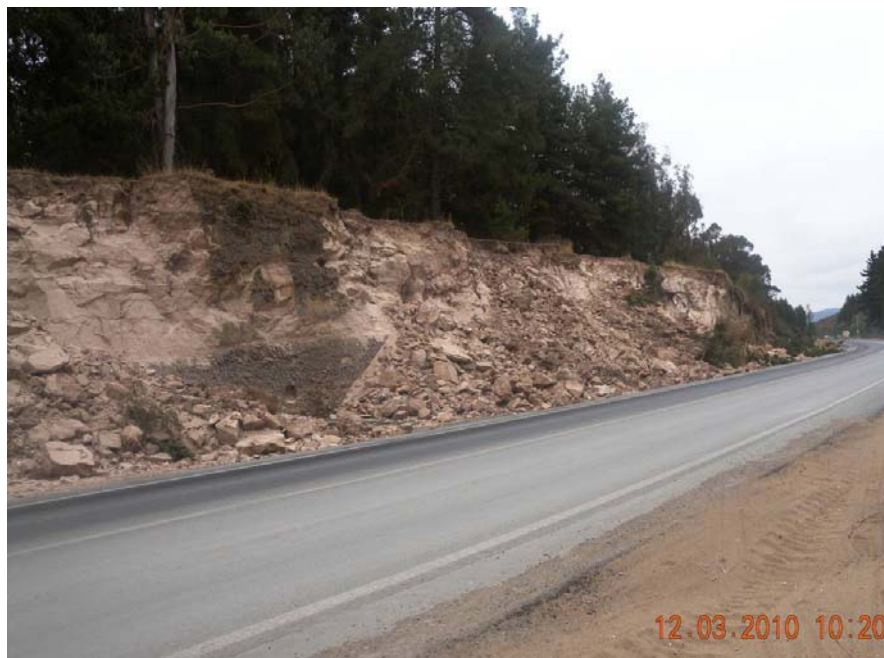
Figure 10.4. Road cut failure in jointed welded tuff north of El Manzano. The height of the cut is about 6 m (20 feet). Picture looking NE (34.144076°S, 71.38000°W).

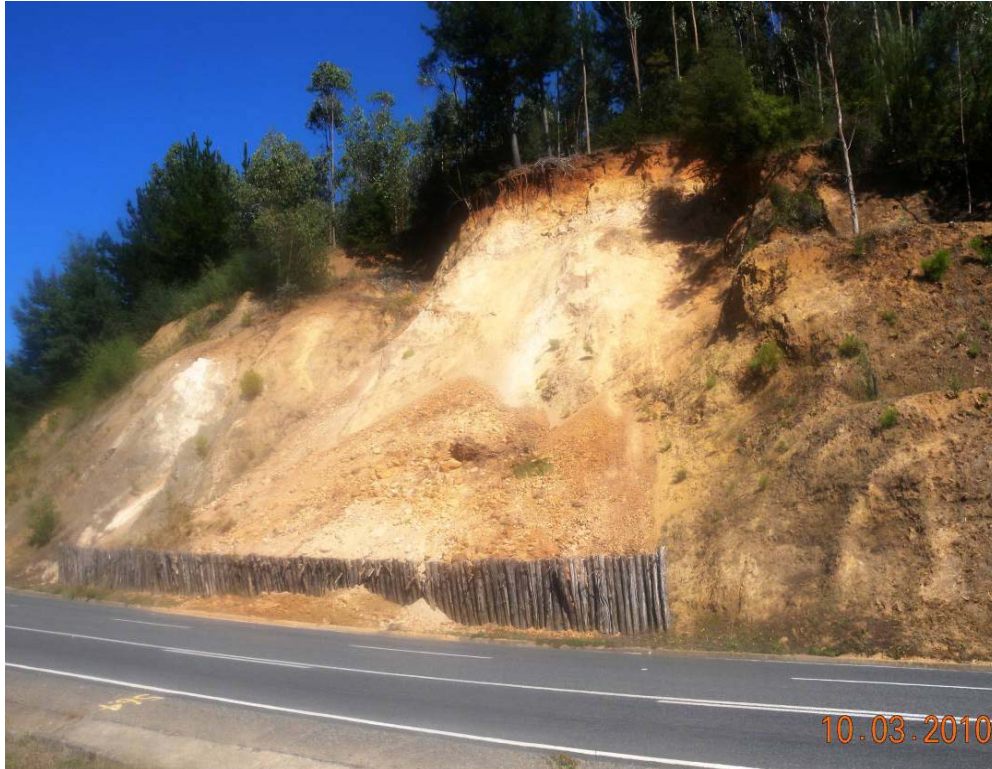
Figure 10.5. Shallow failure in a road cut in highly weathered bedrock (37.256493°S, 72.96018°W, looking SW).

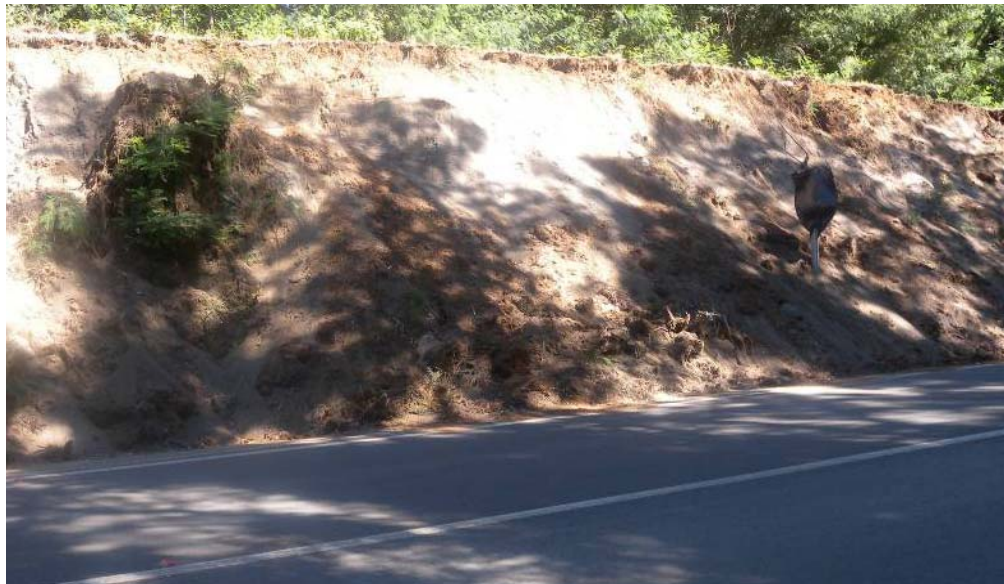
Figure 10.6. Sloughing of unconsolidated fluvial sand in a road cut North of Santa Juana (37.1111°S, 72.9876°W).

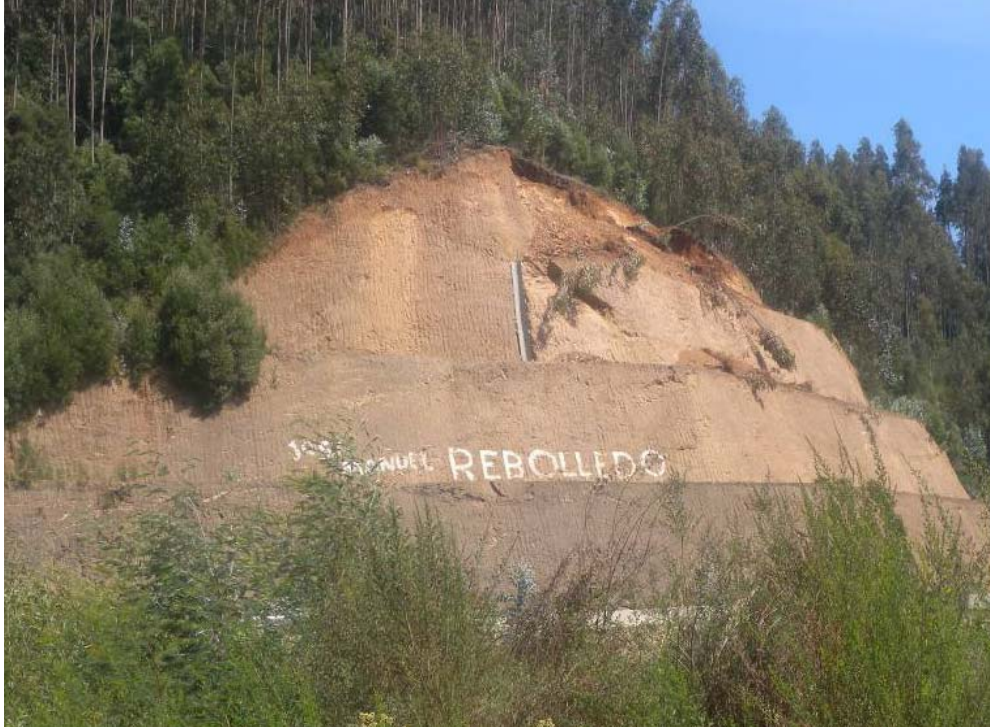
Figure 10.7. Bench failure along a daylighting joint in a road cut in deeply weathered rock south of Lota (37.1213°S, 73.1550°W).

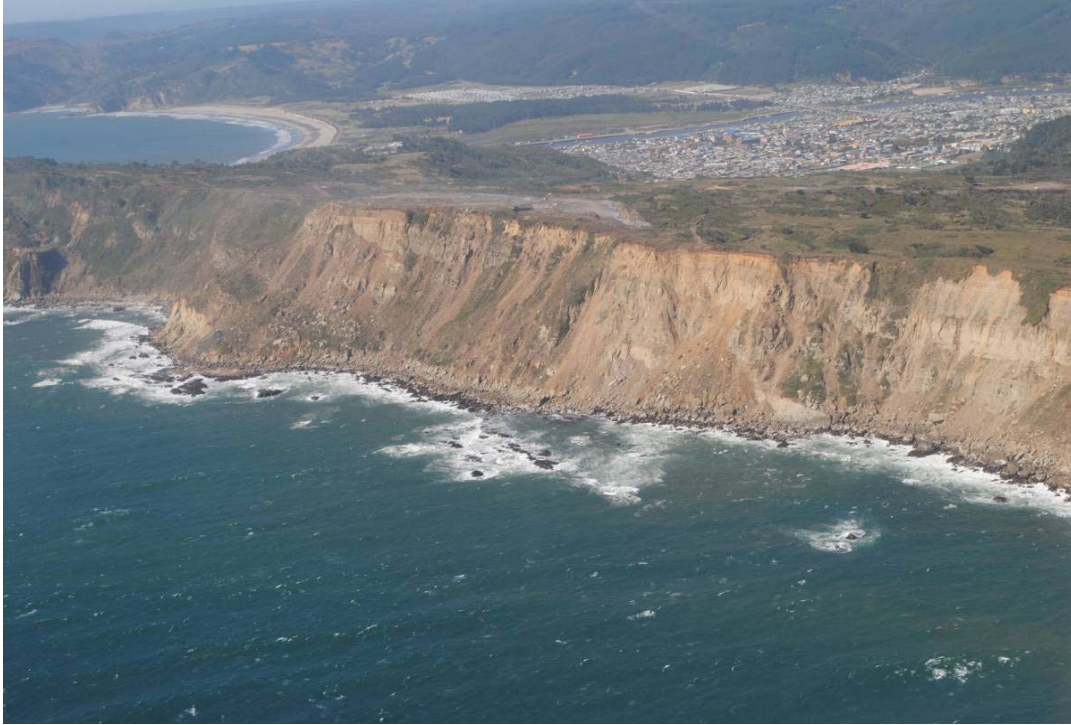
Figure 10.8. Shallow slides along bluffs southwest of Lebu (37.6°S, 73.674°W).

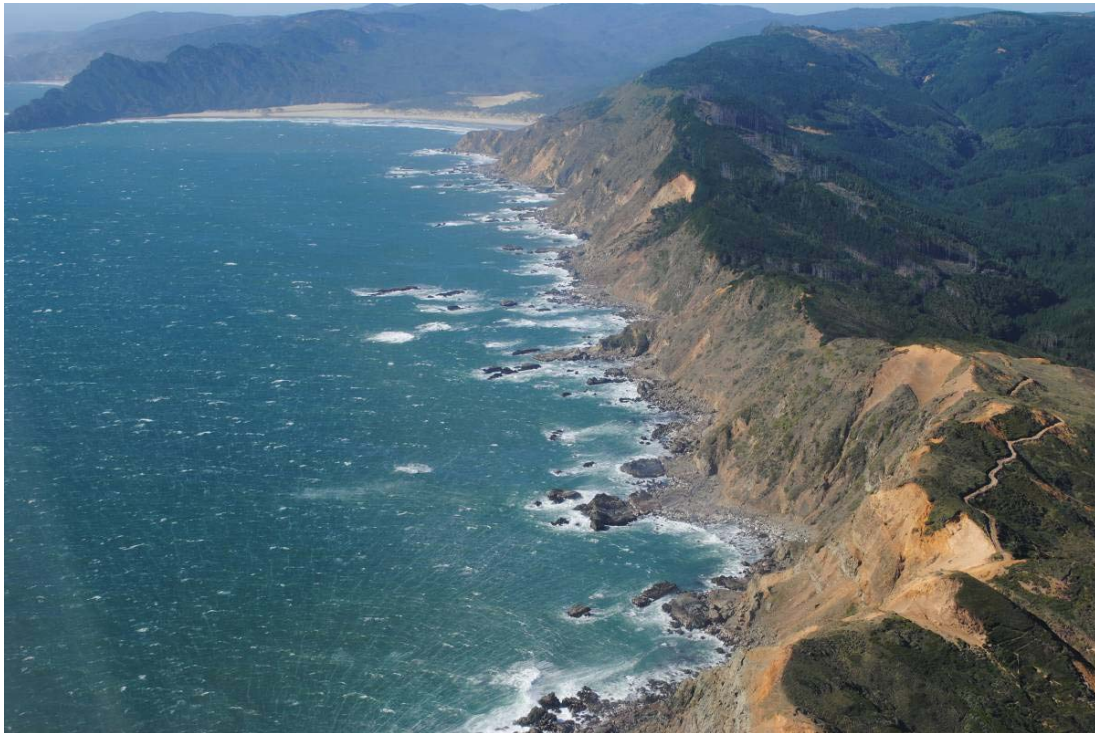
Figure 10.9. Bluffs north of Pta Carneros, southwest of Arauco, showing frequent but not pervasive sliding and raveling (37.326°S, 73.2674°W).

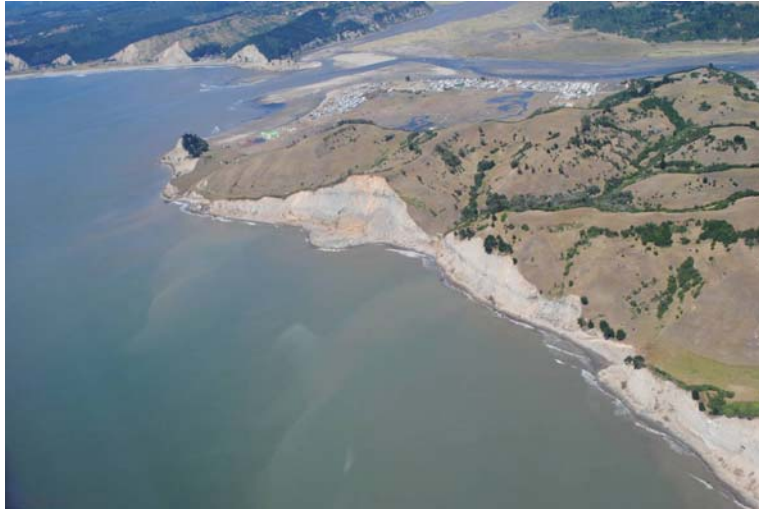
Figure 10.10. Aerial view of the coastal bluffs West of Arauco (37.2205°S, 73.443°W).

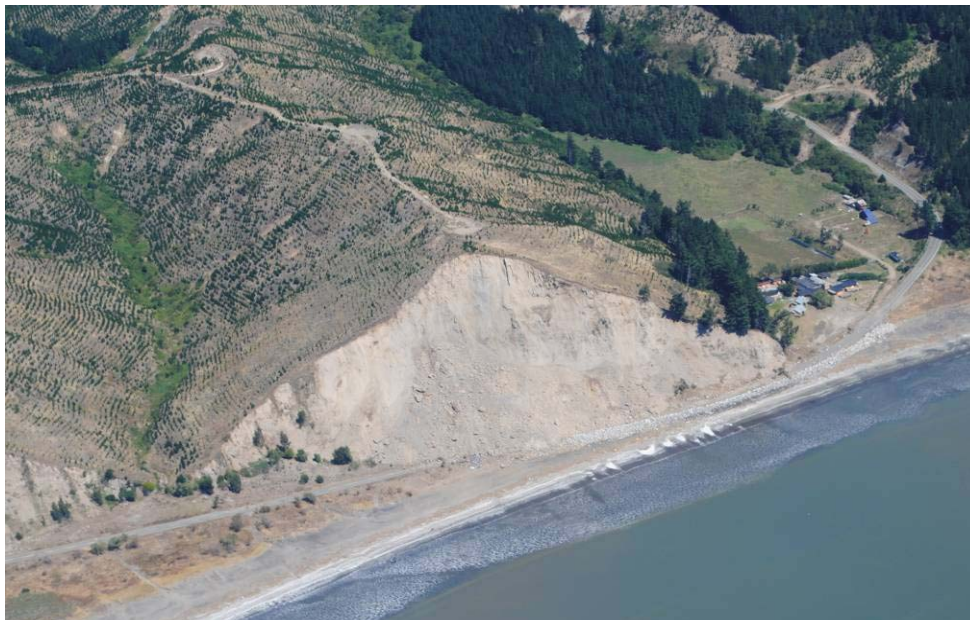
Figure 10.11. Shallow failure along a truncated ridge forcing road closure West of Arauco (37.2437°S, 73.413°W) .

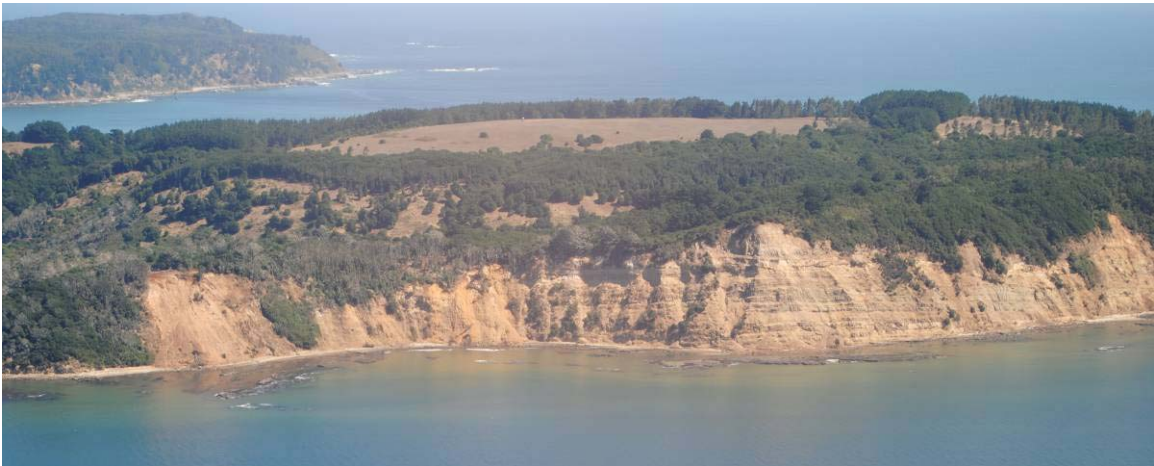
Figure 10.12. Shallow failures and raveling in Tertiary sedimentary rocks on Isla Quiriquina (36.627°S, 73.05°W).

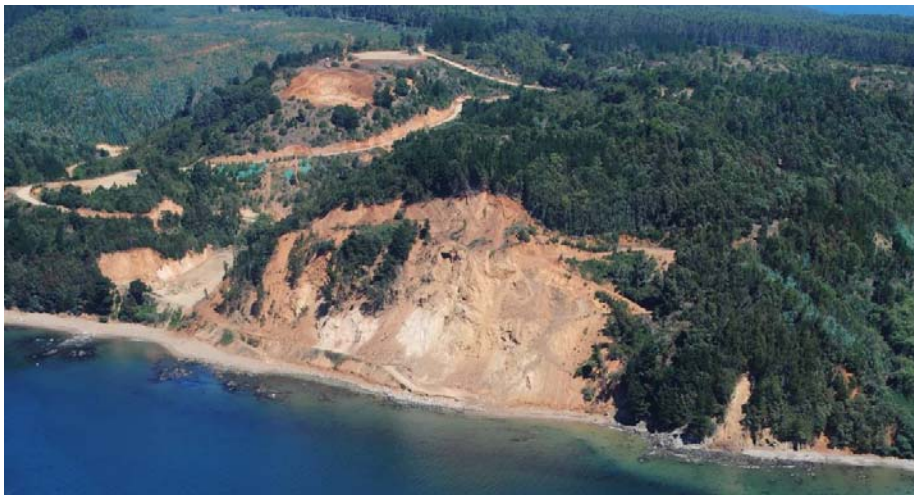
Figure 10.13. Disaggregated landslide complex, Punta Tumbes looking West (36.66°S, 73.098°W).

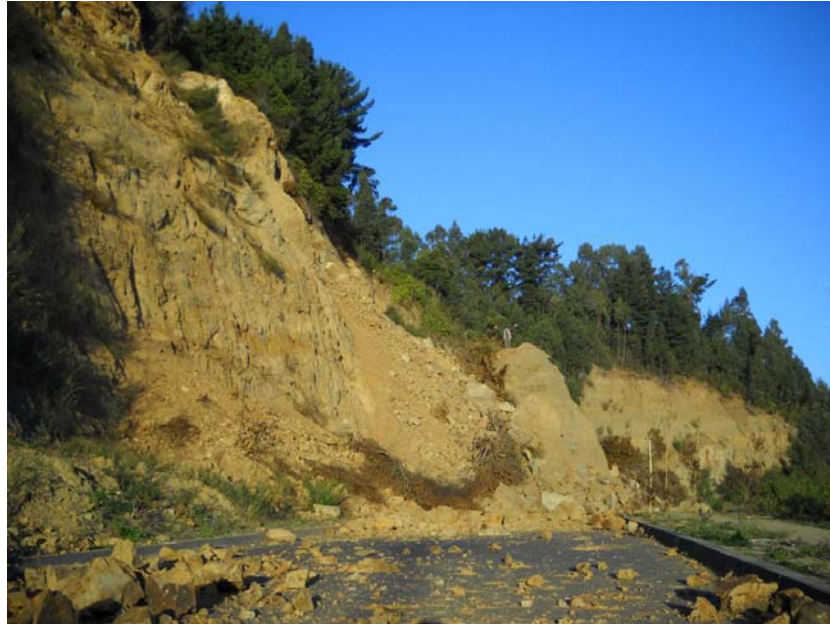
Figure 10.14. Landslide in a road cut in Cocholgue, north of Tome (36.595 S, 72.974 W). Photo and details courtesy of J.M. Lopez.

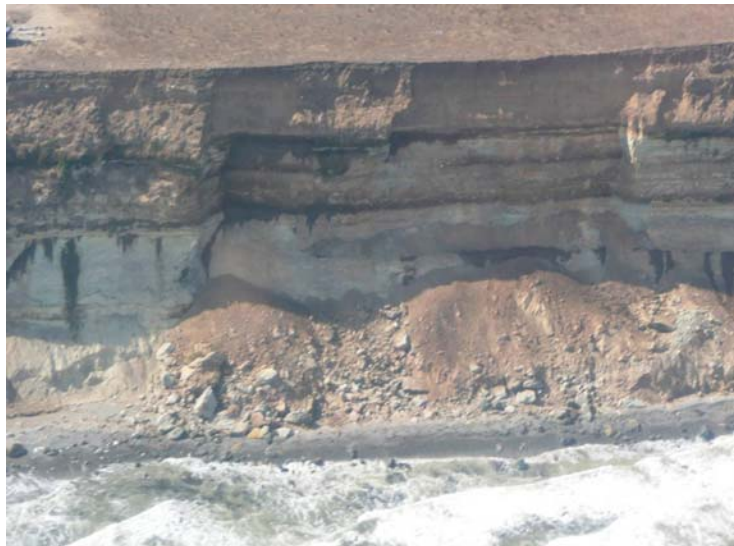
Figure 10.15. Typical shallow failure of steep coastal bluffs, Reserva Nacional El Yali (33.841°S, 71.817°W) .
