GEO-ENGINEERING EXTREME EVENTS RECONNAISSANCE (GEER) ASSOCIATION

Turning Disaster in Knowledge

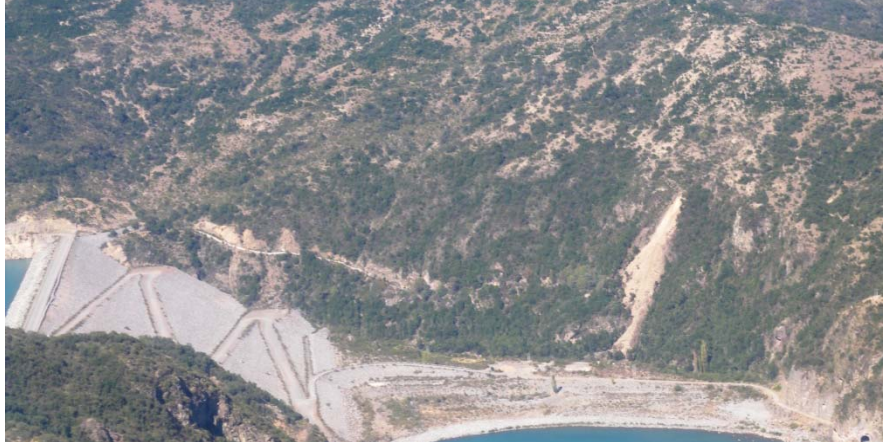
Figure 10.16. Typical shallow disaggregated slide, Colbun Dam (35.668°S, 71.351°W) .

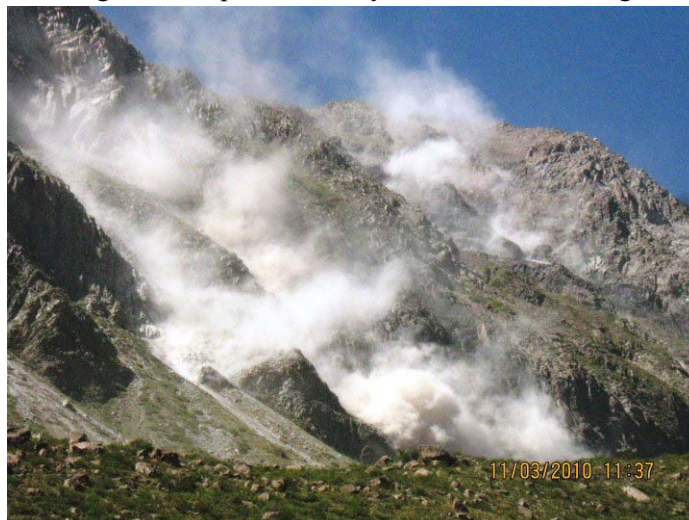
Figure 10.17. Rock falls and shallow debris slides following the M 6.9 event on March 11, 2010 (approx. 34.8°S, 70.5°W). Note, the time in the picture is 20 minutes off. Picture courtesy of Cristian Avila.

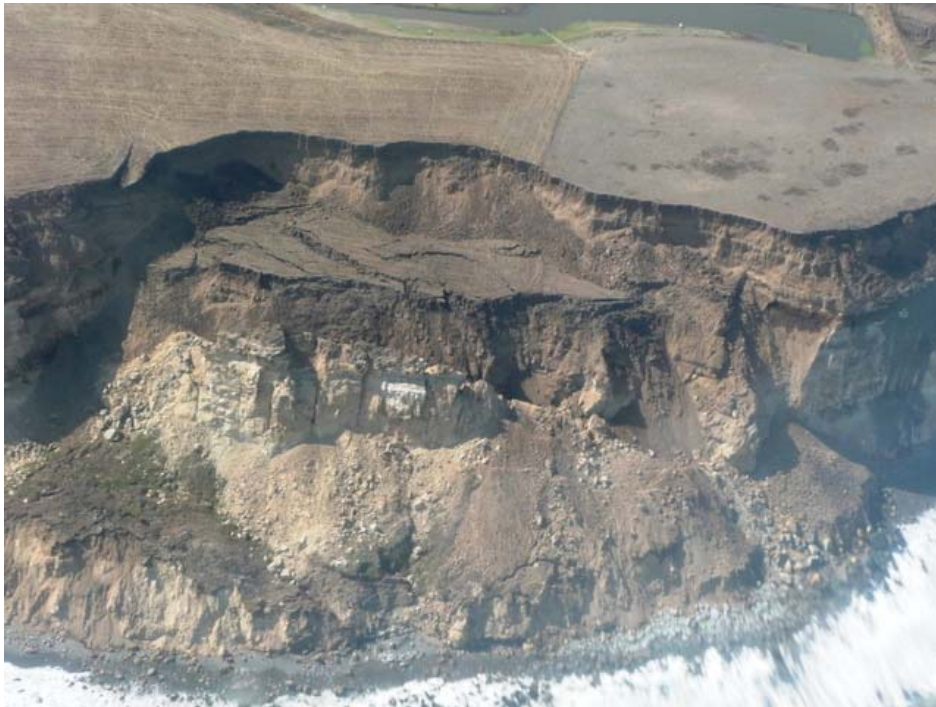
Figure 10.18. Deep-seated bedrock slump in Tertiary sedimentary bedrock capped by marine terrace sediments (33.846°S, 71.821°W).

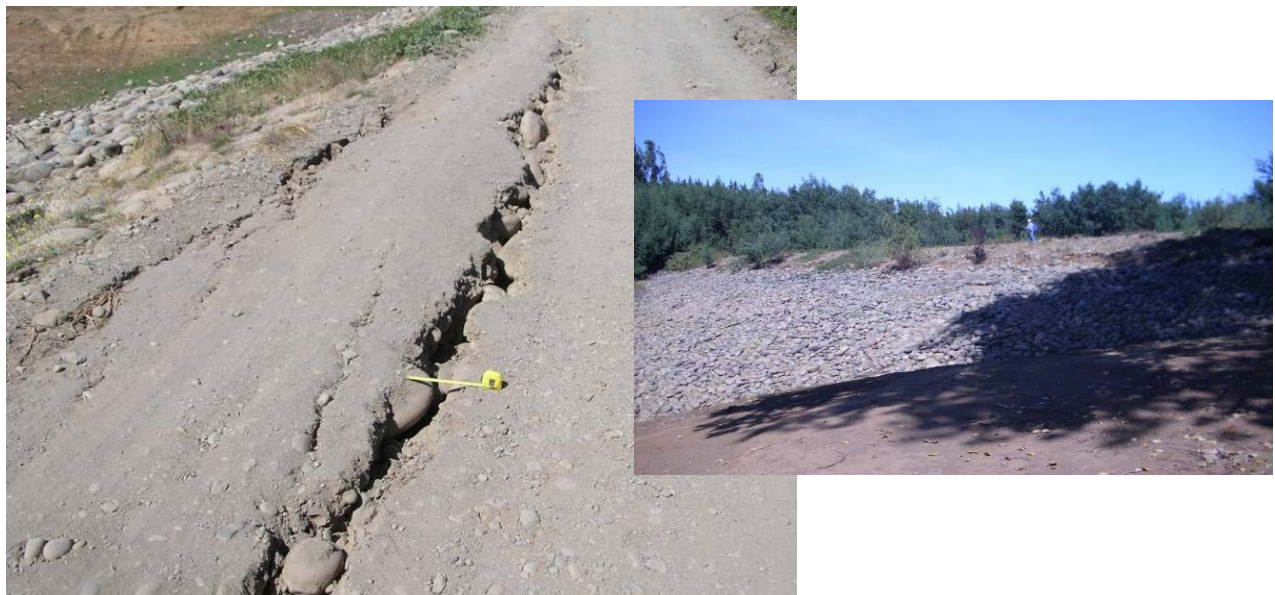
Figure 11.5. March 10, 2010. Cracking of Crest of Small Dam South of Main Coihueuco Dam (S36.645411°, W71.800212°).

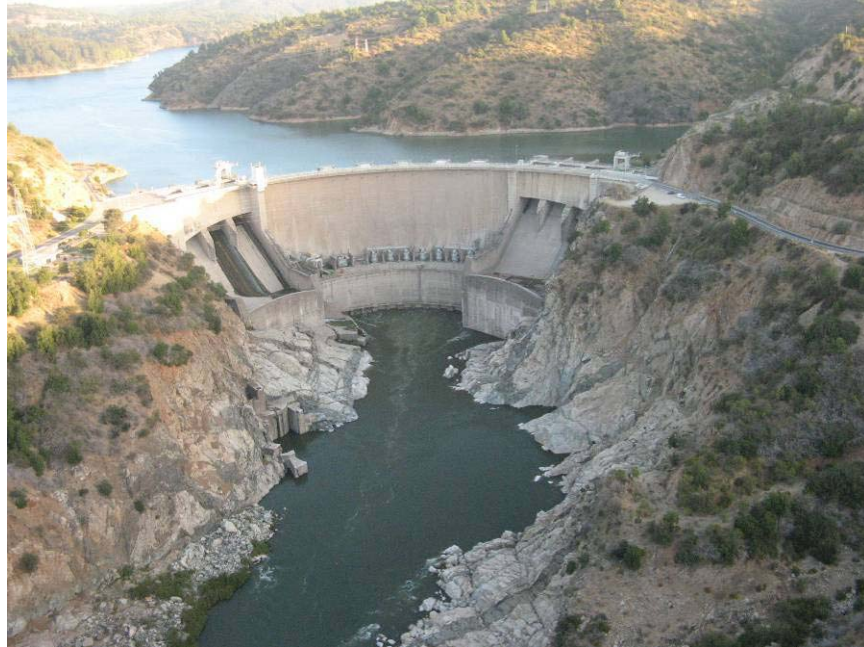
Figure 11.6. March 10, 2010. Rapel Concrete Dam Downstream Face (S34.038754°, W71.590223°)

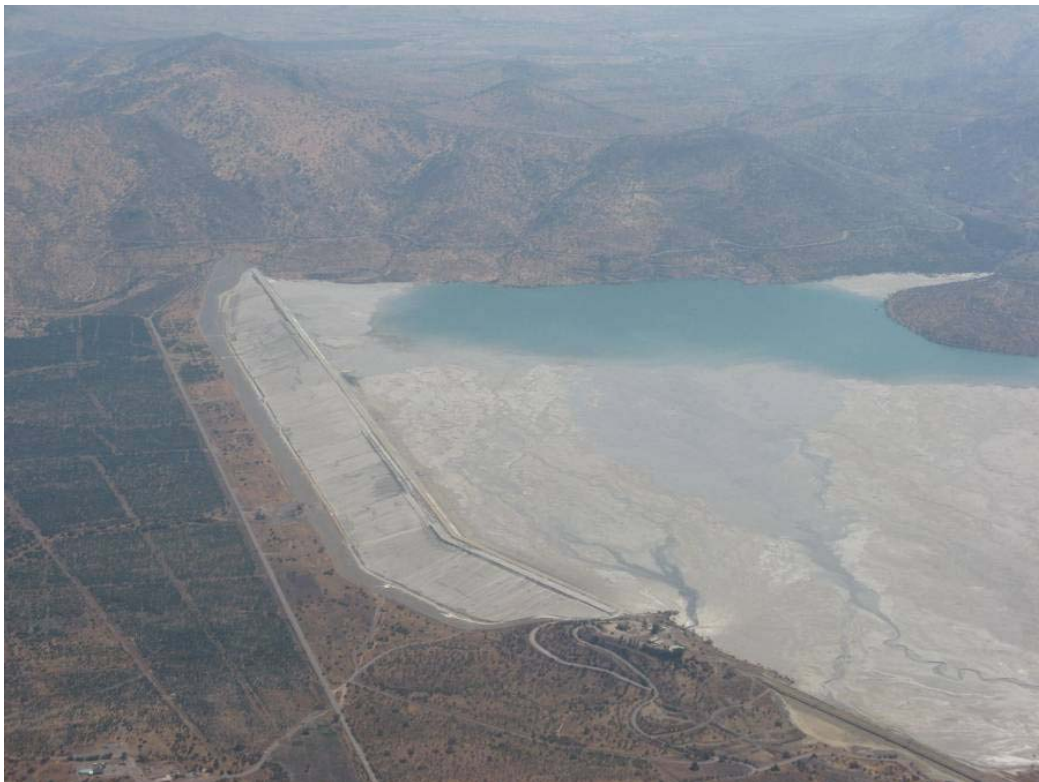
Figure 11.8. March 10, 2010 View of Ovejeria Tailings Dam from Helicopter (S33.054182°, W70.768953°)

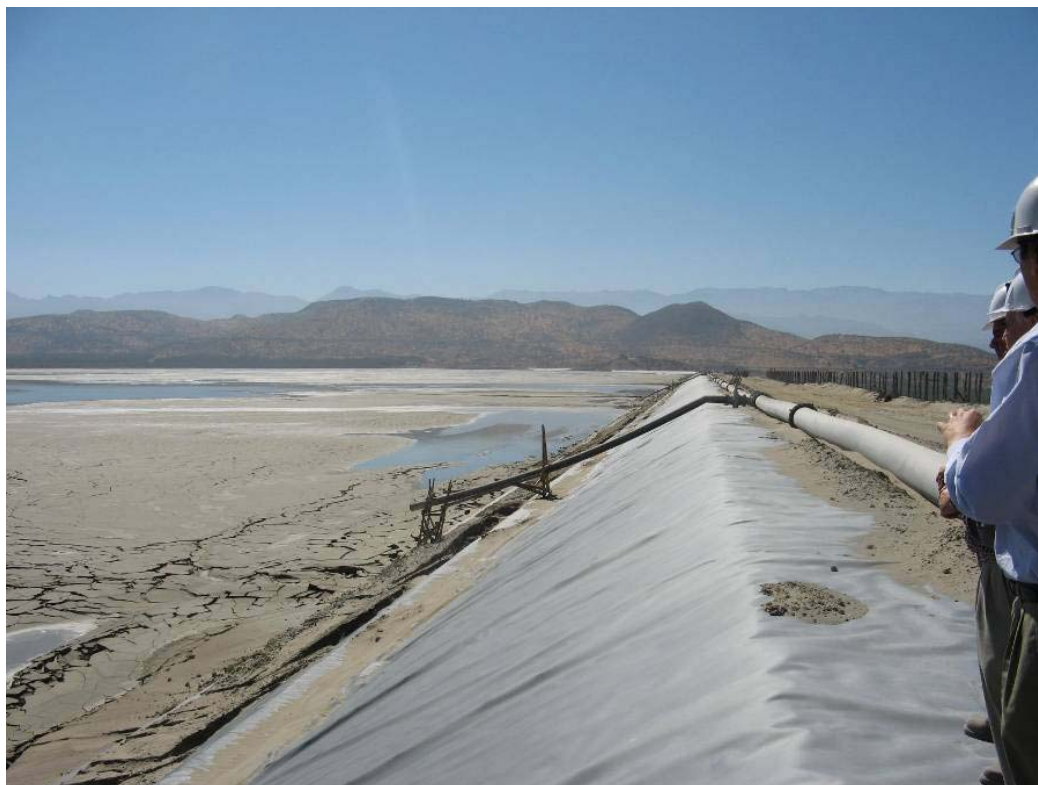
Figure 11.10. March 9, 2010 View along the Upstream Face of the Ovejeria Tailings Dam. There is no damage to the liner and no signs of slumping of the sand beneath the liner
(S33.052911°, W70.807067°)

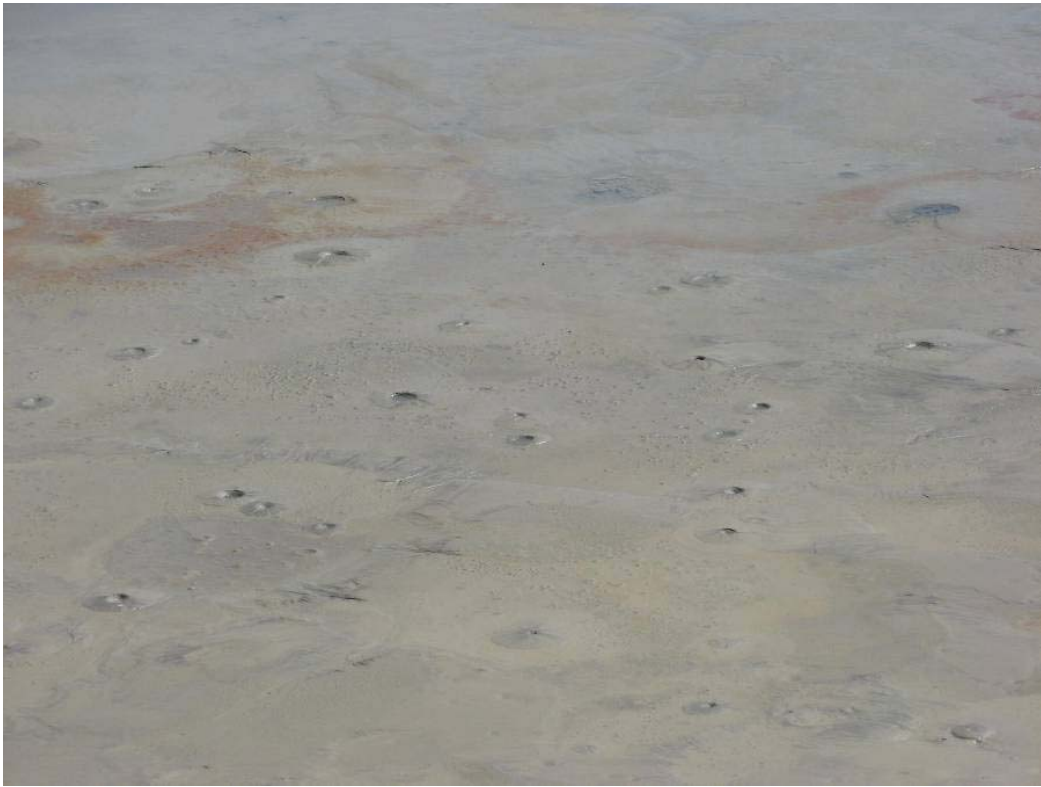
Figure 11.11. March 9, 2010 Sand Boils in Tailings about 10 m Upstream of Ovejeria Tailings Dam (S33.052016°, W70.798687°)

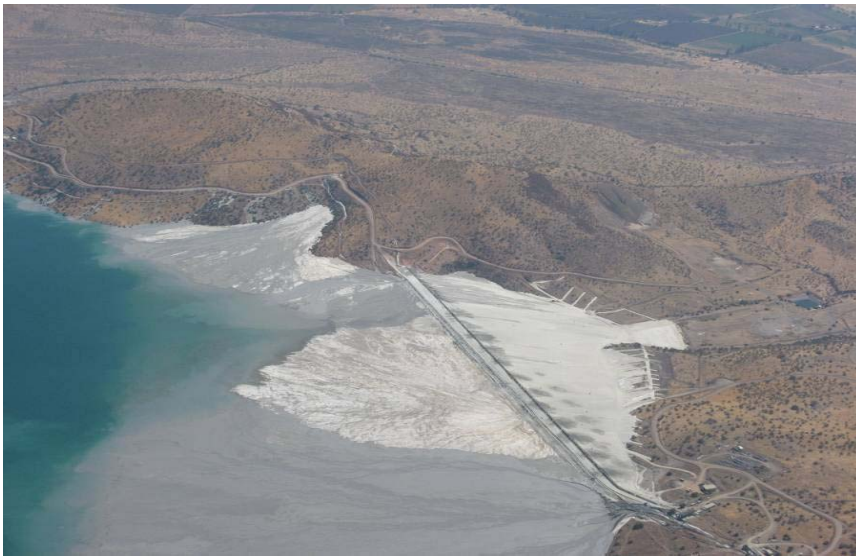
Figure 11.13. March 10, 2010 View of Tortolas Tailings Dam from Helicopter (S33.115406°, W70.733297°)

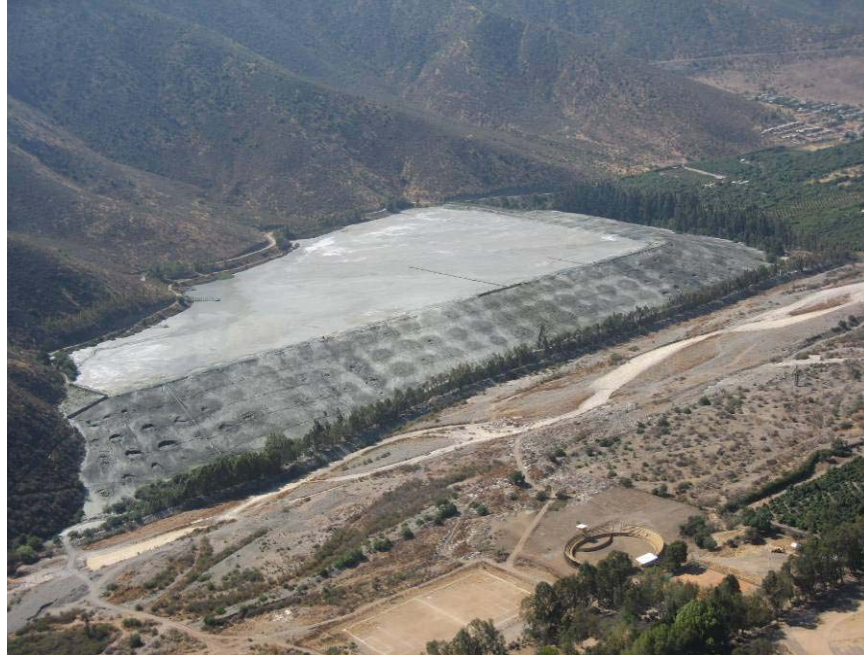
Figure 11.15. March 10, 2010 View of Cabildo Tailings Dam from Helicopter (S32.427724°, W71.077282°)

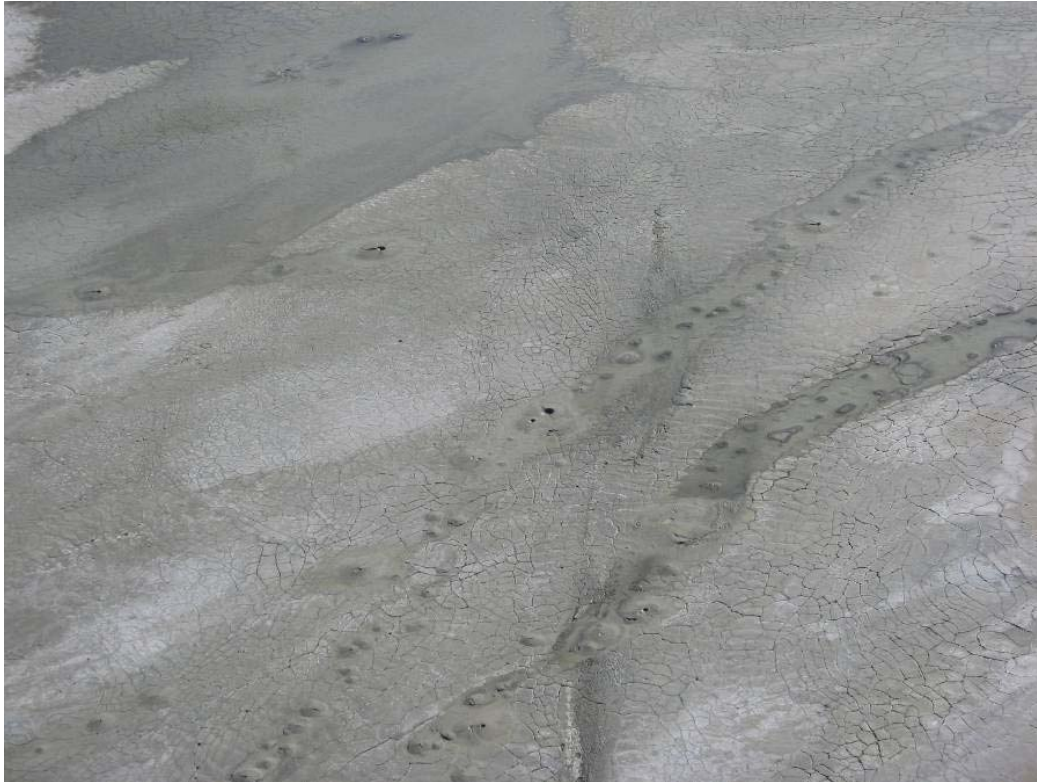
Figure 11.17. March 10, 2010 Sand Boils in Tailings Upstream of Caren Dam (S34.111476°, W71.141992°)

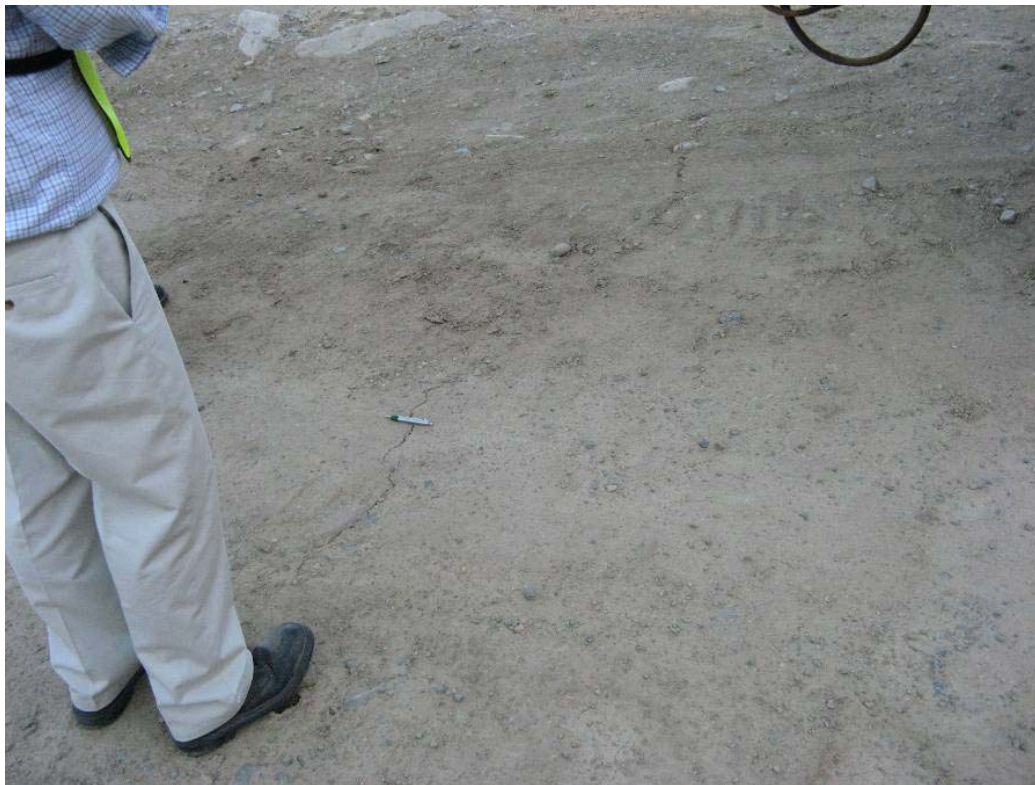
Figure 11.19. March 10, 2010 Millimeter Width Transverse Crack Near the Left Abutment of Caren Tailings Dam (S34.096050°, W71.180748°)

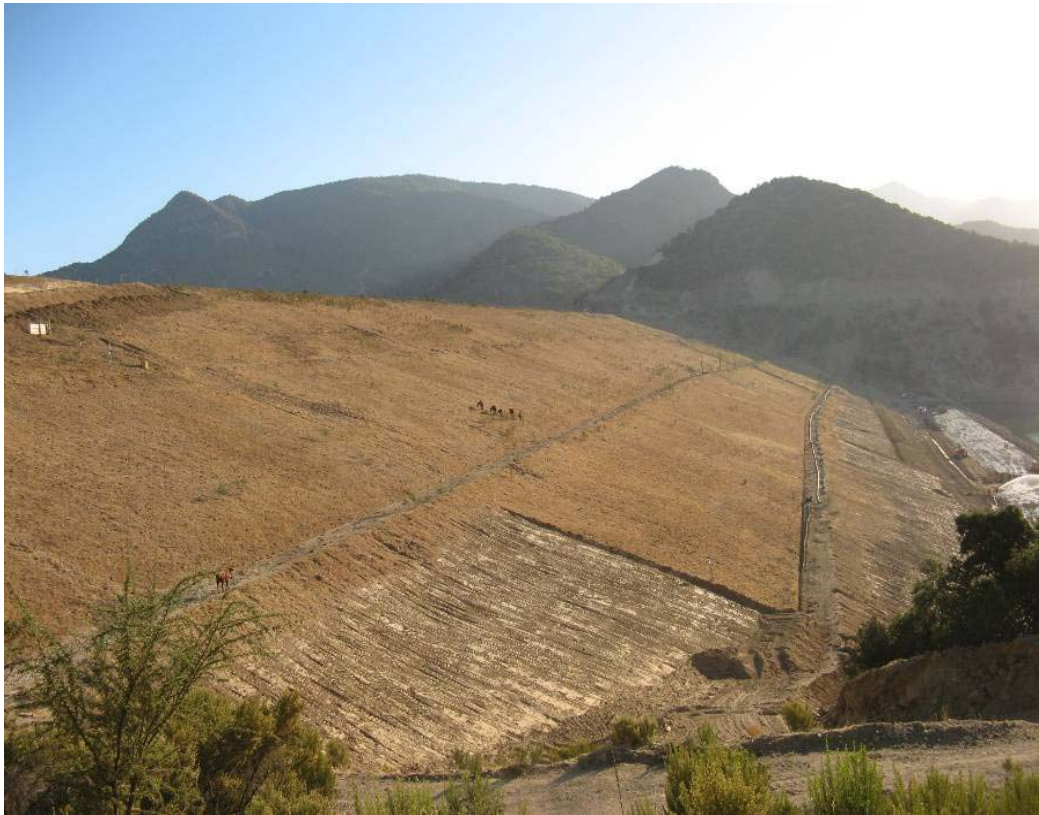
Figure 11.20. March 10, 2010 View of the Downstream Face of the Caren Tailings Dam Showing Progress of Dam Raise Construction (S34.092422°, W71.173250°)

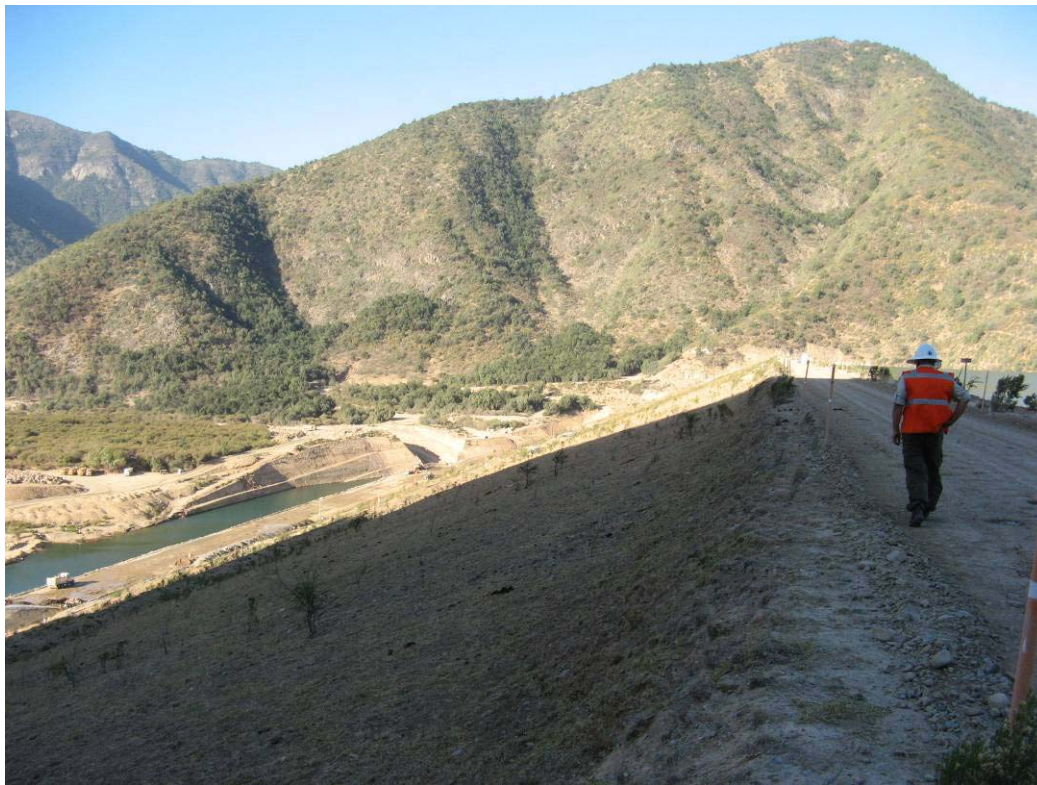
Figure 11.21. March 10, 2010 Crest and Downstream Face of Caren Dam from Left Abutment (S34.095570°, W71.179076°)

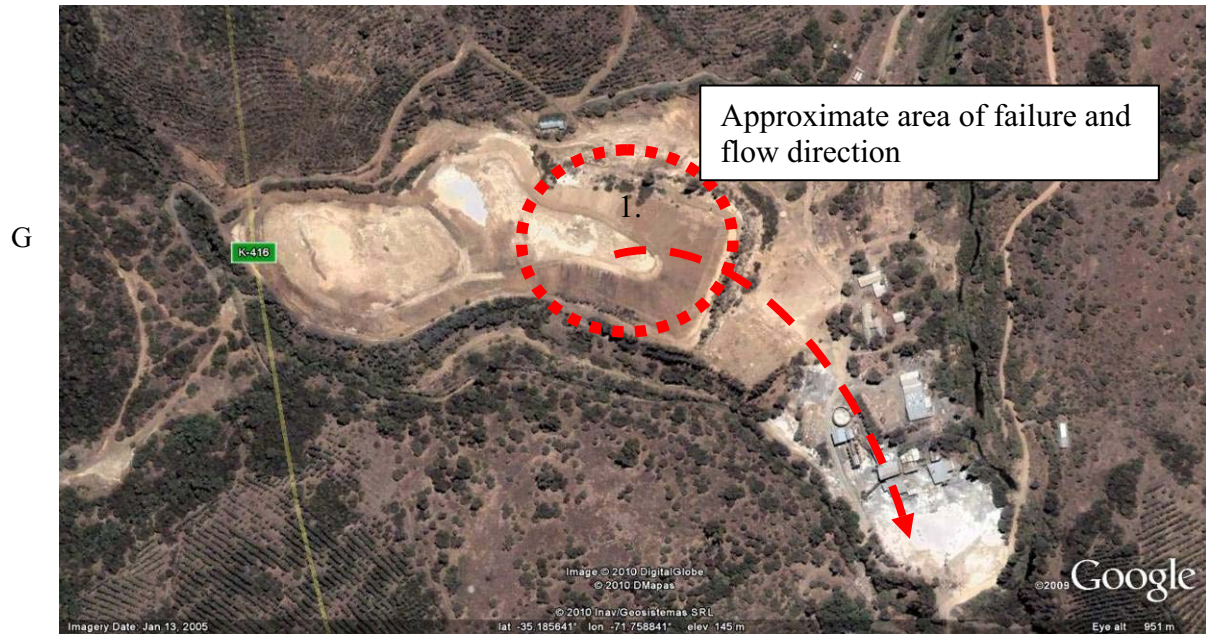
Figure 11.22. Google Earth Image Tailings Impoundment Pre-Failure (35.184679° S, 71.759410° W)

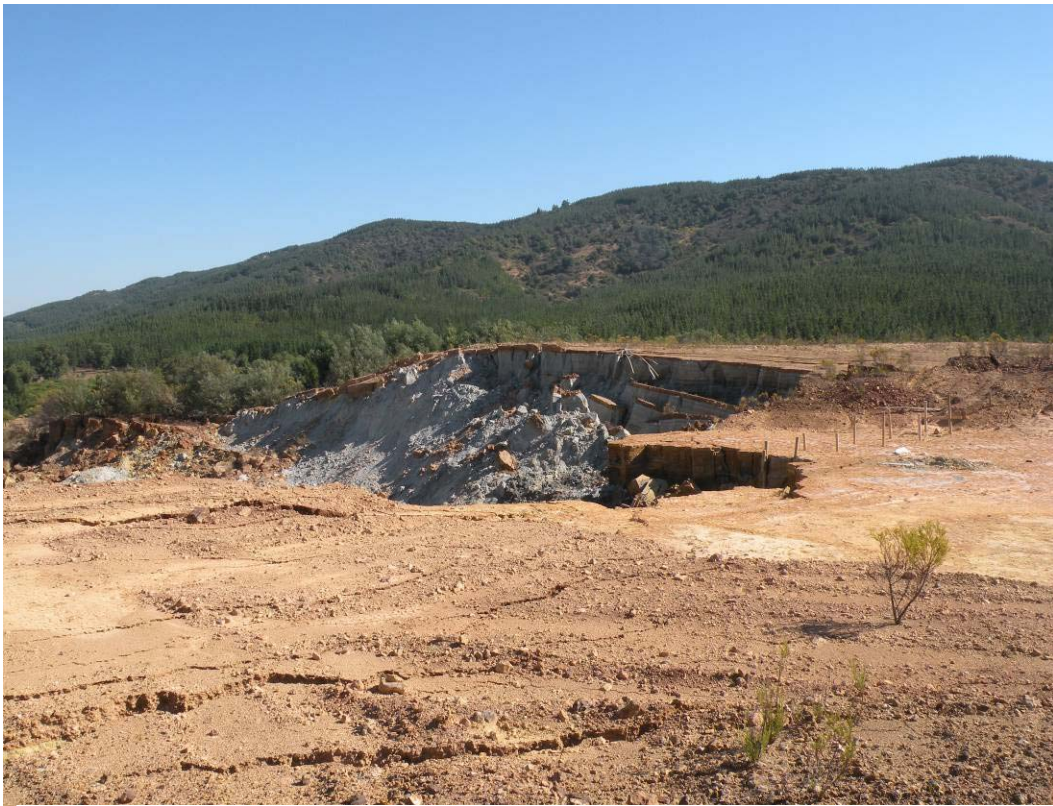
Figure 11.23. March 11, 2010. Upper Scarp of Failed Tailings Impoundment Looking Southwest (35.184679° S, 71.759410° W)

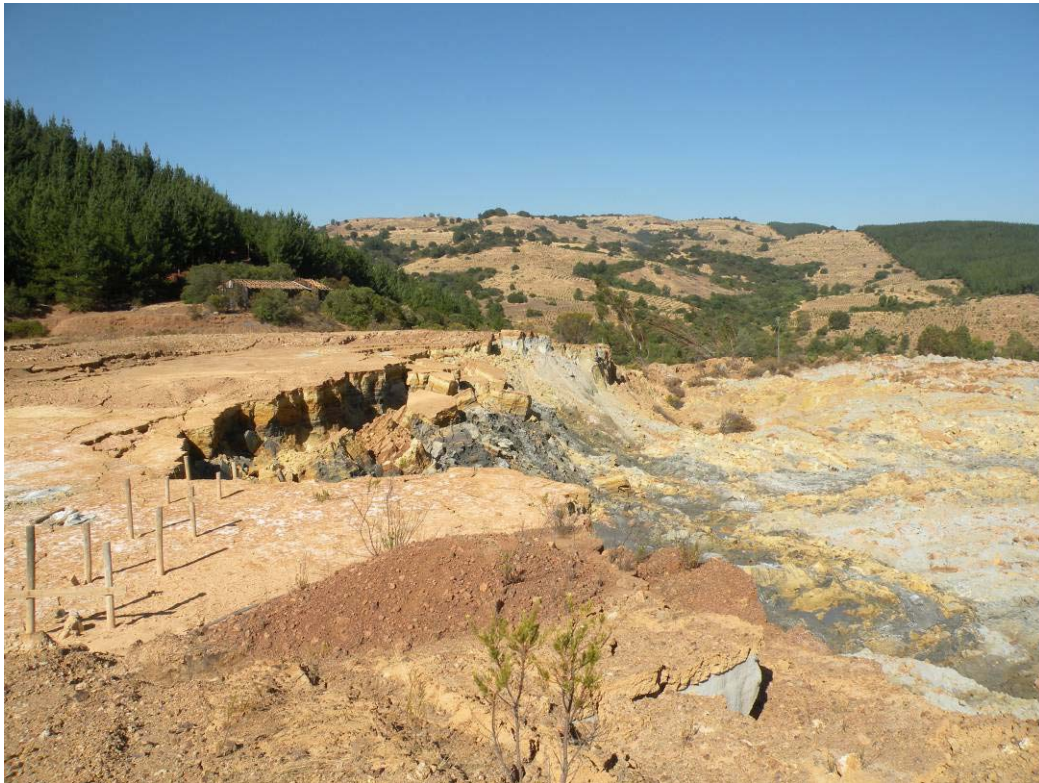
Figure 11.24. Upper Scarp of Failed Tailings Impoundment Looking Northeast (35.184679° S, 71.759410° W)

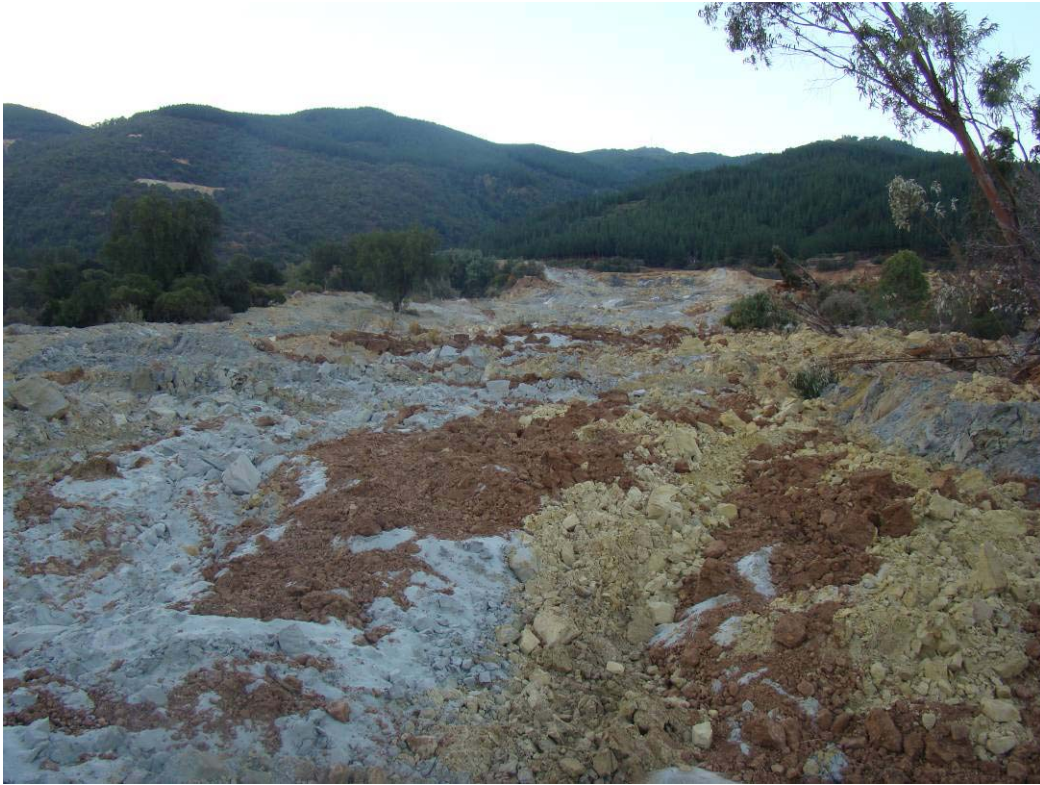
Figure 11.25. March 11, 2010. View Along Flowpath of Tailings
(35.18468° S, 71.759410° W)

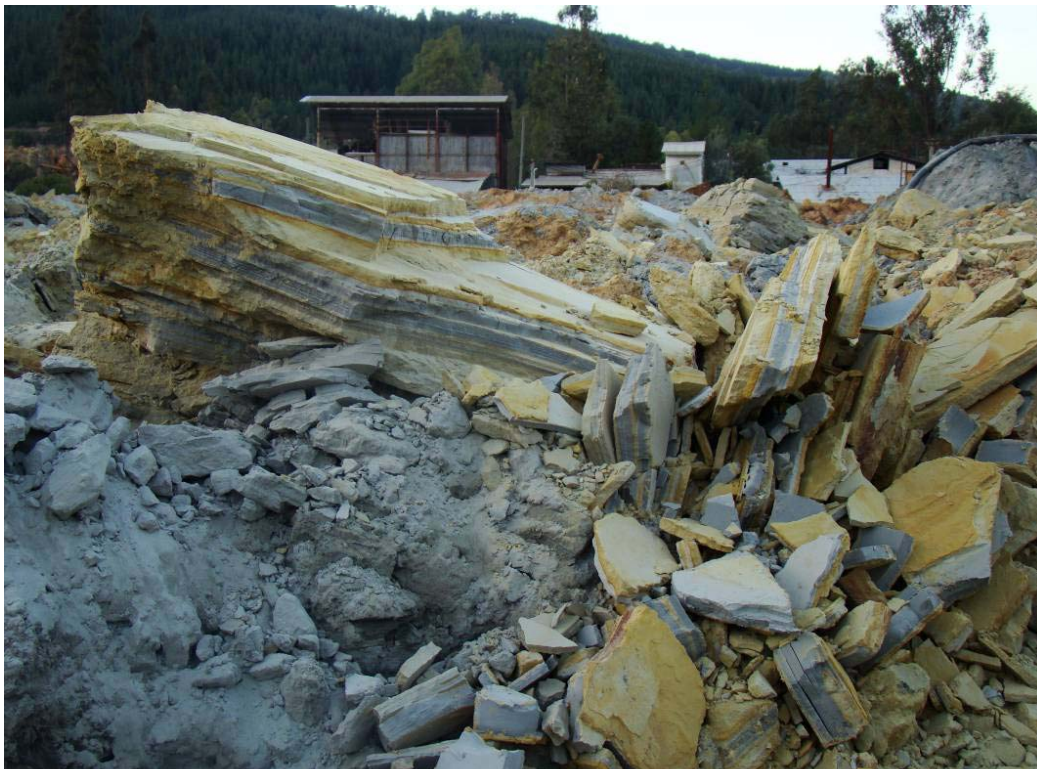
Figure 11.30. March 11, 2010. Variably Oxidized Tailings – Unsaturated Conditions in Upper Portion of Tailings Impoundment (S35.18728°, W71.75781°)

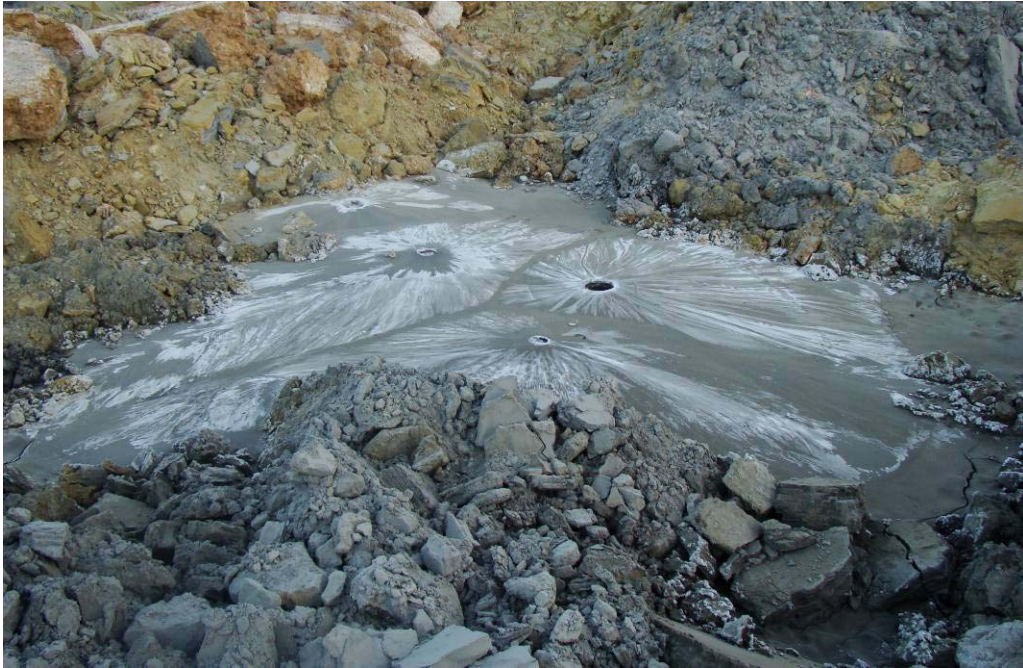
Figure 11.31. March 11, 2010. Sand Boil in Tailings (S35.18872°, W71.75764°)

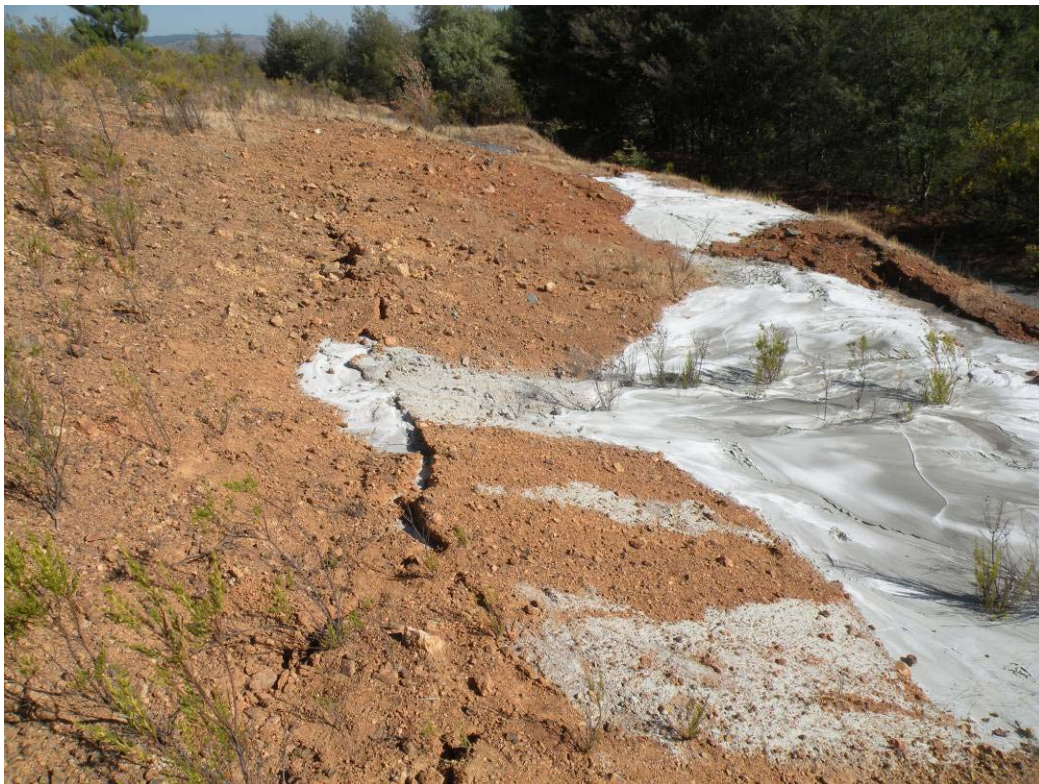
Figure 11.34. March 11, 2010. Ejecta of Tailings from Cracks Indicating Liquefaction of Tailings ($S35.183986^{\circ}$, $W71.761844^{\circ}$)

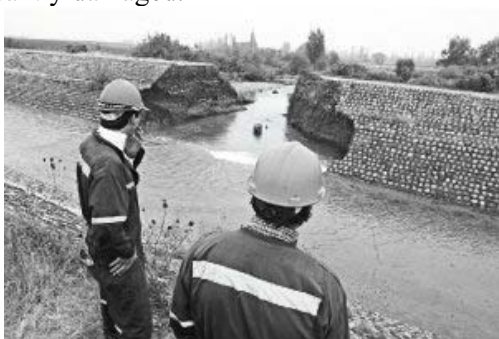
Figure 11.35. Earthen levee breach west of Colbun ($S35.698672^\circ$, $W71.487294^\circ$; photograph taken by Mr. Juan Carlos Romo of the El Mercurio on March 12, 2010; <http://diario.elmercurio.cl>).

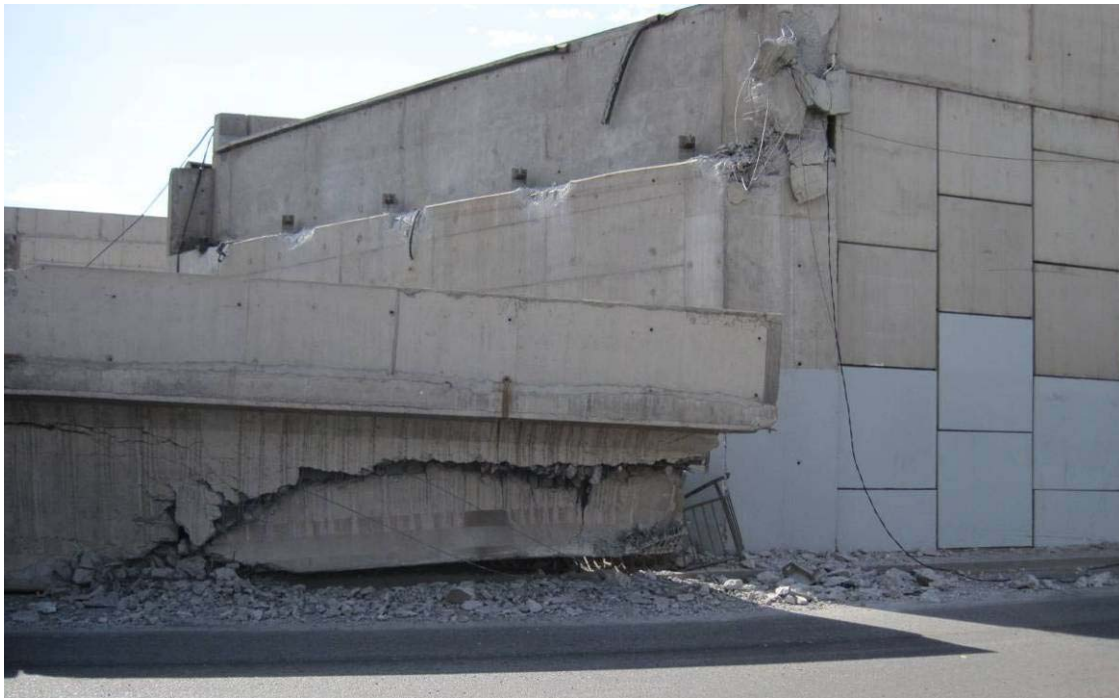
Figure 12.1. Intersection of Americo Vespucio Norte and Independencia. Abutment of a collapsed bridge.
(33°21'57.83"S, 70°41'17.71"W)

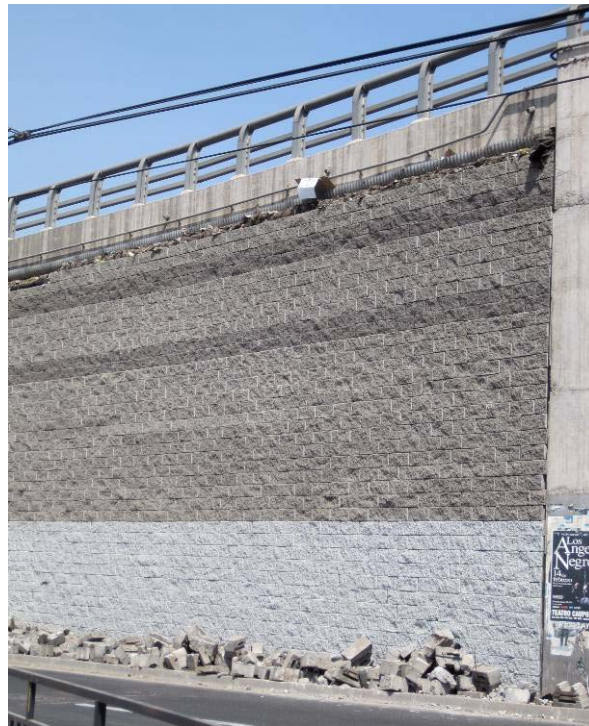
Figure 12.3. Block faced mechanically stabilized embankment, Intersection of Americo Vespucio Norte and Lo Echevers. (33°22'34.54"S, 70°44'52.83"W)

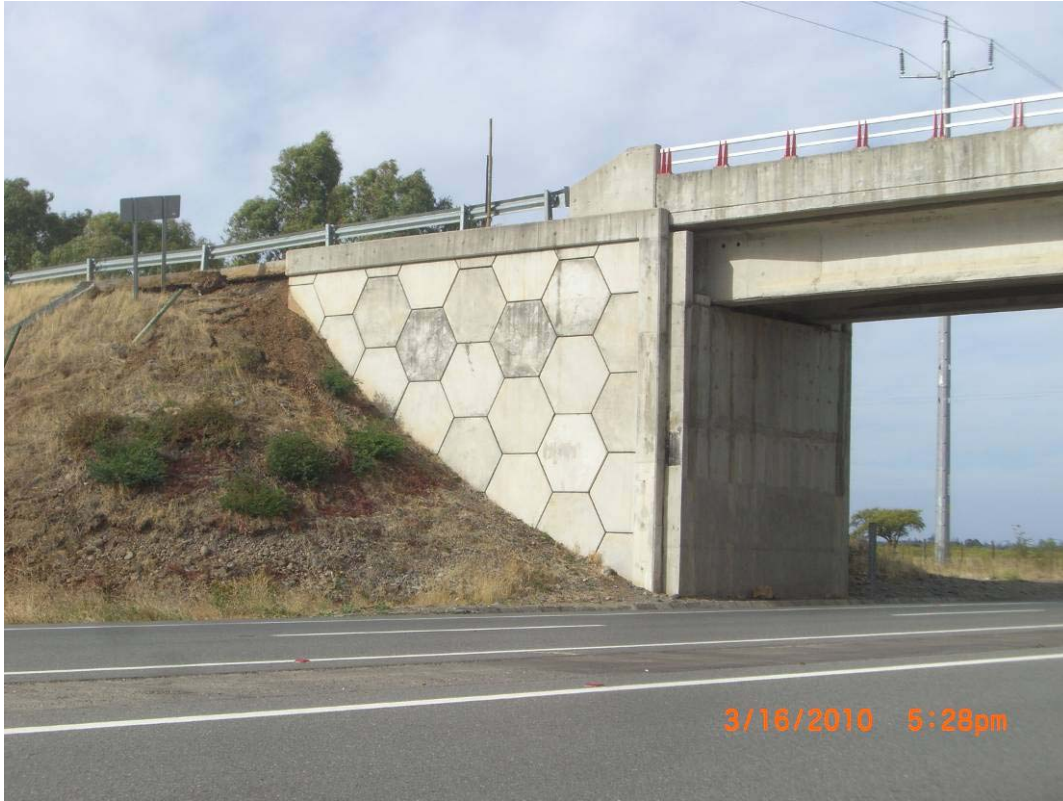
Figure 12.4 Undamaged MSE wingwall on overpass structure over highway 152 west of Chillan despite sliding of adjacent fill slope (S36.6588, W72.2776).

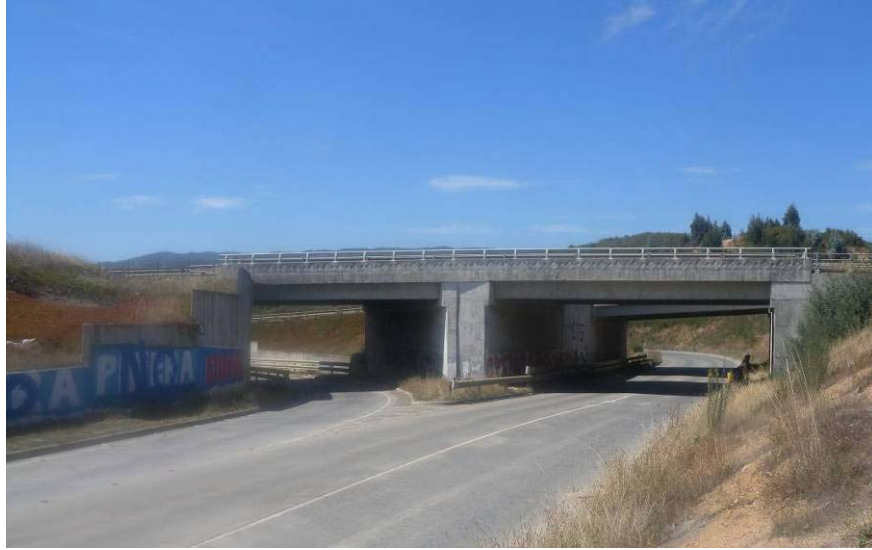
Figure 12.5. Multiple retaining structures for highway overpass structures south end of Coronel (37.0455°S, 73.1421°W)

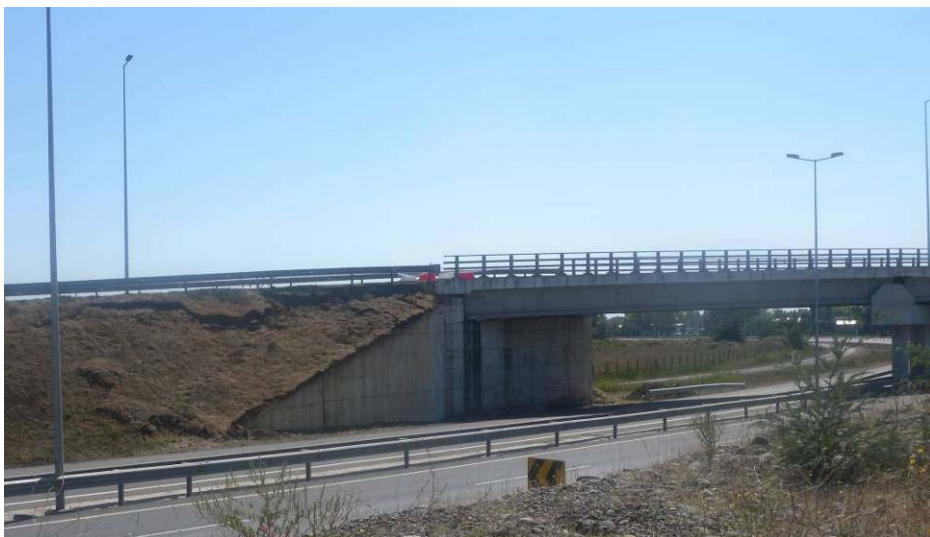
Figure 12.6. Surficial sloughing on a bridge approach embankment, with the abutment showing no evidence of damage, Route 5, north of Chillan.

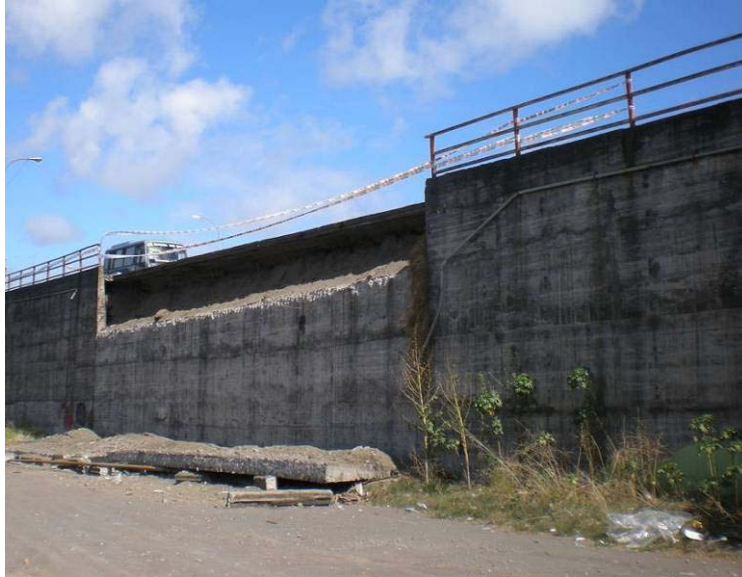
Figure 12.7. Failed reinforced concrete retaining structure in San Pedro.

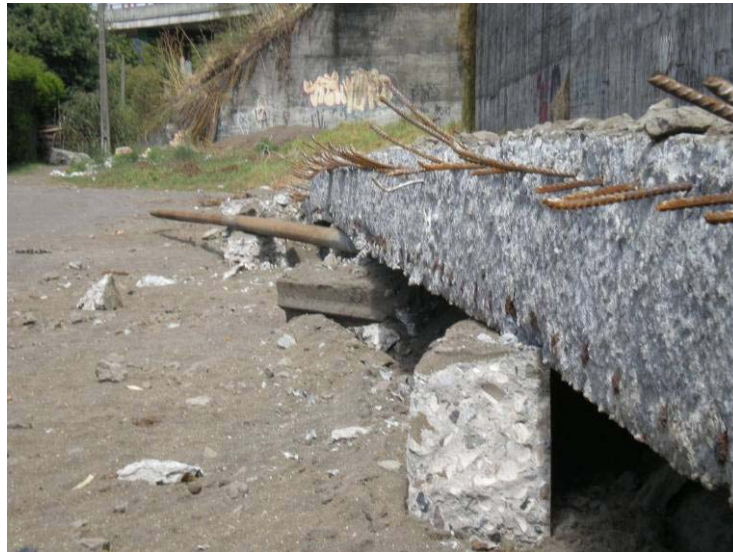
Figure 12.8. Toppled portion of 16-inch thick wall showing bent compression bars and snapped tension bars.

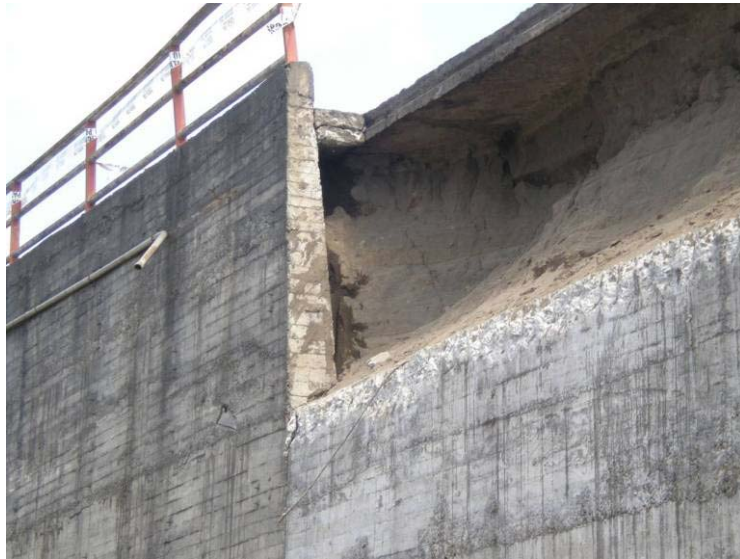
Figure 12.9. Granular fill soils and water seepage evident behind failed portion of wall.

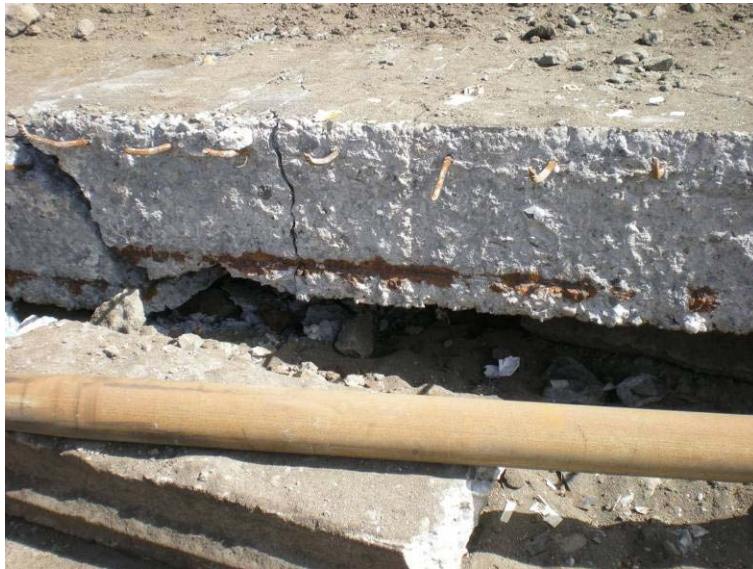
Figure 12.10. Corrosion of horizontal reinforcing steel where water entered the joint.

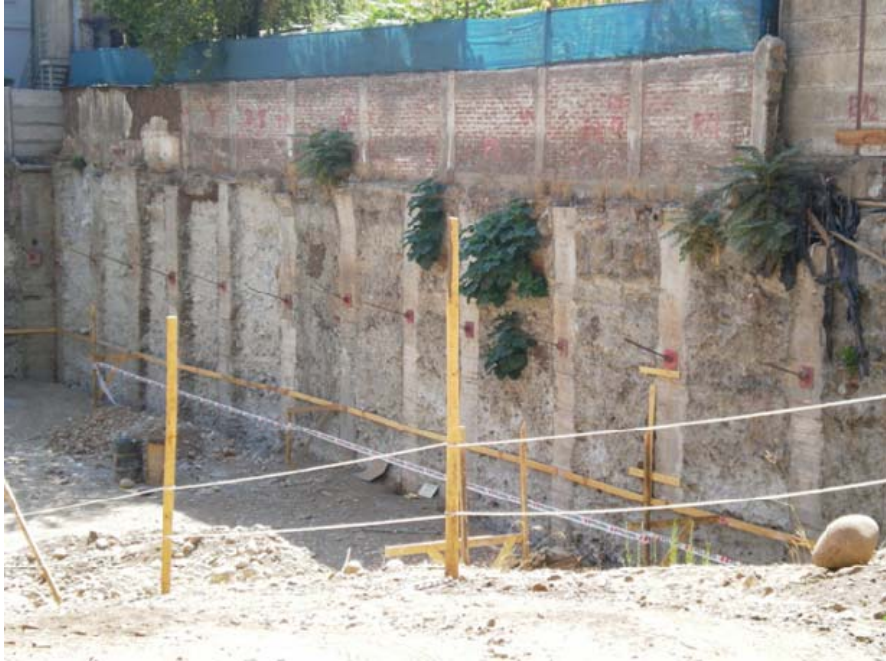
Figure 12.11. Undamaged temporary retaining structure in Santiago.

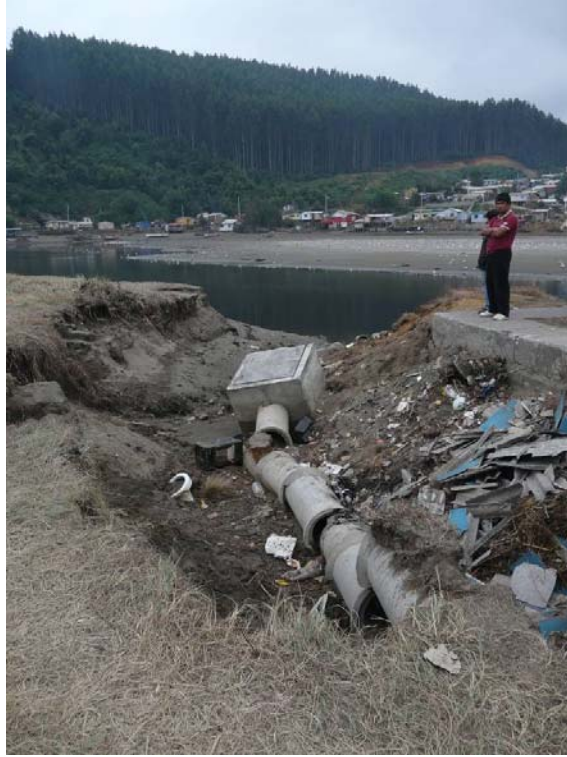
Figure 13.1. Tsunami scoured out the foundation of this storm sewer outfall at Laraquete (S37.165352° W73.188051, 1907 hrs on 03/16/2010).

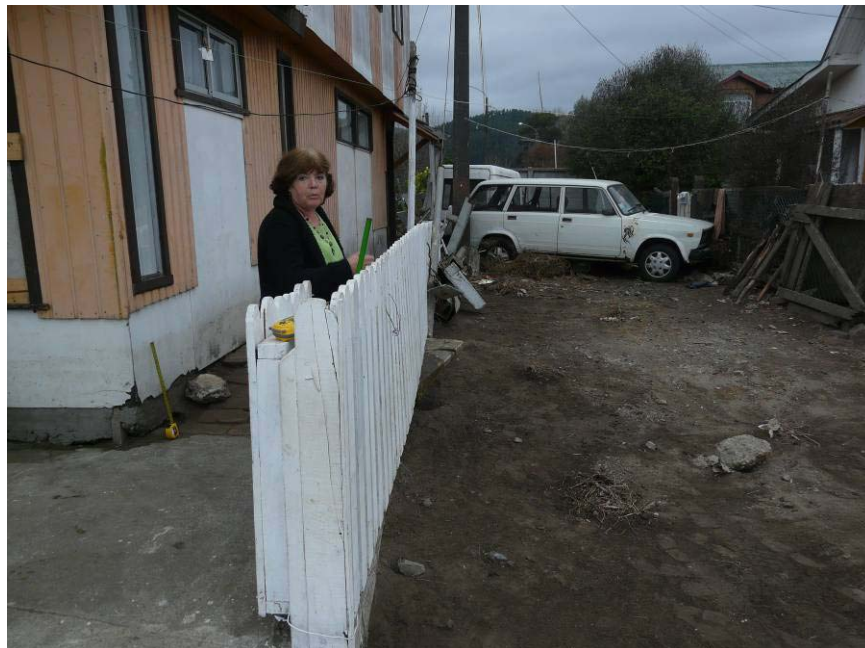
Figure 13.2. Beach-front homes in Laraquete were inundated by the tsunami. At this woman's home, tsunami flow depths reached at least 0.55 m, which transported the white car from the street to the backyard. The tape measure left of the woman indicates the flow depth measured from a water stain on the building (S37.165650° W73.188136, 1915 hrs on 03/16/2010).
