GEO-ENGINEERING EXTREME EVENTS RECONNAISSANCE (GEER) ASSOCIATION

Turning Disaster in Knowledge

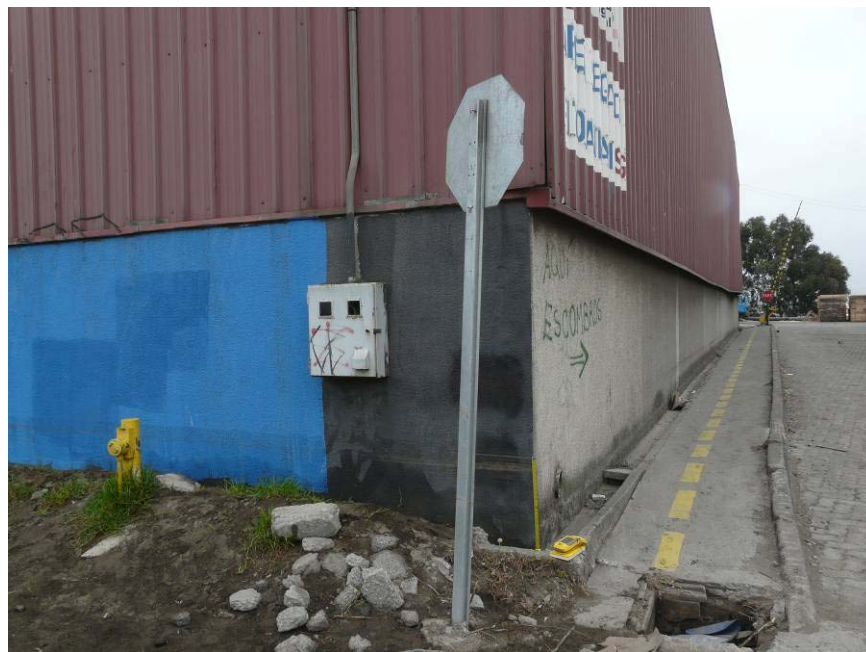
Figure 13.3. Tsunami flow depths reached a minimum of 0.65 m at this waterfront warehouse in Talcahuano along Perez Gacitua Street (S36.728263° W73.109199°, 1136 hrs on 03/16/2010).

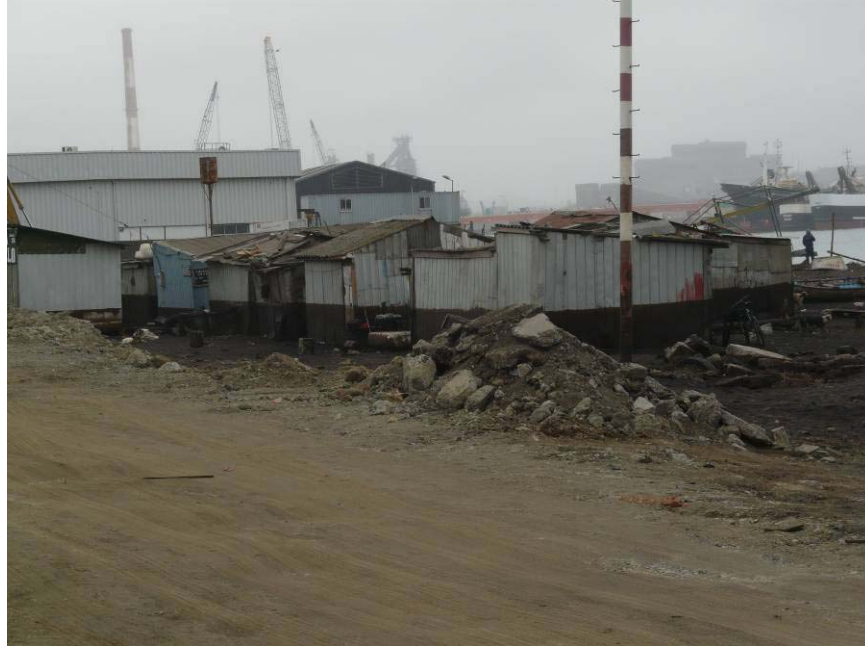
Figure 13.6. One-meter high dark stains on buildings at Talcahuano port facilities along Bahia San Vicente mark the elevation of the tsunami. Major damage of port facilities, including a fish processing plant were caused by a combination of factors, including modest tsunami inundation in areas that dropped vertically due to liquefaction-induced lateral spreading (S36.727076° W73.128058°, 1258 hrs on 03/16/2010).

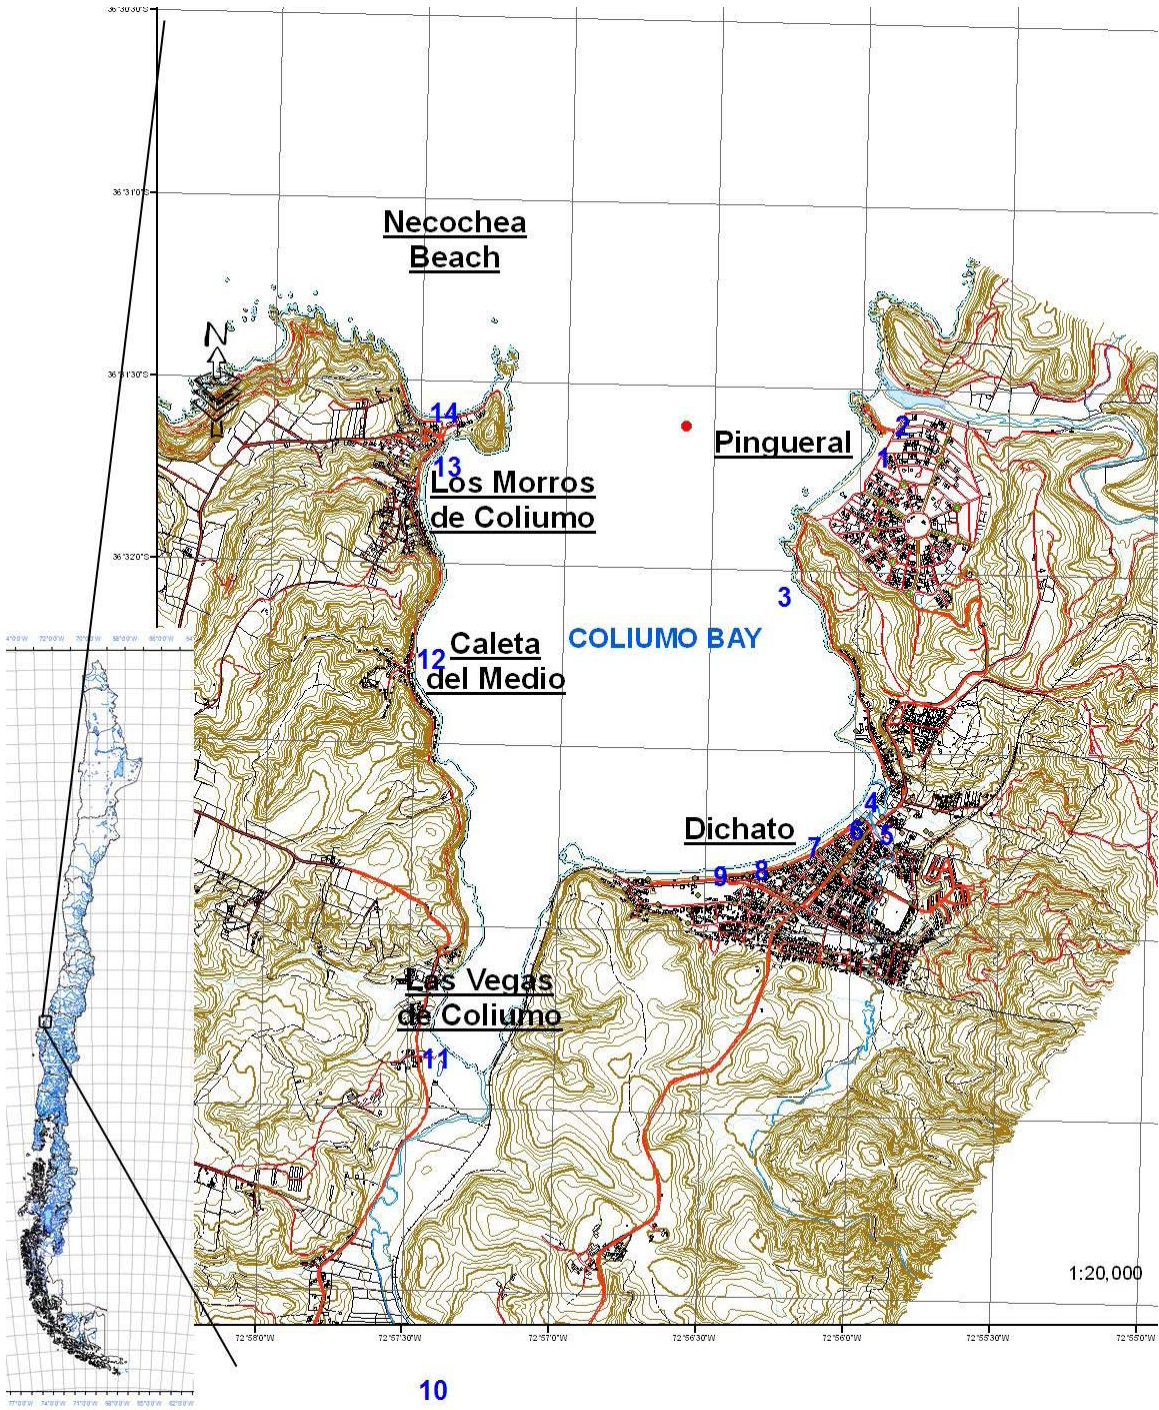
Although the motion of the water was primarily north-south, fishermen on the west side of the bay observed east-west surges during the morning of the 27th February. Large waves that struck the west side of the bay seemed to have been reflected off the eastern shore. Pre and post event image pairs showing tsunami damage are given in Figures 13.12 and 13.13.

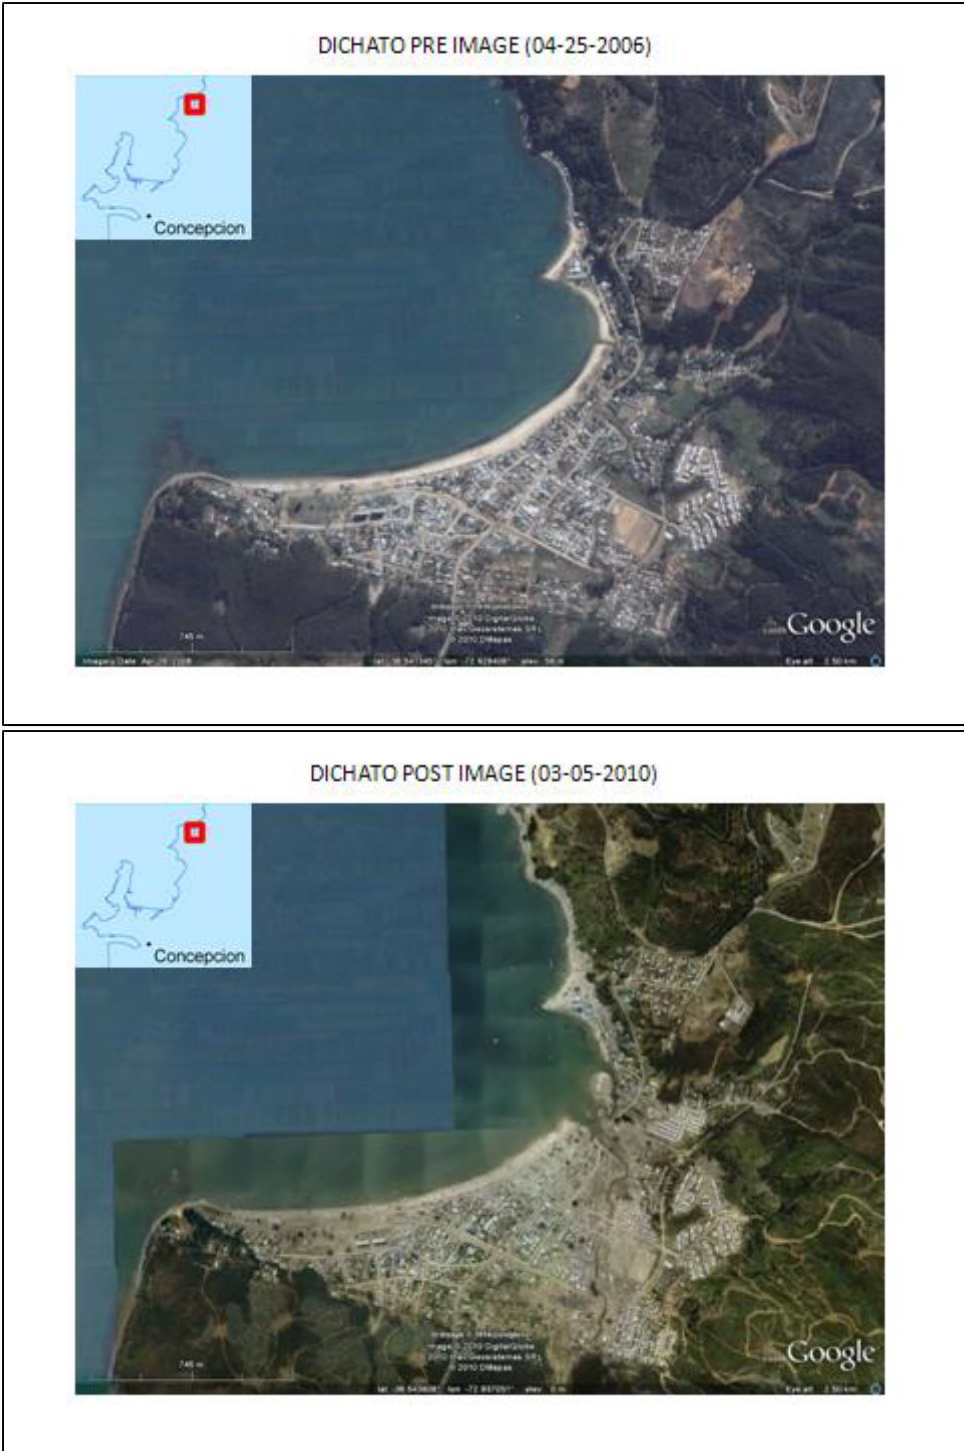
Figure 13.12 Pre/Post Imagery of Dichato (S36.546°, W72.933°)

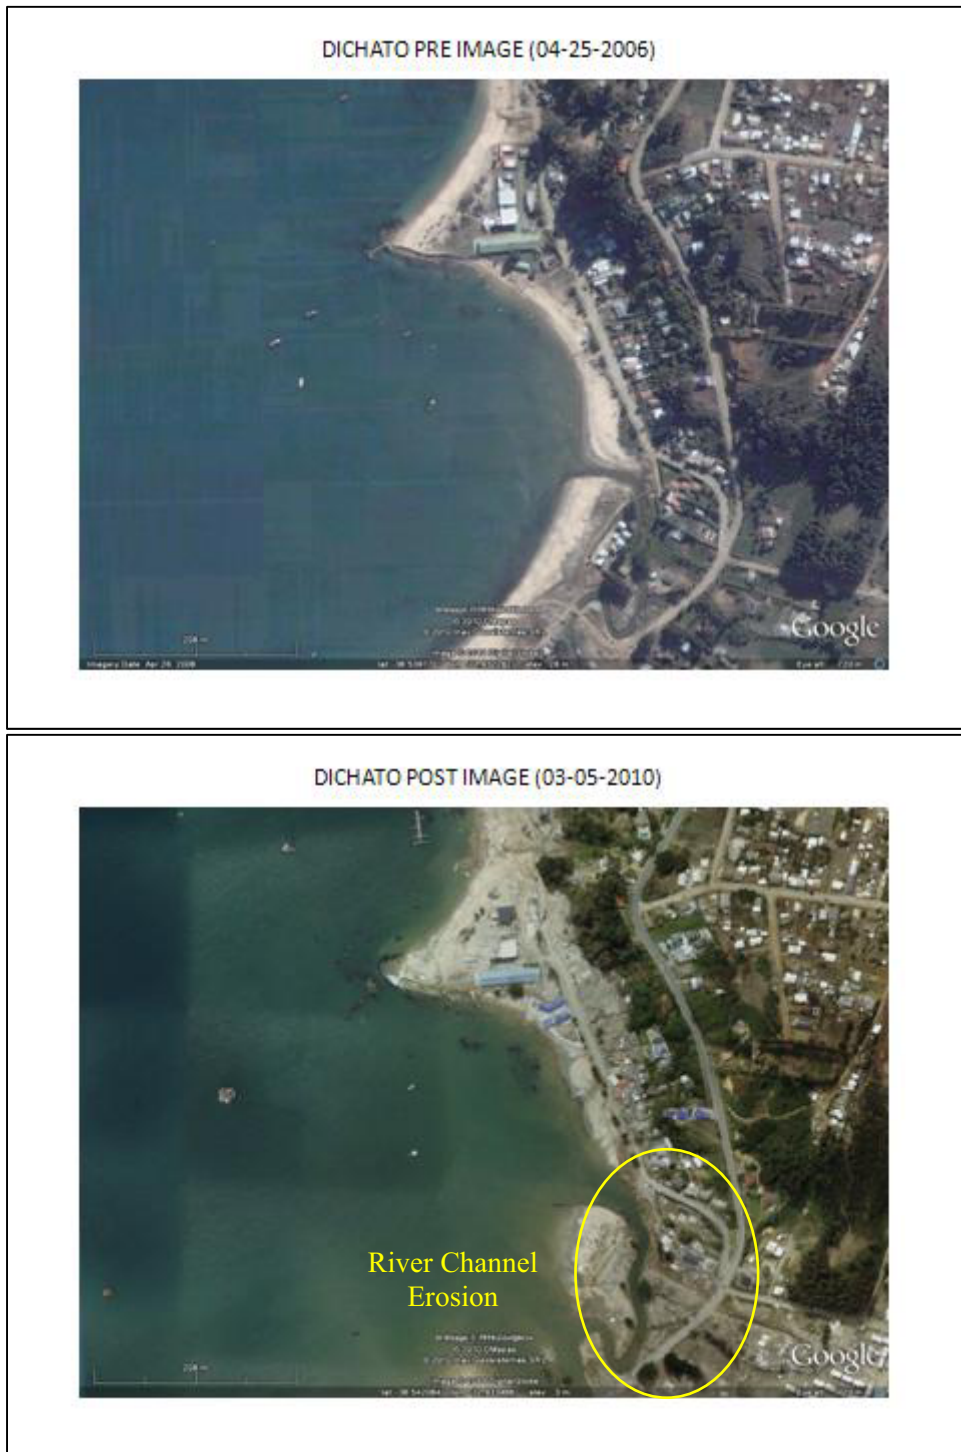
Figure 13.17 Pre/Post Imagery of Dichato (S36.541°, W72.933°)

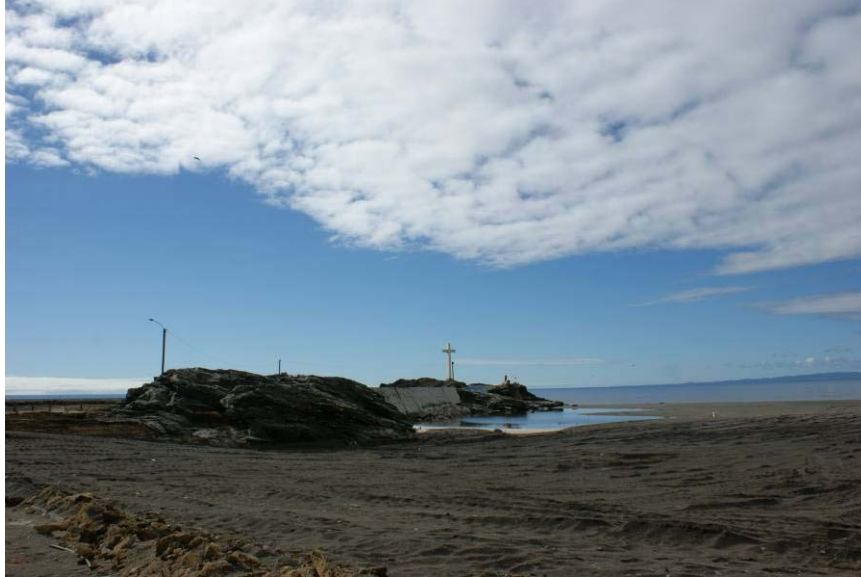
Figure 13.20. Roca San Pedro, a prominent landmark in Curanipe, was almost entirely submerged by the tsunami says one local resident. Only the cross remained above the water (S35.8436°, W72.6390°, 03/17/2010).

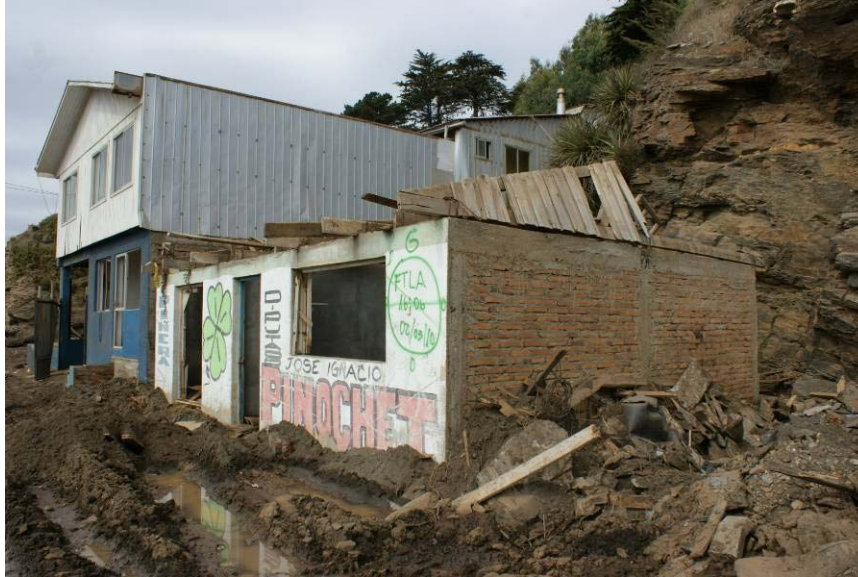
Figure 13.22. The blue and white two-story house in the beach community of El Torreon was heavily damaged by the tsunami and all but the walls of the adjacent vacation house was destroyed. The tsunami arrived at 4:05 am, about 30 minutes after the earthquake, and the water remained high for four hours when it started to retreat around 8 am (S35.8215°, W72.5990°, 03/17/2010).

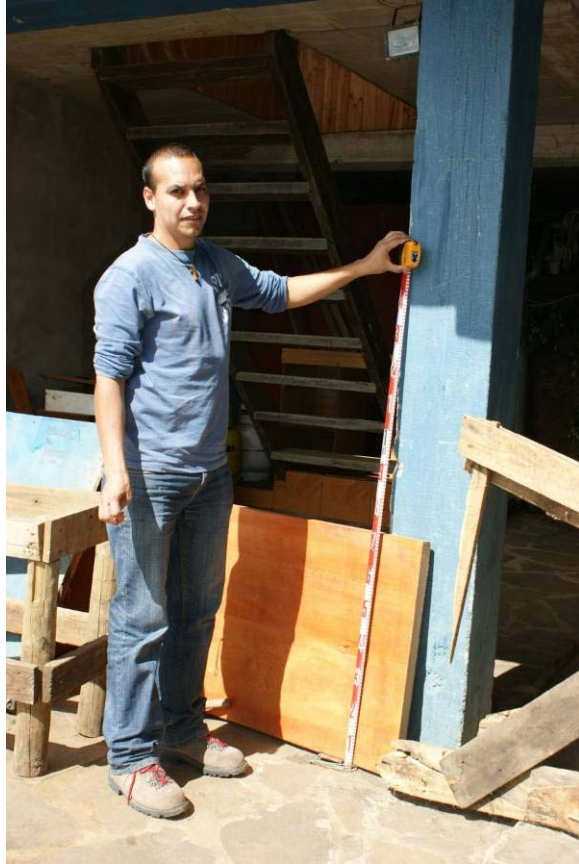
Figure 13.23. On this post inside the first floor of a beach front house in El Torreon, a small community south of Pelluhue, visible lines mark the water height 1.6 m above the ground providing a minimum estimate of the tsunami flow depth at this location (S35.8214°, W72.8215°, ~1556 hrs on 03/17/2010).

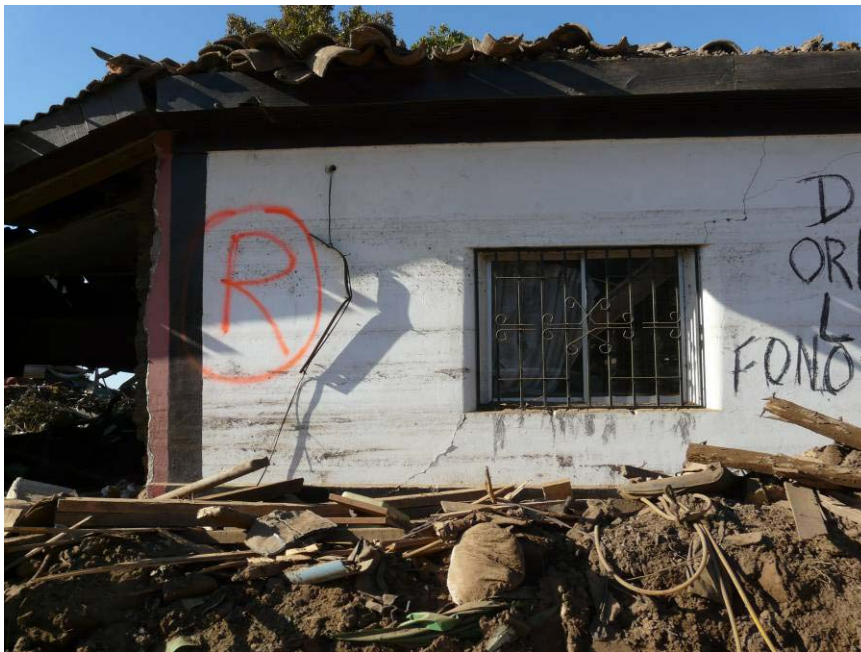
Figure 13.25. Watermarks on damaged buildings in Constitución indicate tsunami flow depths reached at least 2 m along the waterfront on Calle Blanco (S35.336 W72.403, 1757 hrs on 03/15/2010).

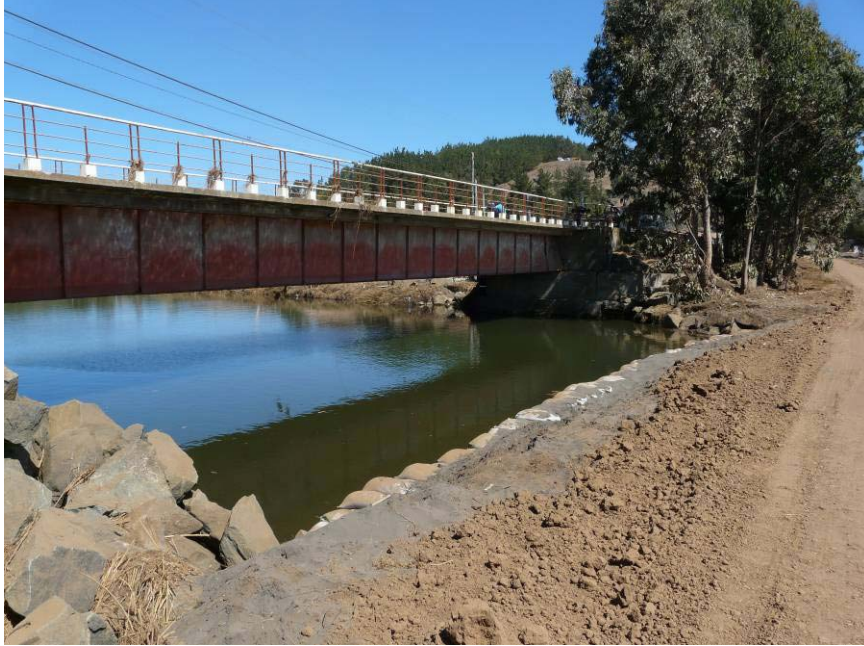
Figure 13.26. Debris clinging to the railing of this damaged bridge in Pichibudi suggests minimum tsunami flow depths reached 5.15 m. Local residents reported flow depths of 6.65 m above the creek. Anecdotal accounts suggest the tsunami moved a bus 80 m up the creek valley. Tsunami damage along coast becomes heavier toward the south of this site in Iloca (S34.880055° W72.155819°, 1515 hrs on 03/15/2010).

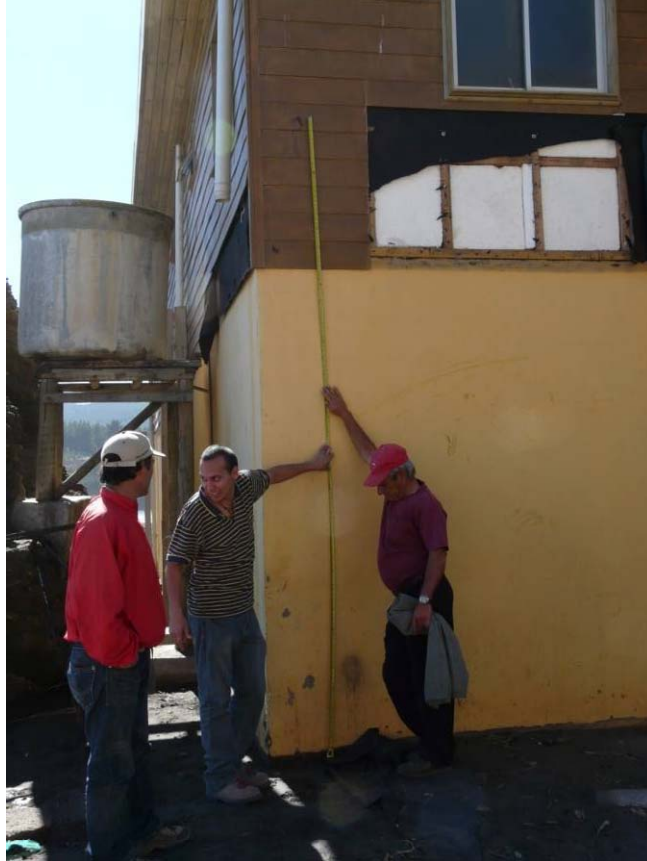
Figure 13.27. Damaged siding on this building suggests tsunami flow depths reached at least 3.5 m at the west end of Bucalemu (S34.640097° W72.044194°, 1130 hrs on 03/15/2010).

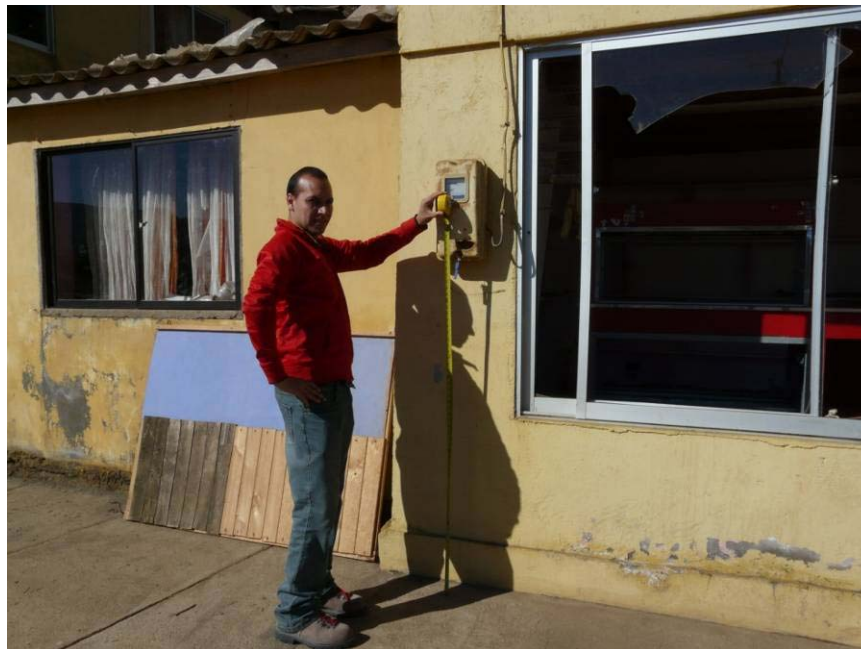
Figure 13.28. Tsunami flow depths reached a minimum of 1.5 m along the waterfront in Bucalemu (S34.641882° W72.043158°, 1051 hrs on 03/15/2010).

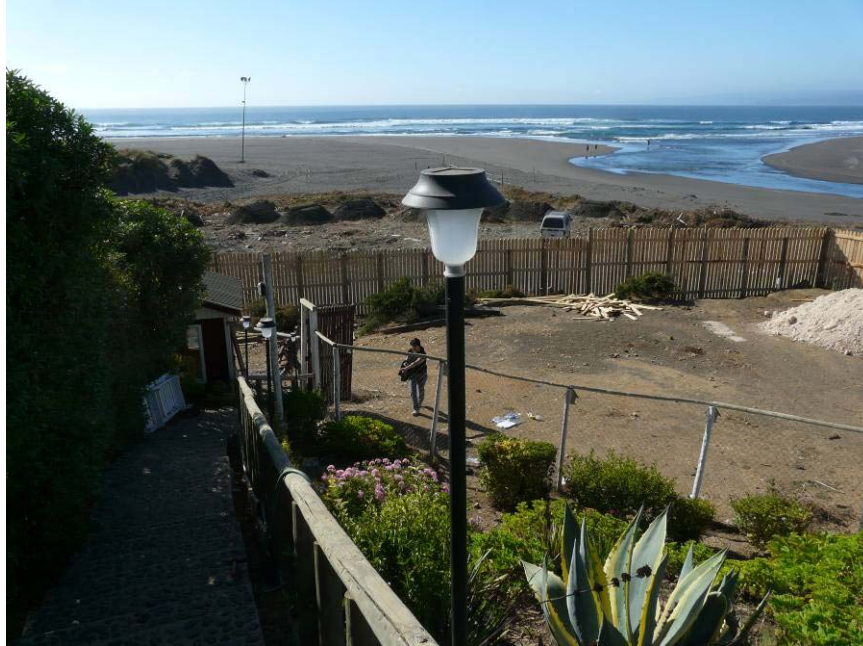
Figure 13.33. Below Cabanas Gusman-Lyon, a local lodging along the water front in Pichimelu, tsunami flow depths reached about 1.5 m, destroyed a wooden fence (in this photo the fence has been replaced by a new one) and washed away cars in the parking area (S34.384288° W72.003774°, 1711 hrs on 03/14/2010).

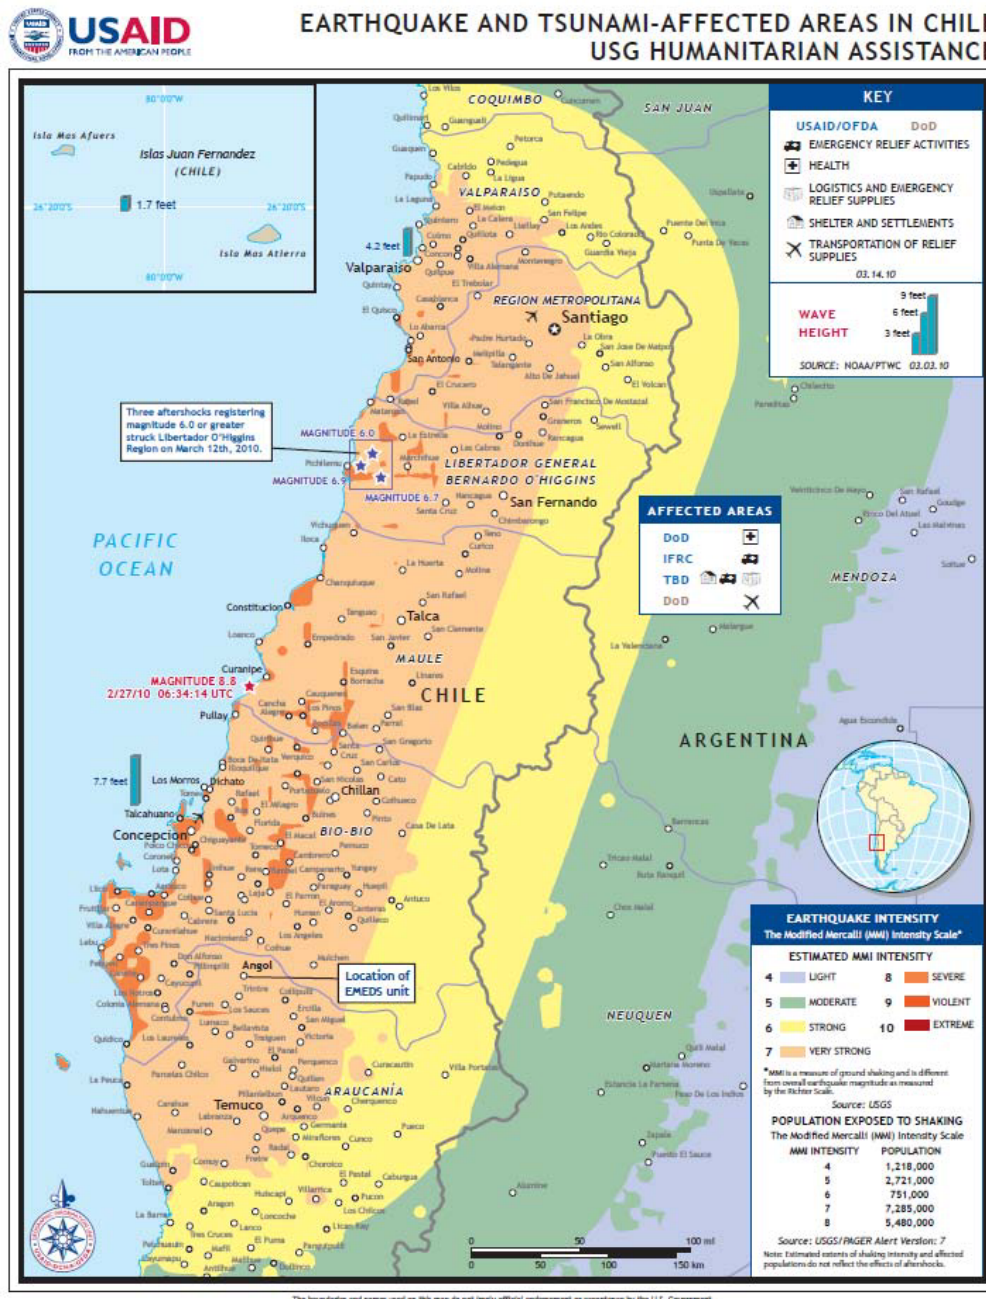
Figure 14.1. Extent of Earthquake and Tsunami Affected Area in Chile
(Source: U.S. AID, March 14, 2010)

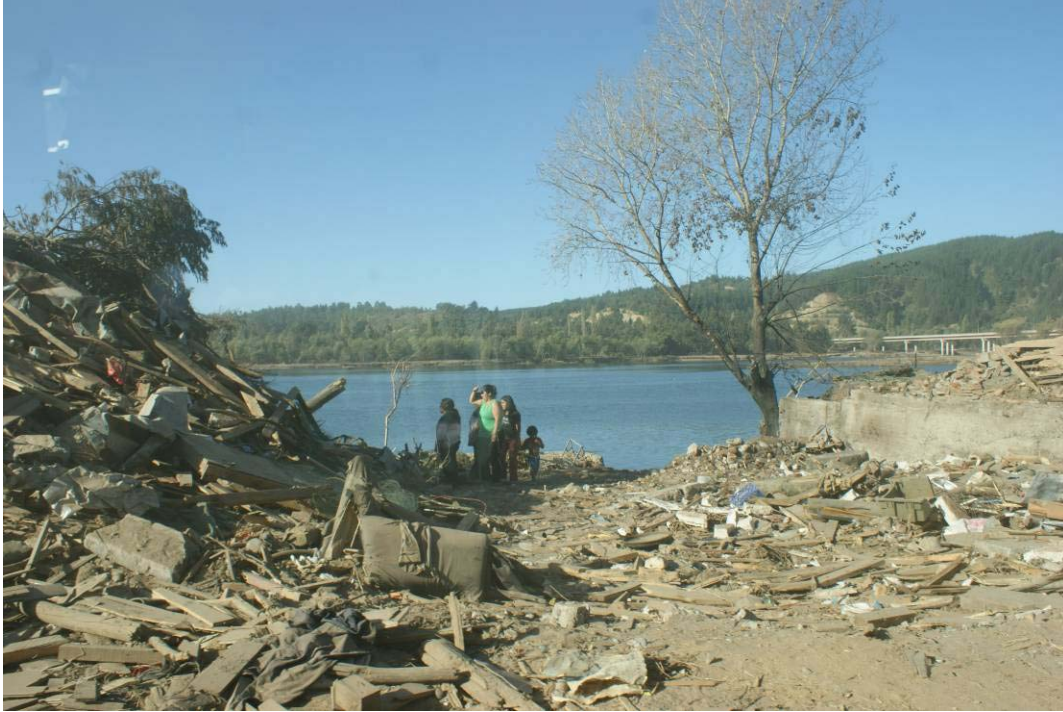
Figure 14.2. Constitucion. Debris removal and road clearing still underway in the tsunami inundation zone along the Maule River. (S35.340323°, W72.396772°; 16:54 hours on 3/15/2010).

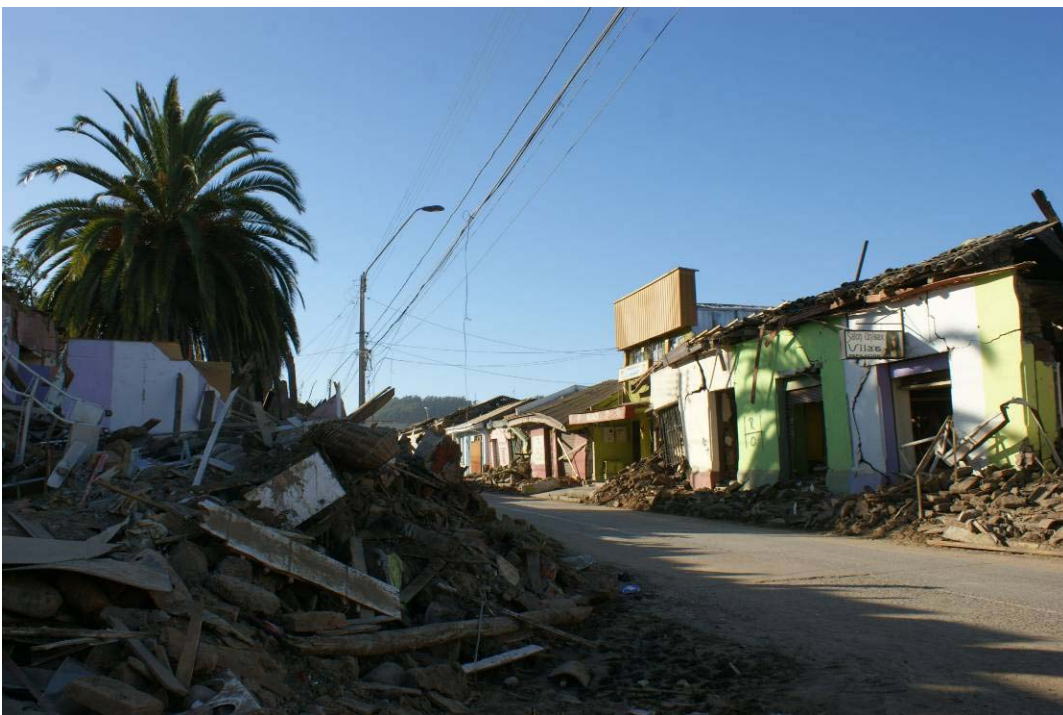
Figure 14.3. Constitucion. Tsunami damage merges with shaking related damage in the older section of the city center with its many adobe and unreinforced masonry buildings. (S35.335383°, W72.410055°; 17:25 hours on 3/15/2010).

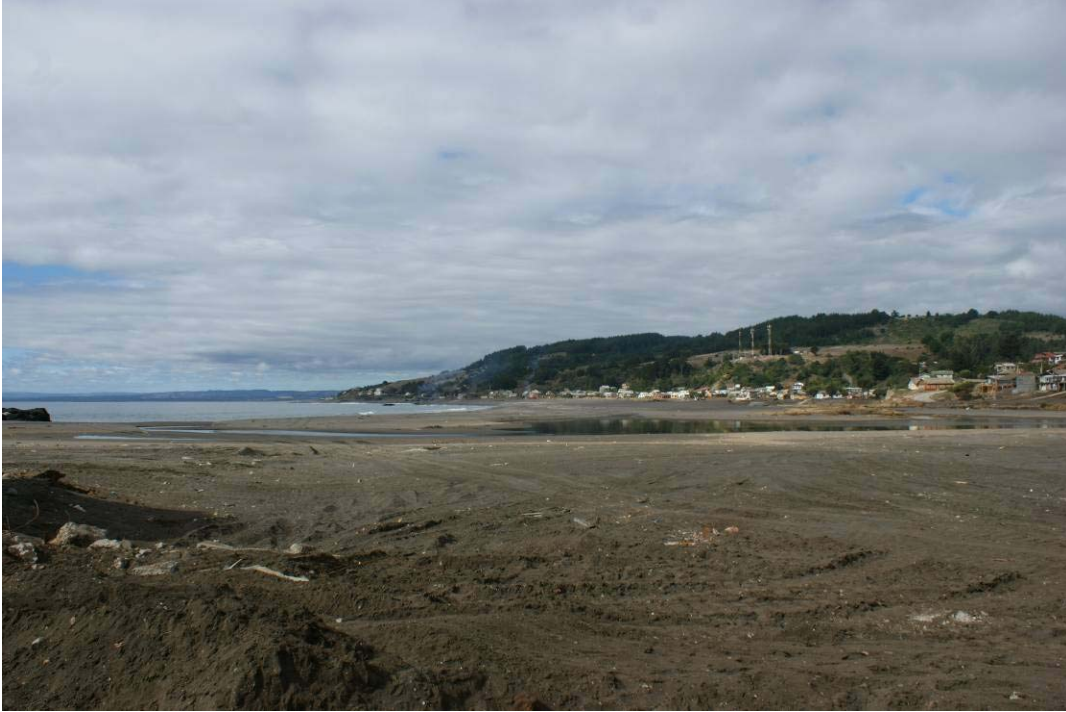
Figure 14.4. Curanipe. Main beach and much of town's debris has been completely cleared.
(S35.843823°, W72.6385°; 15:58 hours on 3/17/2010)

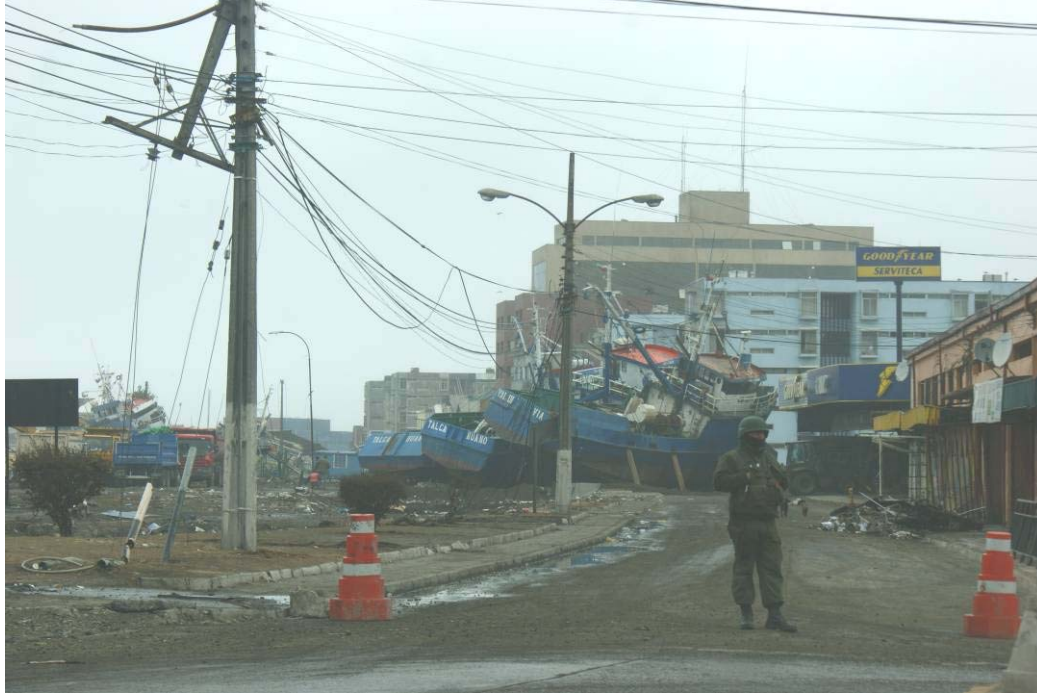
Figure 14.6. Tsunami damage near Navy facilities and bayside port of Talcahuano. (S36.711305°, W73.114808°; 12:39 hours on 3/16/2010)

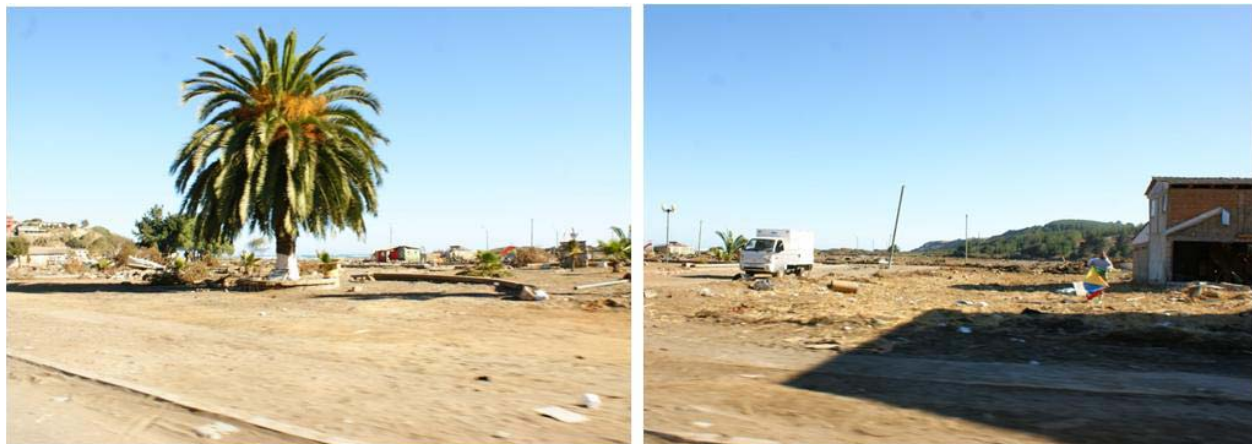
Figure 14.7a and 14.7b Bucalemu.. Much of the tsunami debris and damaged structures had already been removed from the low-lying area along the estuary that had campgrounds, hotels, restaurants, and discos. As many as 500 people were in this area when the earthquake struck. (S34.62552°, W72.038395°; 09:05 hours on 3/15/2010)

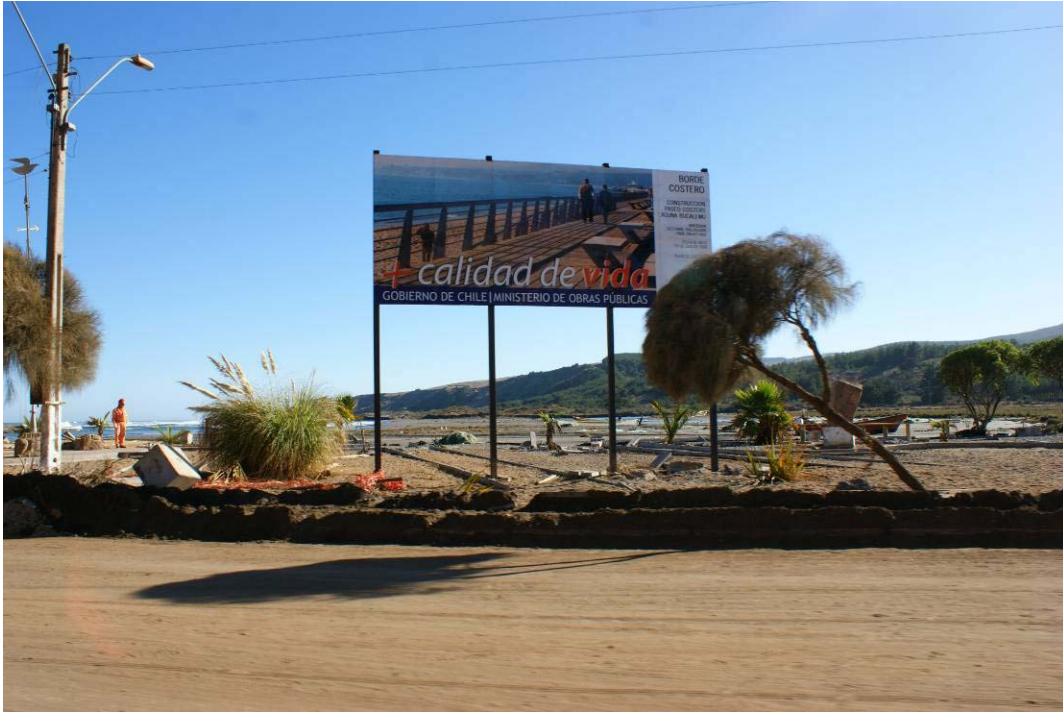
Figure 14.8. Bucalemu. Prior to the earthquake, the town had been expanding the lagoon and constructing a boardwalk along the shore. (S34.642367°, W72.040965°; 09:06 hours on 3/15/2010)

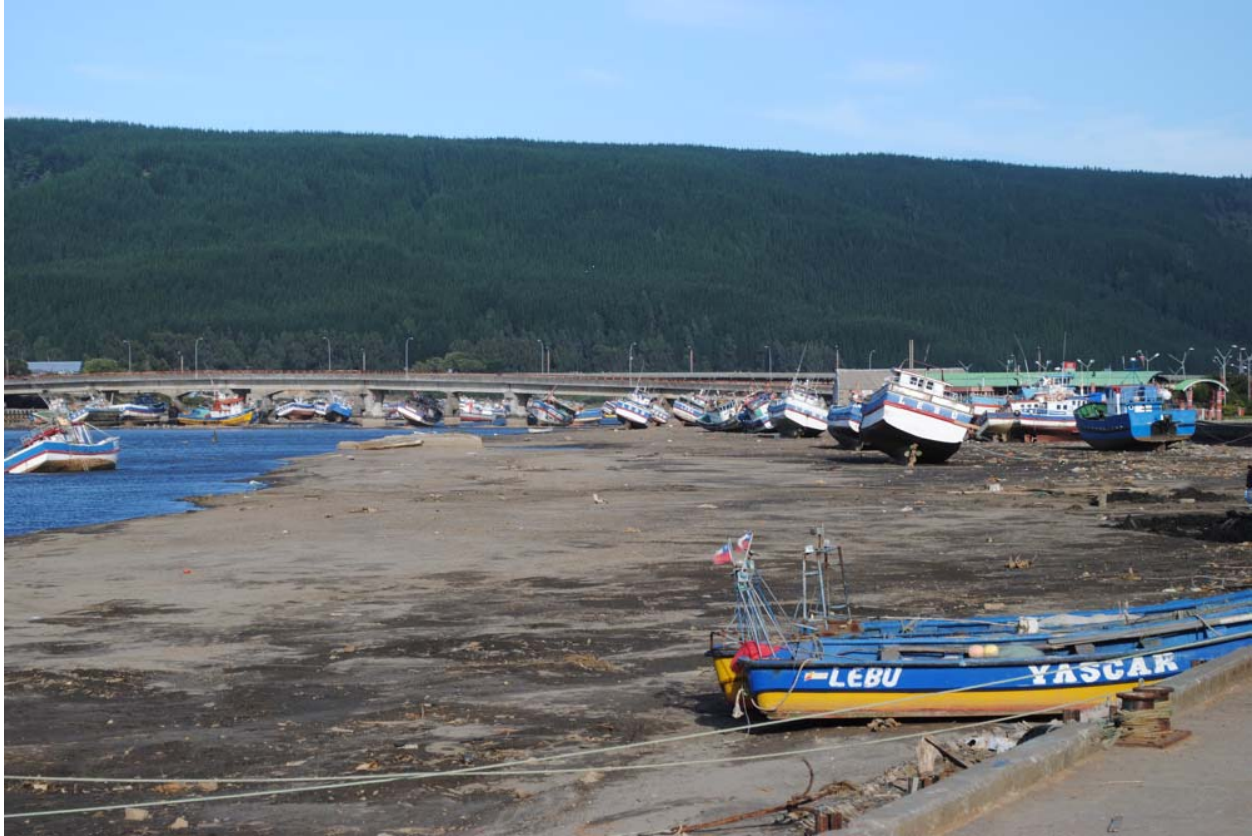
Figure 14.11. Boats stranded in Lebu's Harbor. (S37.603694° W73.654372°; 1800 hrs on 03/10/2010).

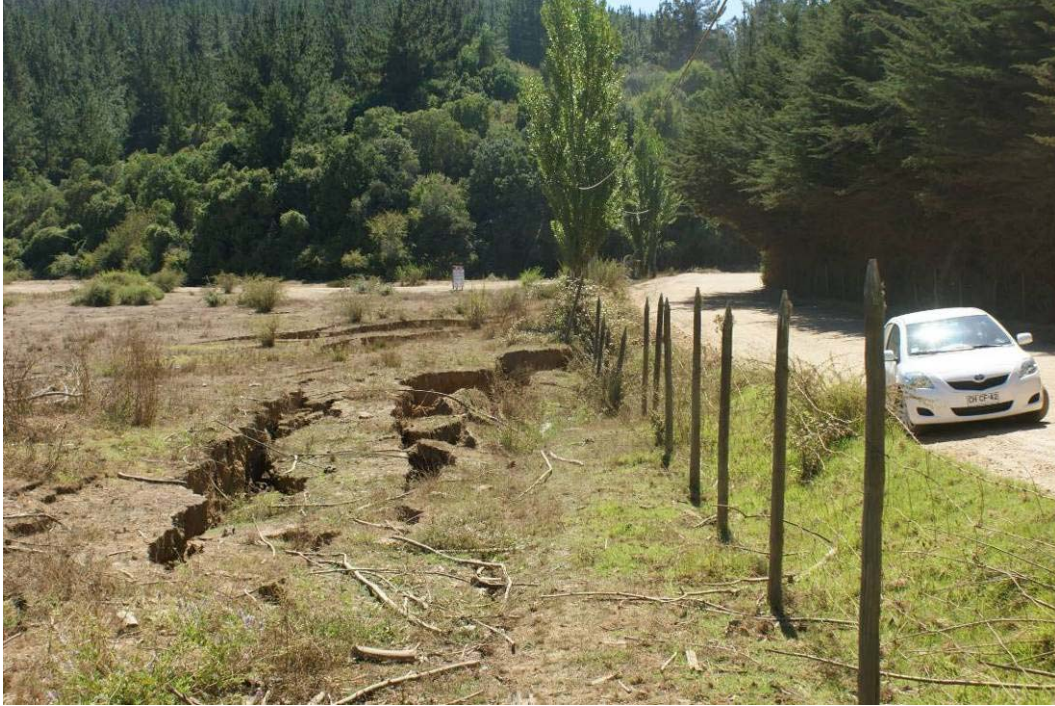
Figure 14.12. Lago Vichuquen,. Lateral spreading on the inland side of the lakefront road.
(S34.39097°, W72.077815°; 12:46 hours on 3/15/2010)

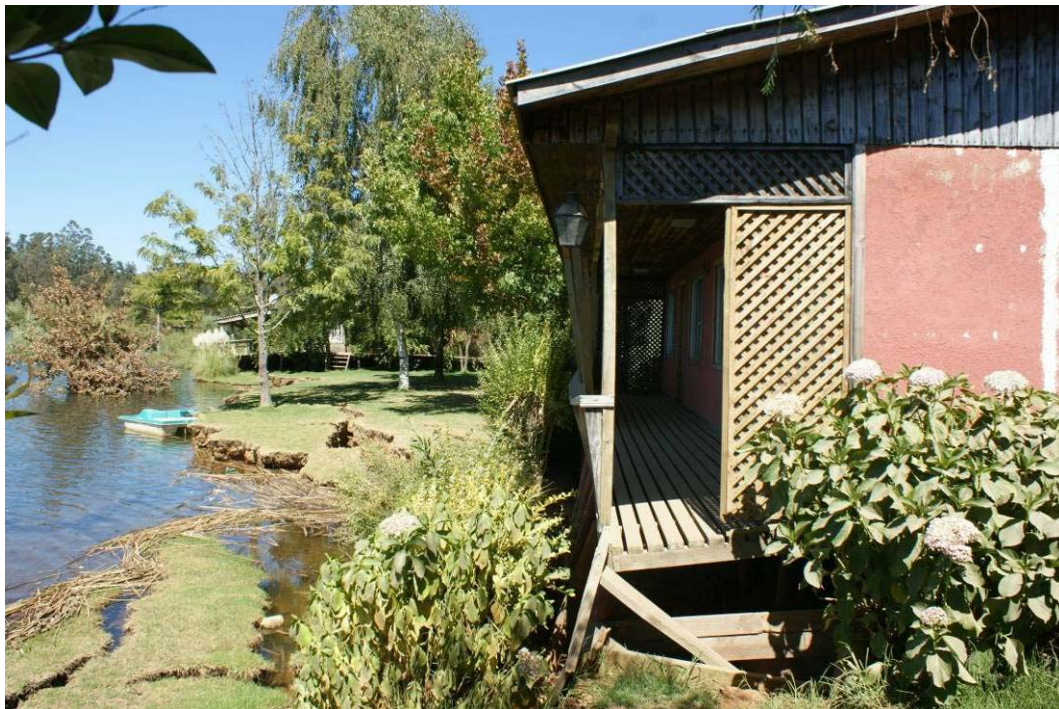
Figure 14.13. Lago Vichuquen. Lateral spreading has affected much of the ground underlying a small lakeside cabana hotel. Some shore side piers of the cabanas were submerged and there was evidence of structural damage as well. (S34.796345°, W72.07885°; 12:58 hours on 3/15/2010)

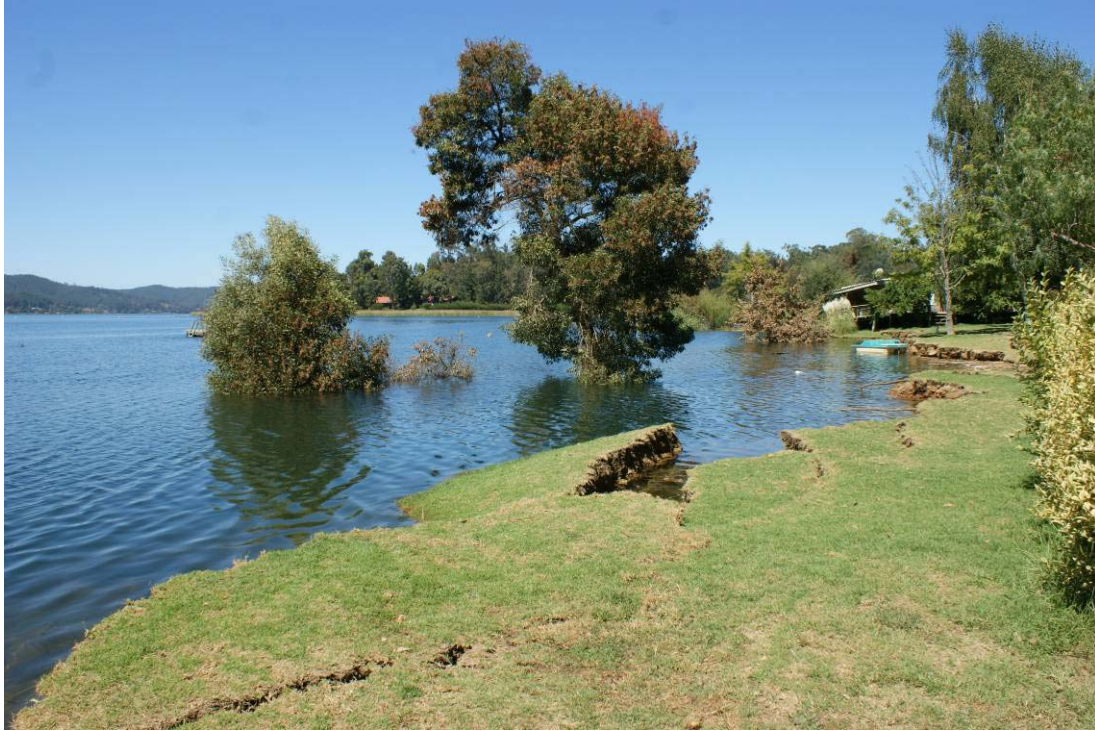
Figure 14.14. Lago Vichuquen, March 15. The lawn, trees, and boat docks are all submerged and there was evidence for submarine landsliding as well. (S34.79634°, W72.078852°; 12:52 hours on 3/15/2010)

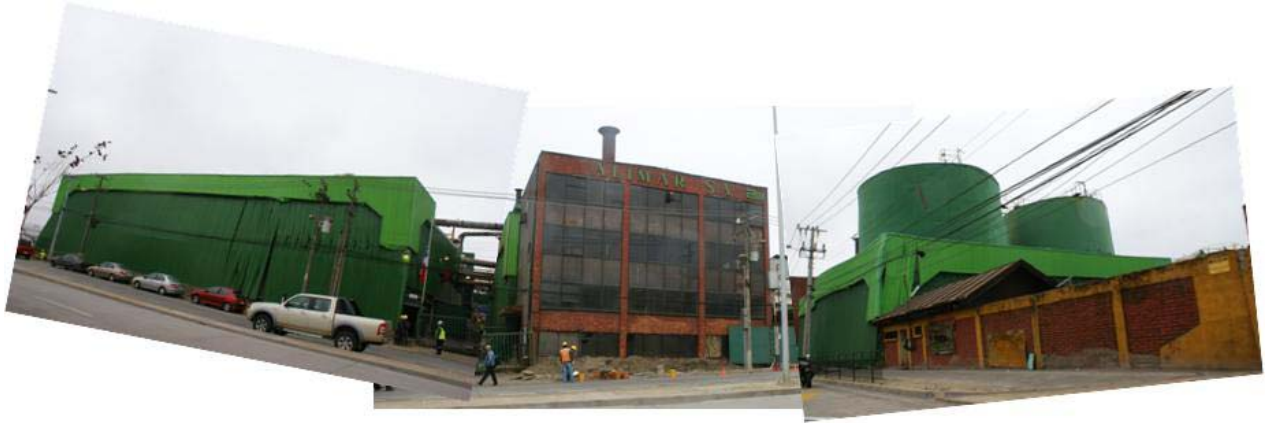
Figure 14.15. Port San Vicente, Talcahuano. The damaged Alimentos Marinos fish processing plant will likely not be rebuilt at this port. (S36.725983°, W73.128817°; 11:45 hours on 3/16/2010)

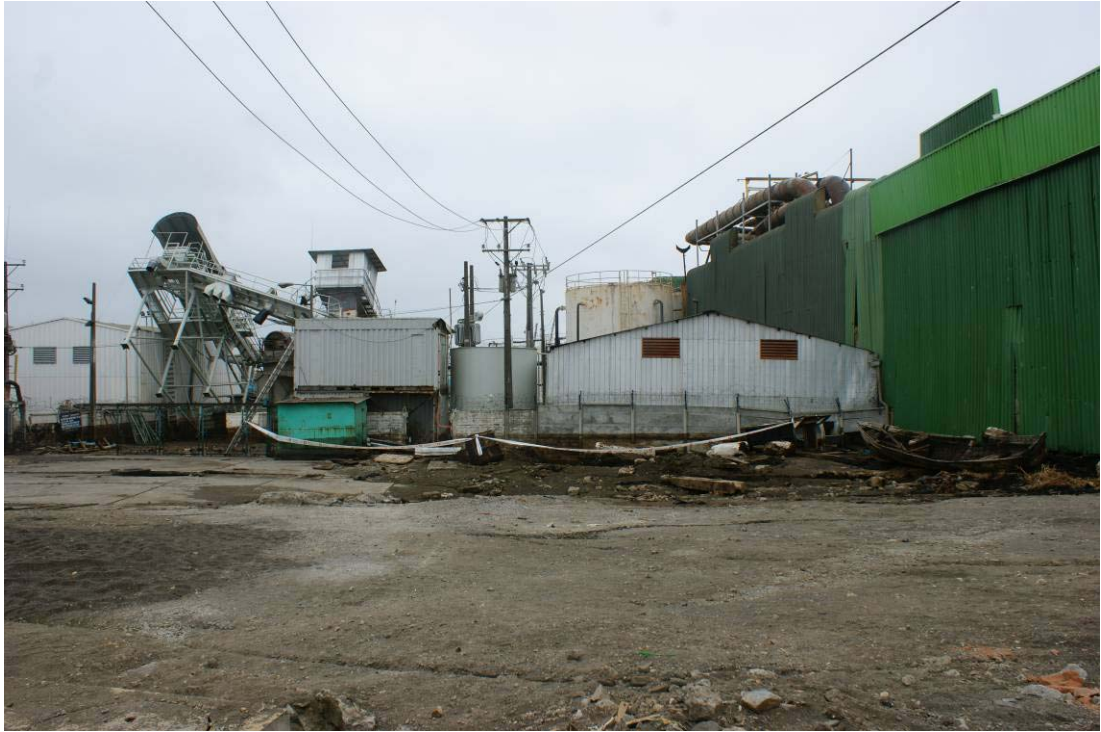
Figure 14.16. Port San Vicente, Talcahuano. The damaged Concesion Maritima fish processing plant. (S36.725892°, W73.128678°; 11:50 hours on 3/16/2010)

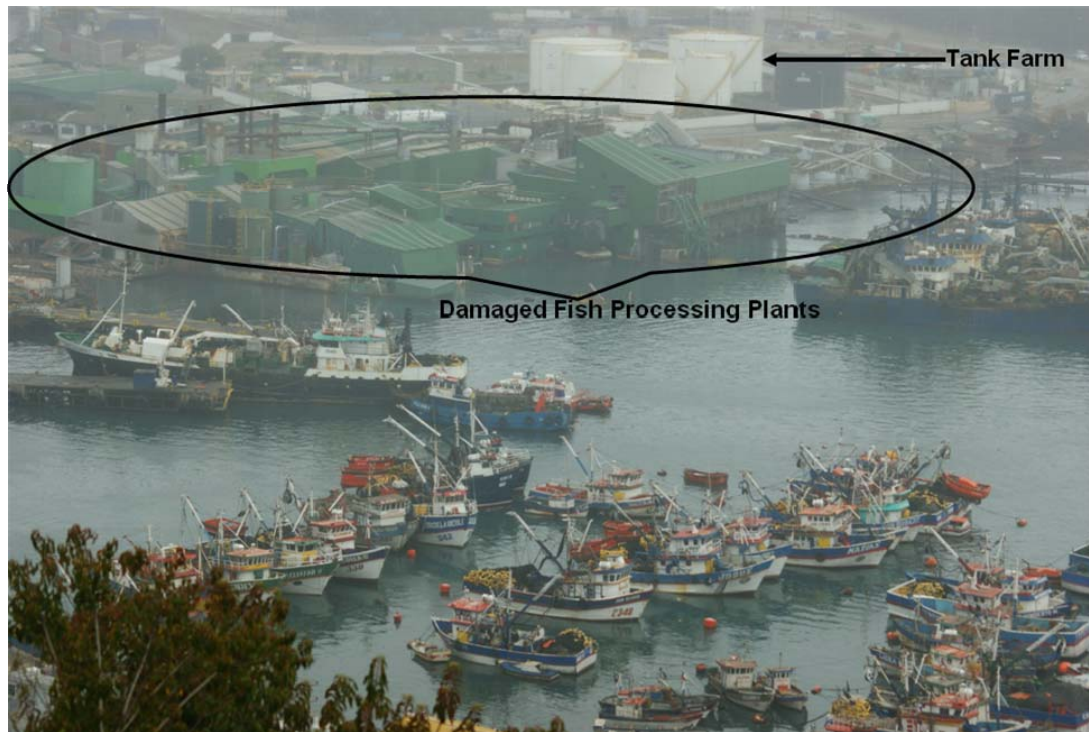
Figure 14.17. Port San Vicente, Talcahuano. View of two damaged fish processing plants and nearby tank farm. (S36.724605°, W73.136475°; 12:18 hours on 3/16/2010)
