GEO-ENGINEERING EXTREME EVENTS RECONNAISSANCE (GEER) ASSOCIATION

Turning Disaster in Knowledge

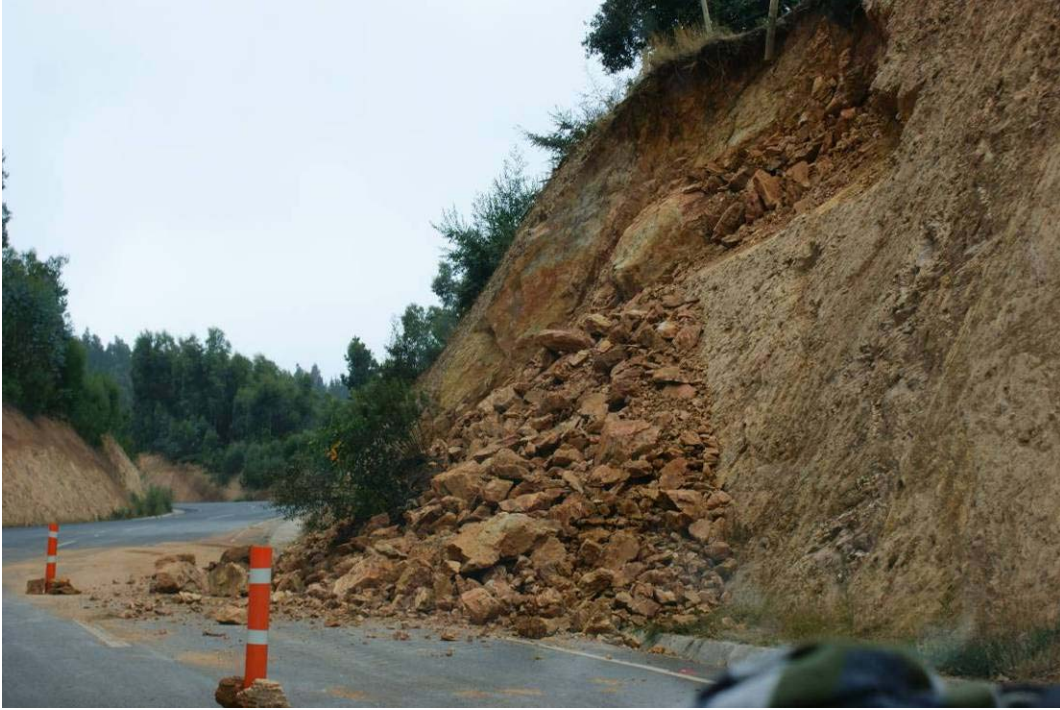
Figure 14.18. Lota Alto, Bio Bio region. Failures on the road cuts along one of two main highways leading to the Port of Coronel and surrounding coastal cities. (S37.047677°, W73.061597°; 15:30 hours on 3/16/2010)

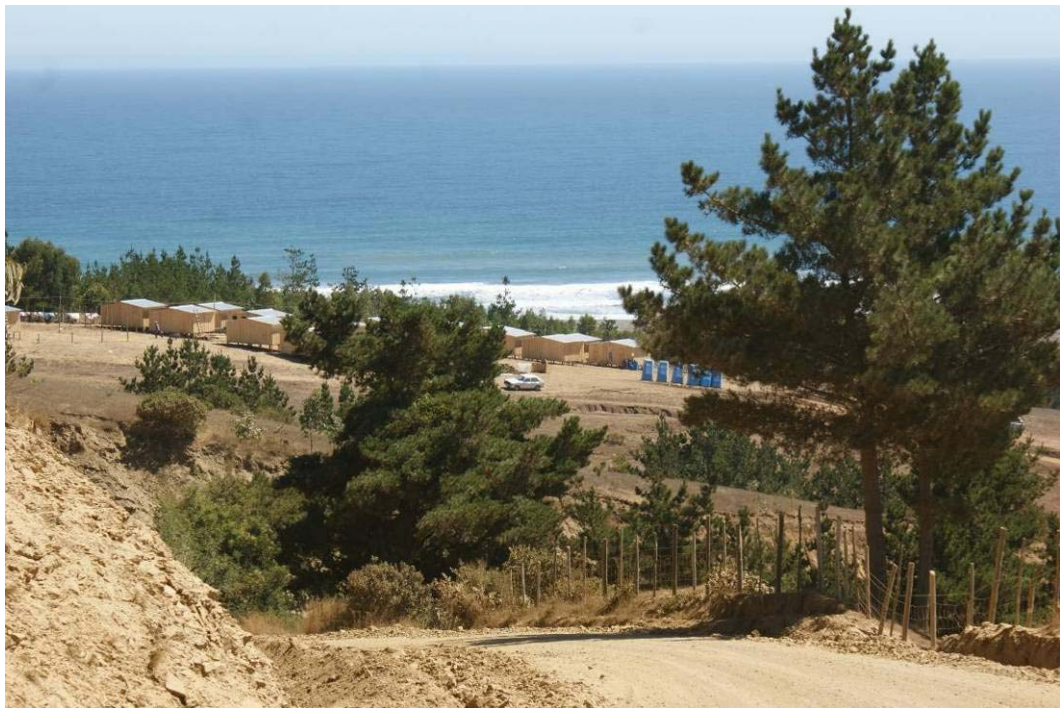
Figure 14.19. Temporary housing settlement being established in the hills above the coast near the town of Lipimavidia. (S34.853393°, W72.135148°; 13:41 hours on 3/15/2010)

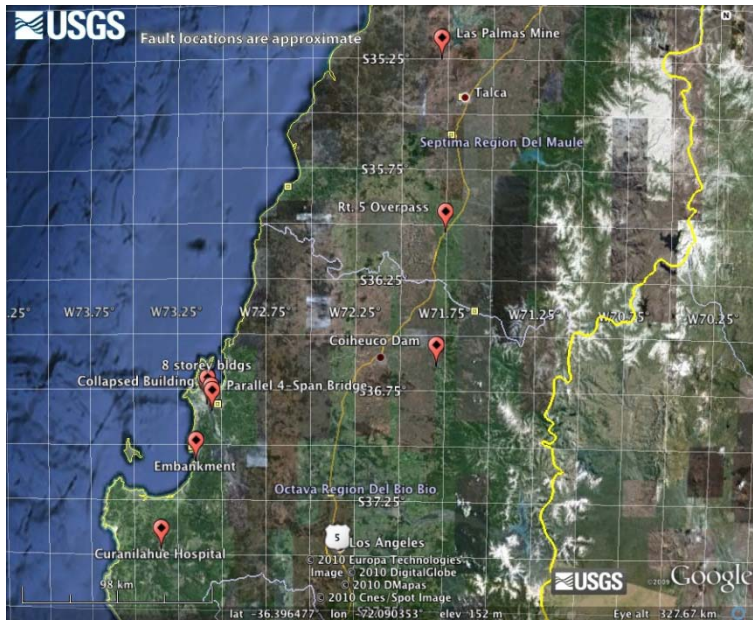
Figure 15.1. Sites investigated during the Phase C reconnaissance. Five sites are located in Concepcion (see Figure 15.2). South of the city, the team investigated the embankment failure on the coast highway and at Curanilahue Hospital. North of the city, the team investigated the Curiheuco Dam, the Ruta 5 overpass embankment failure, and the tailings pond failure at Las Palmas mine.

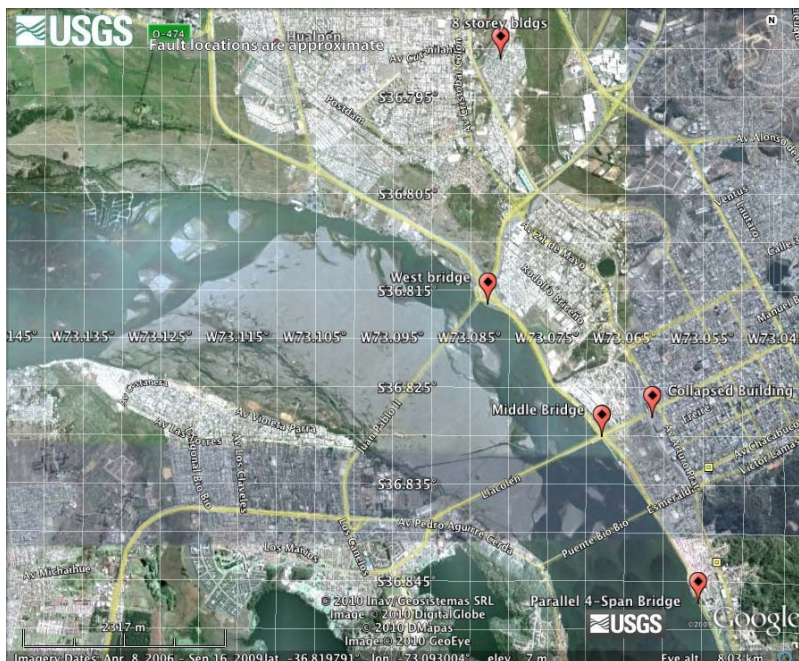
Figure 15.2. Site investigations in Concepcion. Testing was performed at: [1] the Llacolen Bridge approach deck collapse; [2] the collapsed building near the Llacolen

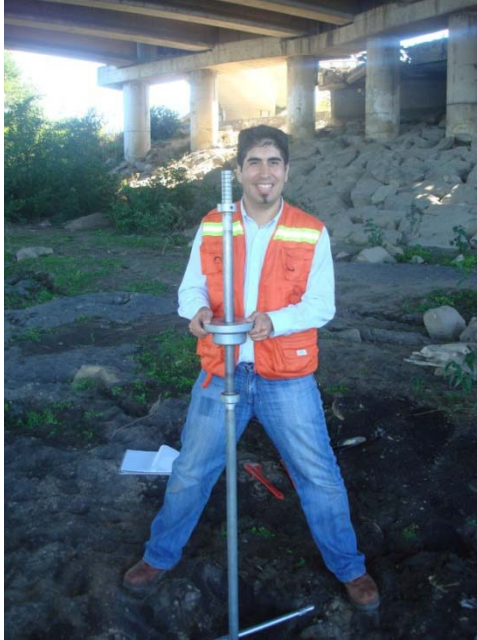
Figure 15.8. Dynamic CPT testing using the manual drop weight.

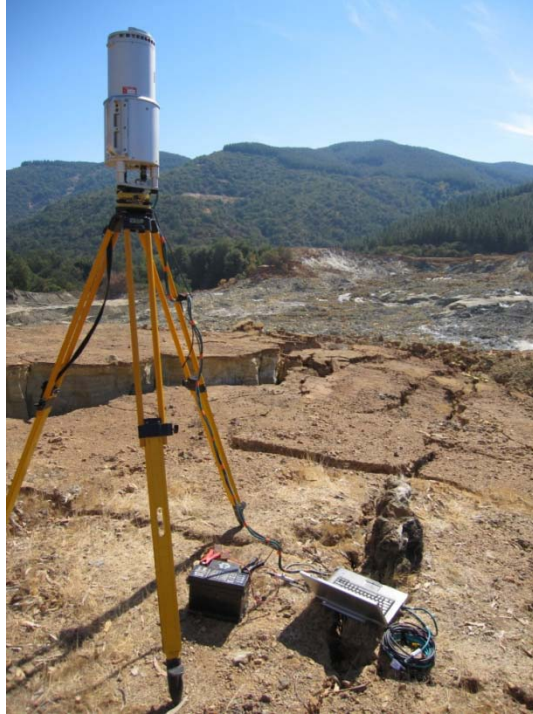
Figure 15.13 Terrestrial laser scanning with a Riegl z420 LIDAR unit at the Las Palmas Mine tailings dam failure. The system uses a PC for data acquisition and a car battery to power the laser.

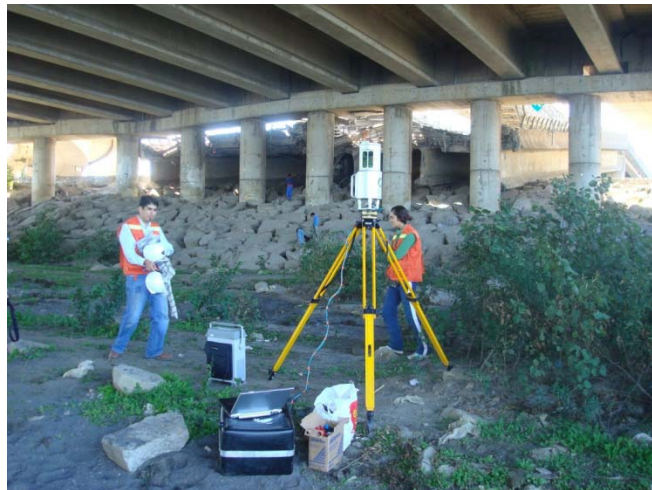
Figure 15.14 Terrestrial laser scanning with a Riegl z420 LIDAR unit at the West Bio Bio River (Juan Pablo 2) bridge.

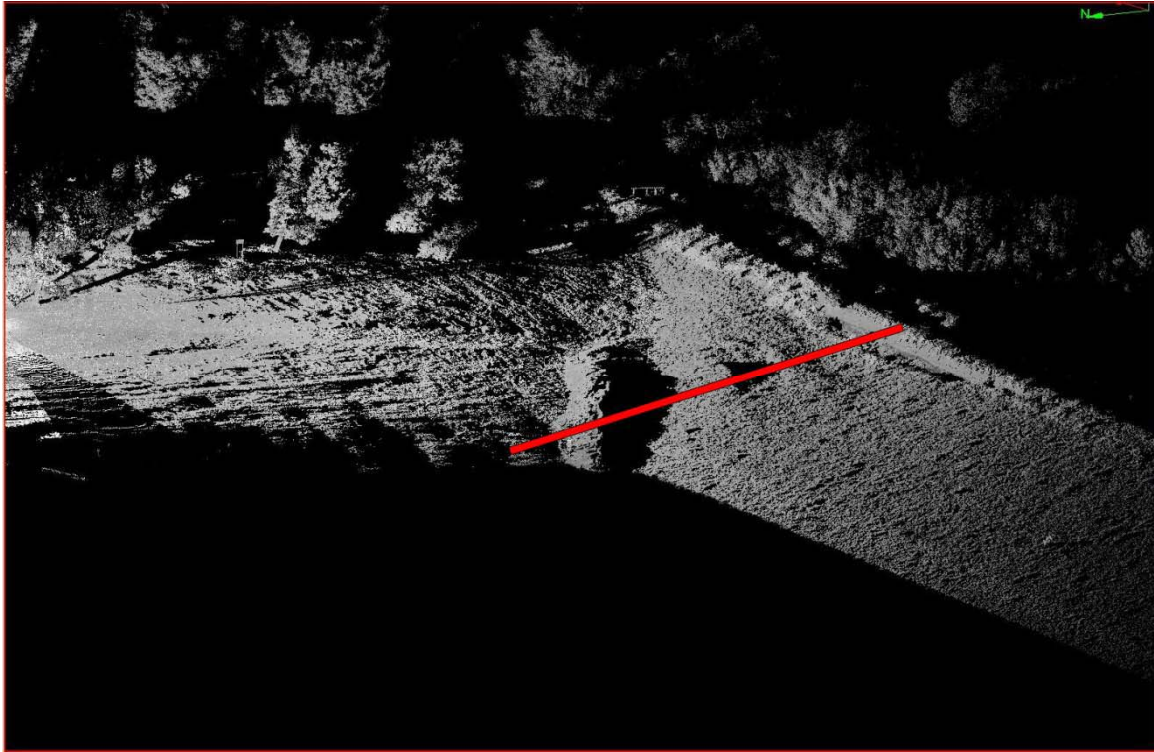
Figure 15.15. Oblique view of slump at the Coihueco Dam (36.63782°S, 71.79700°W; 27 March 2010; 13:00)

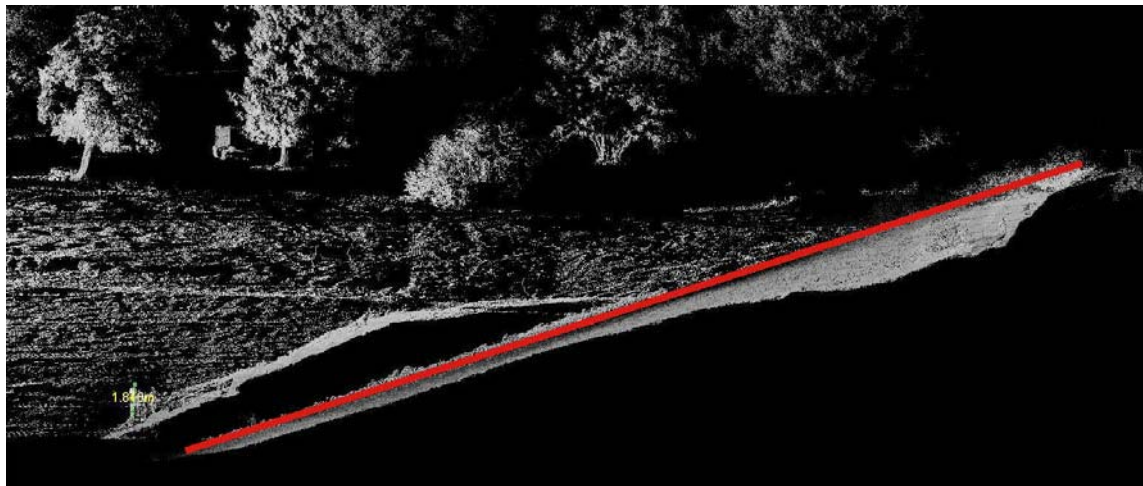
Figure 15.16. Cross section view through the slump at the Coihueco Dam, and adjacent un-failed upstream shell, accented with a Red Line (36.63782°S, 71.79700°W; 27 March 2010; 13:00).

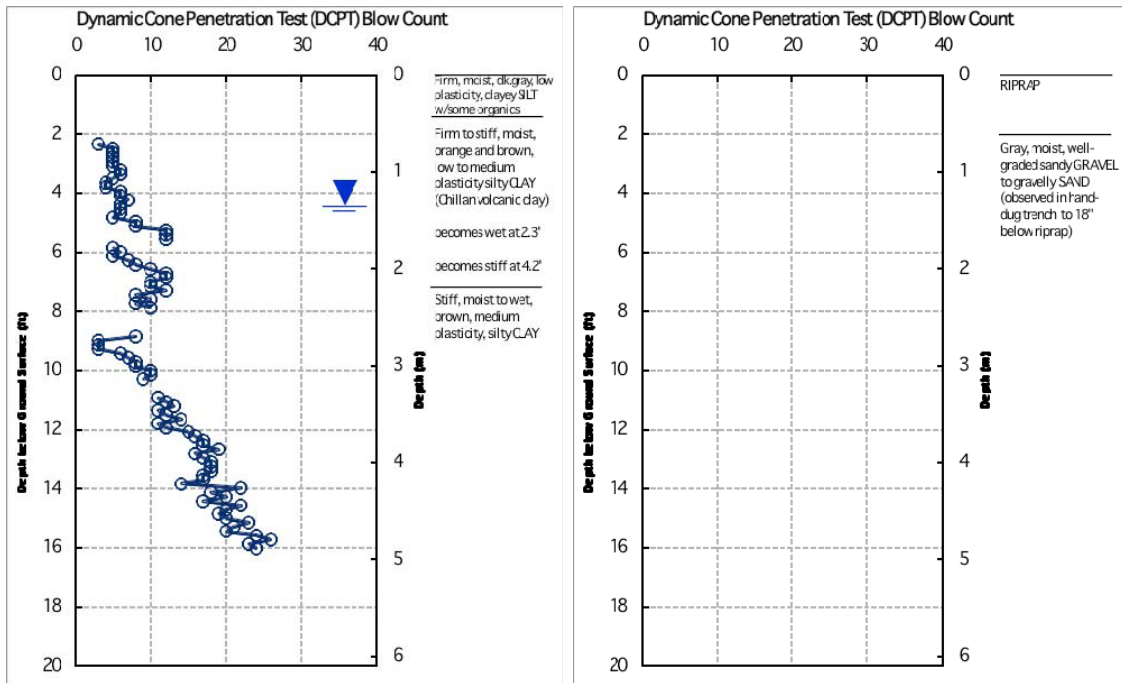
Figure 15.17. DCPT and hand auger logs from sounding performed at toe of upstream slide at Coihueco Dam (36.63782°S, 71.79700°W; 27 March 2010; 13:00) and log from hand-dug trench in upstream slope (36.63737°S, 71.79674°W; 27 March 2010; 16:00).

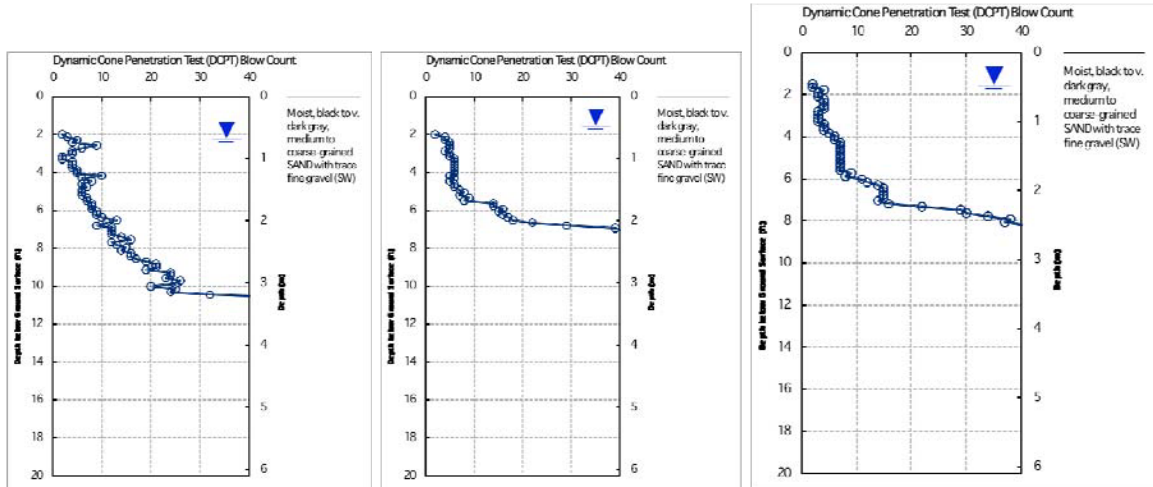
Figure 15.19. DCPT and hand auger logs from soundings performed at middle Bio Bio Bridge (Llacolen Bridge). The DCPTs and hand augers were performed at (36.83029°S, 73.06860°W; 24 March 2010; 11:30), (36.83038°S, 73.06878°W; 24 March 2010; 12:30), and (36.83007°S, 73.06908°W; 24 March 2010; 13:30).

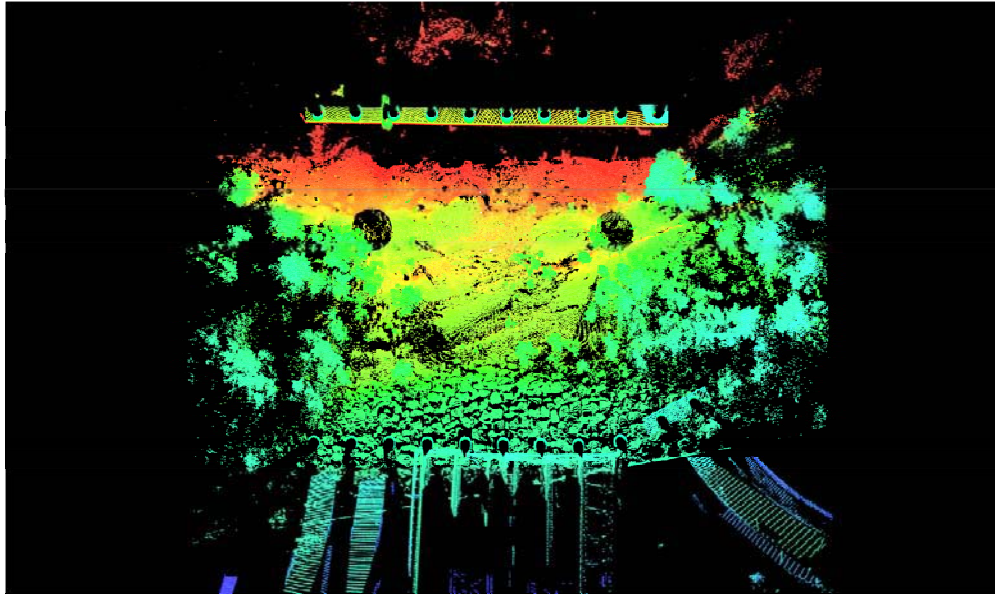
Figure 15.20. Plan view of the LIDAR scans at the Llacolen approach with the bridge deck digitally removed. The unseated approach deck is at the bottom-middle of the image adjacent to and against the circular columns. Outward tilting of the riverward (upper) columns is evident, as are fissures in the soil due to lateral spreading.

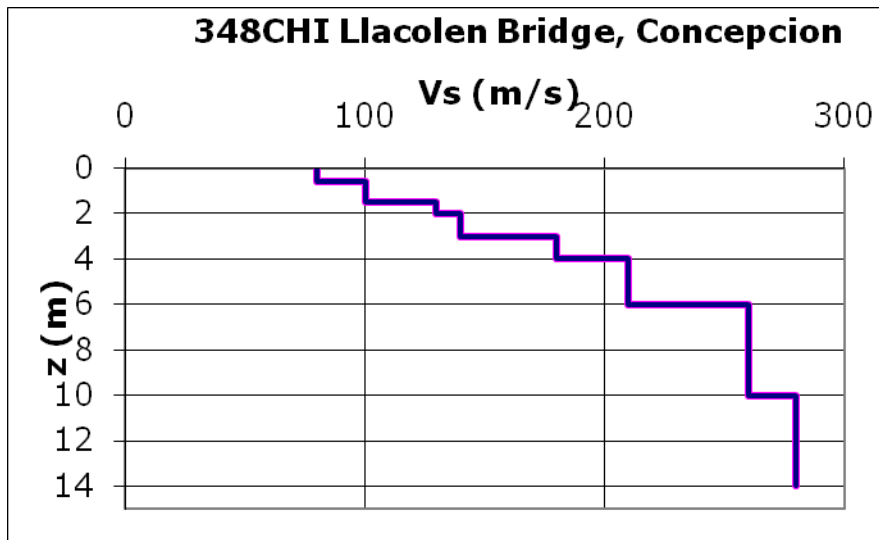
Figure 15.21 Shear Wave velocity log using the SASW method for the Llacolen Bridge approach embankment.

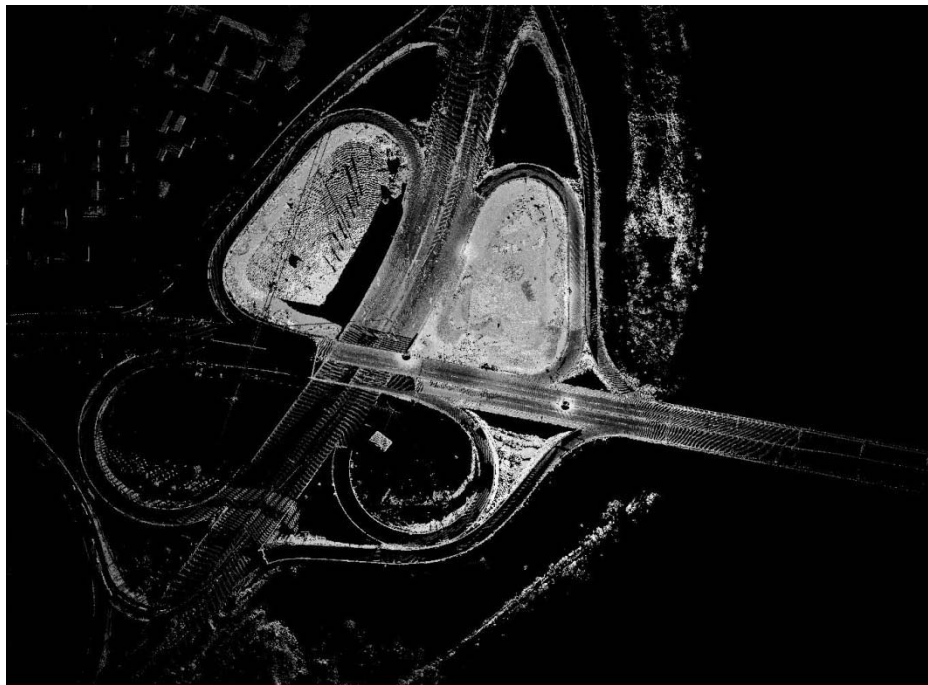
Figure 15.22 . Plan view of the LIDAR scans at the Jan Pablo II bridge approach clover leaf ovals (south is up). Bridge damage was located on the west (right) riverward side of the interchange with the riverfront highway (S36.815864°; W73.083674°).

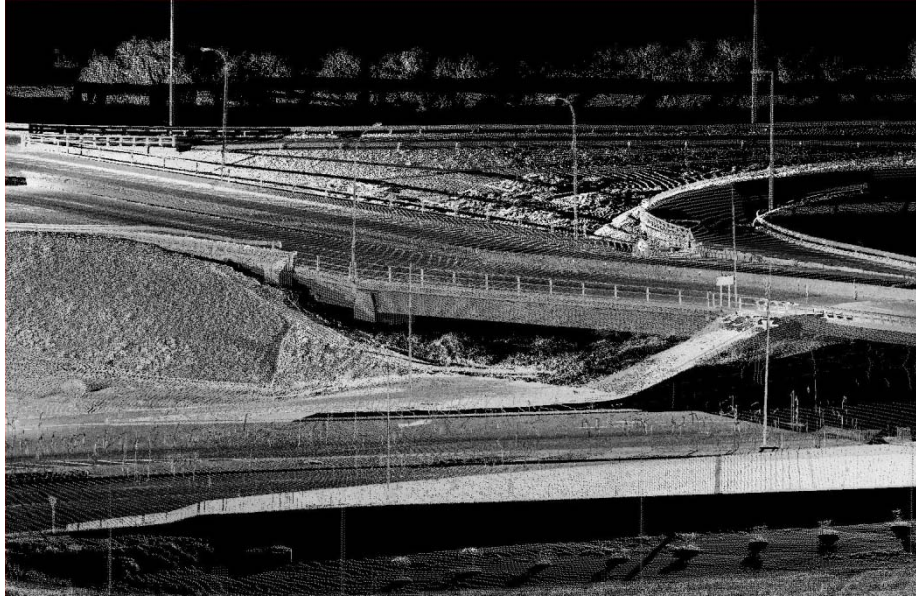
Figure 15.23. Settled bridge pier at the approach embankment of the Juan Pablo II Bridge (S36.815864°; W73.083674°).

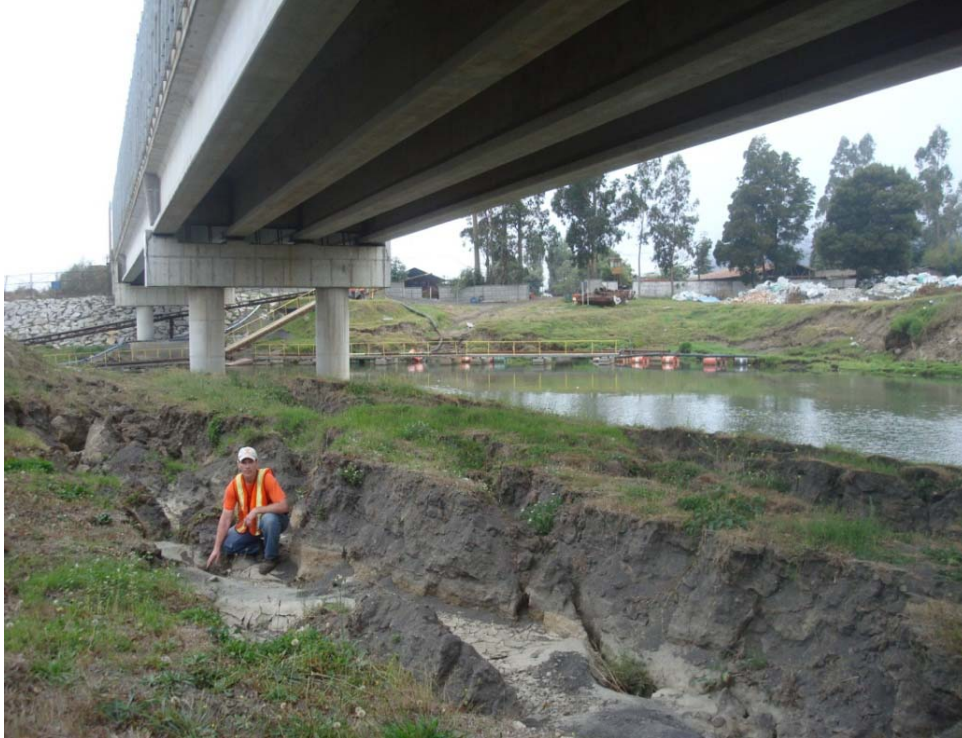
Figure 15.27. Liquefaction-induced lateral spread at Concepcion bridge parallel to the Bio Bio River. (36.84722°S, 73.05530°W; 27 March 2010; 09:25)

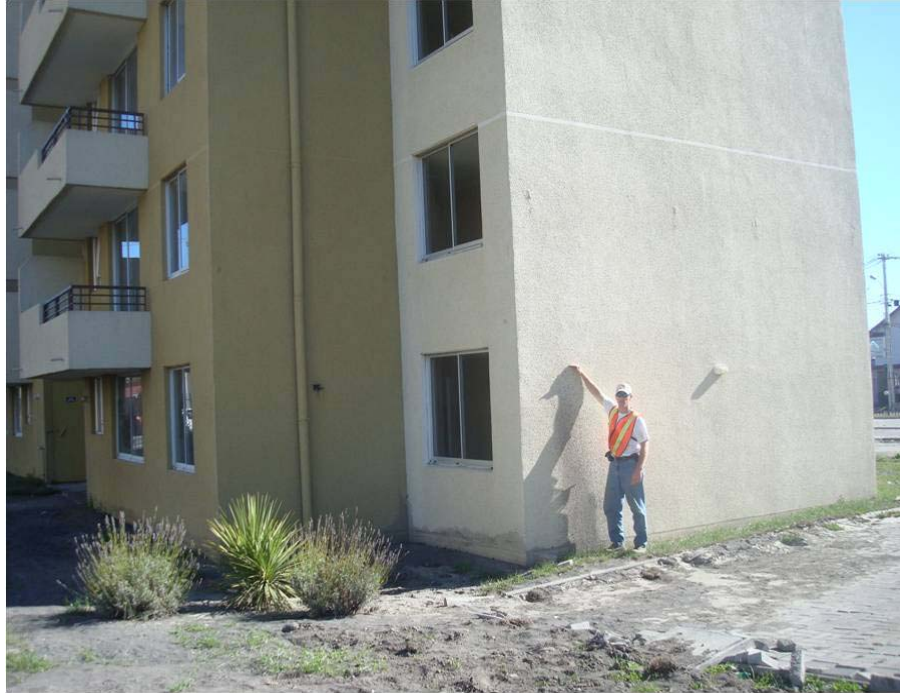
Figure 15.31. Height of ejecta sprayed onto wall of Riesco southwestern 8-story apartment building in Concepcion. Gray soil in foreground of photo also is sandy silt to silty sand ejecta, (36.79076°S, 73.08155°W; 25 March 2010; 16:50)

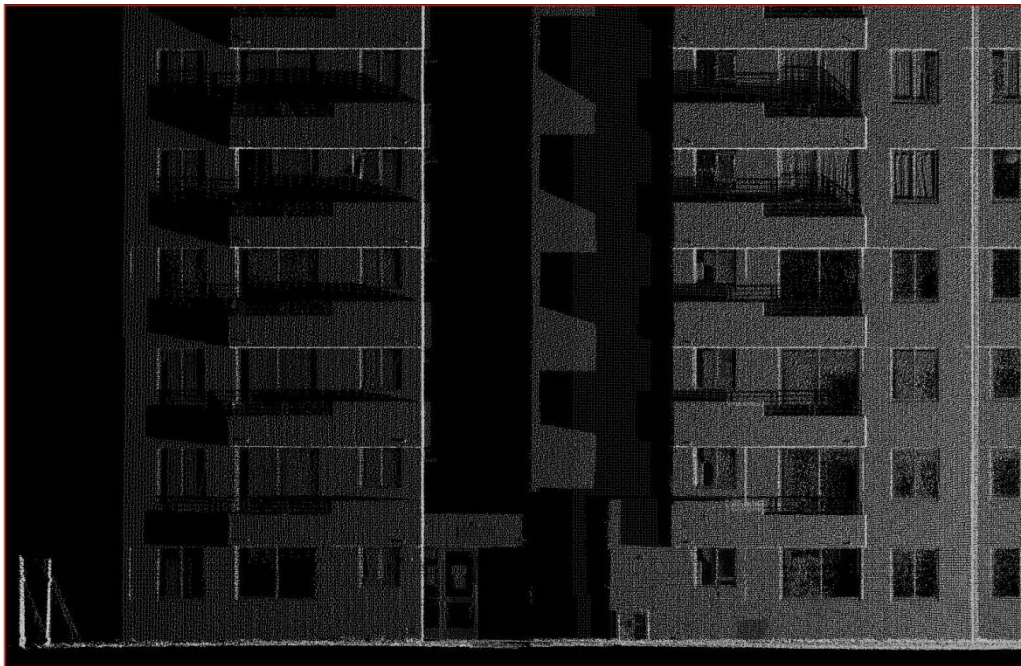
Figure 15.37. Detailed LIDAR imagery of racking of the Riesco Building (Southwest).

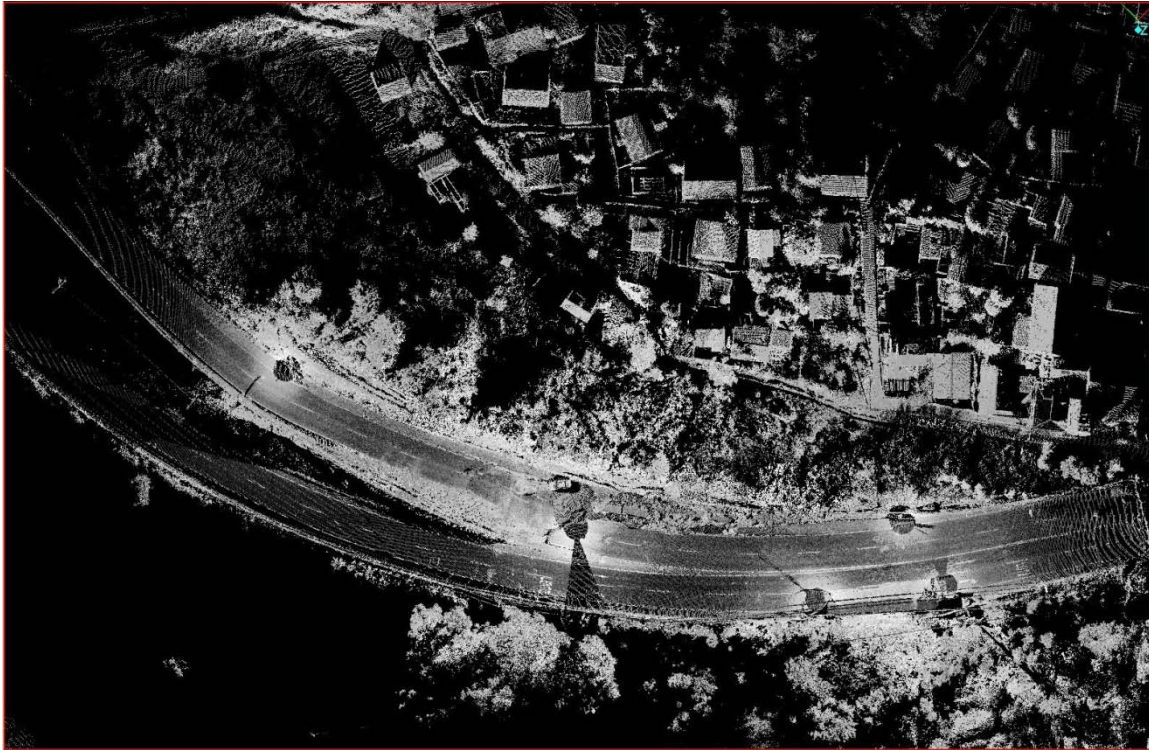
Figure 15.38. Plan view of route 160 embankment failures and neighboring community. One embankment failure is above the fork in the highway, and the second failure is on the lower right side of the merged highways.

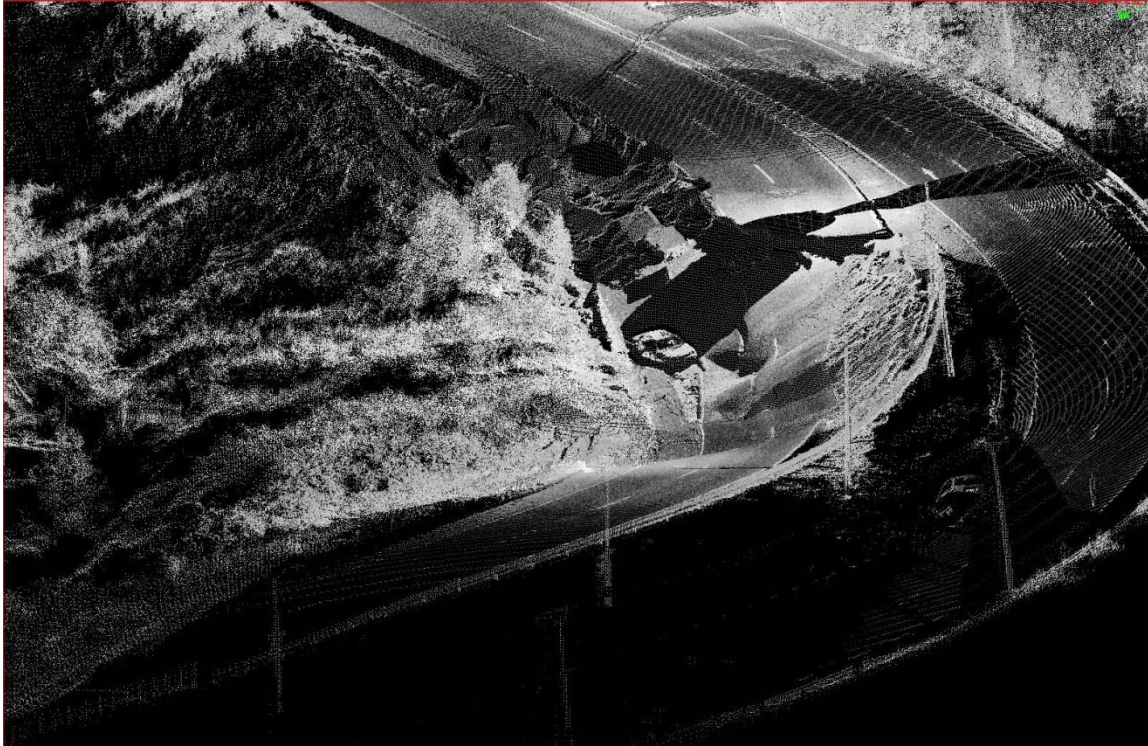
Figure 15.39. Oblique view of route 160 east side embankment failure at the fork in the highway (note vehicle in slide for scale).

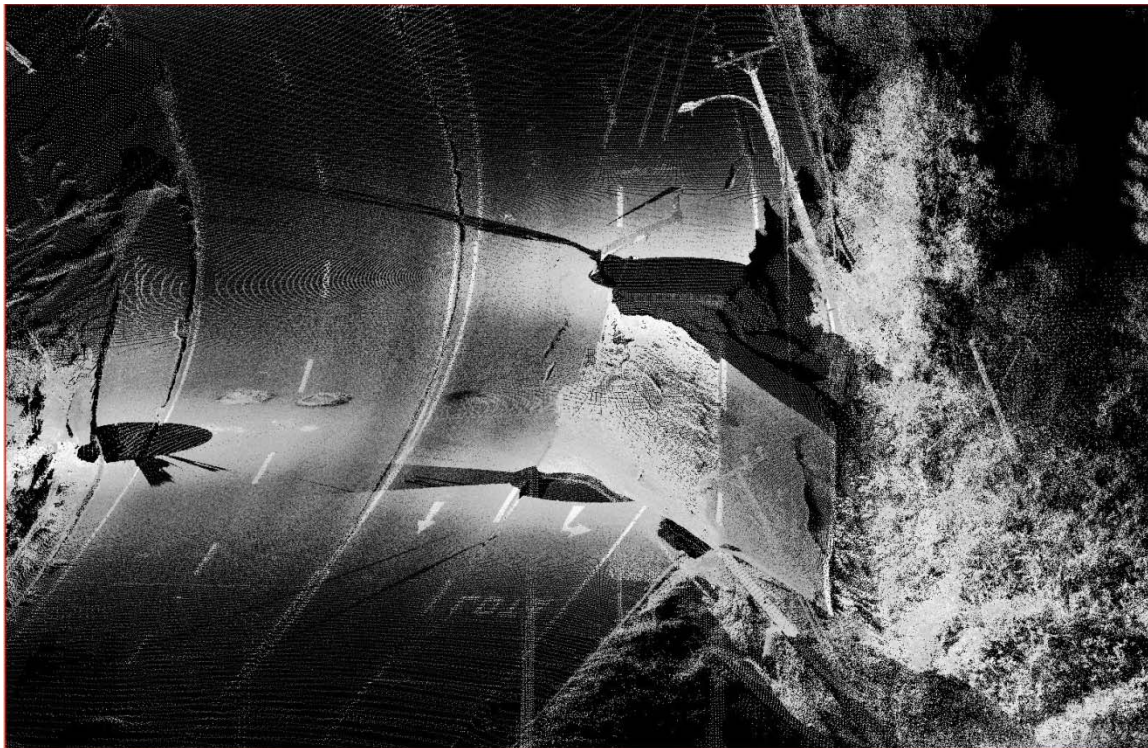
Figure 15.40. Oblique view of route 160 embankment failure along the west side of the merged highways.

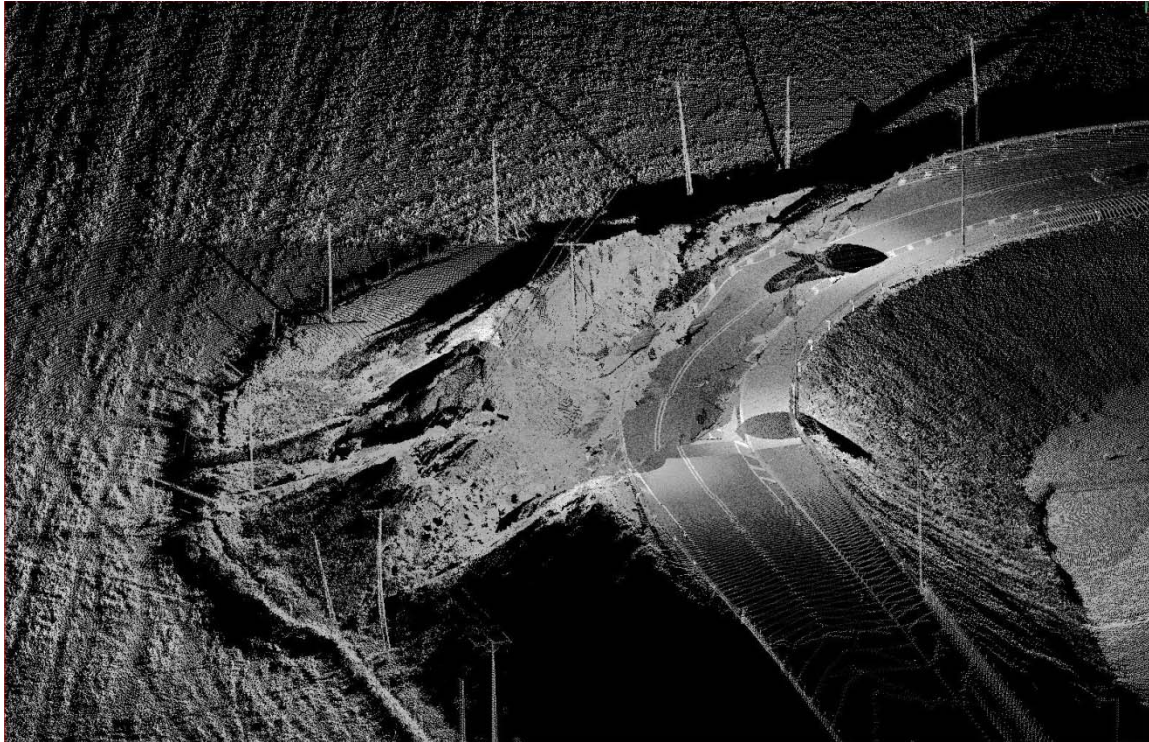
Figure 15.47. Oblique view of the Route 5 overpass embankment failure from the southeast side. The outside curve can be seen to have slid out laterally into the field.

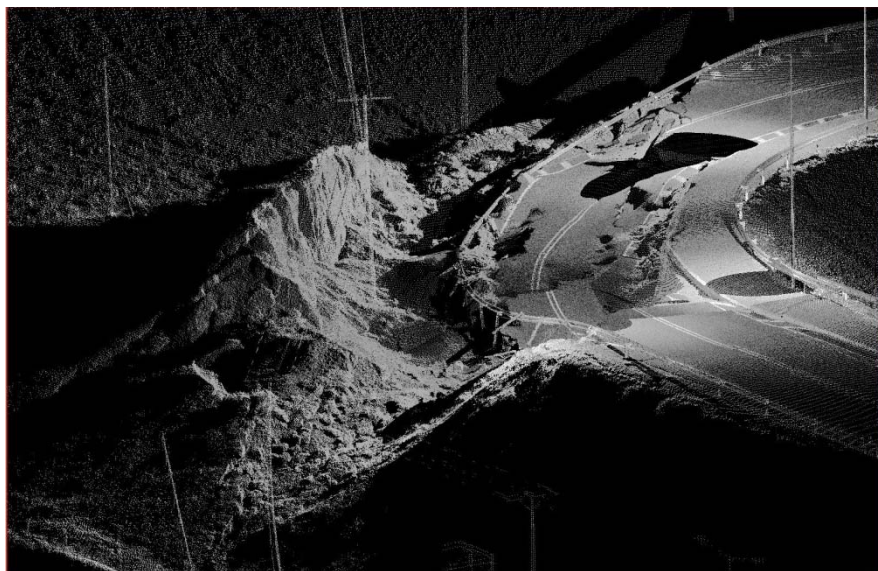
Figure 15.48. Closeup of the Route 5 overpass embankment failure from the southeast side. The embankment along the outside curve can be seen to have slid out laterally 16m into the field.

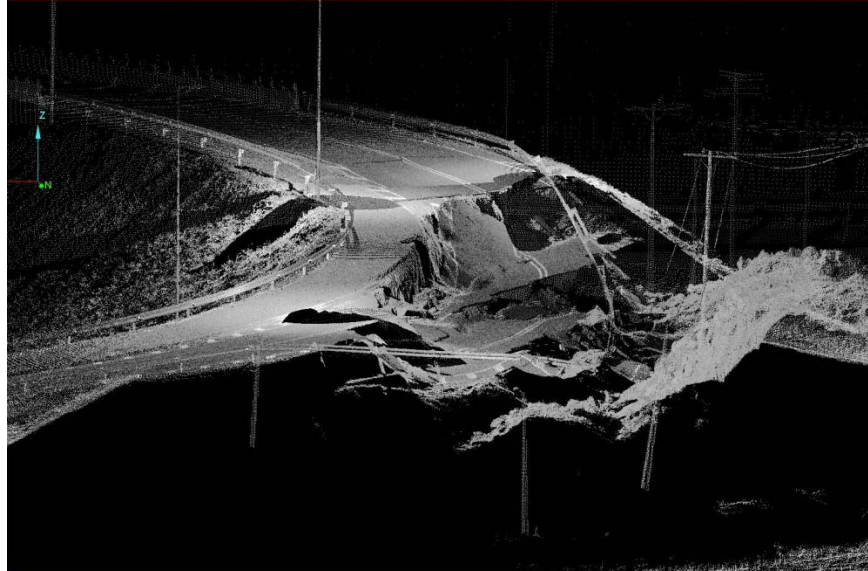
Figure 15.49. Oblique view of the Route 5 overpass embankment failure from the northwest side. Much of the roadbed slumped into the graben left behind as the outside slid out laterally to the southwest.

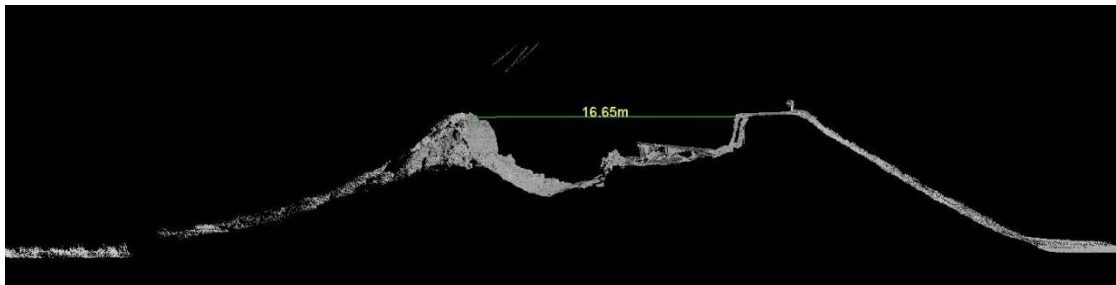
Figure 15.50. Cross-section view of the Route 5 overpass embankment failure from the east. The outside curve slid out laterally opening a large 16 meter graben.

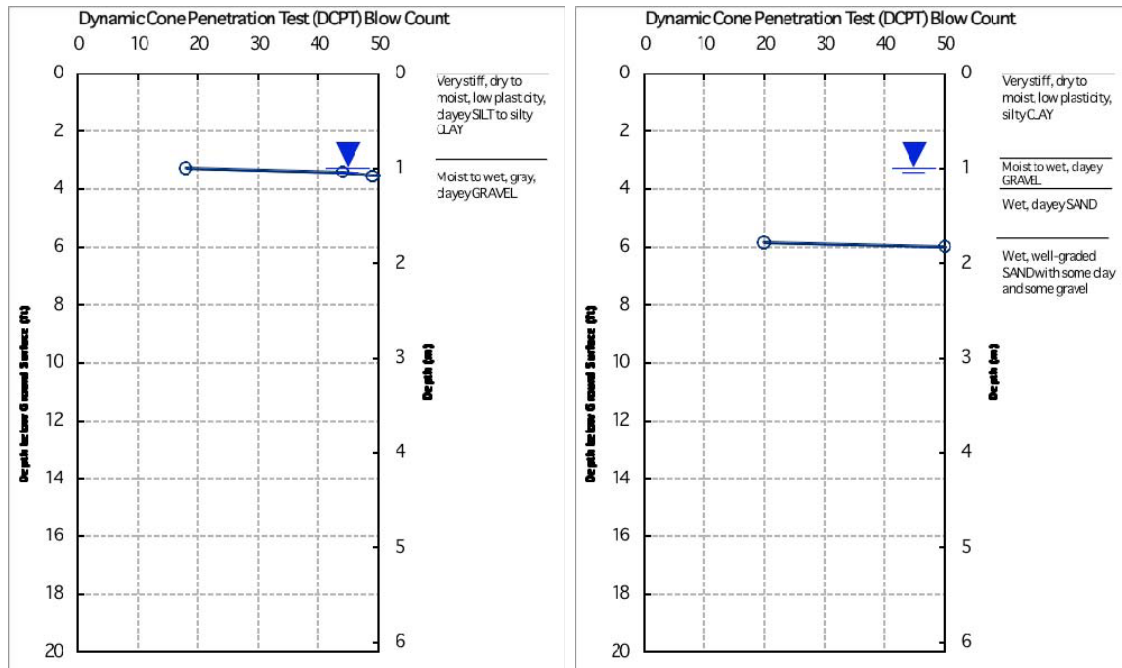
Figure 15.51. DCPT and hand auger logs from soundings performed at Ruta 5 Overpass Embankment. The DCPTs and hand augers were performed at (36.03459°S, 71.75611°W; 27 March 2010; 18:30) and (36.03488°S, 71.75610°W; 27 March 2010; 19:30).

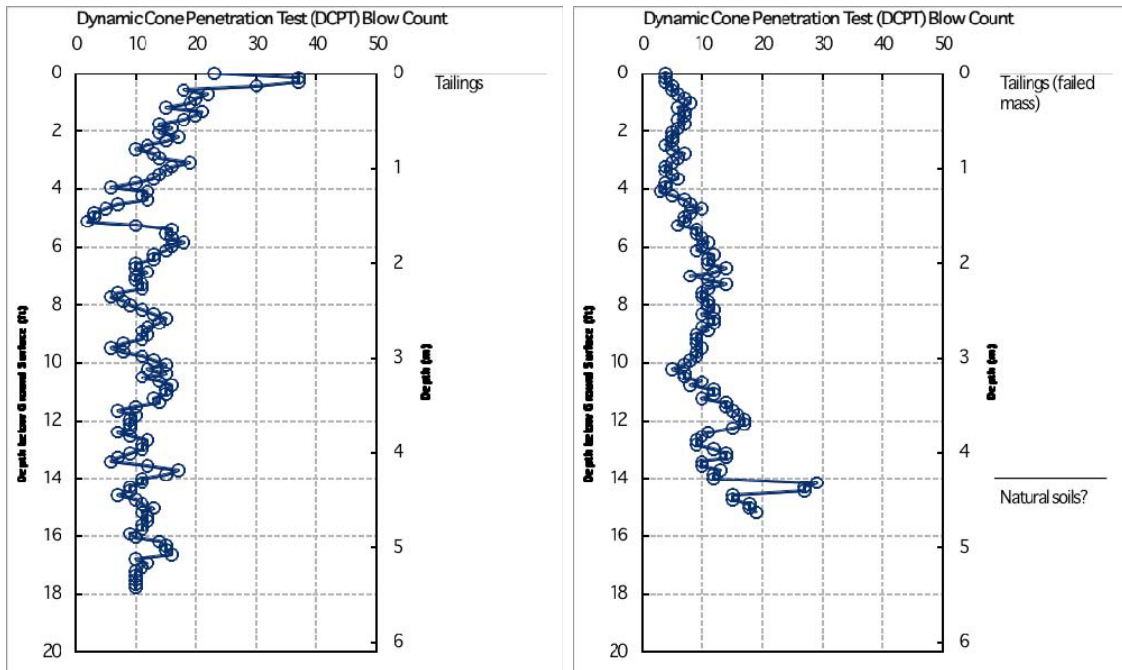
Figure 15.52. DCPT logs from soundings performed at Las Palmas Mine, Talca. The DCPTs were performed at (35.183884°S, 71.76110°W; 28 March 2010; 12:00) and (35.18629°S, 71.75771°W; 28 March 2010; 14:00).

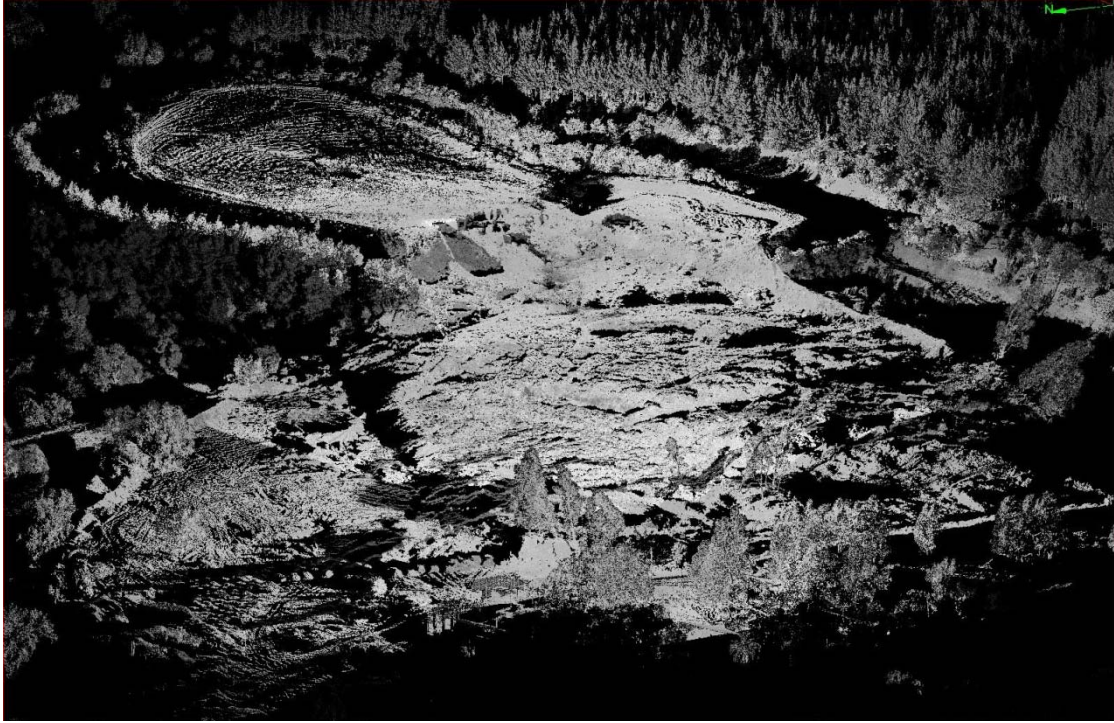
Figure 15.54 Oblique LIDAR view of the Las Palmas Tailings Pond Failure, Talca (35.184679° S, 71.759410° W). The tailings pond head scarp is in the upper-left. The toe of the slide is in the line of trees at the bottom right.

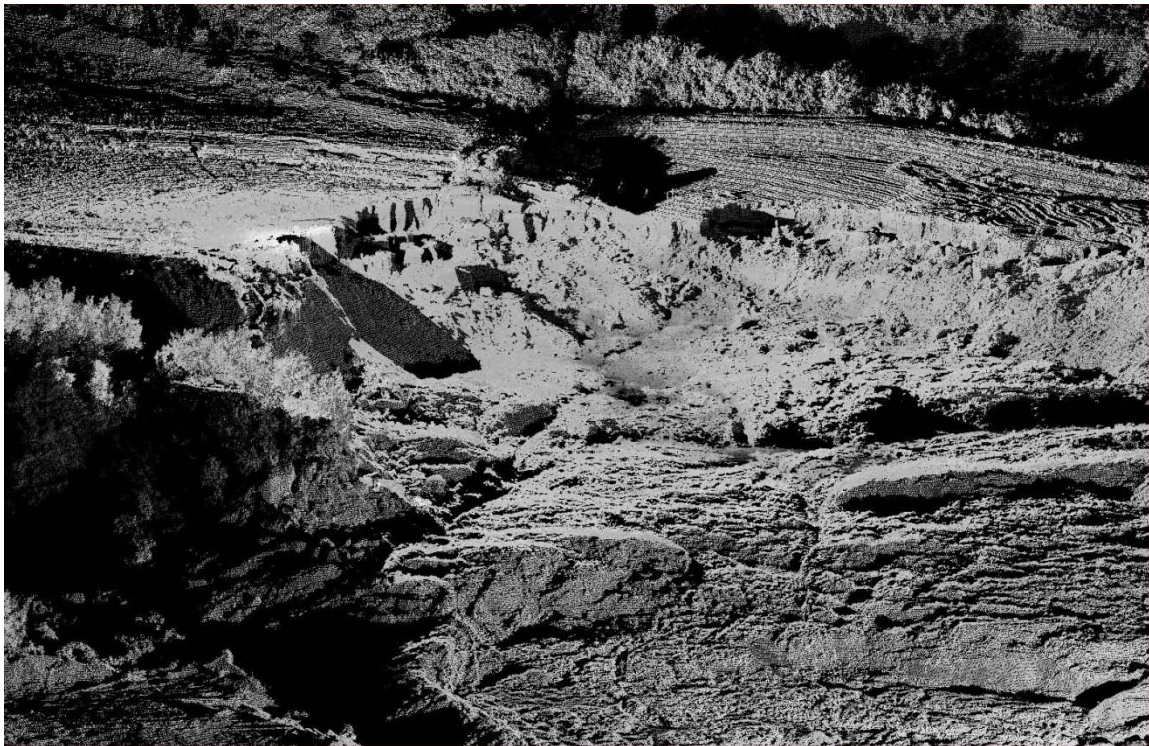
Figure 15.55 Detailed LIDAR view of the head scarp of the Las Palmas Tailings Pond (35.184679° S, 71.759410° W).

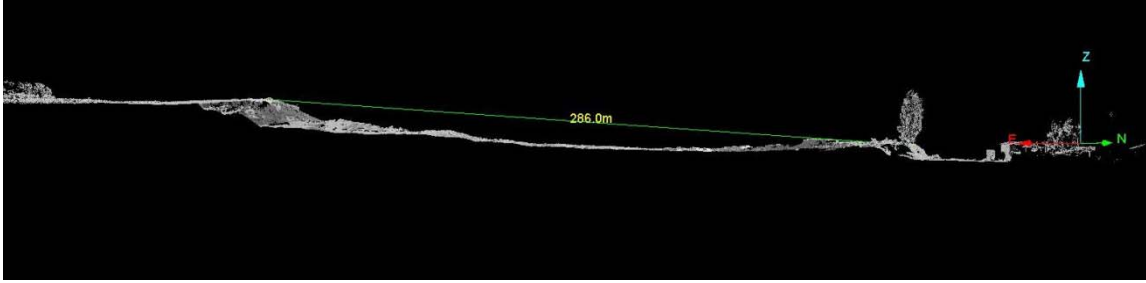
Figure 15.56 Cross-section LIDAR view of the Las Palmas Tailings Pond Failure, Talca (35.184679° S, 71.759410° W). The distance from the tailings pond head scarp to the toe of the slide is between 280 and 320m.

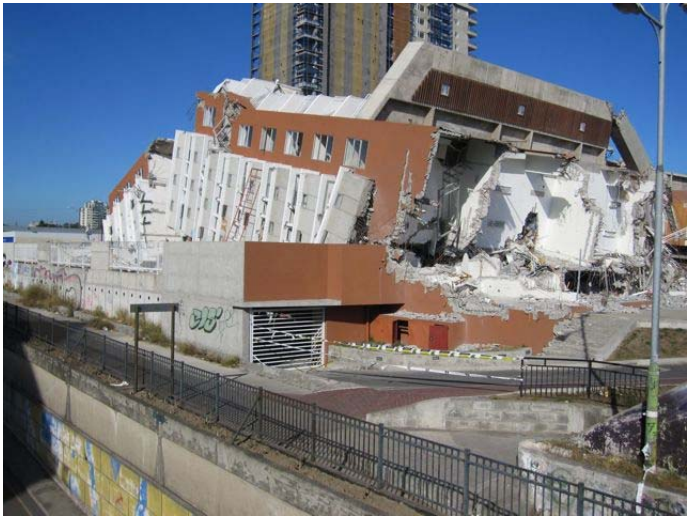
Figure 15.57. Collapsed 14 story building, Concepcion (36.82779S, 73.060777W)

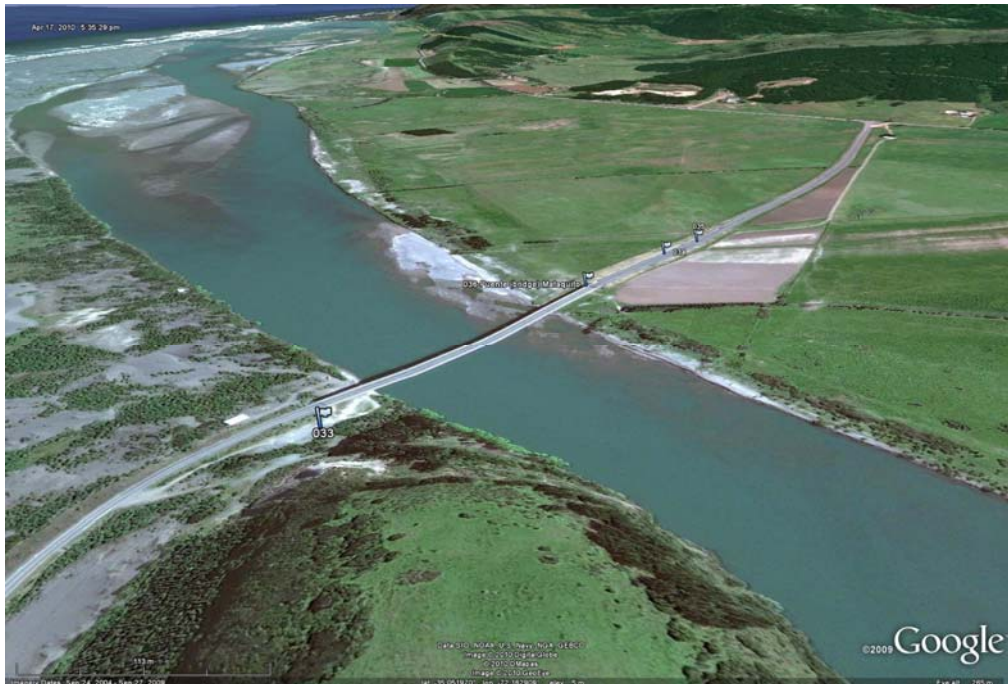
Figure 15.63 Puente Mataquito, looking north, 35.050712°S,72.162258°W, April 16, 2010.

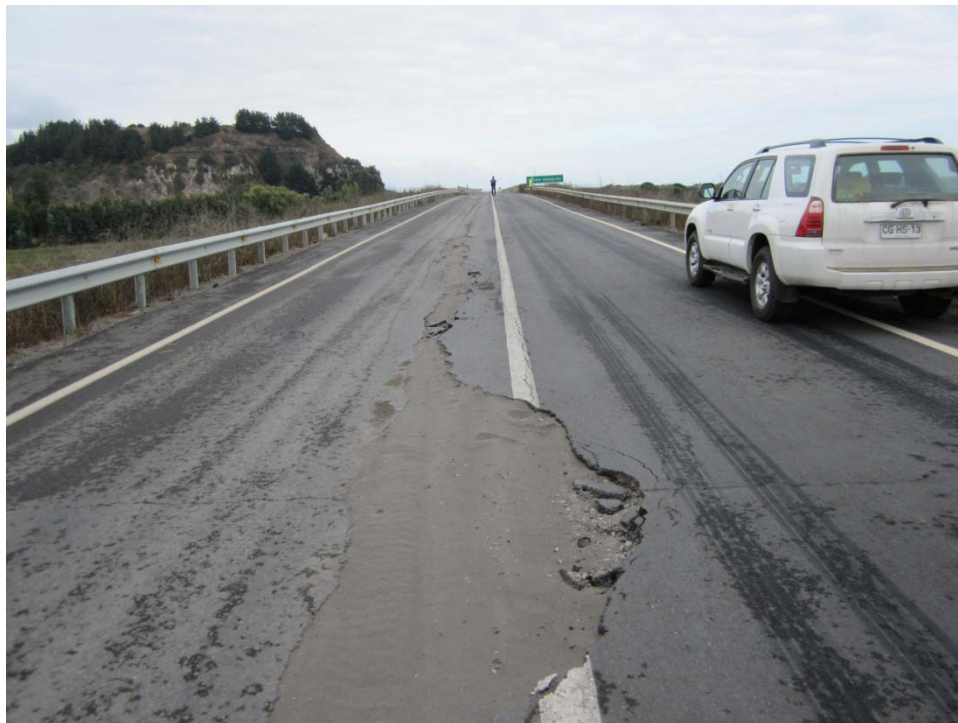
Figure 15.67 Cracking and transverse movement (60 cm on each side) of embankment due to liquefaction of underlying soil, north abutment of the bridge, Puente Mataquito, 35.050712°S, 72.162258°W, April 16, 2010.

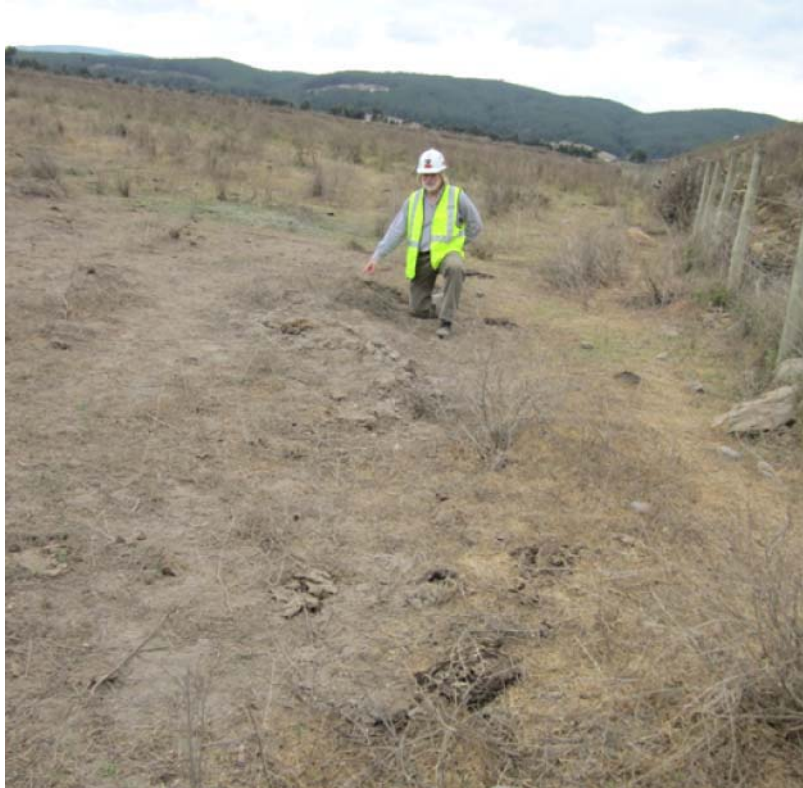
Figure 15.68 Compression ridges at toe of embankment, due to liquefaction of underlying soil and settlement of embankment, north abutment of the bridge, Puente Mataquito, 35.050712°S, 72.162258°W, April 16, 2010.
