GEO-ENGINEERING EXTREME EVENTS RECONNAISSANCE (GEER) ASSOCIATION

Turning Disaster in Knowledge

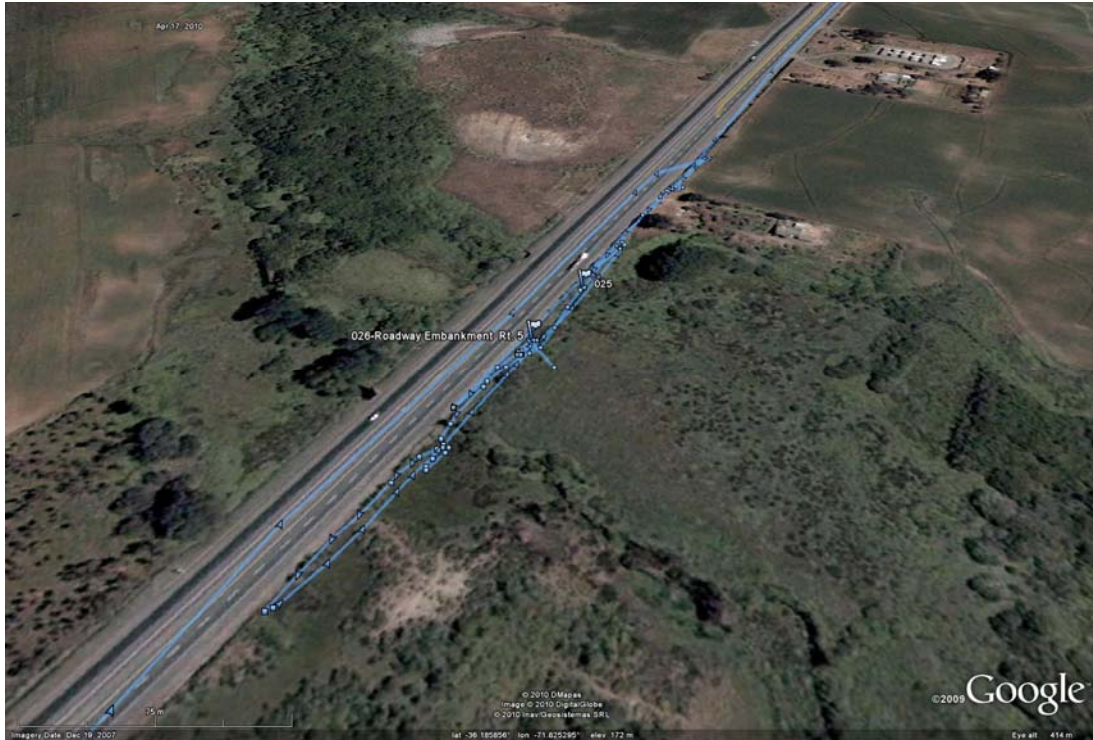
Figure 15.79 Roadway Embankment ~5km south of Parral, north is up, Ruta 5 Sur (36.185671°S,71.825415°W)

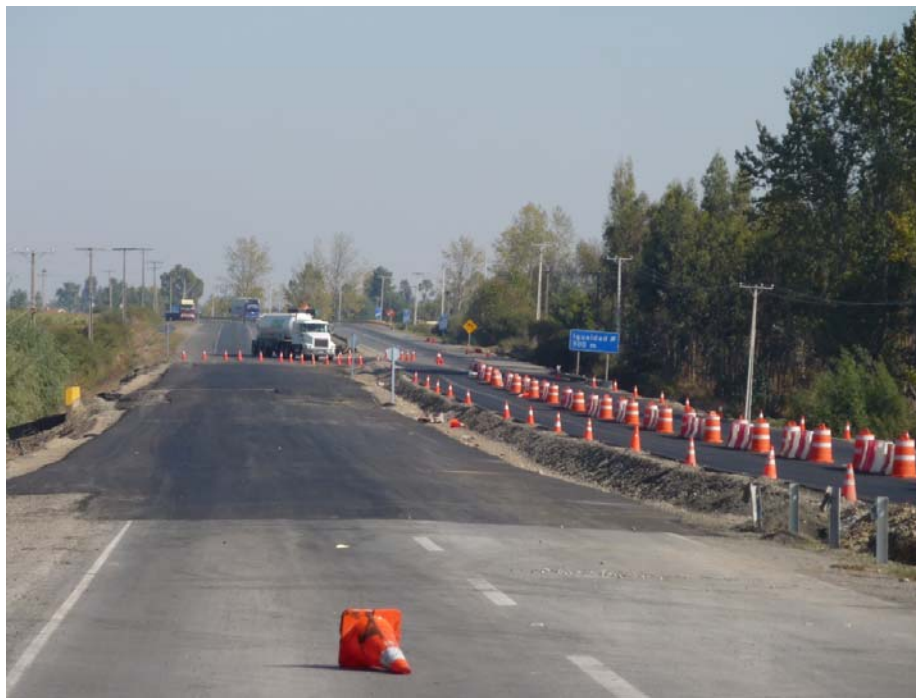
Figure 15.80 North bound lane looking south, Repaired Roadway Embankment ~5km south of Parral, Ruta 5 Sur, April 15, 2010 (36.185671°S, 71.825415°W)

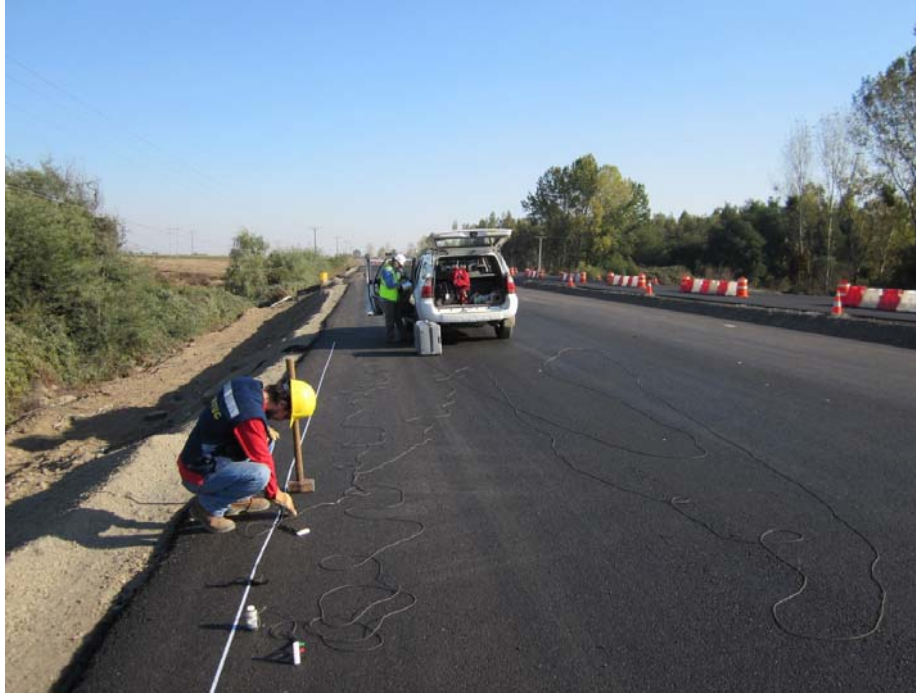
Figure 15.81 SASW line, North bound lane looking south, Roadway Embankment ~5km south of Parral, Ruta 5 Sur, April 15, 2010 (-36.185671°S,-71.825415°W).

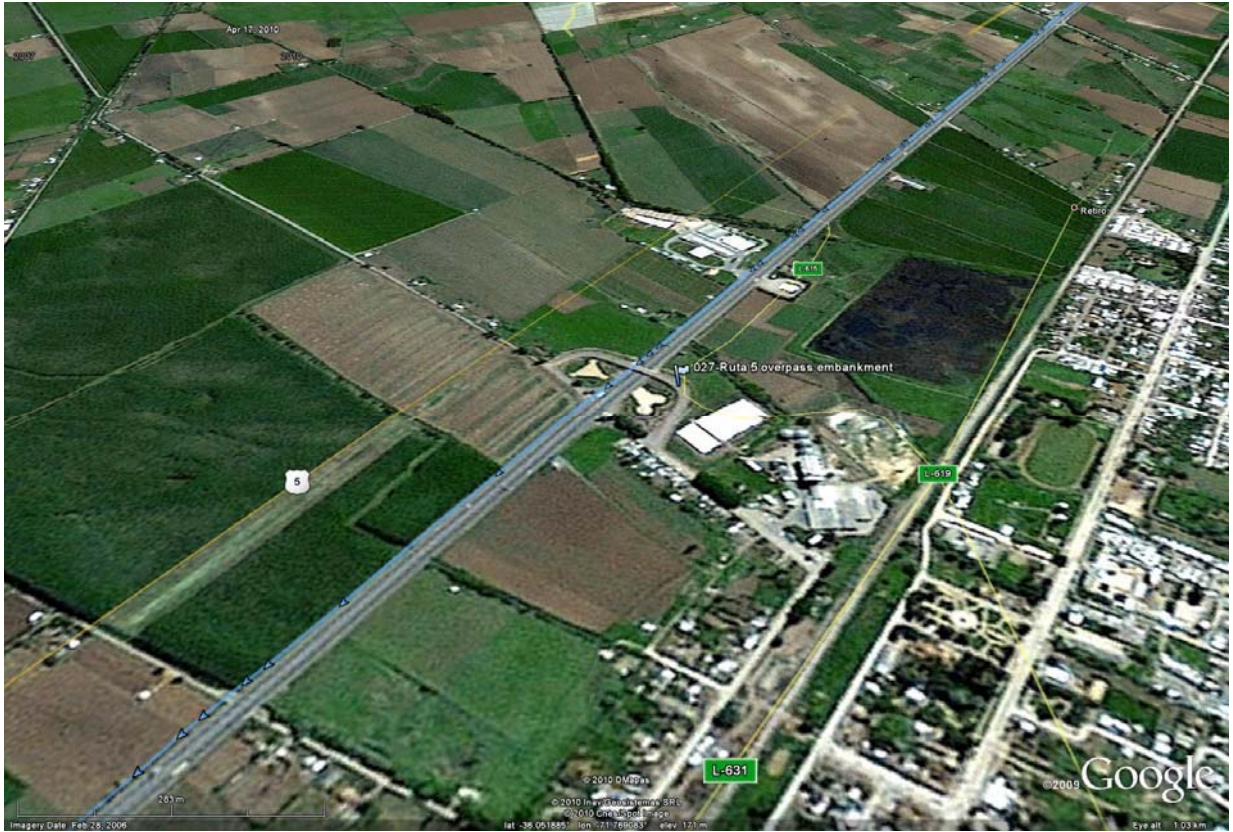
Figure 15.82 Ruta 5 Sur overpass embankment, looking north, to Retiro at Tucapel Mill (36.051209°S, 71.768005°W).

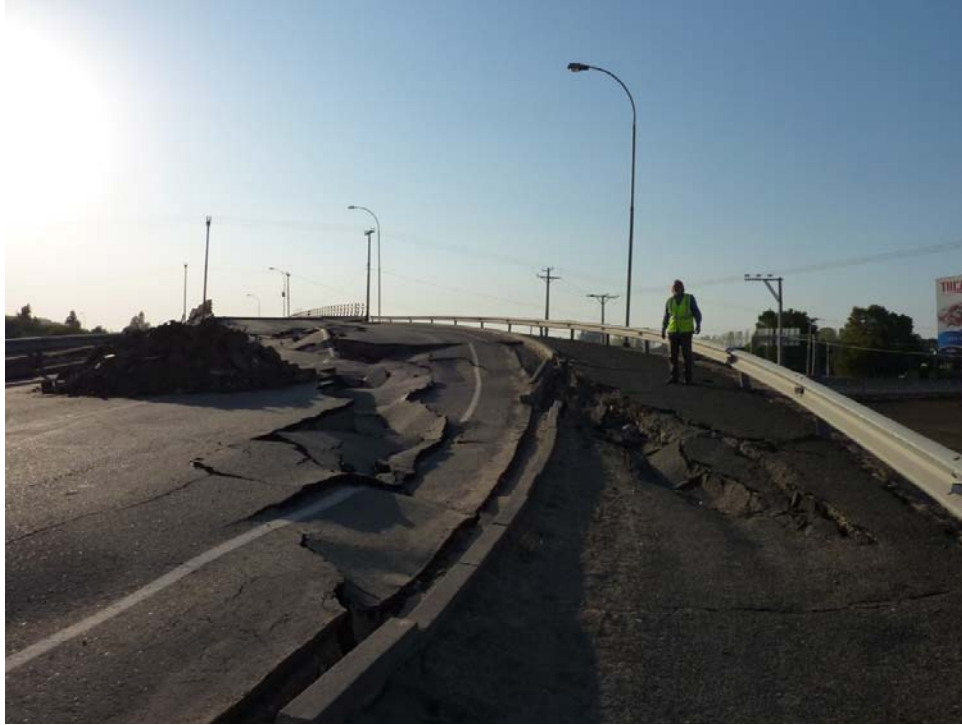
Figure 15.83 Damage to over padded embankment, Ruta 5 Sur overpass embankment, to Retiro at Tucapel Mill, April 15, 2010 (36.051209°S, 71.768005°W).

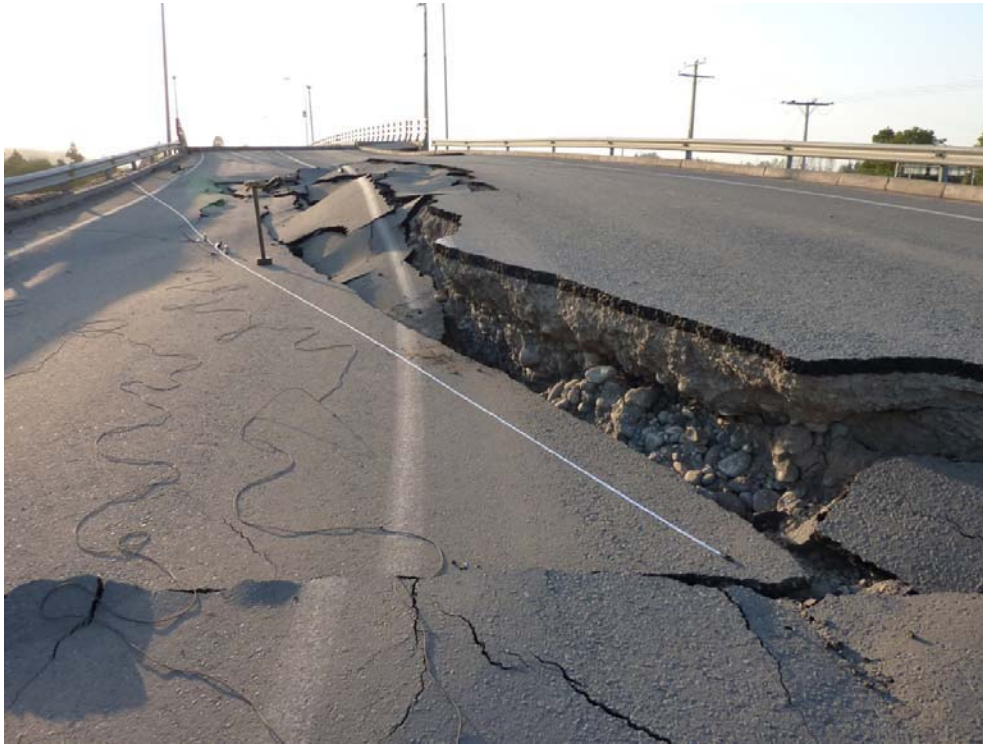
Figure 15.84 SASW line, Ruta 5 Sur overpass embankment, to Retiro at Tucapel Mill, April 15, 2010 (36.051209°S, 71.768005°W).
