AN INVESTIGATION INTO THE NON-UNIFORM DECAY OF HARDWICK STONE

Robert Brough⁴ & Elizabeth Laycock

Hardwick stone as used on the vernacular Hardwick Estate buildings decays in a non-uniform way. Typically stones at Hardwick decay cavernously leaving the mortar matrix behind. Levels of decay can vary dramatically from stone to stone with one stone showing advanced decay whilst adjoining stones are relatively intact. Ten sample buildings giving a total of 1587m² of elevations and with a good geographical spread across the estate were surveyed. Ratings were assigned according to condition. It was shown with 95% confidence that the weathering on the western elevations is significantly worse than that seen on the eastern elevations of the sample buildings. Northern elevations had high levels of stonework in good condition, while western elevations had the lowest. The prevailing wind direction on the Estate is west to north-west. The difference in levels of decay below 1 metre and above 1 metre has been shown to be significant at the 95% confidence level with a slight correlation between levels of stone decay and building height (above sea level). The survey also highlighted stone decay

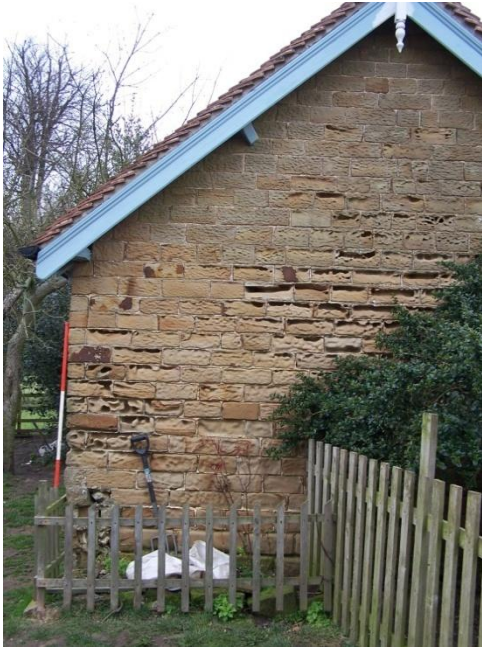
The southern elevation has the lowest proportion of stone in good condition (36%). The eastern elevation has the highest proportion of stone in good condition (69%). The average for all elevations is 55%. The northern elevation has the highest proportion of stone showing signs of decay (42%). The eastern elevation has the lowest proportion of stone in this category (24%).

Figure 2: View of southern elevation Norwood Piggeries

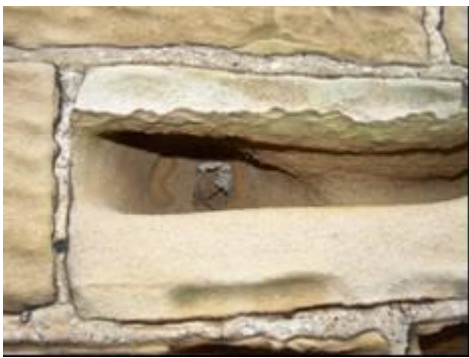
Figure 3: Example of cavernous weathering, southern elevation Norwood Piggeries

Figure 33 is a detailed photograph of one of the stones exhibiting cavernous decay in the southern elevation of Norwood Piggeries. In this photograph it is possible to see that the cavern passes right through the stone and it is possible to see mortar and the rubble core behind.

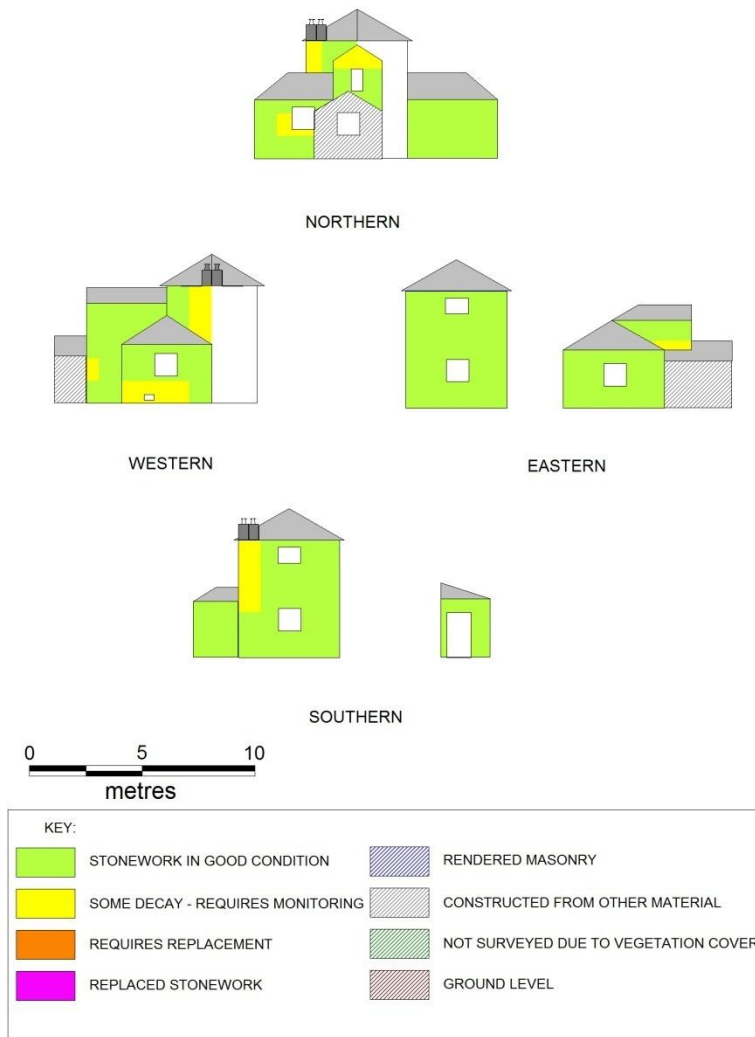
ROWTHORNE LODGE ELEVATIONS

Figure 4: Elevations of Rowthorne Lodge

The western elevation has the lowest proportion of stone in good condition (74.5%). The eastern elevation has the highest proportion of stone in good condition (98%). The average

proportion of stone in good condition for all elevations is 88%. Apart from the flues the other locations where there is stonework showing signs of decay are on the northern gable, around the cill on the northern elevation and mainly at low level on the western elevation.

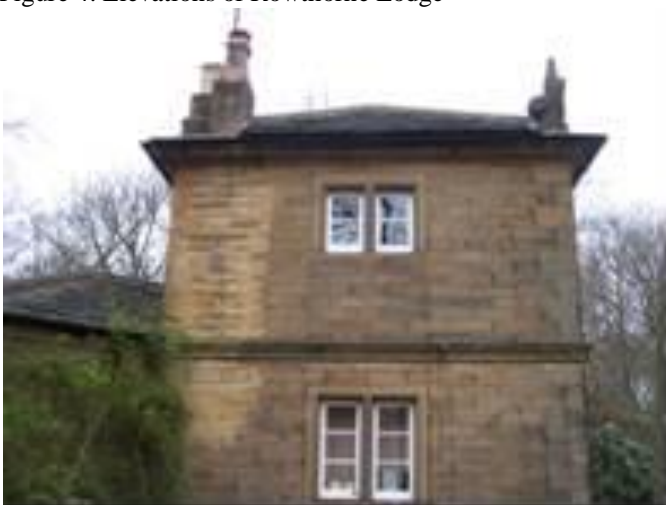
The National Trust vernacular building survey for Rowthorne Lodge states that it was constructed in approximately 1827 (National Trust Vernacular Building Survey - Rowthorne Lodge, 1997, p.1). The central protruding section of north elevation has been extended at ground floor level at some point and is not built with Hardwick Stone. This building, although small, was finished to quite a high standard. It is generally in good condition, and there is no stonework in the worst two categories i.e. needs replacing or has been replaced. The stone showing some signs of decay on upper levels follows the path of the flues due to combustion by-products. The roofs have a slight overhang, this is more pronounced on the roof over the central two-storey section. Figure 54&5 show how the exterior stone decay appears to follow the path of the flue.

Figure 5: Stone decay along route of flue

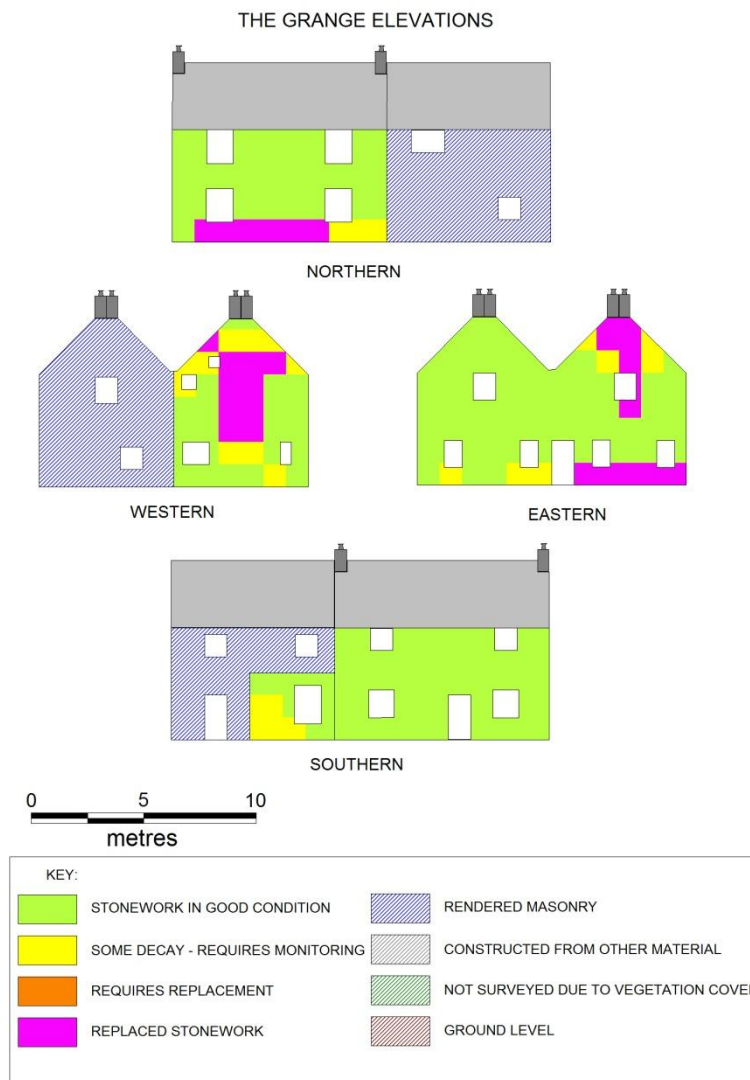
Figure 6: Elevations of The Grange

The elevation with the highest proportion of stone in good condition is the southern elevation (92%), the western elevation has the lowest proportion of stone in good condition at 52%, with an average over all the elevations of 77%. The western elevation has the highest proportion of stone that is showing signs of decay (22%) and also the highest proportion of stone that has been replaced (26%).

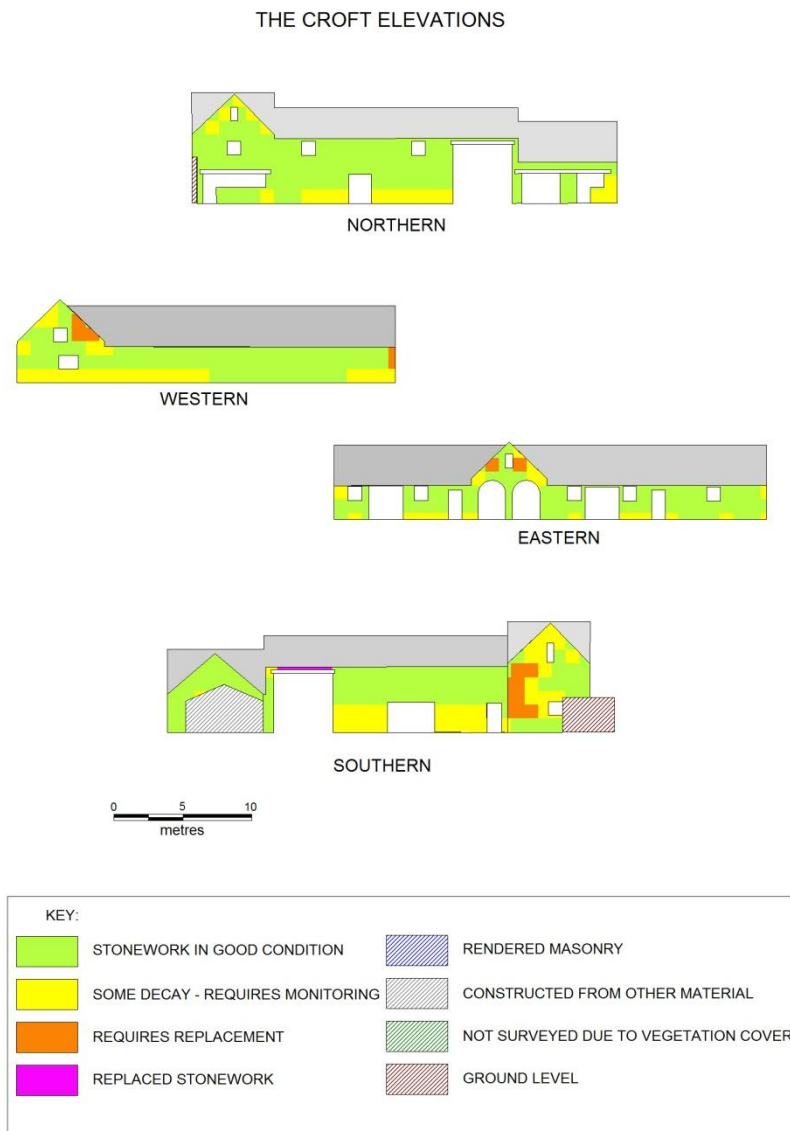
Figure 7: Elevations of The Croft

The elevation with the lowest proportion of stone in good condition is the southern elevation (64%), whereas the highest proportion of stone in good condition was observed on the northern elevation (83%) with an overall average for all elevations of 73%. The southern and western elevations have higher than average figure for stone showing some signs of decay, 28% and 27% respectively. The southern, eastern and western elevations all have some stone requiring replacement, whereas the northern elevation does not. In the case of The Croft Courtyard, both elevations have a low proportion of stone in good condition. The eastern elevation has 44% in good condition, the western elevation fairs slightly better at 52%. The average for these two elevations is 51%. The eastern elevation has a high proportion of stone that is showing some decay (56%), whereas the western elevation has 39% in the same category. The western elevation also has 9% of its stone requiring replacement.

One of the most striking features of this elevation mapping is how the spread of stone showing signs of decay appears to occur high up in the building, towards the southern end of the western elevation which may be attributable to the fact that the southern end is the open end of the courtyard and therefore this part of the building is least protected. Decay at high levels in the elevations can also be seen on the eastern gable of the southern elevation in Figure 7. Another feature of the pattern of stone decay on The Croft is that decay appears to occur on the gables of the buildings parallel to, but offset from, the roof line. This is not shown perfectly by the elevation mapping because the elevations have been split into 1m grids.

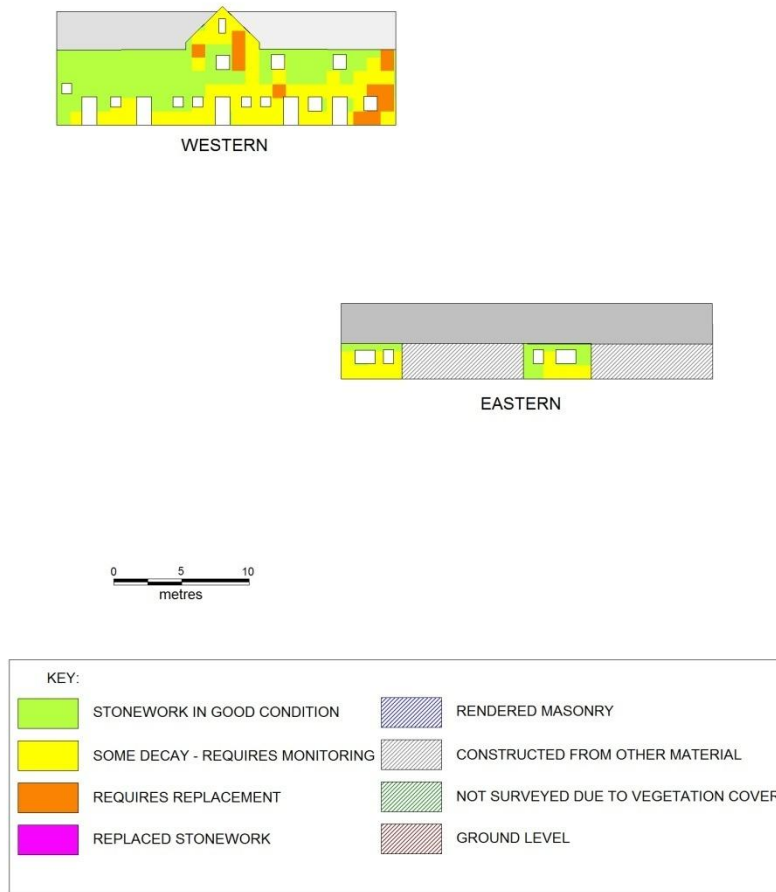
THE CROFT COURTYARD ELEVATIONS

Figure 8: Elevations of The Croft Courtyard

The roofs of the Croft building are dual pitch covered with stone slates. They do not overhang any of the elevations to any significant degree. There are multiple openings to the elevations performing a variety of functions. The condition of the stonework in the elevations varies. The elevation in worst condition is the western elevation of The Croft Courtyard.

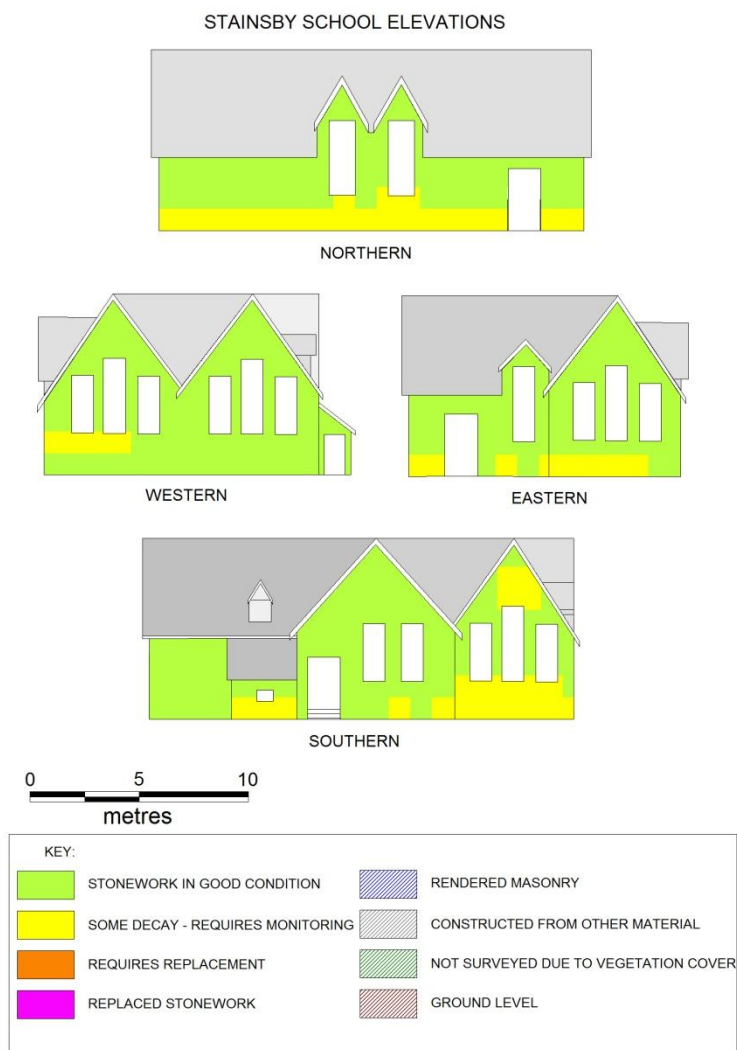
Figure 9: Elevations of Stainsby School

The building is of single storey construction with an overhanging clay tile roof. There are large windows to all elevations with projecting stone cills. Overall the stonework is in good condition. There is no stone in the worst two decay categories and much of the stone is in good condition. Where there are signs of some decay this tends to occur at low level except for some to a gable on the southern elevation and some under a cill on the western elevation. All elevations have high proportions of stone in good condition. The highest proportion occurs on the western elevation (93%), the lowest on the northern elevation (69%). The average for all elevations is 80%. The northern elevation has the highest proportion of stone that is showing signs of decay (31%). The western elevation has the lowest (7.5%)

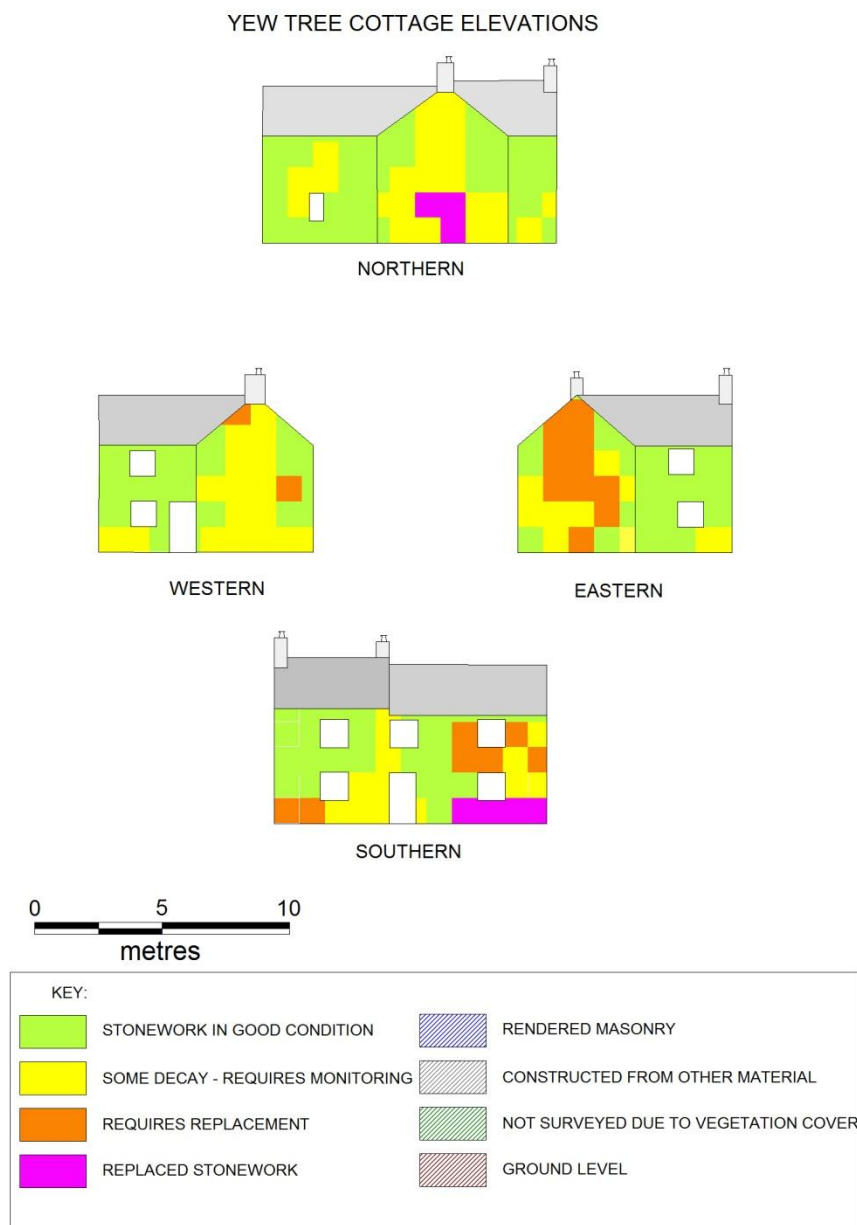
Figure 10: Elevations of Yew Tree Cottage

This may mean that the stone in this building is slightly different to the stone used in other buildings in the sample. It does display the same weathering characteristics however. Figure 10 illustrates the severity and spread of stone decay at Yew Tree Cottage.

The proportions of stone in good condition is low for all elevations, the worst elevation being the southern elevation (48%) and the best being the northern elevation (55%). The western elevation has 50% of stone in good condition and a further 45% showing signs of decay. This leaves 5% requiring replacement. The eastern elevation has the lowest proportion of stone showing signs of decay (23%), but has the highest proportion of stone requiring replacement (27%). The southern elevation has the highest proportion of stone that has been replaced (9%).
