Remote Inspection of a 46 Year Old Buried High Level Waste Storage Tank

Author: J. B. Elder

Savannah River Technology Center
NDE and Materials Reliability
Materials Technology Section

April 22, 2003

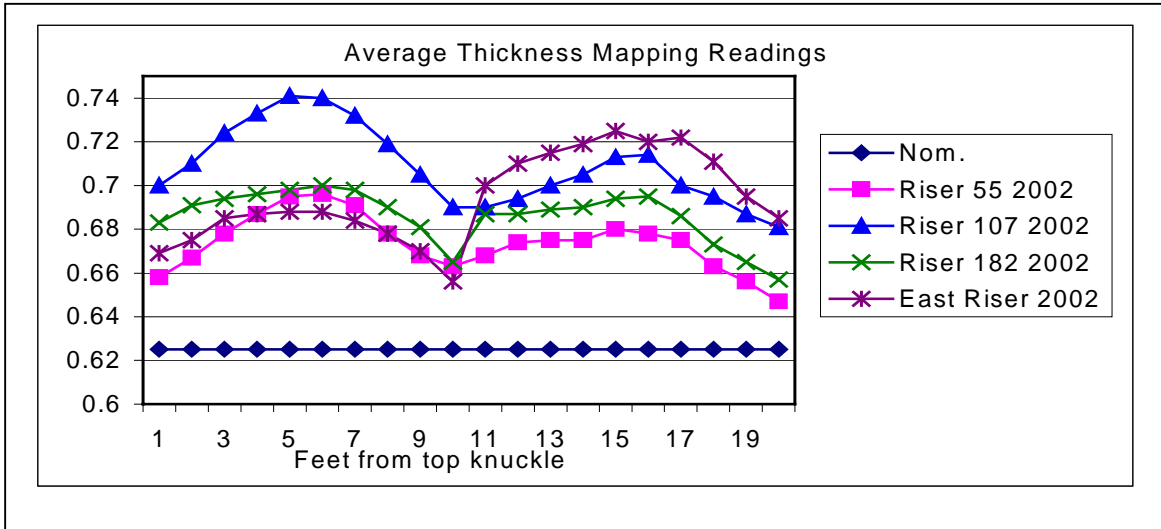
Figure 9: Average Thickness Summary Plot

Thickness mapping was performed on 1% of the circumference of the tank for the entire accessible height of the tank (see Figure 9). These thickness mapping examinations were performed to detect and measure any general wall loss, pitting or interface attack in all regions of the tank including the vapor space. The measurements demonstrate the variability in plate thickness and show that most plates were thinner at the edges than at the interior. However, in spite of the obvious variations in thickness, no reportable wall loss or pitting was detected.

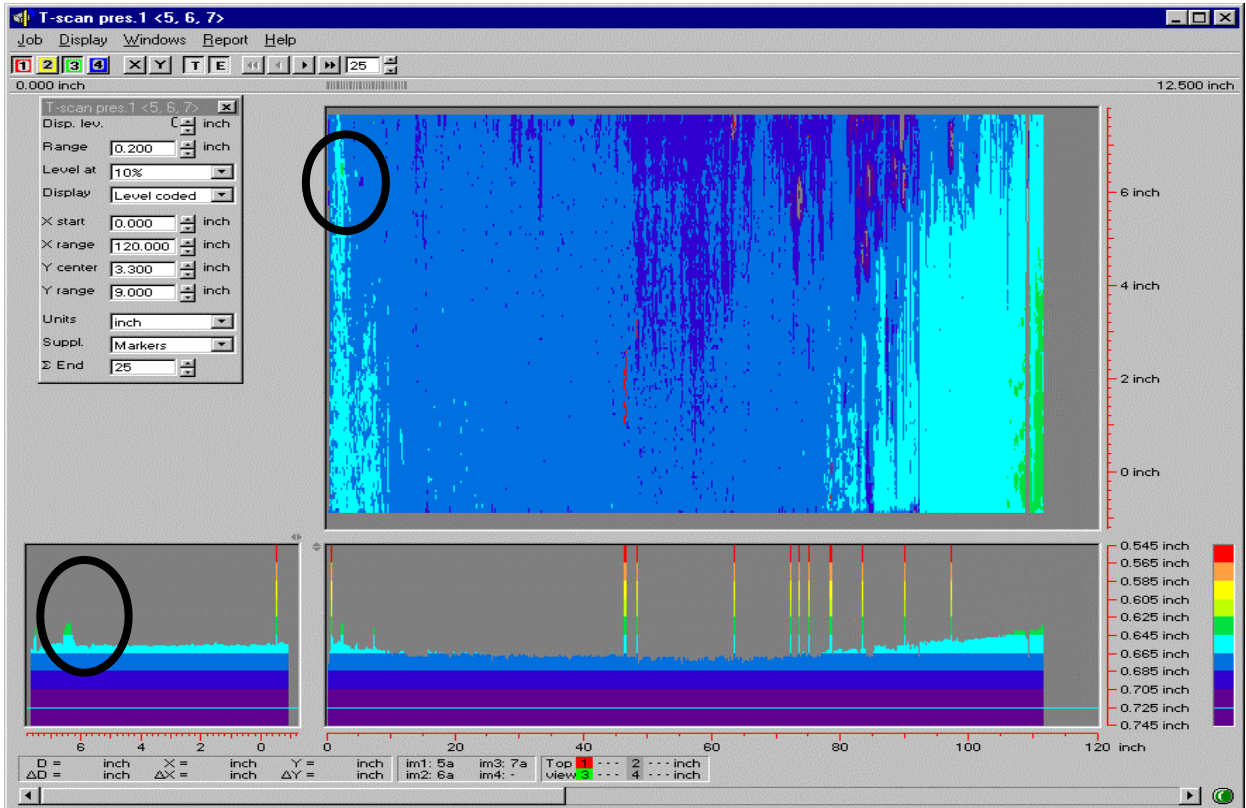
Figure 10: Thickness Mapping Image of Lower Plate, Riser 55

Inspections of Tank 15 through riser IP 55 included one vertical strip for the entire accessible height of the tank. No reportable losses in thickness or pit indications were detected in the vertical strip. The minimum thickness detected in the upper and lower plates was above nominal plate thickness. The minimum thickness detected in the upper plate was 0.639 inch and is near the edge of the plate toward the middle weld. The minimum thickness detected in the lower plate was 0.632 inch. This minimum thickness was detected over an area that was a 0.25 x 0.40 inch and provided an indication approximately 2.5 inches from the middle weld. The minimum thickness at the bottom of the same plate was 0.634 inch. The indication, inside the black circles on Figure 10, was approximately 0.030 inch deep. The image in Figure 10 also shows the plate is thinner at the edges. There are several noise spikes shown in the side and end views. These noise indications were evaluated and determined to be non-relevant. No crack-like indications were detected in this strip.

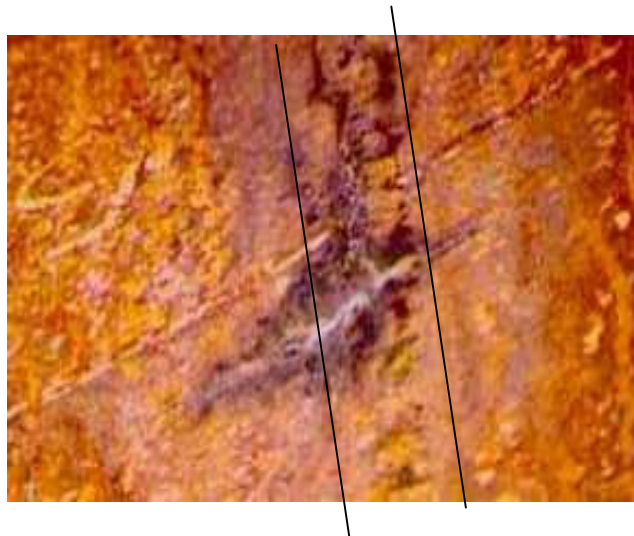
Figure 11: Visual Image of Crack in Upper Plate Vertical Weld, Riser 55

A previously identified leak site in the upper plate vertical weld under riser IP55 was examined. The leak site was 200 inches above the tank bottom and is illustrated in Figure 11 and UT examinations were performed on the side of the weld opposite the riser. The UT examination demonstrated the leakage had been from a through wall crack and further showed a partially through wall crack segment. The through wall portion on the right side of the weld was 1.4 inches long and the total length on that side of the weld was 3.7 inches. Figure 12 shows some of the UT data from this indication.

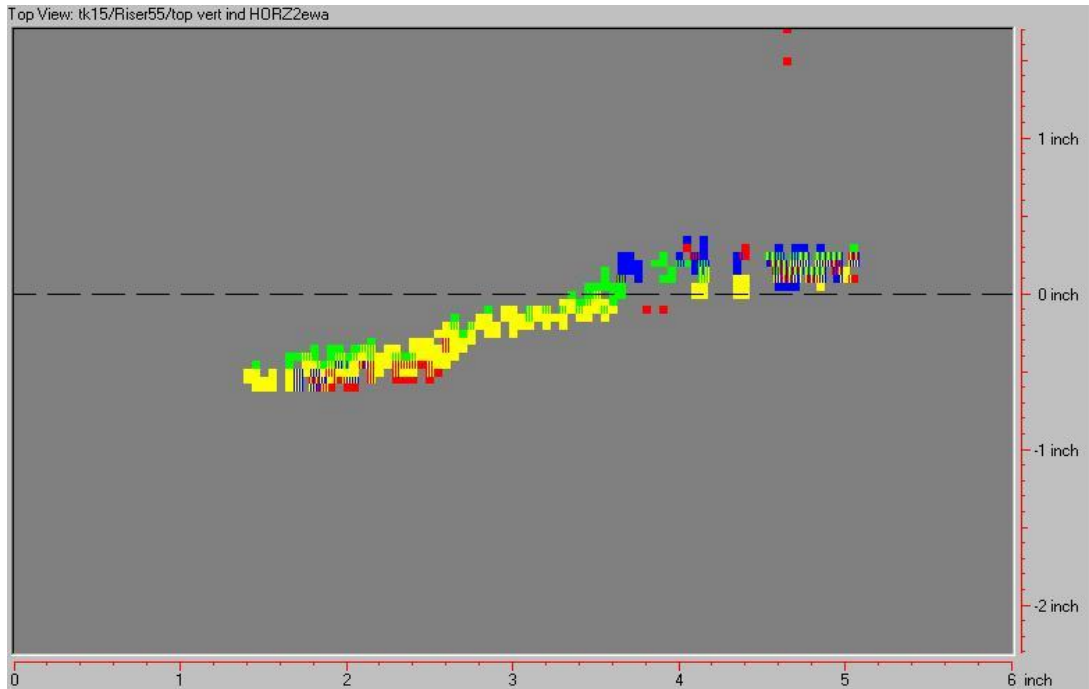
Figure 12 The UT for the Crack Shown in Figure 11

A photograph in Figure 11 is rotated to the same orientation as the P-scan data is shown in Figure 12. The photograph is rotated 180 degrees (up-side down) and the vertical weld edges are marked. Only the part of the indication on the left side of the picture was scanned during the UT examination. The through wall portion of the crack is visible in the photograph and is represented by the blue portion of the P-scan data in Figure 12. The yellow and green portions of the P-scan image indicate the part of the crack that is only partially through the tank wall. The scales on the P-scan data allow measurement of the crack length. These crack lengths (through wall and/or total crack length) are used in tank structural integrity assessments. The difference between the information gained from the visual image and the P-scan data illustrate the value of the UT inspection.

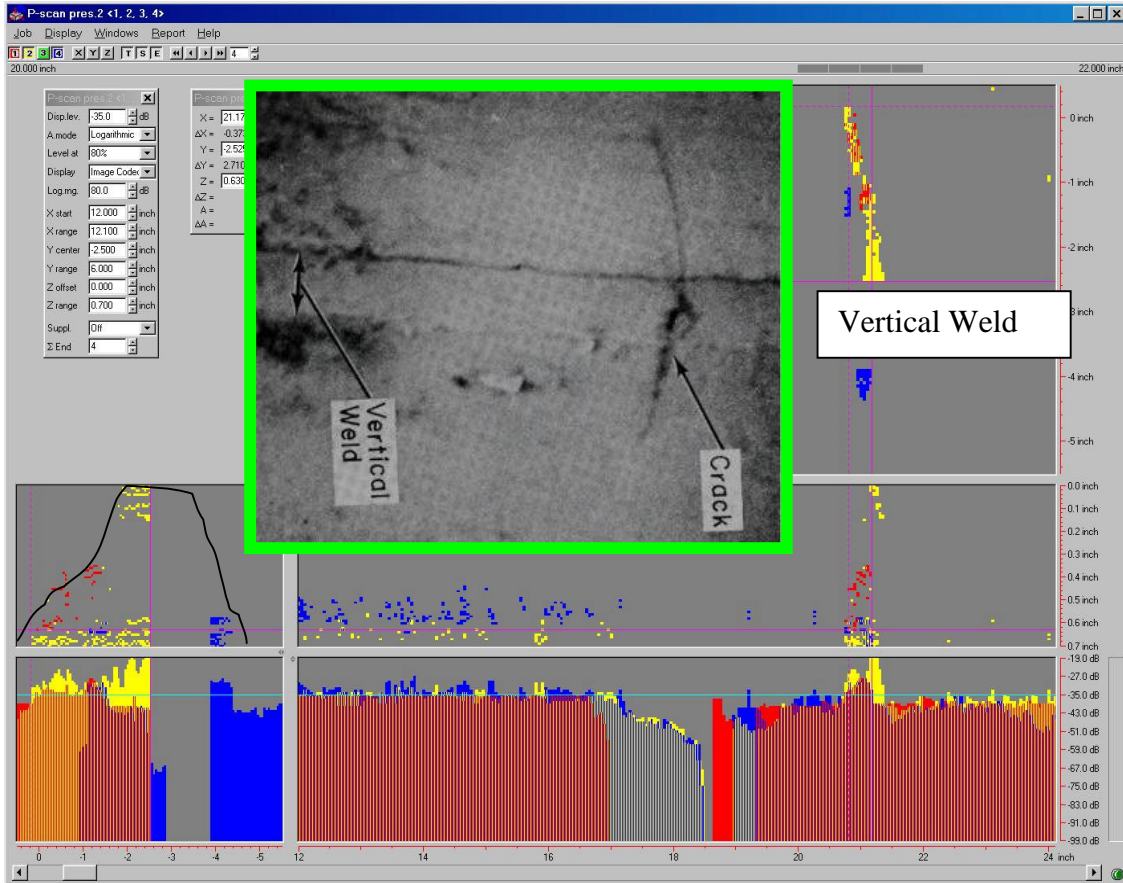
Figure 13: Image of Perpendicular Crack With Liquid Penetrant Results Overlay

The UT inspection also revealed previously undetected indications in the lower plate vertical weld. The through wall indication (see Figure 13) measured 4.5 inches total length and was very similar to stress corrosion crack sites that had been previously identified. The photograph overlay in Figure 13 is from a liquid penetrant inspection that identified stress corrosion cracking in a similar tank in 1962. The recently detected crack is nearly identical to the crack from 1962.

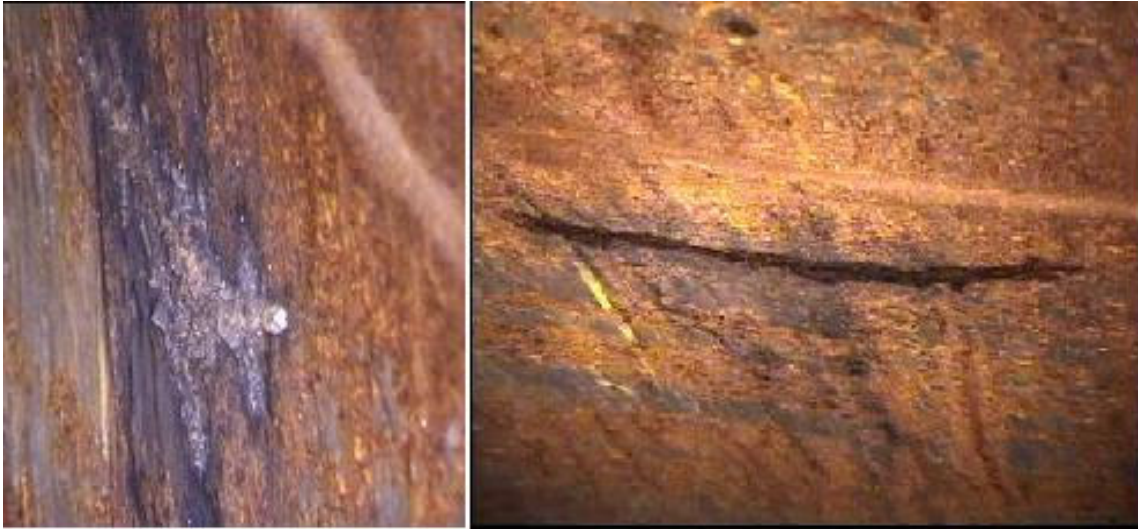
Figure 14: As-Found and Bleed-out Image of Crack at 192 feet, Middle Horizontal Weld

The previously leak site at 192 feet is a horizontal/arched crack in lower plate. The UT examination showed that this crack was associated with a weld repair. The through-wall portion (verified visually with bleed-out technique) of this crack was 10.2 inches long, arch shaped and curved around a significant weld repair to the horizontal weld. The weld repair area appears to be approximately 8 inches long and centered on the through-wall portion of the crack. The total length of the indication was 18.1 inches. As shown in Figures 14 and 15, the indication is longer at the inside surface than on the outside and the ends of the indication are multiple, shallow (partial through-wall) crack branches. This condition was also noted on the indication at 207 feet.

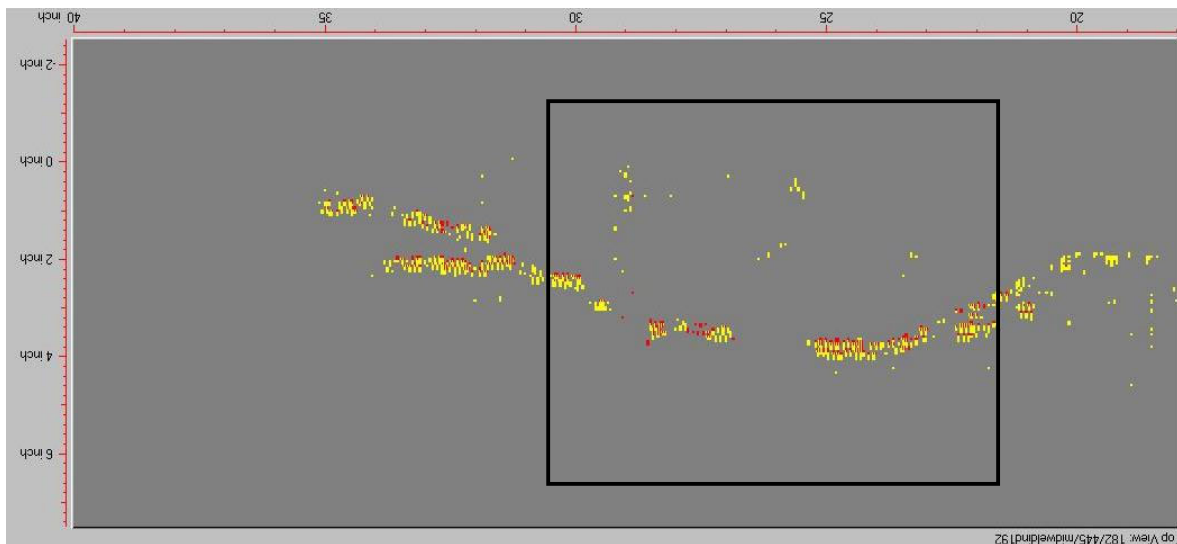
Figure 15: P-scan Image of Crack at 192 feet, Middle Horizontal Weld

Through wall part of crack (shown in Figure 14) inside boxed area. P-scan image rotated to same orientation as visual image.
