**Ferguson, David and Catterson, Victoria M. (2015) Designing for reliability in wind turbine condition monitoring systems. In: EWEA 2015 Annual Event, 2015-11-17 - 2015-11-20, Paris expo Porte de Versailles. ,**

# Designing for Reliability in Wind Turbine Condition Monitoring Systems

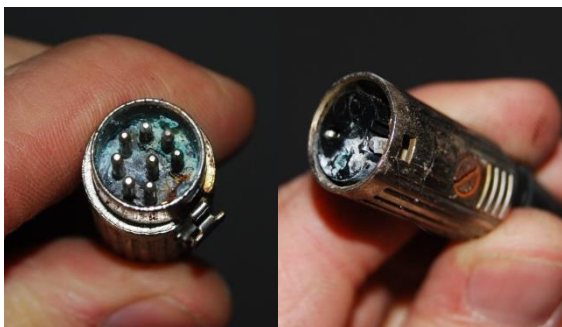
On decommissioning the CMS several factors were found that could have caused signal degradation. One of these factors was the build-up of corrosion on the pins within one of the connectors. It is notable that the sensor with this corrosion was located at the hub of the wind turbine where the main shaft enters the nacelle. This increased corrosion may be the result of increased moisture levels at the hub where precipitation can more easily penetrate the nacelle.

**Figure 1: Connector corrosion**

As can be seen from Figure 4 the connector panel was brought inside of the main enclosure which will reduce the chances of moisture entering at the connectors which could result in corrosion. The sensor cables enter the enclosure via a brushed entry system which although reduces the enclosure's ability to prevent water from powerful jets it will still prevent large volumes of dust entering. To prevent any moisture ingress through drips from above a rubber seal with a flap which extends over the cable entrance was fitted to the enclosure.

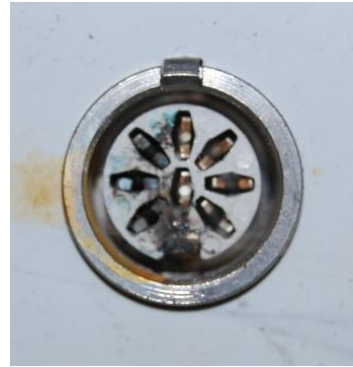
It was also noted that on the junction box for the weather instruments one of the connectors had signs of sparking. There are several explanations as to why this may have happened. One explanation and the most likely is that a build-up due to corrosion caused a short circuit between the terminals resulting in over-currents. Another explanation may be that (prior to any corrosion) moisture had seeped in, possibly due to rainfall, and this caused short circuiting between the terminals.

**Figure 2: Connector sparking**

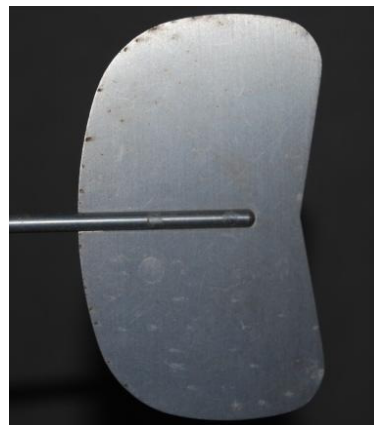
An observation made when removing the weather instruments from the met mast bracket was that the mast had been struck by lightning. A lightning rod that had been welded to the met mast was no longer present and there was evidence of hot sparks from markings on the fin of the wind vane. It is believed that the extreme currents and heat caused by the lightning strike had caused the weld to fail and thus allow the lightning rod to break off.

**Figure 3: Wind vane following suspected lightning strike**

As discussed in the previous section the lightning rod that was attached to the met mast was knocked off by a lightning strike. It was decided that for the new system it would be better not to have a lightning rod at all on the met mast. The reason for this was that unless the rod was fully capable of absorbing the full lightning strike and diverting the extreme current into the wind turbine's lightning system, it would do more harm than good by attracting a lightning strike. Since there was already a lightning rod on the wind turbine's own existing met mast, which sits higher than the new met mast, it would be better to allow it to absorb the lightning strike and direct the over-currents down the wind turbine's lightning protection system. Another precaution taken with regards to lightning strikes is that every part of the CMS equipment is well grounded so that any over-currents that they are exposed to can find an easy path to ground in order to prevent any damage to crucial parts of the system.

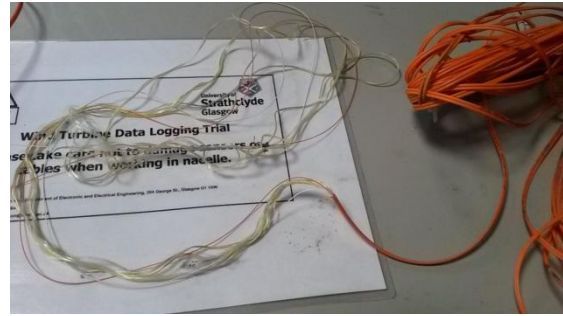
On uninstalling the system from the wind turbine it was discovered that the fibre optic cable had snapped. The way in which the cable was frayed suggests that the cable had snapped after coming under excessive strain as opposed to general wear and tear. It was therefore obvious that this break of the fibre optic cable had resulted in the loss of communications between the enclosure in the nacelle and the enclosure at the base of the tower. This was in fact the second fibre optic cable that had broken this way. It is believed that the reason for this breakage was due to a lack of slack in the cable. The fibre optic cable ran down the tower alongside the four power cables which are separated by a circular spacer. This spacer allows the cables to twist at the same time as the turbine yaws and prevents them from coming under excessive strain through twisting.

**Figure 4: Frayed fibre optic cable**

Fibre optic cable by its nature does not have a lot of flex in it and therefore when subjected to excessive strain will break relatively easily. To prevent the fibre optic cable from coming under excessive strain it must be installed in a way that allows it to have enough slack in it to prevent over straining yet be secured in the right places to avoid any one part bearing the weight of the cable below it. Where possible any new fibre optic cable being installed should follow as closely as possible the path of the existing fibre optic cable which is used for the wind turbine control communications. The most likely location in the wind turbine for the fibre optic cable to come under excessive strain is at the yaw deck. It is therefore crucial within this area to leave sufficient slack to be taken up as the wind turbine yaws. A turbine will typically be able to yaw two complete rotations in either direction before it corrects itself.

As stated previously the fibre optic cable was susceptible to coming under excessive strain causing it to break and therefore prevent data from being sent to the Ethernet data storage drives. To reduce this risk the routing and fixing of the cable was revised. Break points have been added to the fibre optic cable by way of patch cables and couplers. These break points have been added at the locations most susceptible to excessive strain. If the fibre optic cable comes under excessive strain the coupler will allow the main cable and patch cable to separate and avoid a breakage. In addition to the break point a spare fibre optic cable will be installed but not connected. If the one cable is damaged then the replacement can be simply connected in, again reducing data loss.

To reduce the risk of data loss a 2TB USB drive has been incorporated into the main CMS enclosure and connected directly to the cRIO. In the case that the fibre optic cable is damaged as it was previously, the USB hard drive will allow approximately one month's worth of data to be stored locally, significantly reducing the risk of losing valuable sensor data.

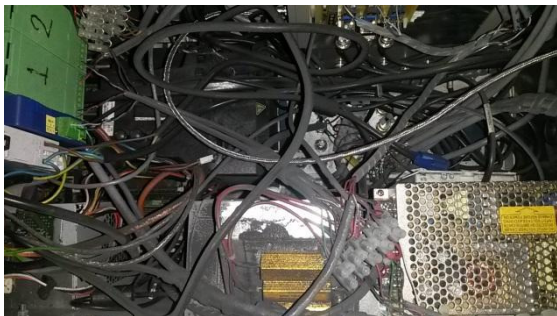
After confirming that the tower base cabinet was functioning as normal attention was moved onto the nacelle enclosure. This is the main enclosure for the CMS and houses all the crucial data acquisition hardware including a PC. On removing the enclosure cover it was found that there was a large volume of thick black dust covering everything.

**Figure 1: Large volume of dust inside enclosure**

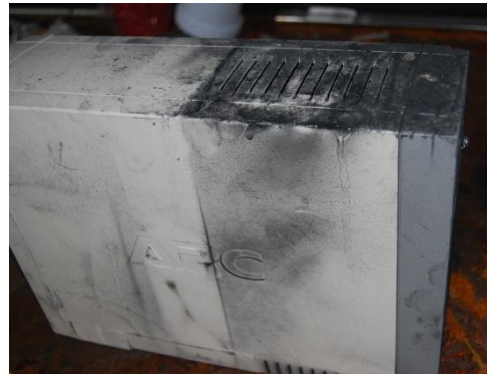
It was found that the UPS would not power on, either when supplied with external power or from a replacement battery. The UPS supplies the power to all components of the CMS within the nacelle, and therefore with it not switching on, nothing else could receive power. This behaviour suggests a serious fault with the UPS.

When the CMS was designed and built a fan was fitted on top of the UPS air inlet in an attempt to increase the circulation of cool air and prevent the UPS from overheating. However it became apparent from the level of dust within the UPS that the fan had in fact caused more harm than good by drawing dust inside of it. Part of the reason for drawing in so much dust was due to the absence of the correct fan filter which would have prevented such a level of dust passing through. However given the excessive volume of dust, even with a filter in place, airflow would soon have been

restricted as the dust saturated the filter. It is therefore believed that the dust drawn inside the UPS by the fan caused the fan to overheat, resulting in its failure.

**Figure 2: Failed UPS due to excessive dust**

By locating the UPS in a separate enclosure, the main CMS enclosure has no requirement for cooling which reduces the risk of excess dust being drawn in by fans. Mounting the UPS in a separate enclosure means that the main CMS enclosure can be smaller, lighter and have reduced electrical noise. Having an additional enclosure for the UPS means that it can also be used for the networking equipment. The enclosure now housing the UPS is mounted in an IP rated enclosure

which has fans built into it with appropriate filters to reduce the level of dust that could enter and risk over-heating. Each of the systems are also fitted with dehumidifiers to reduce moisture levels inside of them.

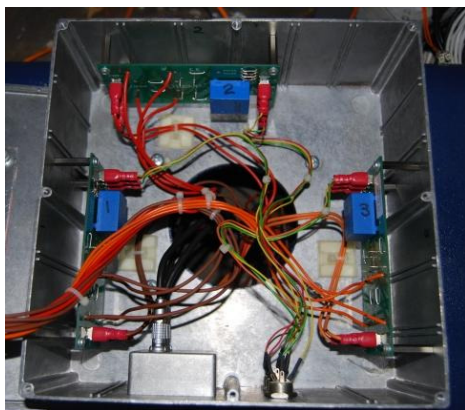
Another notable observation was the difference between enclosures that were IP rated compared to those that were not. The enclosures that had an IP rating of 56 which prevents dust and splashing liquid, had no dust inside them at all (Figure 3) compared to those that had no IP rating (Figure 1). The reason that there were enclosures with no IP rating is because they were purpose built in-house.

**Figure 3: IP56 rated enclosure**
