# Lessons Learned from Dike Failures in Recent Decades

**ABSTRACT:** *The paper describes five different dike failures that occurred in recent decades. The case histories were located on different rivers and involved different loading conditions. The observed failure mechanisms involved erosion and stability problems. The types of erosion observed were both internal erosion due to extreme groundwater flow and external erosion caused by the river flow and wave action. The case involving instability was caused by uplift, i.e., increased hydraulic head led to a sharp reduction in maximum shear strength between subsoil layers. Two cases demonstrate the importance of dike management and maintenance. Despite the variations in the loading conditions and failure mechanisms, all the cases show that the strength of a dike depends not only on the material used to build the dike but also on the strength of the subsoil.*

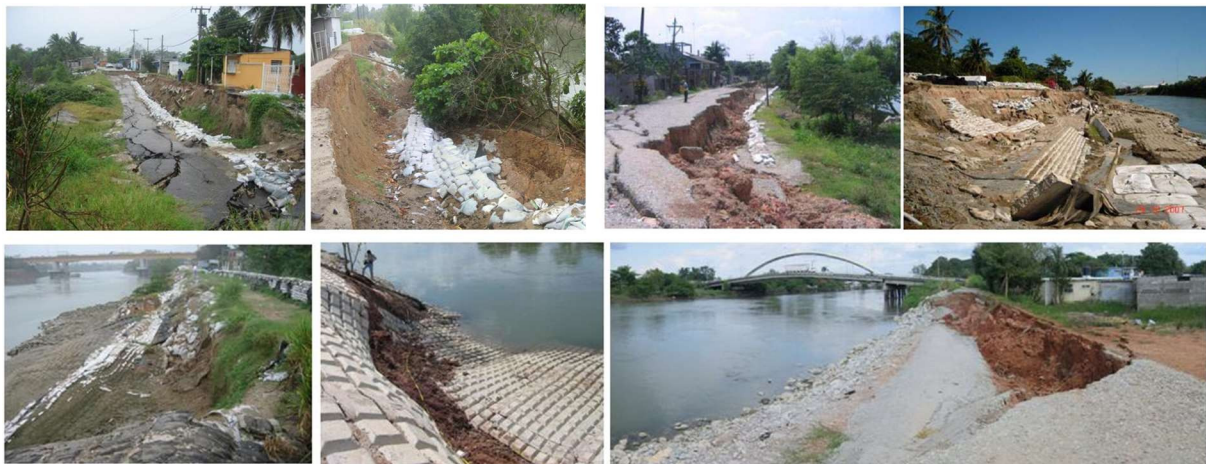
gradients generated by these fluctuations – and rain infiltration in the crests of the dikes (Figure 3). Auvinet et al. (2008) observed that problems in river banks commonly begin with erosion which, depending on the type of soil, can cause piping in some areas, possibly resulting in landslides (Figure 4). These eroded sections are generally protected with dikes consisting of clayey material. Elements that can better withstand erosion by river water are also used, examples being rock fill, systems with concrete bags (*bolsacreto* or *colchacreto*), breakwaters or sheet pile walls. River embankments may also fail when the weight of these structures exceeds the bearing capacity of the foundation soil (Figure 3). Generally, failure occurs in layers with low shear strength such as the highly compressible clays and peats which are found in unpredictable locations along the banks of the rivers in Villahermosa (Figure 1). It has also been found that factors such as scour of the riverbed and overloading caused by the weight of additional protection such as sand bags result in dike instability. In addition, intense rainfall in the region can cause large and rapid variations in the levels of local rivers, lagoons and reservoirs.

Figure 3. Consequences of water drawdown in Tabasco State, Mexico

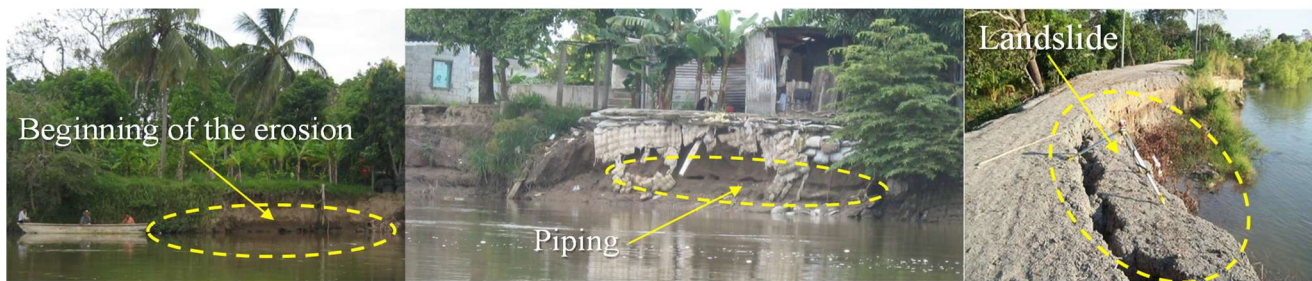
Figure 4. Evidence of instability in river banks and dikes induced by rapid drawdown in Villahermosa.

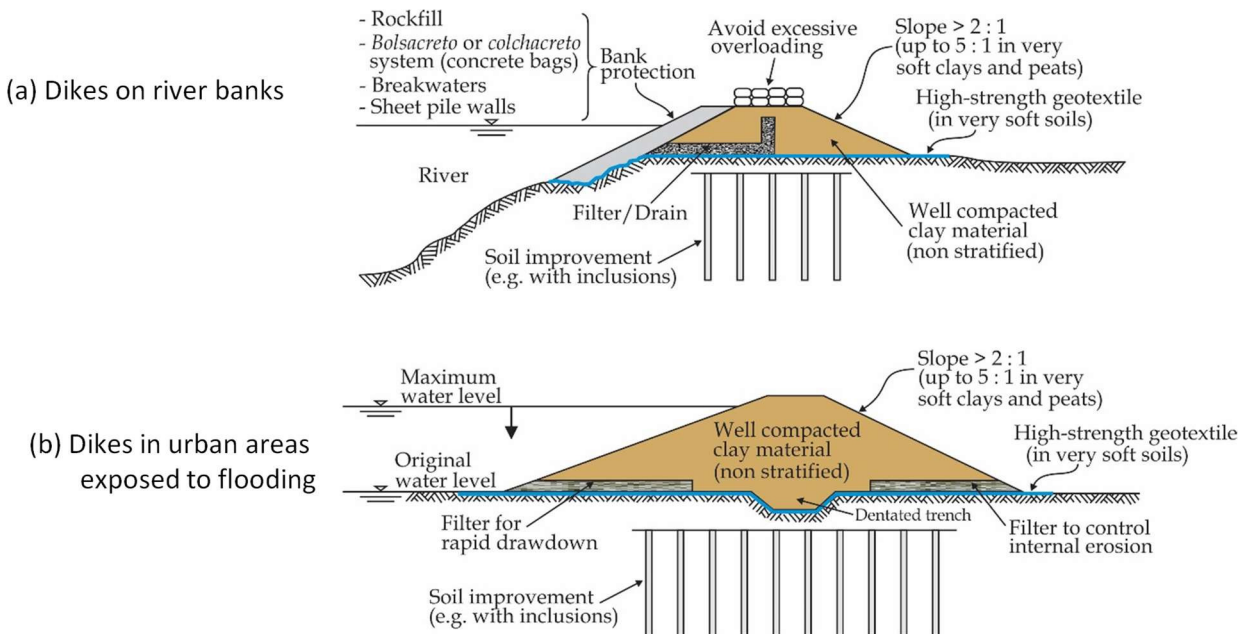
Figure 10. General recommendations to protect Tabasco dikes

This study focused on one of the main problems affecting the stability of Tabasco dikes: the water drawdown phenomenon caused by sudden changes in the levels of rivers, lagoons and reservoirs. Particular emphasis was placed on the study of exit hydraulic gradients at the toe of homogeneous and isotropic dikes. The effects of different parameters (drawdown rate, hydraulic conductivity and slope ratio) for the dikes were assessed in unsaturated, transient-state, flow analyses based on numerical modelling with the finite element method. Based on the results, it is concluded that analyses should consider the susceptibility to erosion of the material used to build the dike. However, analyses should also include measures – such as the installation of drains and filters – to reduce the hydraulic gradients and seepage forces generated inside the soil mass. The results of the analysis led to the practical recommendations shown in Figure 10, which should be taken into consideration for the protection of the Tabasco dikes.

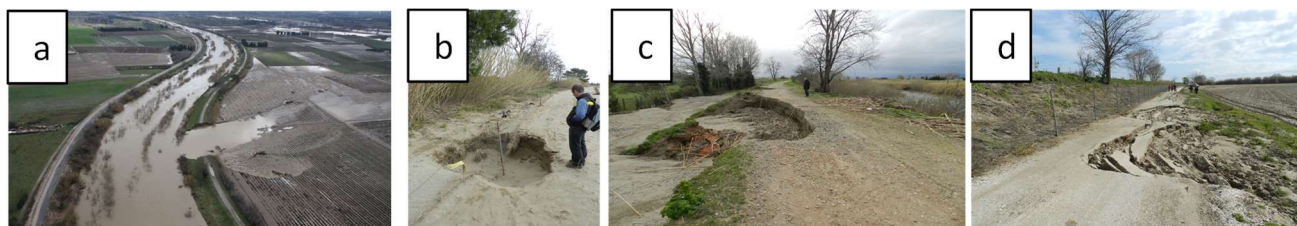
The discharge during this event is also estimated to have been approximately 1000 m<sup>3</sup>/s. There was a breach over a 75-m section in one of the areas prone to sand boils (Figure 14a). The dike itself was eroded, as well as its foundations down to the depth of the minor river bed. The exact cause of the breach is not known because there were no eyewitnesses close to the dike at the time of the breach initiation about 2 hours after the maximum discharge. The breach may have been caused by internal erosion in the dike or the foundation soils, with possible local overtopping following internal erosion and collapse. A large sinkhole was found close to the breach (Figure 14b). Significant additional damage was observed as a result of overflowing (Figure 14c), internal erosion and foundation instability (Figure 14d), as well as internal erosion in the dike itself at one location.

Figure 14. a) The March 2013 breach at the Pia location on the right of the river (photo: DREAL Languedoc-Roussillon), b) A sinkhole close to the breach (photo: Patrice Mériaux, Irstea), c) Damage caused by overflowing (photo: Patrice Mériaux, Irstea), d) Damage to a track on the landward side of the dike caused by under-seepage (photo: Patrice Mériaux, Irstea)

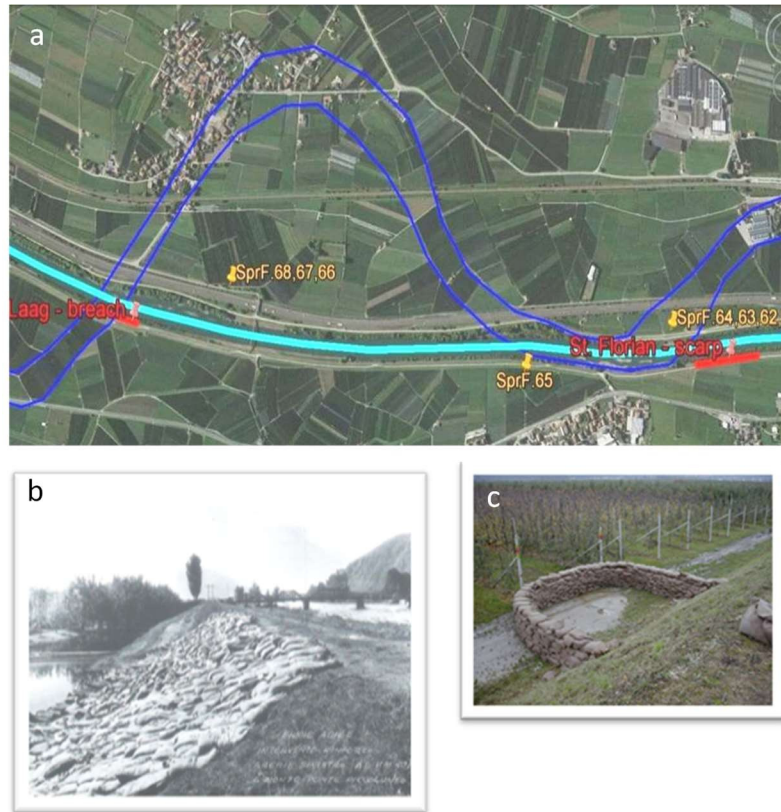
Evidence of water flowing through or underneath the embankment is provided in Figure 18b, c. Ponded backwater often accumulates during a flood event and springs form at the toe of the embankment on the landward side.

The original riverbed meandered through the Adige valley and was straightened at the end of the 19<sup>th</sup> century, as shown in Figure 18a, by constructing the current embankments. The ancient river bed is filled with material that is coarser than the surrounding clayey and silty deposits. At some places the current riverbed intersects the ancient river beds and locally the embankments are founded on the coarse-grained filling. As a result, the hydraulic conductivity of the embankment foundation at these intersections is relatively high and groundwater flows preferentially through these layers.

Figure 18. (a) Current and ancient river bed profiles and spring formation during the flood events in 1997 and 2000 (b) Backwater areas during the 1966 flood (c) Spring formation during the 1997 flood event

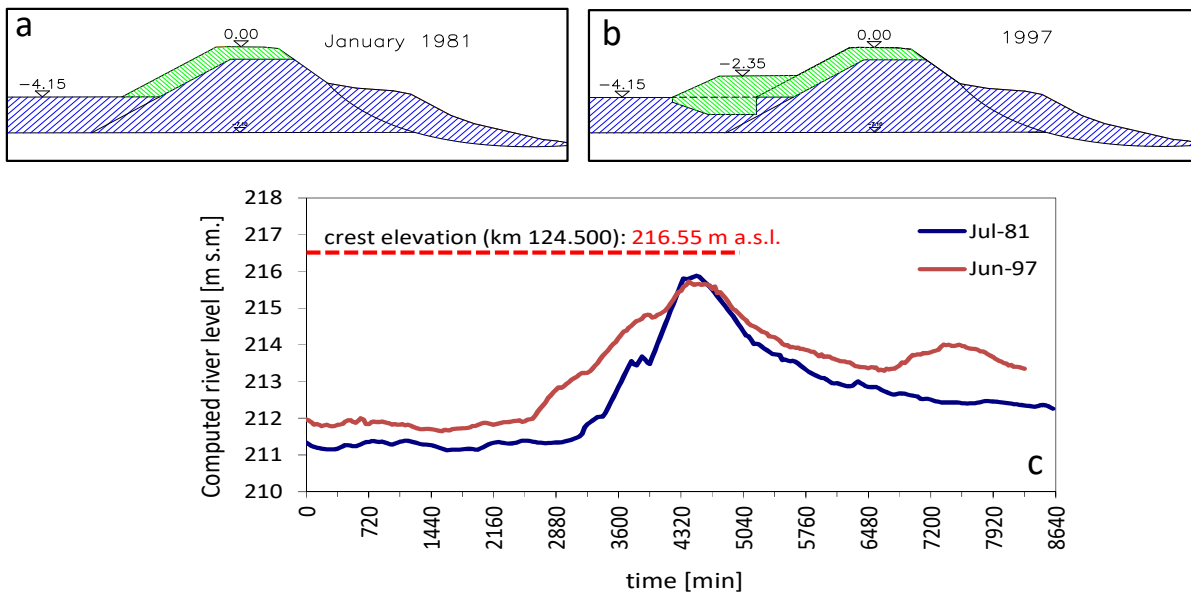
During the flood event in 1997, which was even more intense than the one in 1981 (Figure 19c) no collapse phenomena were observed in the segments that had experienced instability in 1981. This can be attributed to the construction of the berm and the increased stability on the landward side.

Figure 19. a) cross section during the flood event in 1981 b) remedial works consisting of a berm on the landward side, c) the river level during the flood events in 1981 and 1997 The elevation of the embankment crest is also reported as a reference.

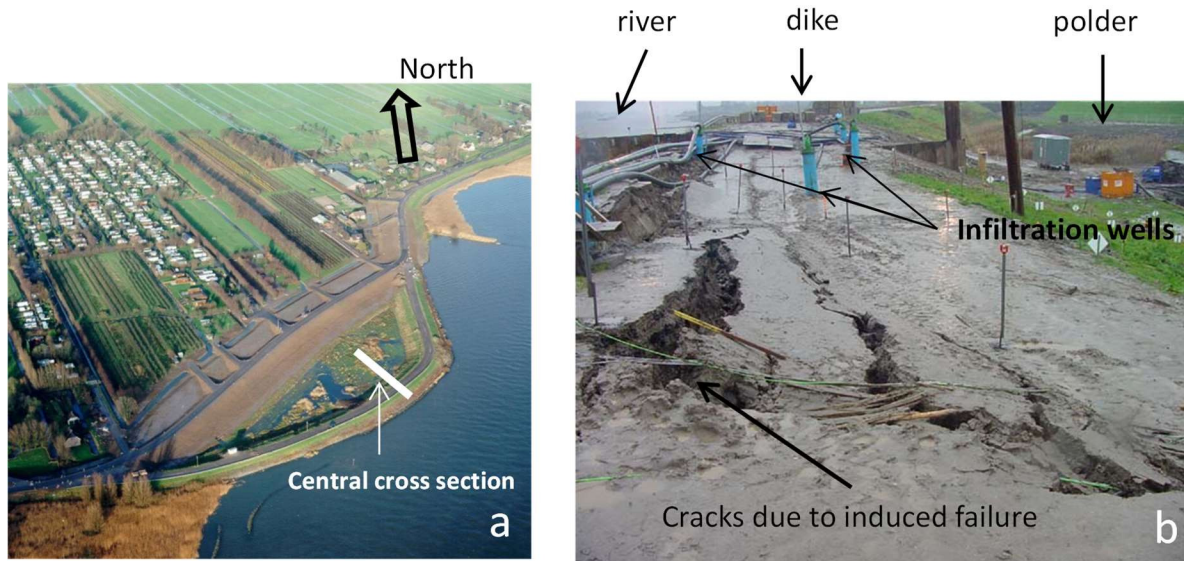
Figure 27. Test site, a; aerial photograph before testing, arrow indicates North direction, white line indicates the location of the central cross section shown by Figure 29, b; failed dike body after testing

The test began at 06.00 on 26 November 2000,  $t = 0$  in the graphs below. Figure 32 shows the river level and the average head in the nine infiltration wells. Infiltration started at  $t = 370$  min, 6 hours after the start of the test. Initially, the hydraulic head in the wells followed the fluctuations in the river level. It should be noted that the test site is close to the sea and that the tidal wave has a pronounced influence on the water level in front of the dike. Although drinking water was used for infiltration, the infiltration wells clogged up after 26 hours,  $t = 1580$  min, reducing well capacity. Due to maintenance, required to regain the full pumping capacity, the hydraulic head was seen to fall between  $t = 1580$  and 2260 min, a period of 11.3 hours (Figure 32). Maintenance was also needed between  $t = 3090$  and 3308 min, a period of 3.6 hours. Failure was observed at  $t = 3450$  min, approximately 2.5 days after the start of the test, in the form of large longitudinal cracks in the dike body accompanied by major subsoil deformation (see Figures 33 and 34). The difference in height at the location of the cracks increased to more than 1.0 m (Figure 27b).

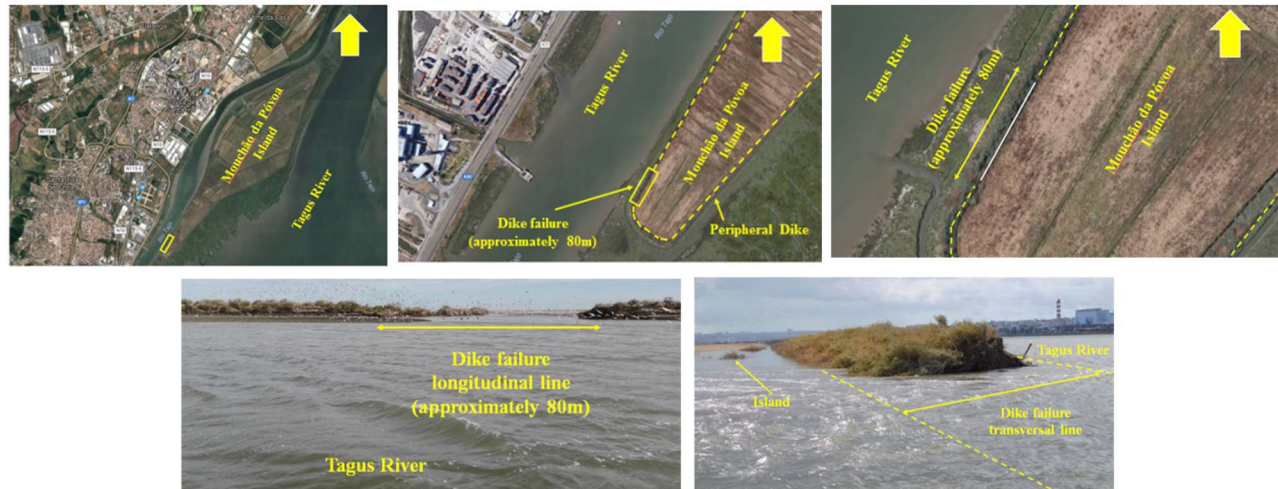
on an alluvium layer protected on the outer face by riprap (rock armour) revetment. The island has been used for agriculture for at least the last 80 years. Figure 38 provides views of the failure that occurred on March 2016.

Figure 38. Location and view of the dike failure.

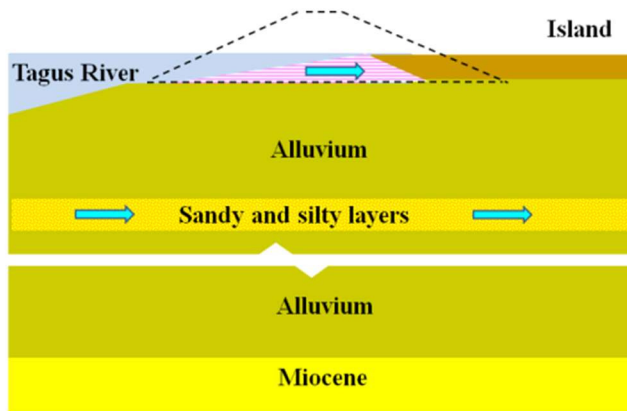
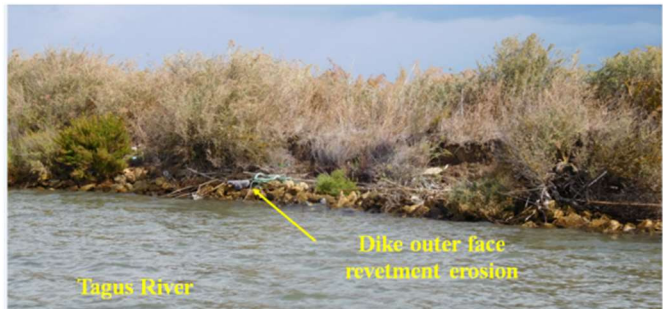
The main failure mechanism is related to the erosion of the clay fill due to water inflow and the mechanical action of the waves on the outer face of the dike. Failure originated with the erosion of the riprap revetment (Figure 39). The presence of a permeable sandy layer below the dike foundations also contributed to the failure mechanism. The actual dike failure began during the severe winter of 2015 - 2016 and involved a section with an overall length of approximately 30 m. When the failure occurred, the water level in the Tagus River was approximately Mean Sea Level, MSL, +4.20 m. In October 2016, the overall length of the dike failure line had increased to approximately 80 m.

**Dike Cross Section – Failure**  
**Failure due to the clay fill erosion (Tagus river waves start to erode the rip rap revetment)**

Figure 40. Dike failure due to the erosion of the clay fill, cross-section and view of the outer face.
