47TH TURBOMACHINERY & 34TH PUMP SYMPOSIA
HOUSTON, TEXAS | SEPTEMBER 17-20, 2018
GEORGE R. BROWN CONVENTION CENTER

Resolution of high vibration on a Generator

Baker Hughes, a GE Company

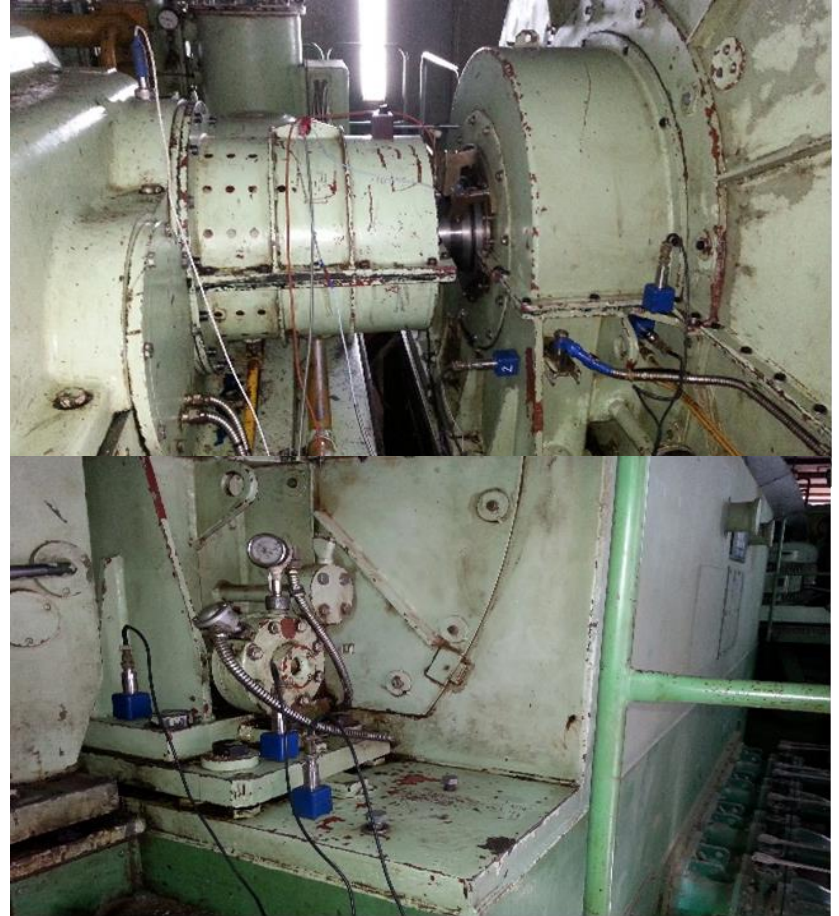
Data Analysis

- Extremely high vibration levels on the generator bearings, pedestal and foundation in the Horizontal direction reached 64 mm/sec Pk (Vertical; 7 mm/sec Pk).

1Xgenerator dominant vibration component.

mm/sec pk		Direct	1X Amplitude	1X Phase
Gen. IB	Horizontal	64	63	88
	Vertical	4.2	3	265
Gen. OB	Horizontal	30	29	65
	Vertical	7	6	238

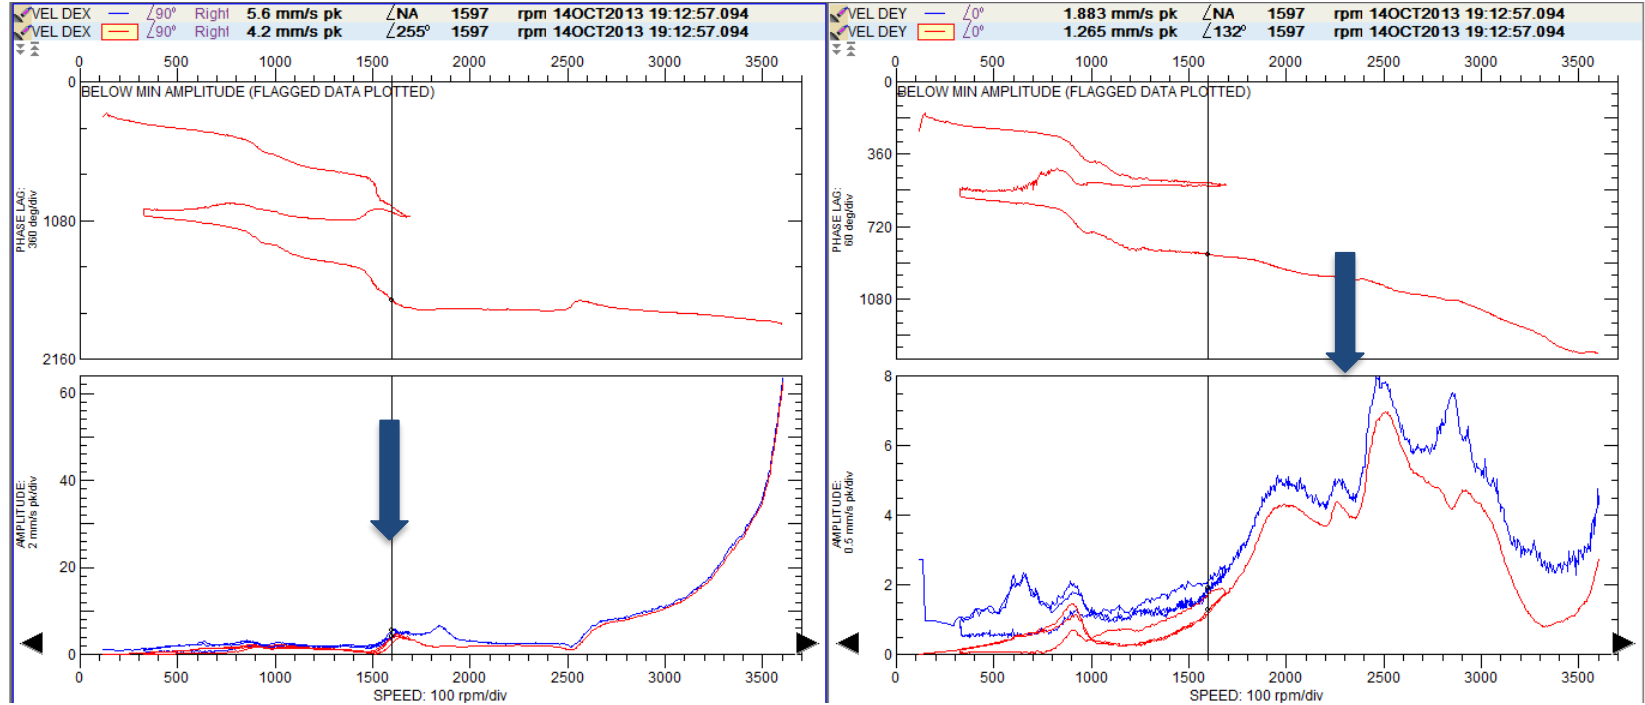
Data Analysis- Startup Bode "cont'd"

Anisotropic system was observed with big difference in the stiffness between horizontal & vertical axes $\Omega = \sqrt{K/M}$

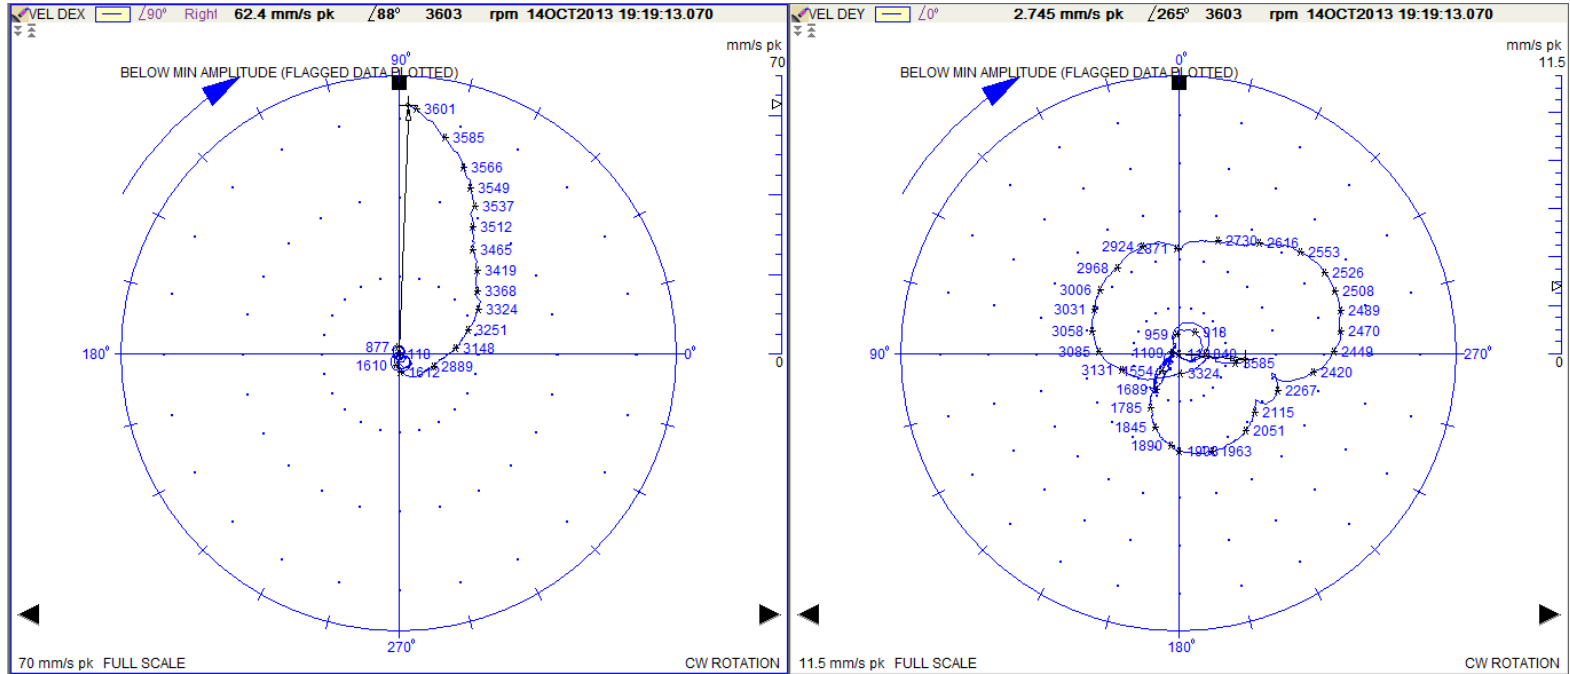
Data Analysis- Startup Polar “cont’d”

Anisotropic system was observed with big difference in the stiffness between horizontal & vertical axes $\Omega = \sqrt{K/M}$

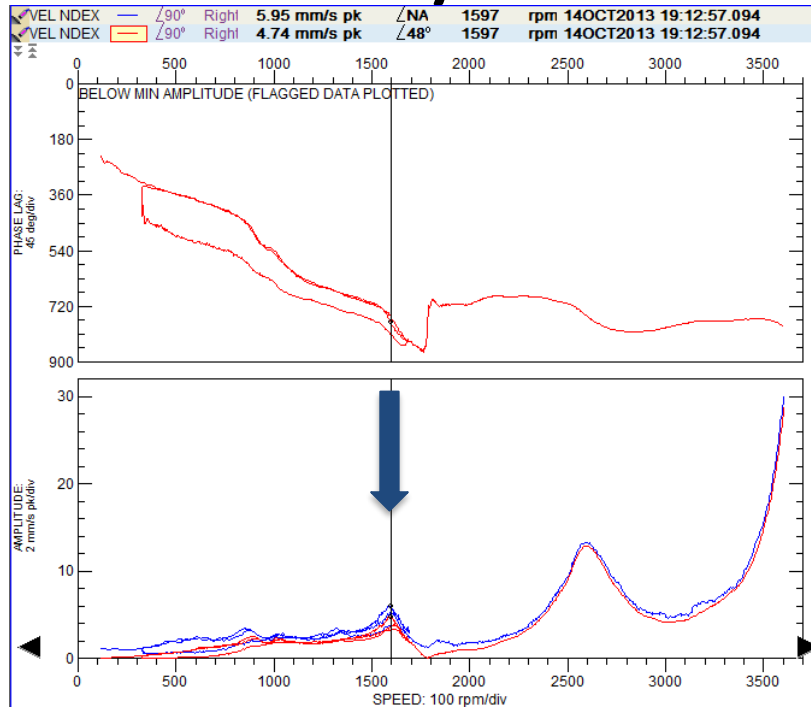
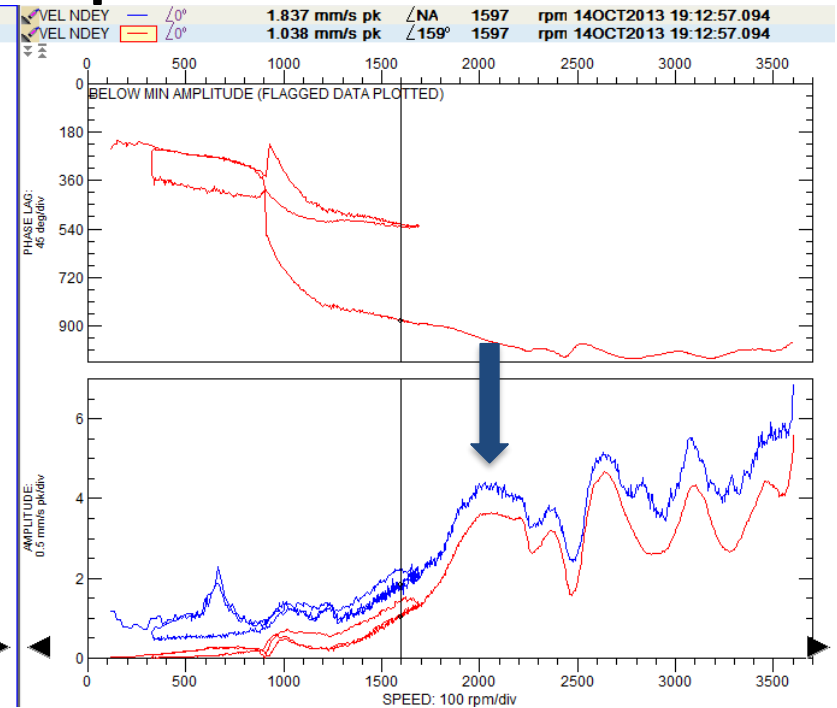
Data Analysis- Startup Bode "cont'd"

Anisotropic system was observed with big difference in the stiffness between horizontal & vertical axes $\Omega = \sqrt{K/M}$

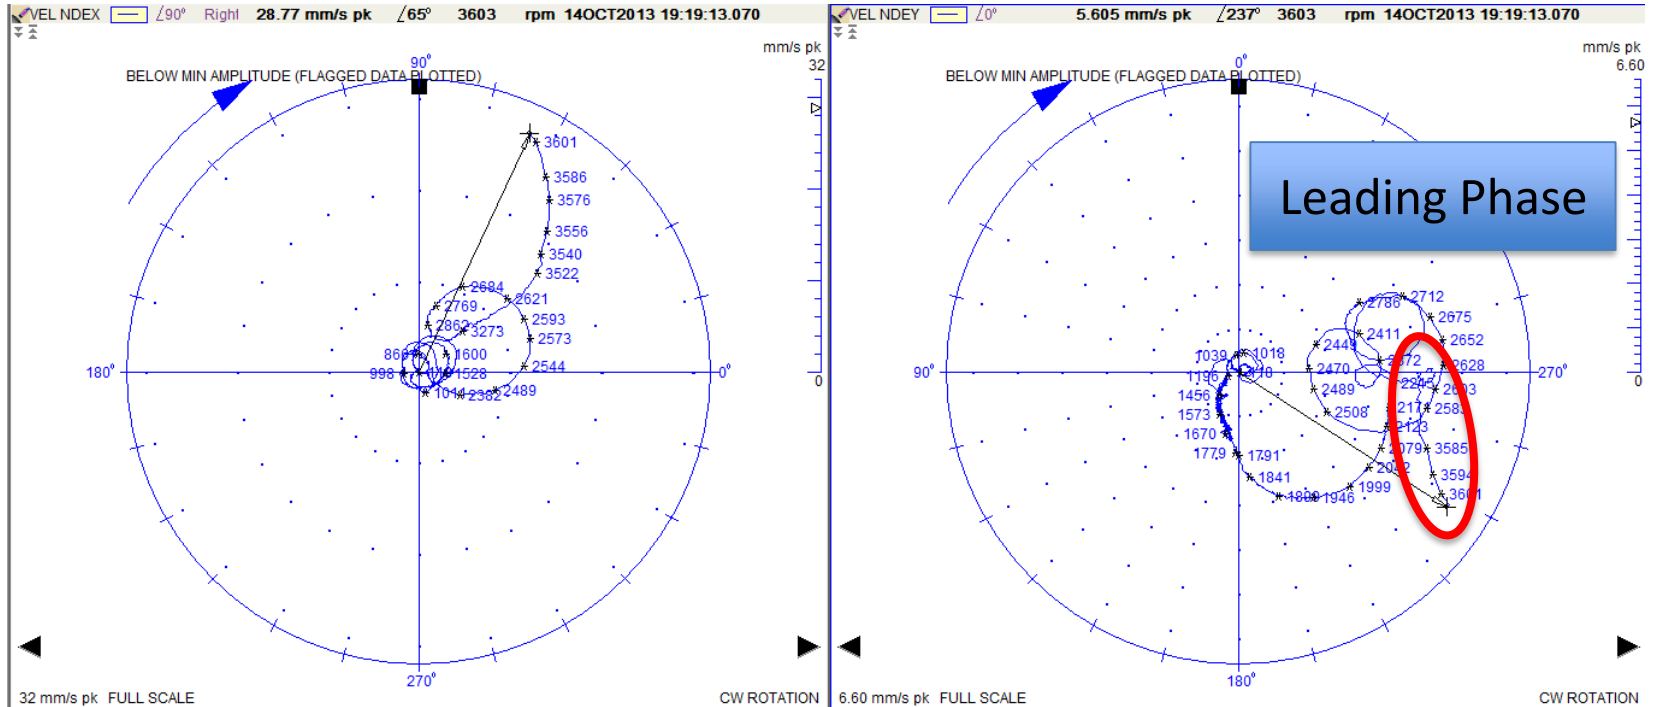
Data Analysis- Startup Polar “cont’d”

Anisotropic system was observed with big difference in the stiffness between horizontal & vertical axes $\Omega = \sqrt{K/M}$

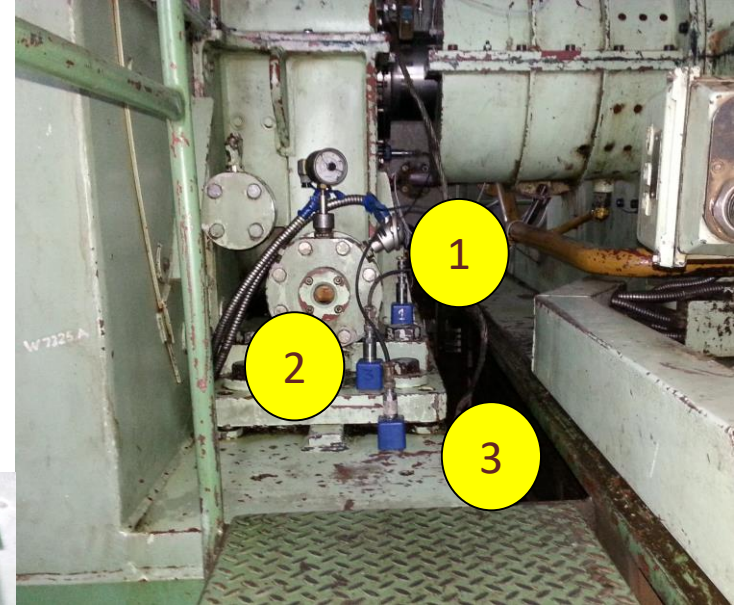
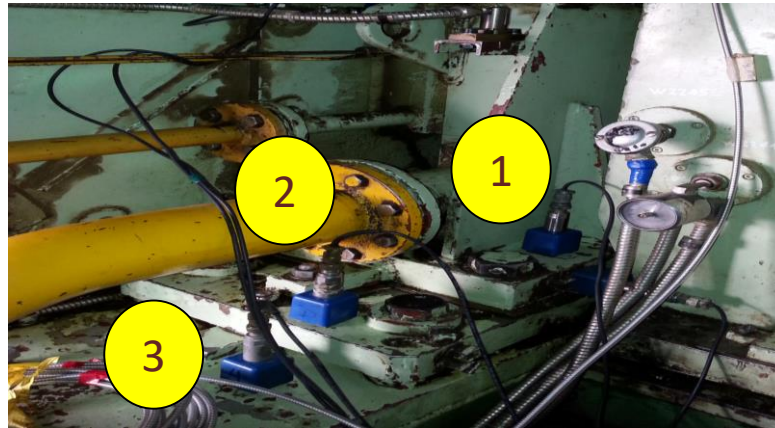
Data Analysis-Structural measurement

mm/sec Peak		Right Side		Left Side	
		1X	1X Phase	1X	1X Phase
IB	Point#1	6.7	222	0.2	65
	Point#2	8.7	230	4.9	54
	Point#3	7.3	221	7.3	60
OB	Point#1	9.9	236	5.5	245
	Point#2	8.3	238	1.6	281
	Point#3	10.1	237	1.3	299

Vibration levels at Foundation Point were Higher than BRG Housing in Vertical Direction

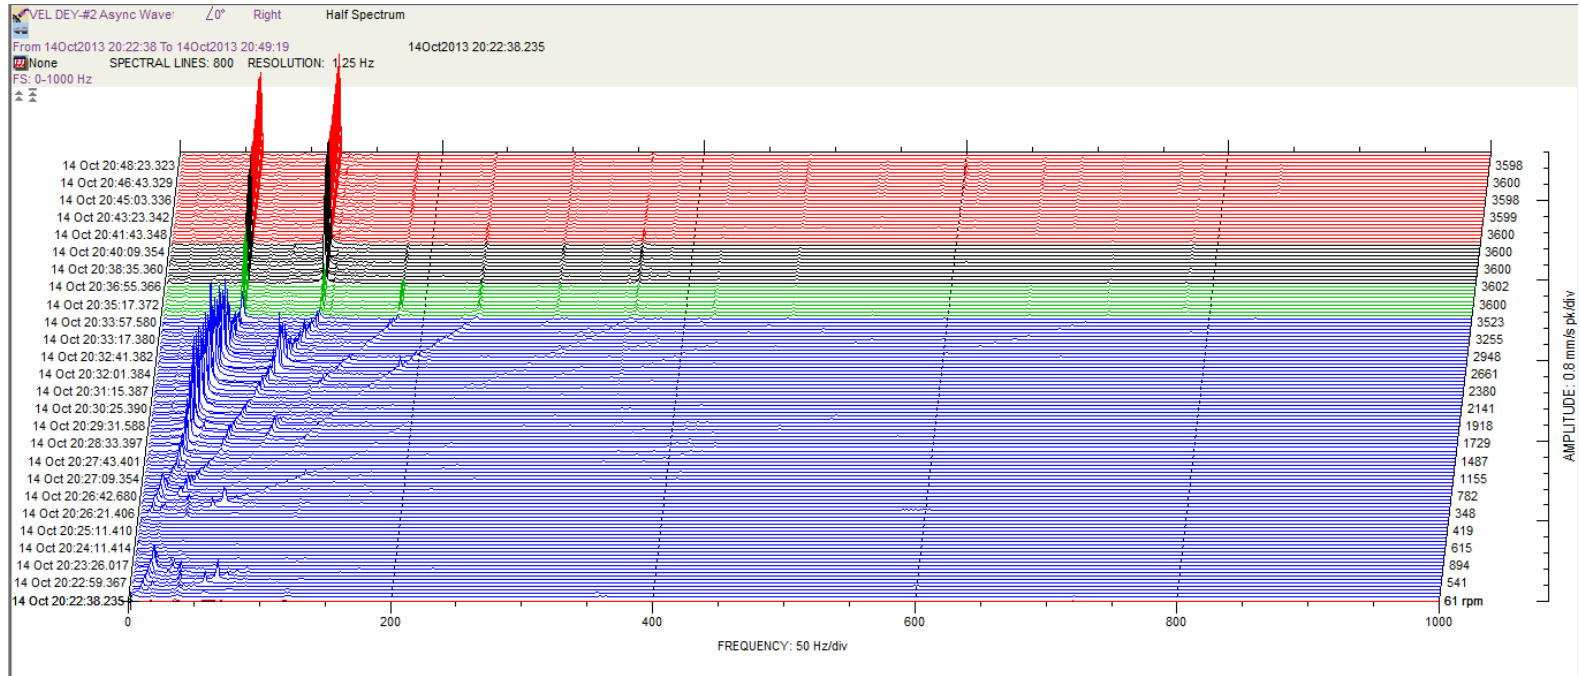
Data Analysis-Waterfall Plot "cont'd"

Generator IB/OB Waterfall Plot (Y- Direction)
showed excitation of 1X harmonics.

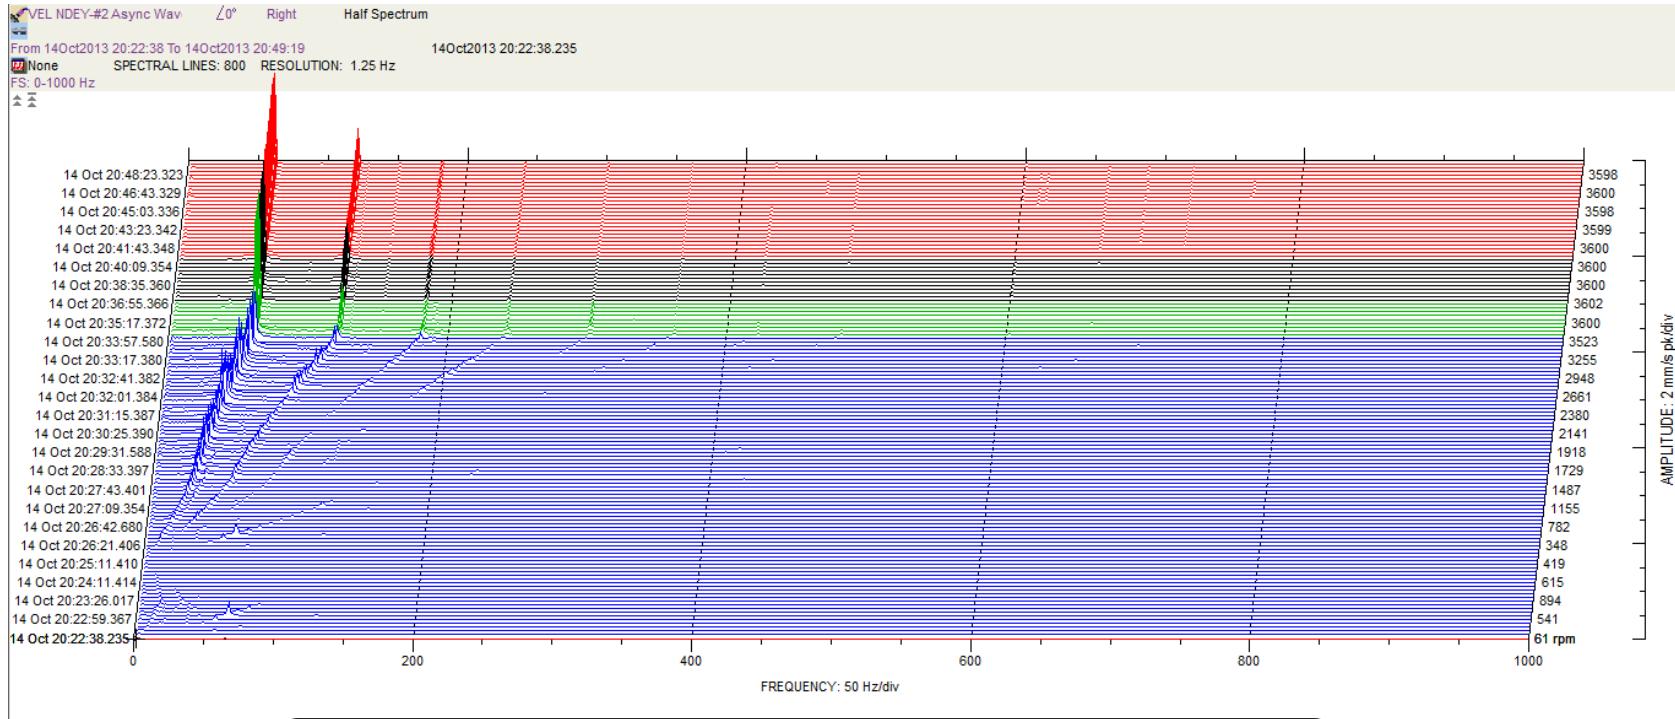
Data Analysis-Waterfall Plot "cont'd"

Generator IB/OB Waterfall Plot (Y- Direction)
showed excitation of 1X harmonics.

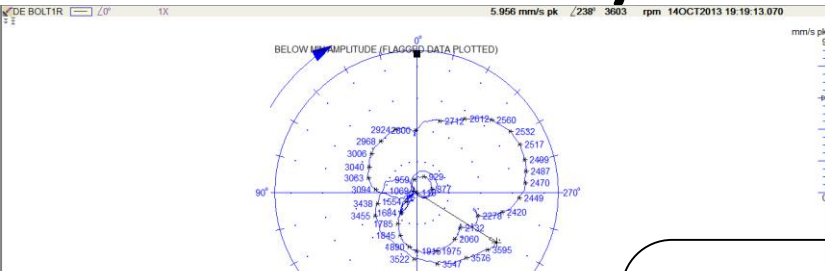
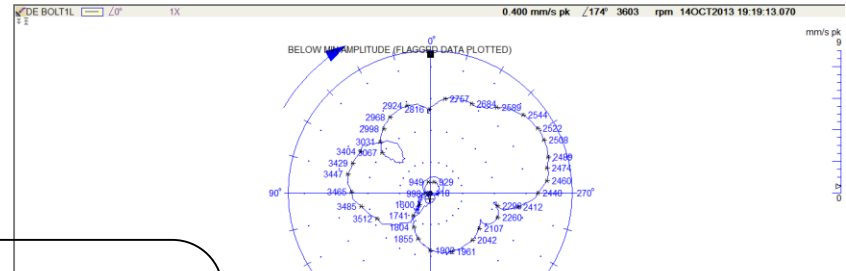
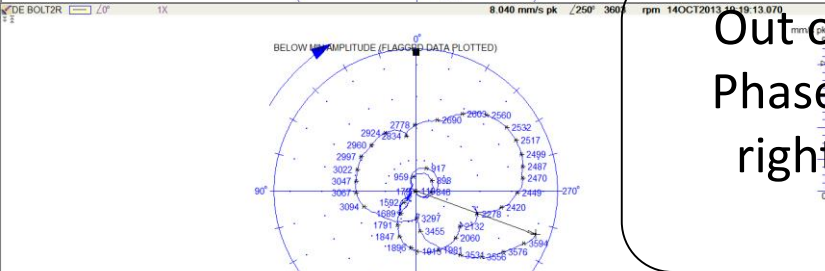
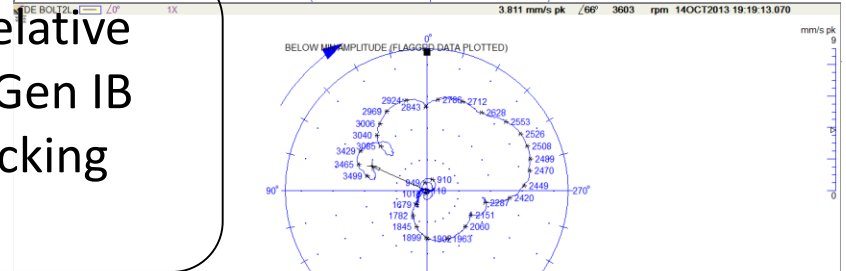
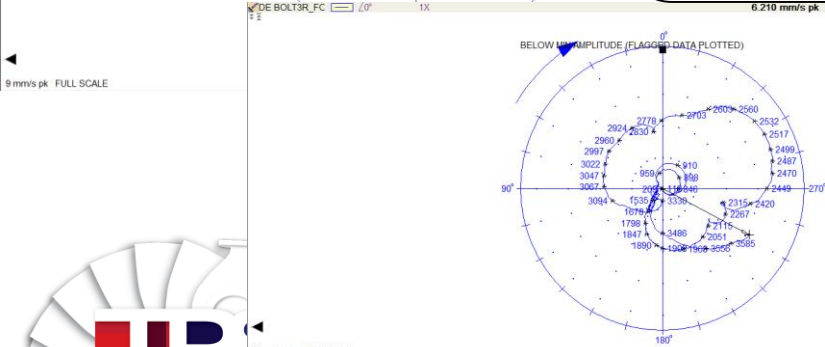
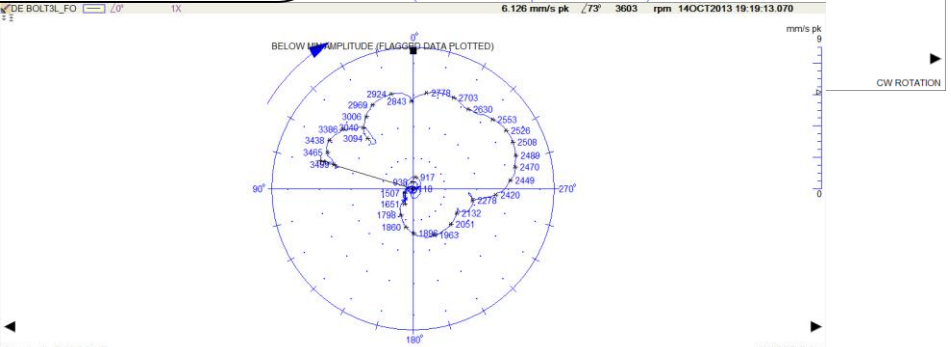
Data Analysis-Structural measurement

Out of Phase/ Relative Phase between Gen IB right & left "Rocking Motion"

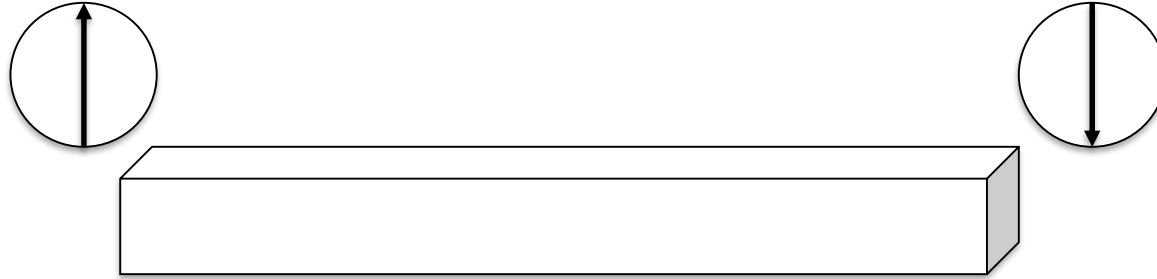
Data Analysis-Base Plate Mode Shape

Out of Phase/ Relative Phase between Gen IB right & left
"Rocking Motion"

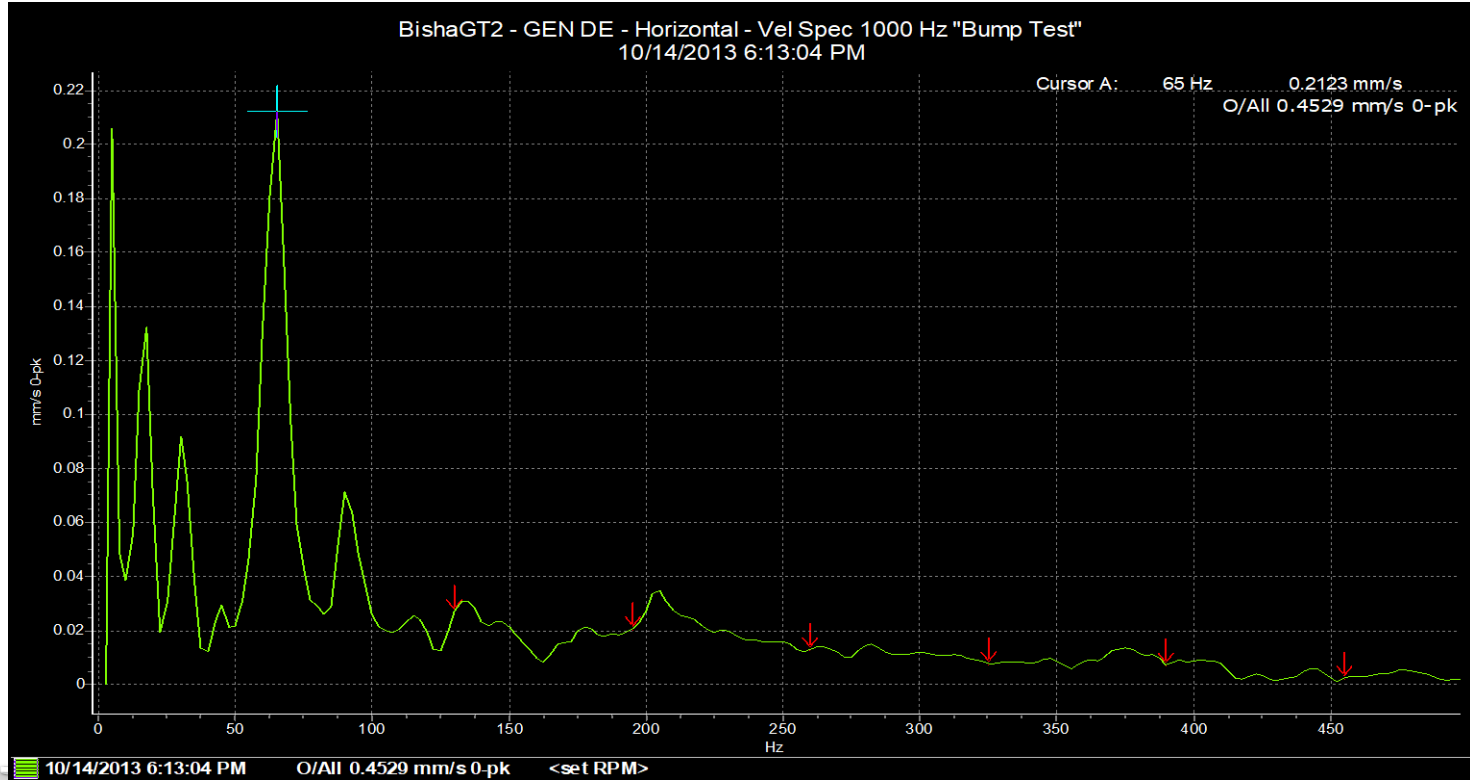
Data Analysis-Impact Test

- The extremely high vibration levels on the generator and structure was mainly due to foundation looseness.
- Rocking motion was observed at Gen IB between right and left side due to looseness.
- Anisotropic system was observed due to different stiffness between horizontal & vertical.
- Bump test showed natural frequencies near to the running speed (65 Hz) in the horizontal direction.
