47TH TURBOMACHINERY & 34TH PUMP SYMPOSIA
HOUSTON, TEXAS | SEPTEMBER 17-20, 2018
GEORGE R. BROWN CONVENTION CENTER

CASE STUDY: Impeller High cycle fatigue failure on a natural gas pipeline compressor following choked flow operation

P. ALAS, F. LIBEYRE and F. MOYROUD

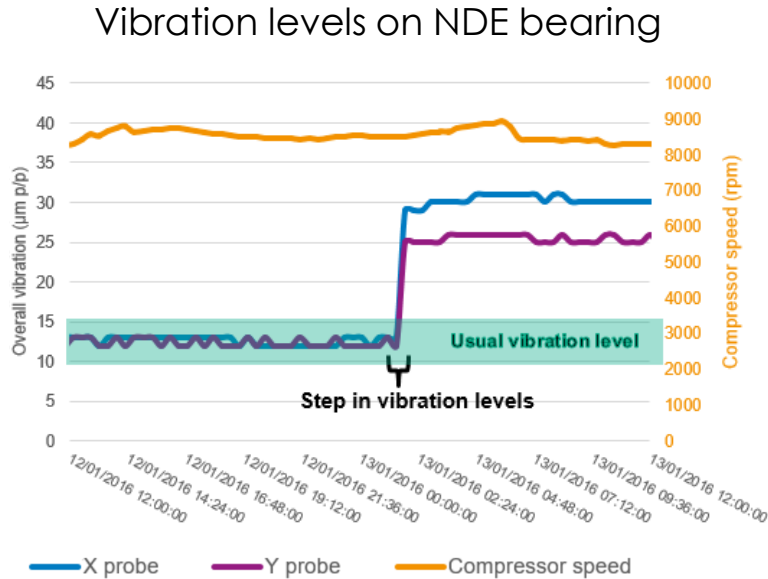
- Vibration levels suddenly multiplied by 2. 7 months later they were multiplied by 3.
- Detected during a periodic vibration analysis, 8 months after step change (alarm levels not reached).
 - Spectrum analysis showed imbalance (1X order).

Machine stopped. Decision to inspect the unit at site.

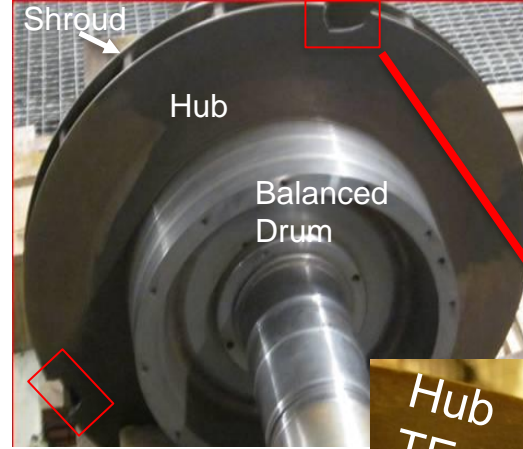
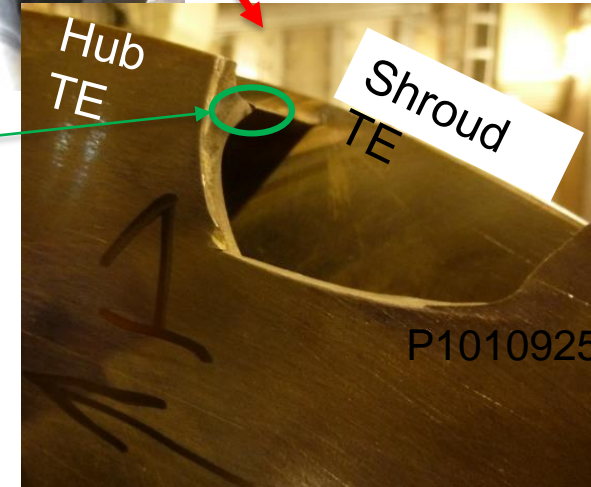
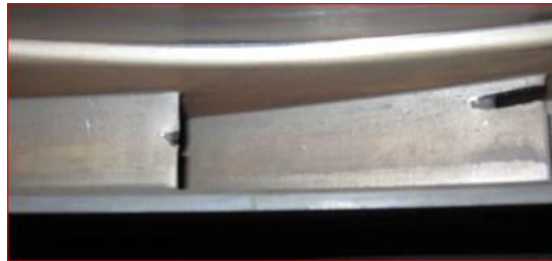
- 2 metal pieces liberated from impeller trailing edge at hub side (single stage rotor)
- Evidence of cracks initiated in the impeller blade tip/hub fillet radius
- Consequential damages at diffuser vane LEs

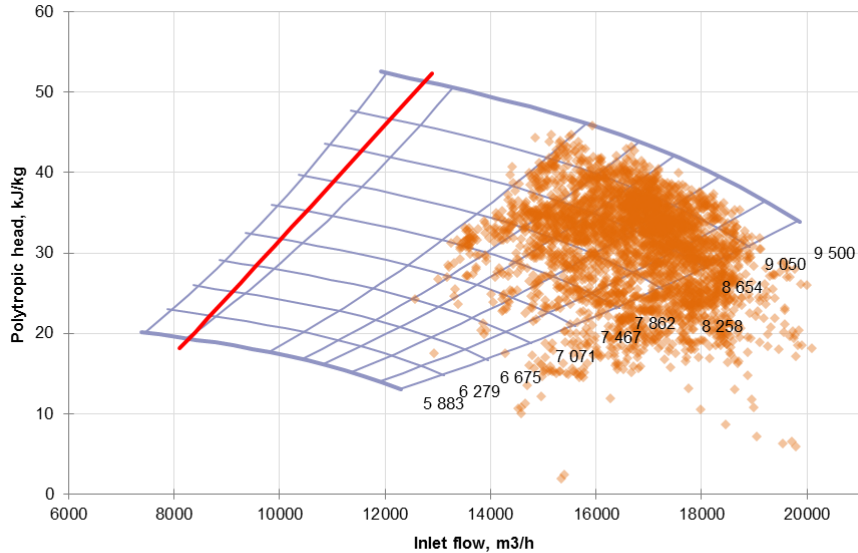
- 1 year of operating data gathered
- Evidence that compressor operation was often beyond defined compressor map right boundary
- Study undertaken by compressor provider to determine if it could be a root cause of the fault

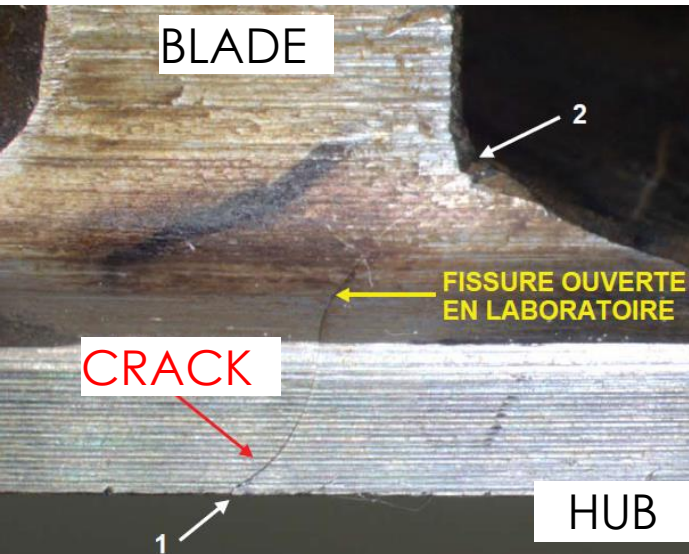
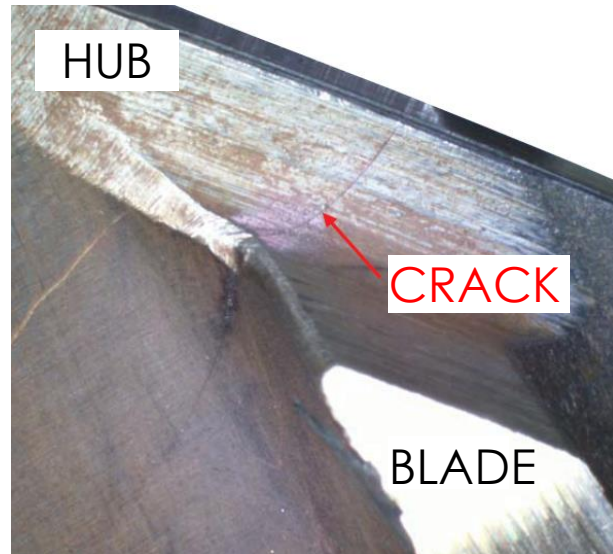
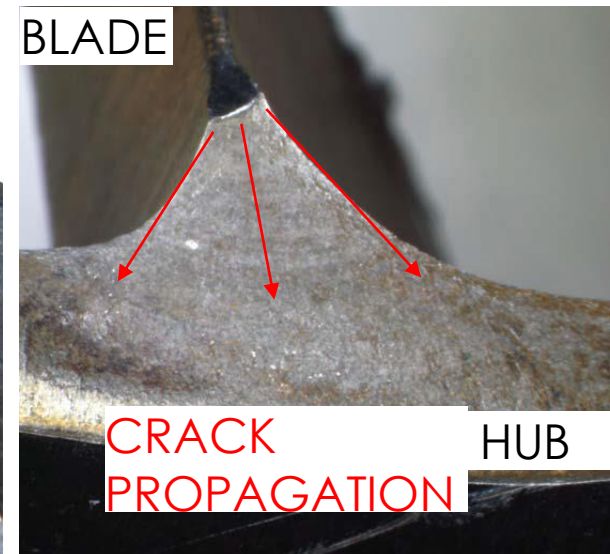
- Cracks found on 4 sectors out of 11 sectors analyzed.
- Cracks fractography are compatible with high cycle fatigue.
- Failure modes related to impeller material, external contamination (corrosion) or wear are ruled out.

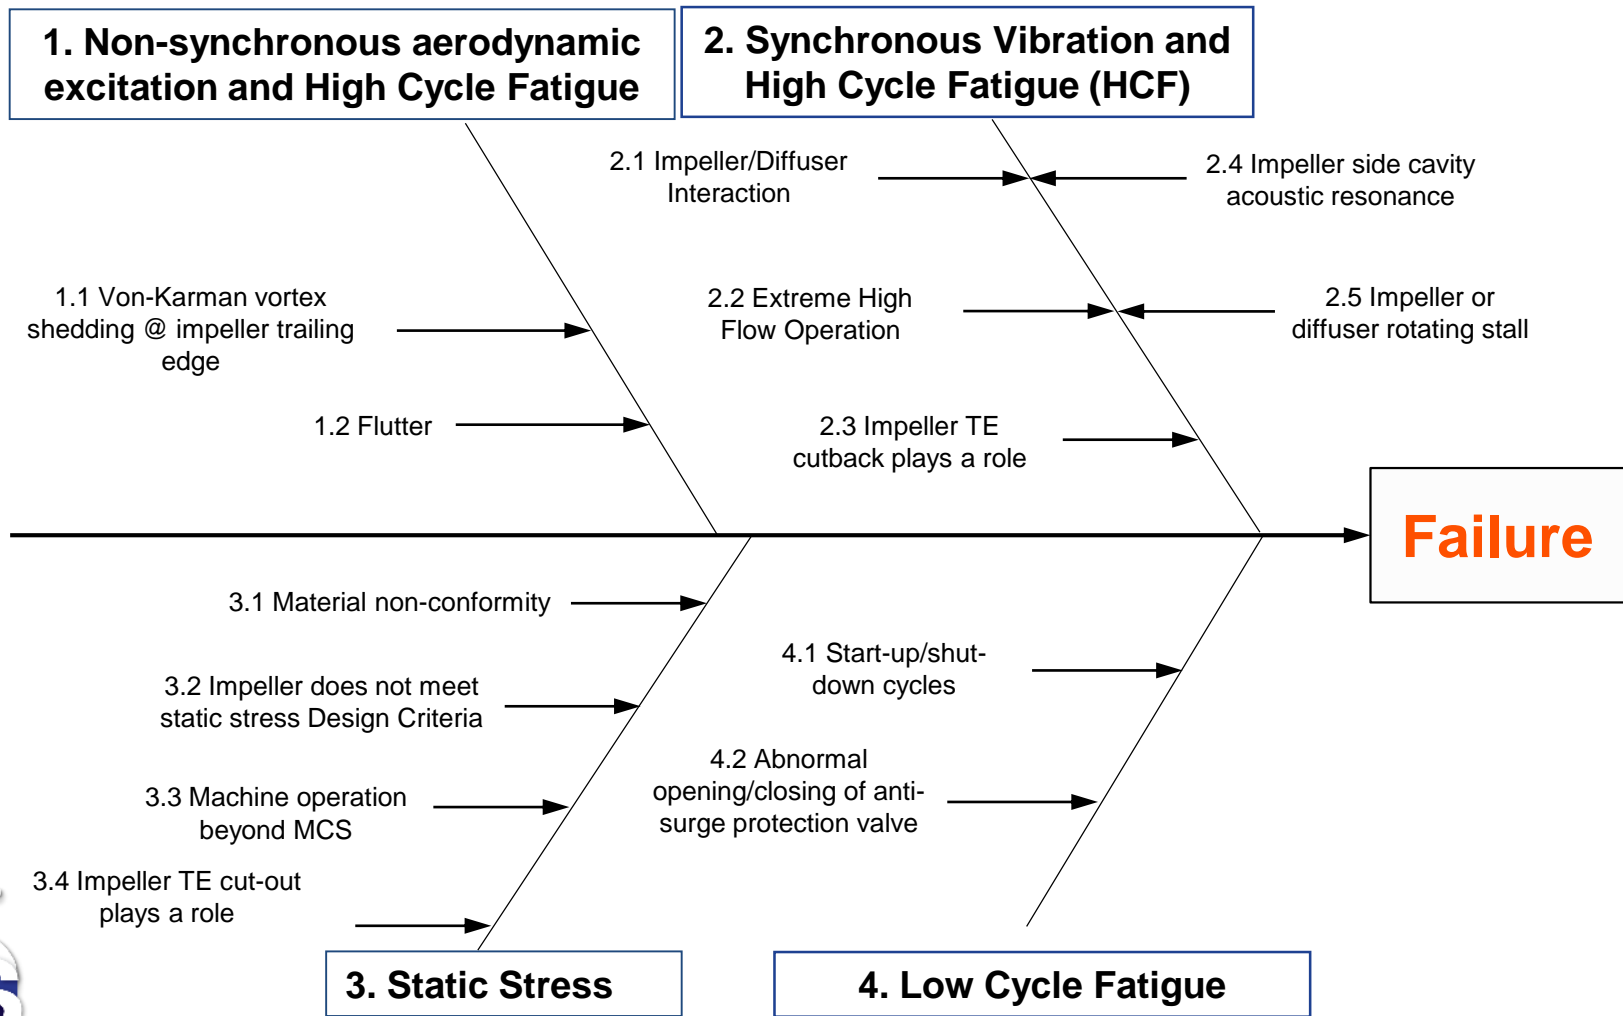
Impeller natural modes and aerodynamic excitations (RCA 2.x)

Crossing at 100% speed between 4.8kHz impeller hub TE mode shape and 32/Rev aero. excitation (vaned diffuser 2nd harmonic)

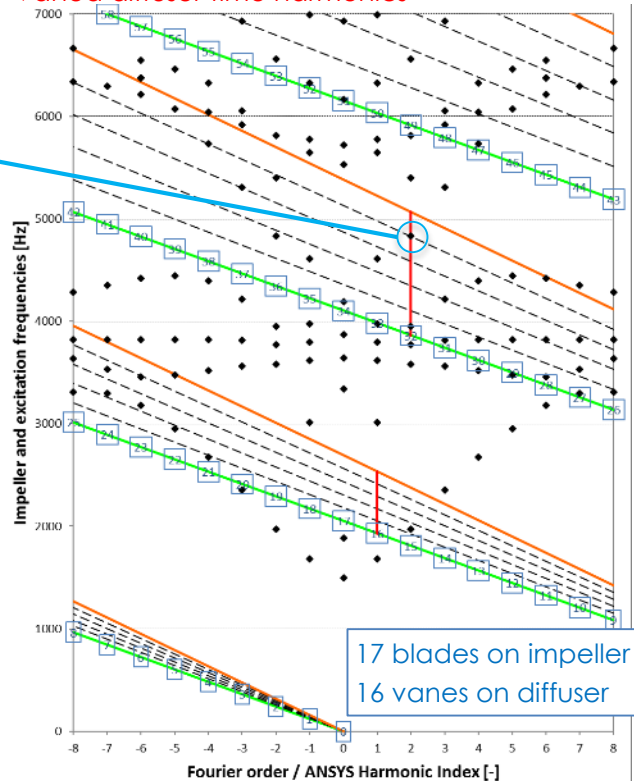
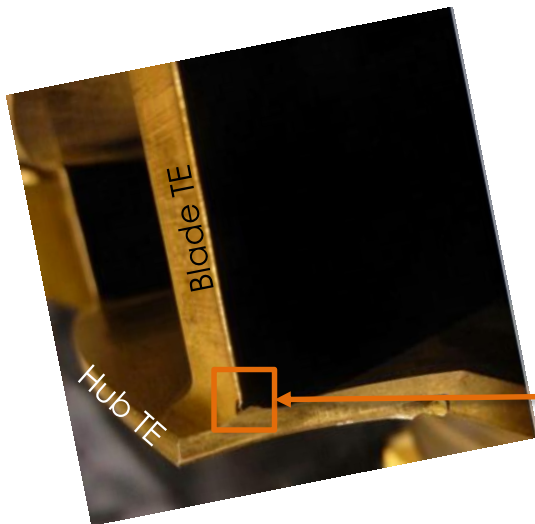
Modal stress field consistent with impeller HCF failure location

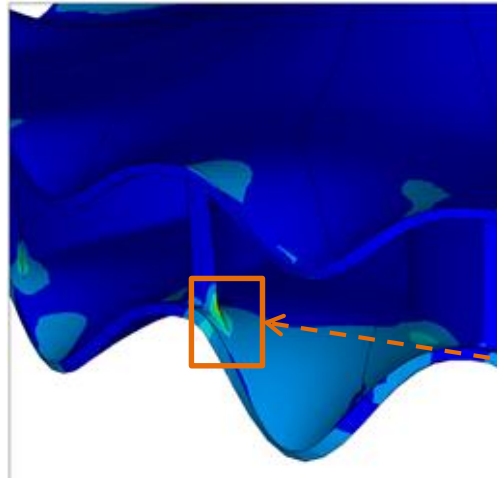
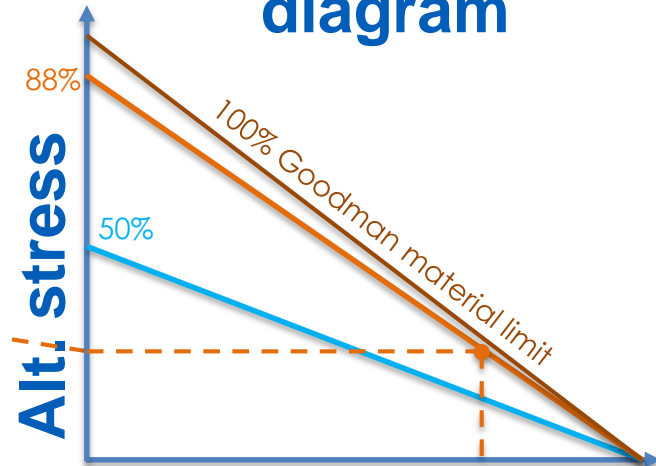
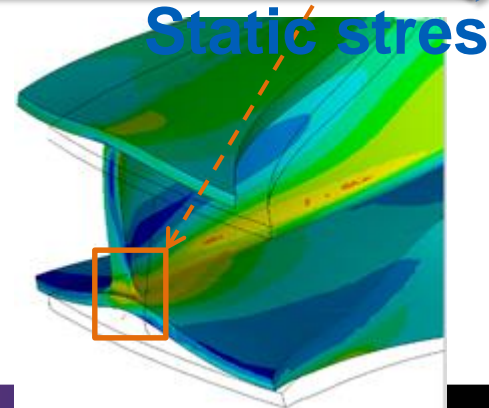
Predicted vibratory resonant response and HCF (RCA 2.1-2.4, 3.4)

Response of 4.8kHz impeller hub TE mode shape to 32/Rev aero. excitation (vaned diffuser 2H)

*: impeller resonant response for mode crossing predicted at 100% speed with aerodynamic forcing amplitude predicted at 105% (worse case)
62 operating hours beyond choke line btw 98/102% speed on the 2013-2016 period

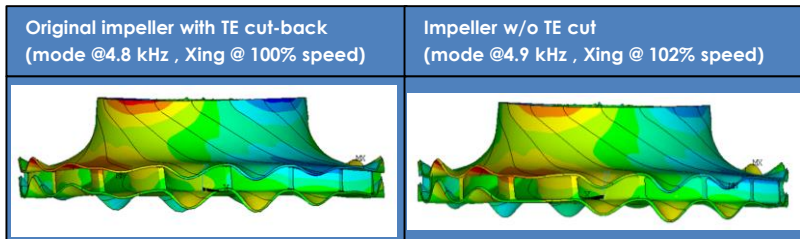
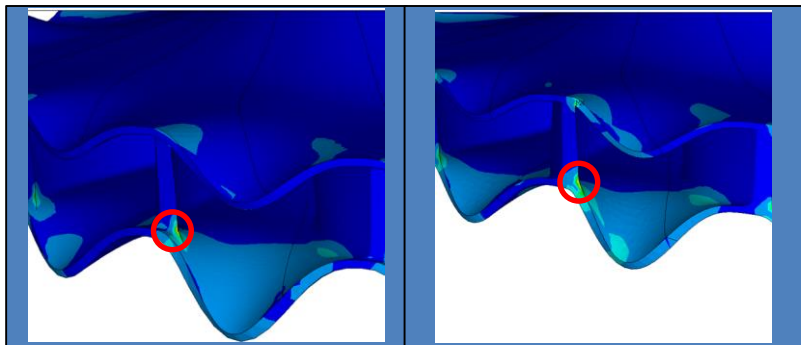
Impeller blade TE(*) cut-back effect (RCA 2.3, 3.4)

+20% in hub fillet peak modal stress with blade TE cut-back VS no TE cut

- FEA predictions show higher static stress on impeller without cut VS impeller with cut-back (added mass effect).
- Same TE mode shape and crossings within operating range (100% vs 102%)
- Lower resonant response predicted for impeller without cut VS impeller with TE cut-back (see table below), for identical aerodynamic forcing and aerodynamic damping
- Eventually TE cut-back has a detrimental impact on durability.

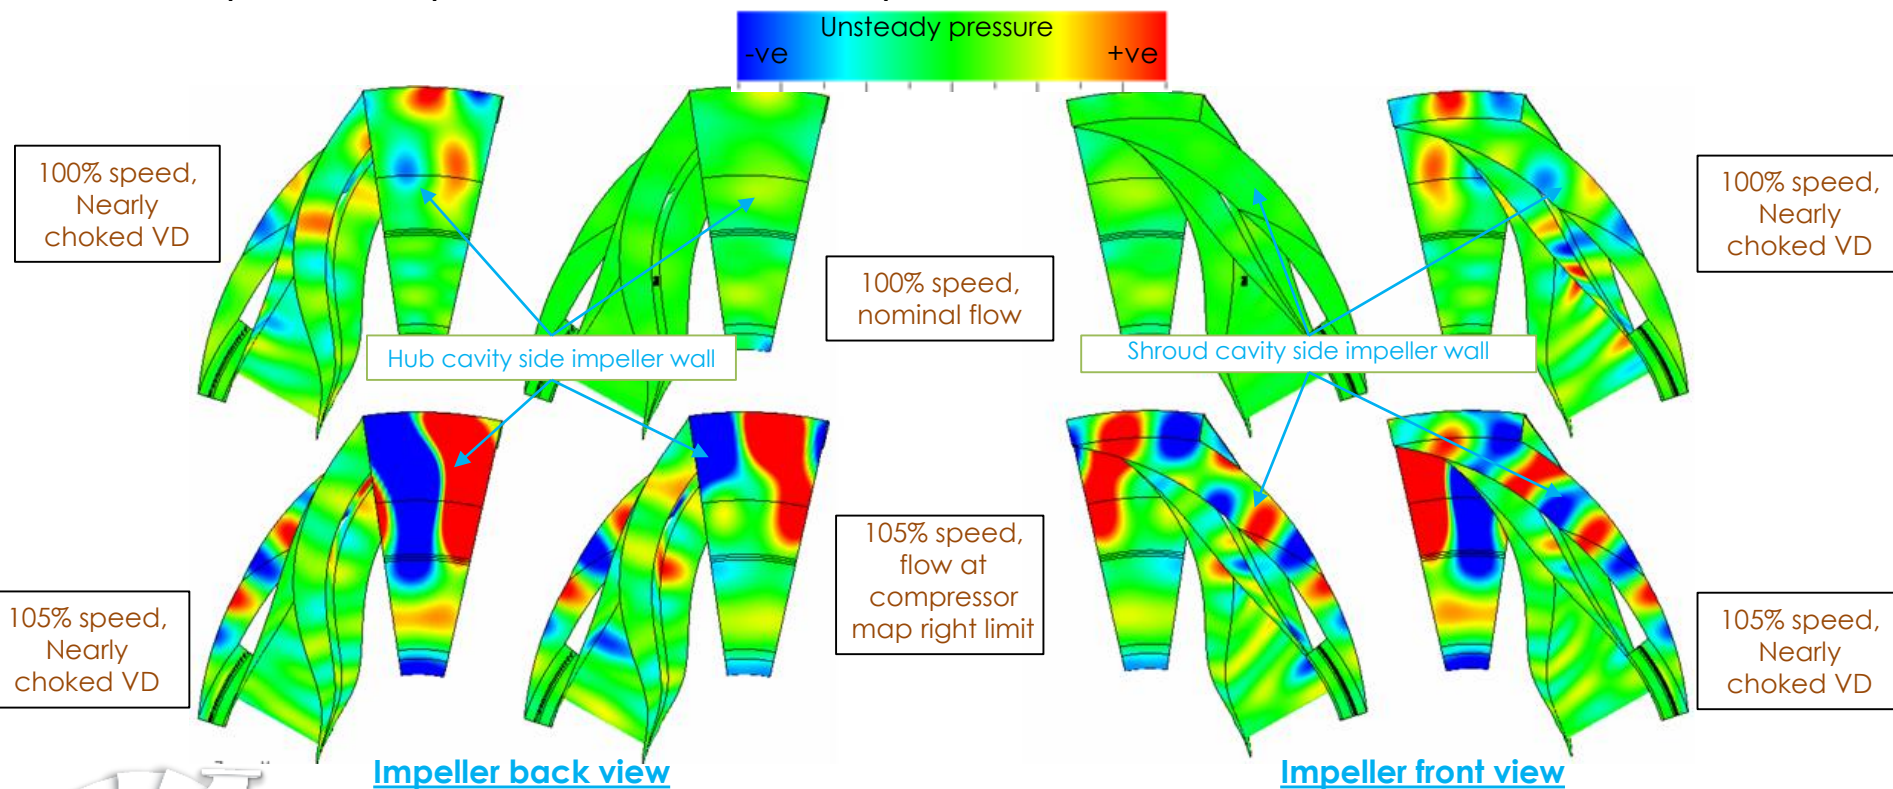
Aerodynamic forcing (RCA 2.1) and acoustic resonance (2.4) 32/Rev pressure perturbations on impeller walls as a function of OP condition

4X in aerodynamic forcing amplitude from nominal operating point to choke flow and 105% speed, due to increased vaned diffuser circumferential flow distortion and high unsteady pressure responses in hub and shroud cavities (acoustic resonances)
