47TH TURBOMACHINERY & 34TH PUMP SYMPOSIA
HOUSTON, TEXAS | SEPTEMBER 17-20, 2018
GEORGE R. BROWN CONVENTION CENTER

Improvement of Rotating Equipment Reliability Using Optical Metrology

Vacuum Bottoms Pumps

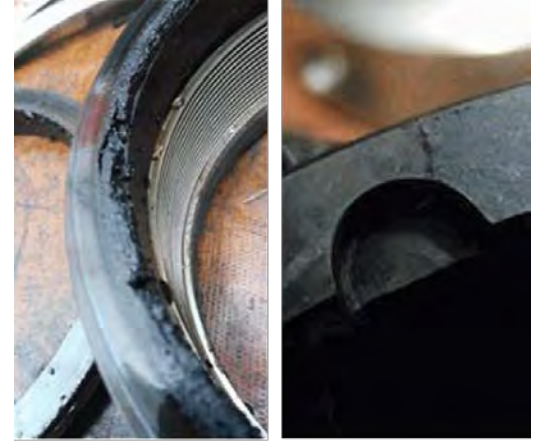
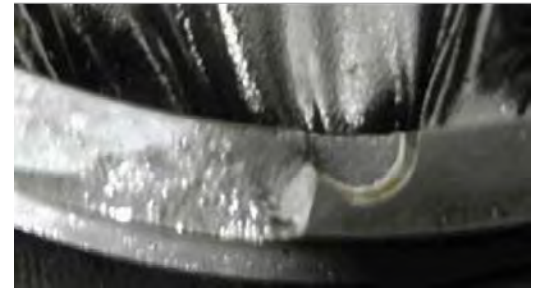
- One of the largest vacuum bottoms systems in the world, commissioned in 2010. The three identical top-top design, radial split, vacuum bottoms pumps experienced poor reliability of less than 12 mo. MTBF.
- Predominately seal failures, these would occur during warm-up operations with the off-line pump being warmed to 473F, affecting the running pump, catastrophic failure during start-up, or slow continuous leaks progressing to full failure.
- Majority of the seal failures followed a pattern of DE stationary face cracking at the drive pin, severe misalignment, photographing on the friction face, blistering SiC face, coning, and coking on the OB face

Above, seal faces that are cracked, blistered and contaminated with coke build-up

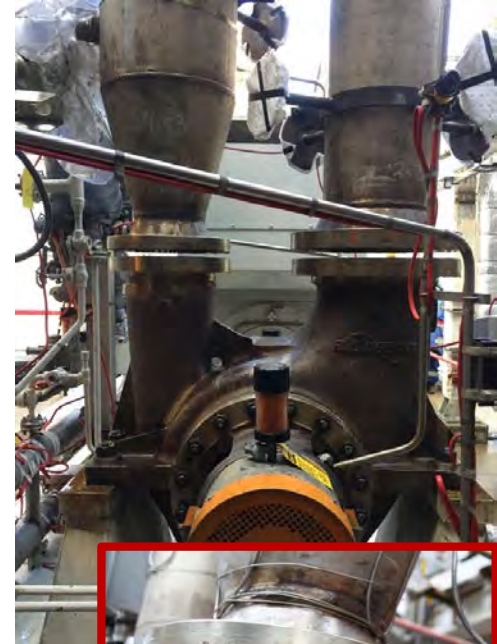
- All of the pumps exhibited severe piping alignment concerns. Typically 0.75" – 1.5" vertically and up to 1" offset.
- It was also determined that during original purchase the pumps were not specified to be stress relieved. High temperature pumps cast from 317L require stress relief or they will experience significant thermal distortion above 400°F. Normal casting procedures and manufacturing process do not normally perform a stress relief.
- Rumors of baseplate grout voids and poor installation practice compounded the situation.
- Hard credible data was missing to make actionable decisions on a path forward.

Above, severe pipe misalignment

- New piping headers were designed and installed during fall 2017 scheduled plant shutdown
- Baseplates were pulled and grouted to best practice
- Pumps were rebuilt and stress relieved
- Pump pedestal bolts were replaced due to previous modifications
- Existing mechanical seal design was deemed acceptable & reused

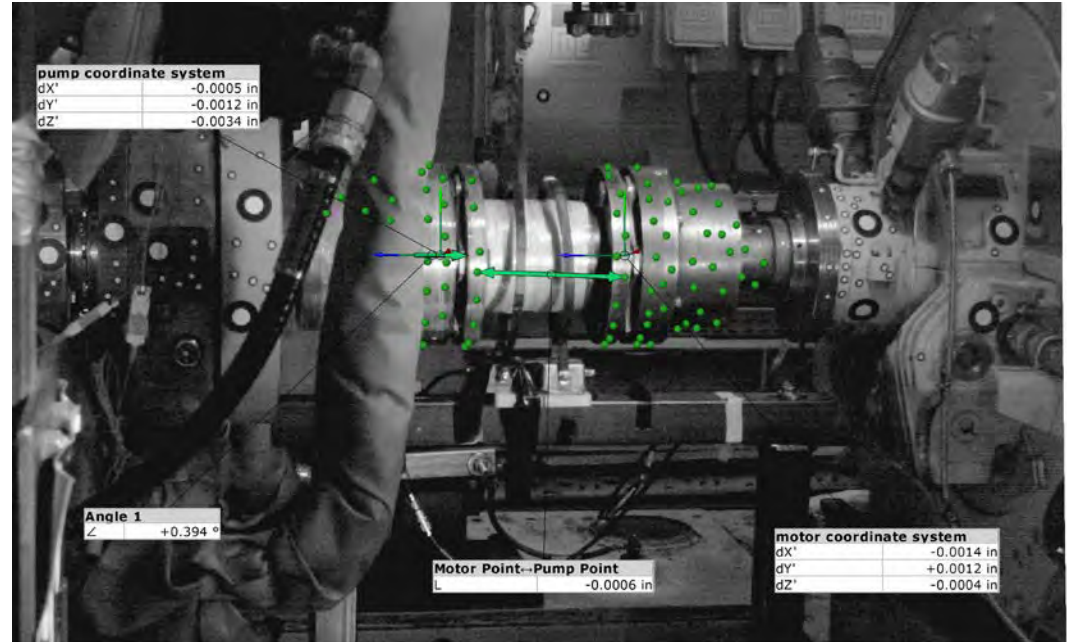
- Coded markers were also installed on the shaft, coupling, bearing housings and mechanical seal gland
- Shaft data was analyzed for conditions that would cause start-up failures
- Movie at right of a pump start-up illustrates the phase relationship across the coupling signifying significant angular misalignment is occurring

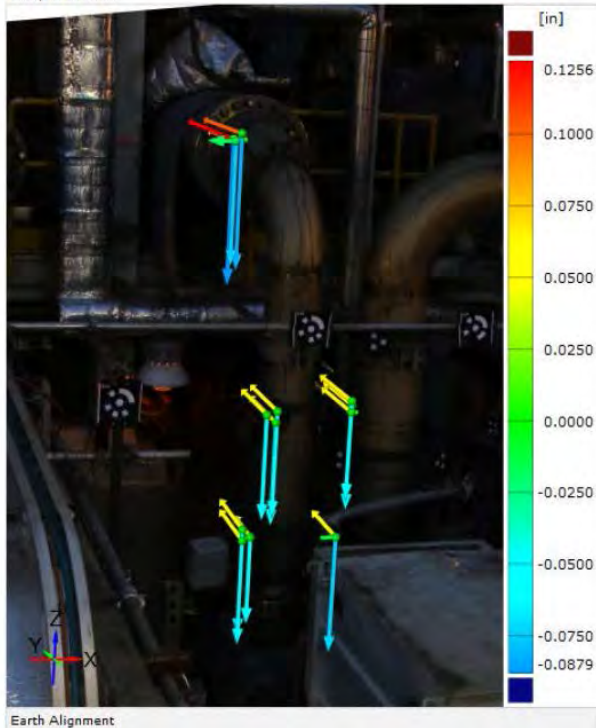
32-G2A Suction Piping while running

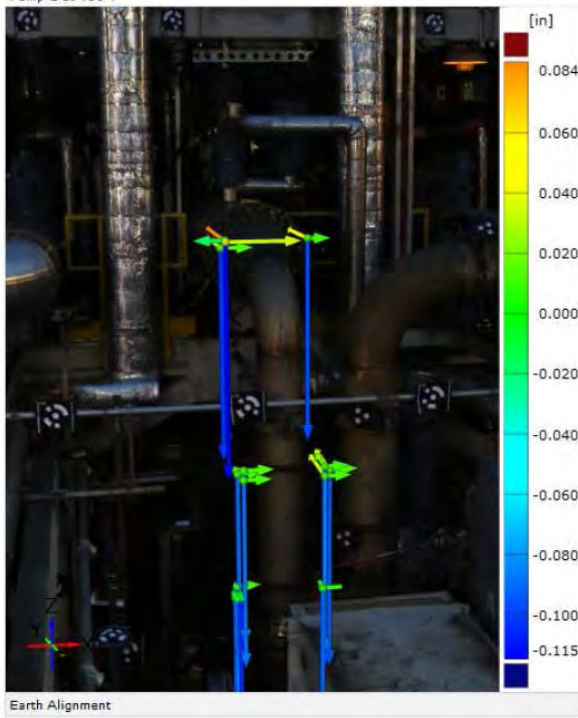
32-G2B Suction Piping, bolted but offline

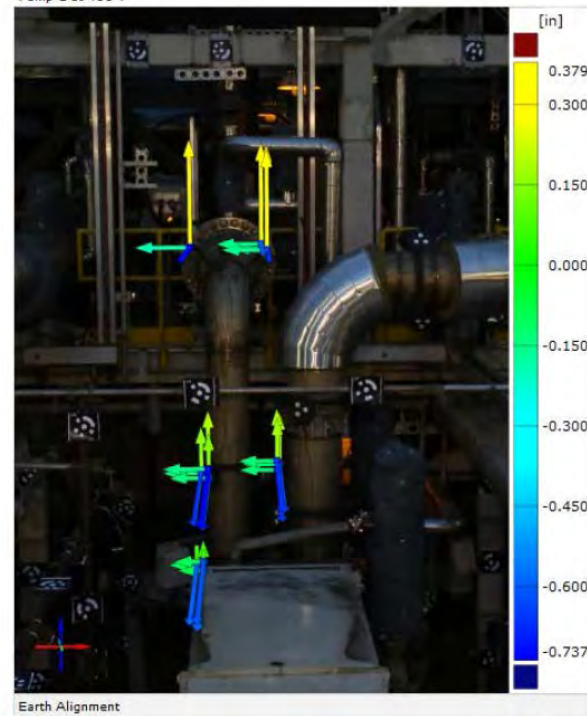
32-G2C Suction Piping being brought to temperature

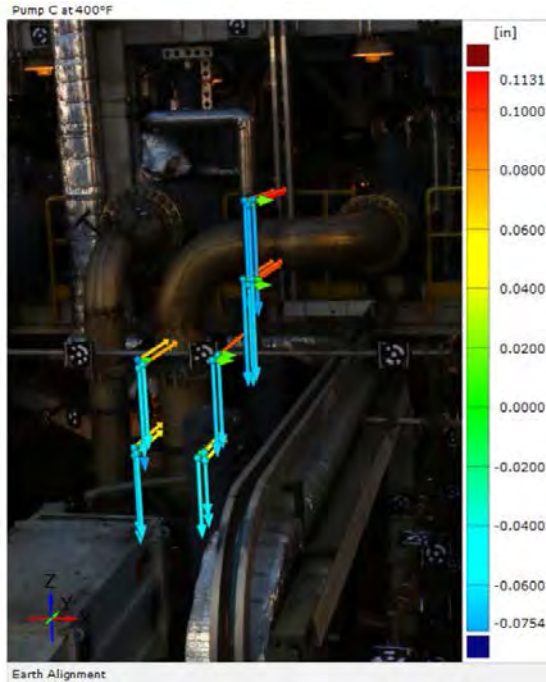
32-G2A Discharge Piping
while running

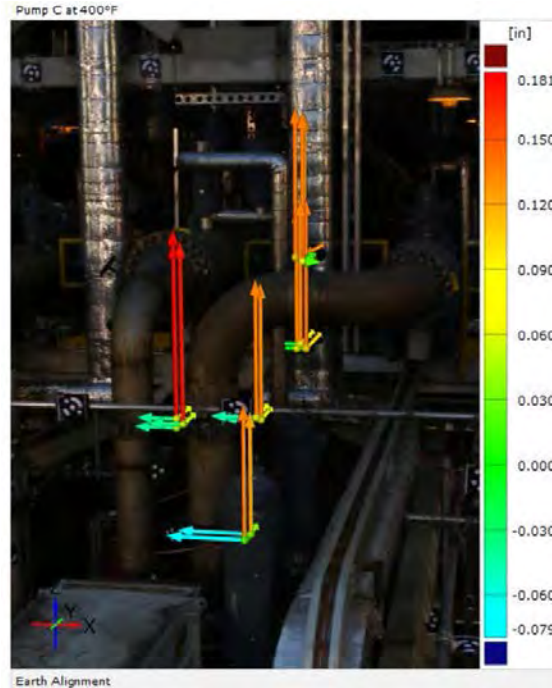
32-G2B Discharge Piping
bolted but offline

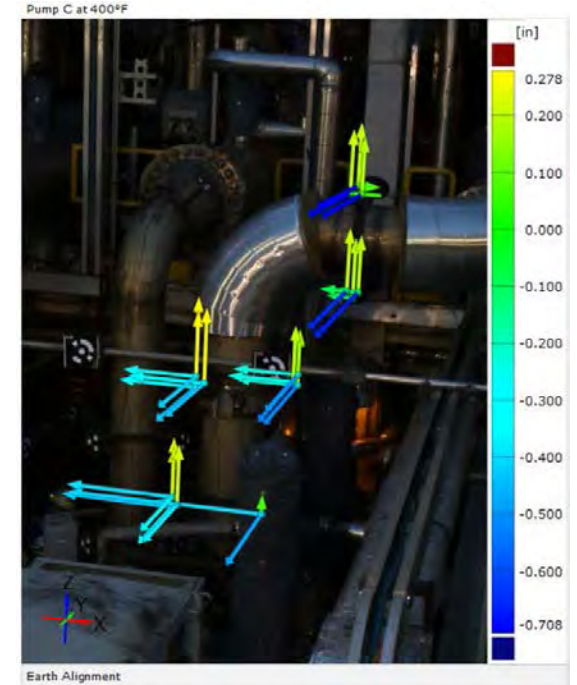
32-G2C Discharge Piping
being brought to temperature

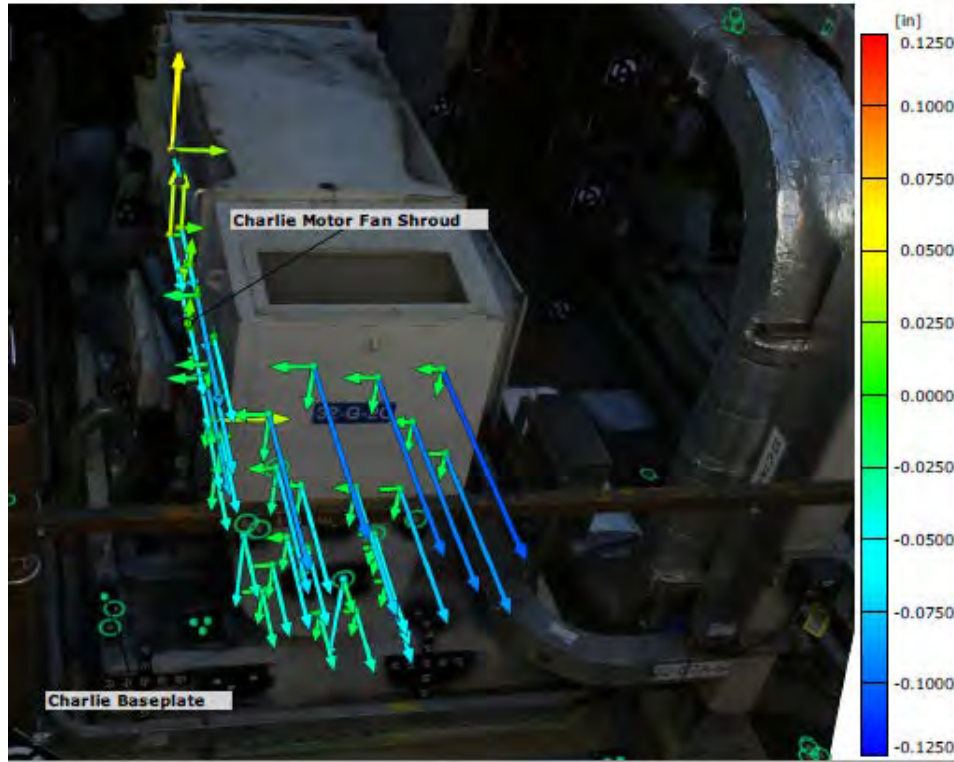
2C Motor displacement @ 400°F with 2A running

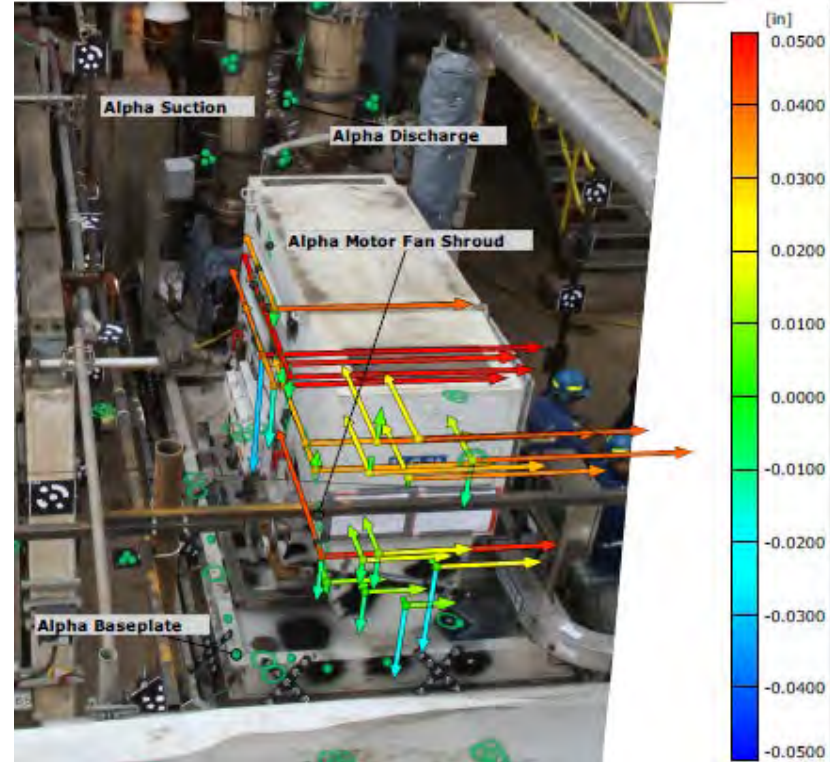
2A Motor displacement with 2A in Hot Standby

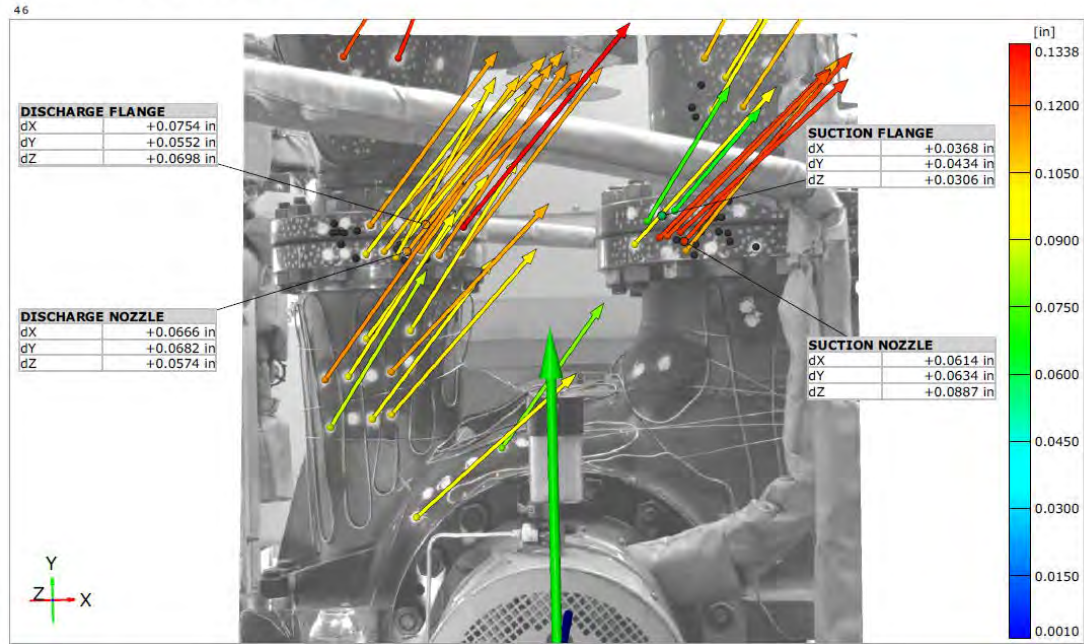
ALPHA AFTER BRAVO BOLTED

- Optical metrology used to look at the piping displacement on the 2A pump as a result of putting the pump back in service and warming to a hot standby condition
- 32-G2B was off line with the suction and discharge flanges bolted
- Resultant Vector Displacement showing movement of piping/ pump flanges and resultant stress in the pump

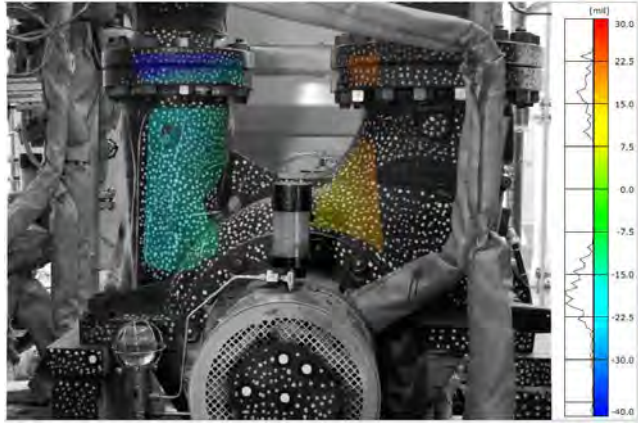
Horizontal X- direction

Pump 2C Displacement @ Running Temperature

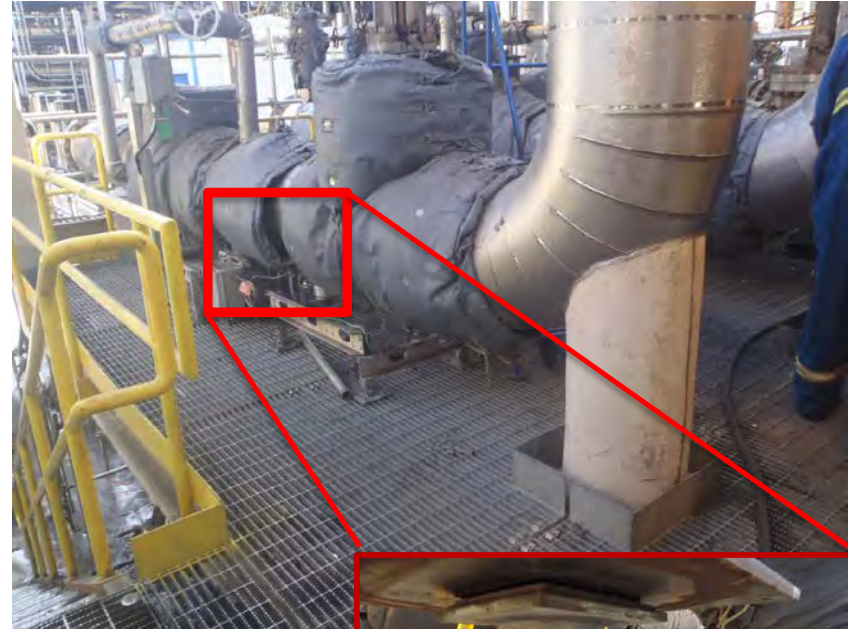
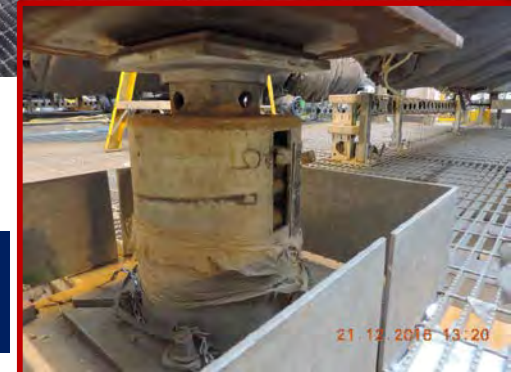
- Current piping forces displace pump nozzles, affect alignments, and distort the casing causing seal leakage
- No anchor points exist for the main headers or on the individual piping runs to the pumps
- Main headers shift when a pump is taken offline putting excessive stress on the pump / baseplate causing seal failures
- Pump baseplate was also inspected and found that grouting was deficient allowing distortion to occur

Friction plate pipe support with spring hanger base for main suction & discharge headers
