"Reparación de Muros de Construcciones Históricas de Tierra Mediante El Sellado de Fisuras y Refuerzos Estructurales Adicionales"

### TESIS PARA OPTAR EL GRADO ACADÉMICO DE MAGÍSTER EN INGENIERÍA CIVIL

# Seismic Simulation Tests to Validate a Dual Technique for Repairing Adobe Historical Buildings Damaged by Earthquakes

# USING MUD INJECTION AND AN EXTERNAL ROPE MESH TO REINFORCE HISTORICAL EARTHEN BUILDINGS LOCATED IN SEISMIC AREAS

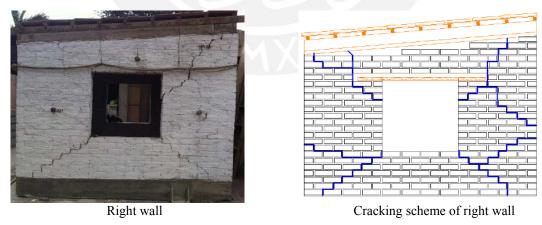
The original, undamaged model was subjected to a sequence of three phases of shaking table tests to induce wall cracking representative of seismic damage as observed in adobe masonry constructions. The first phase, with a peak command displacement D = 30 mm (peak table displacement  $D_{0max}$ = 28.90 mm and peak acceleration  $A_{0max}$ = 0.31g), did not cause any visible damage in the model. During the second phase with D = 60 mm ( $D_{0max}$  = 58.50 mm and  $A_{0max}$ = 0.64g) the model suffered extensive cracking. Large diagonal shear cracks were visible in the lateral (left and right) walls, starting in the corners of the window and propagating outwards. Since the cracks were quite thin (3 mm or less), it was decided to carry out a third shaking phase D = 60 mm ( $D_{0max}$ = 58.50 mm and  $A_{0max}$ = 0.64g) to induce further damage, with wider cracks. This last shaking phase was stopped after 15 seconds to avoid irreparable damage (as occurred in the previous project). Figure 4 shows the cracking patterns on the adobe walls, representative of seismic damage on adobe wall structures.

**Figure 4.** Damage in the original adobe model after second (D = 60 mm) testing phase.

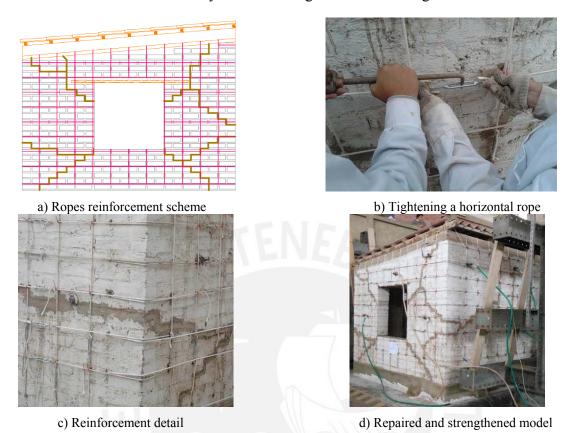
Figure 6. Strengthening of the repaired model with halyard mesh.

After the injected grout had completely dried, all the walls of the repaired model were reinforced with an external mesh made of nylon ropes (known as halyard) with 1/4" nominal diameter. Tension tests performed at the laboratory on pieces of the halyard used for the repair yielded an ultimate strength of 2 kN (nominal ultimate stress of 63 MPa) and a reference modulus of elasticity of 100 MPa. Figure 6 a) schematically shows the provided mesh configuration. The vertical ropes were placed at 250 mm intervals (the length of one adobe block) in two parts. The lower part of the rope, measuring about 1.20 m, was inserted across the wall through the first (bottom) course of mud mortar. The top part of the rope was placed over the walls, nailed to the wooden crown beam and joined to the bottom ropes on each side of the wall, using metal turnbuckles. The horizontal ropes were also placed at 250 mm intervals (two and a half courses of adobe masonry) in two parts joined by turnbuckles. All the ropes were manually tensed by means of the turnbuckles (Figure 6 b). The tensile force provided by the turnbuckles is estimated at 200 N. At each vertical corner, the ropes were placed inside a small plastic tube in order to protect the adobe walls, especially when the mesh coincided with a mortar joint. The meshes on both faces of each wall were joined together by 1/8" halyard ropes (crossties), which crossed the walls through the mortar joints at

selected places. Figure 6 c) shows a detail of the reinforcement elements, and Figure 6 d) presents the retrofitted model ready to be tested again on the shaking table.

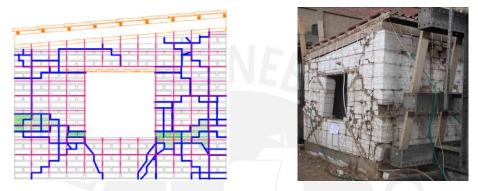
The third testing phase (D = 90 mm;  $D_{0max}$ = 89.30 mm;  $A_{0max}$ = 1.08g) proved the effectiveness of the external mesh reinforcement. If the model had been repaired only with mud injection, it would have collapsed due to this ground shaking. The nylon rope mesh was able to maintain together the large pieces in which the walls had been broken. It was decided to subject the model to two additional intense shaking phases (D = 130 mm;  $D_{0max}$ = 128 mm;  $A_{0max}$ = 1.53g), which produced a significant amount of damage: all the repaired cracks opened and new cracks appeared in all the walls (Figure 8, left). Even though the crown beam got detached due to the damage at the top of the back wall, the reinforcement mesh and the wooden crown beam worked well together in keeping the integrity of the structure, (Figure 8, right). It was noticed that the horizontal halyard ropes, located in the mortar close to the base of the window, started to cut into the mud mortar.

**Figure 8.** Sketch of damage pattern and general view of the model after all shaking phases.
