**FOREIGN MATERIAL EXCLUSION (FME) FAILURES OF LARGE TURBO
ALTERNATORS**

Submitted in partial fulfilment of the requirements for the degree of

MASTER OF SCIENCE (ENG),
Faculty of Engineering, University of KwaZulu-Natal

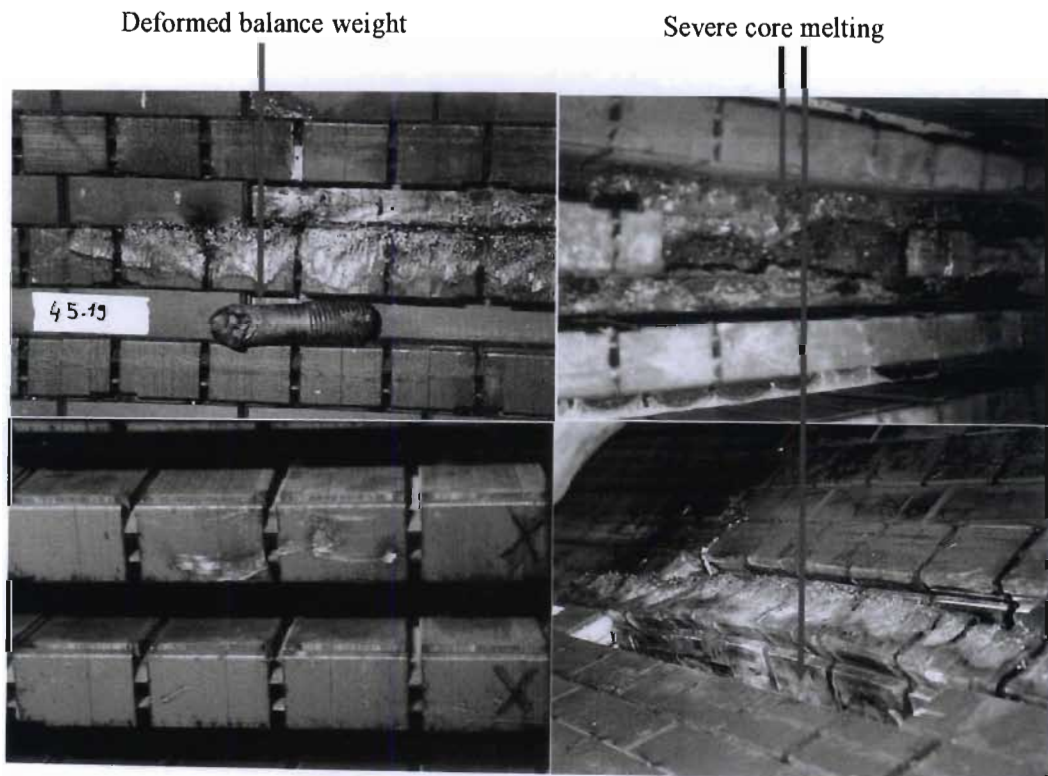
An inspection of the generator revealed significant damage to the stator core. The damage was attributed to a balance weight that had unscrewed from the rotor body and fallen into the air gap during run up. The FM was moved through the gap violently and the magnetic field caused it to pound against the core surface. The FM damaged core laminations and the circulating currents that resulted, caused overheating and the core to melt, as shown in Figure 4-2. The molten core material damaged the adjacent stator bar insulation causing an earth fault.

Figure 4-2: FM and core damage

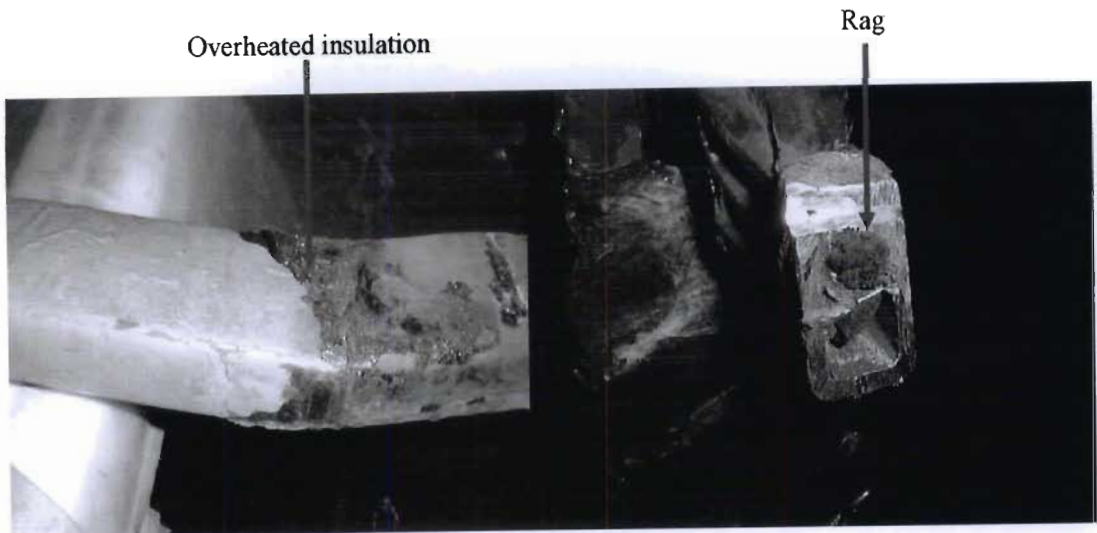
Figure 4-3: Overheated stator bar and FM within water box

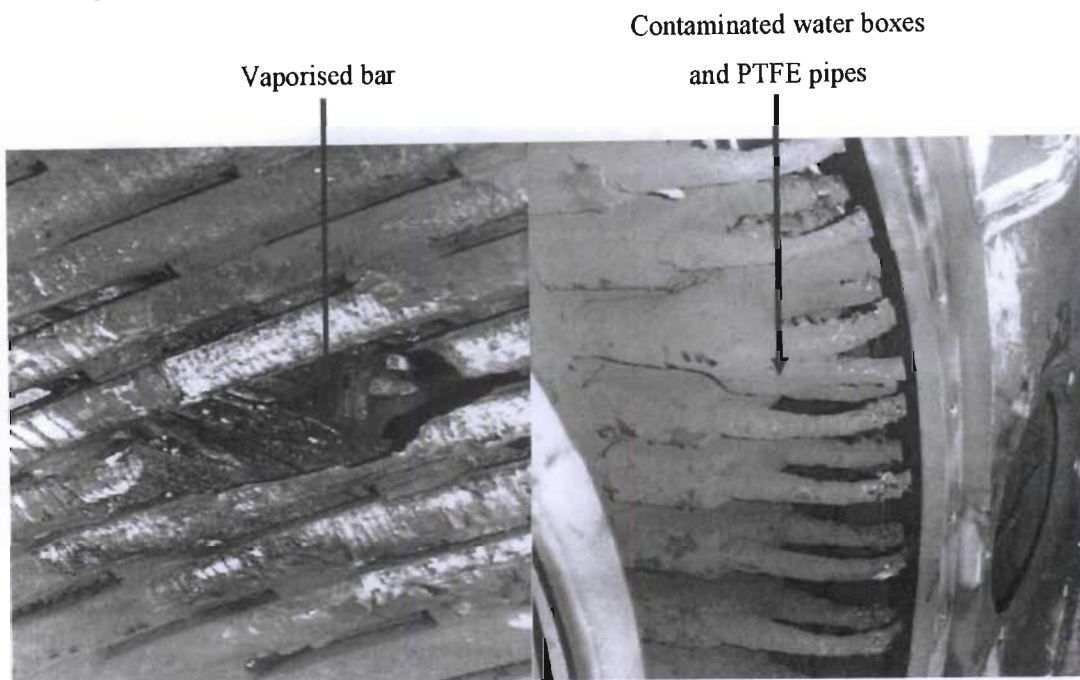
A large number of stator bars were damaged and minor damage was caused to the core. Carbon pollution was deposited throughout the generator including the rotor. The rotor was extensively polluted leading to an earth fault. The rotor had no signs of any physical impact damage.

Figure 4-4: Destroyed overhang bars and extensive pollution

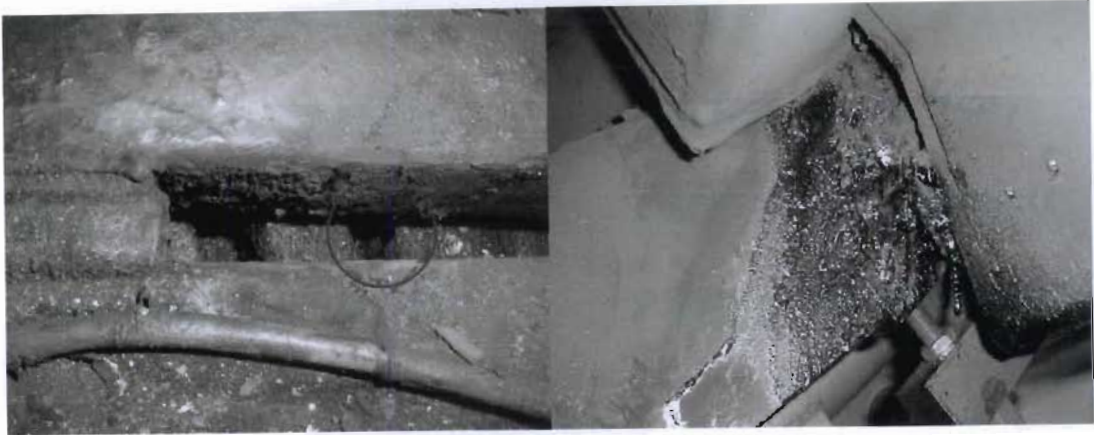
Figure 4-5: Area of extreme heating and bar damage

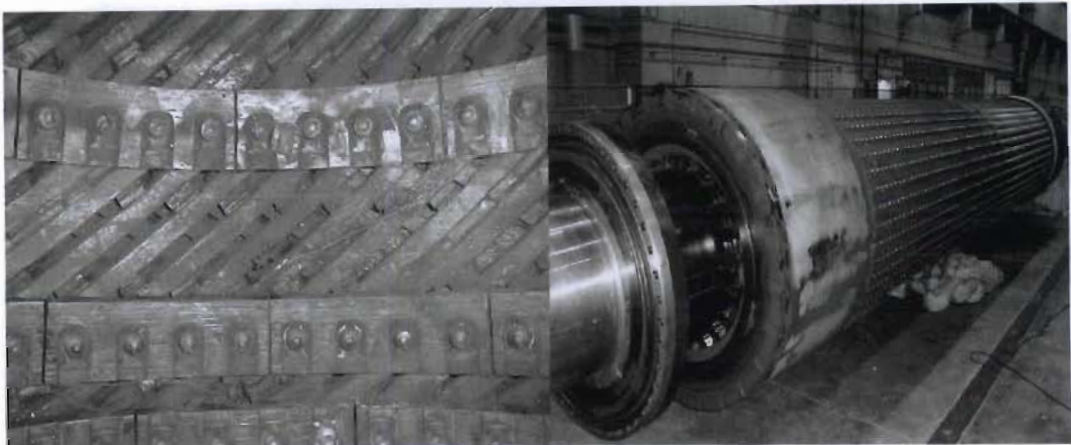
the CRR material and lead to cracking and failure. The stator and rotor were polluted by carbon deposits. The extent of the pollution is captured in Figure 4-6.

Figure 4-6: Global stator and rotor pollution

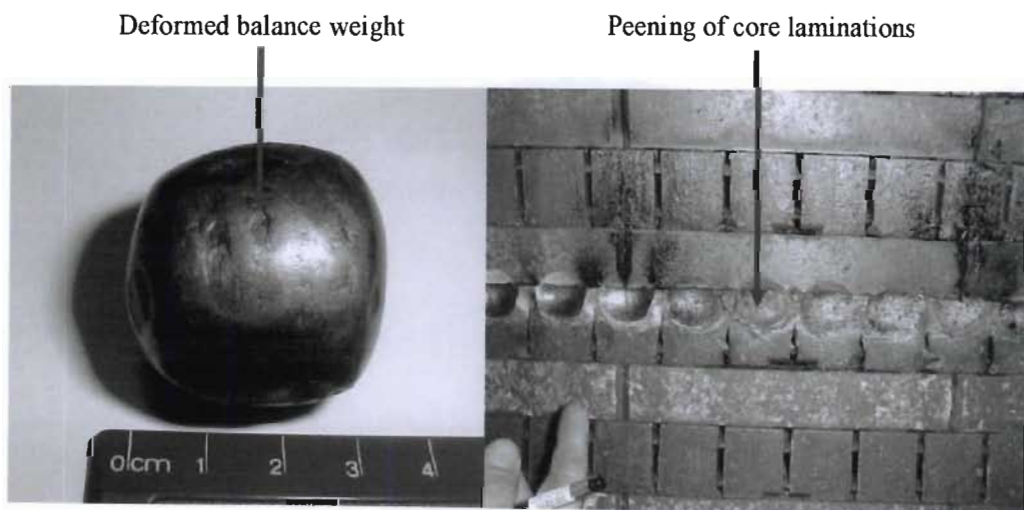
Figure 4-7: FM and core damage

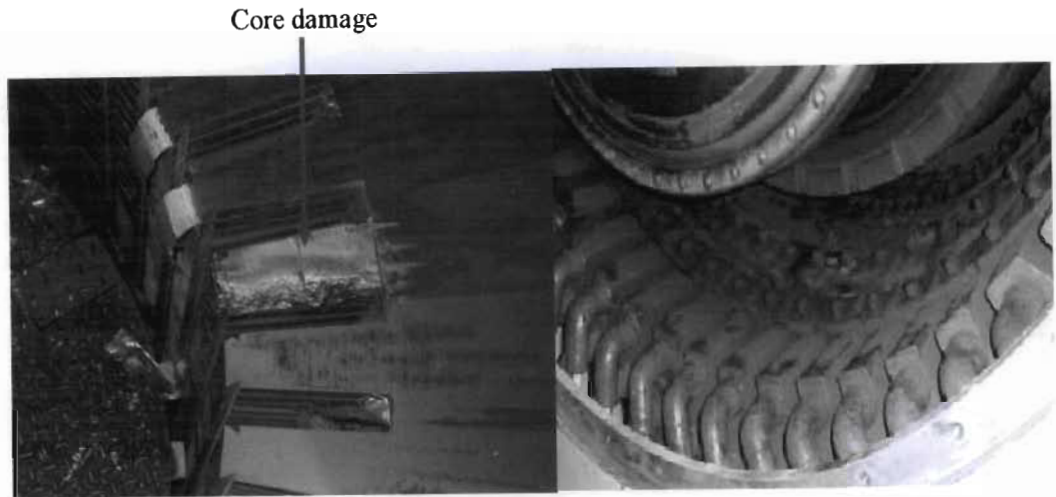
Figure 4-8: Core melting and global pollution of the rotor and stator

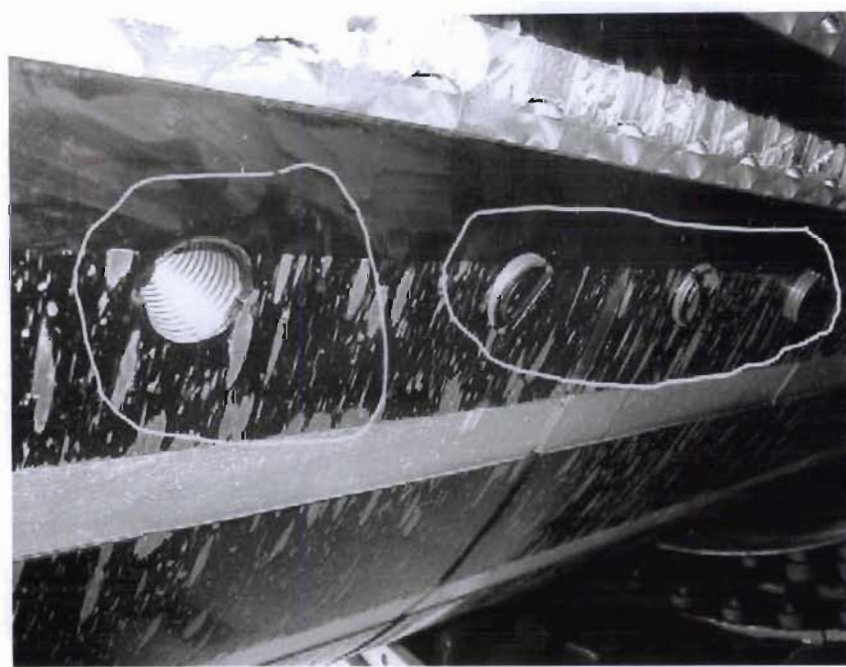
The rotor body and aluminium wedges were damaged severely (Figure 4-9). Due to the design of the rotor wedge, it was able to chip away at the FM and pollute the rest of the generator. The rotor damage is thought to have occurred during barring.

Figure 4-9: Empty balancing plug hole, damage to rotor body and wedges. Further plugs can be seen coming loose.

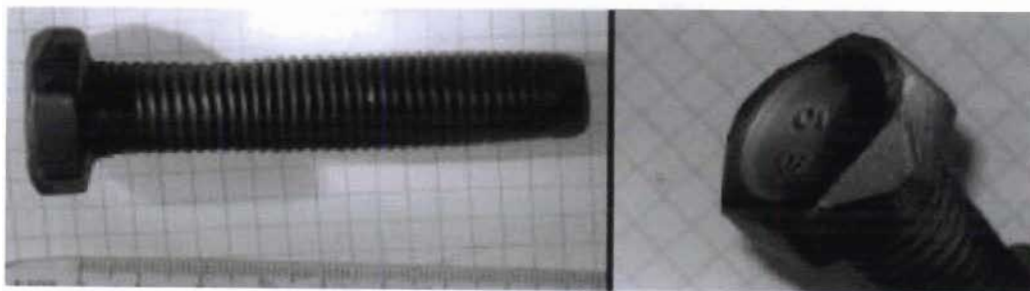
The investigation that followed confirmed an earth fault, and a bolt was retrieved from the generator as seen in Figure 4-10. The bolt was found in the turbine side overhang region. This, along with other unidentified magnetic material resulted in damage to a number of stator bars. There was also a high level of contamination (soot) throughout the generator. Copper deposits were also found on the rotor turbine end CRR.

Figure 4-10: Foreign material

The bolt was tested and found to be similar to the type of bolt used on the stator end winding covers. Debris at the location of the fault was tested and magnetic material was identified. The FM at the failure location was heated up by circulating currents and caused a phase to phase fault.

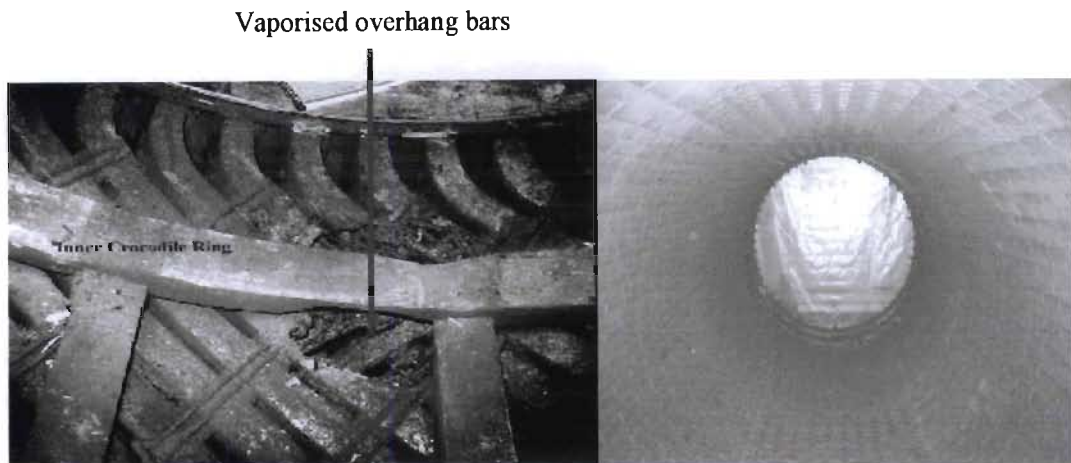
Figure 4-11: Damage to overhang and global pollution of stator.

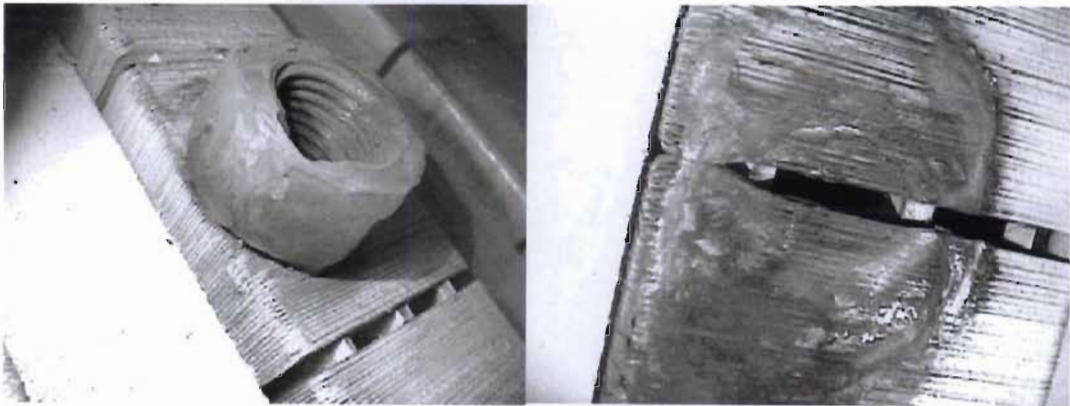
The nut was determined to be from outside the generator and was left in the generator during a previous outage. After an investigation the root cause was found to be a failure in FME procedures.

Figure 4-12: FM and core damage

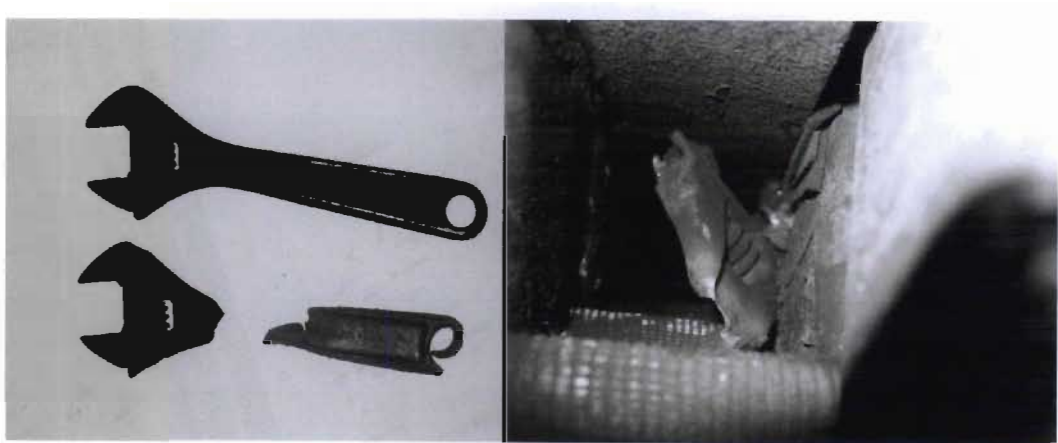
The only information known is that a spanner was left in the stator overhang area that resulted in a catastrophic failure. A series of pictures below chronicle the incident.

Figure 4-13: FM and FM in the stator overhang as found

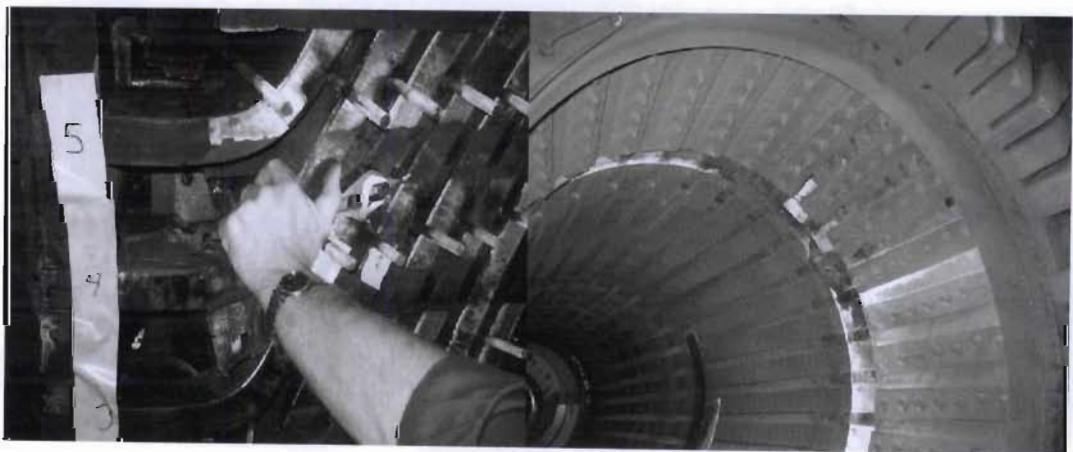
Figure 4-14: Overhang bar damage and global pollution

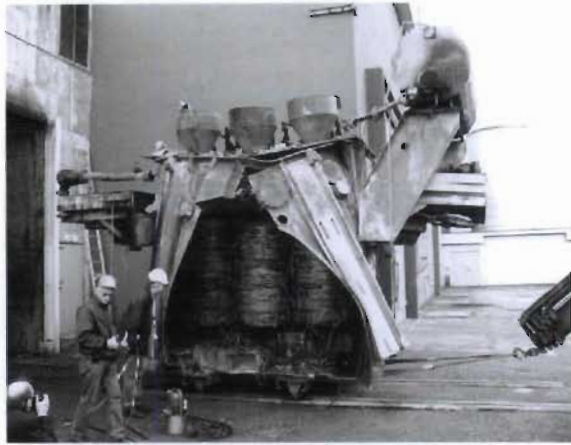
Figure 4-15: Failed transformer

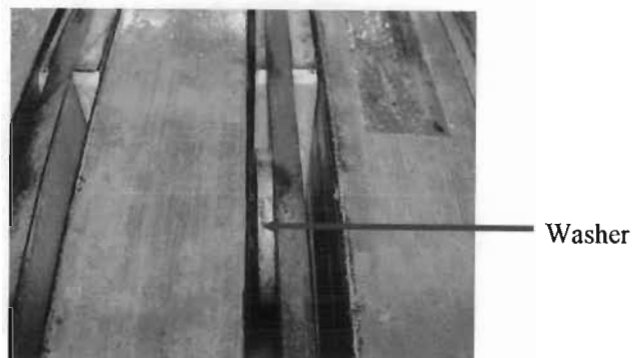
All that is known about this incident is that a washer was left in the overhang of a generator rotor.

Figure 4-16: FM in rotor overhang
