3D-FIB characterization of wear in WC-Co coated composites

Keywords: 3D tomography, WC-Co, wear, thermo-mechanical cracks

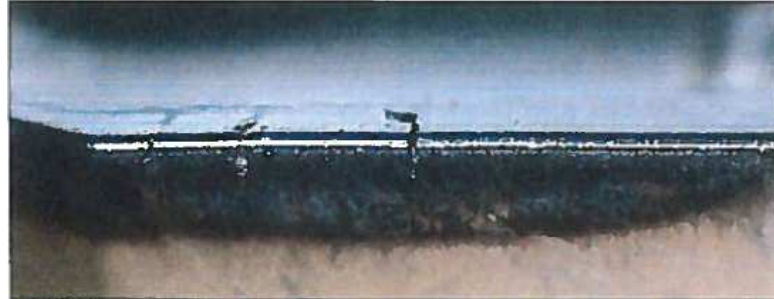
Comb cracks were generated by wet milling tests in grey cast iron. Using this method the inserts are subjected to a high thermo-mechanical cycling condition due to the use of coolant, which causes the formation of comb cracks perpendicular to the cutting edge. In this test the tool life is mostly determined by chipping as a consequence of the comb cracks. So to avoid chipping and make the comb crack visible the test was stopped at 25% of the total tool life (Fig.1.).

Figure 1: Stereographic image of the insert edge after the milling test. 3 comb cracks are clearly visible.

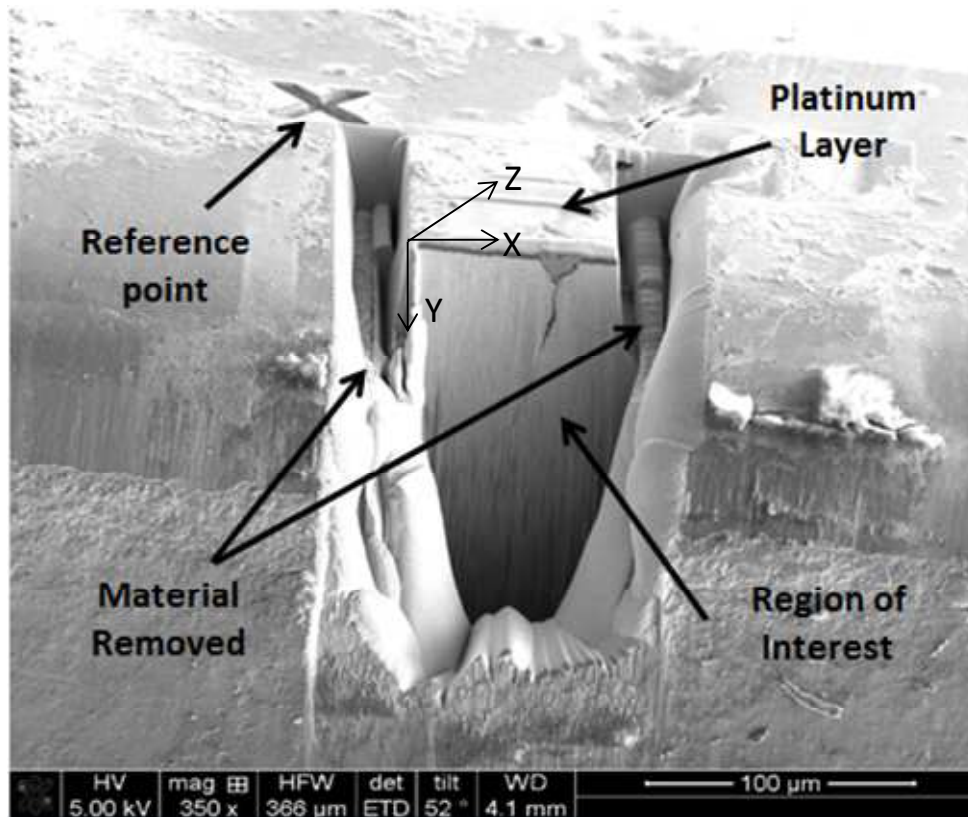
In Fig. 2 an image of the comb crack region after some sectioning in the FIB is shown. The material removal during the serial sectioning was stopped after realizing that no change in the microstructure was taking place. The total amount of images was 400. 319 sections were used to make the reconstruction.

Figure 2: SEM image of the sample during the FIB tomography.

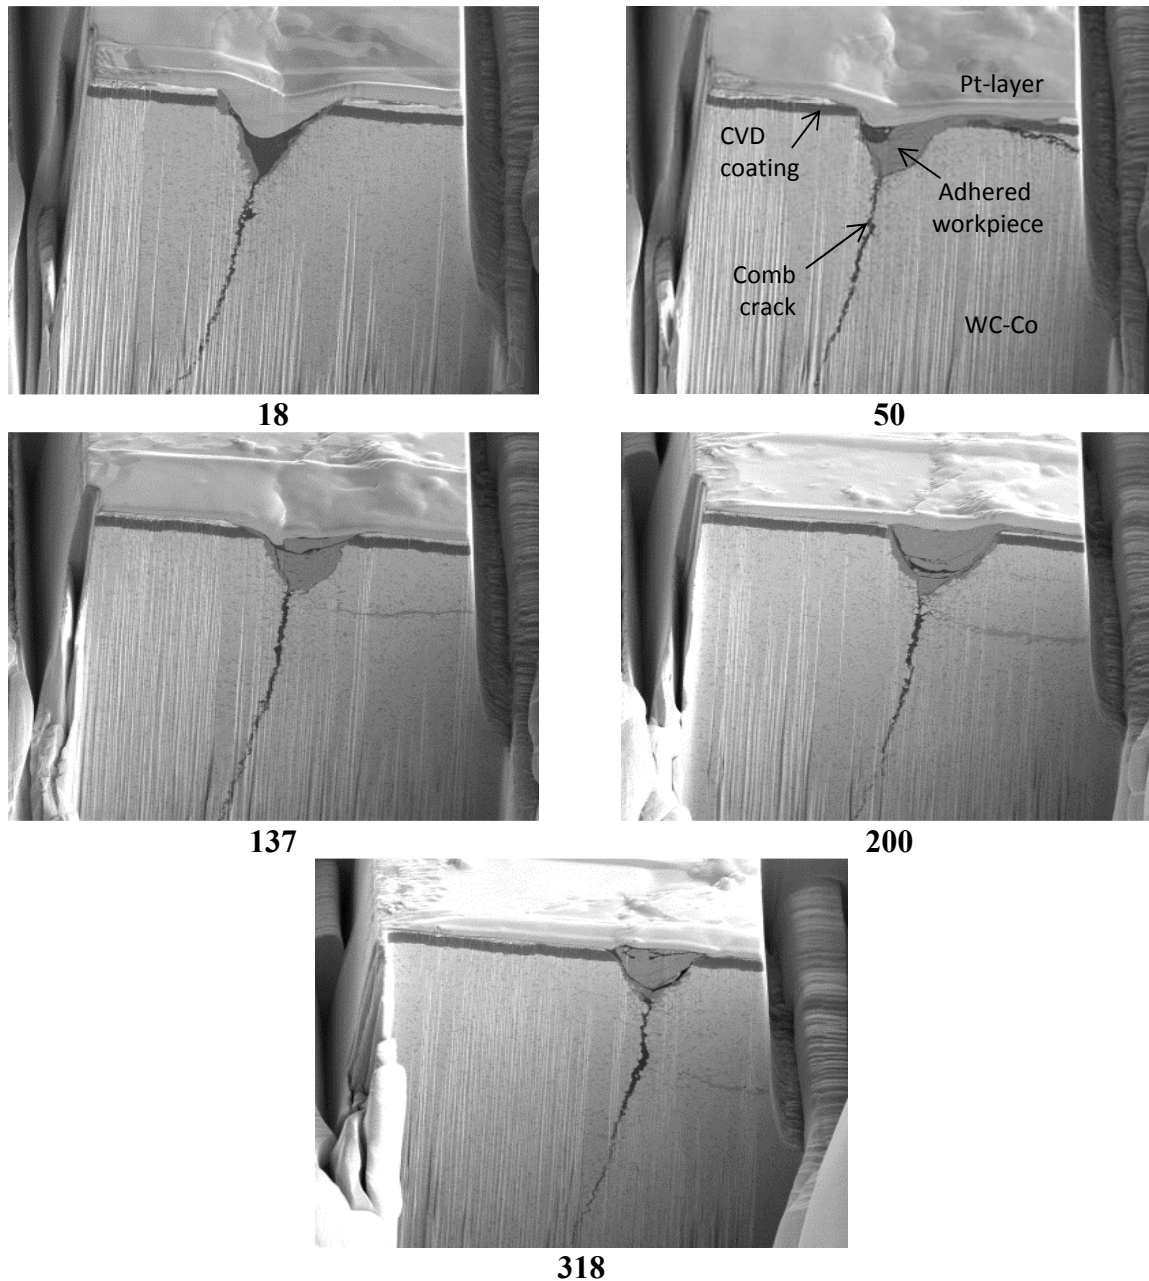
Figure 3 shows a series of images taken by the SEM (slide 18, 50, 137, 200 and 318) which were used for the 3D reconstruction. The images show the microstructure of the region around the comb crack at different distances from the flank surface (z-axis).

These images provide valuable information which is not possible to observe from a single 2D image. In particular the microstructural changes connected to the region around the crack are visible. For example the amount of workpiece material micro-welded to the cutting material varies inside the crack. Also the morphology of the wear track on the crater surface changes in the z-direction. Most interestingly it is observed that other cracks parallel to the edge line are visible. These lateral cracks are inside of the material as shown in slides 50, 137, 200 and 318. It can be observed that the microstructure around the lateral crack region is different compared to the initial microstructure of the material not affected by the wear. The distance of these lateral cracks varies as function of depth (z-axis) which may be assumed as independent cracks; however the 3D reconstruction will allow us to observe that this variation of depth to the edge line surface of the lateral cracks is connected to a particular morphology of them.

Figure 3: SEM images used for the reconstruction, showing microstructure changes at the different places of the region of interest.

Furthermore the formation of lateral cracks may be connected to microstructural changes in the region surrounding the crack, such as depletion of binder by chemical attack of the cooling media, as shown by the 3D sectioning in Fig. 3. The propagation of cracks may be dominated by the interfaces WC-to-Co, which depends on the particle size, distribution of the WC grains but also on the binder composition and the interfacial energy of WC/WC and WC/Co interfaces [7].

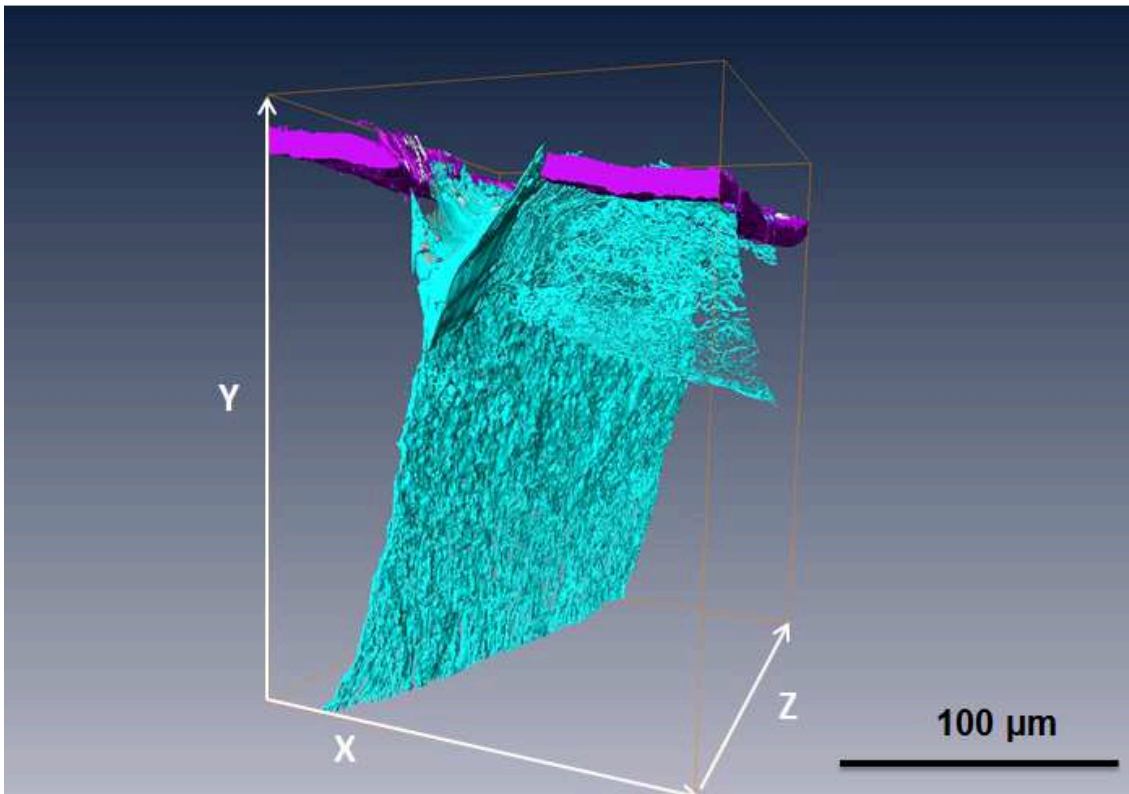
All the 319 images were opened together in the commercial AMIRA software and worked out (aligned and segmented) to obtain the 3 (X, Y, Z) dimensional visualization of the full comb crack and its surroundings. The result is shown in Fig. 4.

From the reconstruction it is observed that, by connecting the lateral cracks images in the 3D reconstruction, they present a particular morphology. The lateral crack has a semispherical morphology, which connects to the crater surface of the insert. This morphology can be more visible if the 3D reconstruction of the lateral crack is intercepted by a dark plane, as shown in Fig. 5. The lateral cracks present this particular form due to the fact that they are formed by the cycling mechanical load (fatigue condition) during the milling process.

Figure 4: 3D visualization of the comb crack investigated. The crack is marked with Cyan and the coating is marked with Violet.

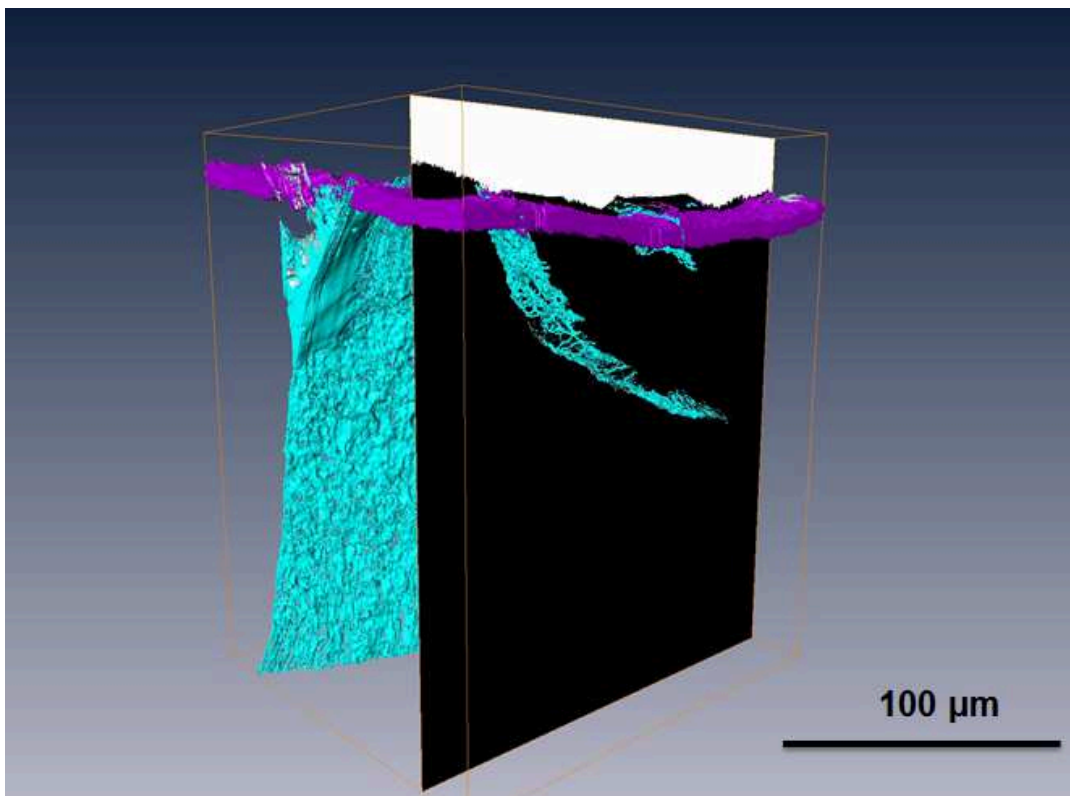
This is typical for brittle materials under cycling (increase/decrease) load condition, as demonstrated by Hutching [5]. It is remarkable that this particular form seems to be connected to the stress field acting in the cutting edge during the machining process, since the stress distribution of forces has the same semispherical form as the one observed in these lateral cracks. This correlation between stress and crack formation has been modelled by Sergejev et al in WC-Co cemented carbides [6]. They carried out theoretical calculations on the geometry of fatigue cracks on cemented carbides developed from cyclical loading (indentation cracks for different indentation loads); and the connection to lateral crack formation. It was determined that the number of lateral cracks that would be observed from one cross section of cemented carbide was dependent on the loading force and the number of loading cycles. The propagation of the primary lateral cracks was considered as giving way for surface fatigue fragments formation. The lateral cracks were determined to propagate with an elliptical form towards the free surface of the material.

Figure 5: The principal crack with the lateral crack, parallel from the surface. A black plane has been drawn in the y-z plane in order to visualize the morphology of the lateral crack.
