Seismic response analysis and damage verification of notojima bridge during noto peninsula earthquake

SEISMIC RESPONSE ANALYSIS AND DAMAGE VERIFICATION OF NOTOJIMA BRIDGE DURING NOTO PENINSULA EARTHQUAKE

S. FUKADA¹, K. MAEGAWA², H. SAKO³ and Y. YAMAZAKI⁴

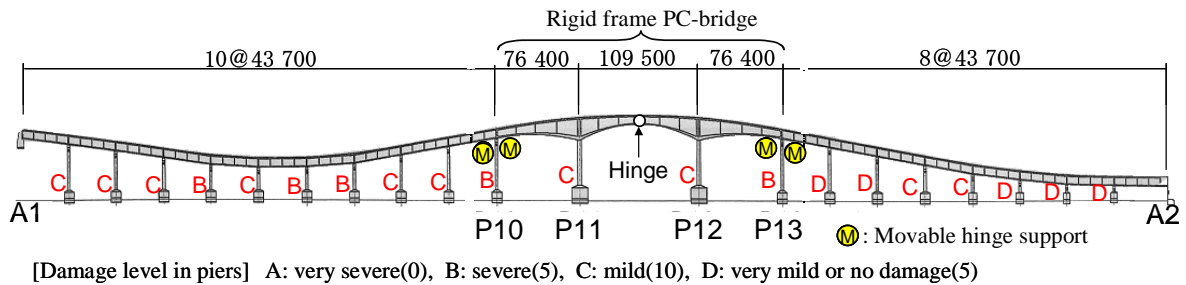
Figure 2 shows the side view of Notojima Bridge. The damage levels in piers, which are indicated with B, C or D, have been judged by visual inspection. The level B corresponds to the reinforcement

Figure 2. Side view of Notojima Bridge and Damage level in piers

break and buckling and/or to the stripping and cracks of cover concrete. The level C corresponds to the local stripping and cracks of concrete covering. The piers on A1 (Notojima Island) side sustained relatively severe damage. Indeed the bridge is longitudinally asymmetric, but the rigid frame PC bridge of central three spans is symmetric. The damages of both piers P10 and P13 were evaluated as the level B, however the crack density of P10 is obviously higher than that of P13 (see Fig.3).

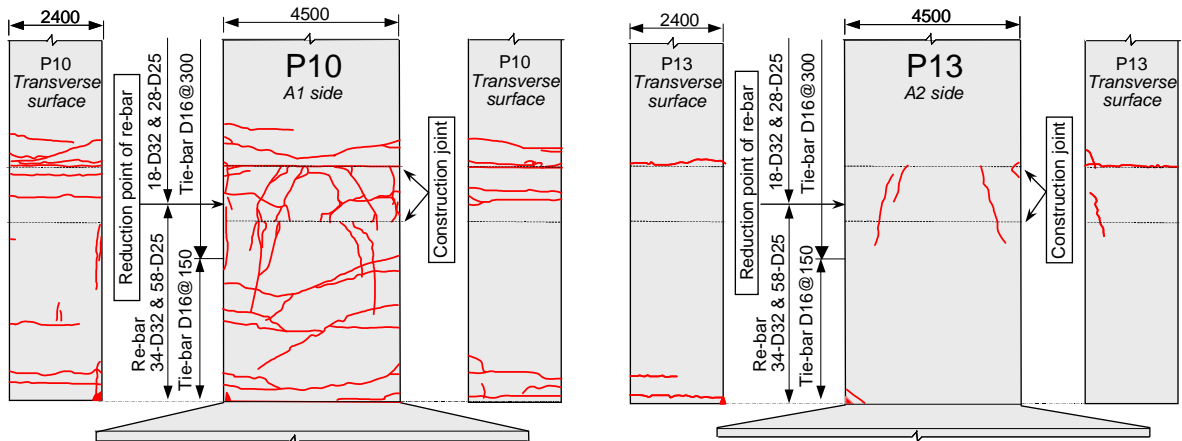
Figure 3. Crack distribution in piers P10 and P13

1. The damages of P10 and P13 in 3-spans continuous rigid frame PC box girder bridge with pin-connection at the mid-span were evaluated by the visual inspection. The crack density of P10 is obviously higher than that of P13.
2. It is clear that the vibration mode and the seismic behavior of the rigid frame PC box girder bridge by 3D eigen value analysis and 3D non-linear seismic analysis, respectively.
3. The analytical damage area of P10 is larger than that of P13. It is found that the difference of steel pipe piles between P10 and P13 might affect the asymmetrical damage.

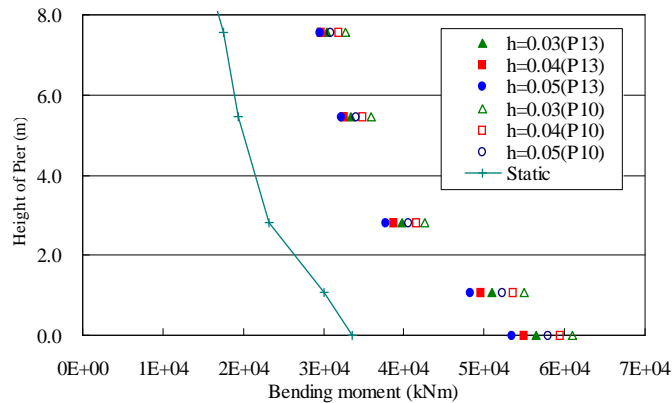
Figure 10. Bending moment diagram

The bending moments of P10 and P13 by the static and dynamic seismic loads are shown in Figure 10. This figure also shows the result of along height of the pier using each damping constant. The damping constants give minor influence on the bending moments. The results of P10 are larger than that of P13. Dynamic amplification at the bottom of the P10 was 1.7 to 1.8 for the static seismic load.

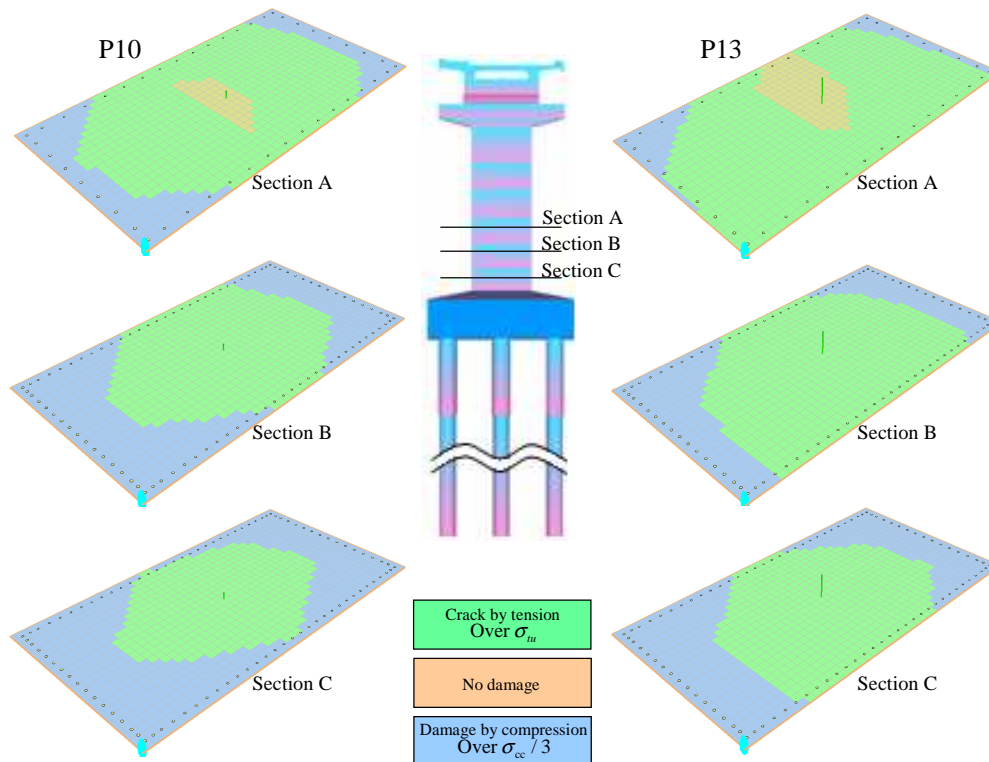
Figure 11 shows the analytical damage ($h=0.03$) of the cross section in P10 and P13. The each contour shows the state of damages in the fiber elements. The damage area of P10 is larger than that of P13. It is found that the difference of steel pipe piles between P10 and P13 might affect the asymmetrical damage.

Figure 11. Analytical damage of the cross section in P10 and P13
