**ESTIMATION OF MALFUNCTION
OF A HEALTHCARE FACILITY IN
CASE OF EARTHQUAKE**

Nebil Achour

March, 2007

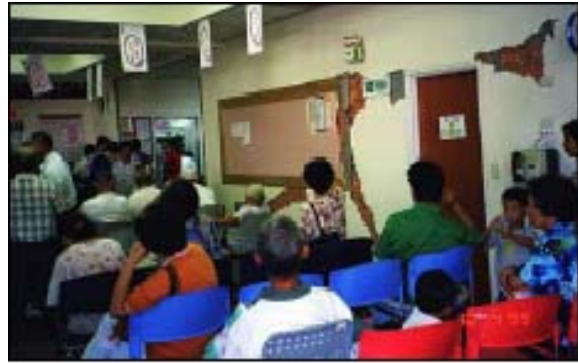
Photo 3.2- Interior damage (1st floor, remained open)
Christian Hospital (Source: Lee et al, 2000)

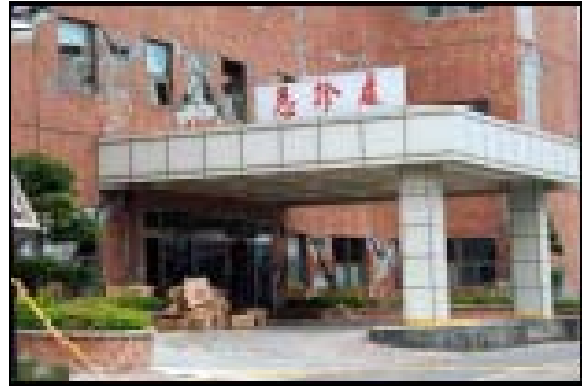
Photo 3.5- Exterior damage, Veteran Hospital

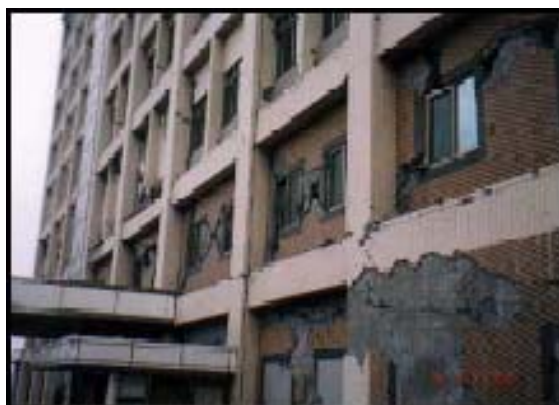
Photo 3.8- Exterior damage, Shiu-Tuan Hospital
(Source: Lee et al, 2000)

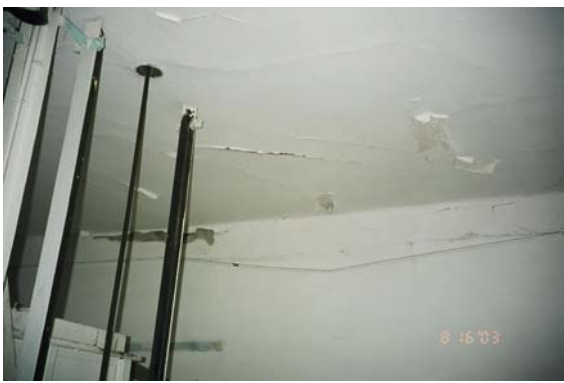
Photo 3.13- Cracks in the structure
CHU Hospital

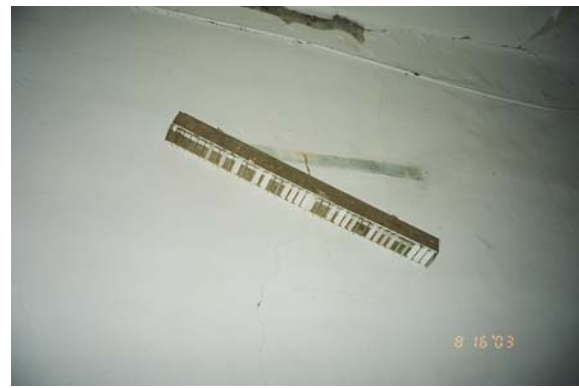
Photo 3.14- Damage to electric equipment
CHU Hospital

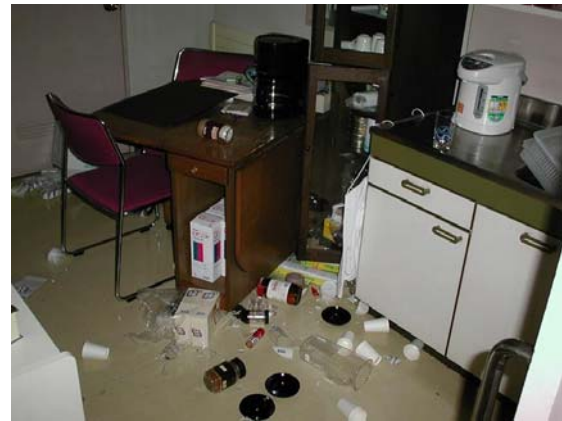
Photo 3.20- Toppling and damage to small equipment, Kushiro Urinary Clinics

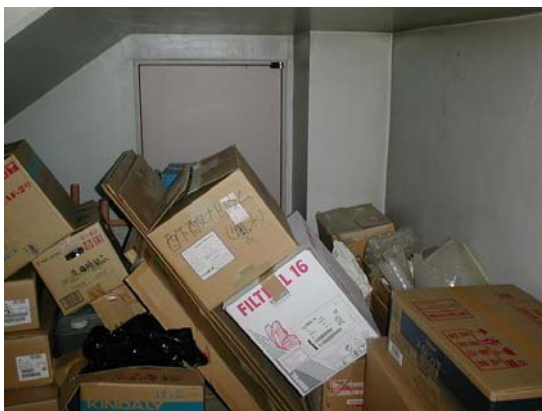
Photo 3.21- Inaccessible door, Kushiro Urinary Clinics

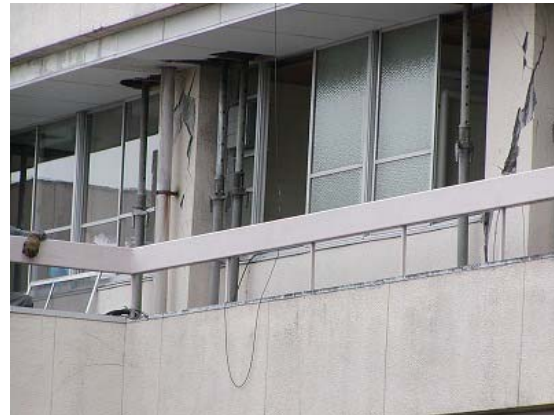
Photo 3.24- Damage to Fukaya Hospital

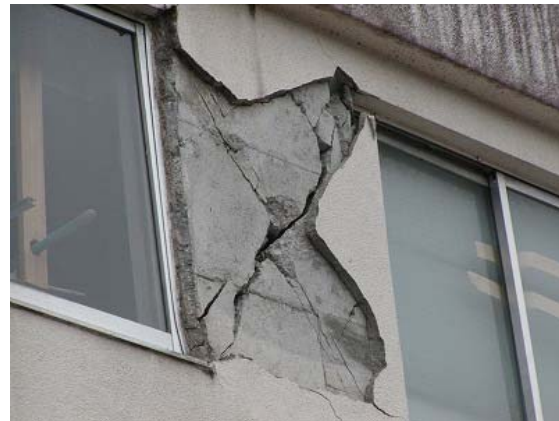
Photo 3.26- Damage to Kashimadai hospital

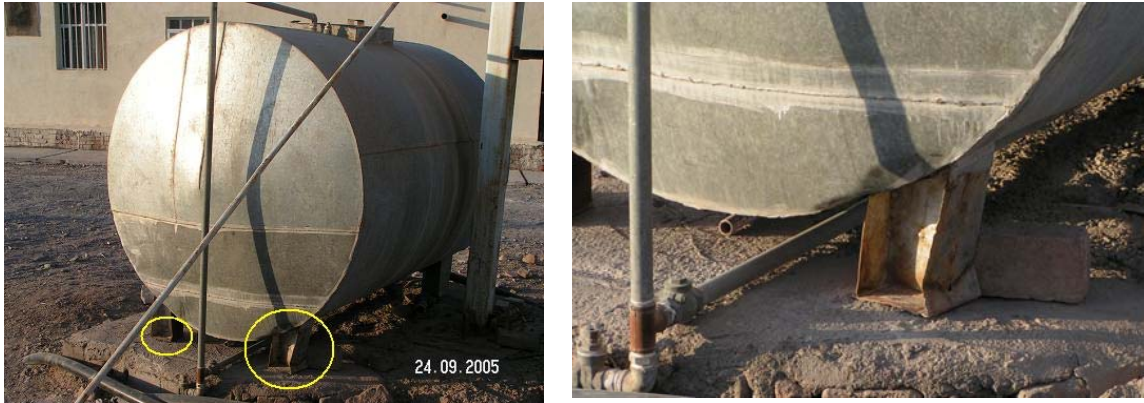
Photo 3.45 and Photo 3.46 show. The buckling was found on all 4 feet with various degrees of severity. However, two of them had serious impact and they affected the tank itself as it is shown in Photo 3.46. The feet should be replaced and the damaged area of the tank should be repaired to avoid any failure in case of another earthquake.

Photos 3.45, 3.46- Buckling of feet of the water tank, Aflatoonian Hospital

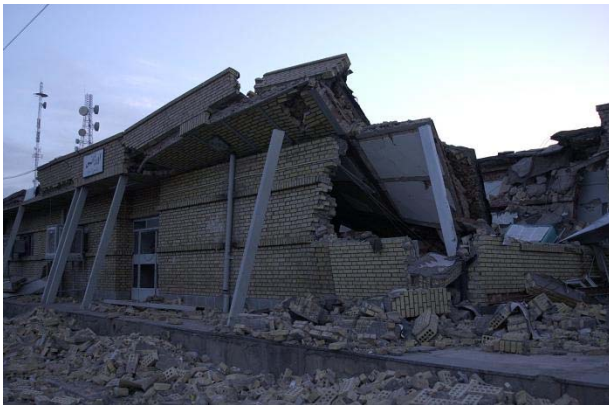
Photo 3.47- Total collapse of Imam Khomeini Hospital February 2004

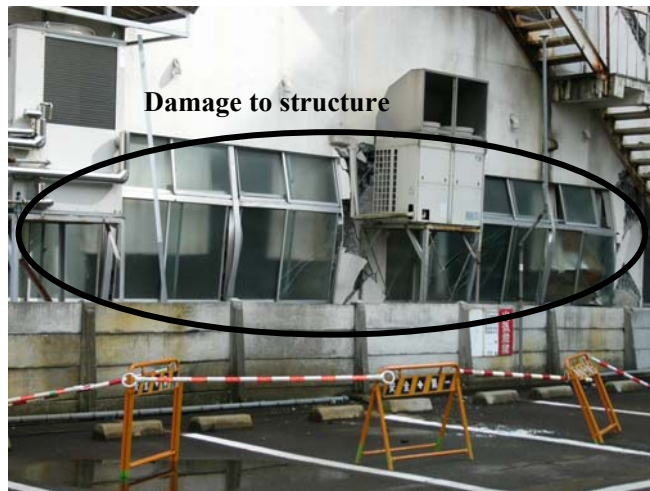
The facility is composed of one building, built in 1978. The shaking caused some cracks in its structure. The facility lost its electric power and water supply for five days; while the gas supply was lost for 18 days from the occurrence of earthquake. The telecommunication system was also inoperable. The loss of electric power caused malfunction to several pieces of medical equipment such as CT scanner, MRI etc.

Photo 3.51- Structural damage to 1968 building, Ojiya Hospital

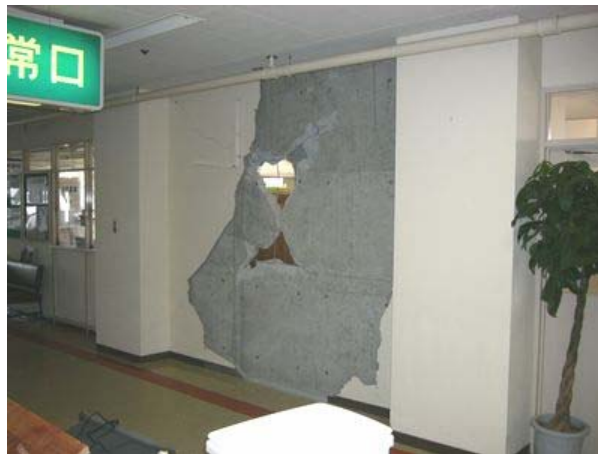
Photo 3.52- Structural damage to 1968 building, Ojiya Hospital

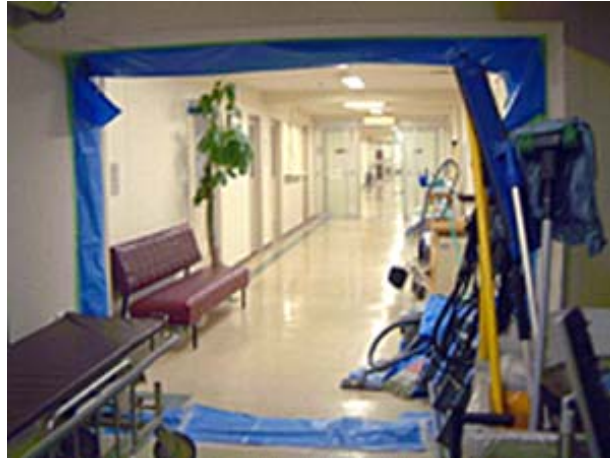
Photo 3.53- Damage to separation joint

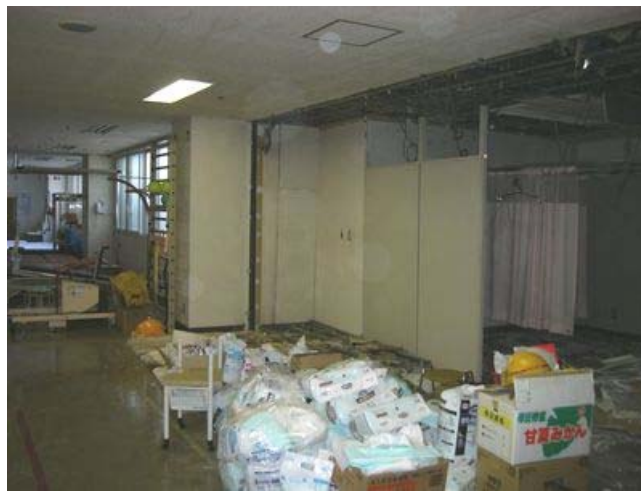
Photo 3.54- Damage to ceilings, Ojiya Hospital

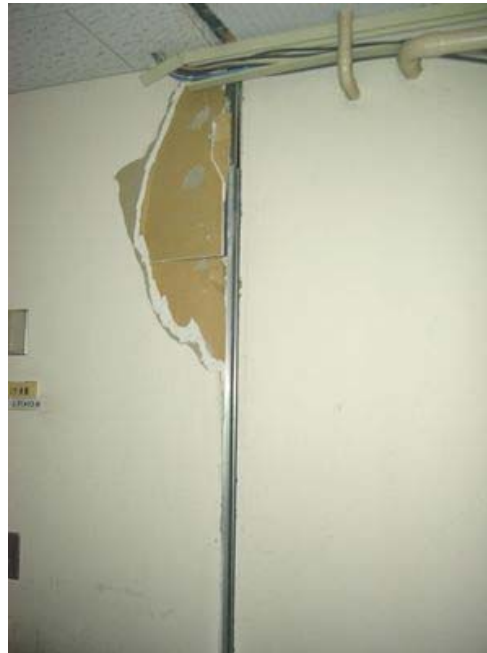
Photo 3.55- Damage to building's joint

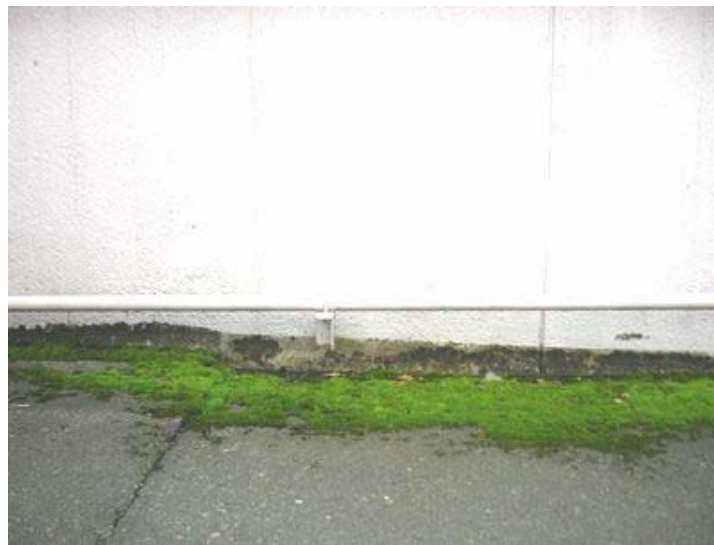
Photo 3.56- Damage caused by liquefied soil

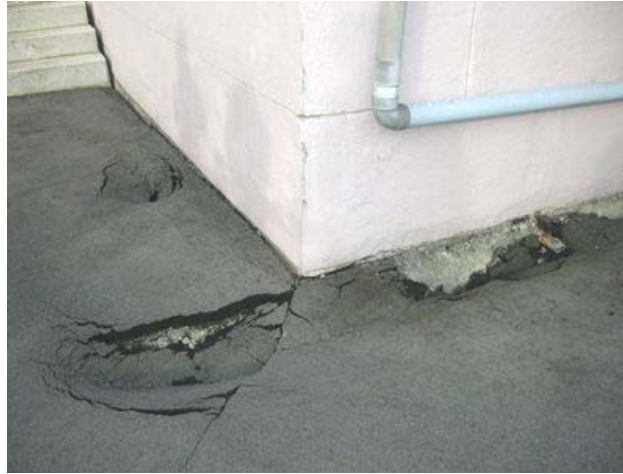
Photo 3.57- Liquefied soil

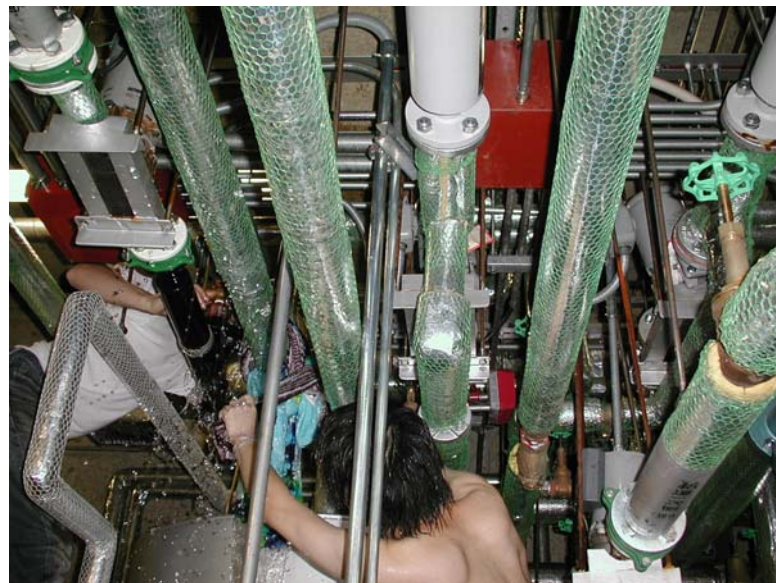
Photo 5.1- Pipe damage, Kushiro Urinary Clinic
