Strain Induced in Cracked Utility Poles and Damage to Dwellings from the Dec 26, 2003, Bam Earthquake

Kazuo Konagai^{1)*}, Masayuki Yoshimi²⁾, Kimiro Meguro¹⁾, Miho Yoshimura¹⁾, Paola Mayorca¹⁾, Masasuke Takashima¹⁾, Alireza Farahani¹⁾, Hossein Tahghighi¹⁾ and Mohammad Keshavarz³⁾

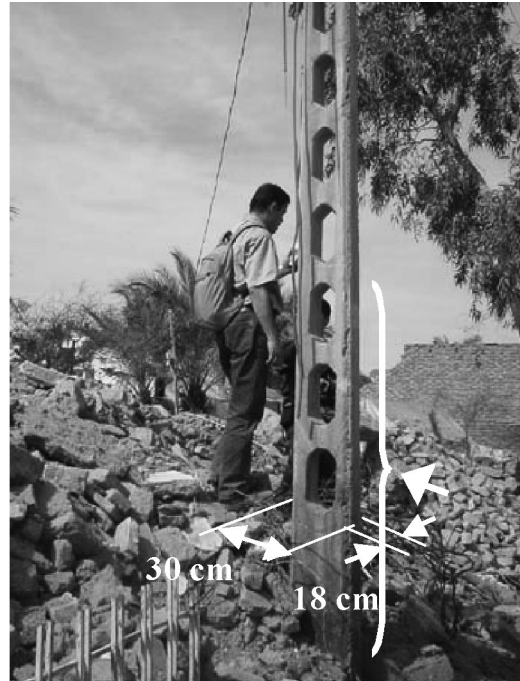
dimensions from area to area, but a thin pole with holes for climbing were the most widely used in the city (Fig. 4(a)), and thus, were chosen as the target.

(a) 8 m pole with holes and embedment depth of 2 m.

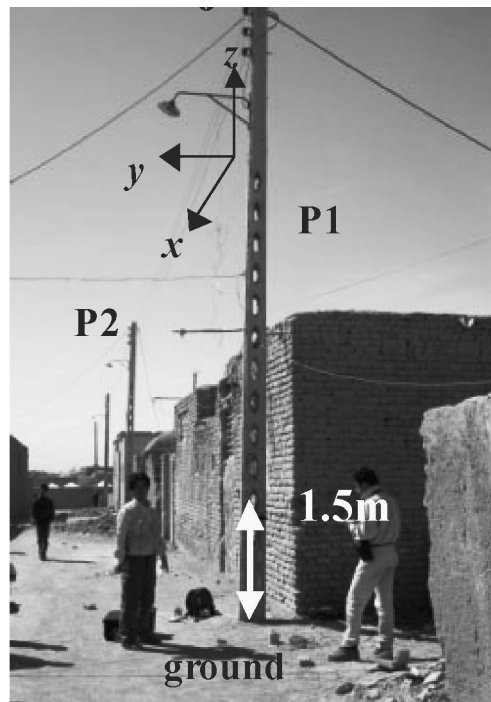
To examine the dynamic features of this type of pole, microtremors were measured at two poles (Fig. 4 (b)). Their characteristics are summarized in Table 1. Bottom holes on P-2 pole were filled in to prevent theft.

(b) Poles P-1 and P-2.

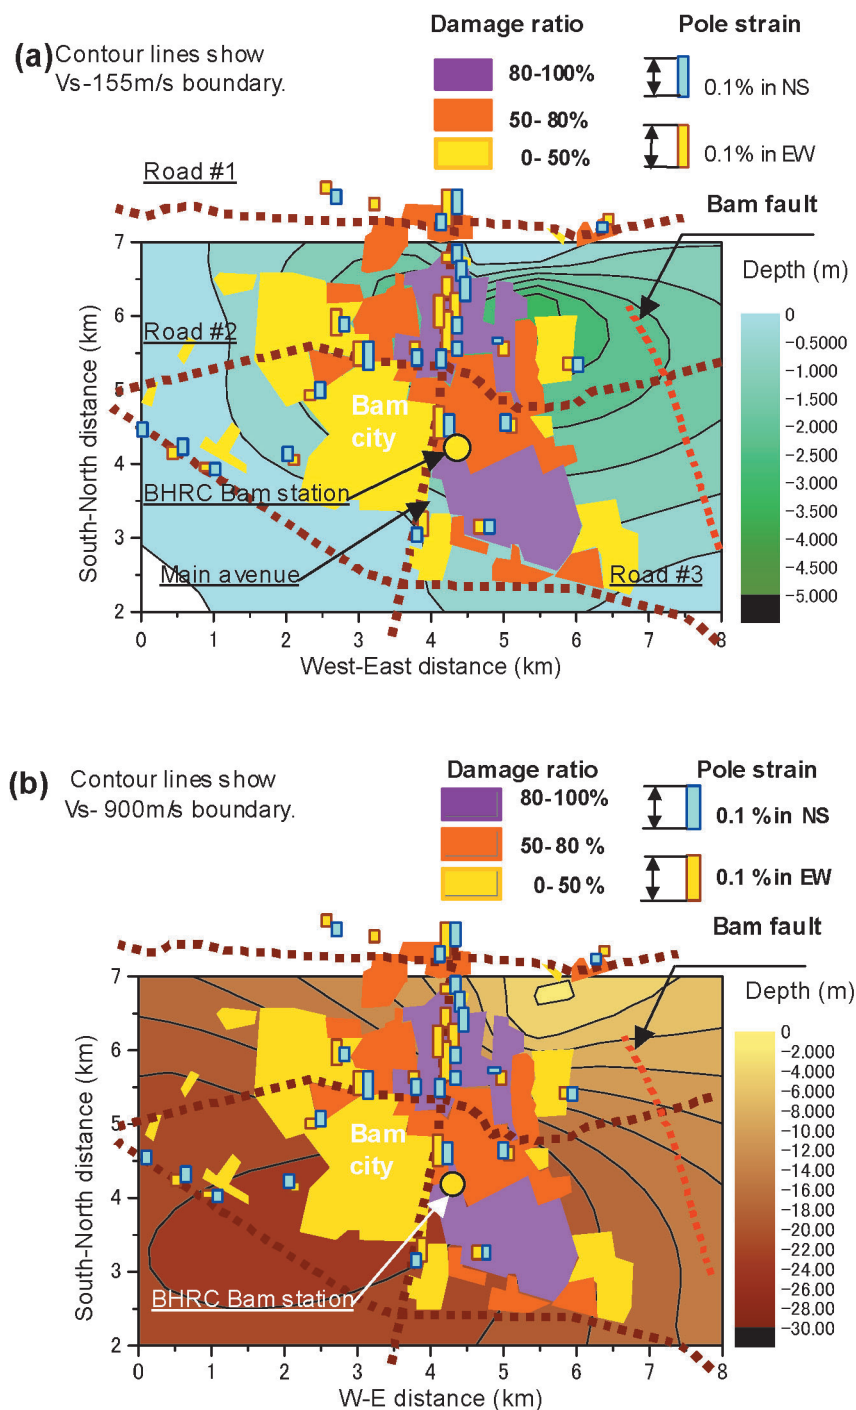
For this reason, crack openings on pole sides without holes were taken to minimize the effects of transmission lines, the cracks caused by the motion of poles in the Y direction. For each pole, crack openings were added up over about a 2 m distance near the lower pole end, and then all of the openings were divided by the distance to obtain the average strain remaining on the pole. A total of 270 poles

were used in both the city and its suburbs. The poles were then divided into several tens of clusters in such a way that each cluster included at least one crossing in it. Because the poles in one cluster line up at least two roads intersecting each other, both north-south (NS) and east-west (EW) average strains were obtained cluster-wise. Figs. 8 (a) and 8 (b) show the distribution of remaining average strains in the city. Contour lines in Figs. 8 (a) and (b) show inferred layer boundaries of shear wave velocities $V_s=155\text{ m/s}$ and $V_s=900\text{ m/s}$, respectively (see Fig. 3), and colored zones show percentages of damage to dwellings mapped by the National Cartographic Center of Iran (2004). In general, strains are large along the main avenue that runs through the city from north to south. Damage was also severe along this avenue

Fig. 8 b Strains remaining in poles: (Damage ratio provided by NCC of Iran, 2004).

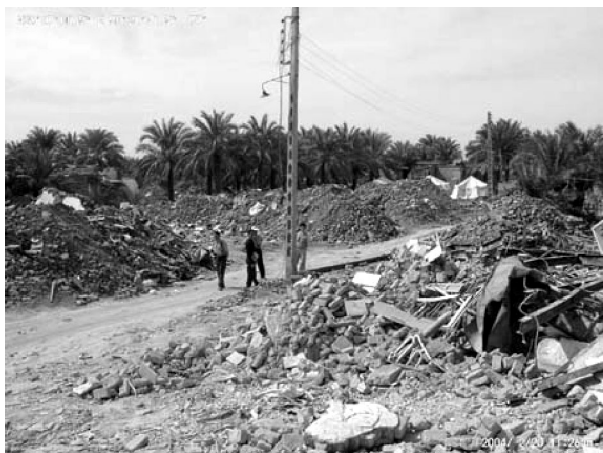
(Fig. 9 a), and it faded quickly as we got some street blocks away from the avenue (Fig. 9 b). Some severe damage to dwellings was also found along Road #2, which used to be an old river trace, and goes through the city from East to West (Fig. 9 c). The strain distribution thus seems to be consistent with the overall damage distribution pattern. However, cali-

(a) Near the main avenue.
N29°07'00.5" E58°21'41.5" 77°.

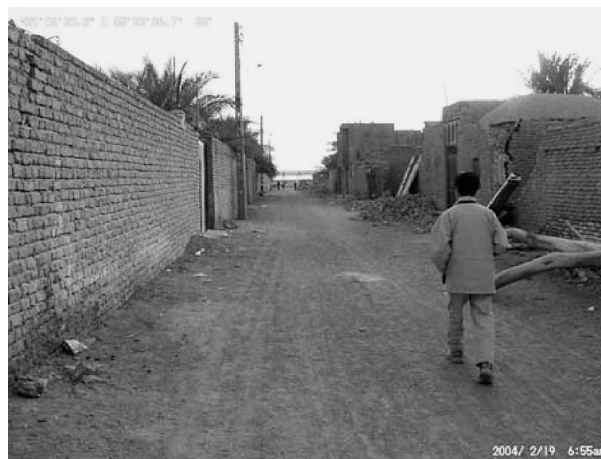
(b) East of the city.
N29°06'23.3" E58°22'36.7" 88°.

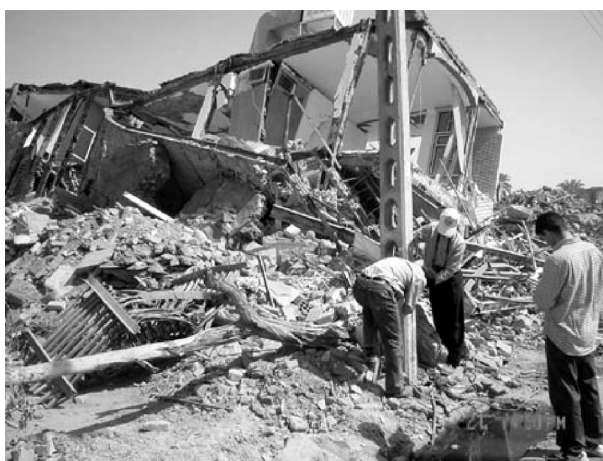
(c) Along the Street #2
N29°06'24.6" E58°21'13.1" 74°.

suburbs. Clusters of poles with relatively large strains were found mostly along (1) the main avenue that runs through the city from north to south and (2) along Road #2, which used to be an old river trace, and goes through the city from East to West (Fig. 9 c). Dwellings along these roads were the most seriously damaged. In general, the distribution of cracked poles seems to have a good correlation with damage distribution, which again showed the high seismic vulnerability of adobe and unreinforced masonry structures.
