Investigation and Analysis of Damage to Buildings during the 2003 Bam Earthquake

Hossein Mostafaei* and Toshimi Kabeyasawa

Earthquake Research Institute, The University of Tokyo

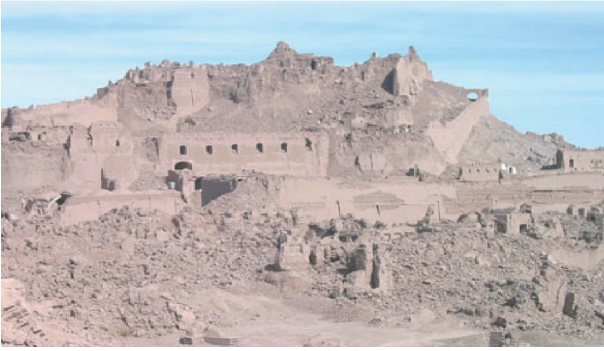
Fig. 10. Arg-e-Bam, example of adobe structure (Ad type).

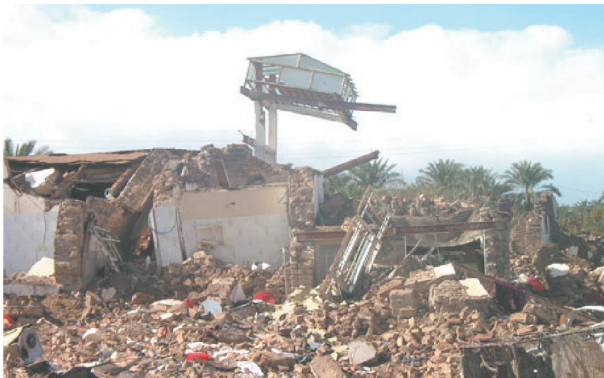
type or M-Ad type. The difference between M and M-Ad is the use of masonry mortar, which is cement for type M and mud-lime for type M-Ad. Figure 11 shows a masonry building in the center of the city, almost 1 km from the site where the strong ground motion accelerogram was recorded.

Fig. 11. Masonry Buildings in Bam, M Type.

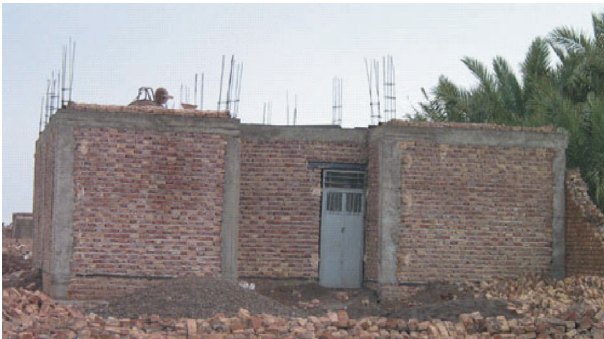
Figure 12 shows a reinforced masonry building with reinforced concrete horizontal and vertical elements as ties. Type M-S also refers to a steel frame building with masonry brick walls, as shown in Fig. 13. In this type of structural system, the masonry walls give supplemental lateral resistance to the structural system and work as confined infill walls.

Fig. 12. Reinforced Masonry Buildings in Bam, M-C Type.

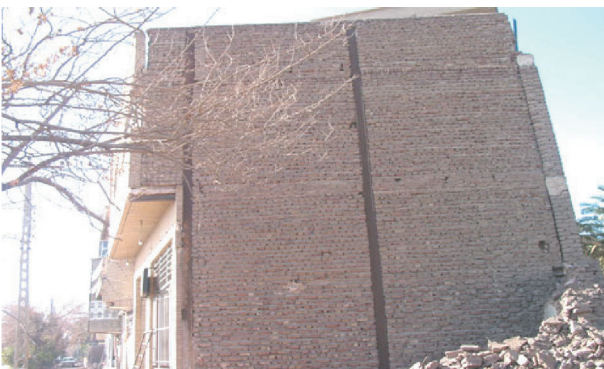
Fig. 13. Masonry with steel frame buildings, M-S type.

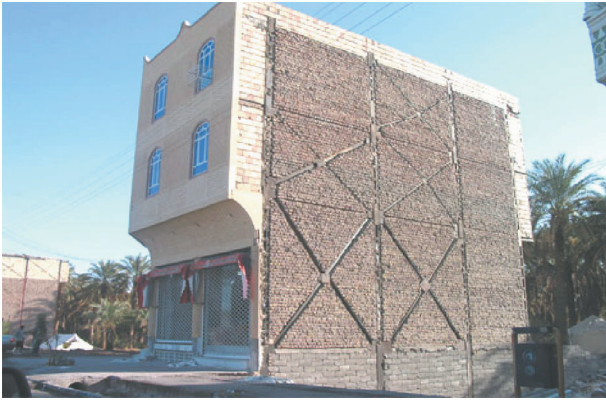
mic code in 1990. It is preferred by owners of conventional buildings, due to the fast and convenient construction process and economic benefits in comparison to a reinforced concrete structure (Fig. 14).

Fig. 14. Steel frame structures with bracing, S-B type.

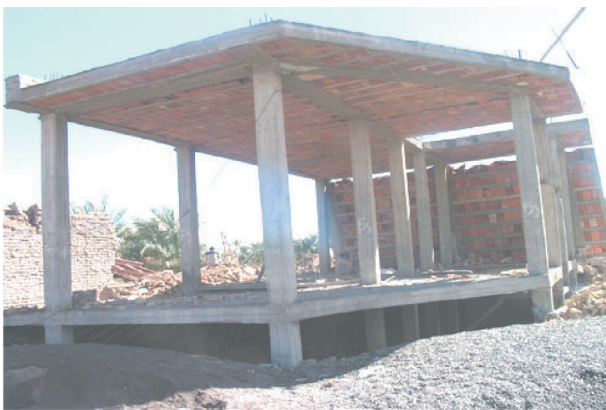
Fig. 15. Two-story RC structure, RC type.

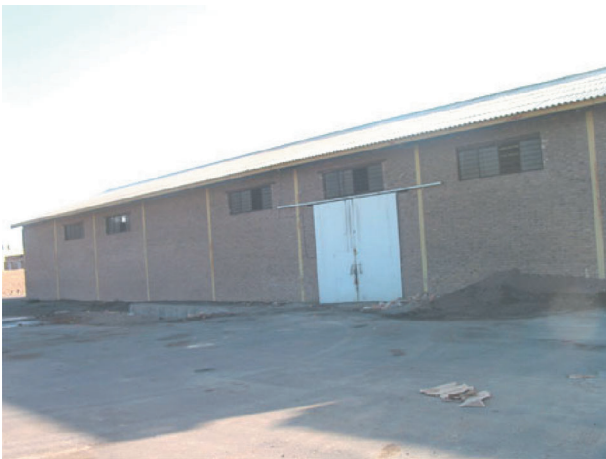
Fig. 16. Special steel frame-masonry structures, M-S-F type.

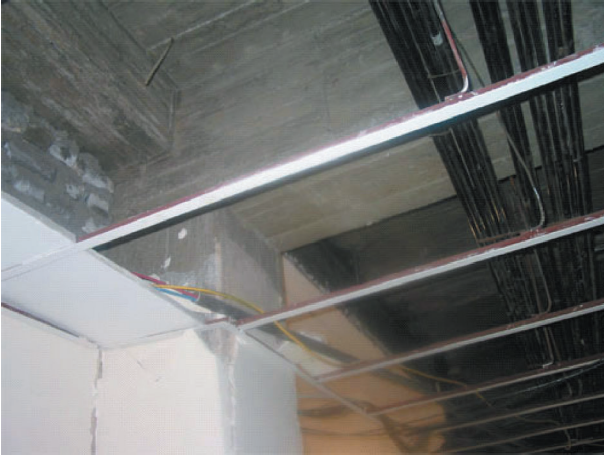
of telephone centers in Bam city (in Zone 1 of Fig. 18, the same zone as the strong motion station's zone) and Baravat village (in Zone 8), as shown in Figs. 21 and 22, respectively. The steel structure of Bam Azadi hotel (in Zone 4) also performed without significant structural damage, as shown in Fig. 23. Based on these observations, it is estimated that the effects of infill masonry walls might be an important factor for the almost linear response of this kind of frame structure. To find the answer, in addition to the statistical damage evaluation presented, a case study of a 3D nonlinear time history analysis for the RC building of the Telephone Center in Bam city,

Fig. 21. A beam-column connection on the first floor of the Bam telephone center, which had no damage (about 1,000 m north of the strong motion station).

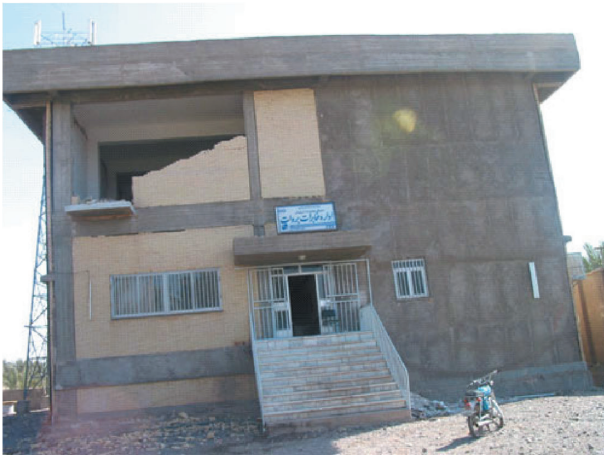
Fig. 22. Baravat village telephone center, which had no structural damage.

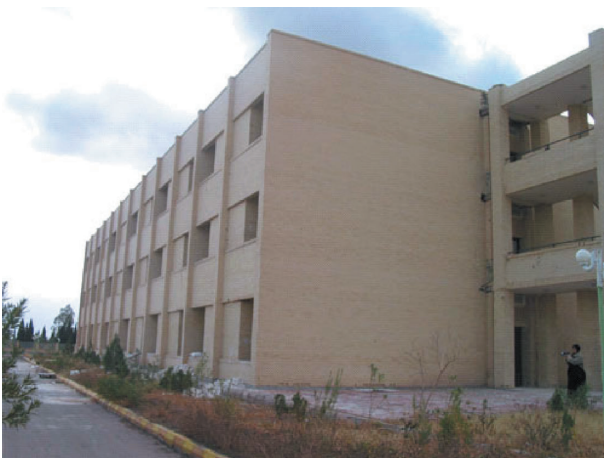
Fig. 23. Bam Azadi hotel which had no structural damage (about 2000 m SW of the strong motion station).
