Damage event analysis of vertical ground source heat pump systems in Germany

Paul Fleuchaus*

and Philipp Blum

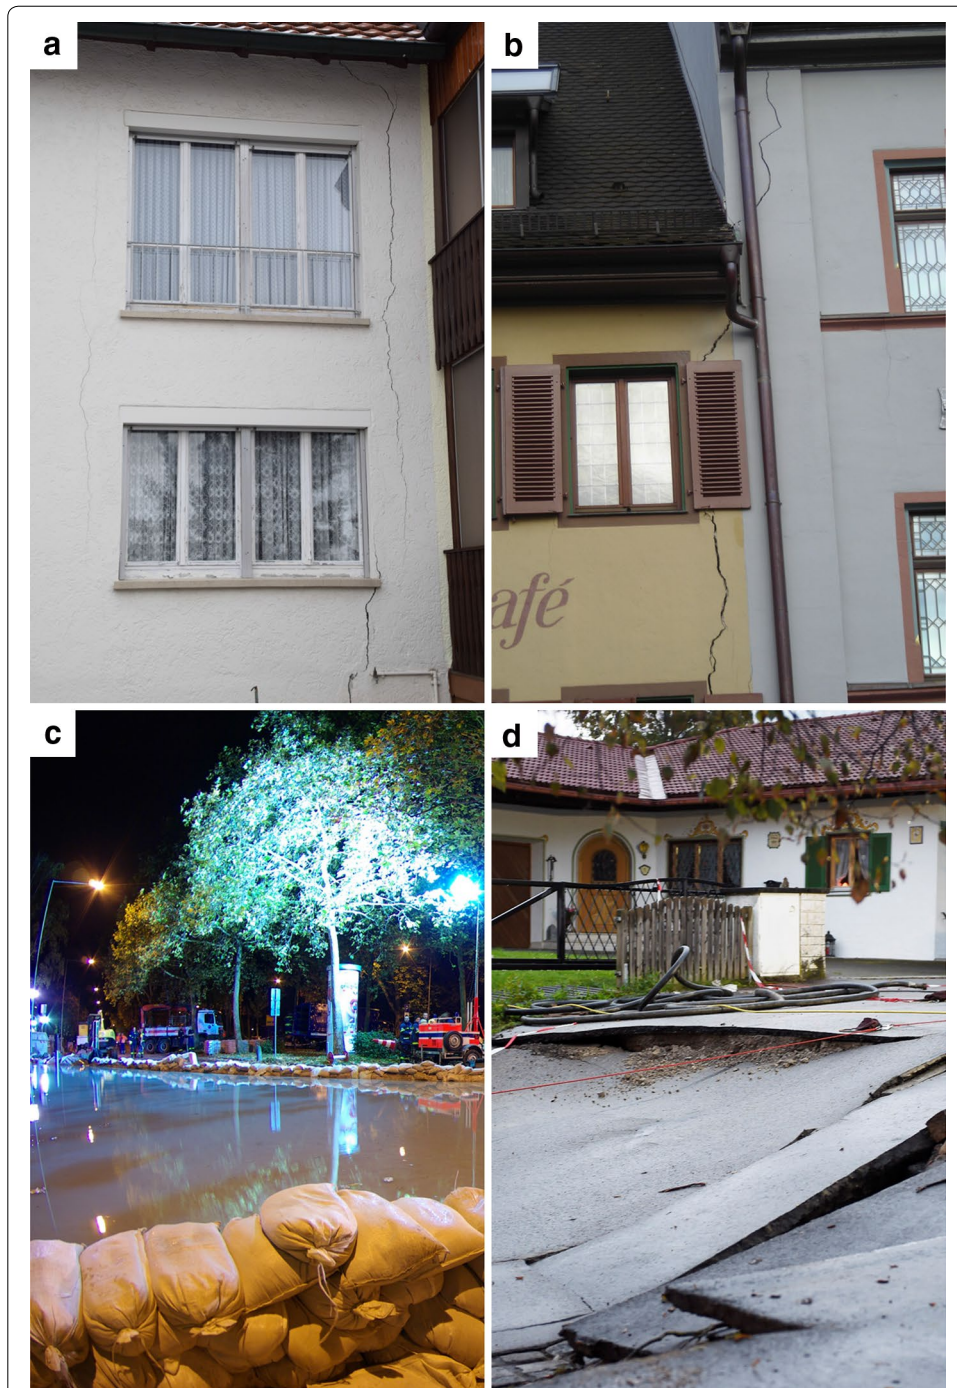
reported first cracks in their buildings, which rapidly propagated (Fig. 3b). In two published status reports, the Geological Survey of Baden-Württemberg (LGRB) provided evidence of the fact that these ground uplifts had been induced by the geothermal drillings (LGRB 2010, 2012). Initialisation of swelling processes by earthquakes was excluded (Sass and Burbaum 2012). With a final depth of 163 m, the drillings penetrated the anhydrite-bearing Keuper formation. Anhydrite turns into gypsum when it comes into contact with water. The transformation process is accompanied by a volume increase of up to 61% (Butscher et al. 2016a).

Fig. 3 Damages in Böblingen (a), Staufen (b), Wiesbaden (c), and Rottach-Egern (d). ©: a Paul Fleuchaus, b Christoph Butscher, c Michael Ehresmann, and d Thomas Plettenberg

To identify the cause of damage, the LGRB made several exploration drillings. Similar to the case of Staufen, inflow of groundwater into an anhydrite-bearing layer had caused the uplifts. The swellable anhydrite layers were located in the Grabfeld formation at a depth of 56–114 m below ground level (Fig. 4). Geothermal drillings reached their final depth in the impermeable Erfurt formation. Hence, upward migration of the underlying confined groundwater of the Upper Muschelkalk was excluded just as in the city of Staufen. Temperature profiles confirmed a descending groundwater flow from the Stuttgart formation into the anhydrite-bearing layers of the Grabfeld formation. Groundwater from the Stuttgart formation found its way through a leaky backfilling. In late 2014, the LGRB took first damage-limiting measures: Post-grouting of the leaky annulus with sulphate-resistant cement and permanent groundwater drawdown below the swellable zones. After this, the temperature profiles indicated a stop of vertical groundwater flow along the installed BHE. A reduced ground uplift rate was measured as soon as the initial recovery measures started (LGRB 2016). The uplift damaged more than 250 buildings and the amount of damage is currently estimated to be around 50 million Euros (StZ 2015).

In November 2009, drilling activities for a near-surface geothermal energy application on behalf of the Hessian Ministry of Finance induced flooding in the city centre of Wiesbaden. Drillings reached a depth of 130 m when a 7-m-high groundwater spring erupted from the borehole. Up to 6000 l/min of groundwater poured over a 400 m² large area around the drilling site (Fig. 3c). Even though the borehole was filled with 56 m³ cement late at night, water discharge could not be stopped. New springs were formed in the vicinity of the borehole. At a depth of 130 m, the exploration drilling hit an artesian aquifer (Fig. 4). With the discharging water, large amounts of loose material were flushed out of the ground. Due to potential subsidence processes, there was an increased hazard of land subsidence. Seismic follow-up investigations, however, did not show any irregularities in the subsurface. The costs of damage were estimated to be 500,000 Euros (FAZ 2010).

In October 2016, a borehole was drilled for the installation of a vertical GSHP system in Rottach-Egern (Bavaria). When drillings reached a depth of 45 m, a 20-m-wide and 2-m-deep sinkhole started to appear (Fig. 3d). Only little information is available about the cause and processes of subsidence. According to first assumptions, drillings hit a groundwater-filled subsurface cavity. The cavity is a relic of a buried ice block formed by landslides during glacial periods (TS 2016). Damage is estimated to be 500,000 to one million Euros.

These measures consisted in the suppression of the leaky backfilling and lowering of the groundwater level by pumping. The uplift rate was reduced from initially 11.0 to 3.5 mm per month. Since it is not possible to recover penetrated water from sulphate-bearing layers, swelling will stop only when there is no more inflow of groundwater (Ruch and Wirsing 2013). The uplift damaged more than 269 buildings (Sass and Burbaum 2010)
