Garnier, Christian and Pastor, Marie-Laetitia and Eyma, Florent and Lorrain, Bernard *The detection of aeronautical defects in-situ on composite structures using Non Destructive Testing*. (2011) Composite Structures, vol. 93. pp. 1328-1336. ISSN 0263-8223

The detection of aeronautical defects in situ on composite structures using Non Destructive Testing

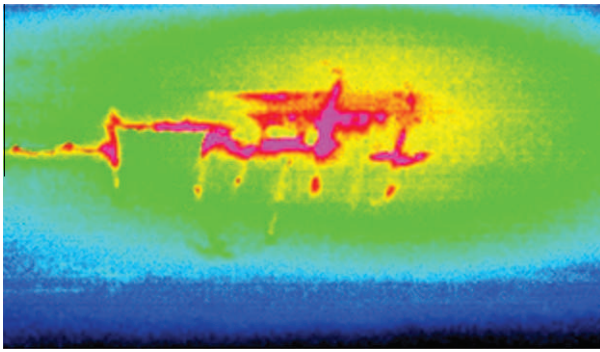
Fig. 4.2. InfraRed Thermography map of Specimen A.

The InfraRed Thermography tests made it possible to identify the presence of defects on Specimen A in a very short time, around 30 s (cf. Fig. 4.2). The size of the pixel is calculated from the images. Therefore, the dimensions of the defects can be determined accurately. Indeed, the defect is 97 mm \times 20 mm. It is obvious that the results obtained with InfraRed Thermography are similar to GVI measurements (maximum deviation around 10%).

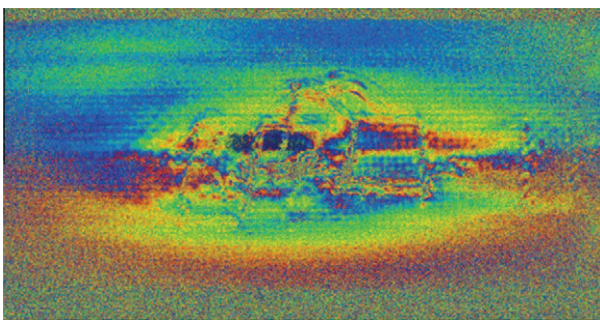
Fig. 4.3. Shearography map of Specimen A.

The defects on Specimen A were identified quickly by Shearography tests, around 1 min (cf. Fig. 4.3). It is important to note that the images obtained by Shearography are not easily analysed. There were many defects on this specimen and Shearography detected them all. This means that a considerable amount of the information was shown on the image, making it illegible. Nevertheless, it was possible to determine the size of the defects. The range of the defect area is 107 mm \times 22.5 mm. The difference between the GVI and the Shearography results represents 9% as regards length and 25% as regards width. This measurement variation is due to the difficult in analysis of the shearographic image.

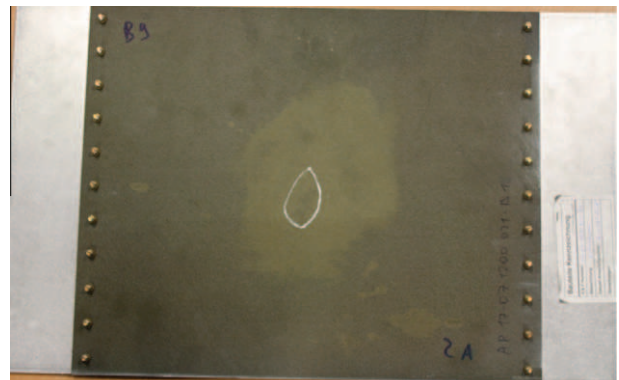
Fig. 4.4. Specimen B: carbone/epoxy plate.

Specimen B damage is the result of a lightning impact which occurred in service. The defect measures 41 mm and 75 mm.

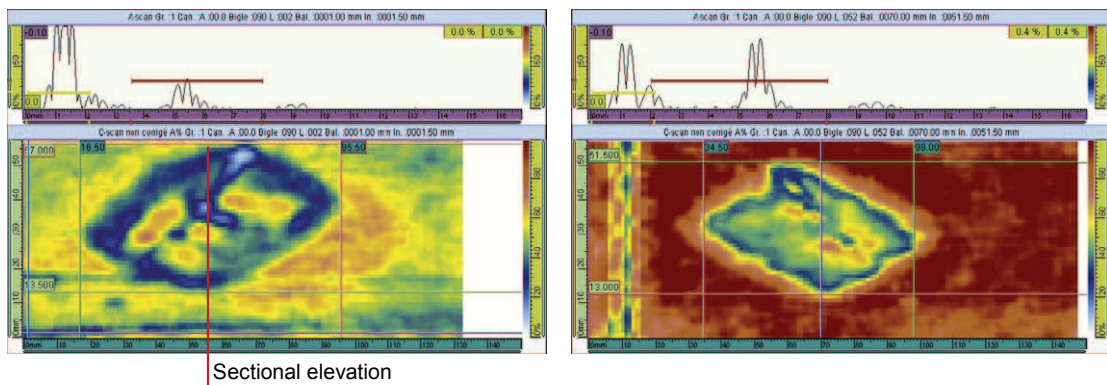
Fig. 4.5. Ultrasonic Testing map of the both faces of Specimen B.

Two C-Scan inspections were carried out : one on the front of the specimen and the other one on the back. For the front surface inspection (i.e. the surface on which the lightning impact is located), the defect measured 43.5 mm \times 79 mm (cf. Fig. 4.5). On the back, the defect measurements were 38.5 mm \times 63.5 mm (cf. Fig. 4.5).

- firstly, signal loss through the thickness of the specimen,
- secondly, surface coating on the back,
- thirdly, position of the probe focus because the defect is on the surface.

The in-depth position is the same from both front and back. The shape of the defect is similar to that of the GVI defect. The actual size of the defect on the specimen and its UT size are virtually the same (around 5%). From the 2D map, a sectional elevation can be traced showing that the defect is on the surface of the specimen (Fig. 4.6).

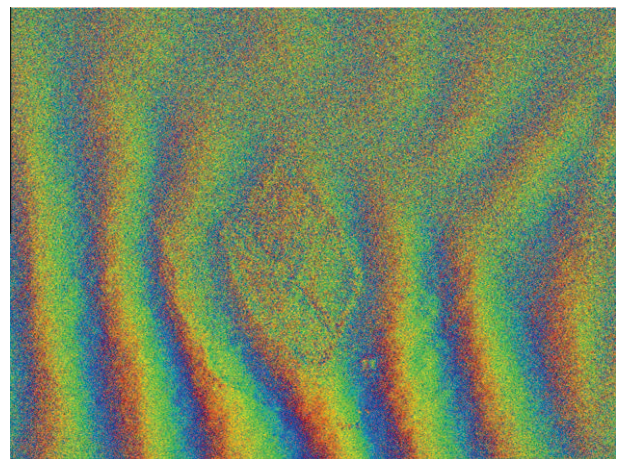
Fig. 4.8. Shearography map of Specimen B.

The defects on Specimen B can be identified by Shearography tests in a relatively short time: approximately 1 min (cf. Fig. 4.8). The size of the defect is 37.5 mm × 59.5 mm. The differences between the GVI and the Shearography measurements are 8% as regards length and 21% as regards width. This difference is due to the fact that the shearographic image is a little fuzzy preventing the size of the defect to be measured properly.

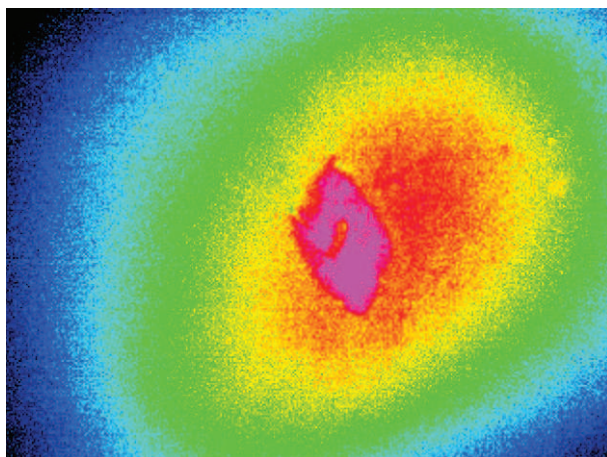
Fig. 4.7. Infrared map of the defect of Specimen B.

2D mapping of the specimen and identification of the defects can be obtained using IR thermography tests (cf. Fig. 4.7).

The size of the revealed defect is 36 mm length and 60 mm width. Its shape is almost the same as the GVI defect on the damaged surface. The variations between the GVI and the IR thermography measurements are 12% in length and 20% in width.

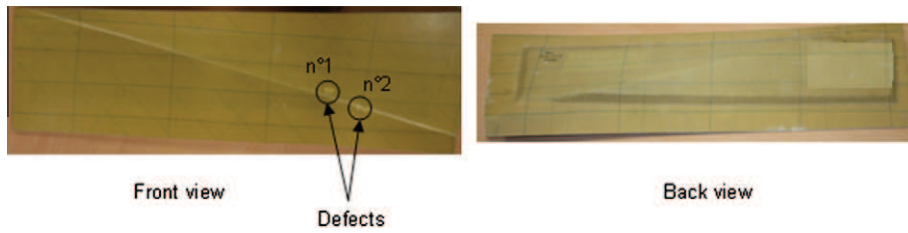
Fig. 4.9. Defects of Specimen C.

The Specimen C defects are two cases of delamination due to the impact of a falling tool or of hailstones. These were created in the laboratory using a drop weight tester. The defect located above geometrical discontinuity is called no. 1 and the defect located on the geometrical discontinuity is called no. 2 (as defined in Fig. 4.9). Defect no. 1 is 13 mm and 9 mm. Defect no. 2 is 18 mm and 8 mm.

For Specimen C, two GVI defects had to be detected. Defect no. 1 was located above geometrical discontinuity and defect no. 2 was located on the angle of this geometrical discontinuity (cf. Fig. 4.9).

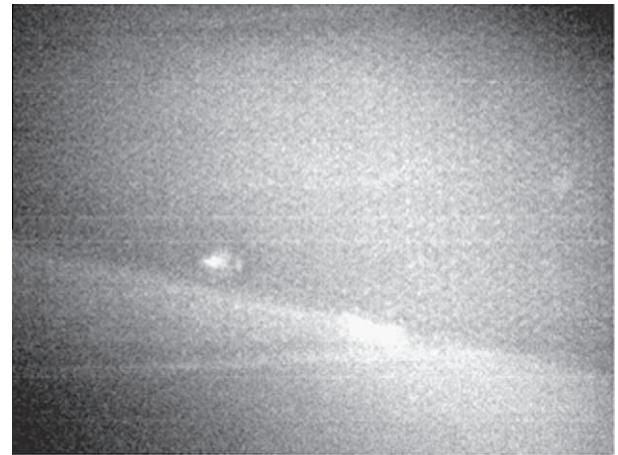
Fig. 4.11. InfraRed Thermography map of Specimen C.

Both defects were determined by InfraRed Thermography within a few seconds (cf. Fig. 4.11). Defect no. 1 is 15 mm × 10 mm. The difference between the GVI and the IR thermography measurements is 15% in length and 11% in width.

The dimensions of the defect no. 2 are 22 mm length and 8.5 mm width. The differences between the GVI measurements and the IR thermography measurements are equal to 22% as regards length and 6% as regards width. The considerable deviation in length can almost certainly be attributed to the focusing problem due to the geometrical discontinuity.

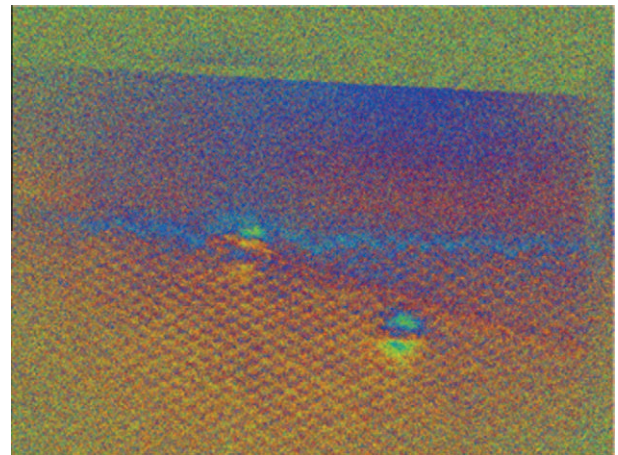
Fig. 4.12. Shearography map of Specimen C.

The defects on Specimen C were identified by Shearography tests within a relatively short time of around 1 min (cf. Fig. 4.12). The image is very clear and the defects are perfectly visible. Shearography therefore seems well suited to the detection of defects in this type of specimen.

Defect no. 1 is 15 mm × 15 mm. The variation between the GVI and the Shearography measurements is 17% in length and 87.5% in width. However, on the shearographic image, the defect appears circular which is not surprising for an impact defect; and so in this case, the GVI measurement may be incorrect.

Defect no. 2 is 15 mm × 8 mm. The variation between the GVI and the Shearography measurements is 16% in length and 11% in width.

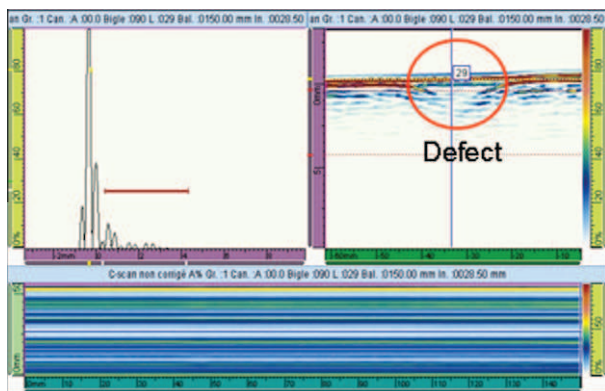
Fig. 4.10. Ultrasonic map on Specimen C.

Defect no. 1 was detected by ultrasonic tests (cf. Fig. 4.10). The geometry of the specimen (defect slightly on the angle) made UT measurement difficult. Thus, only the defect length could be determined: 22 mm. The difference between the GVI and the UT measurements of length is 22%. As shown on Fig. 4.10, the defect was located not only on the surface of the specimen but also in depth.

Defect no. 2 was not detected. Checking this impact was impossible because the device (multi-element probe) was not suitable and the folding angle was variable.
