# Evaluation of Exposures to Metals and Noise in a Boat Maintenance Facility

HHE Report No. 2017-0127-3348

April 2019

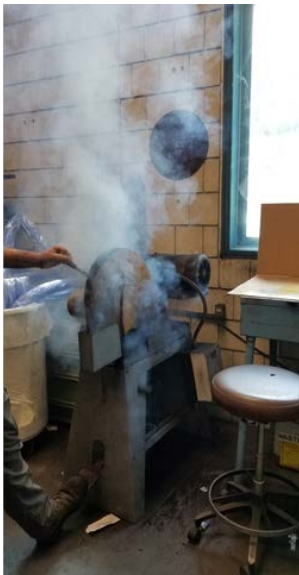
- We observed an employee who demonstrated cutting wire-reinforced hose in the hose room. Employees reported that they could spend up to a half day each week cutting all of the hose that was needed for the week, although we observed no other hose cutting work during our visit. Employees were uncertain of the PPE requirements for this job task. The hose room, which was about two stories high, had a ventilation fan in the ceiling. The fan intake was broken, and employees had inserted a long pole into the opening to prop open the louvers. Even though the fan was operating when the hose was being cut, there was still a large plume of smoke around the saw and the employee (Figure B1). Smoke was moving towards the ventilation fan but the rate of generation was much faster than the rate of exhaust, leading to a buildup of smoke around the employee.

Figure B1. Smoke plume produced from cutting wire-reinforced hose surrounds a worker. There is a ventilation fan in the ceiling that is drawing smoke slowly away. Photo by NIOSH.

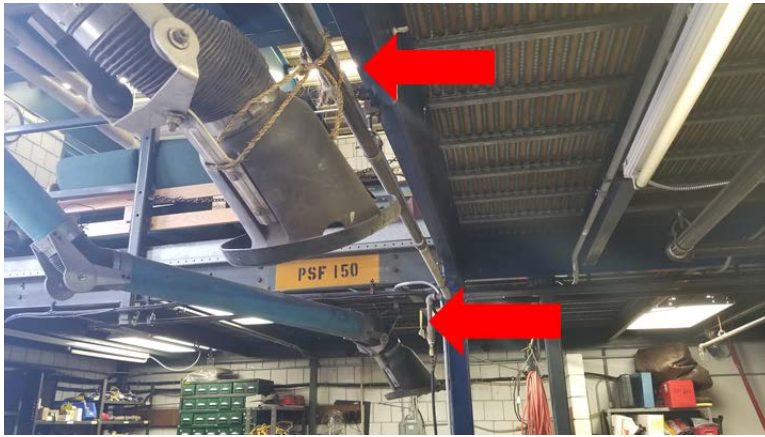
- We saw hoods in the pipe fitter shop that were tied in place over the working surface (Figure B3). These hoods are only effective when they are placed near emissions sources.

Figure B3. The hoods for the local exhaust ventilation system in the pipe fitter shop had been tied to pipes over workstations using ropes. Photo by NIOSH.
