TECHNICAL REPORT NO. 381

Repairs to Jabba at Carnarvon in 2016 August

Steven J. Hale

2016 September 9

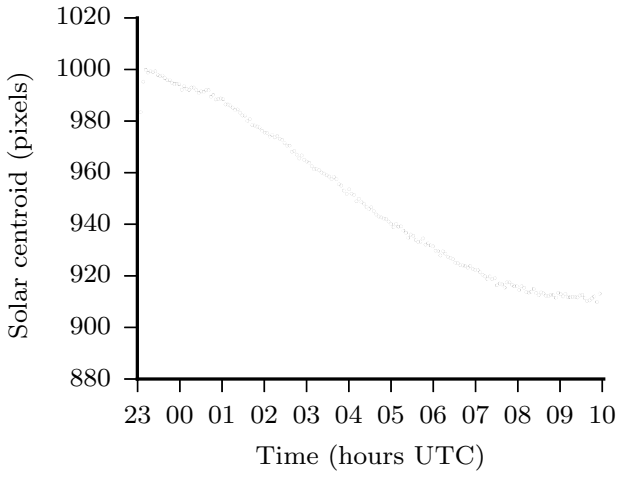
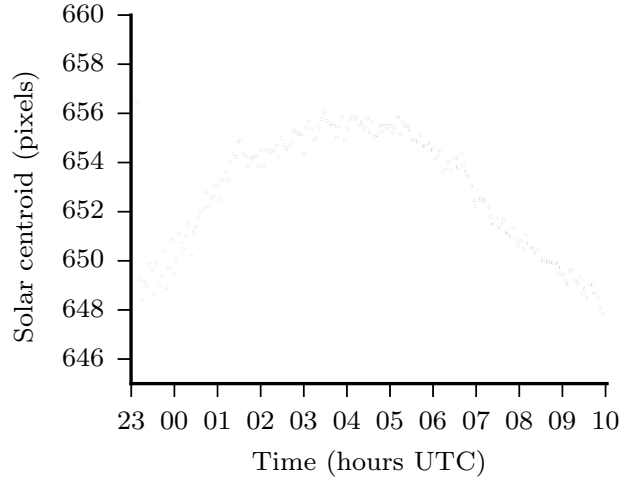
(a) RA position

(b) Declination position

The results are shown in Figure 1. Panel (a) and (b) show the centroid positions of the solar image. The trend throughout the day is possibly due to slight camera movement. It was not possible to attached the camera directly to the mount due to insufficient room, and so the camera was simply cable-tied firmly to the front of Jabba. However this movement seems unlikely, and the drift is more likely to be caused by previously reported mount flexure [6]. It has long been considered that Jabba suffered from chassis flexure, and the spectrometer was stiffened considerably when reinstalled in 2009 July [4]. No performance analysis has ever been performed on the mount, and this is possibly the first time that any flexure has been measured quantitatively. A shift of 100 pixels is equivalent to a third of a degree alignment change from sunrise to sunset, which is a rather large error considering the Sun is half a degree in extent. Carnarvon was the first BiSON site to make use of an equatorial mount, and has a smaller mount than that installed at later sites. The other sites in the network are unlikely to experience this problem.

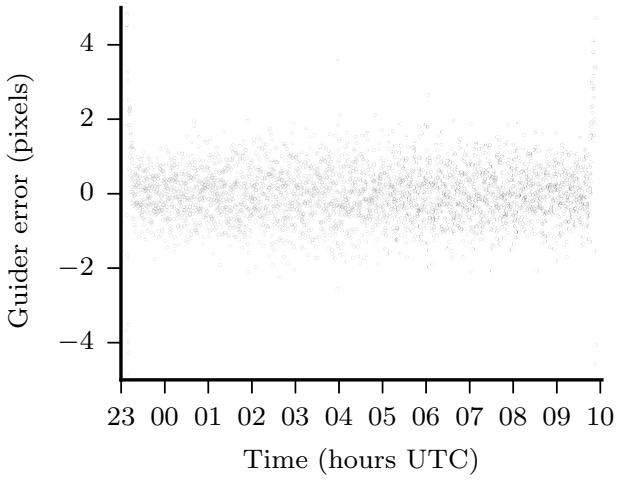
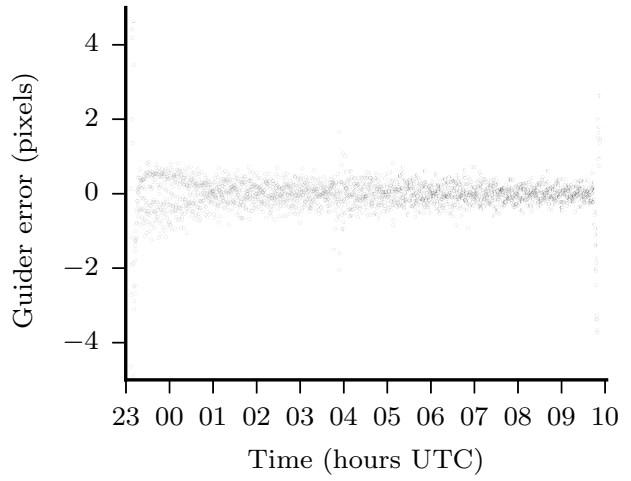
(c) RA position after detrending

(d) Declination position after detrending

Panel (c) and (d) in Figure 1 show these results with a 10 minute moving mean subtracted to detrend the data. Finally panel (e) and (f) show histograms of the performance calibrated in arcseconds. The red dashed-line indicates the equivalent Gaussian profile for the measured mean and standard-deviation.

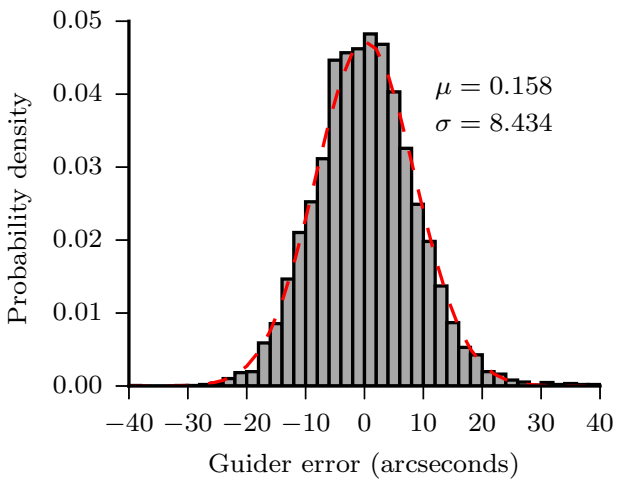
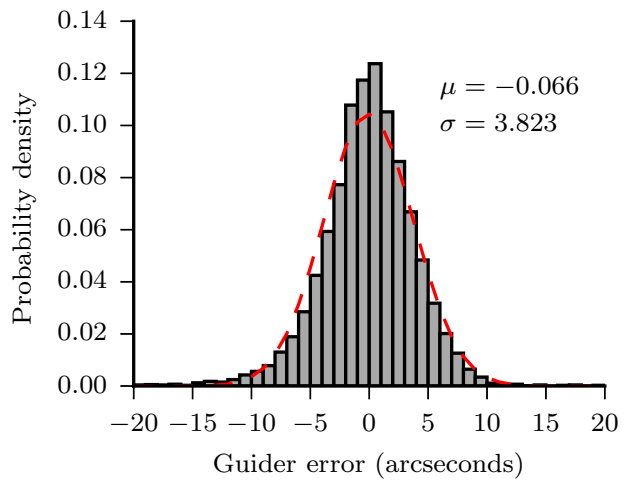
(e) RA performance

(f) Declination performance

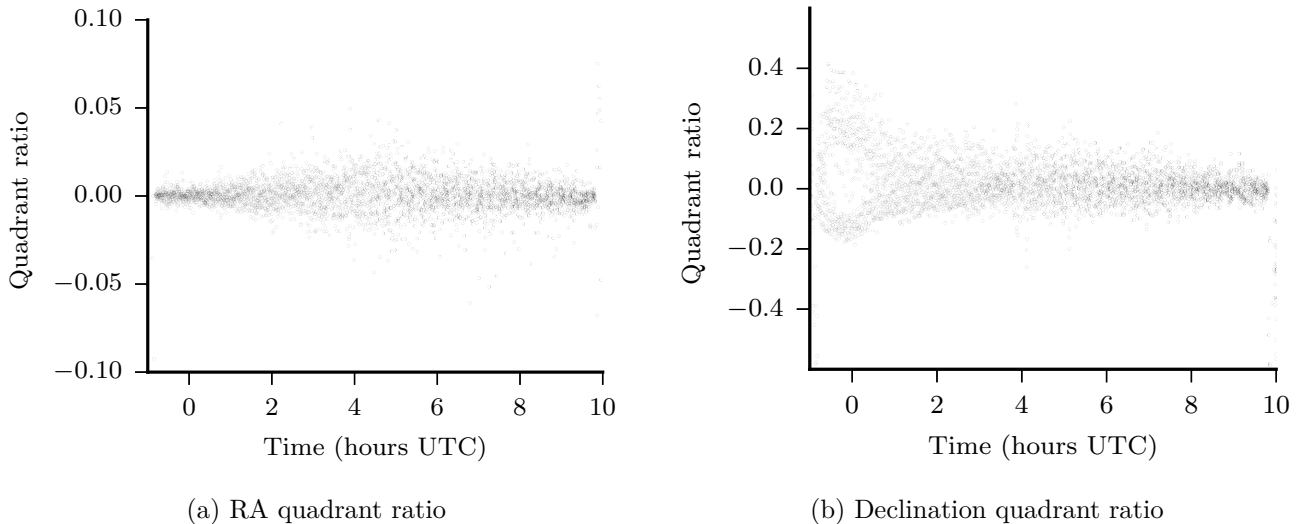
Figure 2: Mount controller quadrant photodiode telemetry from 2016 August 16.

For comparison, Figure 2 shows the telemetry from the mount controller FINE guider telescope quadrant photodiode. The quadrants have been combined into ratios for RA and declination, where R are the respective ratios

and this has unfortunately not yet been done. The mount controller shows no drift throughout the day, and this is expected since the guider could not work with a drift of a third of a degree. Clearly the drift seen by the CCD guider monitor attached directly to Jabba must be either camera movement or mount flexure between the guider and the spectrometer.
