ORIGINAL RESEARCH PAPER

Performance of industrial buildings during the Emilia earthquakes in Northern Italy and recommendations for their strengthening

Dionysios A. Bournas · Paolo Negro · Fabio F. Taucer

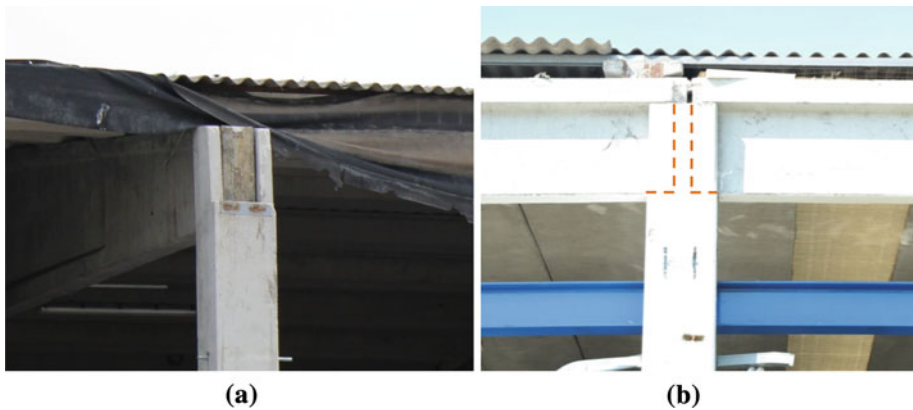
Fig. 7 **a** Seating of double slope precast beams showing the fork at the *top of the column*: seating at an *end column*. **b** Seating at an intermediate column of a “T” section beam (with *dashed lines* indicating the section of the beam at the seat pocket)

The weak link in the vast majority of the industrial buildings visited was the absence of mechanical connections between roof-girders and columns. The most common typology corresponded to double-slope beams, simply supported over special openings (forks) at the top of columns as shown in Fig. 7. This typology was used in Italy during the 60s and 70s for agricultural buildings, now being replaced by the more common flat-roof systems. In this connection typology, the capacity of transferring lateral loads depends entirely on the static coefficient of friction between the supporting surfaces of beam and column and on the length of the beam seating when the friction forces are exceeded by the earthquake force demands.

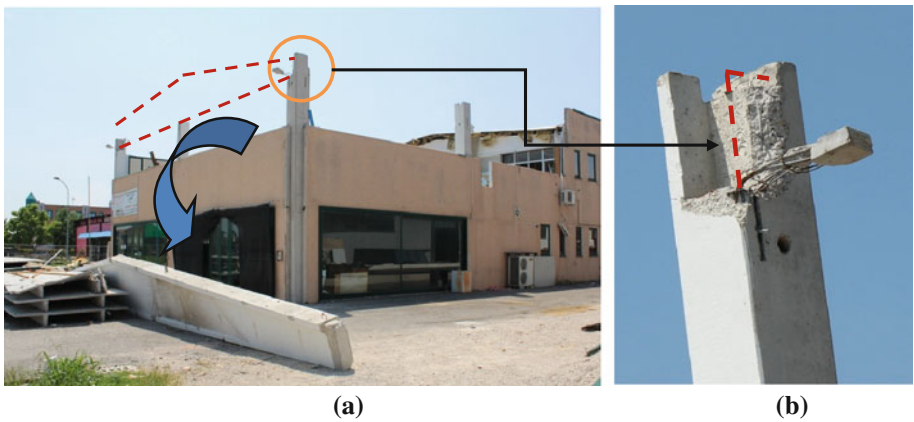
Fig. 9 **a** Out-of-plane collapse of a double slope precast beam after unseating following failure of the lateral restraint of the fork at the seat pocket; **b** detail of the shear failure of the fork

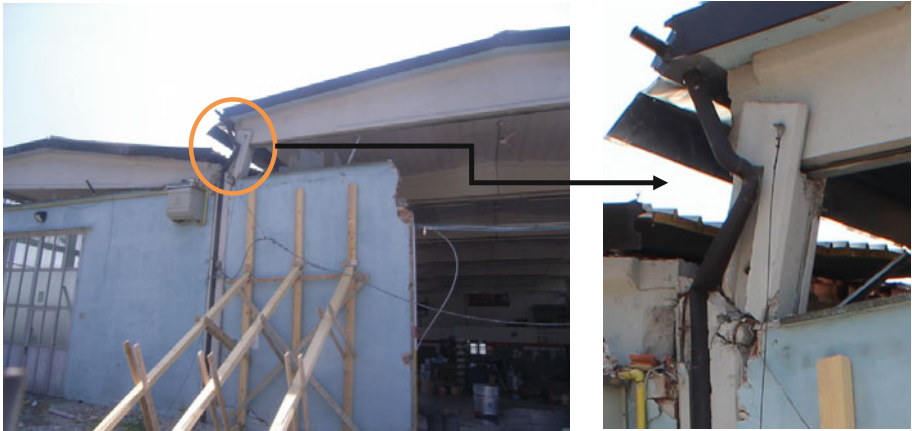
The interaction with masonry panels distributed non-uniformly across the structure often led to non-synchronous displacements at the top of columns, thus contributing to unseating of the girders as presented in Fig. 10. Masonry panels, when not covering the full length of the column, led in many cases to the formation of short-column failures (Fig. 10).

Fig. 10 Loss of the left girder seating due to the interaction with masonry panels (short columns/shear failure)

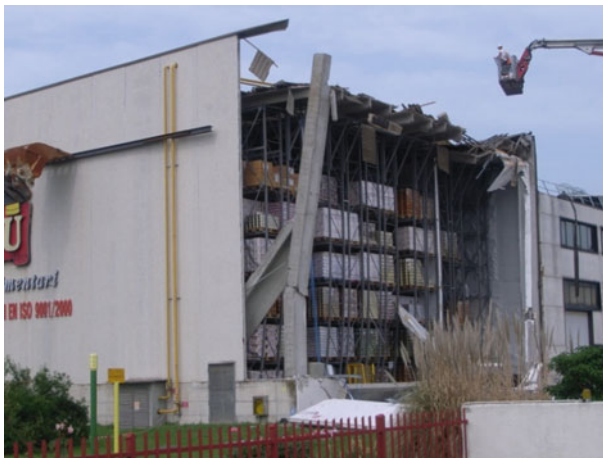
Concerning the loss of seating of beams and columns, it is noted that the flat (Fig. 11) and the sloped roof systems are equally vulnerable. The main difference between the two systems is that the sloped roof corresponds to a generally older design, where the girder has a smaller width (due to its higher section height) that leads more easily to out-of-plane failures.

Fig. 11 Partial collapse of the roof, longitudinal girders, column and front cladding of a flat roofed precast building

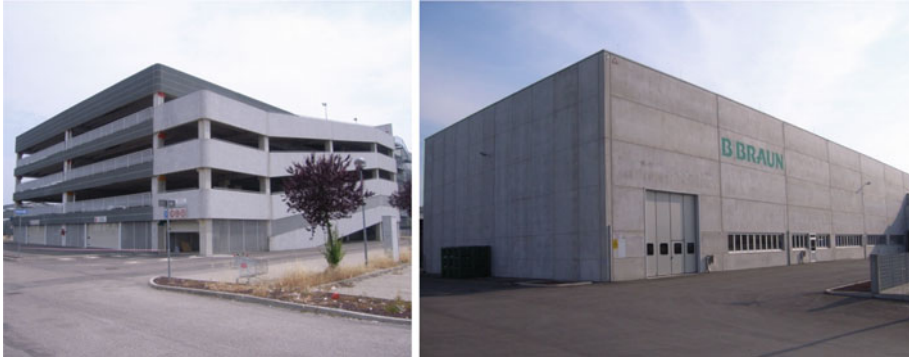
Fig. 13 Recently constructed precast concrete buildings exhibiting good performance

In general, recently constructed precast concrete buildings, including a high-rise precast parking structure, which most probably incorporated steel dowels in the beam-column joints, exhibited apparent good performance, as shown in Fig. 13. It should be noted that, due to safety measures in force immediately after the main shocks, no inspection near or inside these buildings was possible.

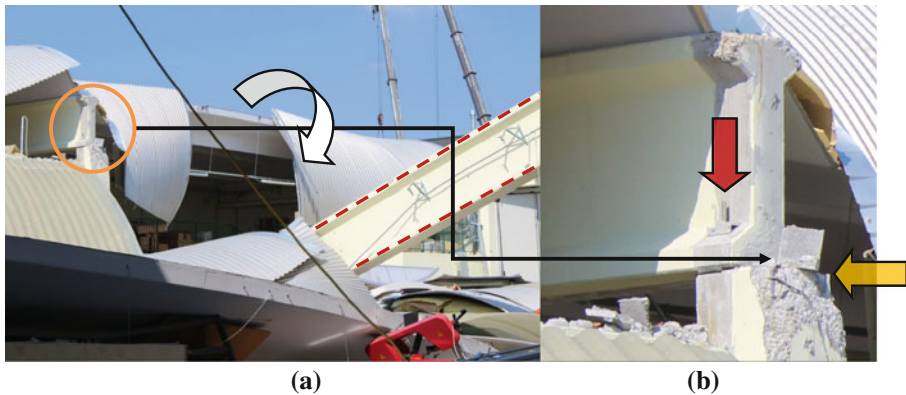
It is worth mentioning that a building completed in 2010 showed partial collapse, in spite of having been designed (according to information provided by the owner) with pinned beam-column connections following the new Italian construction standards. Visual inspection revealed failure at the top of one of the central column beam-column connections. This failure was followed by loss of the girder seating and its subsequent collapse (Fig. 14a).

The rather limited distance of the dowels from the edge of the column and the limited amount of transverse reinforcement might have resulted into the formation of a shear crack across the concrete cover (Fig. 14b), followed by the loss of the dowels anchorage and consequently the loss of the girder seating. This failure reveals the absence of specific provisions for detailing the beam-to-column connections in the current Italian construction standards and the as well as in the Eurocodes (CEN 2004).

Fig. 14 Loss of girder seating in a recently constructed industrial building after failure of the pinned beam-column connection: **a** general overview of the collapsed beam (*red dashed lines*); **b** detail showing failure of the column support at the beam-column pinned connection. *Orange arrow* shows damaged area at the *top of the column*, while *red arrow* shows an undamaged pinned connection

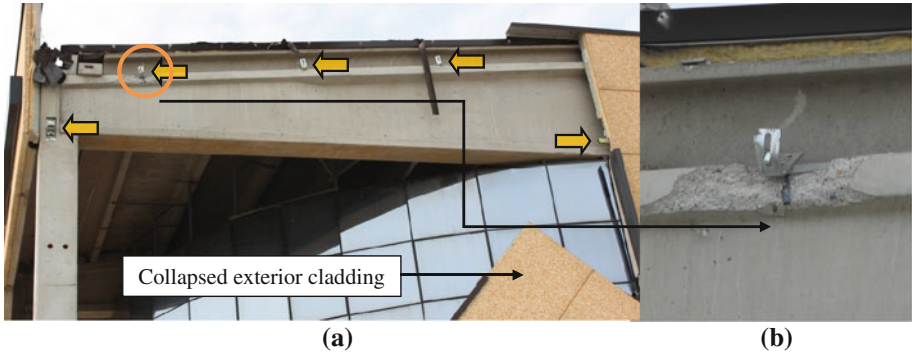
Figure 15a illustrates the in-plane detachment of an exterior cladding element after failure of the connections (Fig. 15b) with the main structure. Similarly, the excessive drifts which were experienced by the precast building in Fig. 16 exhausted the displacement capacity of the connections of the panels, leading to the development of high forces that led to failure of the connections and unseating of the horizontal panel.

Fig. 15 **a** Cladding panel collapse after failure of the connections with the main structure (*orange arrows* showing the location of connections of the collapsed exterior cladding); **b** detail showing failure of the mechanical connection

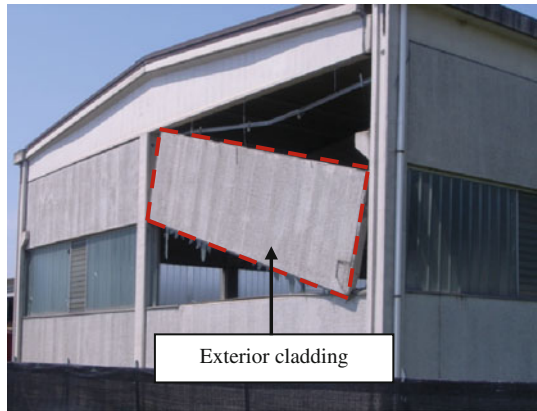
Fig. 16 Detachment of exterior cladding after failure of the connections from the main structure: in plane rotation

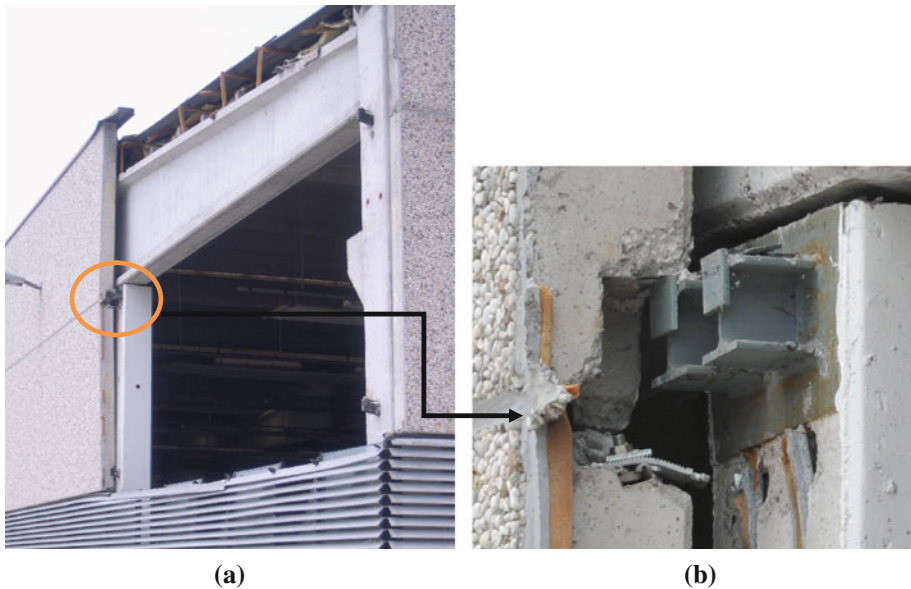
Figure 17a presents a horizontal panel detached from the frame, (possibly) due to the high out-of-plane inertial seismic forces that caused failure of the fastenings (Fig. 17b). In other cases, the high out-of-plane inertial effects led to the development of high rotations (especially when more than two horizontal panels were used—Fig. 18), which together with vertical inertia effects, led to unseating and loss of the panel connection.

Fig. 17 Out-of-plane detachment of horizontal cladding: **a** overall view; **b** detail of the failed fastenings

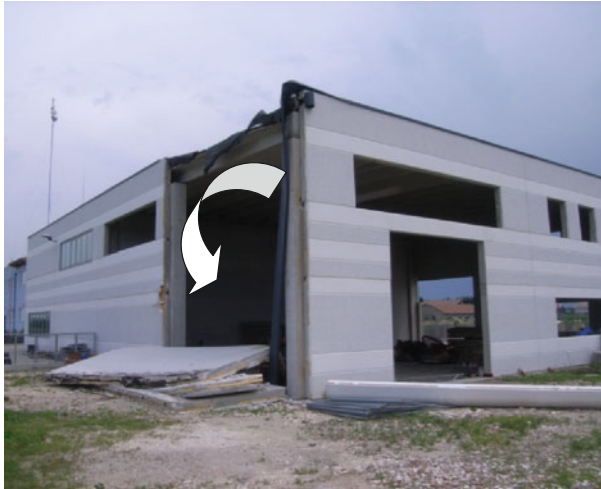
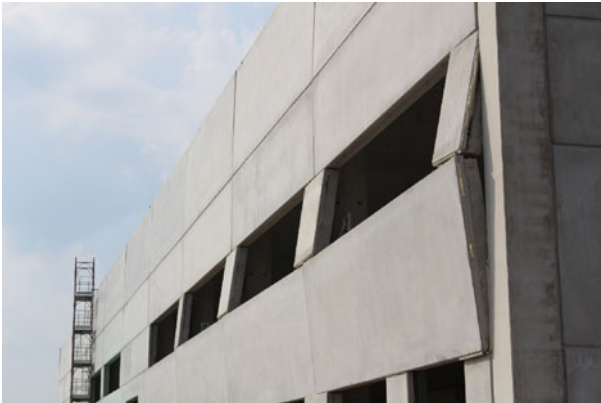
Fig. 18 Out-of-plane overturning of exterior claddings

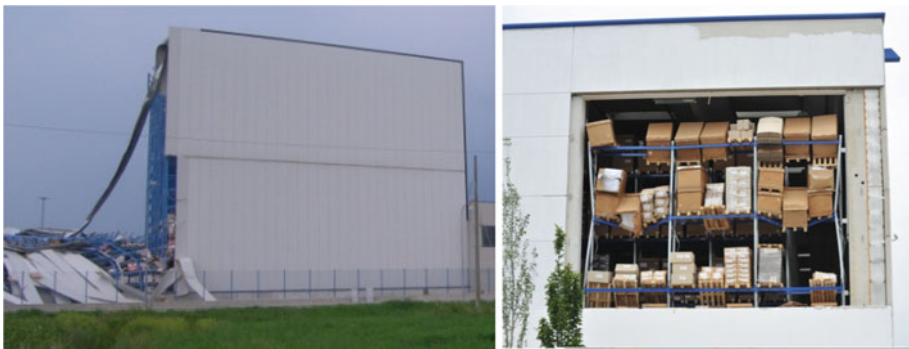
Finally, in some industrial buildings the failure of steel racking systems, especially very tall ones (in excess of 10 m), was observed, with important economic consequences. In some cases, their large mass and the resulting high inertia forces developed during the earthquake induced ramming and consequent collapse of exterior cladding (Fig. 19).

Fig. 19 Collapse and local failures attributed to the failure of rack systems

The field visit revealed that the large flexibility of tall storage racks led to hammering against the main structure and the concrete claddings, which ultimately caused their failure. The provisions for the design of a racking system should exclude the possibility of attaching the steel racks to the structure or to the claddings, and adequate clearances should be provided to exclude the likelihood of hammering.

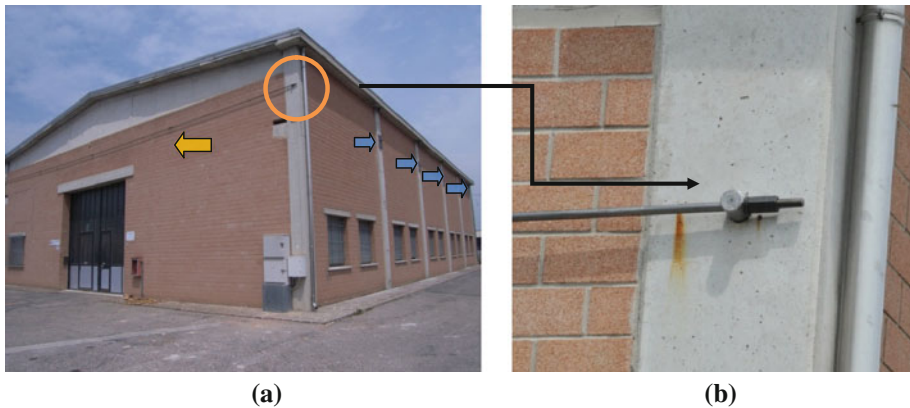
Fig. 20 **a** Steel ties anchorage system installed after the main event to stabilize the structure: *orange arrow* showing the external tie, *blue arrows* showing the internal ties. **b** Detail of the anchorage at the external tie
