Case History

S.R. 237 in Perry County, IN

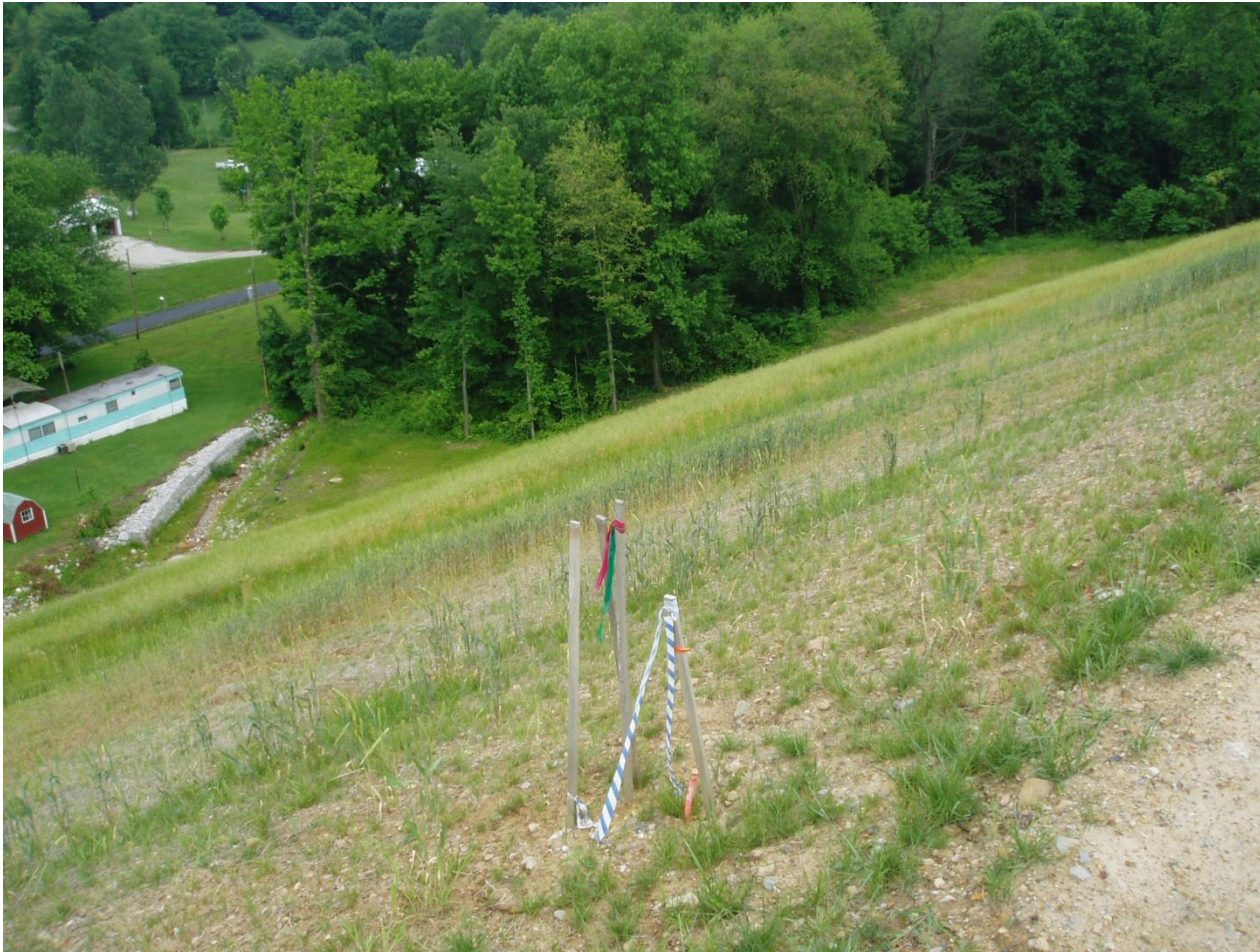
Slope after original construction.

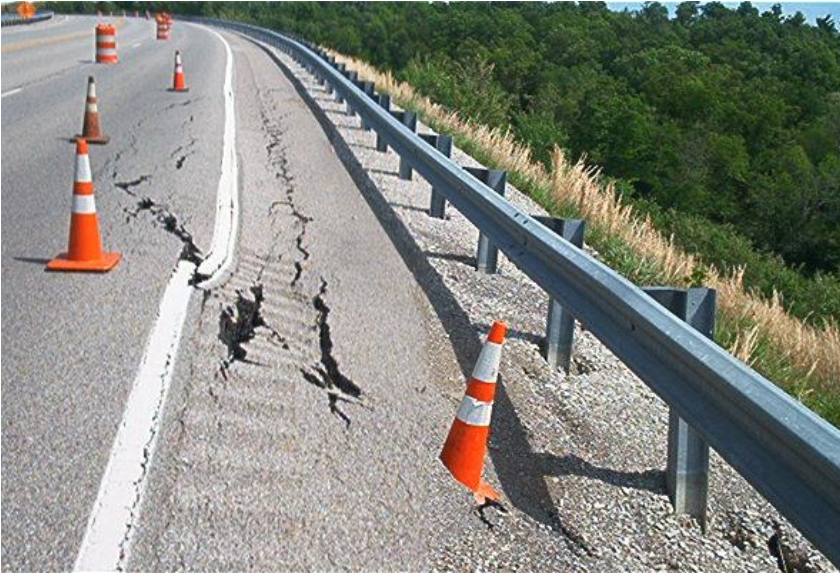
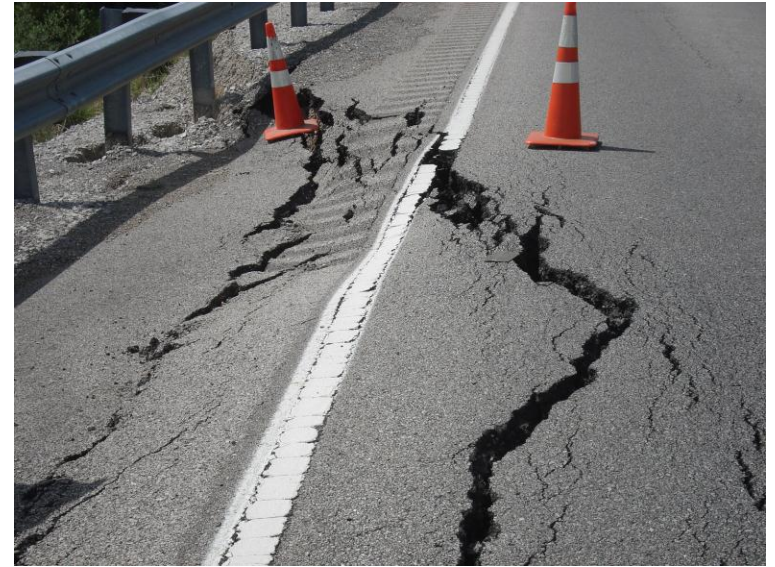
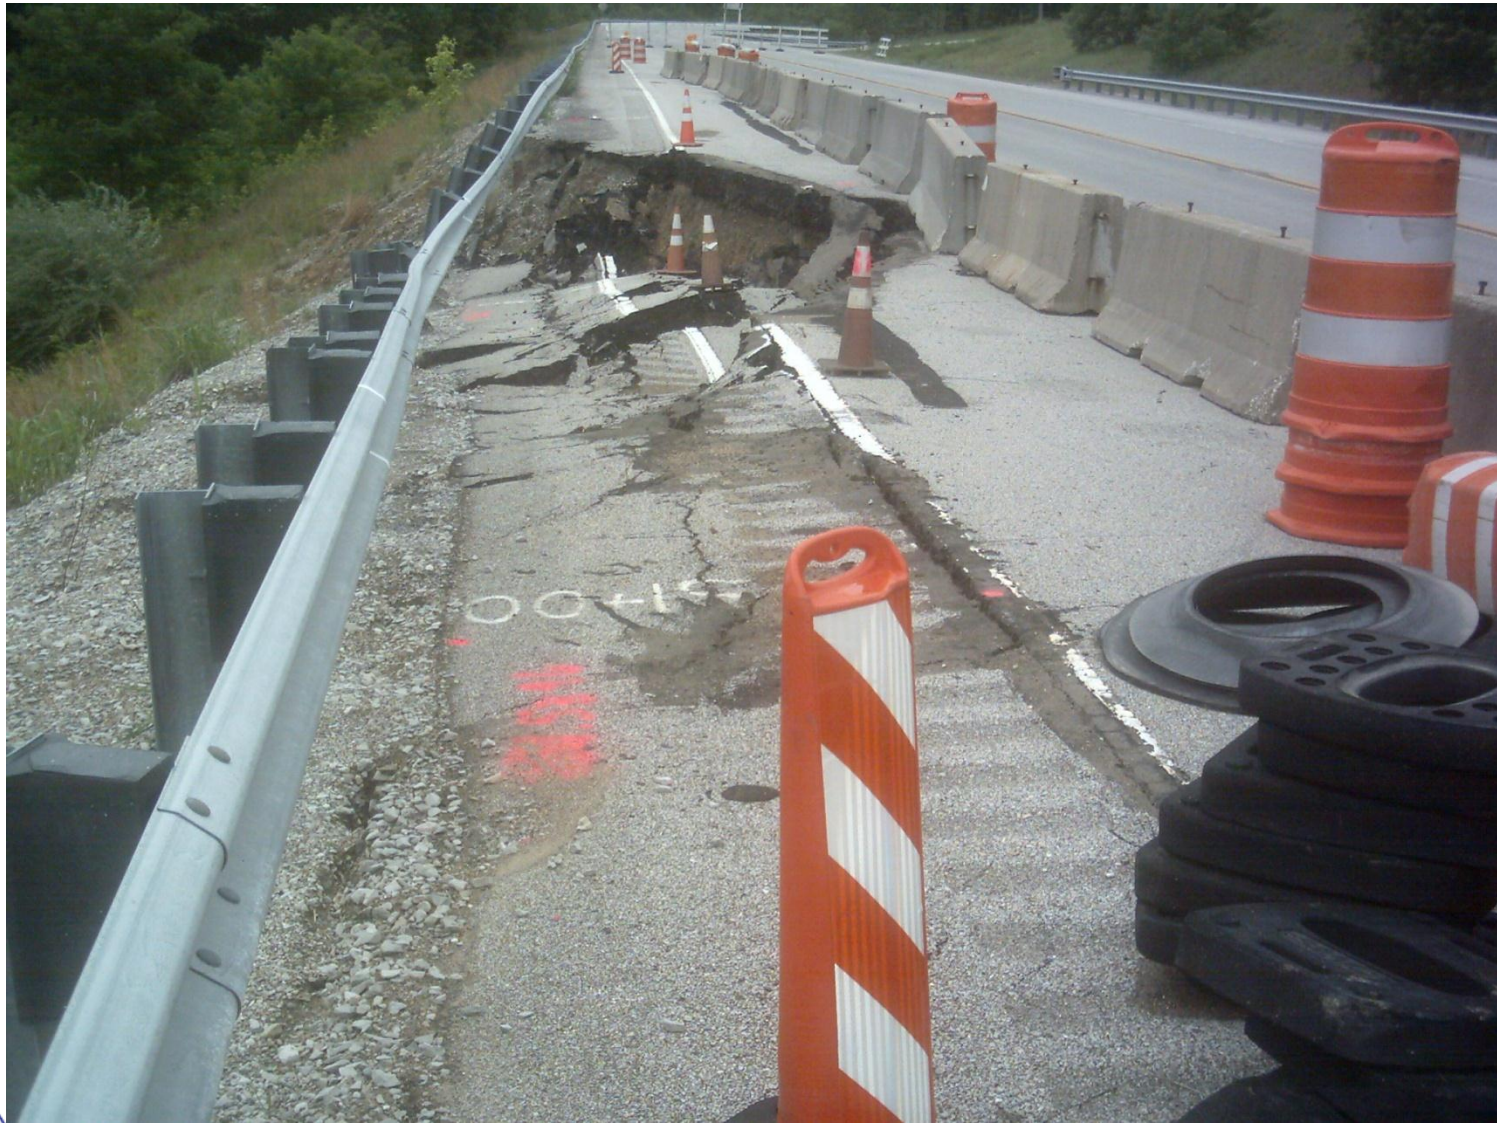
First Slope Failure

- In May 2010 during heavy rain, the slope moved.
- The road edge and guardrail experienced vertical displacement.
- Northbound driving lane closed.

- **Possible causes for the first slide:**
 - Actual slope measured steeper than 2:1 with the height of 112 feet, combined with the type of fill used (co-mingled soil and shale) was unstable.
 - Possible inadequate benching.
 - Water pouring from slope (excessive groundwater).
 - Heavy rainfall in spring.

- A soil nail wall with a design-build contract requiring a seven year warranty.
- Extend outlet drainage pipe to the toe of the east slope.
- The contractor proposed a new H-pile encased in concrete wall with tiebacks and a shotcrete facing after the bid which was accepted by INDOT.

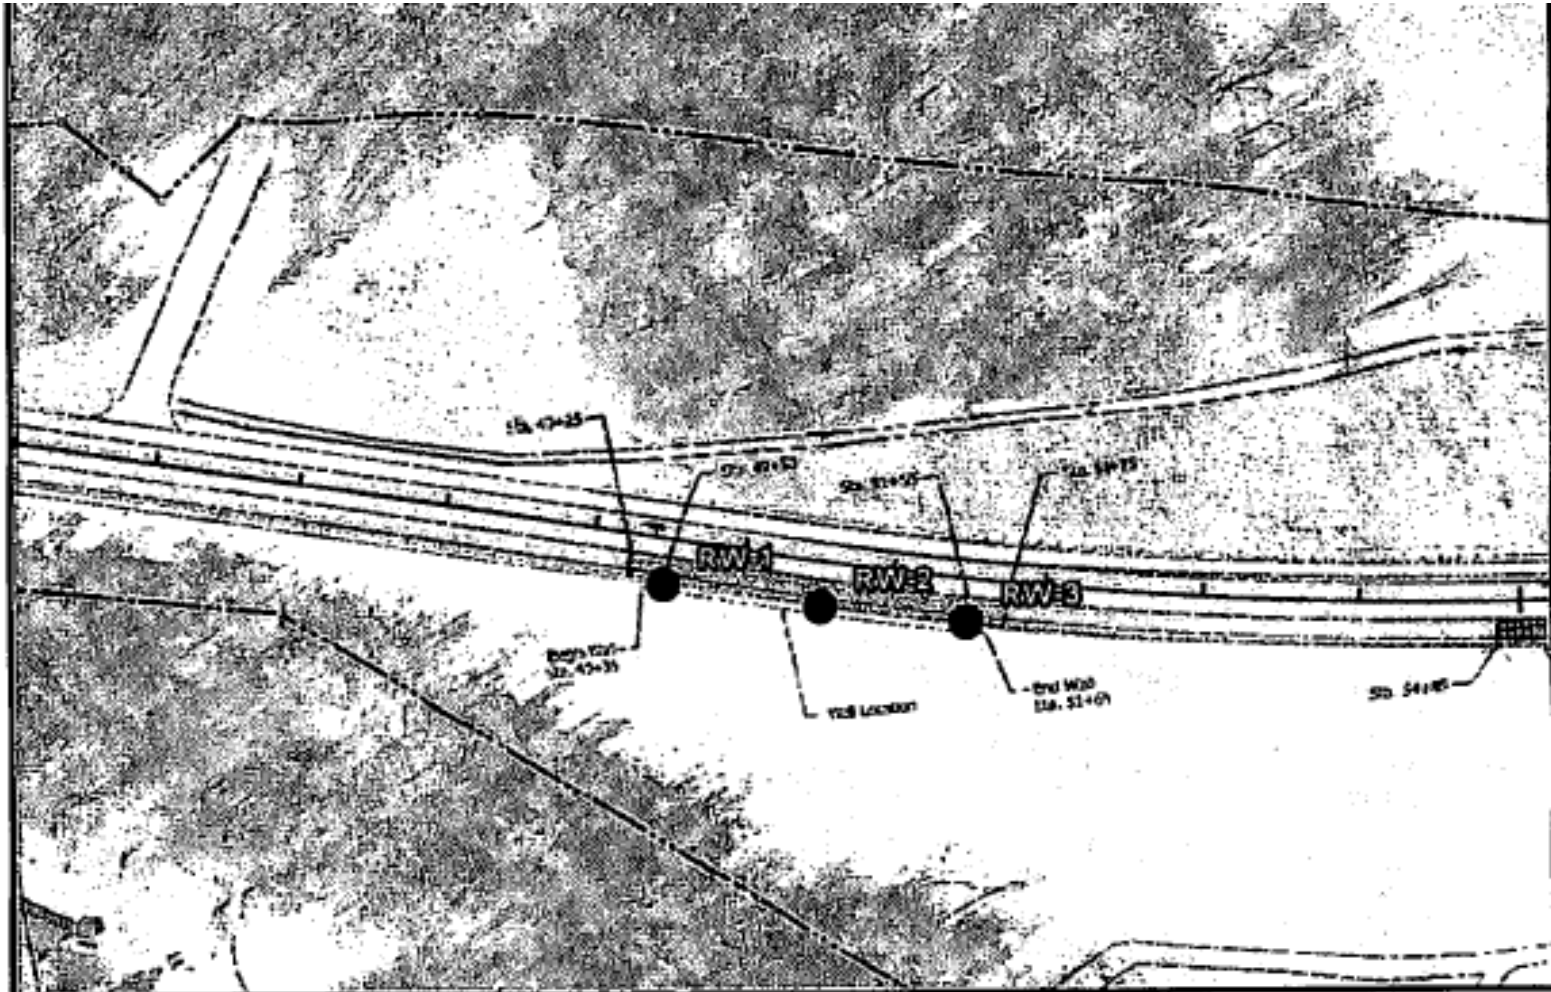
Boring location plan for the first slide.

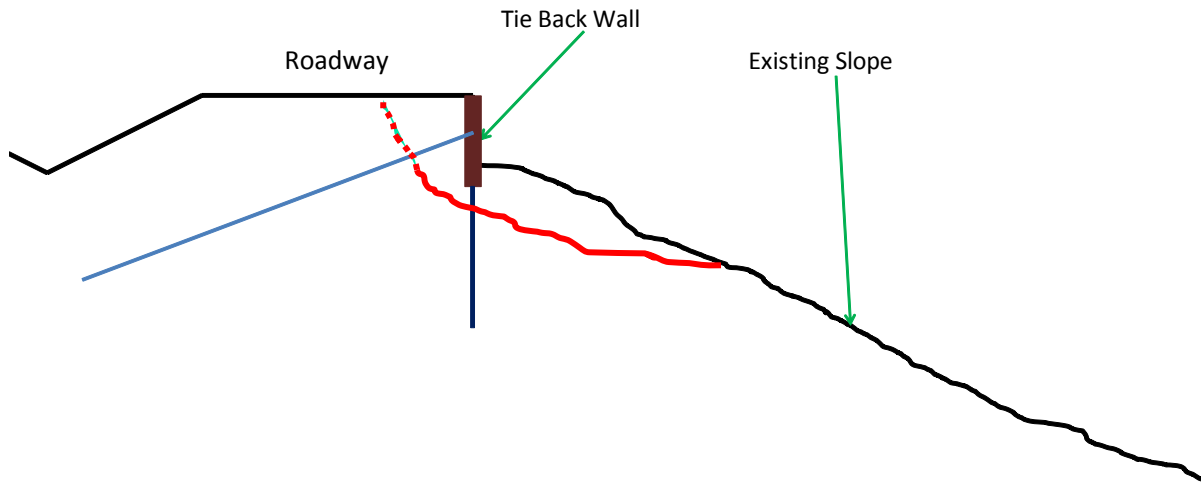
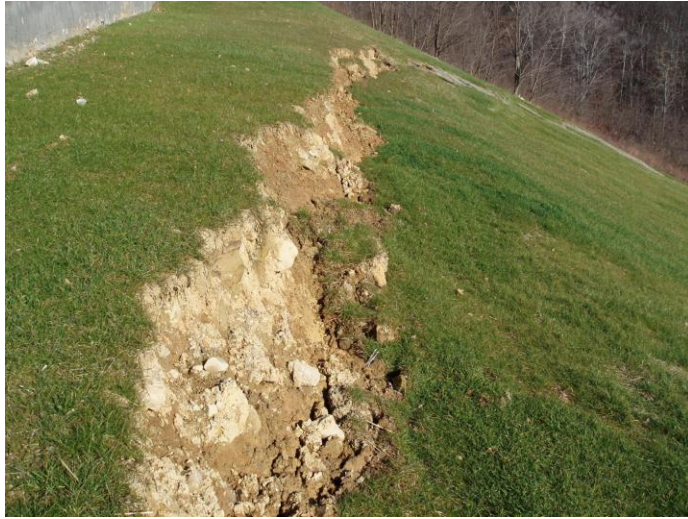
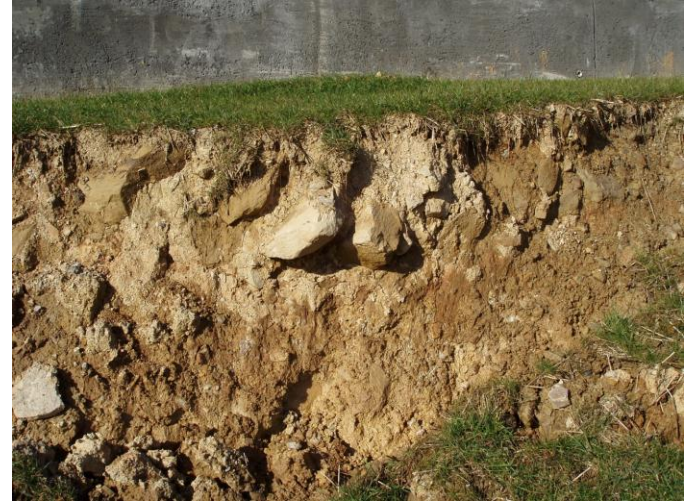
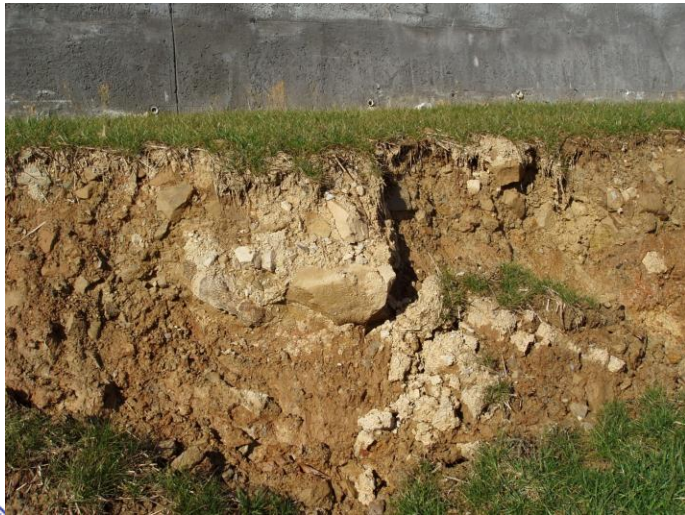
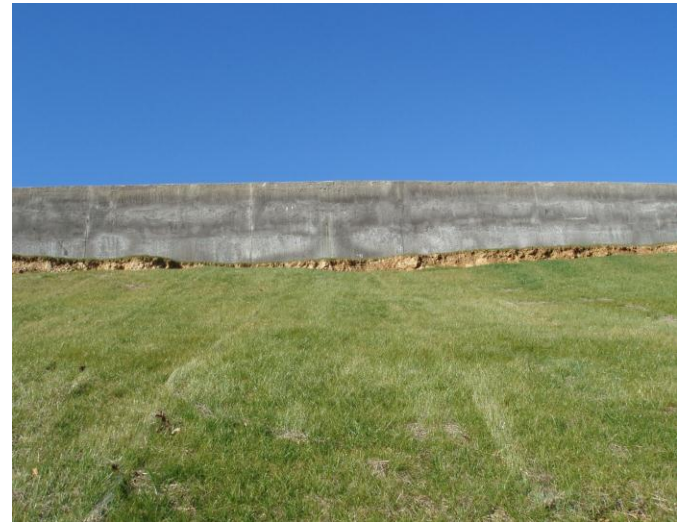
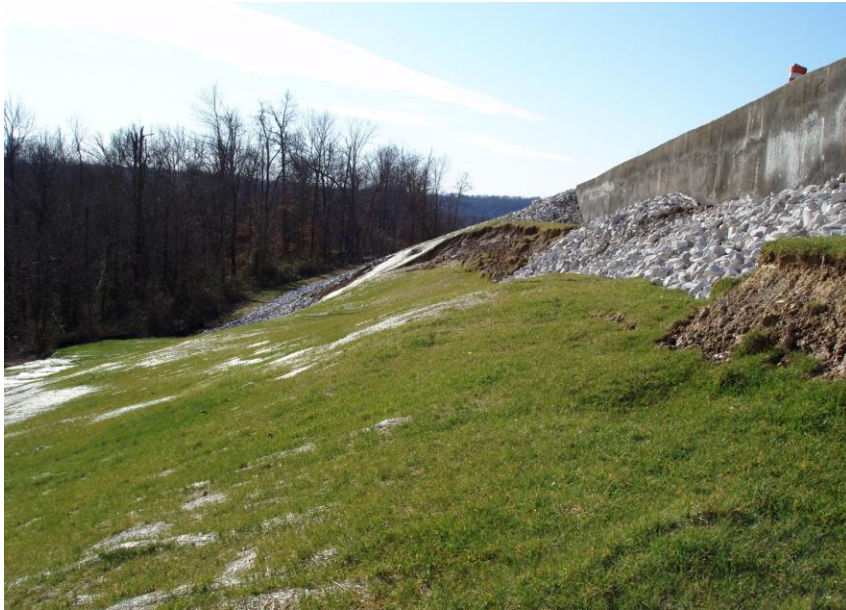
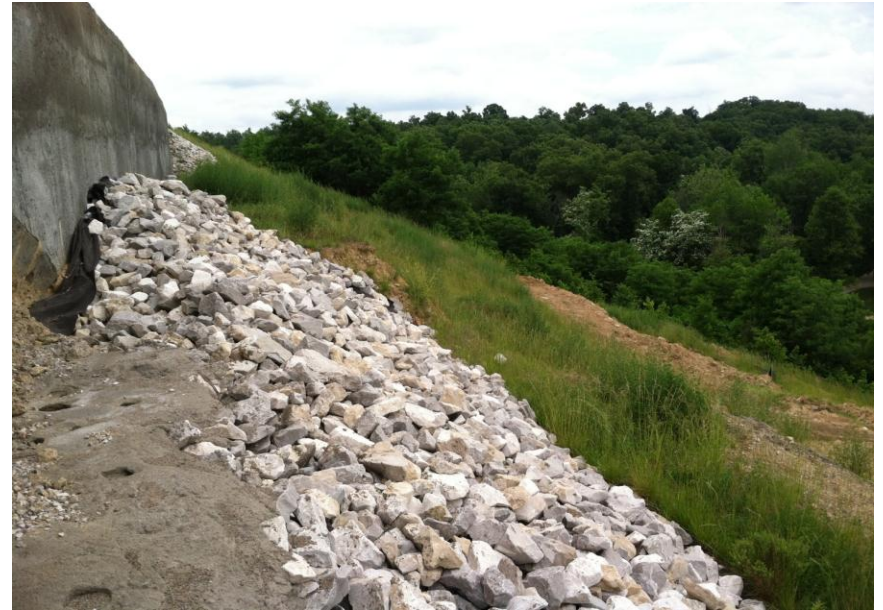
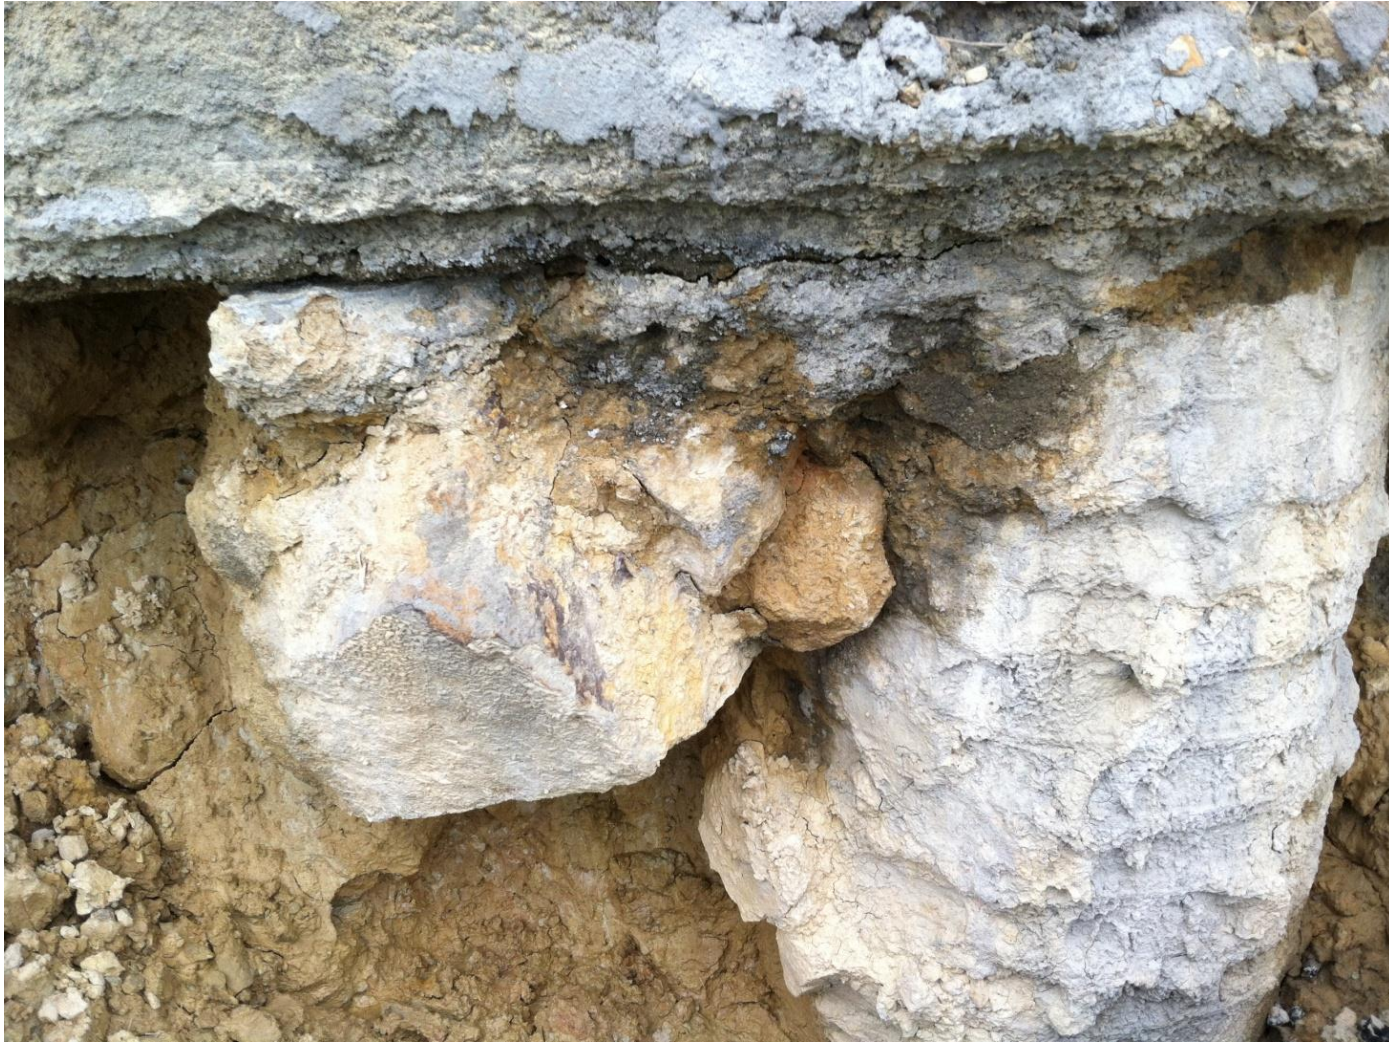
Second Slope Failure

- In April 2012 during heavy rain, the slope in front of the wall moved. It gradually dropped vertically approximately 12 feet due to new failure.

- **Possible causes for the second slide:**
 - Surface slide triggered by heavy rainfall.
 - Failure of outlet pipe of spring box which was buried underneath the roadway.
 - Insufficient investigation after the first slide. Borings were only 40 feet deep.

- Drainage correction: includes spring box repair & horizontal drains

- Rock backfill (chosen)
- Three tier soil nail walls

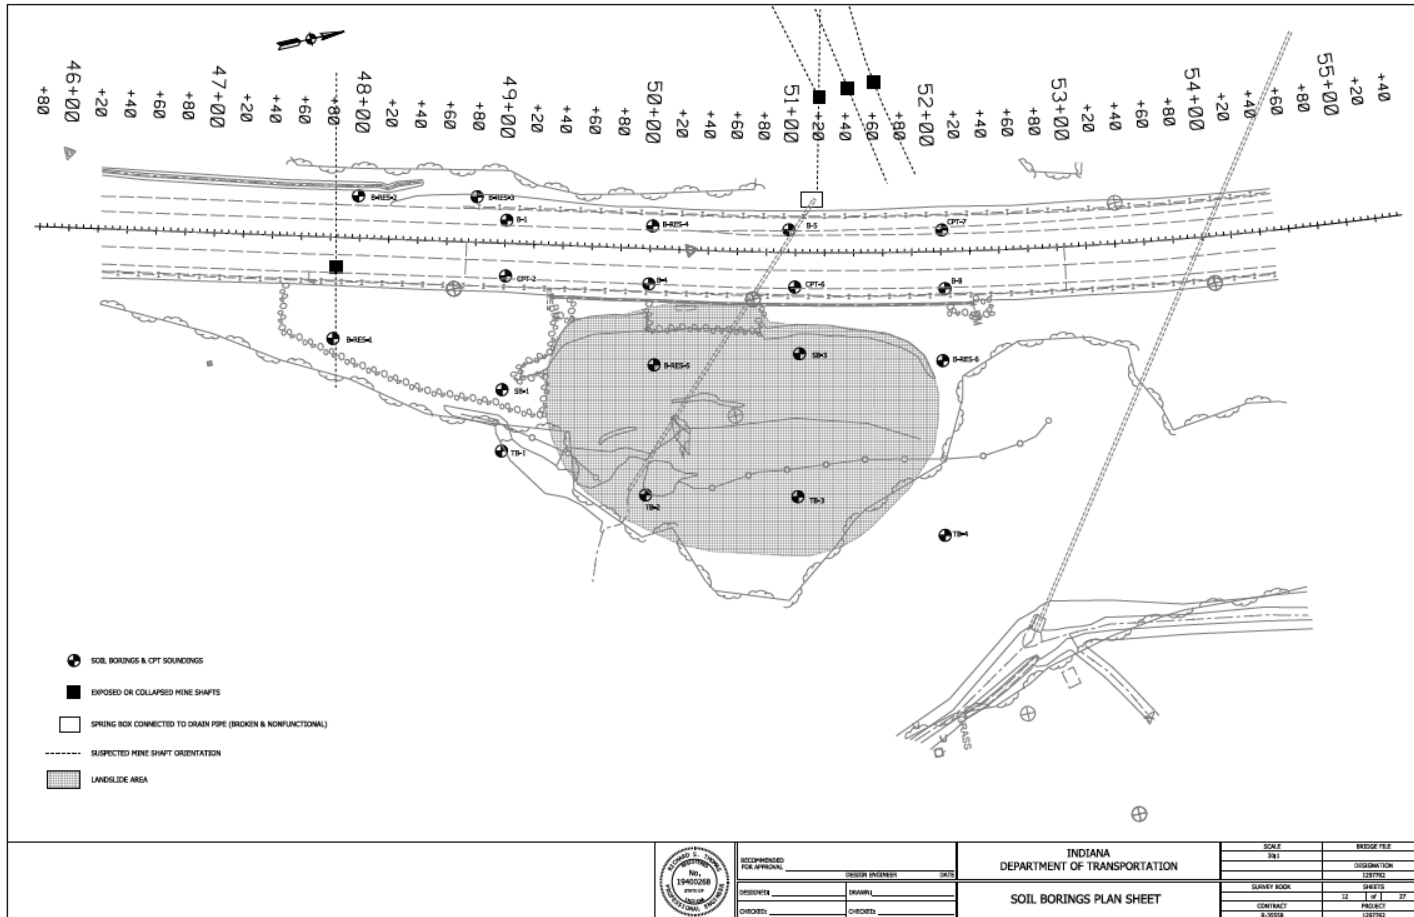
Boring location plan for the second slide.

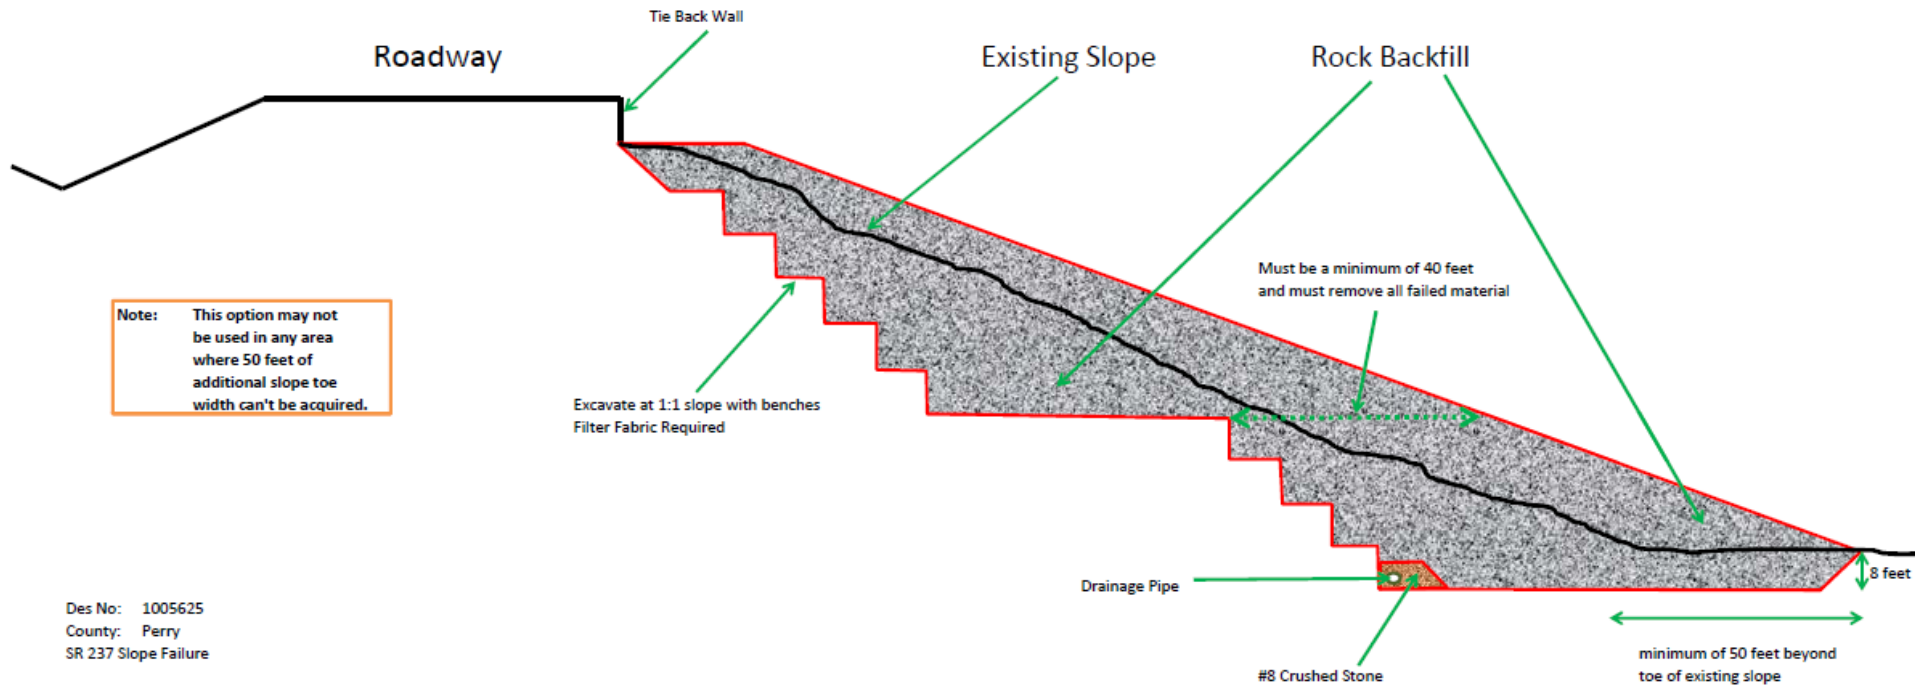
Correction Using Rock Backfill

- Slide aggravated further after letting in March 2013 due to heavy rains.
- Massive amount of water seeped out of the slope.
- The rock backfill was not viable option anymore because it would require the 1:1 temporary slope.
- Potential destabilization of existing soldier pile wall.

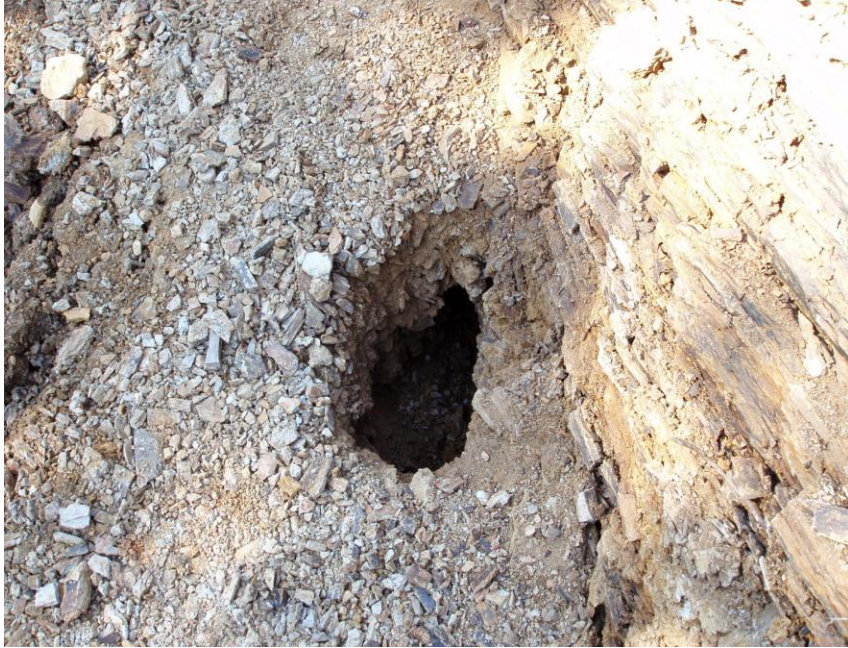
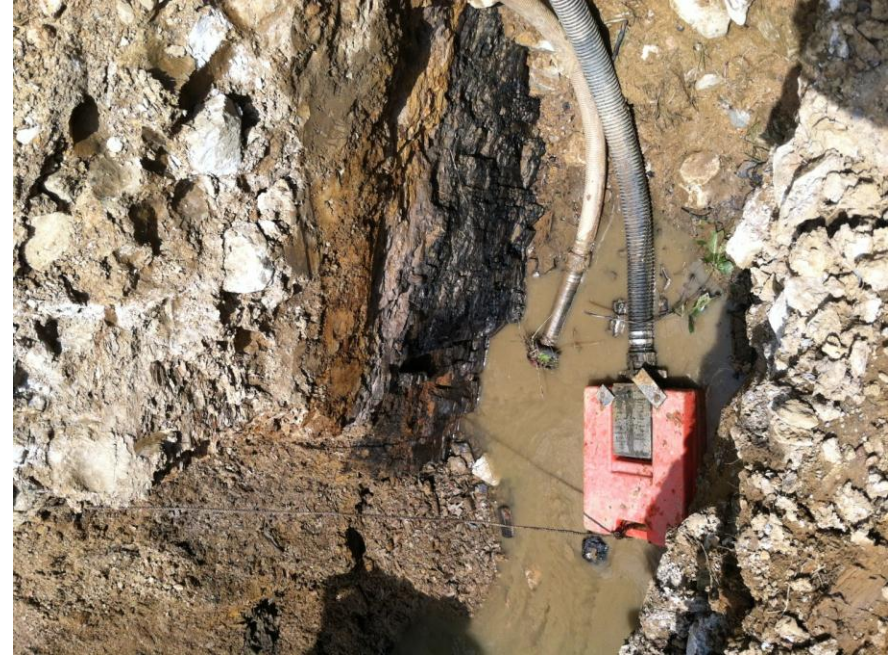
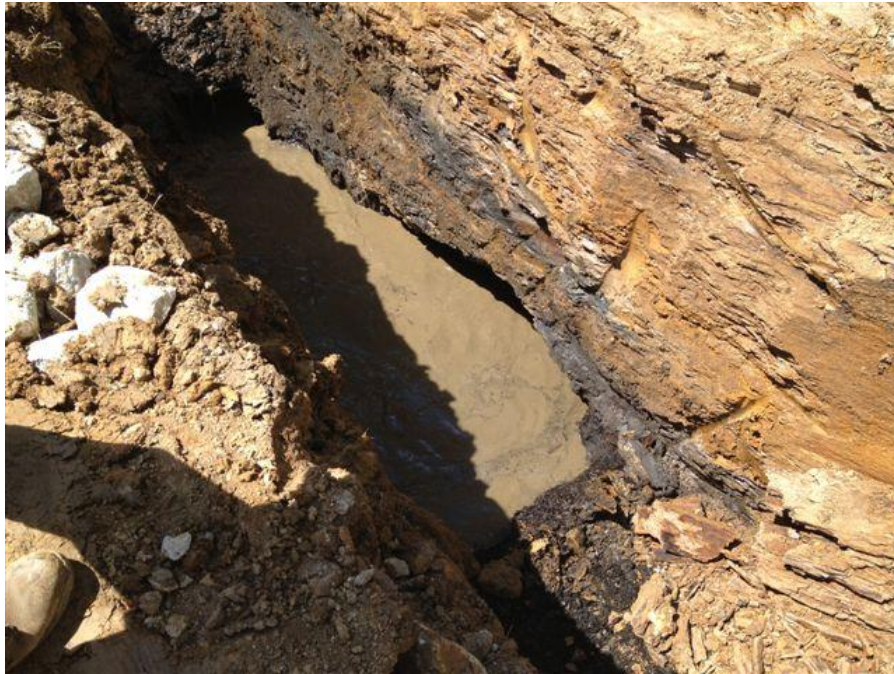
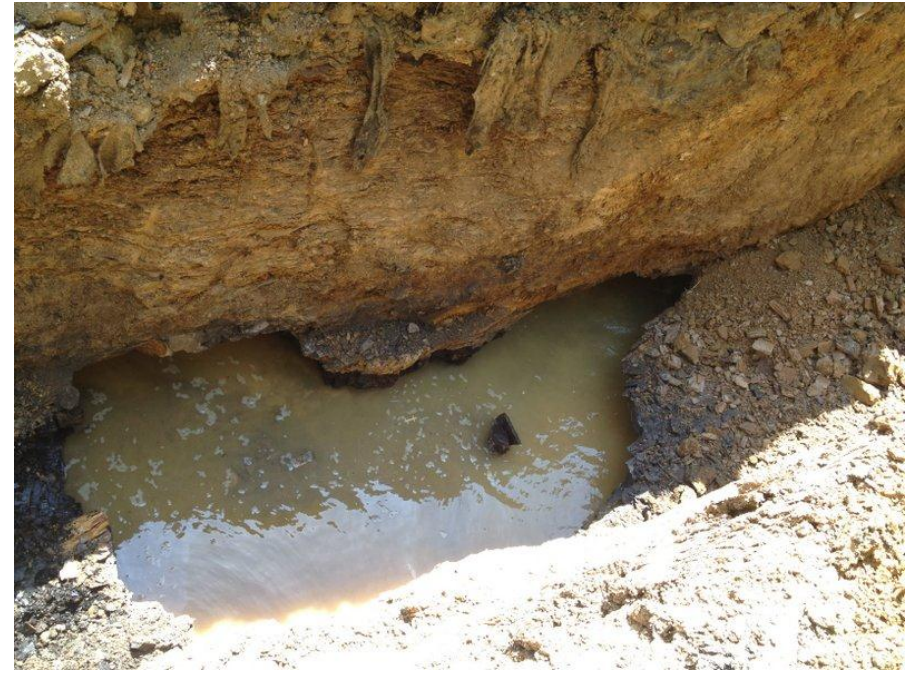
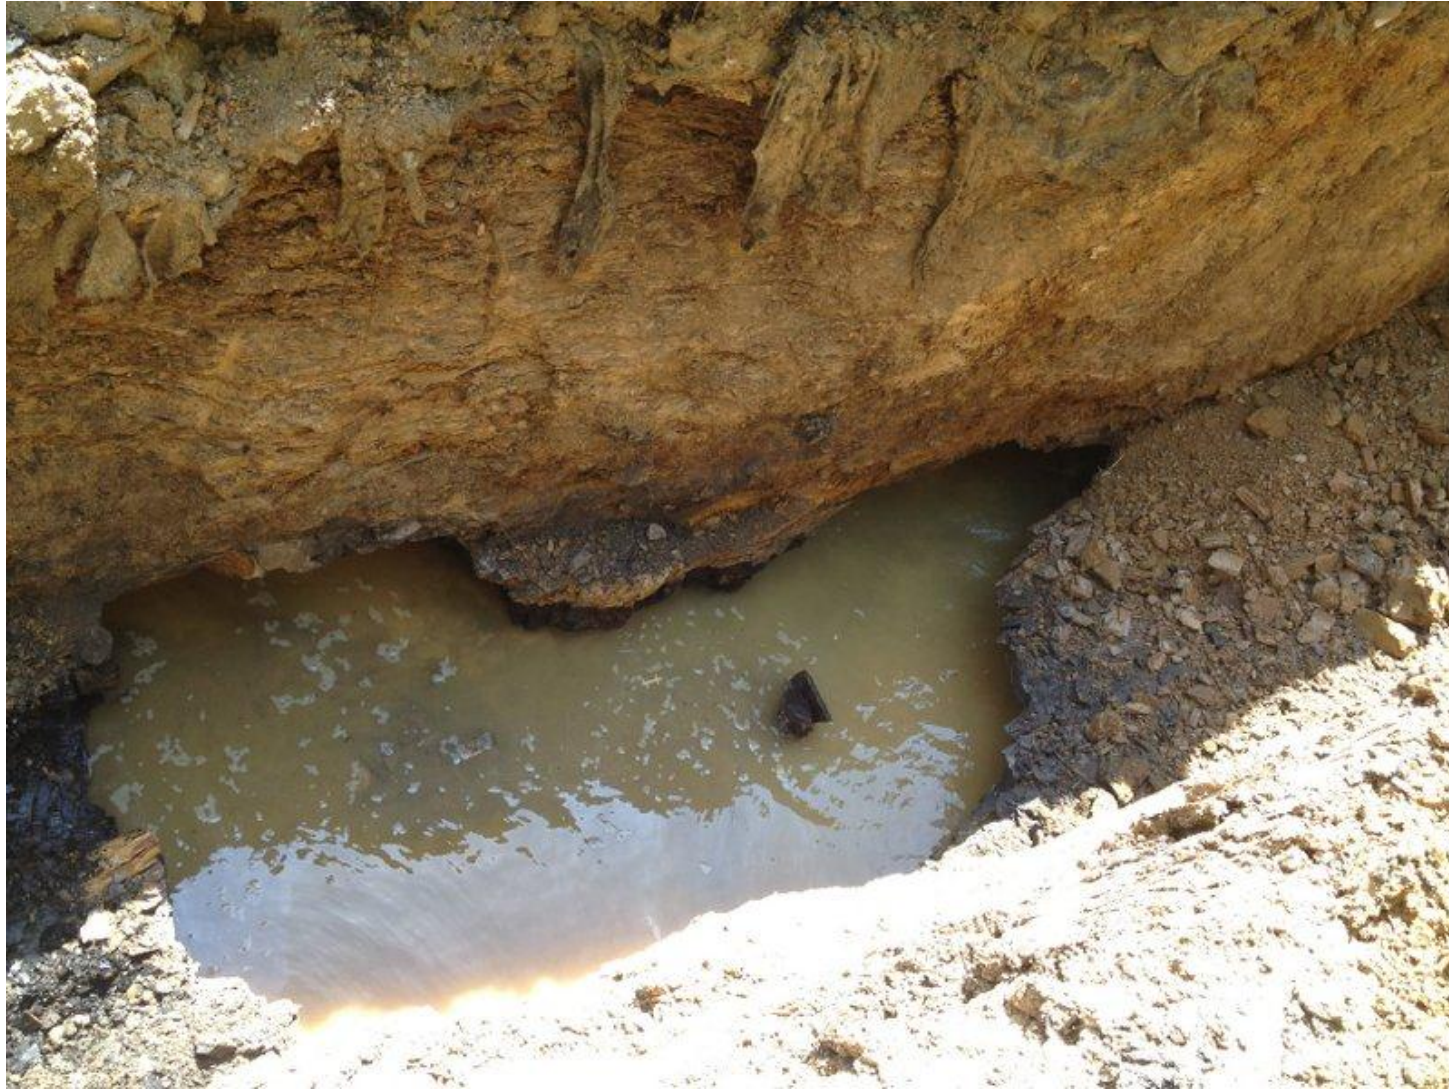
Mine Shaft Discovery

- During exploratory excavation for the spring box repair, coal mine shafts were uncovered.

- Resistivity study done to search for mines.
- More borings to verify the locations of suspected mines under the roadway as per geophysical study (resistivity testing).
- Borings reveal several collapsed mine shafts under roadway.

- Drainage correction
 - Mine shaft interceptor drain
 - Grout the mine shafts

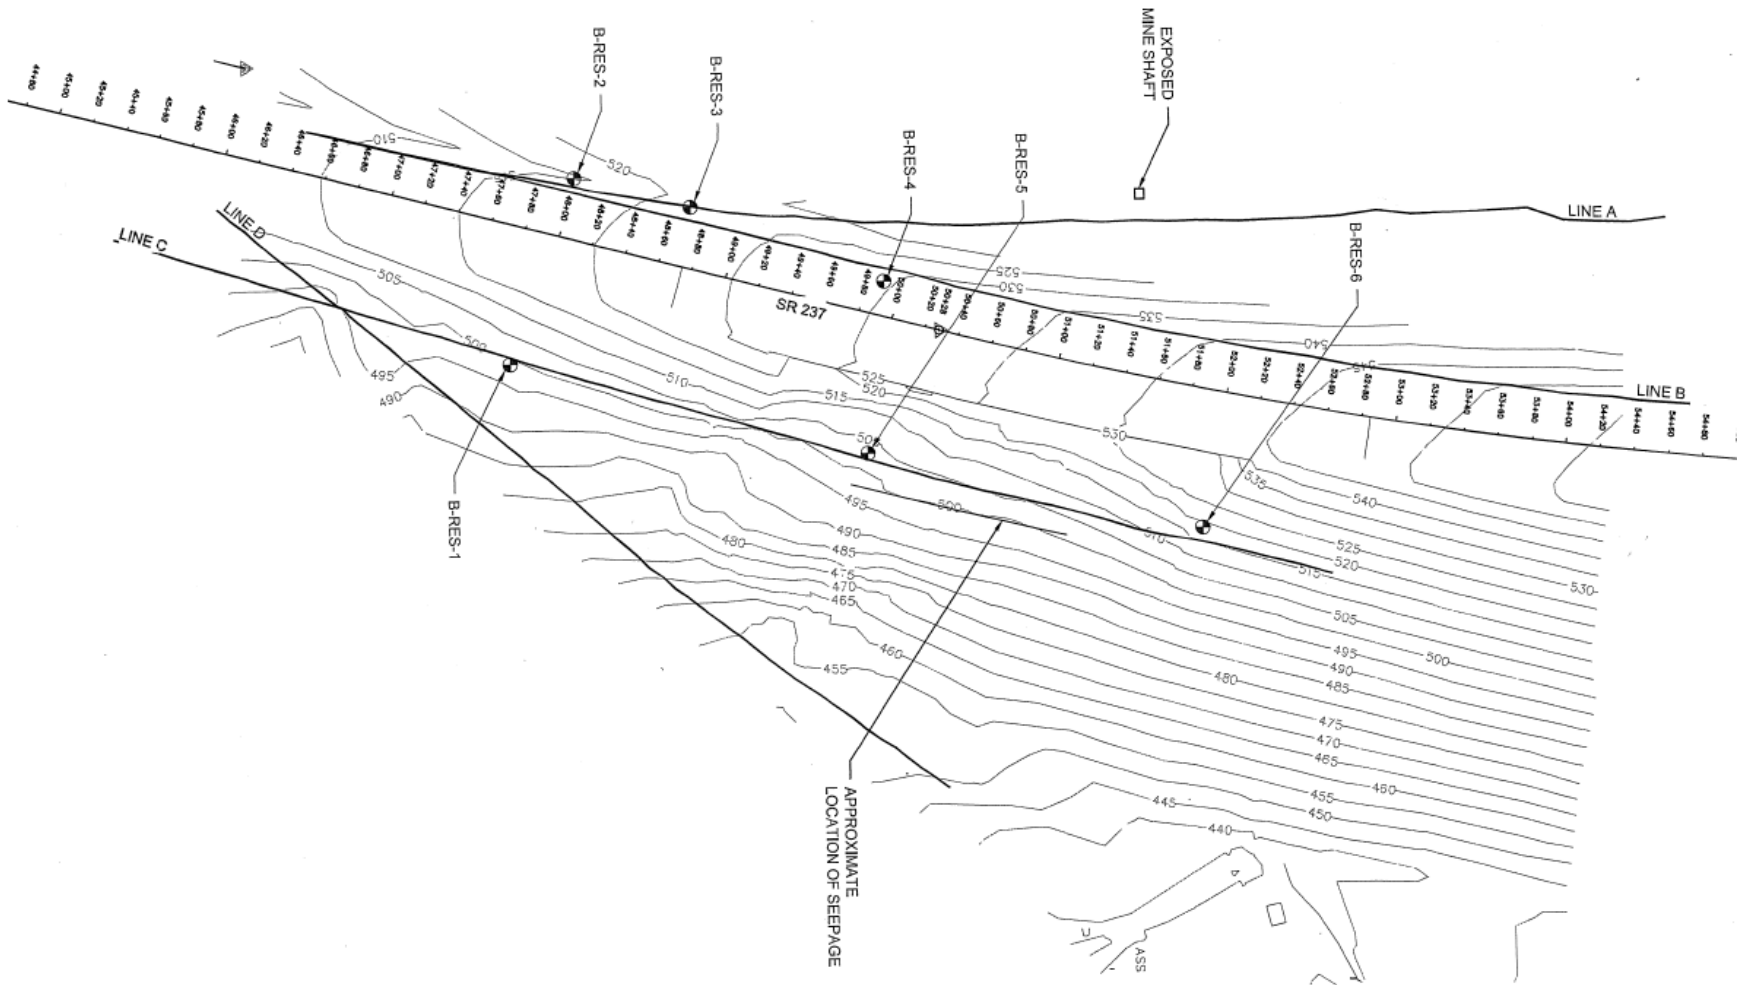
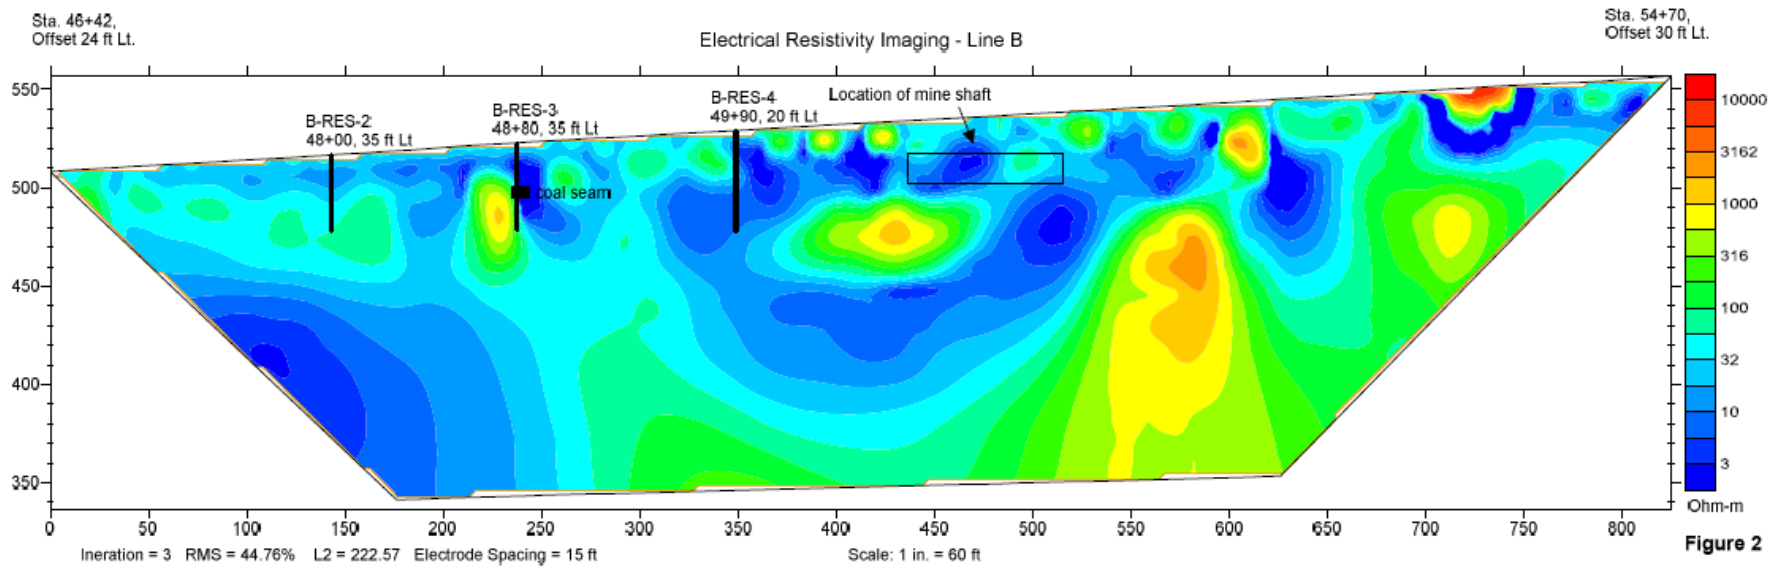
Resistivity Study Results

- Resistivity study done to search for mines.

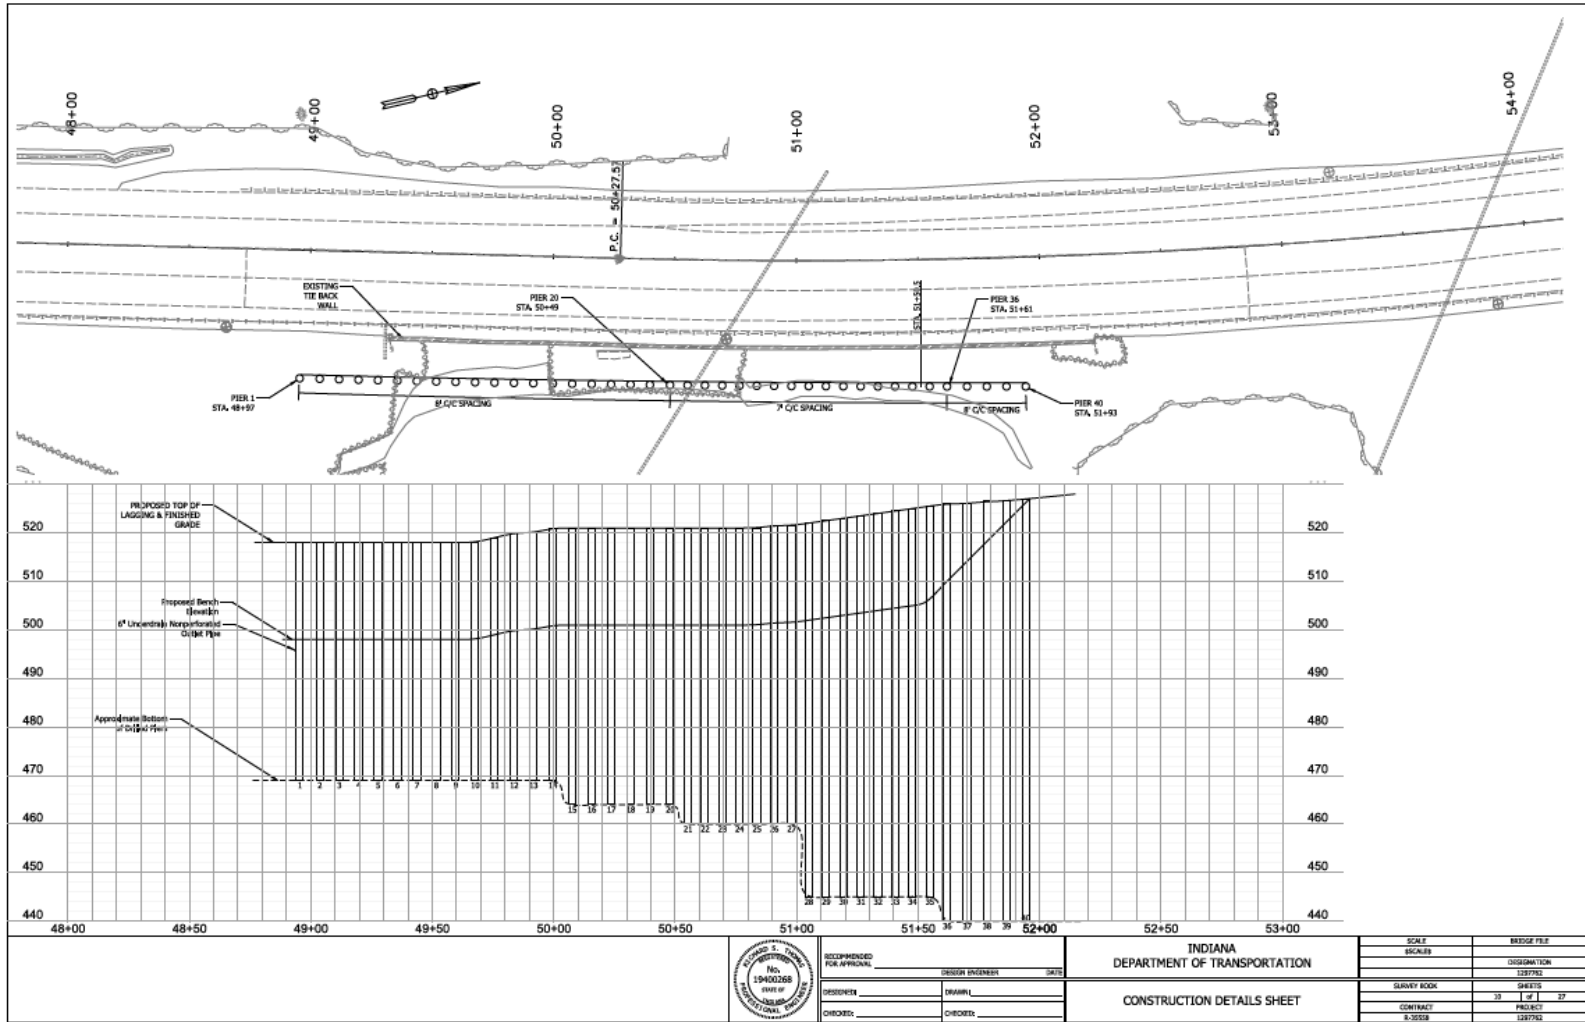
Drilled Shafts and Drain Layout

- The new drilled pier wall was originally proposed to be 15 feet from the existing wall.
- The construction of new drilled pier wall affecting the integrity of existing soldier pile wall.

- Move the proposed drilled pier wall 40 ft away from existing soldier pile wall (25 ft further) to provide safe excavation for inside lagging and backfill.
- Change temporary casing to a permanent casing for drilled piers due to possible co-mingled fill material.
- Provide casing for tieback un-bonded length to avoid major loss of grout due to unclassified fill material.
