Hazards Caused by Uncontrolled Vegetation and Inadequate Maintenance Practice in Earth Dams

Escolano-Sánchez, F., & Fernández-Serrano, R. (November-December, 2015). Hazards Caused by Uncontrolled Vegetation and Inadequate Maintenance Practice in Earth Dams. *Water Technology and Sciences* (in Spanish), 6(6), 137-144.

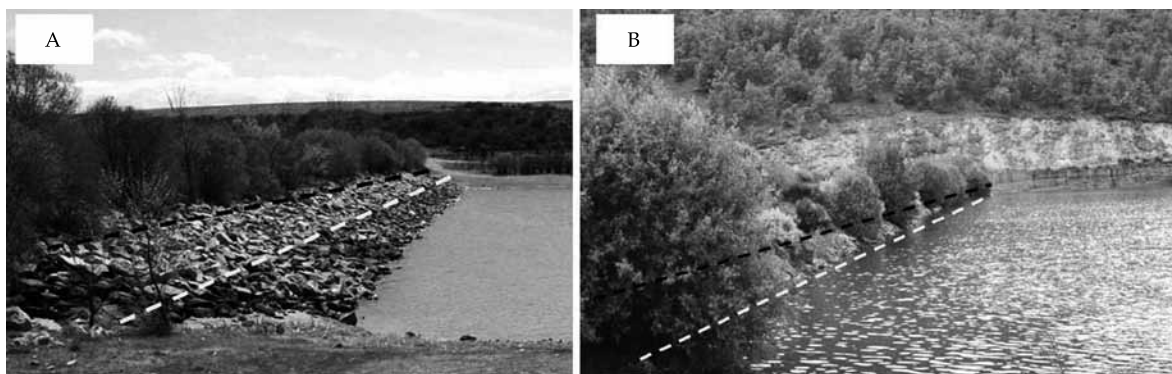
It has been observed that when trees and brush grow on upstream slope they show up by alignments, in general 1-2 m over the saturation line in a regular Full-Supply (reservoir) Level. This behaviour is a matter of fact when the reservoir presents high water level almost all the year (Fig. 1 and Fig. 2).

The most dangerous aspect of tree growth on dam crests and upper upstream slopes is their sudden uprooting. This can result in the displacement of a relatively large amount of embankment material, thereby lowering the dam crest, reducing the effective width of the dam, or facilitating erosion and potential seepage.

Figure 1. Upstream view of a rockfill dam with clay core. (A): White line is Normal Level. Black line is trees alignment (Villagatón Dam, Spain). (B): White line is Full Supply Level. Black line is trees and brushes alignment (Santa Lucía de la Sierra Dam, Spain).

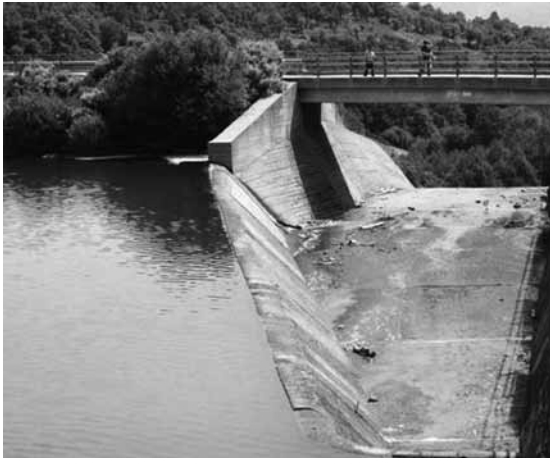
Figure 2. Trees behind a reinforced concrete wall, which is an abutment of the spillway channel bridge. (Santa Lucía de la Sierra Dam. Spain).

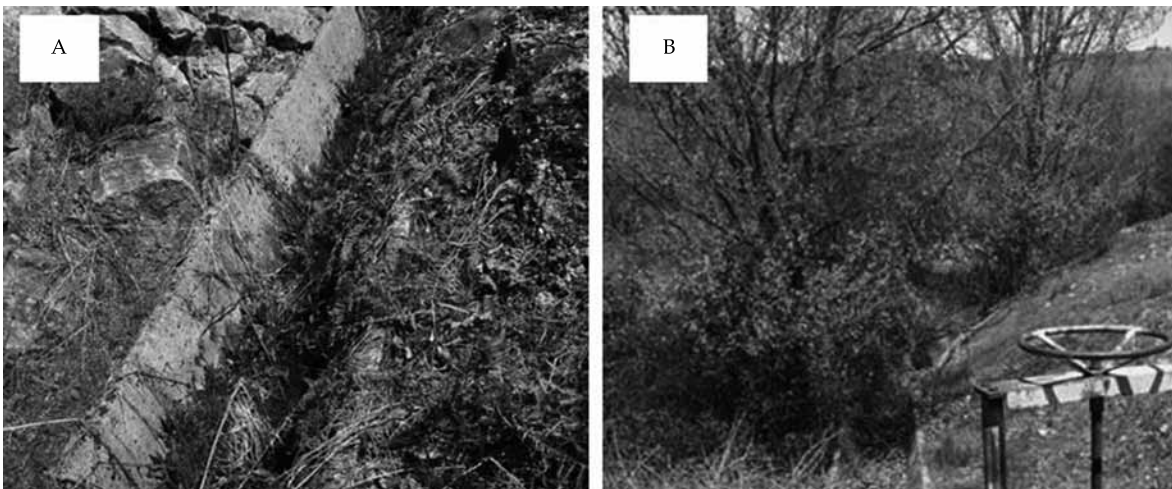
Trees growing in wall backfills or close to water channel fabric and other dam structures are able to push walls, uplift channel foundations and become an obstacle on the free flow of

Figure 3. A: Drainage net element of a downstream berm reducing cross-section of water flow. B: Trees rooted behind a service surplus channel downstream of an earth dam.

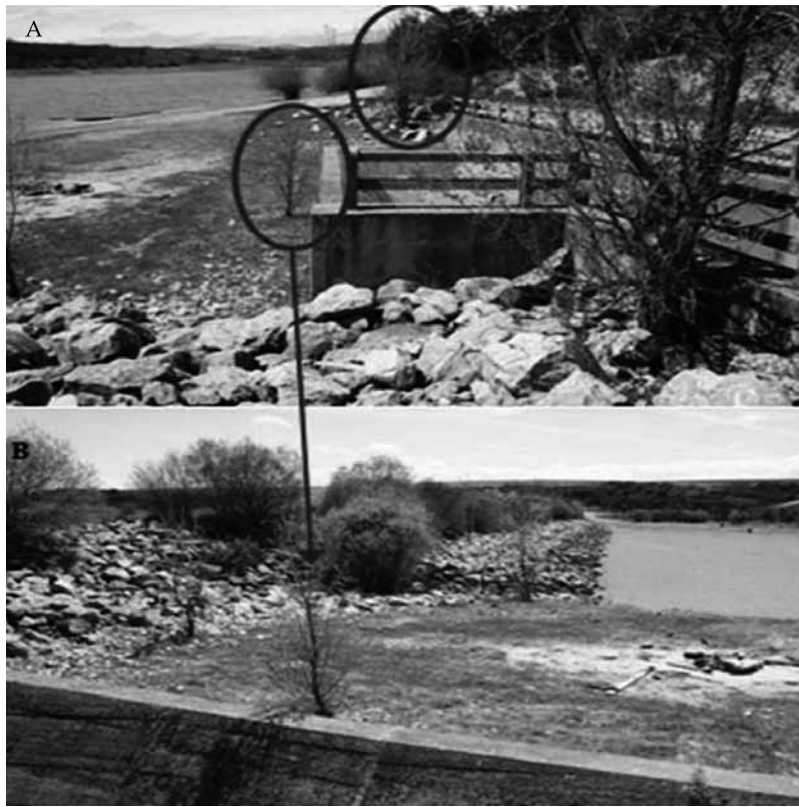
Vegetation invades drainage elements reducing the free water flow cross section. In other case, roots uplift the channel reducing or reversing the angle of descent, forming puddles (Fig. 4). The potential problem has to do with the eventual overflow of water.

Figure 4. Small trees growing close the static crest spillway of a small dam.

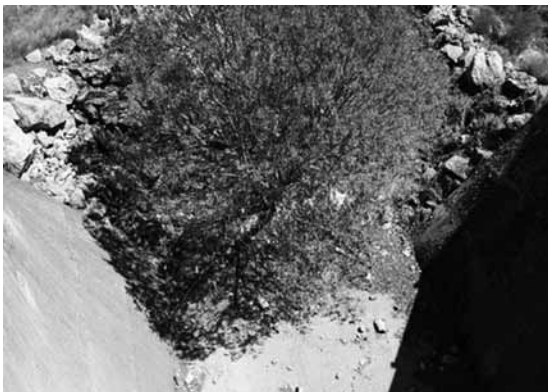
Spillways are the most important safety elements on dams, so they must be always clean of brushes and tree trunks which can prevent the correct water flow in normal or emergency dam-work situations (floods). Trees growing on the reservoir near the spillway lip are water obstacles (Fig. 5), and potential clogging bases. For the case depicted in Fig. 6 of a tree that has grown just in the middle of spillway, in the upper side of the downstream slope, should have also been removed to prevent potential problems of seepage, erosion, burrowing animals, etc.

Figure 5. Big tree growing just below the dam crest in the spillway channel of an earth dam, under the spillway dam crest bridge. The channel continues with a rip-rap cover along the downstream slope.

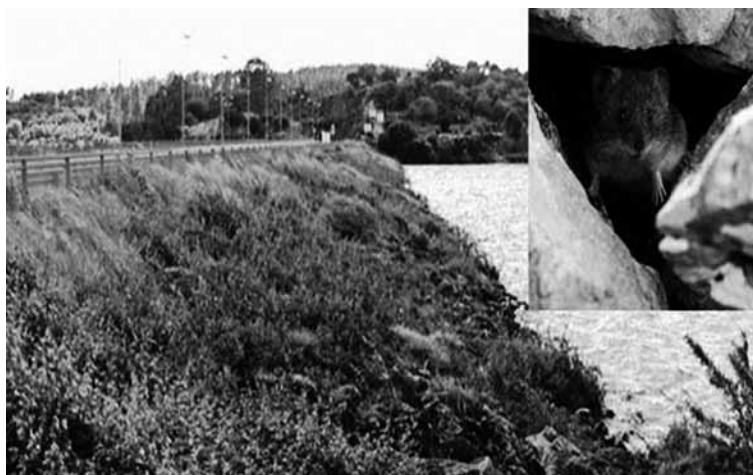
Rodents burrows on the upstream and downstream slopes can dramatically alter how a dam controls the water pooled behind the dam. Many species excavate dens and burrows within embankment dams, causing large voids that weaken the structural integrity of the dam.

Figure 7. European snow vole (“*Chionomys nivalis*”), typical on the north of Spain, living inside an earth dam. (Horno Tejero Dam, Spain).

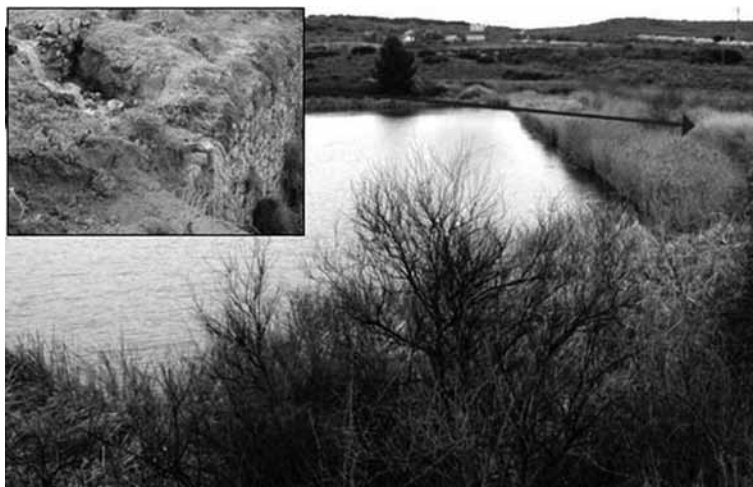
Inadequate spillway output maintenance can develop back erosion if channel covering has not been well designed. This is a minor problem since it can be solved by (e.g.) extending a rip-rap bed. The real problem is uncontrolled overtopping. The case of Ontígola Dam (Spain), a dam constructed by 1552, covered by vegetation, is an example of surface erosion related to vegetation growth (Fig. 9), while brush prevent from observing the uncontrolled overtopping as the most hydraulic dangerous behaviour of the dam.

Figure 8. Surface erosion caused by overtopping of a 1552 construction year wall-dam (Ontígola Dam, Spain).
