INTEGRATED KNOWLEDGE ON A THREE-DIMENSIONAL BASIS: THE FOUNDATION OF THE CONSERVATION PROJECT AND POSSIBLE IMPLICATIONS IN THE BIM AREA THE CASE OF THE PORTRAIT ROOM OF PALAZZO BOREA D'OLMO IN SANREMO

2. THE CASE OF THE PORTRAIT ROOM OF PALAZZO BOREA D'OLMO IN SANREMO

The case study here presented is the eighteenth-century Palazzo Borea d'Olmo, in Sanremo. On the Palace, a cause of its historical, artistic, architectural peculiarities, and its involvement in the history of the City, are a protection and an environmental restriction, according to Law 1089/1939 and Law 42/2004. The recent study, conducted over a fairly limited period of time, focused on the Family Portrait Room on the second noble floor of the Palace.

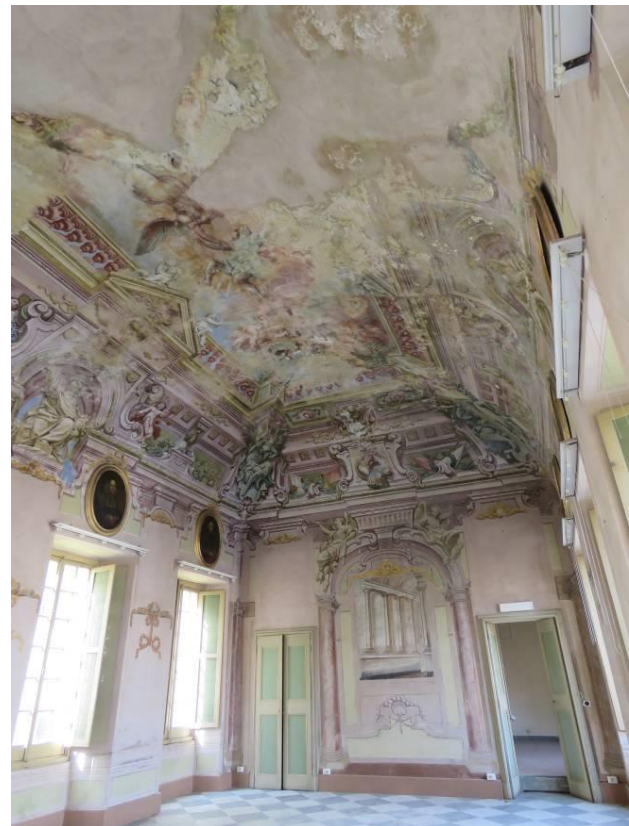
The Hall is decorated with eighteenth-century frescoes and it has been seriously damaged by "accidents of various kinds", strengthened over the time and manifested themselves in a repeated manner, never fully fronted and solved.

Figure 1. Family Portrait Room on the second noble floor of the Palazzo Borea d'Olmo, Sanremo (IM).

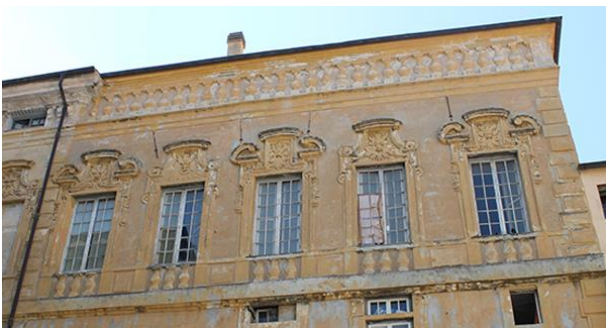
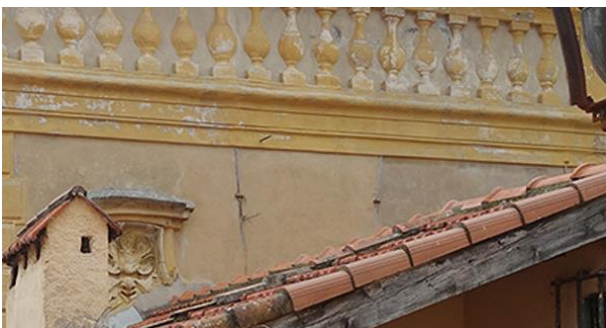
1. The persistence, on the façade, of the bolted end-plate of metal chains that have been cut and removed inside the building.
2. The reconstruction of a large portion of the vault, recognizable by the different building technique and by the loss of the fresco decorations.

Figure 5. External view of the Family Portrait Room, 2018

Figure 6. External view of the Family Portrait Room, 2018

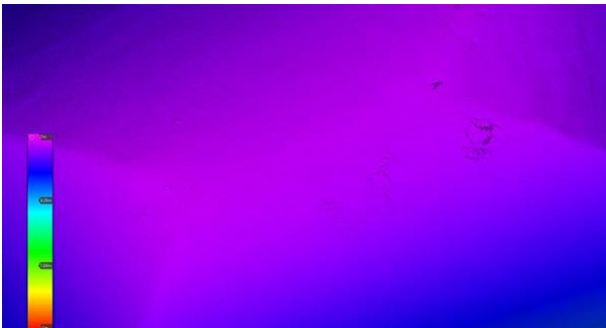
- The RGB visualization provides realistic colour photographic image (Fig. 7);
- The DEM visualization can be set with customizable colour scales in order to obtain the best graphic data reading. The DEM represents the distribution of heights in relation to the base level 0.00 (level of first scan). The DEM therefore highlights the deformations, the lesions and the discontinuities of the vault due to the different reconstructions. It emphasizes the swellings and plaster detachments attributable to degradation, infiltration, prolonged action and repeated humidity (Fig. 8);

Figure 8. DEM three-dimensional view - 3d model of the vault elaborated with laser scanning

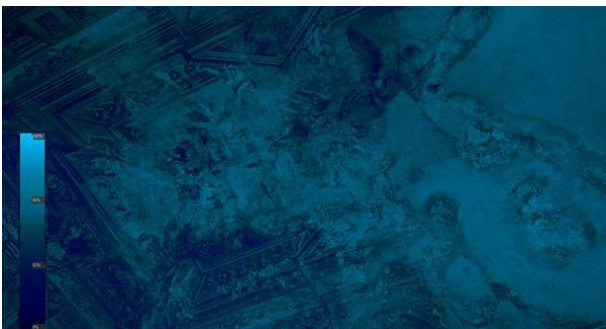
- The reflectance visualization scale (Fig. 9), customizable in order to obtain the best reading of the data, highlights the distribution materials according to their light reflection level. In this way it is possible to distinguish the materials with lower reflectance (greater absorption of the laser beam) and those with higher reflectance (low absorption of the laser beam).

Figure 9. visualization in reflectance scale (custom colours) - 3d model of the vault elaborated with laser scanning

The comparison, instead, between the RGB view of the 3D model (dense cloud) and the reflectance view has clearly highlighted the problems of humidity and infiltration in the contact areas between the original masonry vault and its rebuilt portion after the collapse.

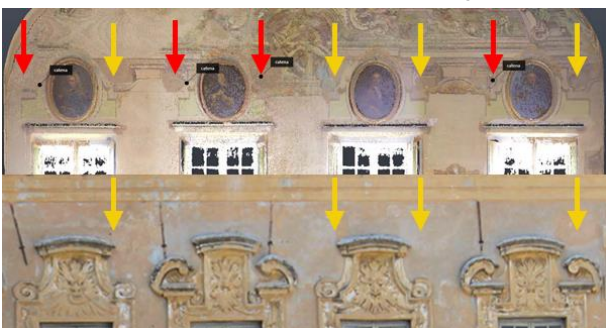
Figure 10. Interior and exterior view of the Family Portrait Room. The red arrows indicate the existing bolted end-plate; the yellow arrows indicate the plaster swellings detected where the bolted end-plate are no longer in place.

The result has been particularly effective to find out the plaster resumptions where the metal chains were removed even if today the external metal end-plate no longer exist (Fig. 10).

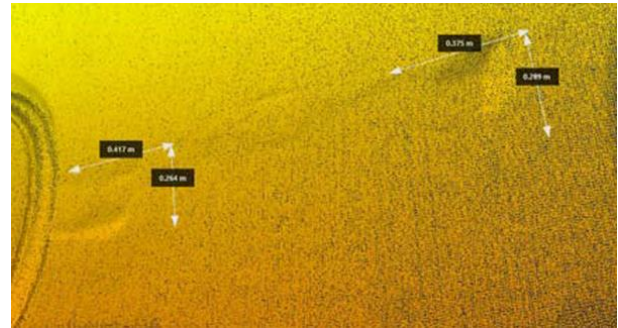
In these points, the layers of plaster and paint have marked swellings and detachments that can be seen with the DEM display of the point cloud. The comparison with its RGB version allowed us to verify the chromatic difference of the plaster. (rif. Fig. 10, 11, 12).

Figure 11. DEM three-dimensional view of the dense cloud: detail of the points where the metal chains have been removed.

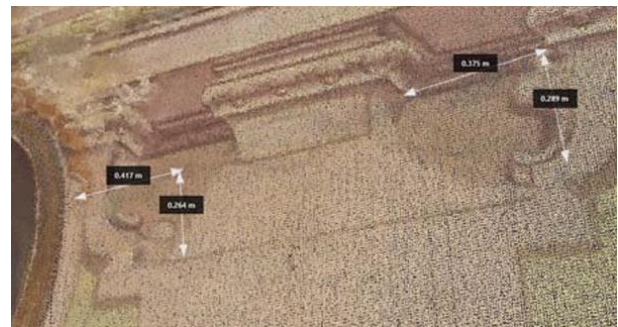
Figure 12. RGB three-dimensional view of the dense cloud: detail of the chromatic differences of the plaster in the points where the chains have been removed.

The result of the thermographic survey confirmed that the plaster and frescoed surfaces are continuously and cyclically subject to sudden changes in temperature and humidity. The deficiencies observed at the structural level and the already highlighted reasons are the main cause of the heavy degradation of the frescoes (rif. Fig. 11).

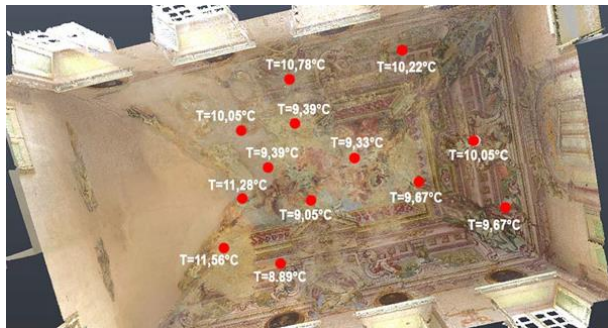
As can be seen in the image below (fig. 13), the temperatures detected at the lower level of the frescoed vault were very close to the external temperatures.

- Long-time lack of environmental air conditioning system at the time of the survey;
- degradation of walls, window parapets and sills;
- presence of lesions on the vault and on the perimeter walls;
- degradation of the windows wooden frames, lack and breakage of some panes,
- general humidity in all rooms of the second noble floor;
- presence of several infiltrations (and therefore of persistent humidity) in the other rooms.

Figura 13. Temperature distribution to the intrados of the vault detected with a thermal imaging camera.
