INTEGRATED SURVEY TECHNIQUES: PRELIMINARY STUDIES FOR THE CONSERVATION OF VILLA GALVAGNINA

KEY WORDS: Villa Galvagnina, integrated survey techniques, decay mapping, cultural heritage preservation

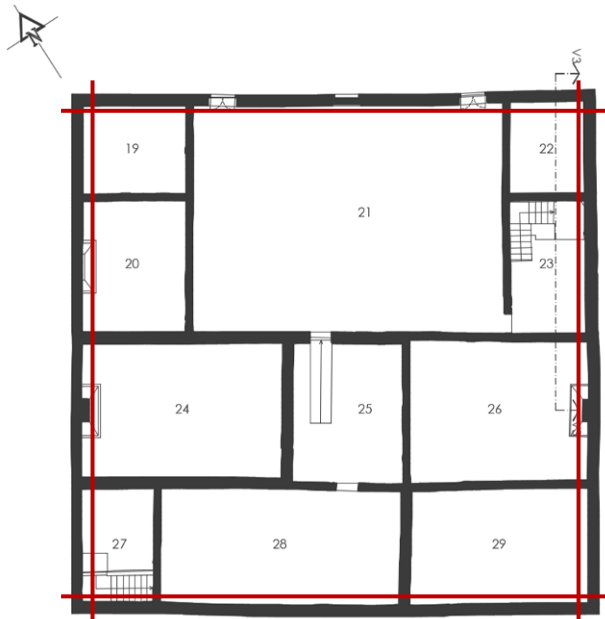
The horizontal sections obtained from the points cloud show two deformation mechanisms of the masonry walls. The south-eastern and the south-western walls show an out-of-plane

deformation that could be due to a horizontal bending (Fig. 8). This deformation may have been caused by the earthquake and aggravated by the action transmitted by the internal walls. The internal walls and the south-west and north-west external walls also show a little out-of-plan deformation.

Figure 8: First floor plan H2, out-of-plane deformation of the masonry walls (Municipality of Mantua).

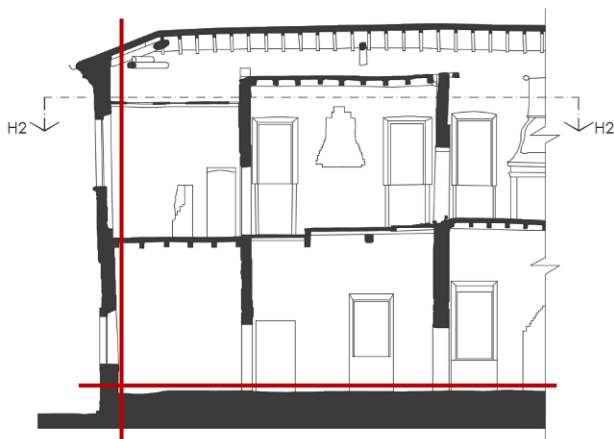
An outward rotation of the upper east corner of the building seem to be caused by the load of the roof, maybe exacerbated by a foundation subsidence, given a confined floor sinking (Fig. 9).

Figure 9: Vertical section V3, the overturning of the external walls and the floor sinking (Municipality of Mantua).

The vertical sections show the overturning of the external walls, particularly evident in the middle part of the wall, except for the north-eastern front, the maximum overturning of which is near the east corner.

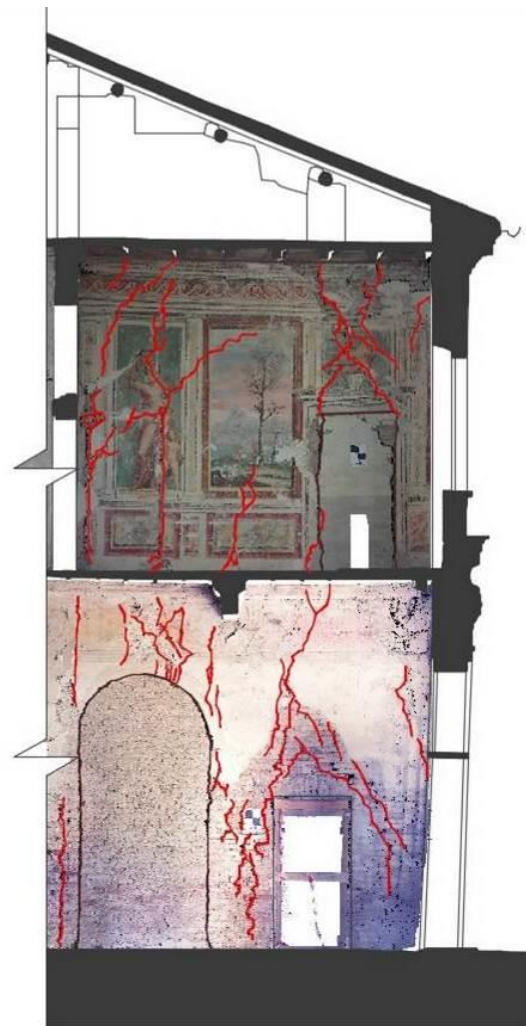
Figure 10: Details of the crack pattern.

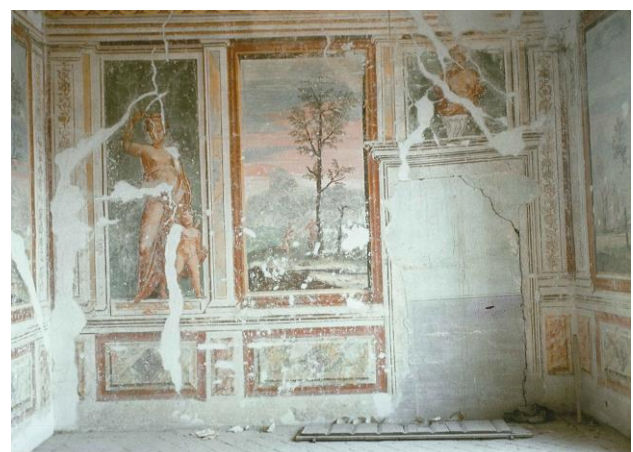
Figure 11: Crack pattern, room 28, 1990 (Private archive Federico Merli).

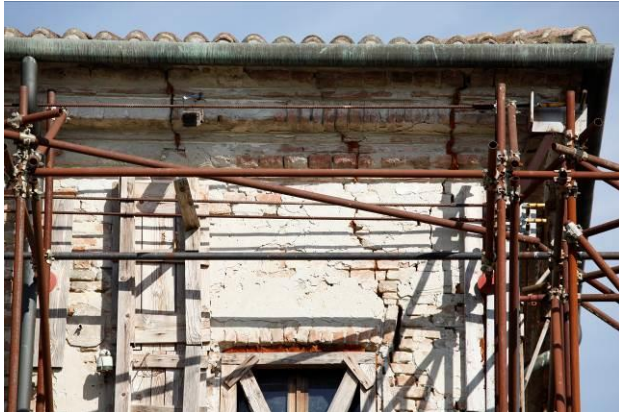
The cracks at the top of the external walls, in particular, appear to have been caused by the outward thrust of the roof (Figure 12 and 13). This problem, as already mentioned, does not seem to

have been effectively solved by the replacement of the wooden structure.

Figure 12: Cracks due to the outward thrust exerted by the roof.

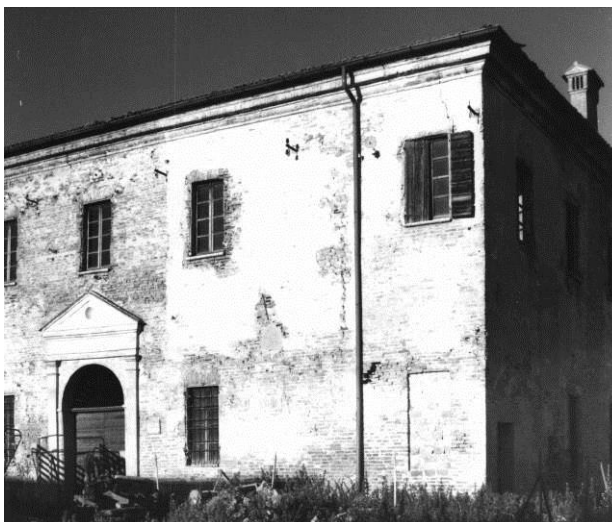
Figure 13: The main front of the villa in the 1960's. The crack due to the outward thrust exerted by the roof can be seen in the upper right corner (Private archive Alberto Ferrari).

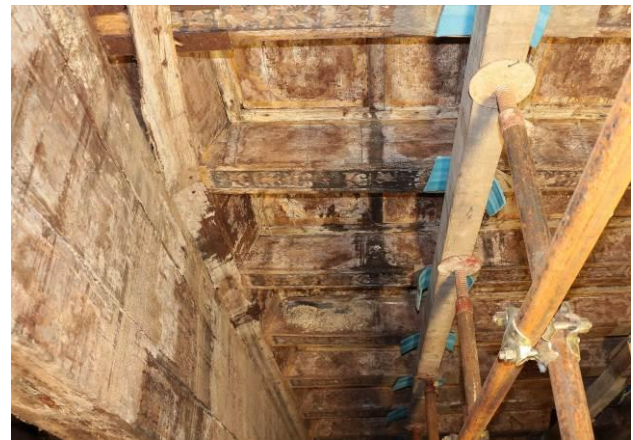
Another obvious problem concerns the severe damage suffered by the painted wooden floors that show localised rotteness and collapses. The structural behaviour of all the wooden elements will have to be thoroughly investigated in order to develop an

Figure 14: Wood decay, main hall.

effective strengthening action. The wooden floors behaviour under static and seismic loads can be improved by means of a thin collaborating steel slab or collaborating multilayer panels. Both of these techniques, while giving up the intactness of the pavement, make it possible to build anti-seismic shear-resisting, even if the multilayer panels lead to worst results in terms of flexural response.

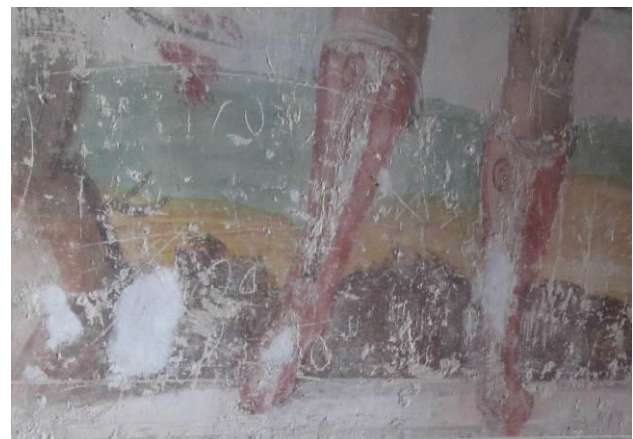
Figure 15: Wall paintings decay, room 4.
