ENGINEERING GEOLOGICAL ASSESSMENT (EGA) ON SLOPES ALONG THE PENAMPANG TO TAMBUNAN ROAD, SABAH, MALAYSIA

Rodeano Roslee^{1,2*}, Felix Tongkul^{1,2}

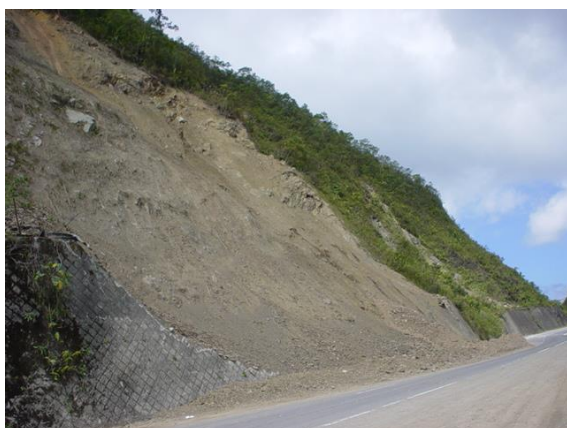
Results of a detailed analysis of soil slope stability are presented in Table 3. Considering cut slopes, all the major lithologies are involved showing that this type of failure is not mostly controlled by lithology. The failure volume scale involved generally small to large in size possibly endangering road users. In term of weathering grades, the materials that underwent failure were in the ranges from grade IV to VI (Figures 3 to 6). Weathering is the main factor causing failure with the depth of weathering influencing

the volume of material that fails. It appears that grade IV to grade V materials actually failed with the overlying grade VI material sliding or slumping down together with this material during failure. Physical and mechanical properties of 84 soil samples indicated that the failure materials mainly consist of poorly graded to well graded materials of clayey loamy soils, which characterized by low to intermediate plasticity content (9 % to 28 %), containing of inactive to normal clay (0.34 to 1.45), very high to medium degree of swelling (5.63 to 13.85), variable low to high water content (4 % to 22 %), specific gravity ranges from 2.57 to 2.80, low permeability (9.66 X 10⁻³ to 4.33 X 10⁻³ cm/s), friction angle (φ) ranges from 7.70° to 29.20° and cohesion (C) ranges from 3.20 KPa to 17.27 KPa. Soil slopes stability analysis indicates that the factor of safety value as unsafe (0.56 to 0.98). The presence of ground water, slope angle, removal of vegetation cover, lack of proper drainage system, artificial changing, climatological setting, geological characteristics and material characteristics are additional factors contributing to the failures.

Figure 3: Shallow slide (T1 – a) at KM 35 (SS5) shows the failure movement are starting to move into several discrete blocks through the development of transverse cracks

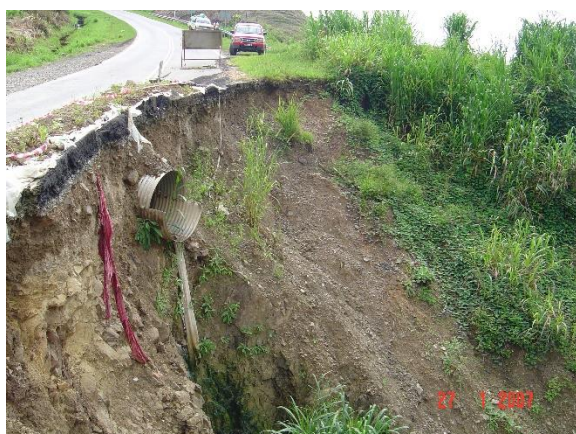
Figure 4: Embankment failure in the form of a deep slide (T1 – b) at KM 45 (SS6)

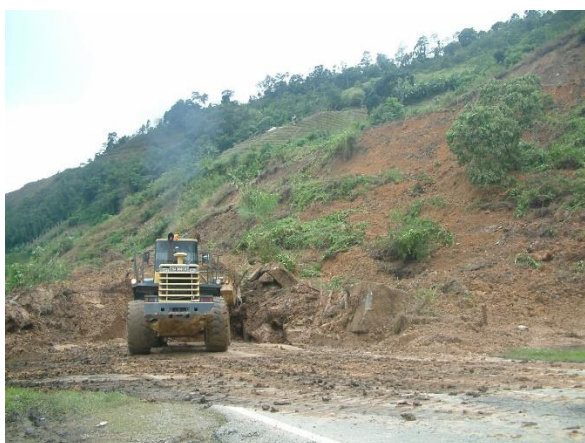
Figure 5: Earth flow (T3-a) showing the settling soil block suffers from fracturing, stumping or flowing considerable lateral movement along the basal mobile zone is common, as is upheaval of the terrain down slope of the failure (Location: KM 88 (SS17))

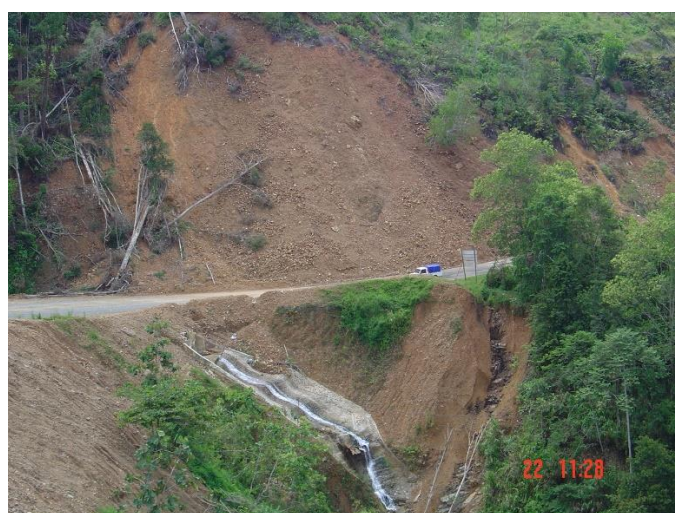
Figure 6: Complex failure (slump flow) (T5 – b) at KM96 (SS19) shows the failure movement are starting to move into several discrete blocks through the development of transverse cracks

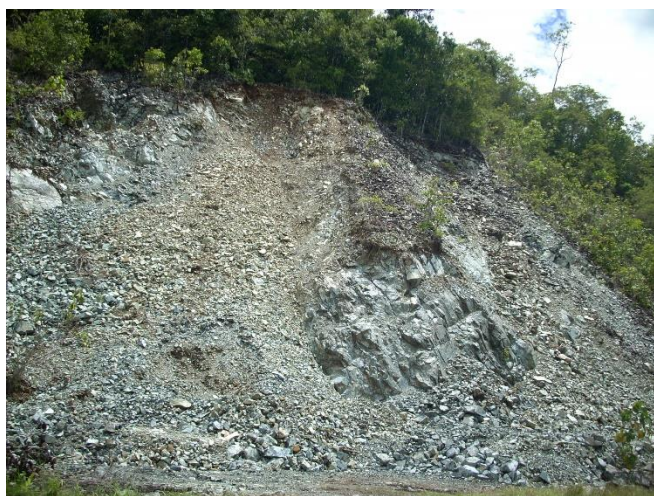
Table 3 shows the results of a detailed analysis of rock slope failures. Although rock slope failures contributed only 33 % (10 failures) of the total failures, they involved large volume of weathered and brecciated rocks (Figures 7 & 8). The main factor contributing to rock slope failures was the orientation and intensity of discontinuity planes. That is why rock slope failures occur most frequently along the highway on sedimentary rocks, which were highly brecciated and fractured. Generally, the failed material underwent only moderately to completely weathering (grade III to V). The rock properties characterization for 10 rock samples indicated that point load strength index ranges from 0.33 MPa to 0.52 MPa (moderately weak) and uniaxial compressive strength range from 7.81 MPa to 12.57 MPa (moderately weak). Kinematics slope analyses indicates that the variable potential of circular, planar, wedges and toppling failures modes as well as the combination of more than one mode of aforementioned failure (Figure 9). Rock slopes stability analysis indicates that the factor of safety value as unsafe (0.52 to 0.95). Other factors contributing to rock slope failure are the presence of groundwater, climatological setting, joints filling material, high degree of rock fracturing due to shearing, steep of slope angle, high intensive of faulting and folding activities and locating at the fault zones area.

Figure 7: Circular failure (crushed) (B1 – b) at East KM 21 (RS1) shows the surface weakness (revealing) within the structure, which composed of coherent crushed rocks on the gently sloping discontinuities

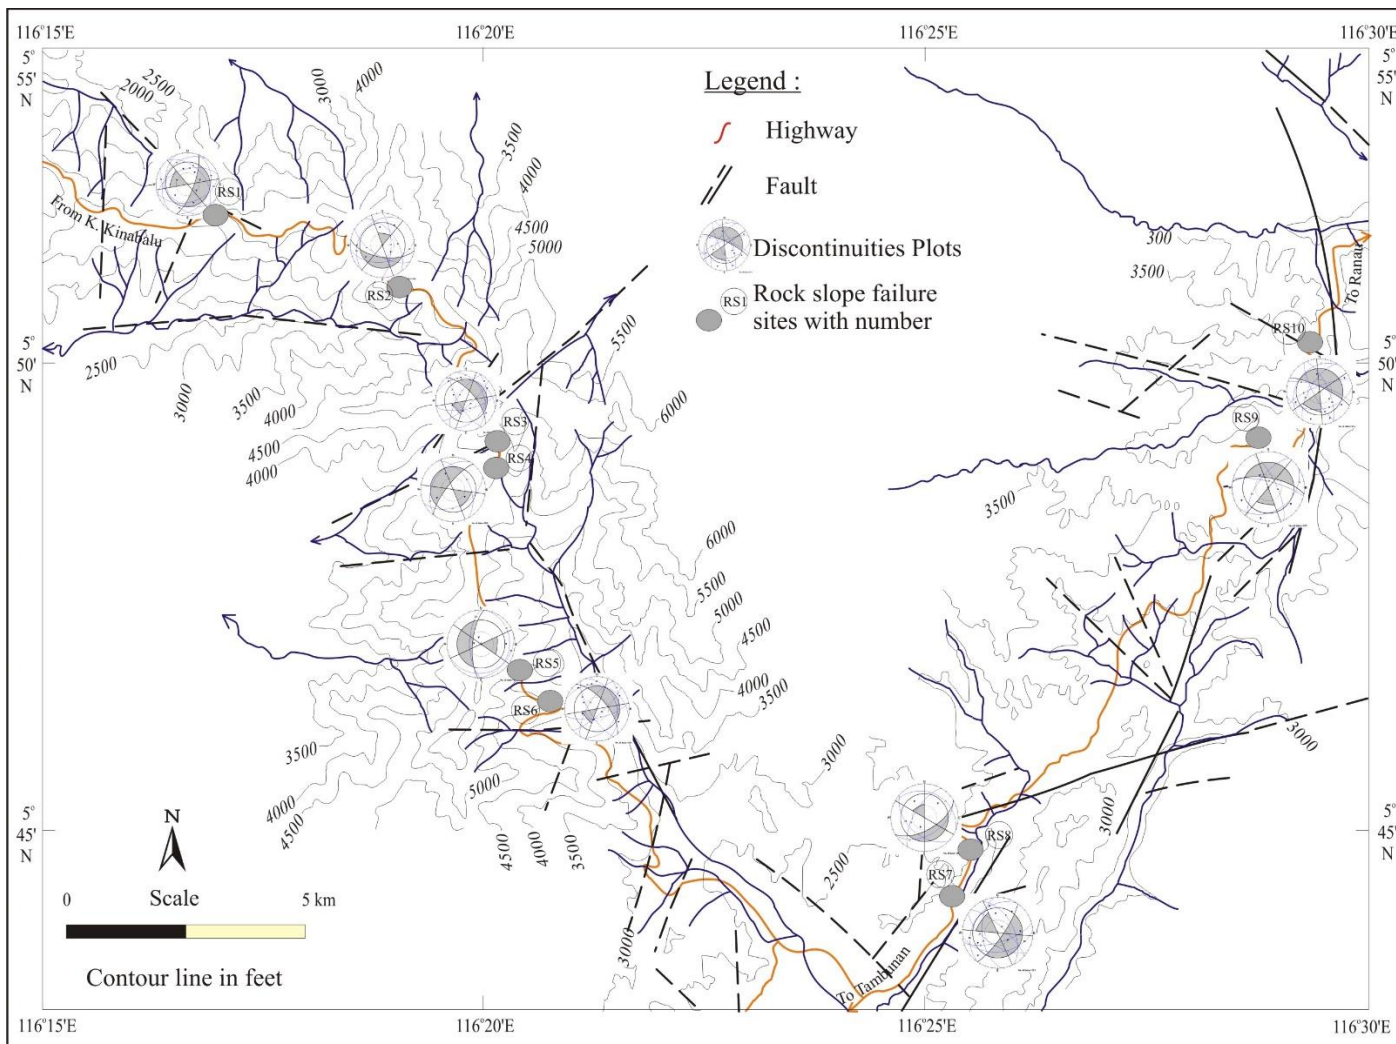
Figure 9: Streoplots and view of rock slope failures in the study area
