Considerations on damage to bulb turbine shafts from iron Gates II

Abstract. During operation, the turbine bulb shaft is subjected to static specific stresses (tension, compression, torsion) and dynamic (fatigue, random vibrations). These stresses are the effect of hydraulic forces and moments developed on the rotor blade, the weight of the rotor (with or without oil) in the console and inevitable vibrations, which creates a rotating mass unevenly distributed over the axis of symmetry of the turbine. Observations made on the turbine bulb shafts of the Iron Gate II CHE have revealed cracks in the connection area of a shaft flange that engages it with the turbine rotor. Examination of these cracks leads to the conclusion that they are specific to the inevitable fatigue demands in exploiting the tree and enhancing the environment in which they work. Therefore, in the paper, a presentation and analysis of the damage of bulb turbine shafts from CHE Porțile de Fier II, after a significant number of hours of operation.

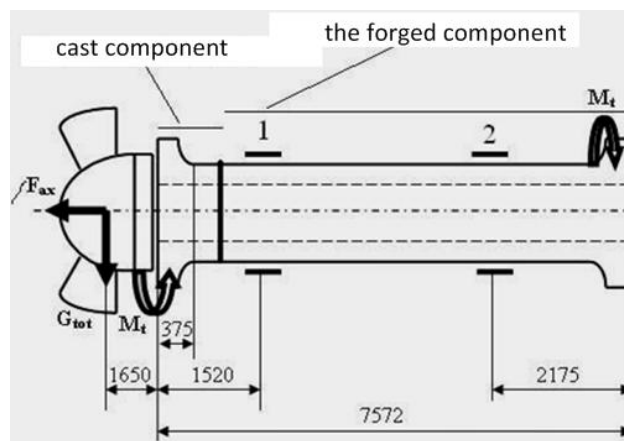
Figure 1. Bulb turbine shaft construction

The bulb turbine shaft, Figure 1, is made of two components: a casting consisting of the turbine rotor coupling flange and a cylindrical and a forged portion formed by the coupling flange with the electric generator shaft and most of the cylindrical part with which it engages and in the axial radial bearing.

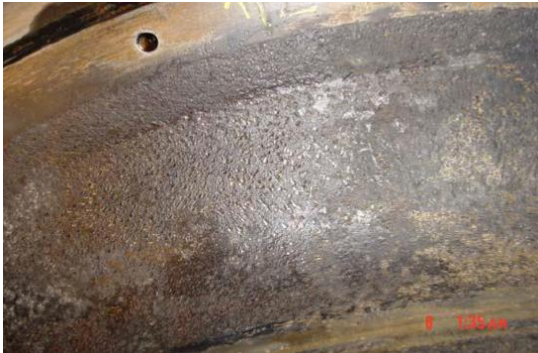
The proportion of chromium and nickel (especially chromium) is insufficient to confer increased corrosion resistance including intercrystalline corrosion. Given the influence of manganese on crystalline grains, we appreciate that the main alloying element determines a rough structure of the flange blank. In the case of castings, this structure determines both large crystalline grains and some unevenness in their dimensions. Preserving the initial composition, with small percentages of chromium and nickel, makes the corrosion resistance, Figure 2, remain relatively low, which does not improve the propagation of the cracks initiated.

Also, turbine operation has been consistent with specific, continuous, controlled and controlled regimes. As a result, the incriminated areas were checked by non-destructive specific methods, at each stop of the Romanian aggregates. After a control of about 130,000 to 140,000 hours of operation, a network of circumferential cracks was observed in the coupling flange of the shaft with the turbine rotor. This has led us to appreciate that crack initiation was caused by specific requirements, material constitution, processing technology and working conditions (humidity), as seen in Figure 2.

Figure 2. Surface Corrosion Points

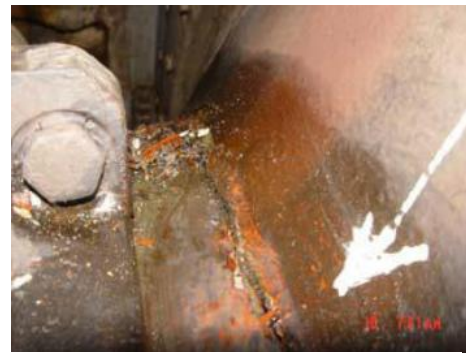
- lack of macroscopic plastic deformations or dimensional changes (cracks, etc.), as seen in Figure 3;

Figure 3. Cracks in the connection area of the shaft flange

Analyzing the image in Figure 3a we can see:

- The zigzag shape of the circumferential crack is more evident, reflecting the existence of micro-zones with increased strength that required circumvention;
- Chemical corrosion occurred even under the protective coating layer;
- There are cracks in areas close to the second radius of connection (near the arrow). This aspect shows the high degree of stress generated by the high stresses induced by the high stresses on which the tree part is in the console.

Small crack removal operations are required because they can develop on a spring the circle of the circumference of the shaft taking an irregular shape, caused by propagation through areas of lesser or greater resistance, ultimately leading to the breaking of the shaft.
