Analysis and management of avariation to a fluvial transport vessel caused by collision

Abstract. In general, the body of the ship is a welded metal structure made up of the shell and bone. The paper aims is to analyze and present the solution for the collision damage to a river transport vessel. The problem is treated as in the case of a typical failure of welded constructions. In this regard, the fault will be described, after which the stages of the fault remedy will be presented.

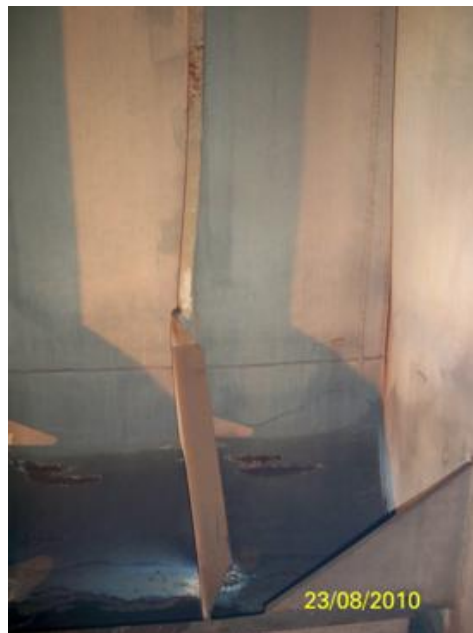
The weakening of the longitudinal resistance, by deformation of the blade, affects the body of the ship, considered a beam on the elastic medium (water). This weakening of the longitudinal resistance can cause the body to break in two loading and transport conditions.

The deformation of the blade in the area of the shell and the bottom of the vessel can be seen in Figure 3.

Figure 3. Deformation of the blade in the shell and bottom of the ship

- Transition and removal of the transverse blade in the area of the shell, on 4 ribs. The blade in the area is made up of the HP 120x8 profile. Replace the profile at a height of 1.75m.

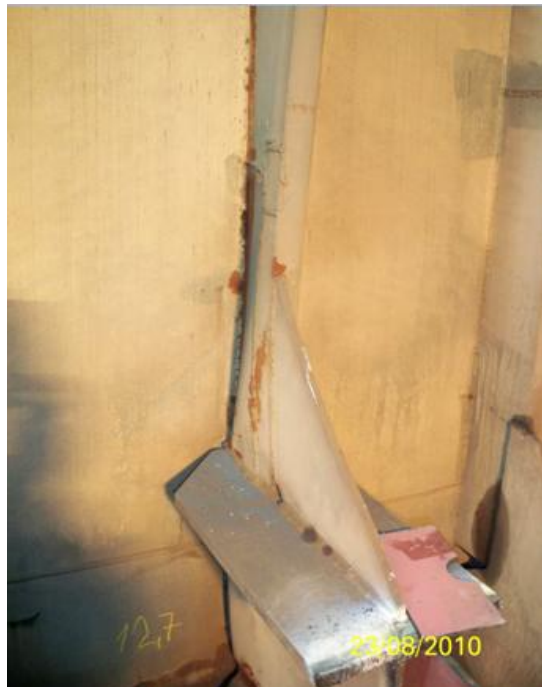
Figure 4. Cutting and removing the portions damaged in a varanga - heart and payment

- Ting and removing a portion of the reinforced blade from the bottom and the gourd: for four varges the heart is cut, the thick sheet. 8, on an area. of 1250 x 600 mm and cut out the 120x10 payload on a 1400 mm vario length, as shown in Figure 4.

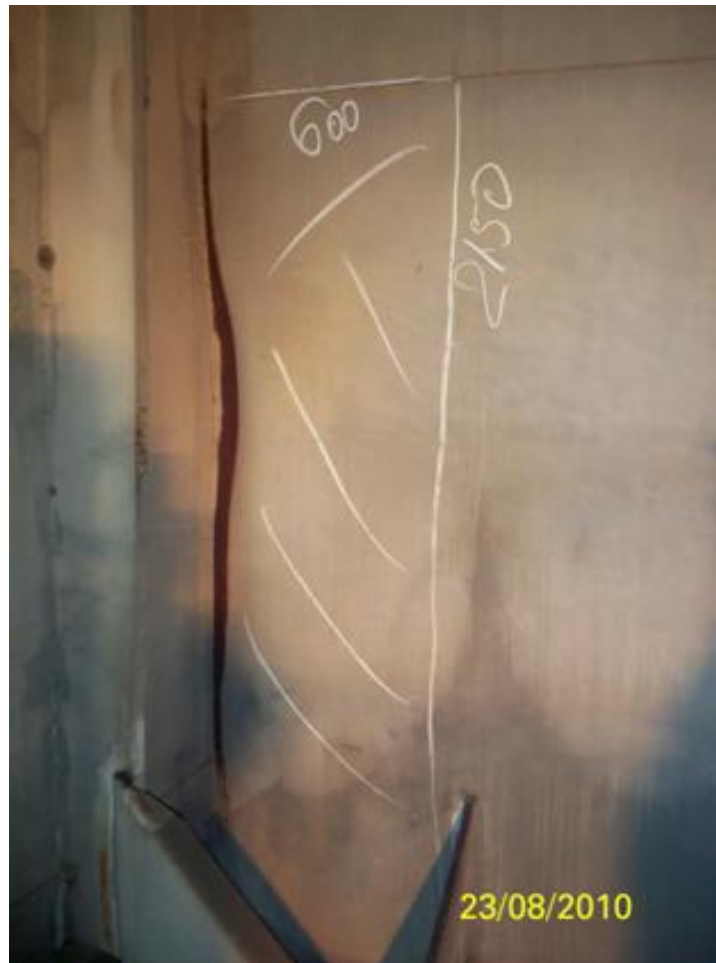
The damaged area of the sheat metal of the transverse wall can be seen in Figure 5.

Figure 5. Damaged area of the transverse wall board

- The removal and removal of a watertight cross-section of the wall, which has suffered deformations, the dimensions being 2150 mm, height and 600 mm width, the sheet having 8 mm thickness, as shown in Figure 5.

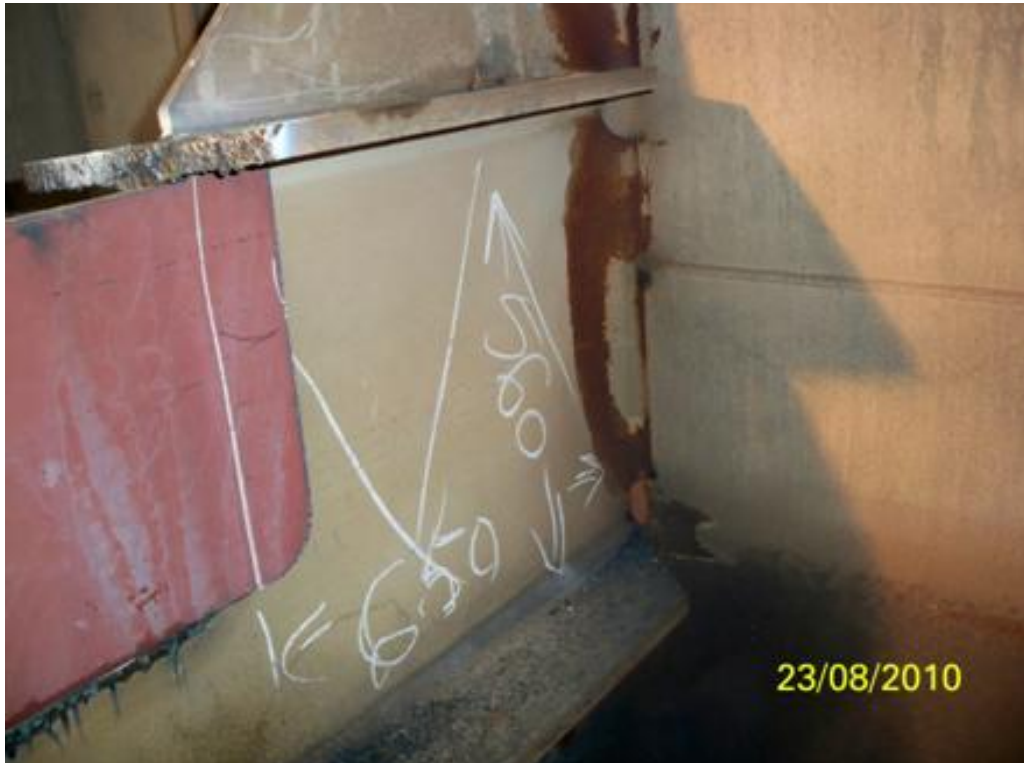
Figure 6. Sheet insertion in the heart - the heart plate

Figure 6 shows an insertion of blackboard in the heart.
