SEISMIC RISK ASSESSMENT OF HISTORIC CONSTRUCTIONS: COMPARATIVE ANALYSIS OF MASONRY AND ADOBE CHURCHES IN ITALY AND CHILE

Daniela Díaz Fuentes^{*1}, Michelangelo Laterza¹ and Michele D'Amato¹

¹Department of European and Mediterranean Cultures, University of Basilicata, Via Lazzazera, Matera, Italy.

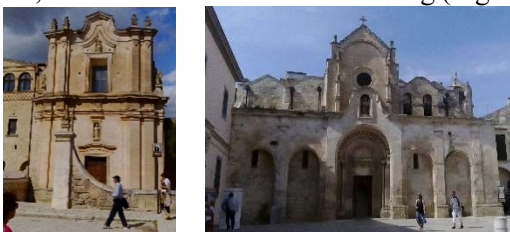
Figure 1. Churches of Sant'Agostino and San Giovanni Battista, Matera, Italy.

In terms of vulnerability, the Italian churches present: an asymmetric floor plan, large openings in the façade, slender walls, openings near the edges of the structure and stone vaults which cause thrusts in the aisle and apse. Regarding the LV1 method, the vulnerability index of Sant'Agostino is 0.55 and of San Giovanni is 0.49. The most vulnerable collapse mechanisms were the apse overturning and the damage at the top of the façade respectively.

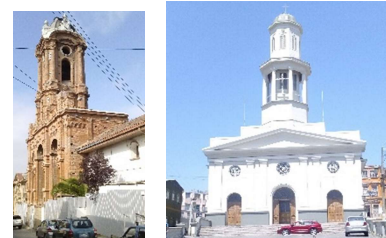
Figure 3. Churches of San Francisco Barón and La Matriz, Valparaíso, Chile.

As regards the churches in Valparaíso, they present an asymmetric floor plan, a high bell tower, large openings in the aisle and openings near the edges of the structure. In the case of San Francisco Barón, the loss of the roofing and the wood columns left the church incapable of developing a box-behavior and exposed to weathering. Concerning the LV1 method, the vulnerability index of San Francisco Barón is 0.75 and of La Matriz is 0.43, and in both churches, the most vulnerable collapse mechanisms were the bell tower and the bell cell.

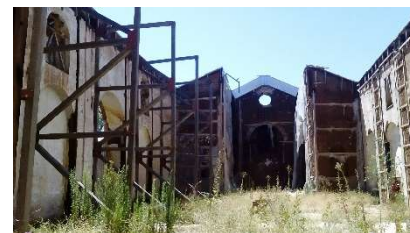
The church of San Francisco Barón was consolidated in 2012 with a wooden structure within the adobe walls. Since then, two fires have burned this structure, the roof and the wooden columns, leaving the church in a state of ruin (Figure 4). The adobe walls keep deteriorating due to weathering, and there are collapses near the apse.

Figure 4. Interior of the church of San Francisco Barón, Valparaíso, Chile.
