*Treto bridge.*

## Treto Bridge Refurbishment (Cantabria, 1905-2016)

### ABSTRACT

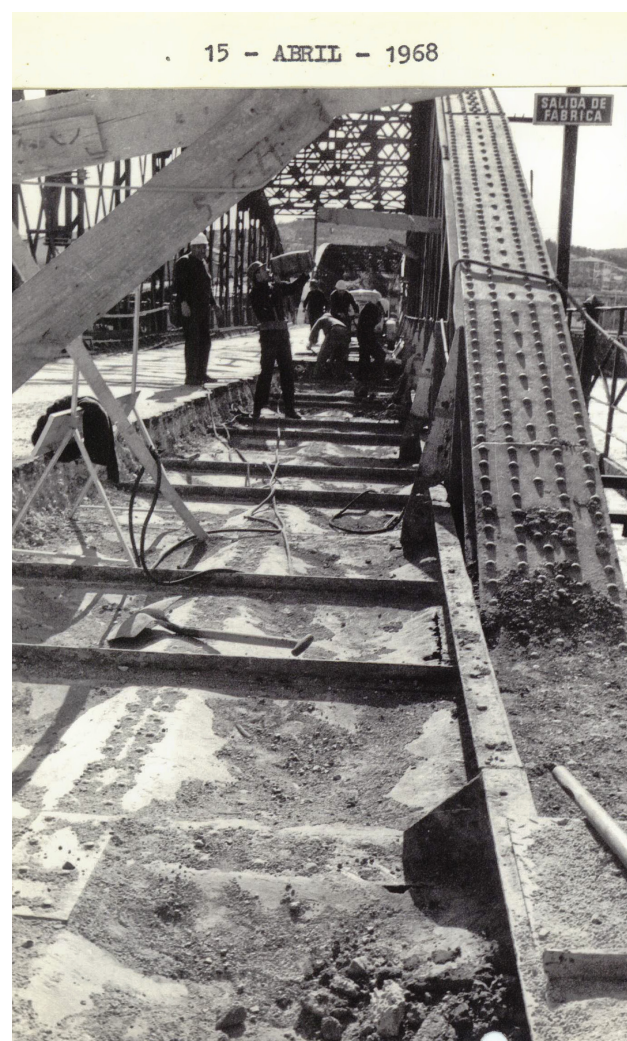
It analyzed for the first time the conditions of resistance and stability and looked for a solution to reactivate the turn of the mobile section, although finally it was blocked. To know the resistant characteristics, a load test was carried out, and it was observed that in all the sections the deflection produced (3 mm in the mobile and 12.5 mm in the fixed ones) recovered completely, from which it was deduced that the stresses were in elastic period. A chemical analysis of the steel of the bridge determined that the material was easily weldable by any procedure, and thus all the unions intervened, of more than half, were repaired. The stiffness of the diagonals was also increased by welding them a metal sheet because they were considered to be very slender and, in addition, they produced a lot of noise when the vehicles passed, causing them to vibrate and clash. The broken vaults were reinforced by adding pieces of sheet metal. And the slab made of planks of the board was replaced by another one made of steel sheet, and the sidewalks also of wood by others of 8 mm fluted sheet with an asphalt layer. The drainage was also improved and the entire metal structure was painted. The trace of this intervention has been observed and valued in the current intervention.

Figure 3.  
*The repair of the year 1968*

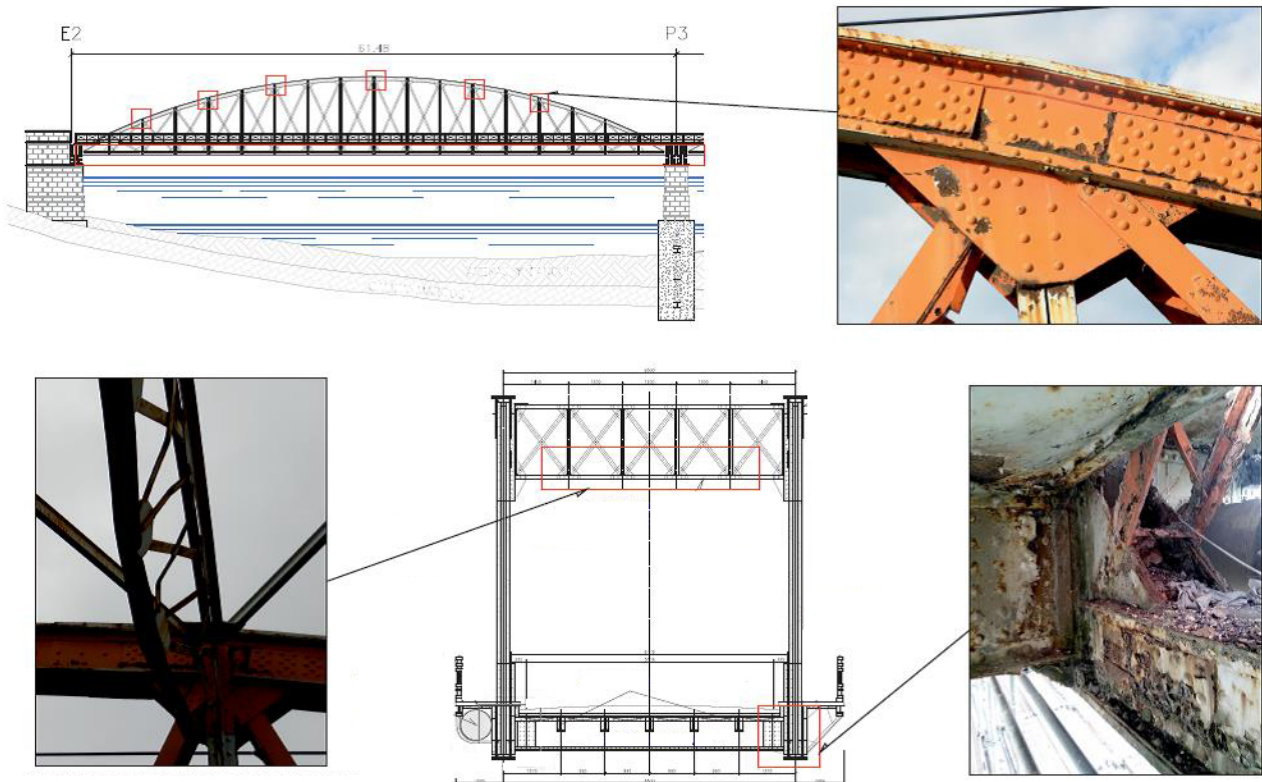
- Corrosion, up to breaking, in numerous elements of the structure, highlighting the connections between upright and diagonals, between ties, between joists and main beams. It is a generalized damage caused by the deterioration and / or absence of surface protection, and serious because it endangers the safety of inaccessible pieces. At the meeting points of the elements,

water accumulates easily, which intensifies corrosion, deteriorating the rivets and gussets and decreasing the strength of the joint. The same and with similar consequences has happened in the metal sheets that make up the support slab of the padding of the platform.

Figure 4.  
Corrosion in metallic elements. Situation of the arch.

After the removal of the material and the encapsulation, a new visual inspection made it possible to evaluate the remaining thickness of the steel and calculate the reinforcements needed to restore the resistant sections, both of the fixed and mobile sections. Packs of sheets capable of transmitting loads were formed, replacing the section of steel lost by corrosion. In order to form these packets, it was necessary to remove pre-existing sheets that prevented access to untreated layers, and to clean and treat them before placing the new ones. The sanitization consisted of a superficial cleaning by mechanical means and the application of Sigmafast 20 which is a primer based on alkyd resins modified with zinc phosphate. The new sheets, after being treated with blast and Sigmacover 280 primer, were put into operation.

Thus, all the lower knots of the transverse-tie and lower-upstright were reinforced in the fixed sections of the arches, as well as 32 upper knots in the upper-tie upstright connection. In the diagonals of the arches, all the unnecessary link lattices were removed, placed in previous repairs, getting back the transparency that it had in its original form. All upper bracing lattices between arches and 16 vertical struts have been replaced. In the case of the mobile section, the longitudinal beams and transverse beams have been reinforced.

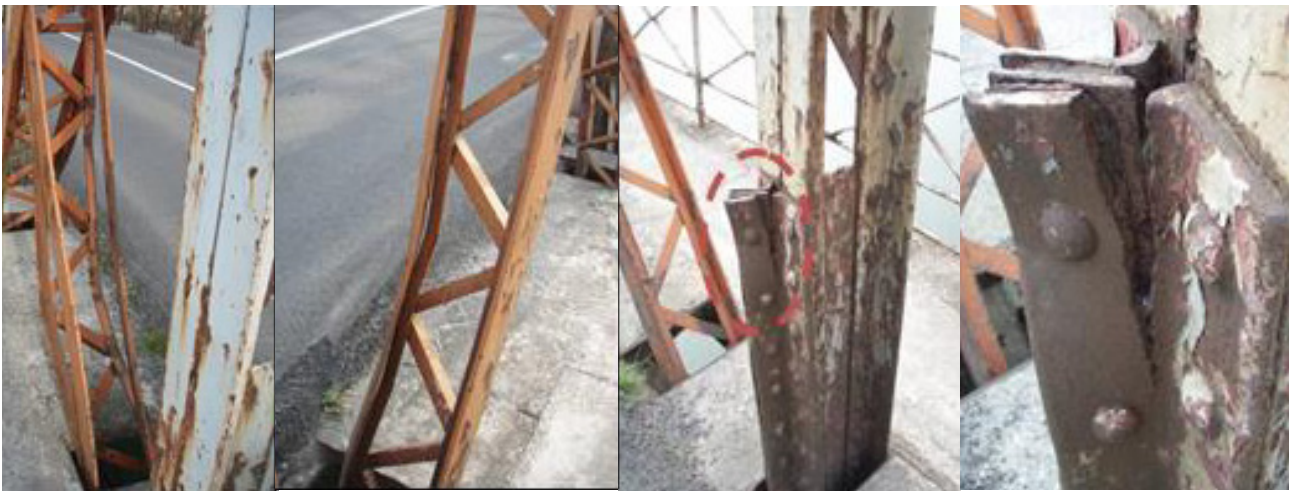
Figure 5.  
*Deformations and breaks due to impacts*

- Cavities in the floor, under the buttress.
- The damage caused by the use of the bridge are:
- Deformations in diagonals and upstright caused by vehicle impacts. The typology of the bridge, the scarce horizontal gauge and the absence of protection elements explain the numerous collisions that have occurred, leading to the breakage of elements (brackets, diagonals).
  - Bulges and displacements in masonry parapets of buttress.
  - Breakage of parapets and slab
  - Leaks

It has been verified the good functioning of the posts, which have not been replaced except those hit or those that have lost a lot of section. The lower part of them, usually deteriorated, has been reinforced by providing two "U" profiles in the anchoring areas of the transverse stringer.

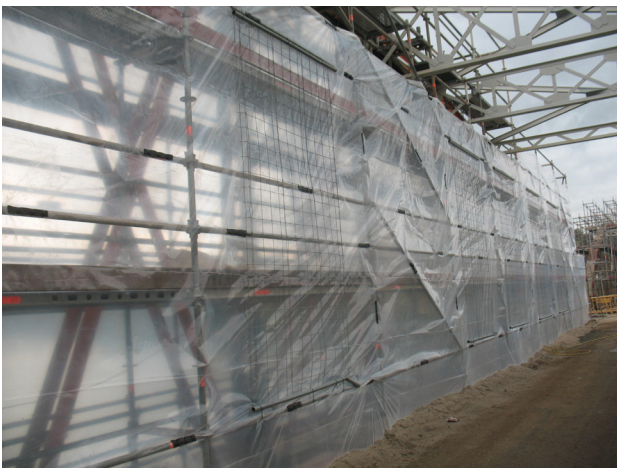
Figure 6.  
View of the encapsulated scaffold

For this, a scaffolding encapsulation system was designed, in sequential advance, consisting of an outer heat shrinkable plastic sheet that surrounds the scaffolding and a tarpaulin that wraps the upper face of the lower parts of the scaffolding, forming an enclosure to accumulate the waste generated in this cleaning operation<sup>14</sup>.

This system has revealed two advantageous evidences: one, that the material that forms the encapsulation allows to work in the interior with conditions of temperature and humidity adapted for the sandblast tasks and first primer, and another, that the control on the waste generated is optimal, both in its deposit and extraction.

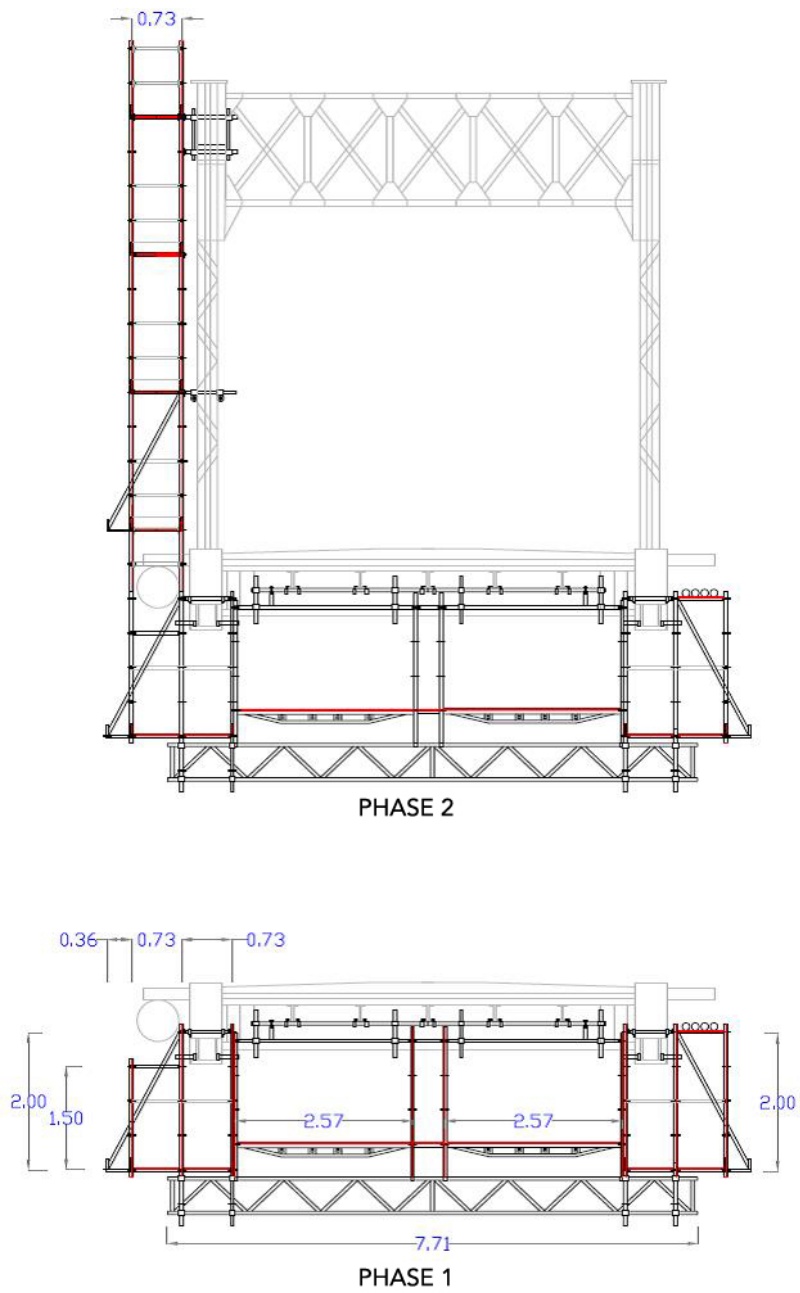
Figure 7.  
Modular scaffold Allround System by Layher

It was necessary to have a working platform under the bridge deck, which was made using modules of the Allround system by Layher. It was placed suspended from the deck by vertical tubes and anchored to it. It configured a scaffold that in addition to the suspended platform had four levels of modules placed on the outside of the arches.

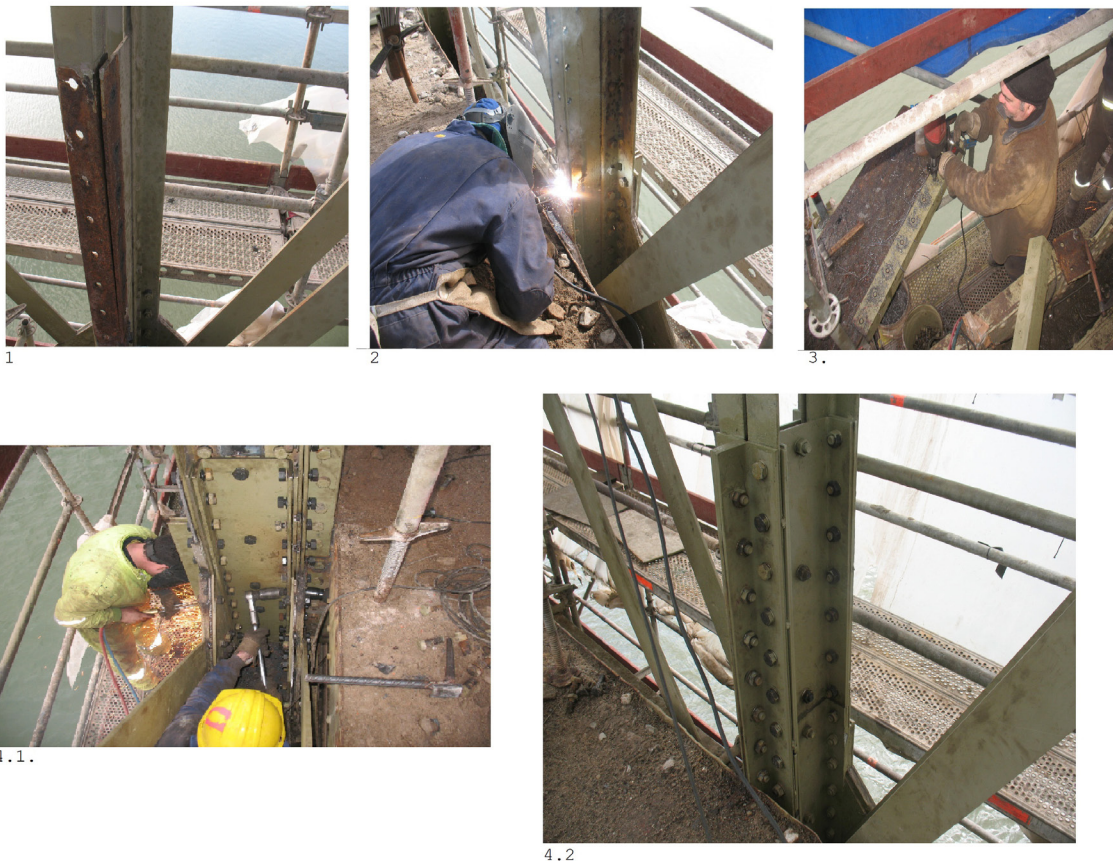
**Figure 8.**

*Angular reinforcement process: 1. removal, 2. installation, 3. welding, 4. strengthening parts*

All the metallic elements have been joined to existing ones by means of high strength screws, as well as lost, broken or loose rivets. In total, 22,000 rivets have been removed, replaced by as many screws, longer (Standard 14399-4) because repairing the thickness of the sheet packs is increased.

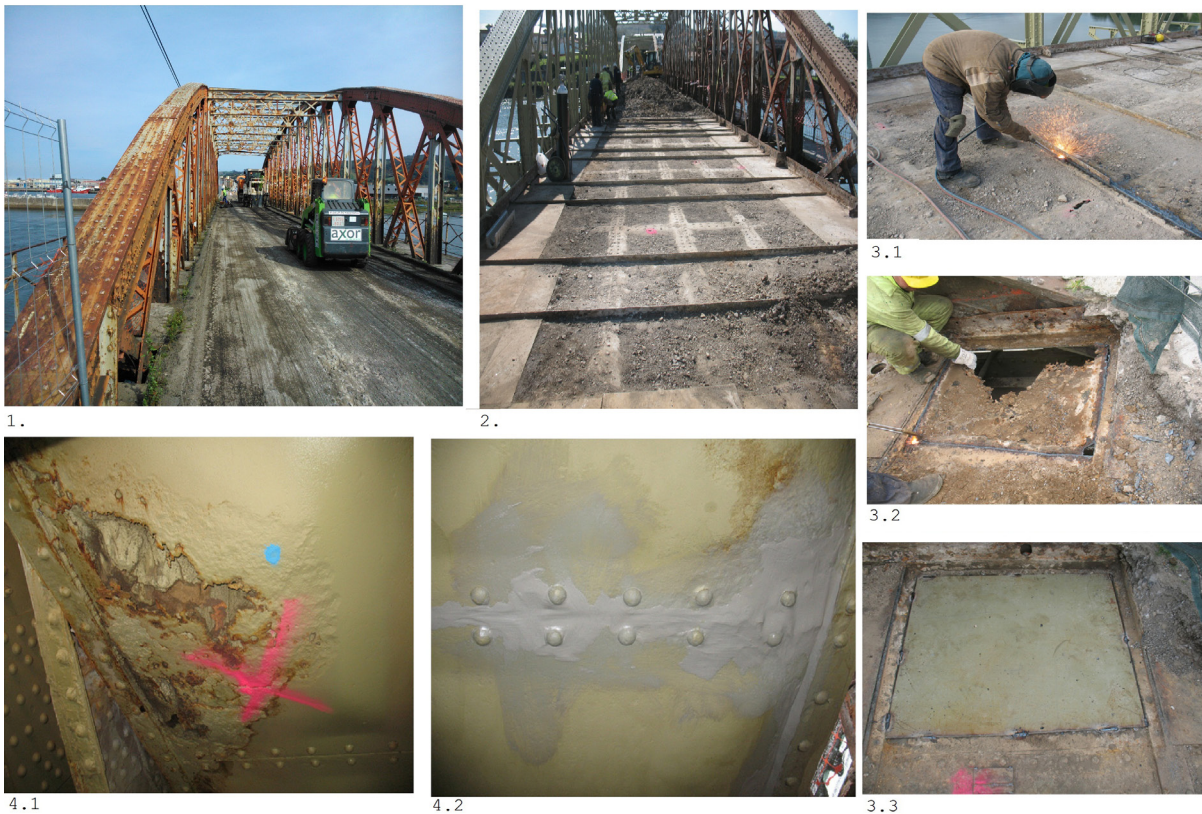
**Figure 9.**

*Deck repair process: 1. 2. removal road surface, 3. 4. replacement and/or repair of small vaults*

The actions on the platform began with the elimination (up to 44 cm thick) of the existing agglomerate on the metallic vaults (8 mm thick sheet) that make up the framework between transverse and longitudinal beams of the deck, which constitute a typological

singularity of this bridge. After the milling of the entire layer of the firm, the slab of the fixed sections of the bridge was analyzed. Based on the results of the structural analysis, a reinforced concrete slab (HA30 / B / 20 / IIIa) with nominal top face coating of 35 mm and a crack opening limit of 0.2 mm was executed. The slab is placed concreted on the original vaults and works without connection to the metallic structure except for the head of the transverse beams to which it is connected by two rows of connectors.

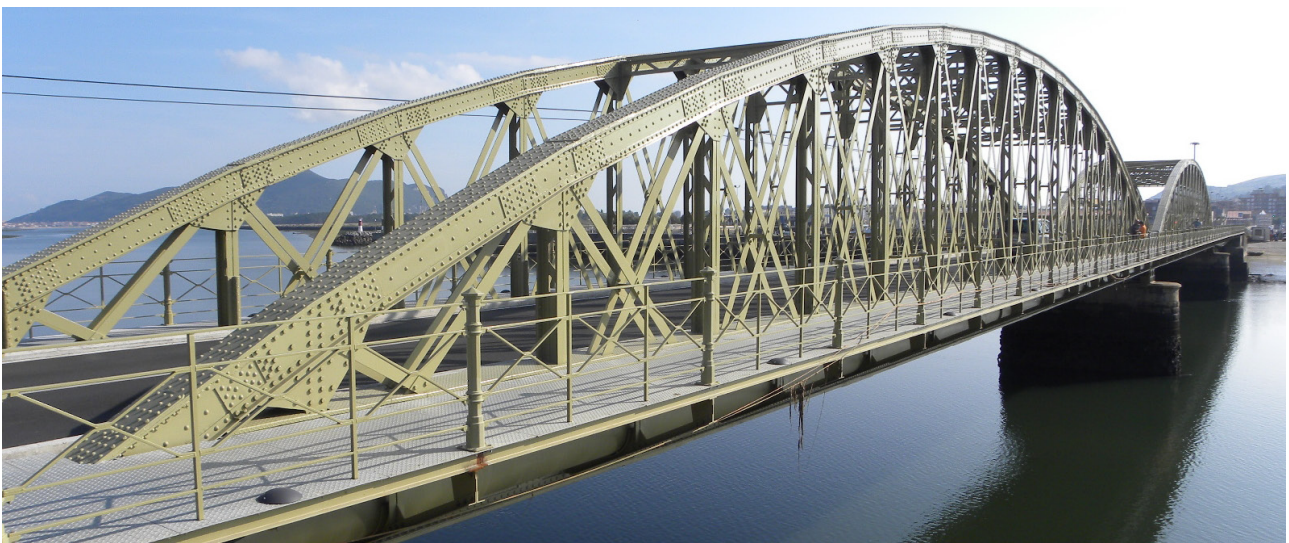
Figure 10.  
Current status of the refurbished stretches

The entire surface of the sanitized metal structure has been protected with a coating system resistant to the marine environment, with thickness between  $280\mu$  and  $400\mu$ , which involves the following steps: sealing of the joints capable of retaining water by means of a sealing bead and a thixotropic adhesive, a component based on polyurethane, of permanent elasticity and fast curing (Sikaflex 11FC); to improve the appearance of the surfaces, thicknesses are recovered with a special putty formed by a thixotropic structural adhesive, bicomponent based on epoxy resins without solvents and selected fillers (Betopox 920P Propamsa); degreasing with application of a solvent and cleaning with absorbent rags of the residual cutting oil and burned areas; mechanical and manual brushing of the welds, returning to sandblast the rusted areas and repainting; To eliminate the

The application of the paint has differentiated the areas below and above the deck, according to EN ISO 12944-5 which in addition to requiring a high life expectancy, considers the part on the industrial category deck and part under marine category deck. In the former (C5-M, life expectancy > 15 years), a high-thickness polyamine adduct epoxy two-component coating between  $150\mu$  and  $200\mu$  (Sigmashield 880) was used; and in the second (C5I, life expectancy > 15 years) two coats of epoxy primer of  $70\mu$  (without solvent cured with polyamine, Sigmacover 1500) and  $60\mu$  (with zinc phosphate of two components and high solids, fast curing and recointable low temperature, Sigmafast 278); and two other layers of  $50\mu$  each of acrylic aliphatic polyurethane (Sigmadur 550). This system of painting has been chosen to temper corrosion as effectively as possible, given the evidence that this deterioration process has been the main cause of the poor condition of the bridge.
