DISMANTLING AND RECONSTITUTION OF PRASAT SUOR PRAT, ANGKOR THOM, CAMBODIA

This paper presents a geotechnical aspects of dismantling process of one of masonry towers named Prasat Suor Prat that had been constructed in the end of 12th century during the Angkor Period in Cambodia. A series of 12 towers had been constructed from south to north along the east side of Royal Plaza in Angkor Thom.

One of the towers, named as N1 Tower, was found badly displaced with inclination of about 5 degrees to the north-west and horizontal spreading at the foundation level. The Tower was dismantled before restoration work by JSA (Japanese Government Team for Safeguarding Angkor) to study possible mechanism that had caused inclination of the Tower and horizontal spreading of stair stones. Dismantling upper structures as well as foundation mound were performed by archaeological trench. The trench had revealed the mechanism of deformation of the structure as well as foundation. Before the dismantling, was the inclination caused by tilting of the foundation mound caused by general sliding failure of the foundation towards adjacent pond. However, it was revealed that the mound was not tilted but kept hor

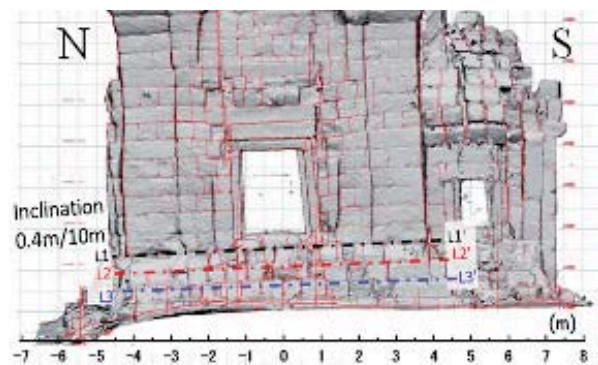
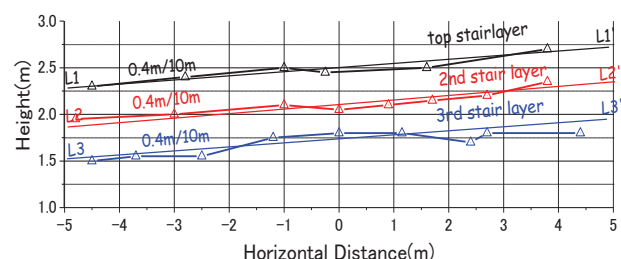
Fig.7 Inclination of step stones at the west side, N1 Tower

Fig.7 also shows contour lines of equi-settlement relative to the south-east corner of the foundation.

The horizontal line of side face stones of foundation mound was inclined to northwards. The levels of upper surface of the top (L1), the second (L2), and the third (L3) lines in the upper part of Fig.7 were measured at several points and plotted in the lower part of Fig.7. The inclinations of these side stones of the foundation mound were found about 0.4m per 10m of horizontal distance. The inclination of the foundation as well as upper structure suggested that the inclination of the Tower might have been caused by such ground deformation as sliding failure.

from Main Tower and Antechamber. The bottom level of the upper structures was the same level of top level of side step stones. As already stated, the top level of step stones had inclined to northwards with settlement of 0.4m for horizontal length of 10m as shown in Fig.7 and also indicated in Fig.8 as well.

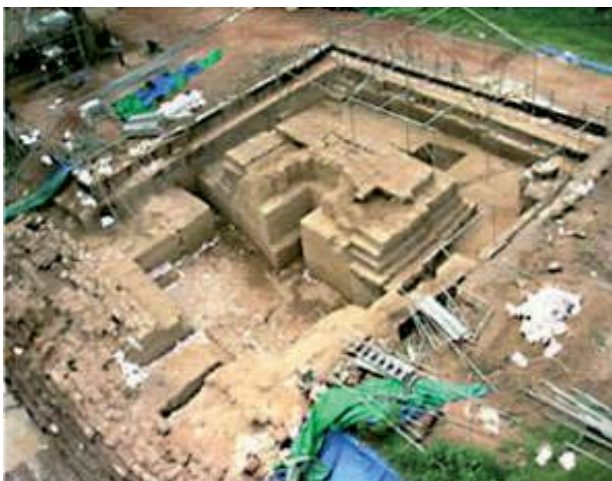
Photo 4. Archaeological trench at N1

Photo 4 shows the trenched site of N1 Tower of Prasat Suor Prat, where vertical section was exposed.

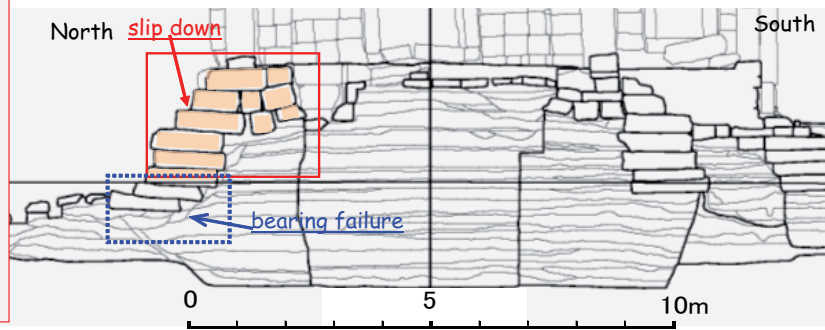
Fig.9. Mode of failure of step stones at the north side

It is estimated that the bearing failure at the base had been the initial step of the failure that caused to drag the upper step stones to slip down as shown in Fig.9.

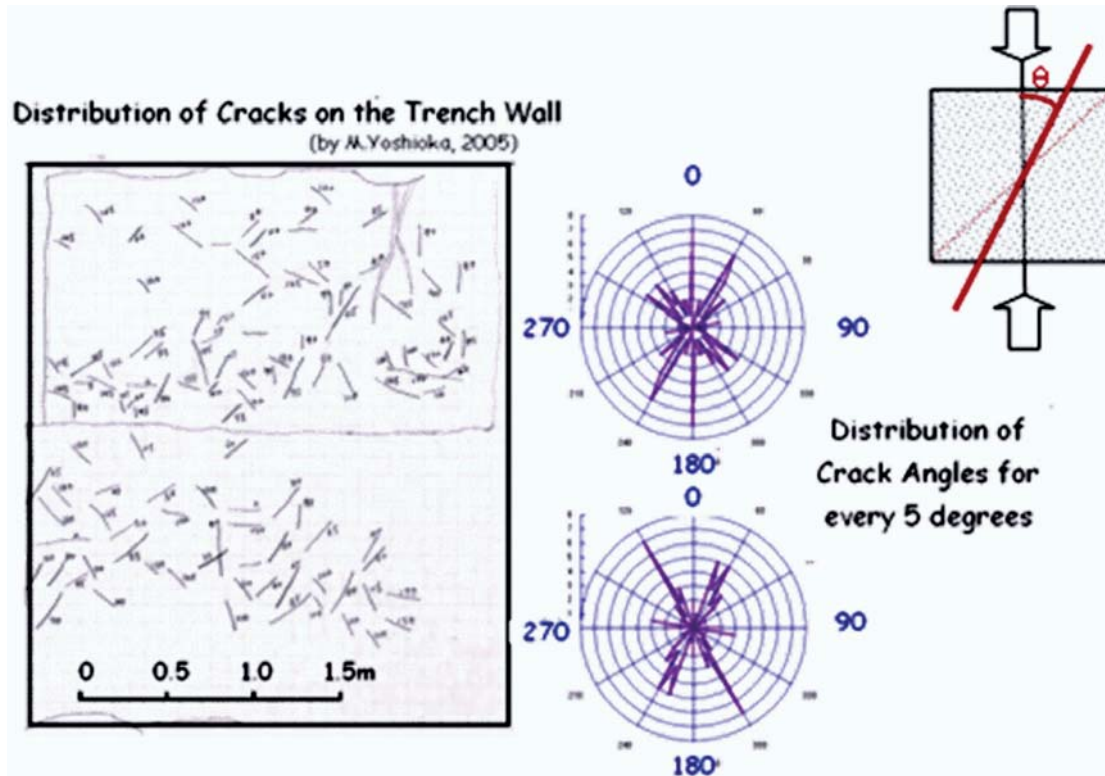
Fig.11. Sketch of streak lines in the section shown in Fig.8

The area shown in Fig.8 was further divided into two sections of upper and lower part as shown in Fig.11 and the distribution of the angle of streak lines were analyzed and the distribution patterns of the angles of streak line from the vertical line are plotted in Fig.12. The strong tendency of the angle of 30degrees from the vertical direction was obtained, which suggests the streak lines correspond to shear surface under failure.
