The value of multiple earthquake missions: the EEFIT L'Aquila Earthquake experience

Keywords L'Aquila Earthquake · Field survey · Strong ground motion · Building damage · Return mission

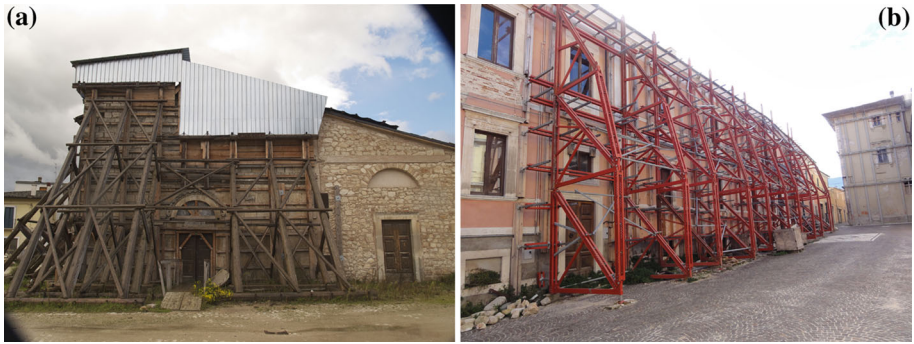
Fig. 1 Shoring system made of **a** wooden and **b** steel trusses used to prevent out of plane failure of masonry walls/panels

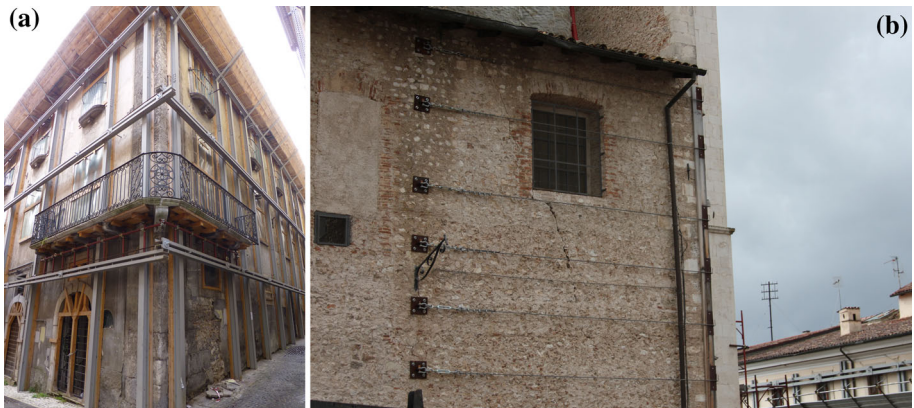
Fig. 2 Shoring system made of **a** steel frame to prevent combined mechanisms or overturning of the top floor and **b** steel cables, to prevent in plane failure and overturning of the corner

The most extensive post-earthquake deployment of temporary works in L'Aquila are shoring structures, since overturning of masonry façades (or parts thereof) is the most commonly observed failure mechanism (Modena et al. 2010). Safety interventions for this failure mode are seen to involve traditional wooden or steel truss systems (Fig. 1). The struts and ties form a buttress that prevents the overturning of the entire façade. The trusses are connected transversally and braced to prevent buckling and create a spatial truss. The possible effect of hammering between the façade and the shoring system, which may be triggered by aftershocks, is prevented by anchoring the top of the propping system to the wall, and the base to the foundation of the wall or to an independent system able of resisting the seismic load. A second system, made of vertical steel posts and horizontal ties is used extensively when floor structures have detached from façades and these show a crack pattern consistent with in-plane failure. Variations on this system comprise horizontally laid wooden planks, polyester straps or steel cables which wrap around the building with the aims of confining the masonry of the façade and of anchoring it to orthogonal walls (Fig. 2). The example in Fig. 2a is more appropriate when the connection between adjacent façades needs securing or when a combined mechanism causing out-of-plane failure of the façade and in-plane failure of its orthogonal walls is present. The steel cable system shown in Fig. 2b is suitable for

restoring the box behaviour of buildings with corner failures. In cases where the causes of failure are likely to comprise both in-plane and out-of-plane failures, a combination of the two shoring systems is required (Modena et al. 2010).

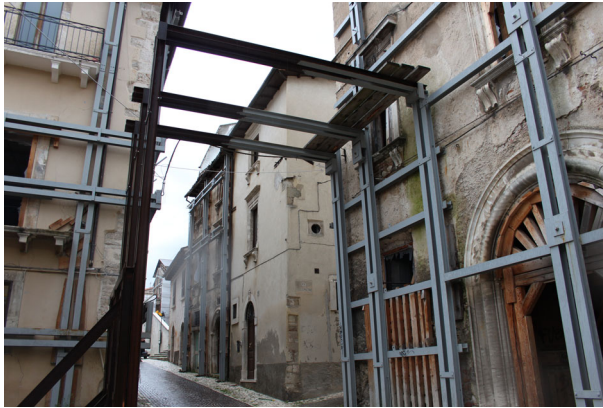
Fig. 3 Shoring system applied to buildings facing onto a narrow street

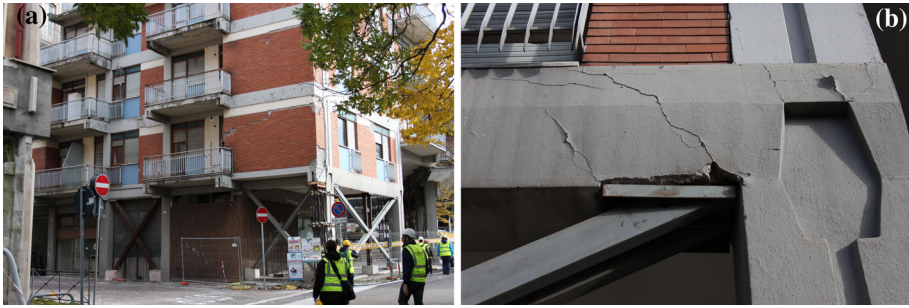
Shoring of existing structures was almost exclusively used for masonry structures, with very few observations of reinforced concrete buildings. It is considered that the primary reason for this relates to the number, vulnerability and historical significance of the masonry structures viewed. However, a secondary explanation relates to the inherent residual strength

Fig. 4 Shoring of a Reinforced Concrete structure to prevent soft storey collapse. **a** Building elevation **b** shoring bearing against existing structure

of reinforced concrete structures that are stable in the temporary condition but require retrofit to return them to full service. It should also be noted that severely damaged reinforced concrete structures had either collapsed or been demolished at the time of the EEFIT return mission.

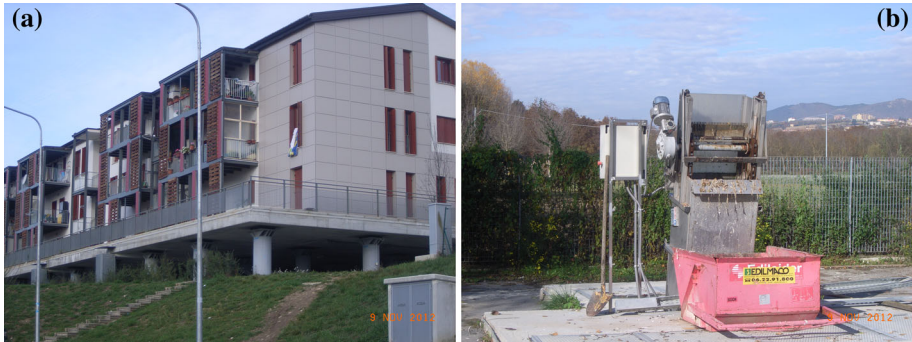
Fig. 8 Photograph of a C.A.S.E. building in the Bazzano site (a), and the inadequate sewage filtering site alongside the Aterno river (b)

The state of maintenance of the C.A.S.E. buildings remains adequate, but it is not clear how long this situation will prevail. Coppito 3 has landscaping problems, in that the state of maintenance of the public open space is very poor. When they were interviewed, residents complained about difficulties and delays in getting repairs done.

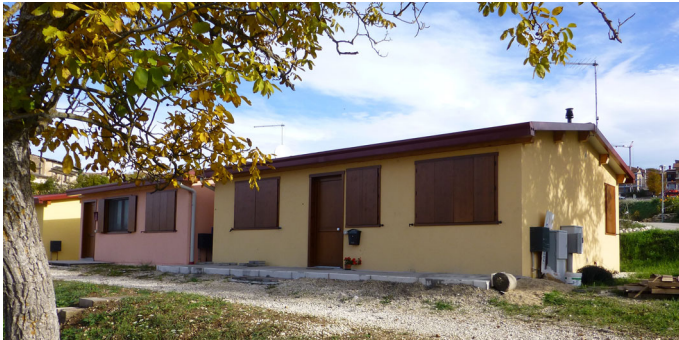
Fig. 9 Example of a MAP house in Fossa

maintenance problems (e.g. water infiltration) being observed at San Gregorio, where the quality of construction appears significantly worse than in Onna.

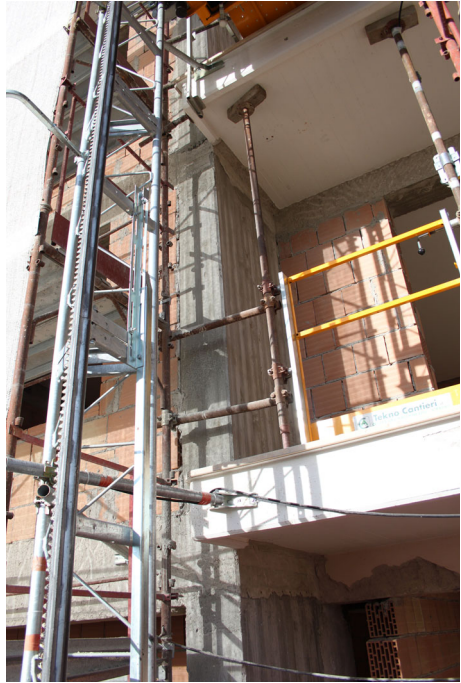
Fig. 10 Via Francia, Pettino.
Photograph of extended
perimeter column

Very similar repair and strengthening schemes were observed in the sites visited. In a typical retrofit observed in Via Francia, Pettino, perimeter columns were strengthened by increasing their depth from approximately 0.4–1.5 m over the full height of structure (see Fig. 10). Due to the cantilevering edge of the floor slabs, the face of the new column was flush with the slab edge. As the height to depth ratio of the column was approximately equal to two, the columns will behave as ‘ductile walls’—i.e. walls where the performance is governed by bending. Photographs provided by site staff suggest that longitudinal and transverse reinforcement provided in the column extensions were at close centres, at or

<100 mm, with longitudinal bars approximately 12–20 mm in diameter and transverse steel approximately 8–10 mm in diameter. Site staff informed the EEFIT team that the foundation ring and ground beams had also been improved as part of the works.

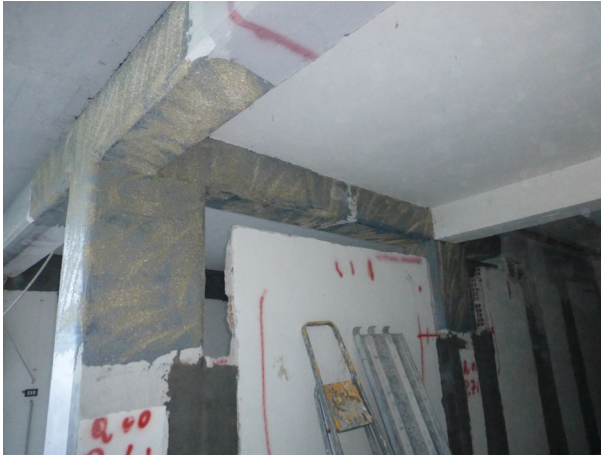
Fig. 11 Between Via Del Colle and Via di Strizzoli, Pettino. Beam/column joint strengthened with carbon fibre FRP. The image also shows that polypropylene mesh has been applied to connect the infill and columns

RC frame strengthening with FRP was almost universally adopted across retrofits and refurbishments visited, often in combination with the widening of columns or addition of shear walls. FRP was observed to be applied to beams, columns and beam-column connections to avoid brittle failure and improve ductility. FRP was also applied to beam-column connections to strengthen them against potential stresses imposed by infill panels (forming strut-like behavior in earthquakes). On apartment buildings, infill masonry panels were removed and replaced, with a polypropylene mesh fixed to beams and columns at edges to help restrain the masonry panel (Fig. 11). The aim of this modification was to prevent toppling of the panels, but not preclude damage.

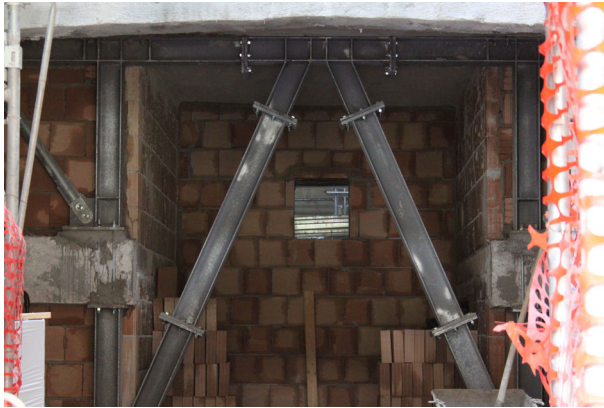
In a very few cases steel frames were observed to have been applied or base-isolation introduced. For example, a new steel frame was observed to be applied to the concrete frame of a five storey block of apartments in L’Aquila (see Fig. 12). Three identical apartment buildings in Pettino were demolished and replaced with new structures incorporating seismic isolation at basement level (Fig. 13a). The five storey reinforced concrete frames incorporate garage space on the ground floor, are infilled with clay bricks and are approximately 28 m × 14 m on plan. A grid of 6 × 4 concrete columns in the new basement support 24 ‘FIP Industriale’ base isolators (Fig. 13b). The base isolators support a 400 mm thick RC slab and are in turn supported by 1.5 m high concrete columns that are a cruciform shape on plan and sit on a 600 mm thick raft foundation. It was noted on site that the cruciform section provides good biaxial stiffness while maintaining room for inspection and replacement of bearings if necessary. The basement retaining walls had been detailed to accommodate lateral displacement using a ‘dog-leg’ gutter detail, with also a vertical gap of approximately 15 cm at the slab edge.

Fig. 12 Condominio Vico Picenze, L’Aquila. Retrofitted steelwork observed from the site boundary

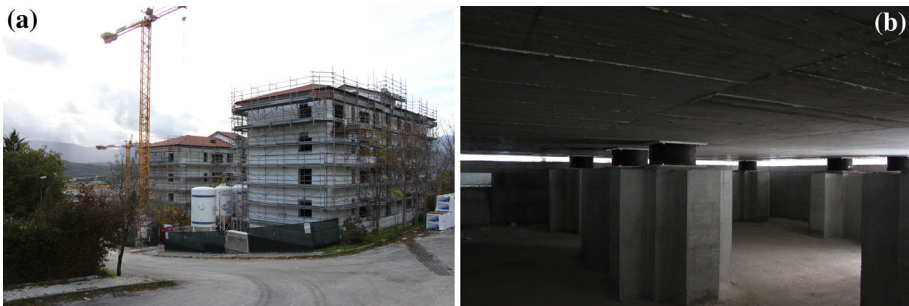
Fig. 13 Via Francia, Pettino. **a** Photo of the base-isolated buildings and **b** view of the base isolators in the basement

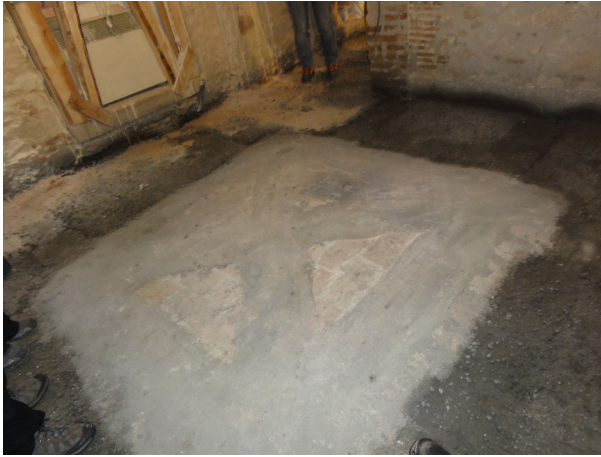
Fig. 14 reinforcement of a cross vault with strips of FRP laid at the extrados

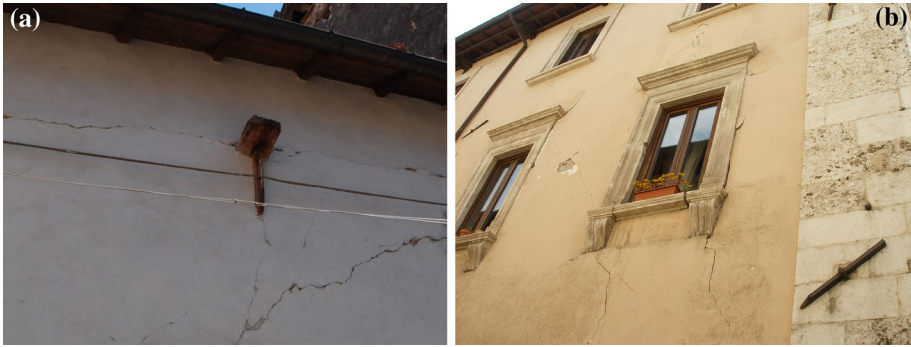
The Linee Guida (Circolare n. 26/2010) recommend the use of ties and anchors to connect vaults and timber floors to walls, and walls to walls. A thorough review of traditional and modern solutions, their effectiveness, shortcomings and possible improvement by use of dissipative devices is included in D'Ayala and Paganoni (2013) and some surveyed examples are illustrated in Fig. 15. In the few sites undergoing repair or strengthening at the time of the return mission, there was no evidence of such strengthening devices being implemented.

Fig. 15 Two examples of traditional reinforcement: **a** timber tie, **b** wrought iron cross tie inserted in a quoin

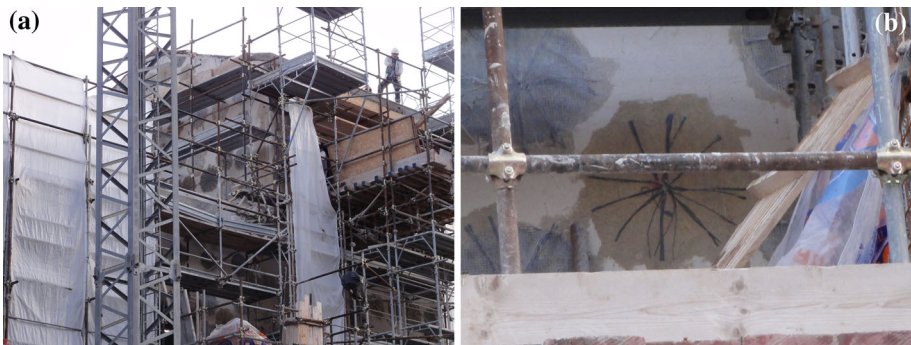
In the only on-going project seen during the return mission, it was noticed that transversal reinforcement was applied to masonry walls by use of FRP bars, drilled through the thickness and then anchored by opening the threads as a star (Fig. 16). In the Guidelines issued in 2010 (Circolare n. 26/2010) it is stated that “the use of reinforced cores should be limited to cases where there is no other alternative due to the extreme alterations and disturbance produced vis

Fig. 16 Extensive use of reinforced coring with grouted injection with epoxy resins on the end wall of a five storey residential palace in the historic centre of L’Aquila

a vis [its] doubtful effectiveness, especially in the presence of walls with several wythes not well connected. In any case the durability of the strengthening element, whether of stainless steel, composite plastic materials or other material, should be ensured and the grouts used should be compatible with the original materials”. Moreover it is advised that this type of intervention only has at best a local effect (Circolare n. 26/2010).
