An Investigation of Excessive Seepage from the Al-Fulaij Recharge Dam, Oman

Y.E.A. Mohamedzein*, S.M. Al-Hashmi and A.A. Al-Rawas

Department of Civil and Architectural Engineering, College of Engineering, Sultan Qaboos University, Muscat, Oman

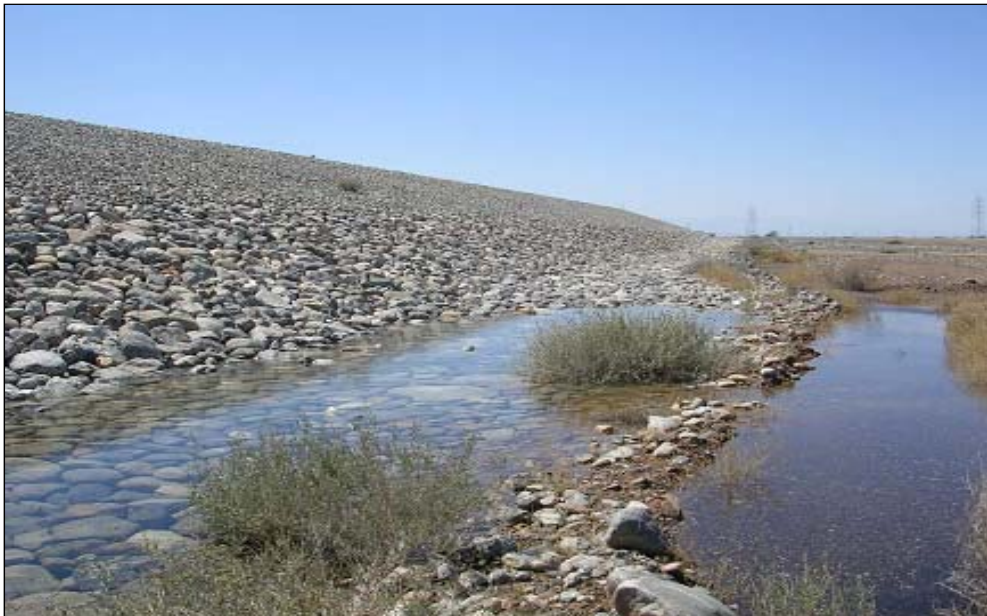
During floods, significant seepage has been observed at many points downstream of the dam (Fig. 3). As a result of the gypsum occurrence, numerous sinkholes, probably a few hundred within the reservoir basin just upstream of the dam, were formed. They are

Figure 3. Seepage from the dam.

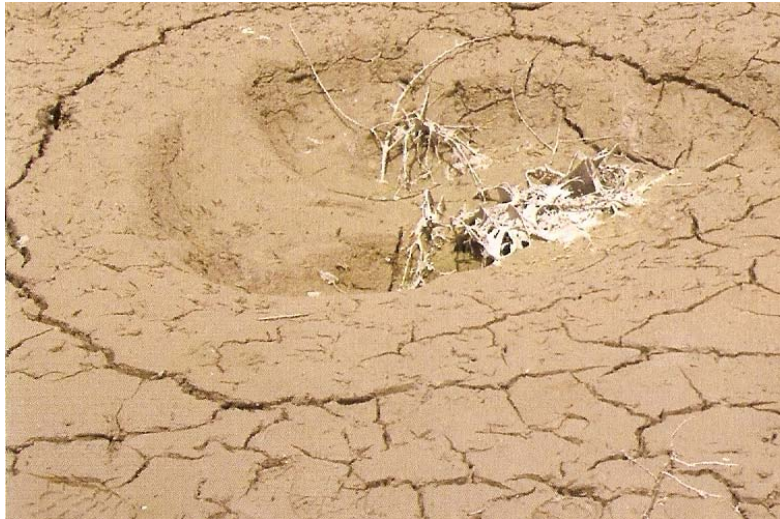
mostly circular but sometimes elongated, sinuous and channel-like (Fig. 4). Typically the sinkholes are 0.4–0.6 m in diameter with a depression of about 0.2 m deep, with the occasional sinkhole measuring 0.3–0.4 m deep (Binnie Partners Overseas Ltd. 2001).

Figure 4. A sinkhole in reservoir area about 40 m from the dam heel.

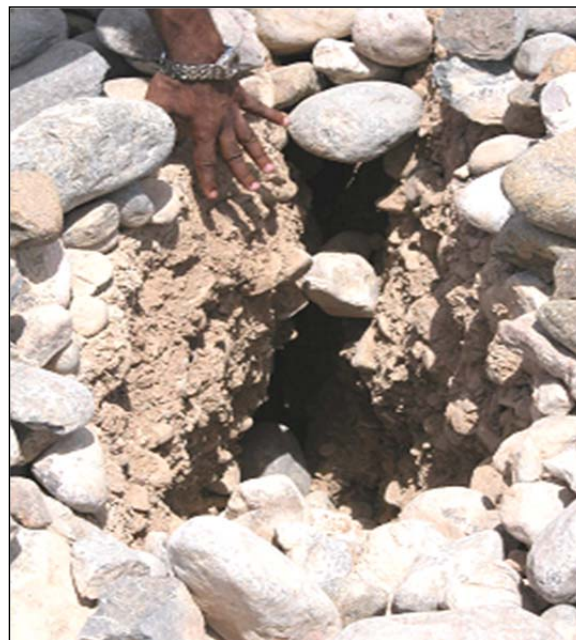
Figure 5. Crack in the crest of the dam at chainage 2+700.

A crack in the crest of dam embankment about 5–7 m long and 80–100 cm deep running parallel to the dam axis was also noticed at about chainage 2 + 700 (Fig. 5). The formation of this crack may have been due to some settlement in the foundation caused by gypsum leaching from the foundation.

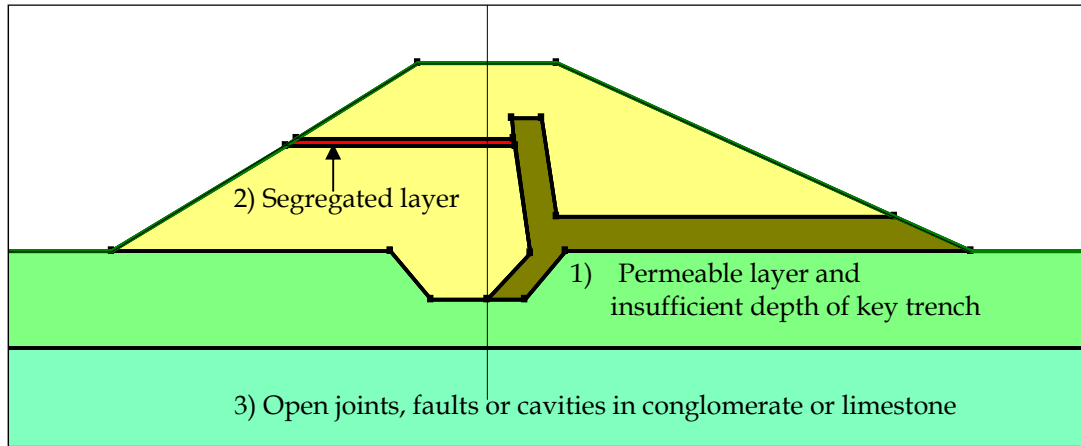
- The presence of a permeable soil layer beneath the dam as a result of gypsum material dissolution and the insufficient depth of the key trench.
- Seepage through the limestone or the hard strata as a result of cavities, faults, or open joints.
- Seepage through the dam body because of the segregated layers of fill.

Figure 6. Possible causes of seepage.

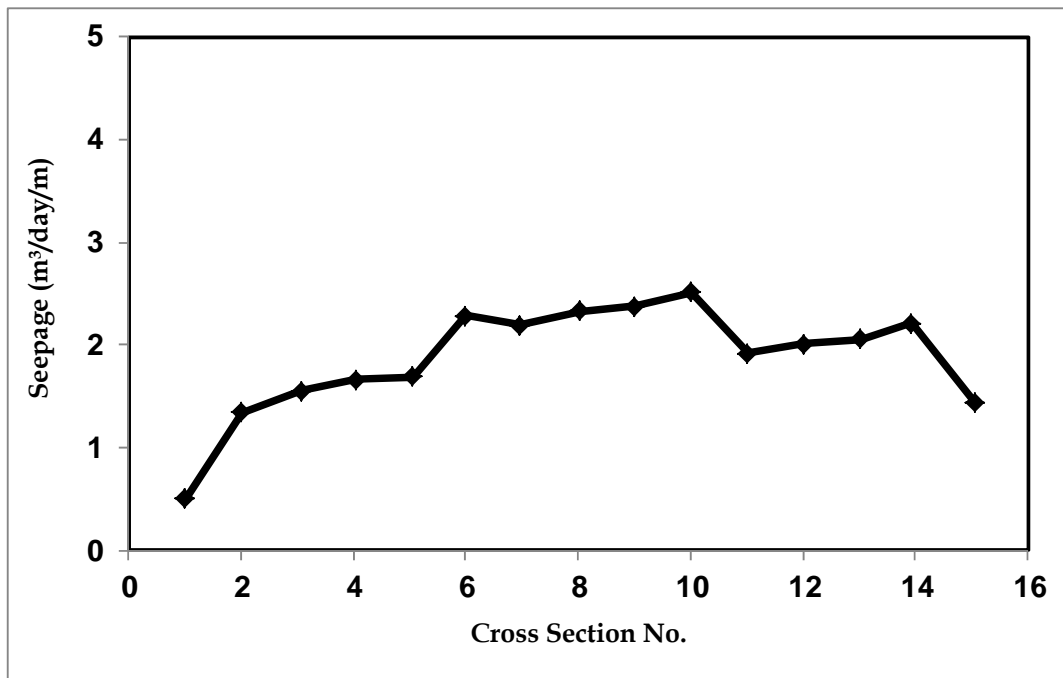
Figure 8. The seepage modeling results of the design case of Al-Fulaij dam.

The seepage modeling results of this case (Fig. 8) show that the seepage quantities of the design case range from 0.50–2.450 m³/day/m (total seepage 1250 to 6125 m³/day). During the impoundment, 5,000–12,500 m³/day of seepage was noticed per day. Based on this, trials were carried between 5,000 and 12,500 m³/day out using the modeling program to find out the corresponding k-value of the foundation

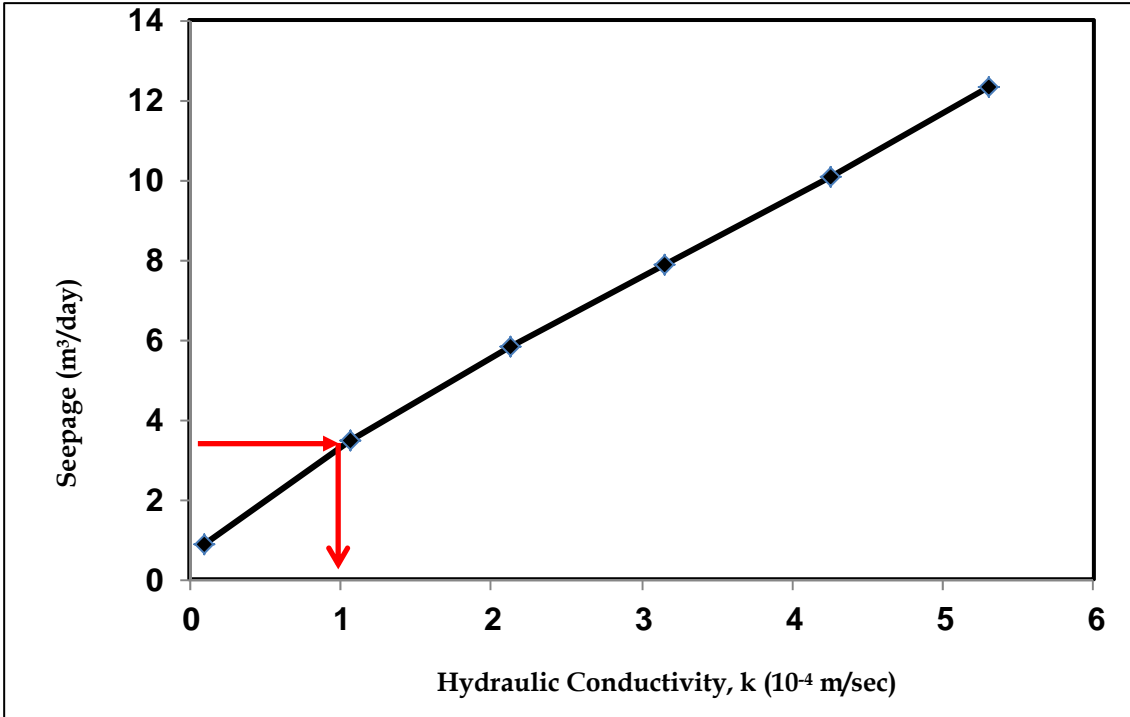
After conducting the trials, the average k-value was estimated at 1.00×10^{-4} m/s (Fig. 9). It is clear that the average foundation permeability was higher than the one obtained during the feasibility study. This is because the leaching process of gypsum material as a result of water flowing underneath the dam created voids within the dam's soil structure.

Figure 9. Trails to obtain the revised k-value of the foundation material.

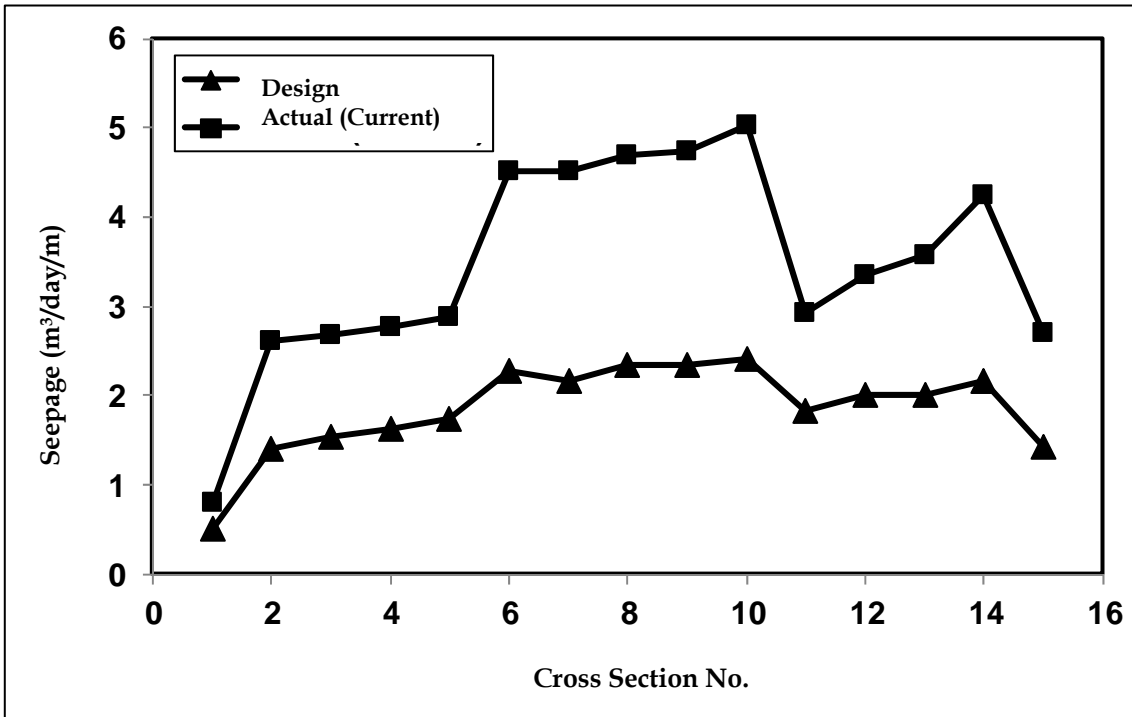
In this section, the actual case was simulated using the revised permeability value of the foundation material. The results that were obtained from the modeling of this case along with the design case are presented in Fig. 10. As can be seen, the seepage quantities of the actual case ranged from 0.85–5 m³/day/meter with a total amount of seepage between 2,125–12,500 m³/day, which is about double the seepage for the design case.

Figure 10. The seepage modeling results of the design and actual cases.

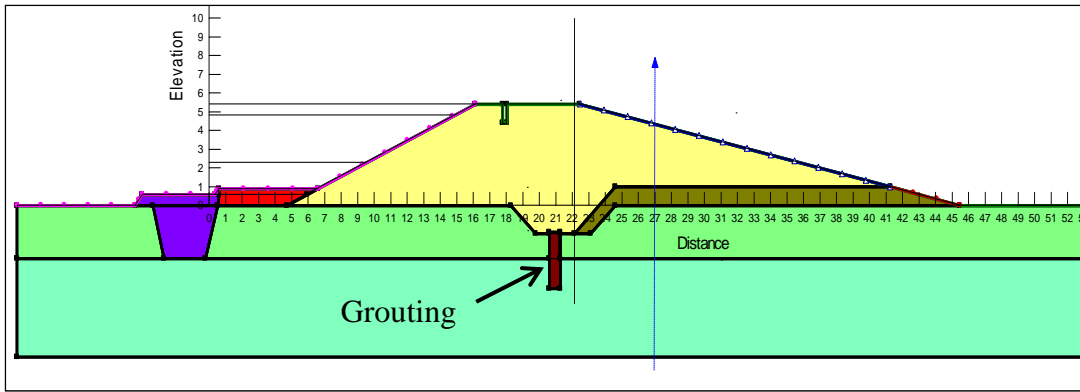
Figure 11. Grouting at the dam foundation as modeled in the program.

cutoff wall as shown in Fig. 11. The results of the dam modeling with the grouting curtain along with the current case are shown in Fig. 13, which demonstrates that the seepage quantities after applying the grouting range from 0.5–2.6 $\text{m}^3/\text{day}/\text{meter}$ (500–2,600 liters/day/m) whereas the seepage quantities of the current case range from 0.85–5 $\text{m}^3/\text{day}/\text{meter}$ (850–5,000 liters/day/meter). This shows 41–48% expected decrease in the seepage quantities. It is very important to mention here that grouting also has the advantage of improving the stability of the dam which is achieved by making the foundation denser since it will replace the materials which were washed away and prevent any depression or settlement of the dam foundation.

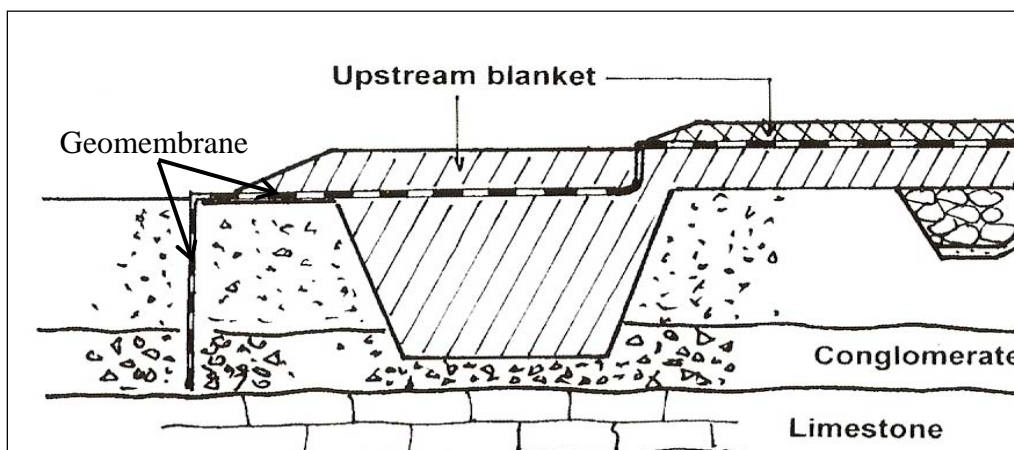
Figure 12. Dam with geomembrane.

A geomembrane can also be used to control seepage by inserting sheets of this material on the upstream face of the dam and extending it down to be anchored in the limestone (Fig. 12).

The figure shows the seepage profile of the dam when using the geomembrane. The value of hydraulic conductivity (k) used in the program for the geomembrane was 10^{-9} m/second. As can be seen from Fig. 13, the seepage quantities after installing the geomembrane range from 0.4–1.8 $\text{m}^3/\text{day}/\text{m}$ (400–1,800 liters/day/meter) whereas the seepage quantities of the current case range from 0.85–5 $\text{m}^3/\text{day}/\text{m}$ (850–5,000 liters/day/meter). This shows an expected decrease in the seepage quantities between 53–64%. This means that technically using the geomembrane is the best way to solve the seepage problem. However, from a financial point of view, this solution would be very costly because the installation process is very expensive and requires special techniques and care. The need to remove all the riprap and provide a smooth layer as well as supports will increase the total cost. Al-Hashmi (2010) presented a cost estimate for the two remedial options.

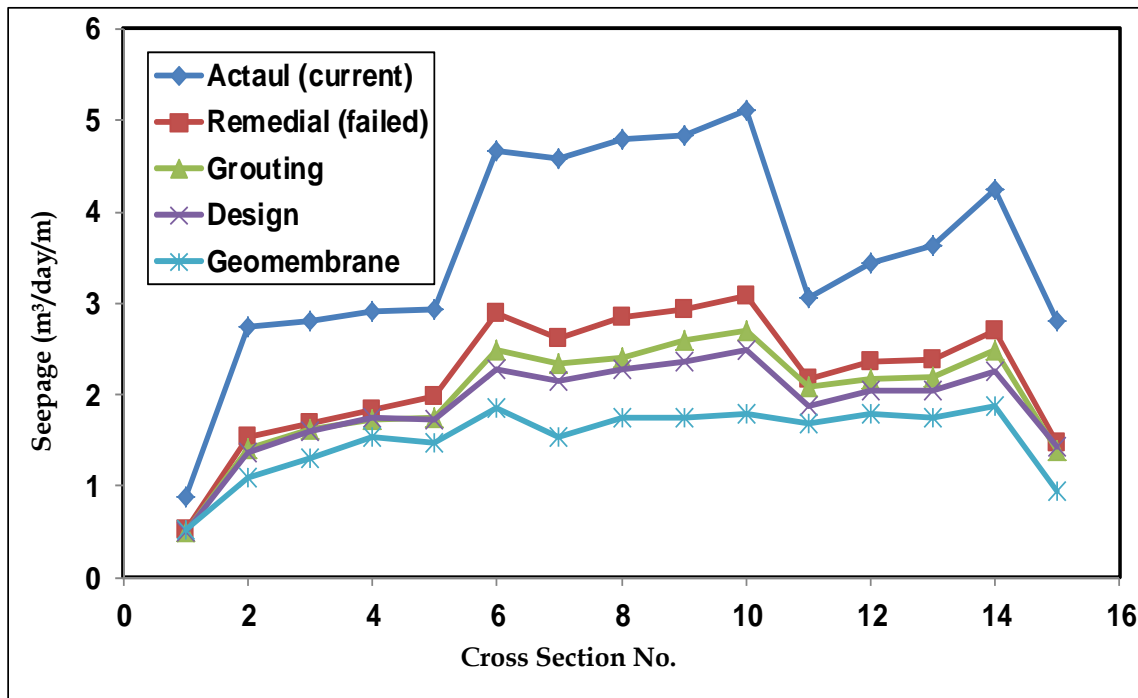
Figure 13. Seepage quantities profile of all cases.
