Case Report

Computed Tomography Scan and ICD Interaction

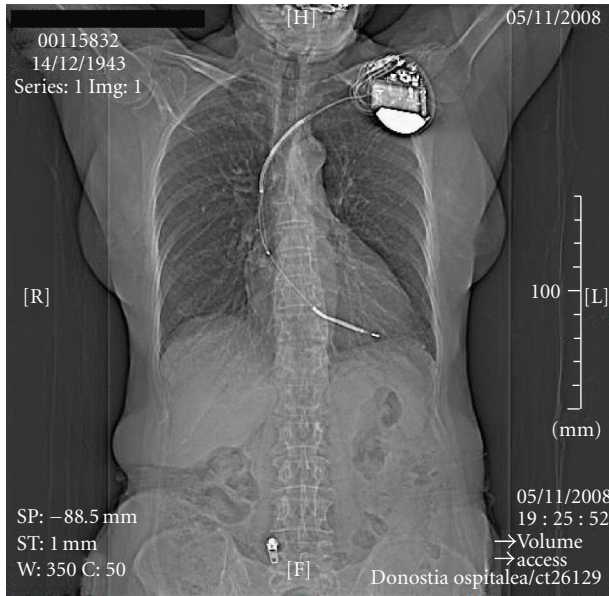
This exam was conducted with a CT Volume Access Somatom (Siemens Medical Solutions, Forchheim, Germany). The study began at 19 : 25 and ended at 19 : 34; it yielded 36 images in 6 series together with the initial topogram (Figure 1). No complications occurred during the exam and the patient was sent home.

FIGURE 1: CT topogram. Initial topogram of the scan, showing the implanted device in the left pectoral zone and both electrodes. Arrows: date and time of scan.

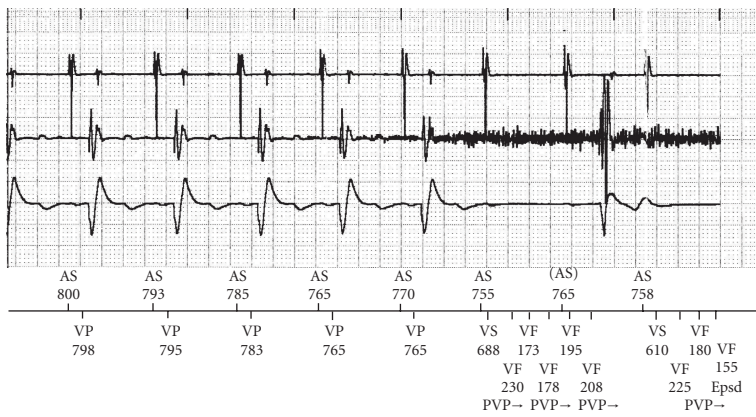
(a)

Analysis of the stored electrograms of the episode, which coincided with the time of the thoracic CT scan, reveals an oversensing in the right ventricular channel interpreted by the device as ventricular activity. The oversensing provokes the charge of the capacitors and at the same time causes significant pauses due to inhibition of ventricular pacing (Figure 3). The patient did not show any symptoms during or after the exam.

FIGURE 3: Electrograms of episode 460. Oversensing due to artifacts that start capacitors charge and provoke ventricular pacing inhibition.

Due to the coincidence in time of both and the absence of other known interference causes, we can conclude that the oversensing is caused by the CT scan.

- (i) Use the lowest possible dose of radiation and during the shortest possible time.
- (ii) Programme the device to “Off” (ICD) or in safety mode (pacemakers).
- (iii) Have a pacemaker/defibrillator programmer, an external defibrillator and emergency medication available.
- (iv) After the examination, reprogramme the device to “On” or back to the initial programming. Check the full and correct functioning of the device.

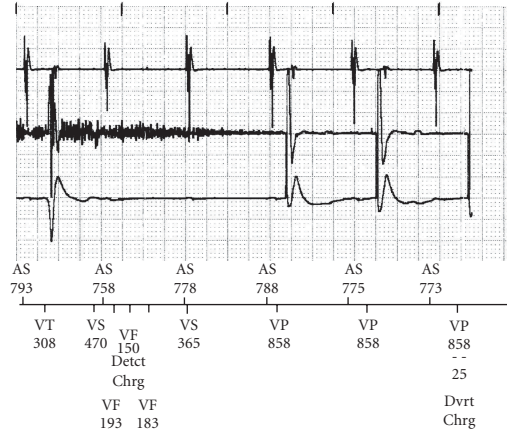
(b)

EGM previo al intento (máx 10 seg)
 Detección inicial Zona FV
 Frec. A media pre-intento 78 min⁻¹
 Frec. V media pre-intento 214 min⁻¹
