Stability evaluation of modernized bank protections in a culvert construction

Mariusz Cholewa^{1*}, Karol Plesiński¹, Katarzyna Kamińska¹ and Izabela Wójcik¹

Abstract. The paper presents stability evaluation of the banks of the Wilga River on a chosen stretch in Koźmice Wielkie, Małopolska Province. The examined stretch included the river bed upstream from the culvert on a district road. The culvert construction, built over four decades ago, was disassembled in 2014. The former construction, two pipes that were 1.4 m in diameter, was entirely removed. The investor decided to build a new construction in the form of insitu poured reinforced concrete with a 4 x 2 m cross section. Change of geometry and different location in relation to the river current caused increase in the flow velocity and, as a consequence, erosion of both protected and natural banks. Groundwater conditions were determined based on the geotechnical tests that were carried out on soil samples taken from the banks and the river bed. Stability calculations of natural slopes of the Wilga River and the ones protected with riprap indicate mistakes in the design project concerning construction of the river banks. The

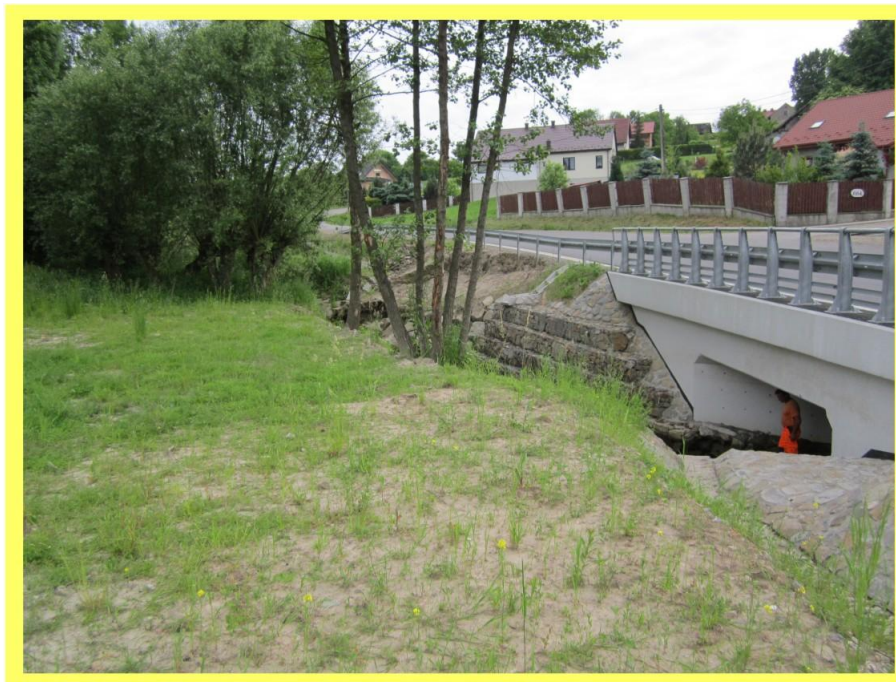
Fig. 3. Culvert on the upstream side and the view of damages

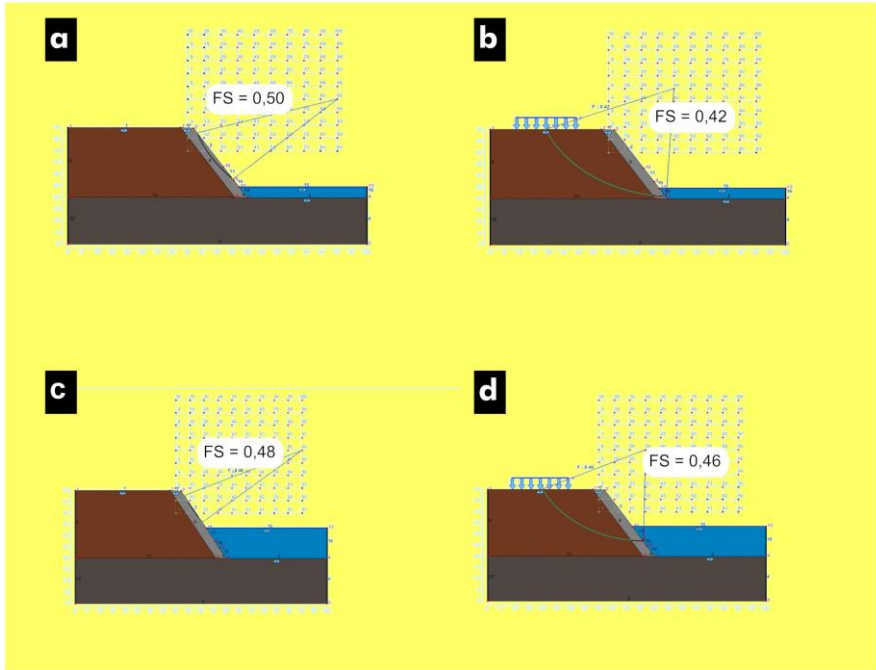
Fig. 6 Calculation scheme for the first model – at low water level a) without any load, b) vertical load of 1000 kN. Calculation scheme for the second model – at high water level c) without any load, d) vertical load of 1000 kN

Scheme presented in Fig. 6a shows the results of calculations at low water level – parameters of the soil (Tab. 1) and geometry of the slope resulted in the value of the global stability factor of safety at 0.50.

Apart from total saturation of the slope, the scheme in Fig. 6b assumes that there is a heavy transport vehicle on the top of the road, which was presented on the scheme as vertical load of 1000 kN. The factor of safety is 0.42. Failure surface goes deeply into the road.

When the water level is high (Fig. 6 c,d) the values of the factor of safety do not differ significantly from the first model. Adequately it was 0.48 for the road without any load and 0.46 when there is a surface load of 1000 kN.

All obtained results of the factor of safety are below the limit value of 1.0 (Tab. 2). When the water level is low it undermines the base of the slope and at the same time the water filtrates through the ground from the opposite side of the road embankment. During the low and medium flow, in the hole scour, the average values of velocity at measurement points were in range from $V = 0,210$ m/s to $V = 0,333$ m/s. The maximum values at vertical measurements points were equal from $V = 0,223$ m/s to $V = 0,370$ m/s. Then, the values measured above the river bed were in range from $V = 0,060$ m/s to $V = 0,32$ m/s. The river bed is a natural drainage element for the adjacent area, so water supply to the river banks has to be taken into consideration [8, 9, 10]. When the water level is high the hydraulic pressure is compensated by the water pressure. Although another unfavourable phenomenon connected with water uplift pressure occurs (decrease in the value of density in the calculation scheme) [11, 12, 13]. It should also be noticed that high current velocity washes out and lifts the soil material.
